**CITY OF VAUGHAN
HERITAGE VAUGHAN COMMITTEE
AGENDA**

Heritage Vaughan Committee Report

TITLE: REDEVELOPMENT OF HERITAGE PROPERTY AND NEW INFILL DEVELOPMENT LOCATED AT 2291 MAJOR MACKENZIE DRIVE, MAPLE HERITAGE CONSERVATION DISTRICT (REFERRED)

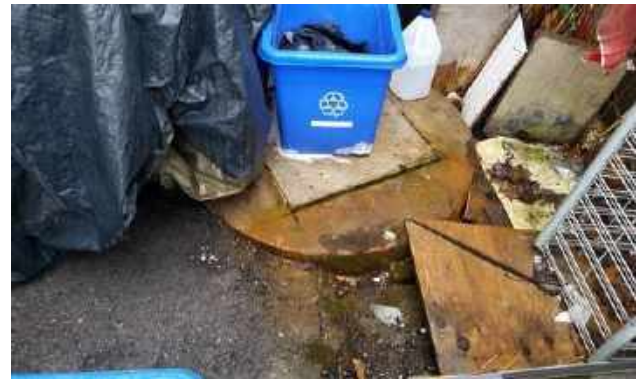
Debris noted in east side yard. Old / unused septic catch basin also noted)

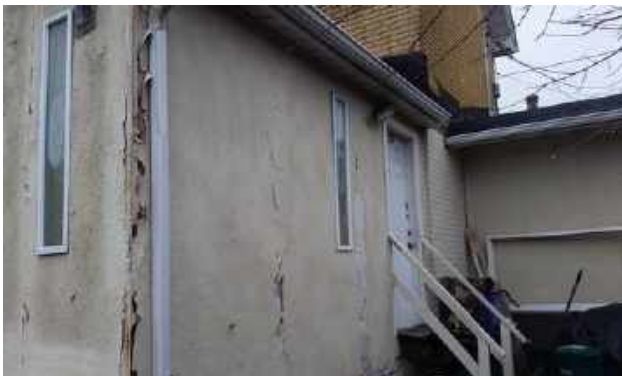
The dwelling includes an enclosed porch on the east side of the dwelling that is a wood frame structure covered with OSB that has a stucco finish applied to it. The foundation for this structure was not visible as the exterior wall finish extends to grade level and likely below. However, this structure was noted in a poor state of repair at the time of inspection.

The condition of the exterior wall suggests that moisture has penetrated underneath the sheathing / stucco causing water related damage. The finish is peeling off and mould has formed on the surface.

Also noted were issues related to roof flashing which is not installed in a workmanlike manner and as such its condition is likely contributing to the issue of moisture penetration into the walls.

Porch enclosure, east side yard

The only way to repair this structure is to remove the damaged exterior finish, evaluate the underlying wood structure, repair / replace any deteriorated components and then replace the sheathing and finish materials. In addition, doing so will likely require a mould remediation effort. Consultation with a qualified contractor specializing in mould remediation and restoration is required.

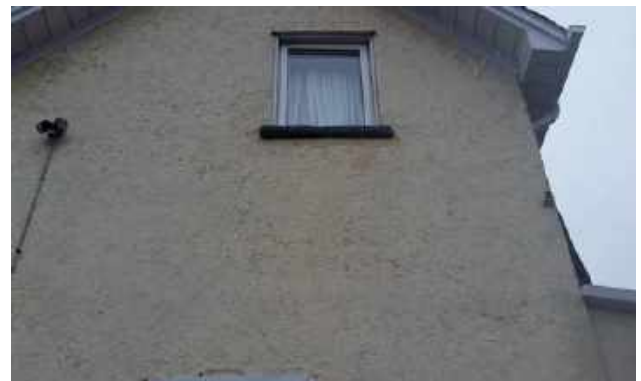
Rear stucco wall. Discoloration, especially under window sills noted.

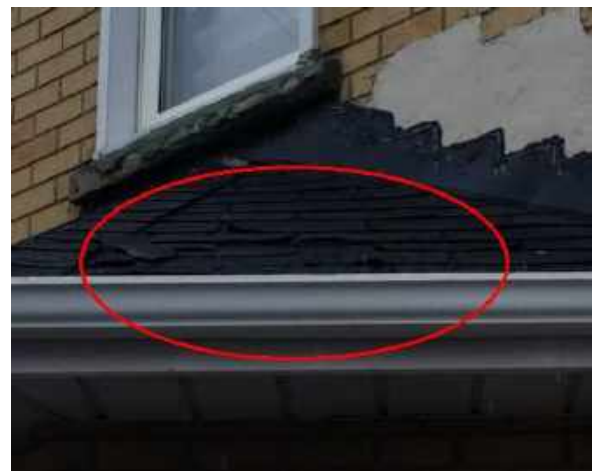
Some shingles deterioration noted in places. Likely due to moisture penetration.

The owner is advised to budget to replace the roof covering on lower roof planes within the next 3 - 5 years
based on the anticipated life cycle. Replacement of the covering should include evaluation of roof sheathing
(and replacement as required) which may have sustained damage in areas reliant on wall flashing to
maintain water tightness. Consult with a qualified roofing contractor.

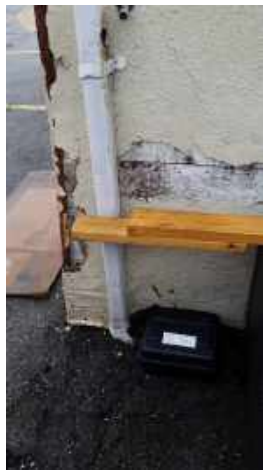
Downspout noted as extending into below grade drain pipe

Consult with a drain contractor to scope and determine the discharge point for the downspouts so as to ensure they are functional and result in removal of water away from the dwelling.

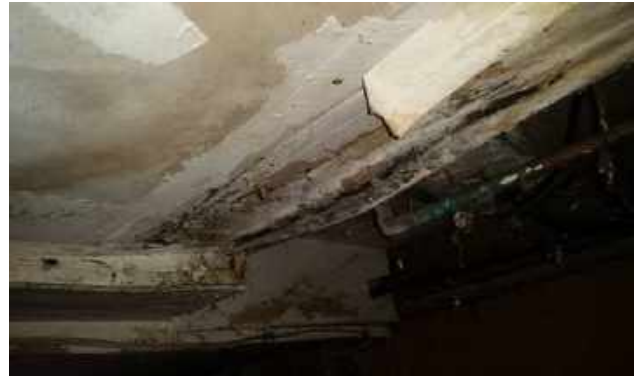
Drywall on basement ceiling is damaged by moisture. Mould growth also visible.

Removal of all drywall as part of the required mould remediation.
Consultation with a mould remediation contractor and then a professional engineer / designer to evaluate the condition of the wood floor structure in addressing any structural damage / alterations in place intended to modify the original structure.

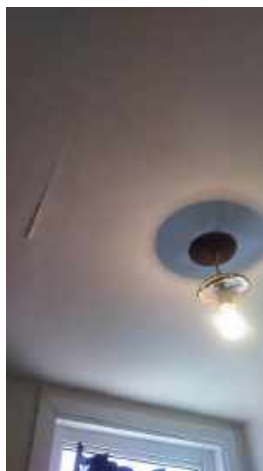
Light fixture with missing cover

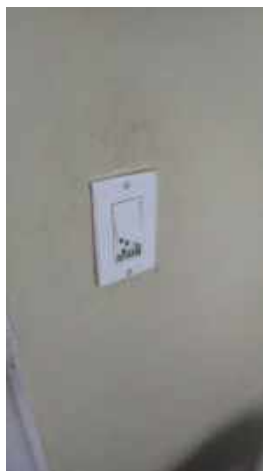
Broken bedroom light switch

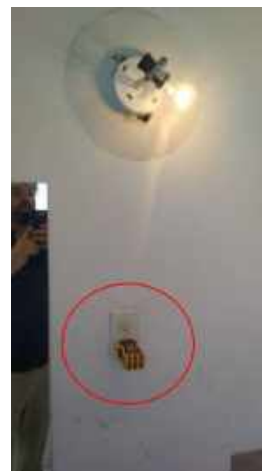
Inoperative outlet (also exposed bulb above)

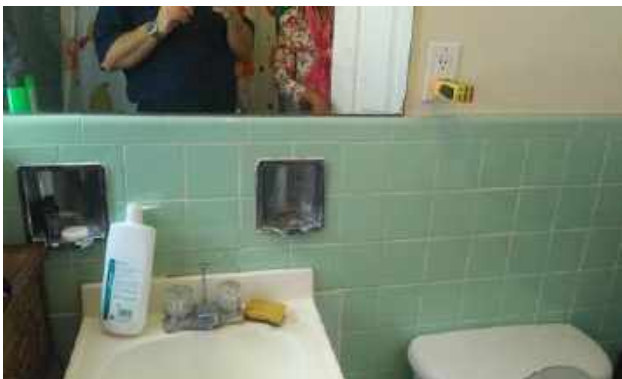
Non GFCI outlet (also open ground condition noted)

For improved safety replace outlets / circuit breaker serving electrical outlets near bathroom sinks with GFCI type. Consult with a qualified electrician as required.

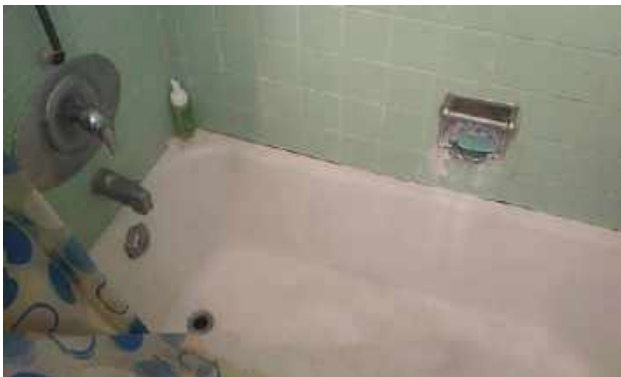
Main floor bathroom tub is old / worn

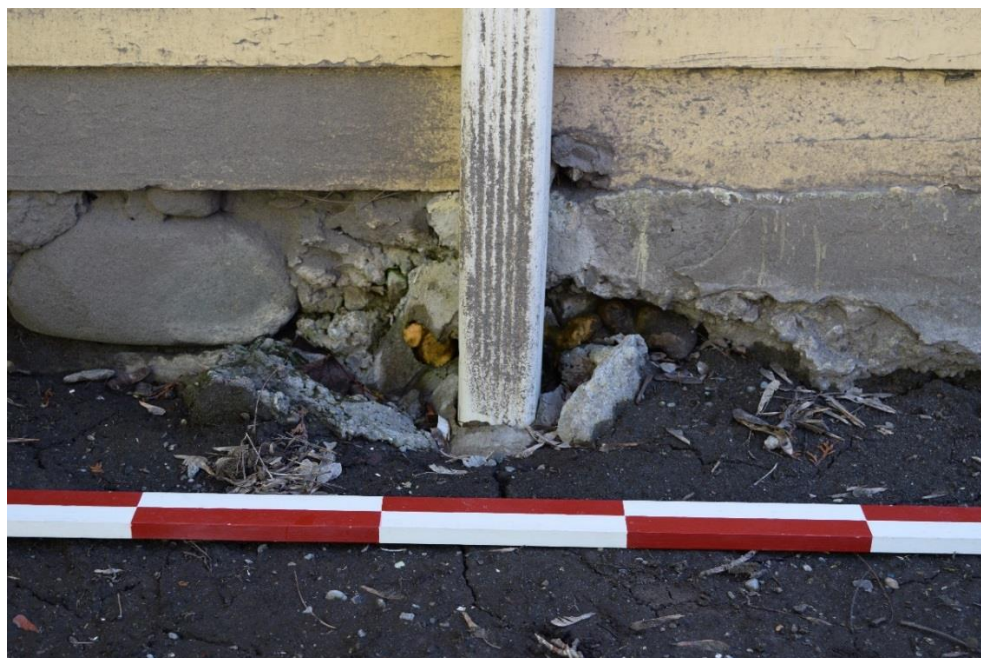
Figure 46: Mortar and concrete damage on the north foundation wall at a downspout location.
