46 CENTRE STREET, VAUGHAN CONSERVATION PLAN

PREPARED FOR
DAVID GRANT-RUBASH
PHAEDRUS STUDIO

REV. II - FINAL

SEPTEMBER 17, 2021

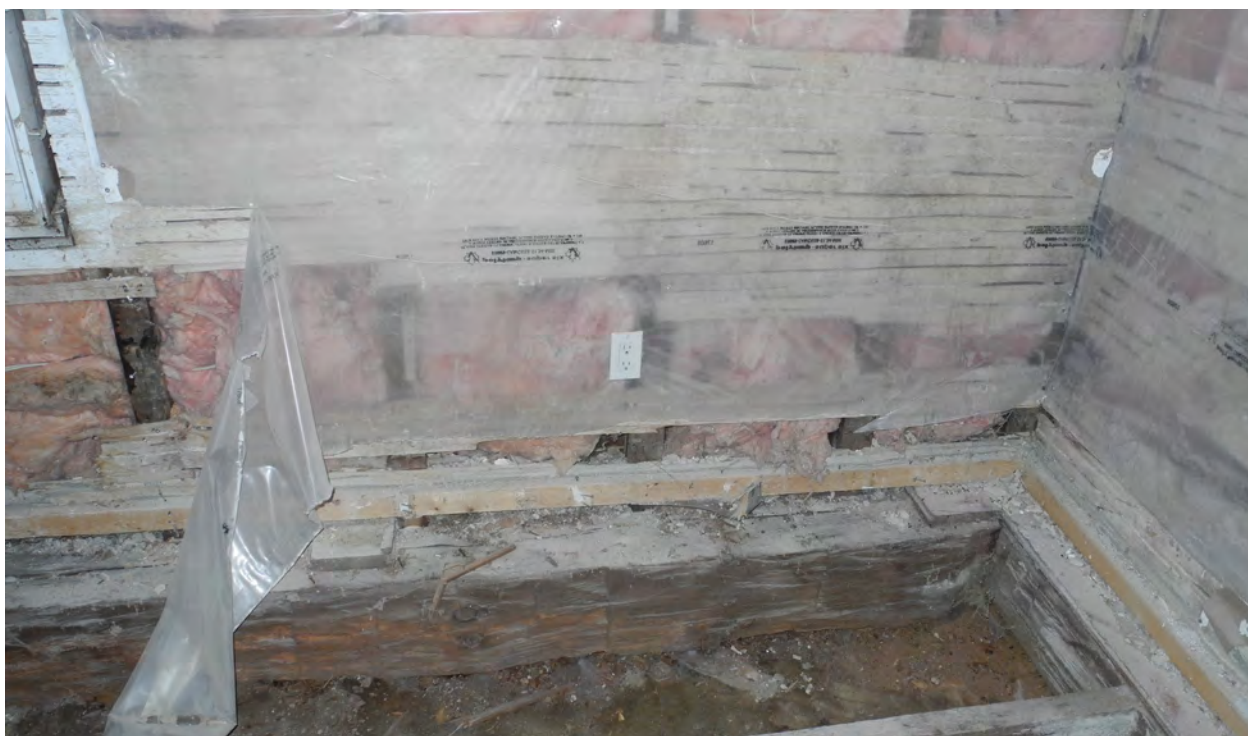
The main house walls are framed into a heavy timber sole plate set directly on soil a few inches below grade. There is no separate foundation, except on a portion of the north wall, where the brick wall of the partial basement under one of the additions underlies the timber sole plate.

Figure 6: South end of the Main House's east wall, showing sill plates set directly on the soil (CBCollective, 2020).

- The existing foundation consists of a heavy timber sole plate resting directly on soil a few inches below grade. While the timber sill has performed well for approximately 180 years, it is now severely deteriorated and has failed structurally in some locations. It is not considered practical to replace the existing timber with new material resting directly on grade. Instead, a poured concrete foundation wall extending below the frost line will be installed.

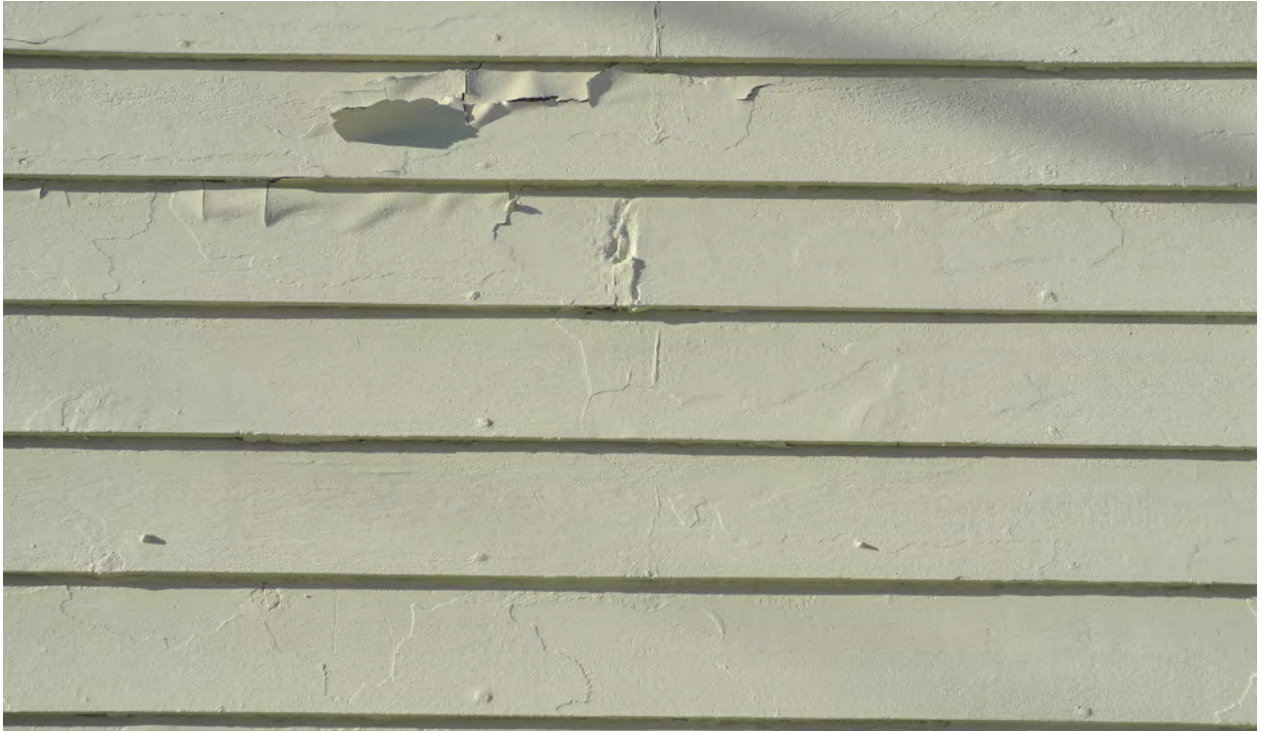
Wall cladding consists of painted clapboard siding affixed with machine cut wrought iron nails. The lowest three courses have been replaced with an aluminum siding of similar dimensions and finish to the wood. Exterior corners are finished with corner boards featuring a bead at the corner itself. Replacement material appears to have been used at the exposed portion of the main house's north elevation (metal or vinyl) and at the gable end of the tail addition. The siding is in worn but fair condition overall. Paint failure is found throughout, in some cases revealing older finishes below (Figure 13). The wood is weathered but sound where exposed with relatively little cracking or rot observed. A section of unrepaired nail holes with associated paint failure is found above the front door of the main house, likely related to previous signage. There is extensive splitting and cracking of board ends related to nails, typically near the outside corners and adjacent to windows (Figure 14). Numerous services penetrate or are mounted on the siding; in some cases penetrations are unsealed, likely resulting in water penetration.

Figure 7: Detail of typical cladding, with nails, paint failure, and previous paint visible (CBCollective, 2020).

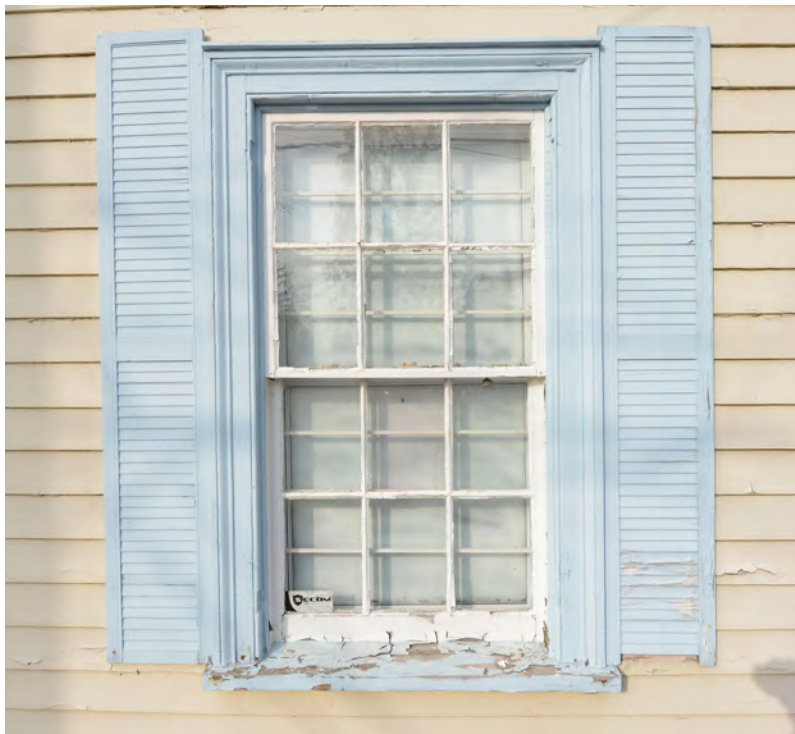
Figure 8: East window on the Main House's north elevation, showing typical configuration, casings, sill and shutters. Hinge mortises from earlier functional shutters can be seen on the inside of the left casing (Michael Scott Architect, 2020).

Shutters: the existing shutters are not original, in poor condition, and are not functional. The presence of hinge mortises on the casings of the south-facing windows suggests that functional shutters were previously fitted to these windows. Existing shutters will be removed and replaced with new functional shutters fabricated to match historic examples.

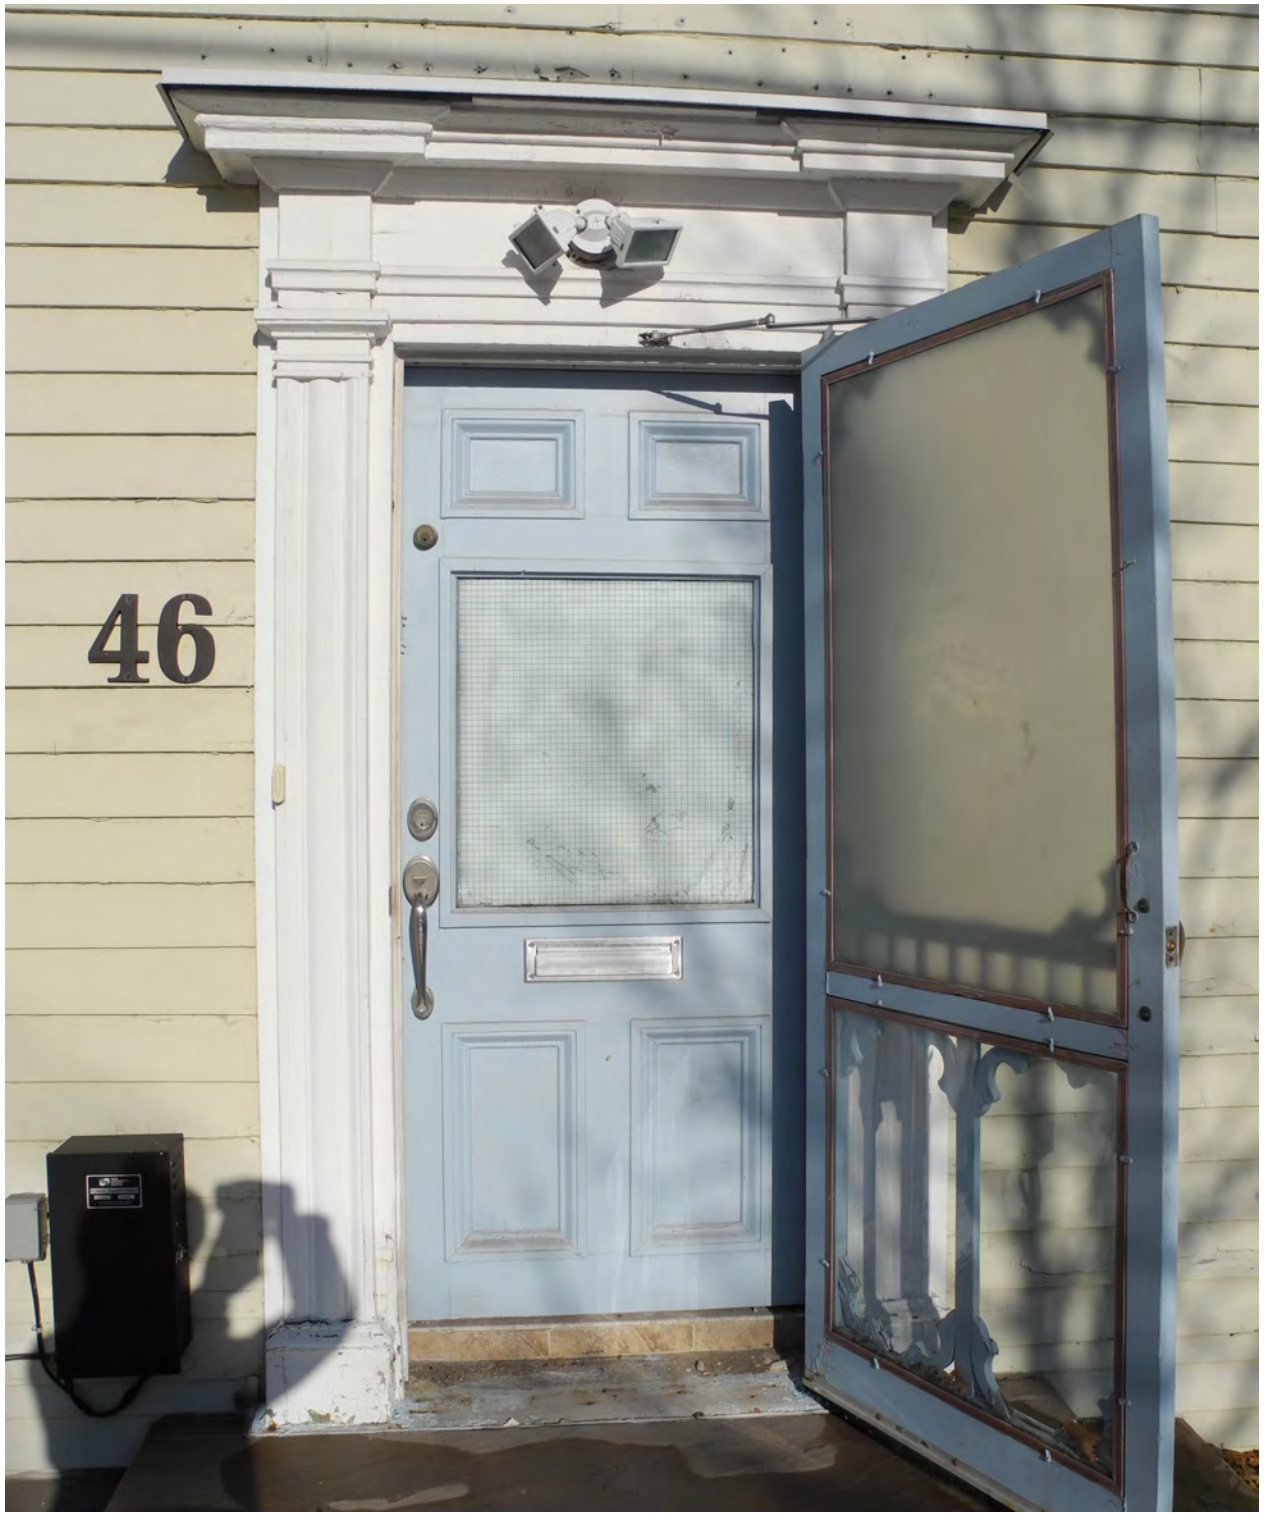
The modified panel door is in good condition, displaying minor paint failure/cracking at horizontal surfaces and joints. Door surround is in fair to good condition. Integrity of the assembly is very high, with only a small band missing material atop the west pilaster. Minor paint failure throughout, with the bases where the pilasters contact the sill displaying more paint failure and a small degree of rot (Figure 24). An inappropriate light fixture penetrates the centre of the frieze, and the flashing over the cornice does not respond to the undulations of the profile, harming the overall effect (Figure 25). The door sill is in poor condition, being highly worn from total finish failure and environmental exposure.

Figure 9: Main House front door showing modified panel door and screen door set within classical surround (*Michael Scott Architect, 2020*).

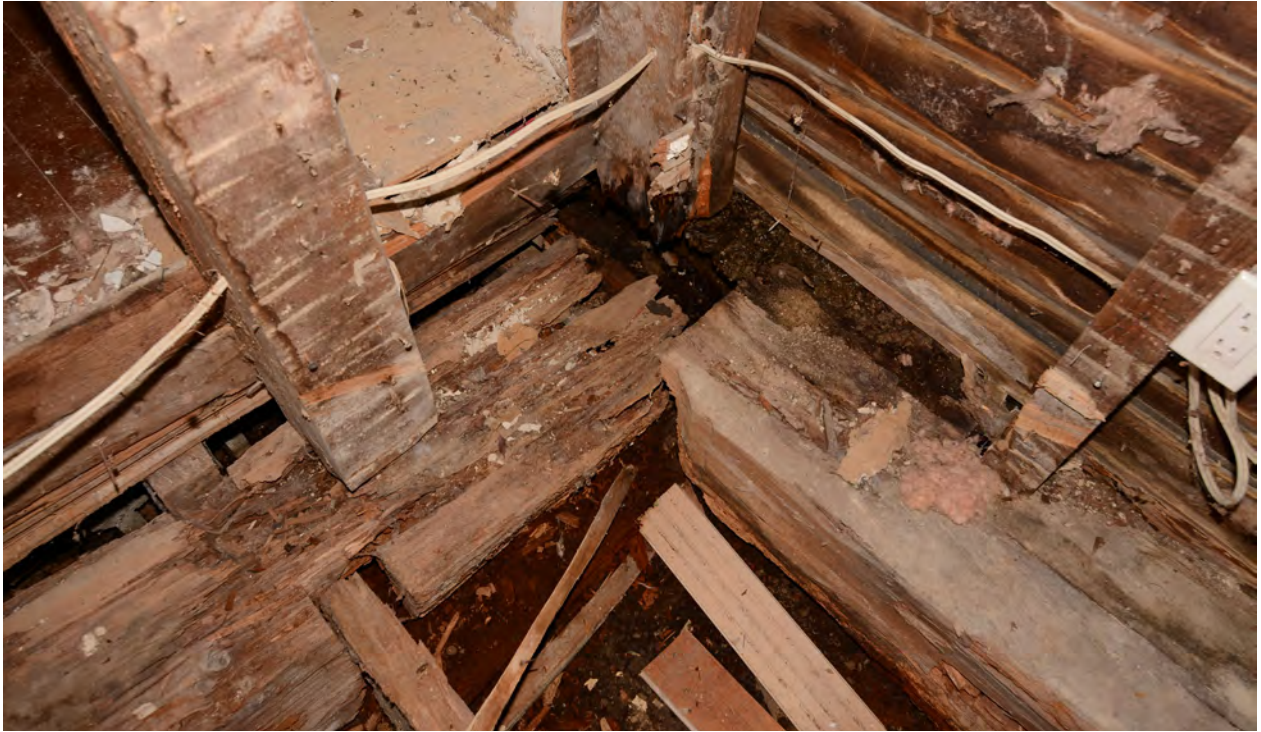
The timber sole plate and other framing shows evidence of decay to a greater or lesser extent in all locations where it is exposed for review. A substantial portion of the timber at the north-east corner is heavily decayed, resulting in complete loss of structural integrity and dropping of the building framing above by several inches (Figure 10). The decay and resulting settlement has evidently been a longstanding problem, as interior evidence shows that the floor had previously been leveled by the addition of a tapered finish. Significant water penetration under the wall is visible in the area (exacerbated at the time of review by a disconnected downspout) and this has presumably resulted in accelerated decay of the timber.

Figure 10: Detail of heavily decayed sill plate at north-east corner of Main House. Deterioration has caused sill plates to separate from each other as well as vertical posts, and drop several inches (*Michael Scott Architect, 2020*).

- The existing timber sole plates will be removed and replaced with a new dimension lumber sole plate supported on the new concrete foundation. It is anticipated that the bottom ends of the existing timber posts will be slightly trimmed to ensure that all remaining material is in good condition and the new sole plate installed a few inches above the level of the existing timber.

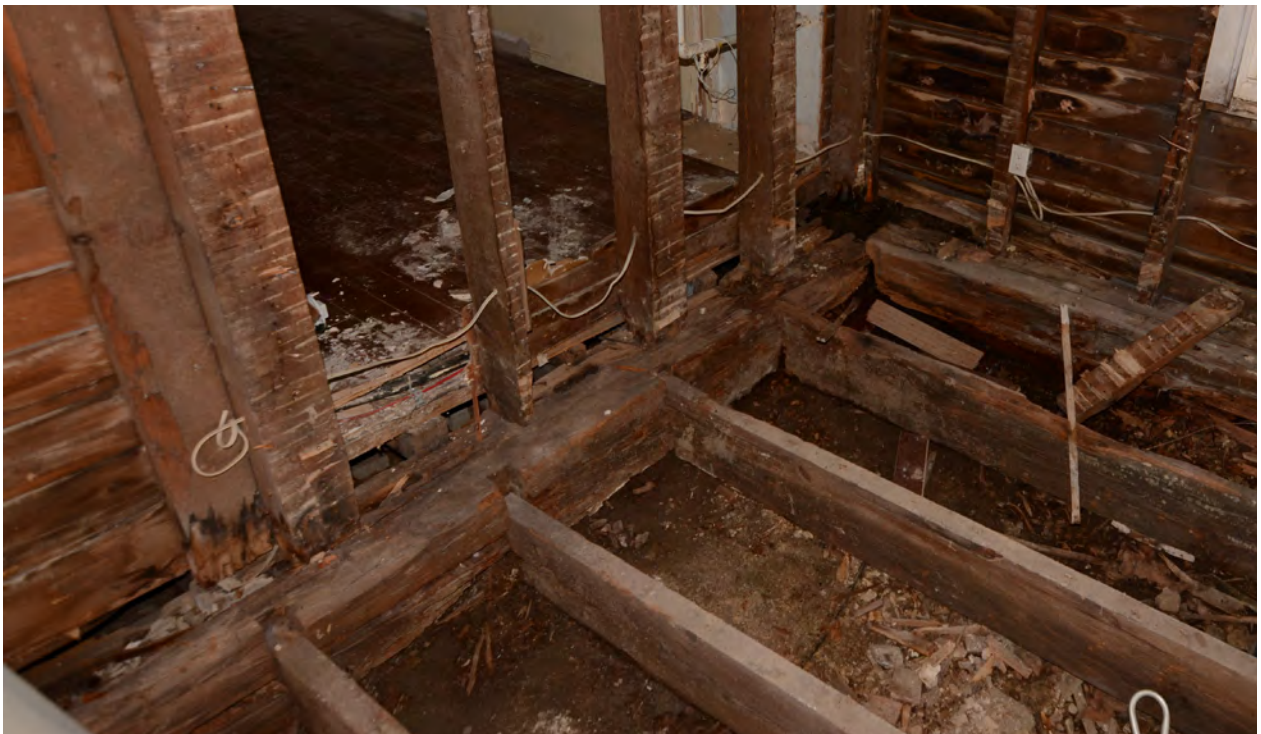
Figure 11: Detail of Main House's north wall, showing floor joists and posts mortised directly into the sill plates (*Michael Scott Architect, 2020*).

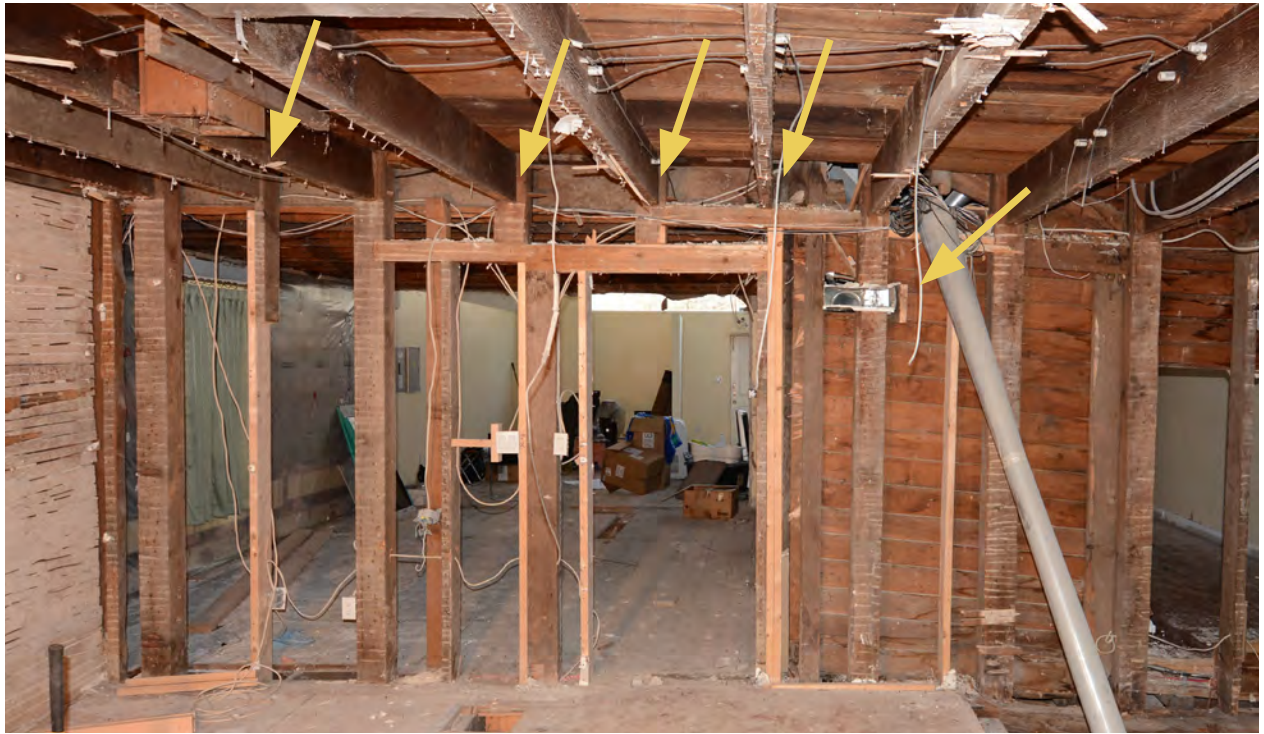
- There have been several alterations to the posts on the north wall to accommodate openings in the wall; these were carried out without regard to the structural integrity of the timber frame. There are some partial repairs in modern lumber, but the framing in this area requires further review for structural integrity (Figure 12).
- The bases of a number of wall posts in the north-east corner are heavily decayed, and in some cases are no longer attached to the sole plate.
- As a result of the decay in the north-east corner that portion of the house has dropped several inches

Figure 12: Photograph of Main House's north wall showing numerous and significant modifications to the original framing system. Yellow arrows indicate original posts that have been modified or severed (*Michael Scott Architect, 2020*).

- Some timber posts are in poor condition at their lower ends and will require repair by splicing on or sistering of new or salvaged material.
- An entirely new ground floor assembly (new joists and subfloor) will be installed.

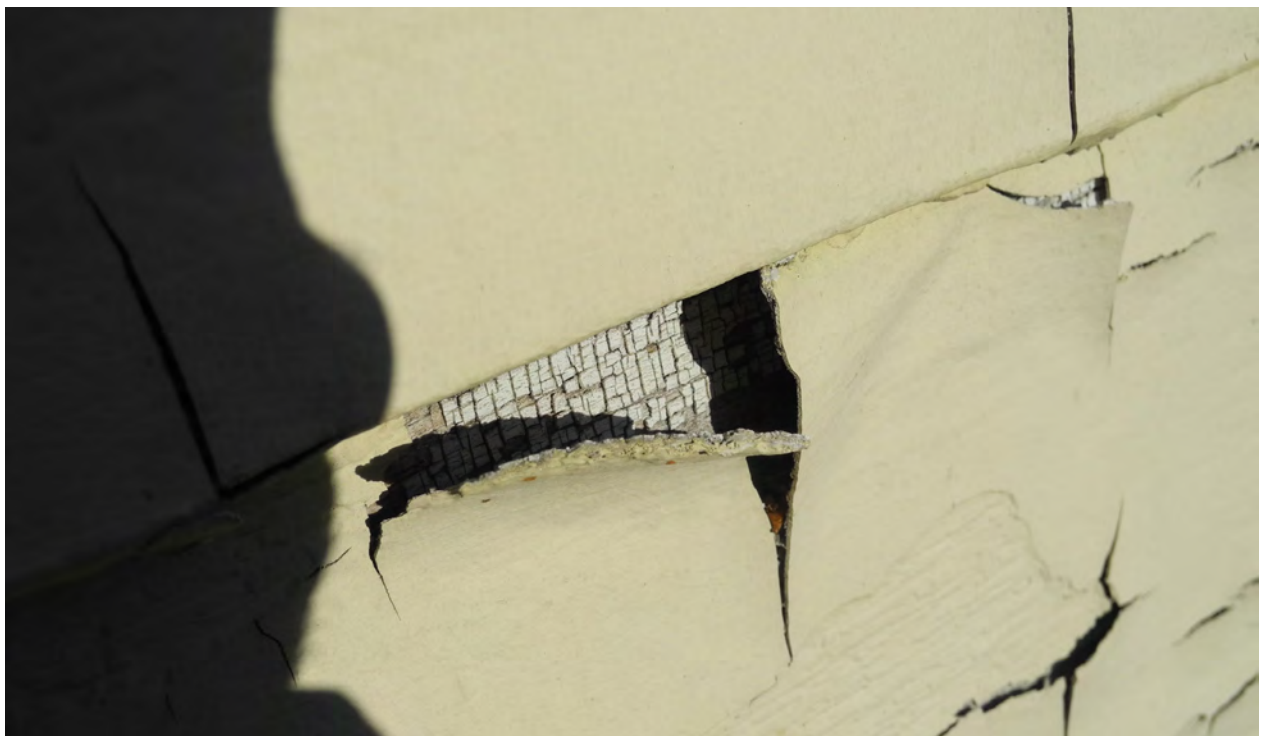
Figure 13: Detail of cladding, showing advanced paint failure revealing revealing earlier finishes beneath (*CBCollective, 2020*).

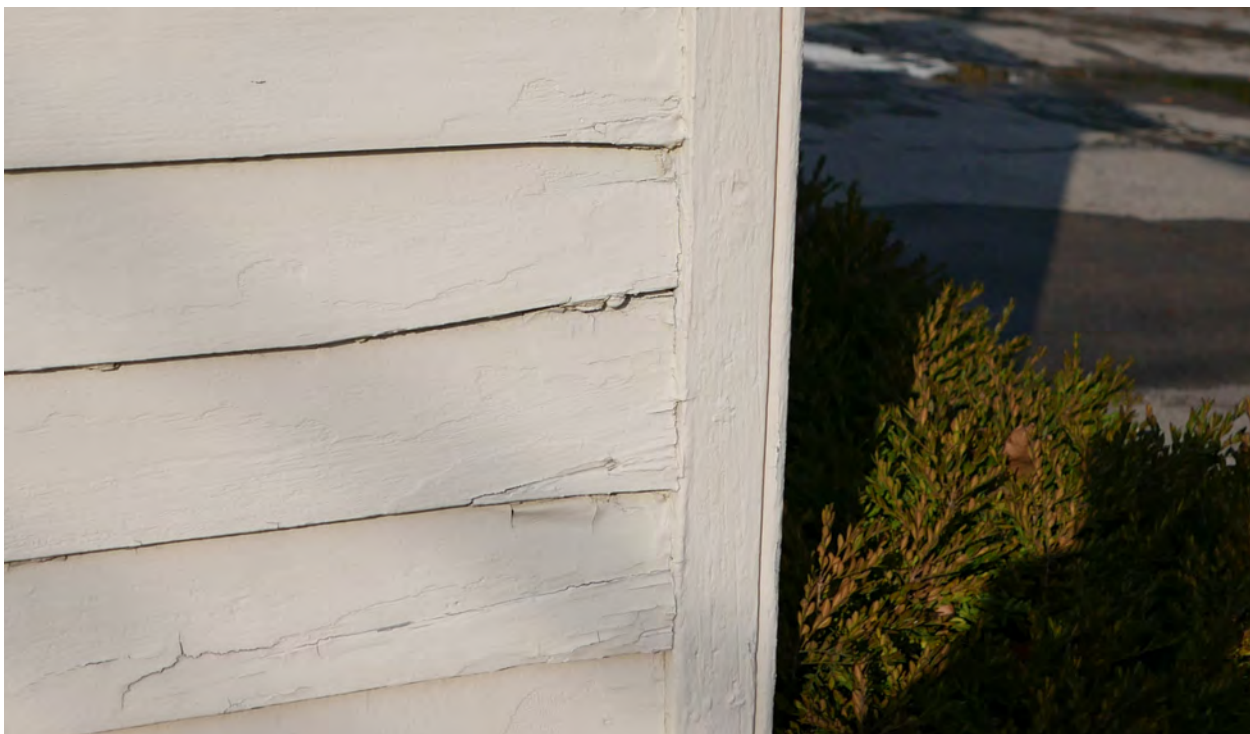
Figure 14: Detail of Main House's south-east corner, showing cracked cladding related to nail locations (CBCollective, 2020).

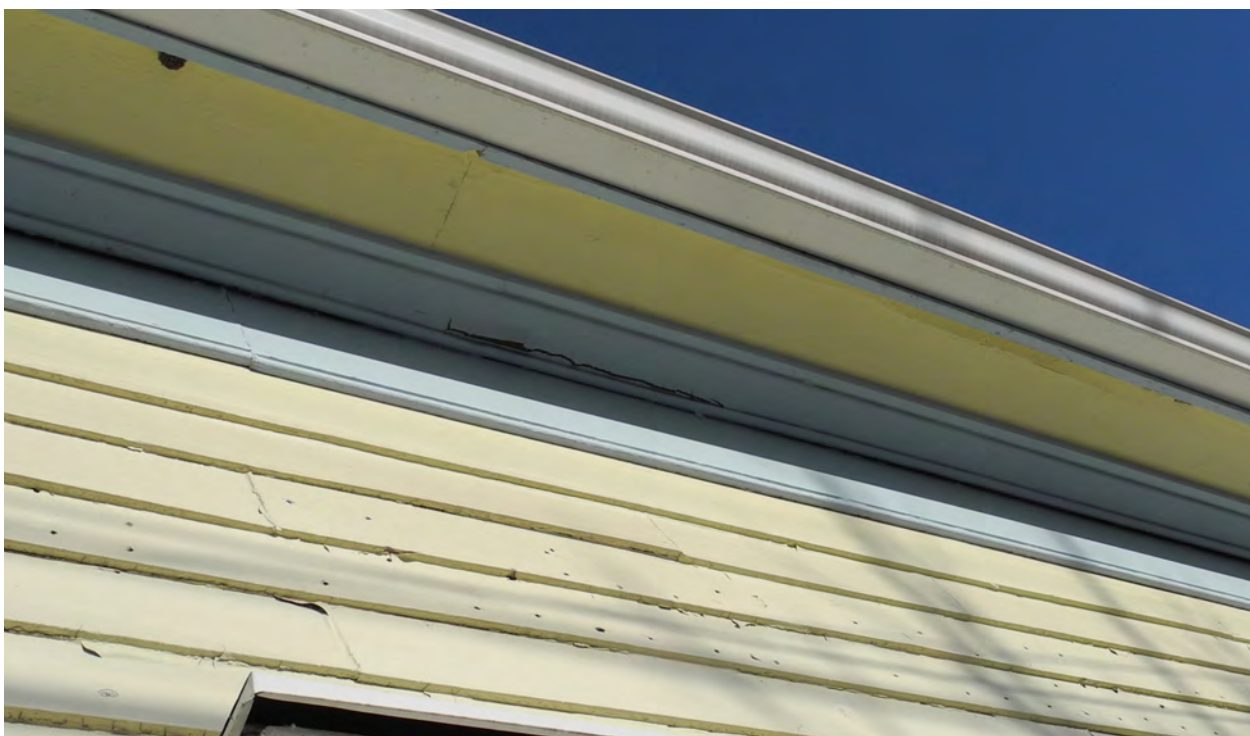
Trim at the top of the walls beneath the flat eaves consists of an ogee and beaded frieze board. On the gable ends the trim is a simple beaded board painted to match the siding. The trim is in fair condition overall. Light to moderate paint failure observed throughout, while wood generally appears sound (Figure 15). Open joints and minor misalignments throughout are commensurate with the age of the building.

Figure 15: Detail of frieze board and mouldings above front door, showing good overall condition with paint failure (CBCollective, 2020).

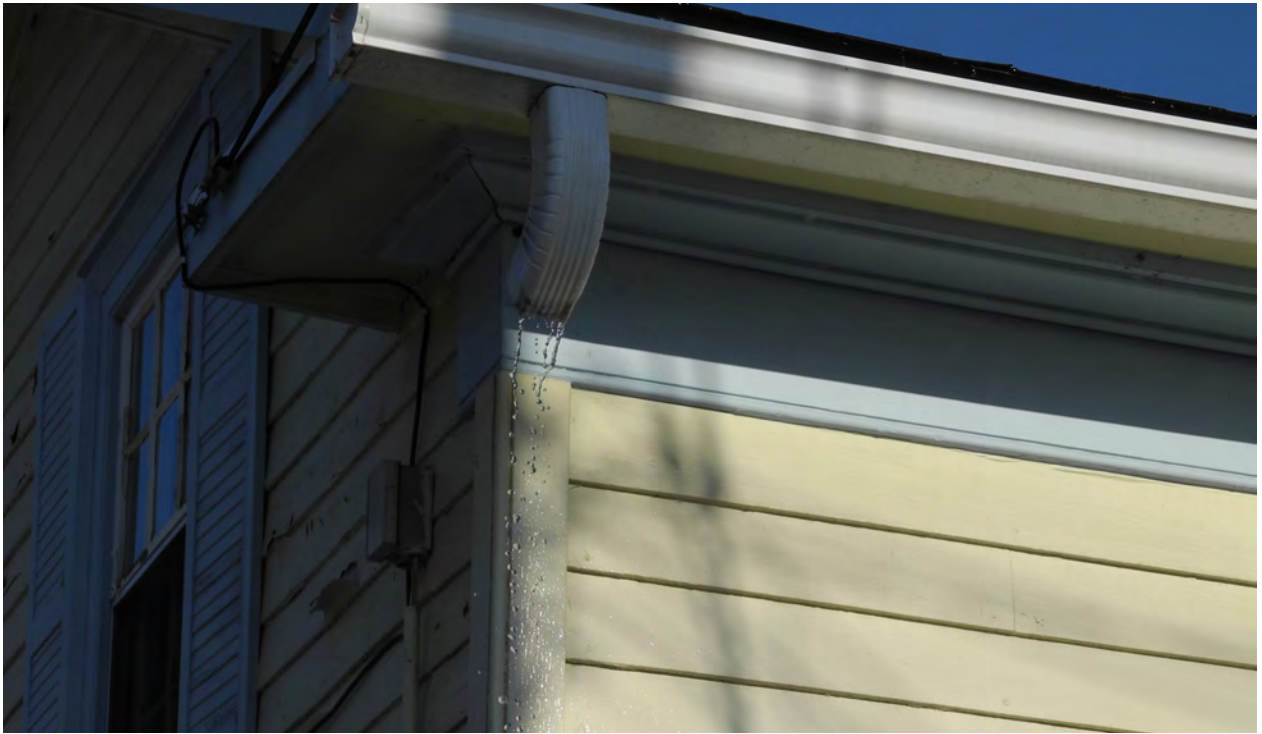
Modern aluminum eavestrough and downspouts are in fair condition where present. The front eavestrough is not properly secured, and both downspouts serving the Main House are improperly terminated and discharging water onto the siding (Figure 16).

Figure 16: Eaves and disconnected downspout at south-west corner of Main House, showing water discharging directly onto the cladding (CBCollective, 2020).

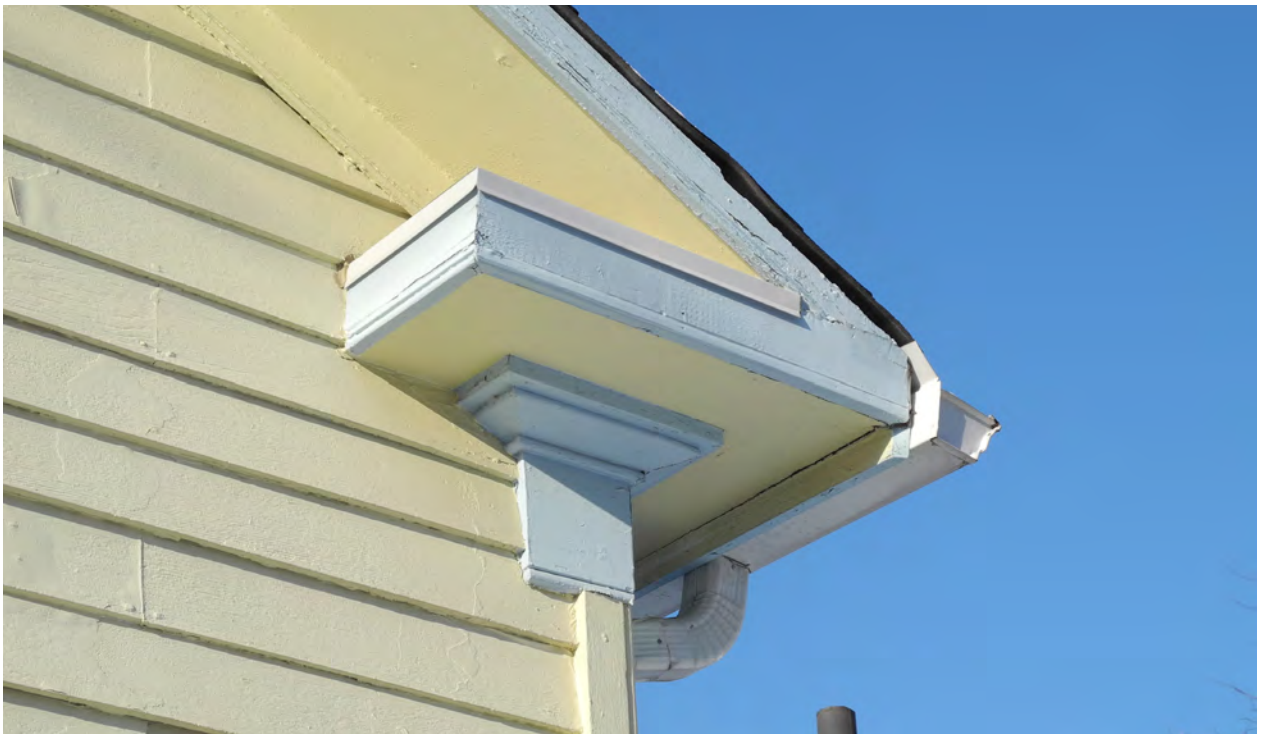
Wood fascia is used throughout both the Main House and tail addition. The fascia is a mix of unadorned dimensioned lumber and (presumably historic) fascia boards embellished with a bead profile. Fascia boards are in fair to poor condition. Paint failure was observed throughout, with decay and warped wood apparent in many cases as well (Figure 17). Boards displaying historic detailing are generally in poorer condition.

Figure 17: Detail of fascia and soffit at north-east gable return. The historic fascia board is deteriorated, and that of the return is poorly detailed. Note the oversized fascia board on the north elevation (CBCollective, 2020).

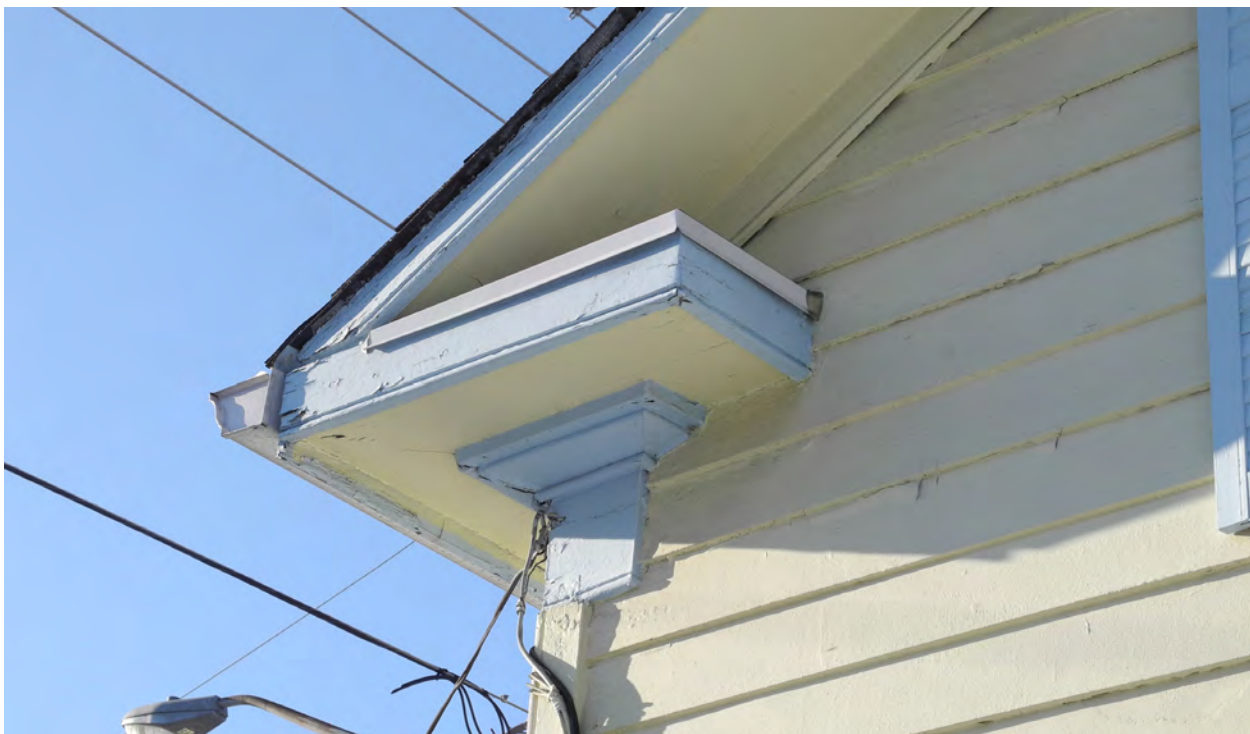
The soffit is finished in dimensioned lumber, in fair condition, displaying a moderate amount of paint failure throughout. Wood beneath is weathered, but not compromised to the degree of the fascia boards (Figure 18).

Figure 18: Detail of fascia and soffit at south-east gable return. Soffit boards are in good shape overall and display paint failure. Oversized fascia boards are apparent on the south elevation (CBCollective, 2020).

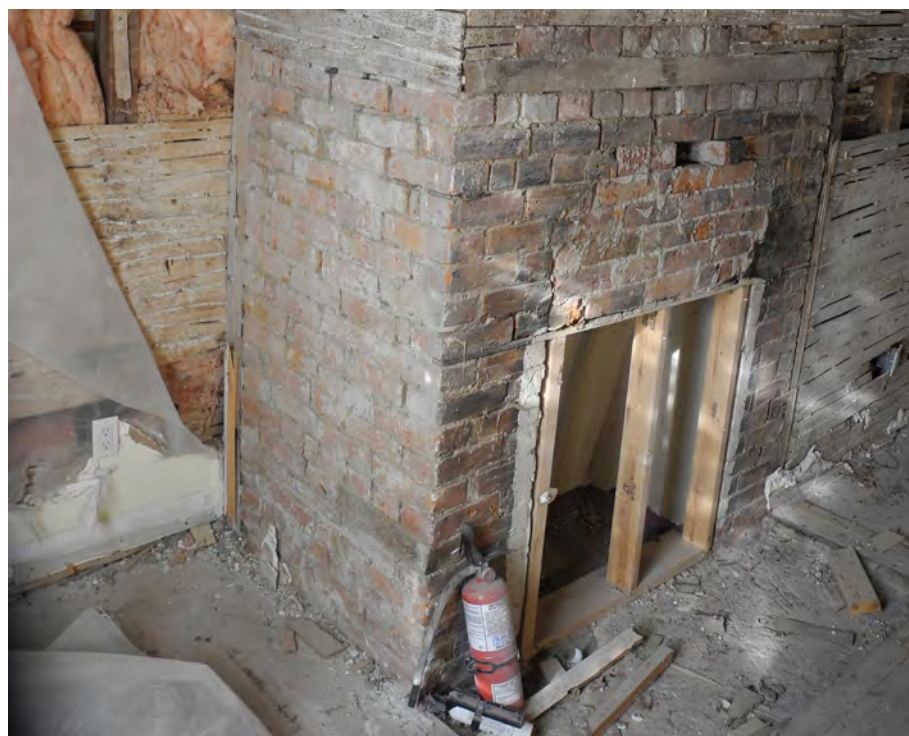
Masonry on the building is limited to the chimney and fireplace. The chimney runs completely inside the wood frame building and is not exposed on the side of the building except above the roof line (Figure 19). Where exposed on the interior the masonry appears to be original and in sound condition. The portion above the roof has been reconstructed in modern brick and appears to be in good condition. The metal chimney cap is oversized and visually unappealing (Figure 20).

Figure 19: Masonry chimney structure, built entirely within the timber structure of the Main House (CBCollective, 2020).

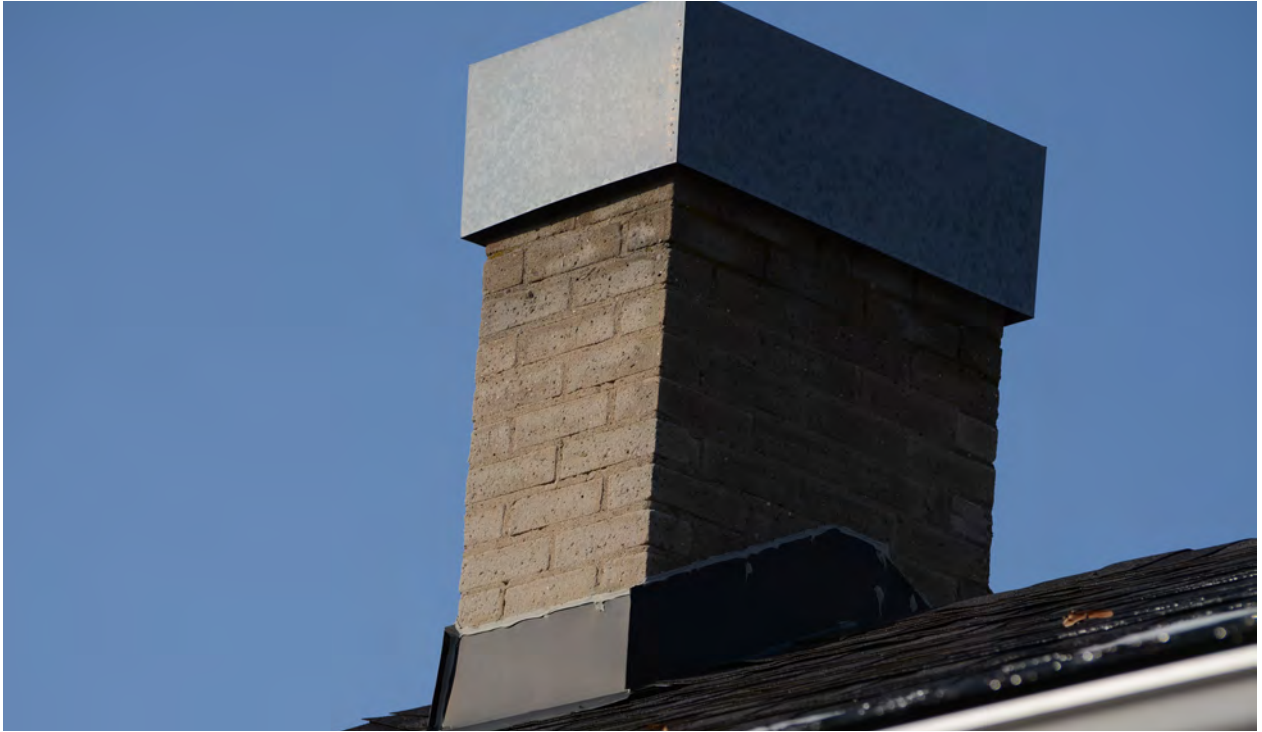
Figure 20: Detail of exterior chimney showing masonry, galvanized cap, and flashings all in good condition (*Michael Scott Architect, 2020*).

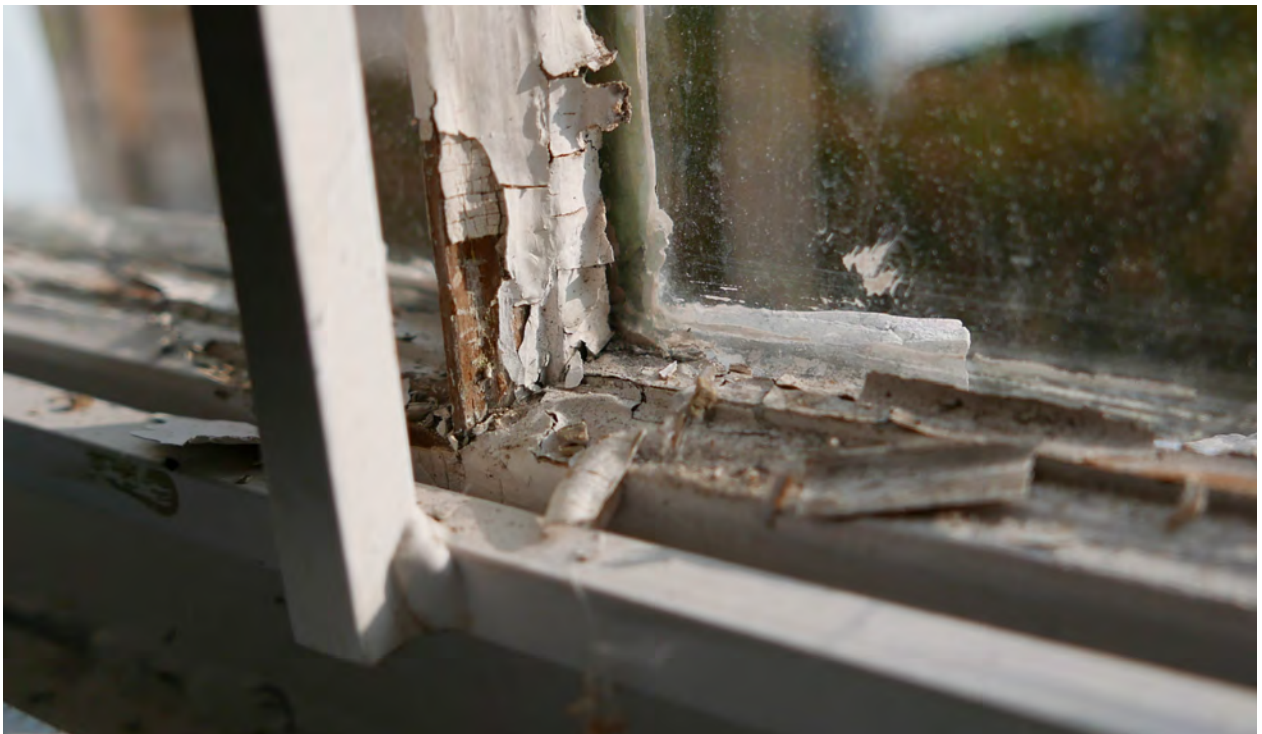
Historic window sashes are in fair condition overall. Paint failure is common throughout, with cracking exposing bare wood in isolated areas (Figure 21). Integrity of rails and stiles is generally sound. Muntin bars are in fair shape, with some damage to interior profiles, and the odd tenon missing or damaged (Figure 22). Putty failure common throughout. There are several instances of cracked glass at second storey windows.

Figure 21: Detail of south-east window, showing paint failure where the muntin bar is mortised into the rail. The wood is in good condition at this location, and older crazed finishes are visible (*CBCollective, 2020*).

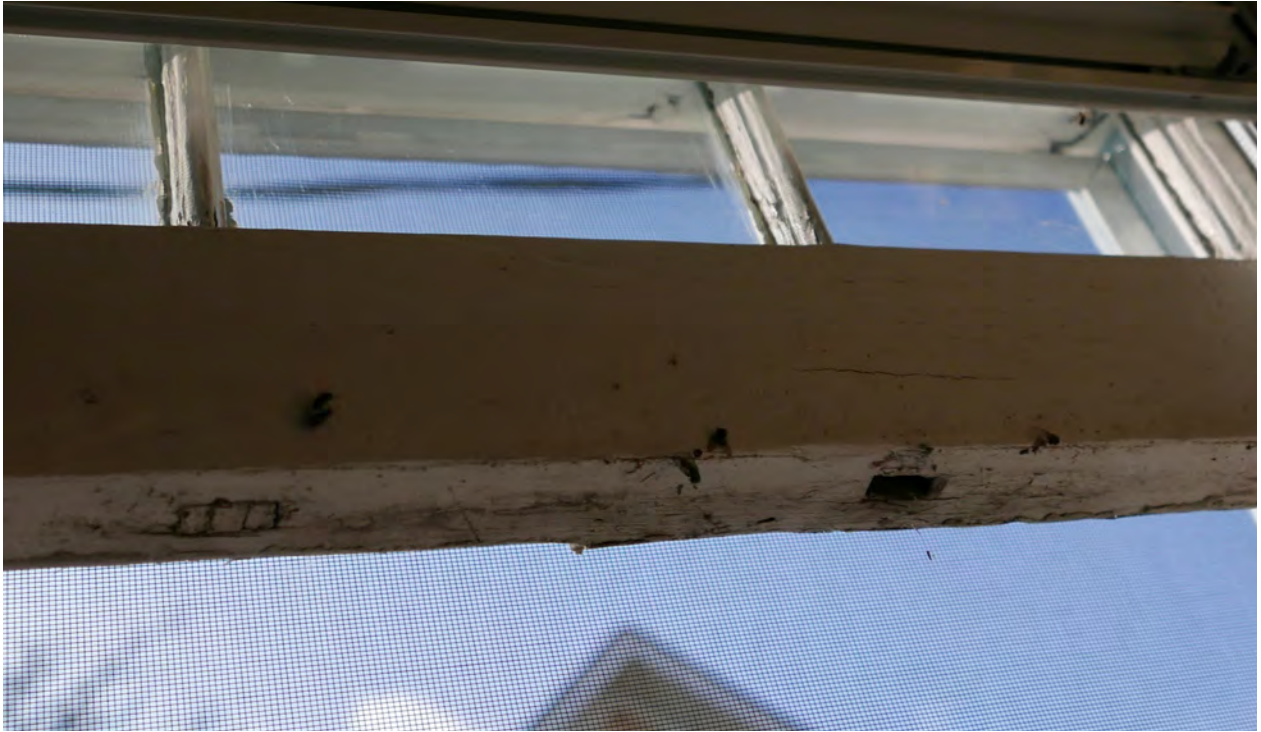
Figure 22: Detail of the bottom rail on the west elevation's south window. The muntin bar's wedge-tenon has broken off and is missing. Sash is still structurally sound but should be repaired (*CBCollective, 2020*).

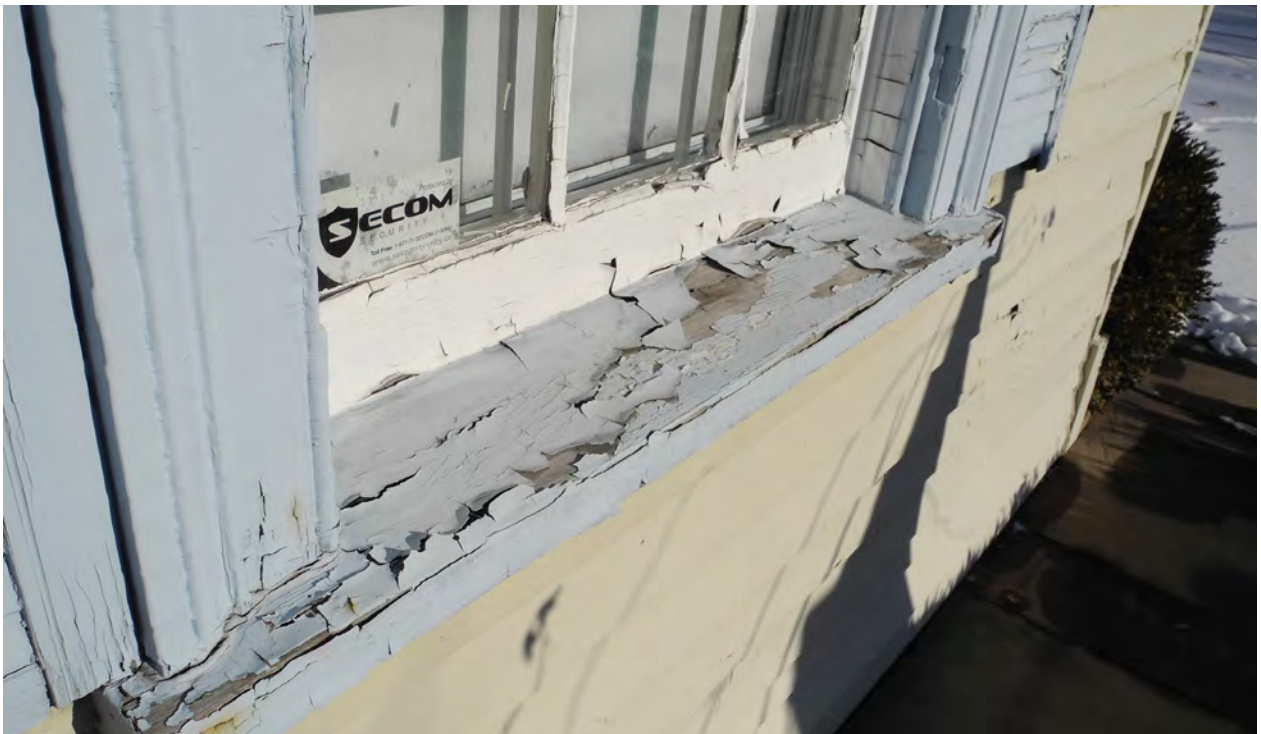
Sills are in fair to poor condition, though not beyond repair. Paint failure on sills is common revealing previous finishes and bare wood. Light paint failure found throughout surrounds, which worsens at butt connection with sill (Figure 23). Shutters are not historic; they range in condition from good to poor on an individual basis.

Figure 23: Detail of severe paint failure on sills, and at the bottom of the casings. Note mortises for earlier functional shutters on the far casing (*CBCollective, 2020*).

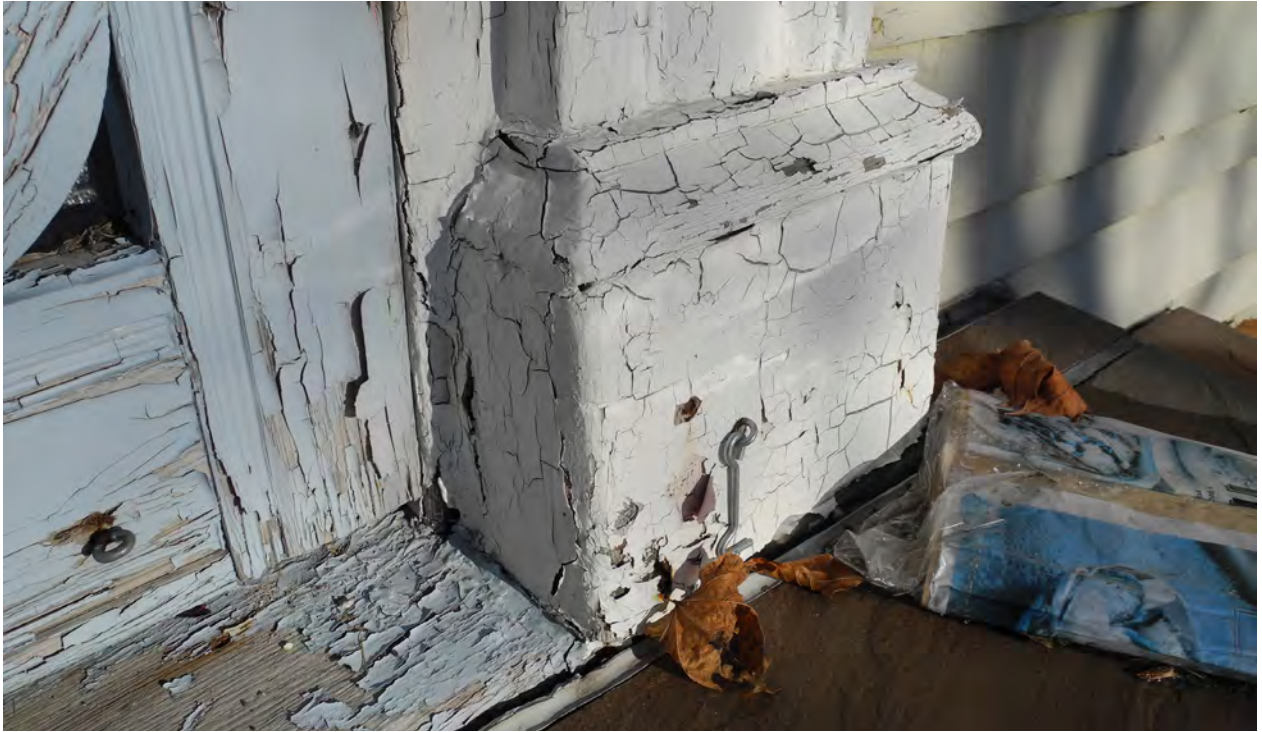
Figure 24: Door surrounds are in good shape overall, with paint failure most pronounced at the pilaster bases (CBCollective, 2020).

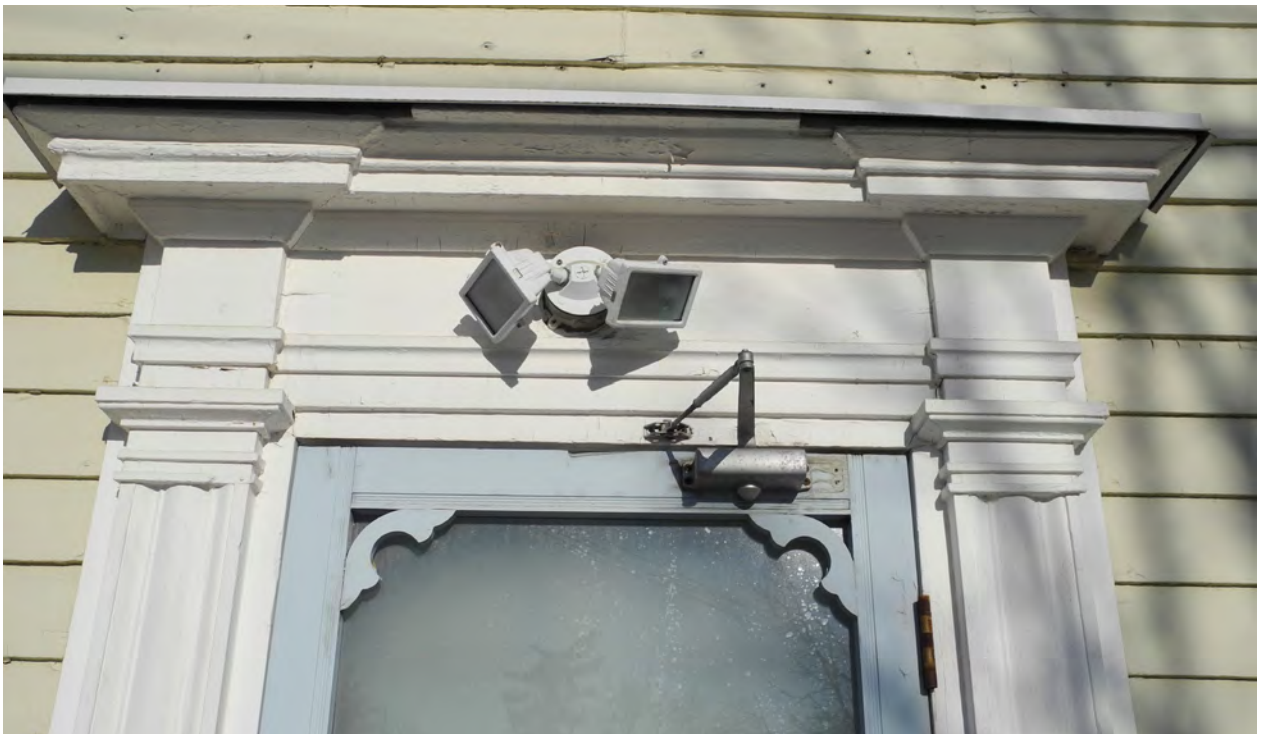
Figure 25: Flashing over the door surround is in fair condition, but it obscures the plan of the surround, effectively diminishing the detail's legibility (CBCollective, 2020).
