46 CENTRE STREET, VAUGHAN CONSERVATION PLAN

PREPARED FOR
DAVID GRANT-RUBASH
PHAEDRUS STUDIO

REV. II - FINAL

SEPTEMBER 17, 2021

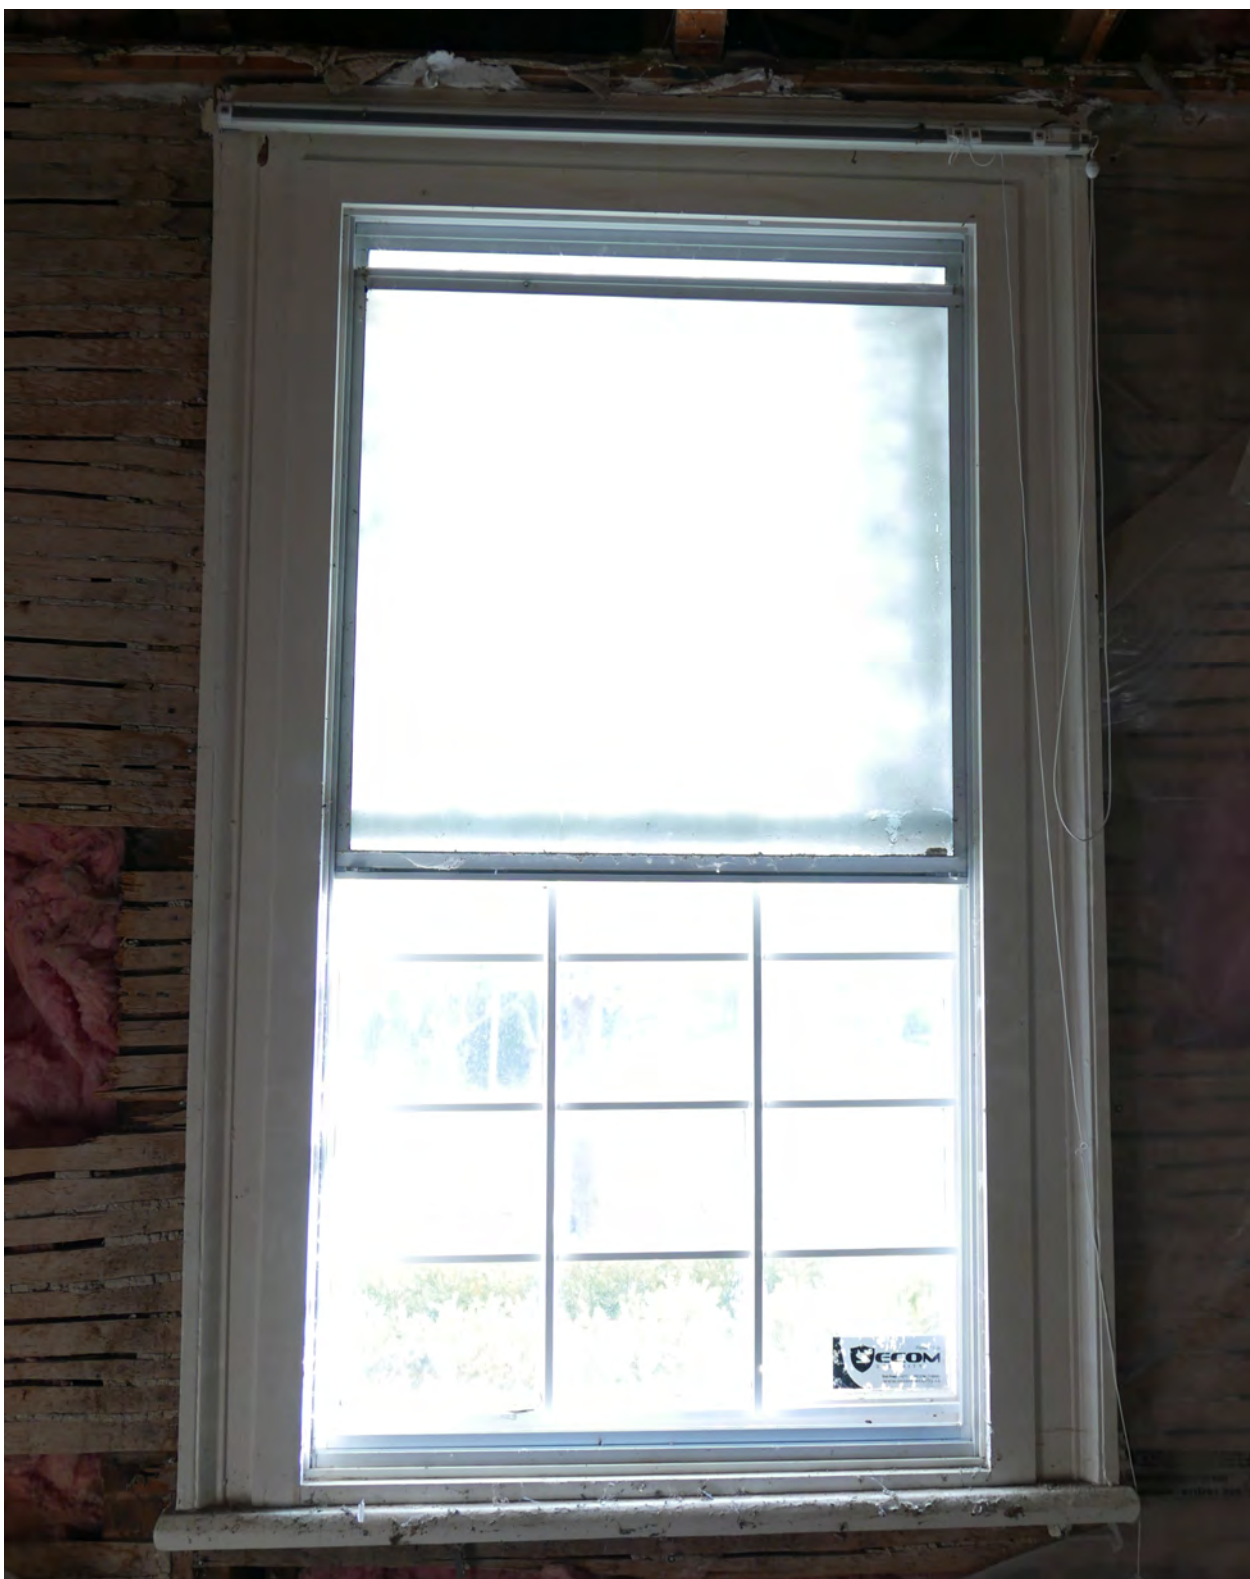
Figure 26: Historic casings remain at the Main House's interior windows, despite being obscured by storm windows. Profiles differ slightly on the ground floor windows (CBCollective, 2020).
