**Re: Planned Construction at 226 Arnold Avenue, Thornhill**

## Assignment

Davey Resource Group (DRG) was contracted by Joe Garber of 59 Rodeo Drive (herein known as the Client) to inspect a mature tree located in his backyard. The arborist was to determine the potential impact on the tree from proposed construction of a new house on the neighbouring property at 226 Arnold Avenue, Thornhill and to advise on what changes to construction plans would safely minimize injury to the subject tree. Site visit was performed by ISA Certified Arborist Rashid Azimov (ON-2591A).

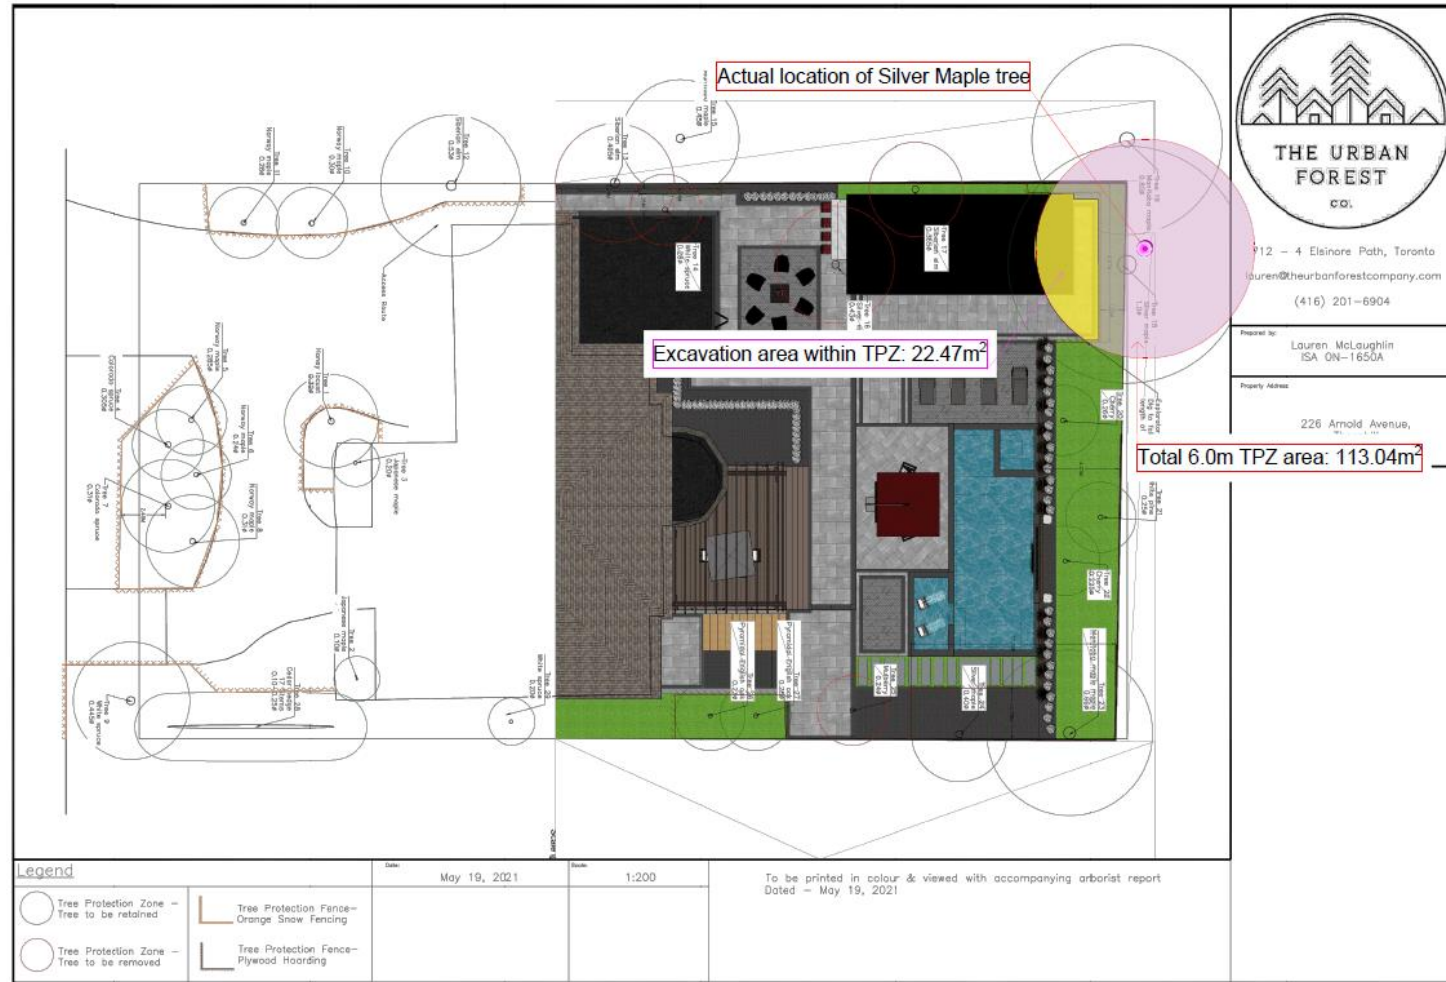
- The canopy measures 18m high, and the branches of the tree extend 11m away from its center.
- The subject tree is located 60cm away from the property boundary with 226 Arnold Avenue, as measured from the top of the root flare on the trunk to the boundary fence that is aligned with the boundary as laid out on site plans.
- Construction site plans indicate that the proposed patio will primarily be located 1.10 meters away from the subject tree at the closest point to it. However, after assessment we discovered that actual tree location is 2.13m away from the planned construction.
- Total construction and excavation comprise 19.87% of the area within the subject tree's TPZ.

Construction at 226 Arnold Avenue, as planned, would take place well within the 6.0m radius Tree Protection Zone of a 96cm DBH Silver Maple tree belonging to the neighbouring owner at 59 Rodeo Drive. As planned, excavation for building a new interlock patio and cabana would require severance of the root system belonging to the subject tree at 1.26m from its base. This distance correlates to approximately 1.3x the diameter of the tree away from its base. According to research done by Dr. E. Thomas Smiley, trenching for construction is advised to be no less than 3 times the trunk diameter distance from the tree. This correlates to performing excavation at 2.88m away from the subject tree. This would require revised site plans to place the interlock patio at approximately 3m away from the subject tree at the closest point to it.

**Figure 1 – Cropped Site Plan of 226 Arnold Avenue showing proposed building footprint. Approximate area of excavation within TPZ of the Silver Maple is indicated. 22.47m<sup>2</sup> equals 19.87% of the TPZ. Closest excavation distance of 2.1m from tree threatens structural instability**

As planned, construction at 226 Arnold Avenue would require removal of roots within 19.87% of the subject tree's TPZ. This would cause a substantial amount of stress and injury to the tree that it would not likely fully recover from. The removal of roots at the planned proximity to the tree would likely cause a loss of its structural integrity, raising the risk of it falling during high winds. Ideally, construction should take place entirely outside of the Tree Protection Zone distance of 6.0m. However, if a compromise were to be made to permit construction inside the TPZ in a way that ensures the tree's long-term survival and stability, then it is my recommendation that site plans be revised to locate the interlock patio and cabana more than 3.6 meters away from the subject tree, which allows for some additional root space to be preserved considering the tree's lean. I also recommend low impact excavation (hand-digging or air spading), excavation for patio bedding to be no more than 20-30cm and for cabana foundation no more than 60-90 cm deep. This would reduce root and canopy loss, which would assure the tree's long-term recovery from any

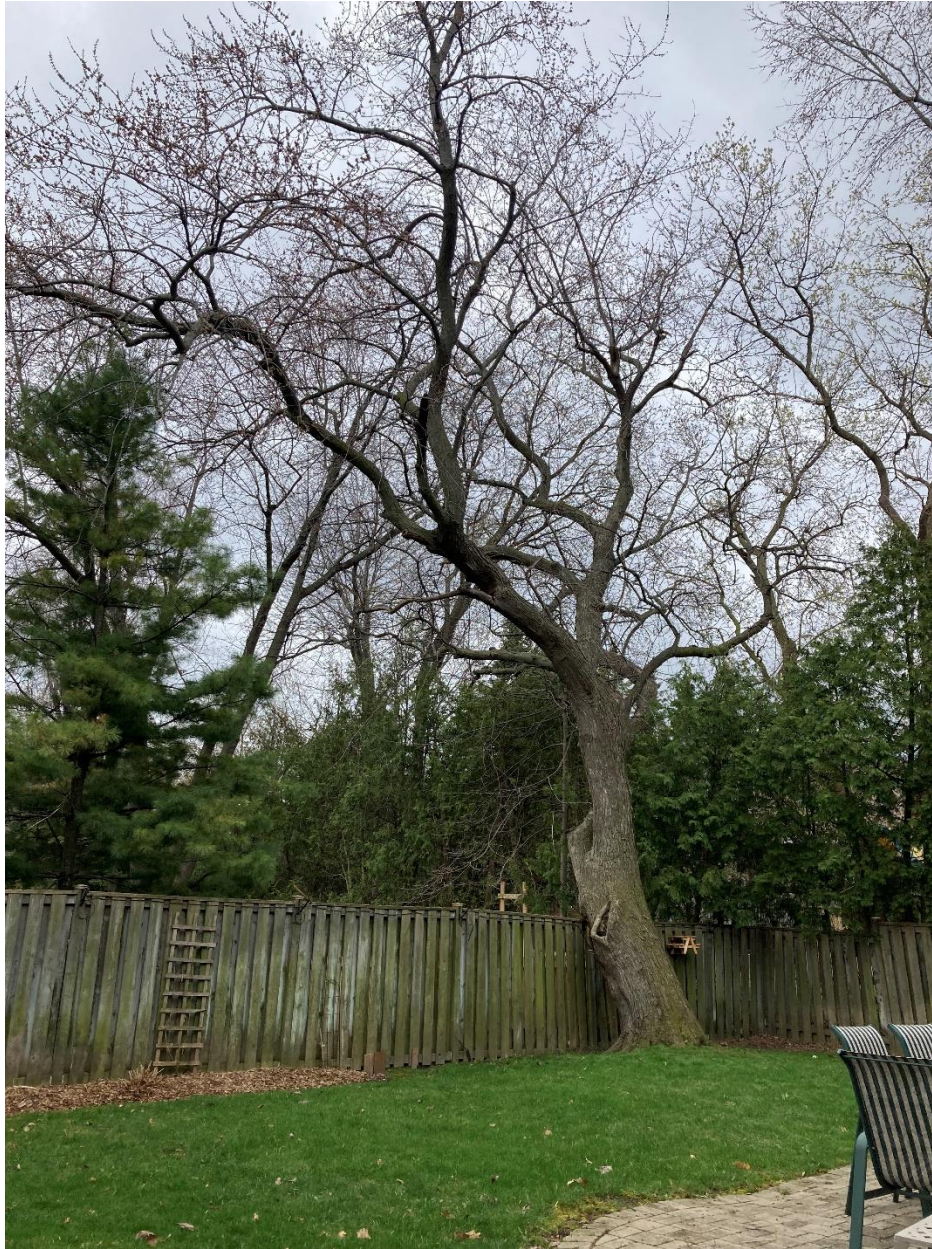
- The tree of concern is a 96cm DBH Silver Maple (*Acer saccharinum*). The minimum Tree Protection Zone distance from the subject tree under Vaughan By-Law chapter 185-2007 is 6.0m. No construction work may occur within this distance away from the tree without permit approval from the City of Vaughan. Overall tree condition is fair.

**Figure 2 – View of the subject tree as seen from the northwest corner of the client’s backyard, looking south. The tree is fair condition.**

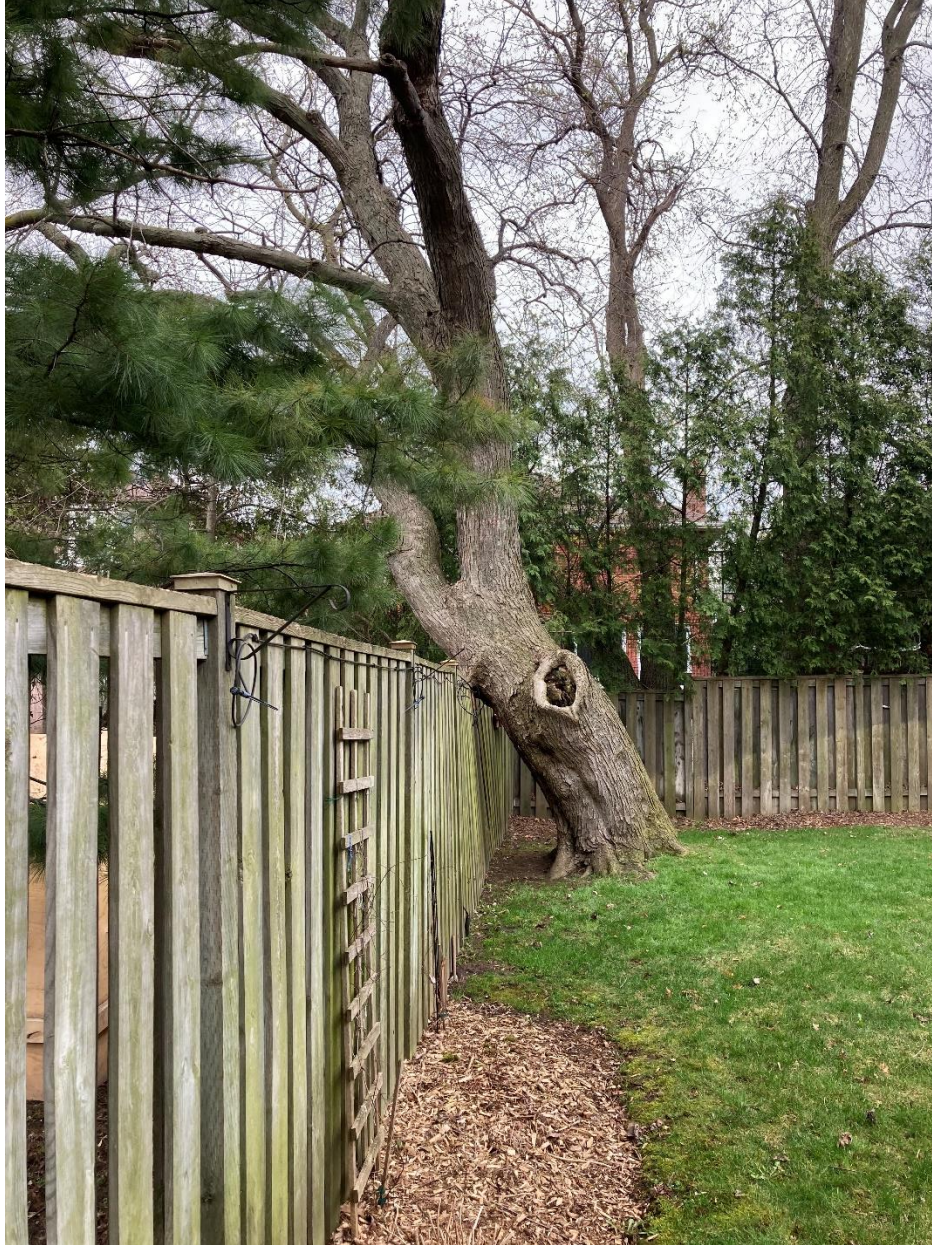
- Main trunk of the tree has significant lean (25°) to the direction of proposed construction. At 1.4m high from ground, the trunk has a large (30x44cm) cavity, which appeared from cutting one of major leaders. Internal wood decay can be seen from the cavity. The vertical ribs (response growth) at bottom side of the leaning main trunk are also potential evidence of internal decay.

In addition, the subject tree has several structural defects like significant lean to the direction of proposed construction, signs of heartwood decay in main trunk and girdling roots on the opposite side of tree lean, which may lead to tree failure.

**Figure 3 – View of the base of the subject tree. The tree has significant lean and large cavity.**

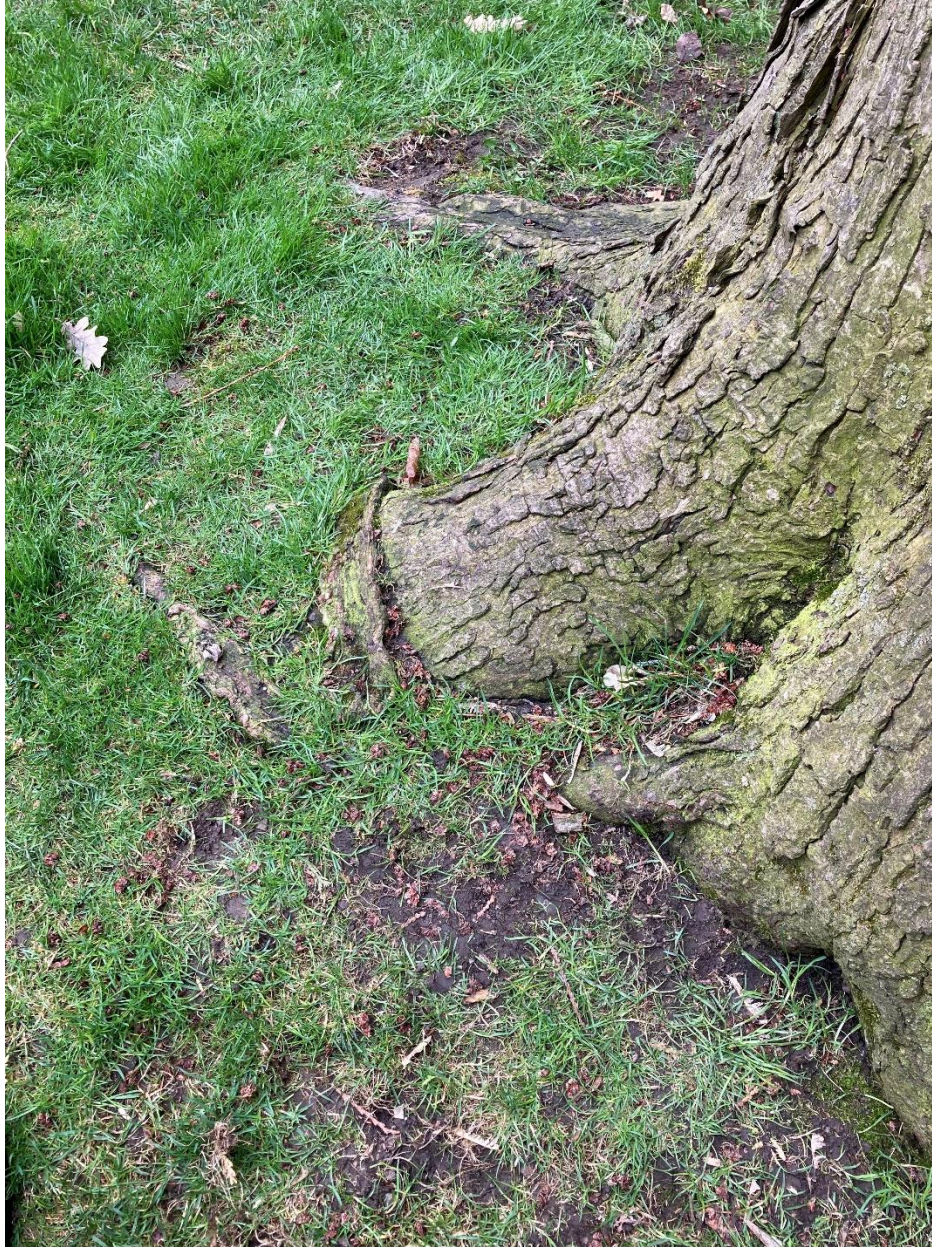
- On the opposite side of the lean girdling roots were observed.
- The main trunk 2.3m high divides into two codominant stems. The union is V-shaped and an included bark is present.

**Figure 4 – Girdling roots on the opposite side of tree lean.**

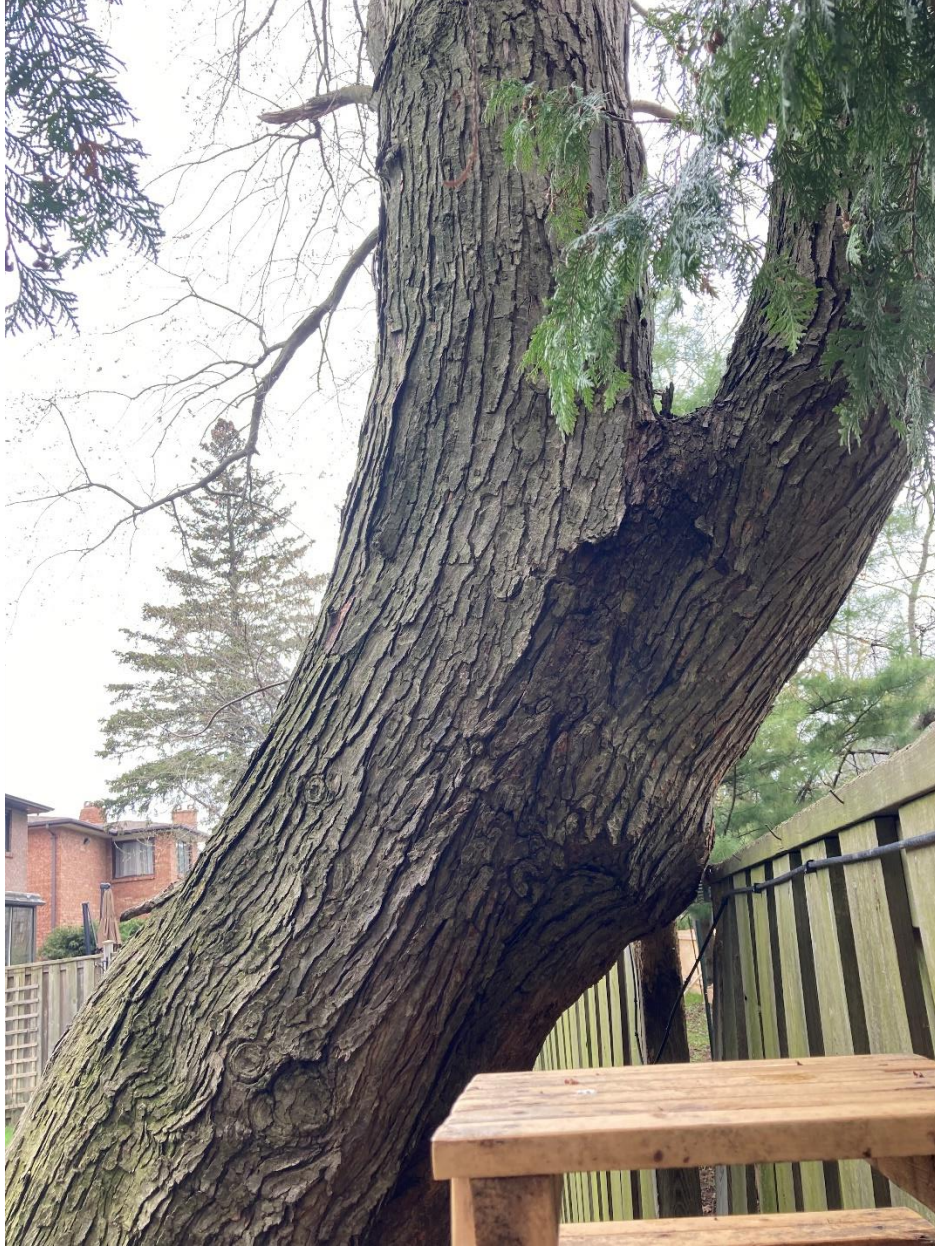
**Figure 5 – V-shaped union and included bark.**
