Conservation Plan for Heritage Resources - 8204 Kipling Avenue, Part of Lot 9, Concession 8, Township of Vaughan, now City of Vaughan, Regional Municipality of York, Ontario

Project number: PHC-2021-026

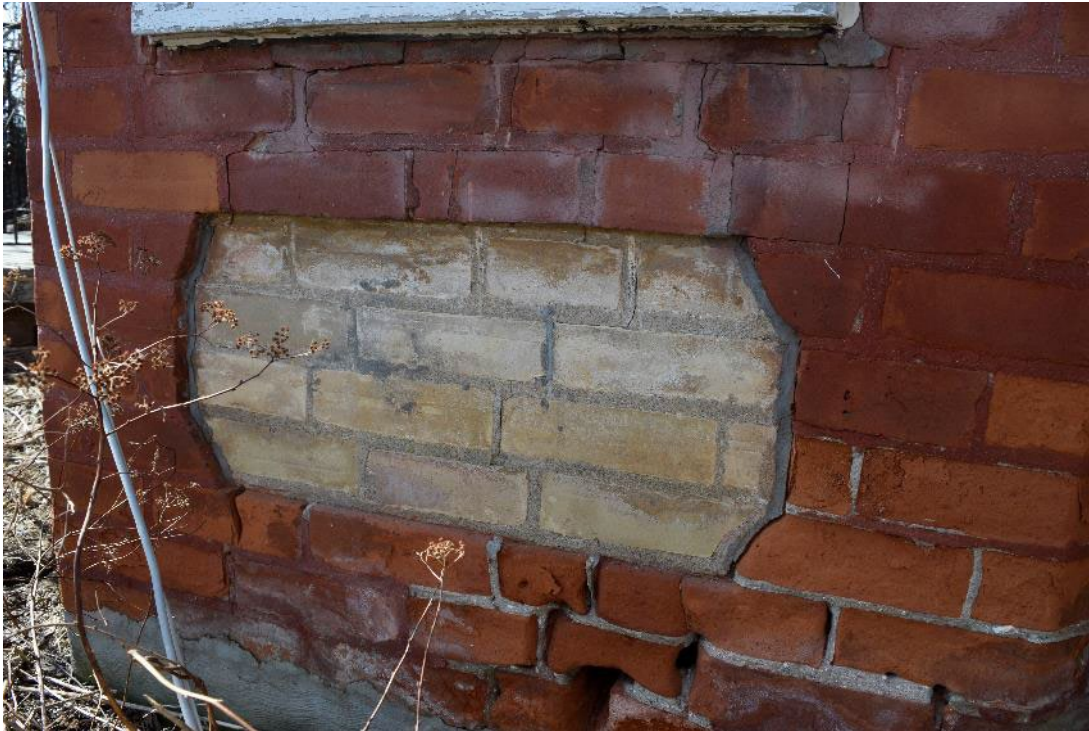
Image 17: Closeup of brick panels located below structural openings on bays, note extensive water damage to brick and mortar

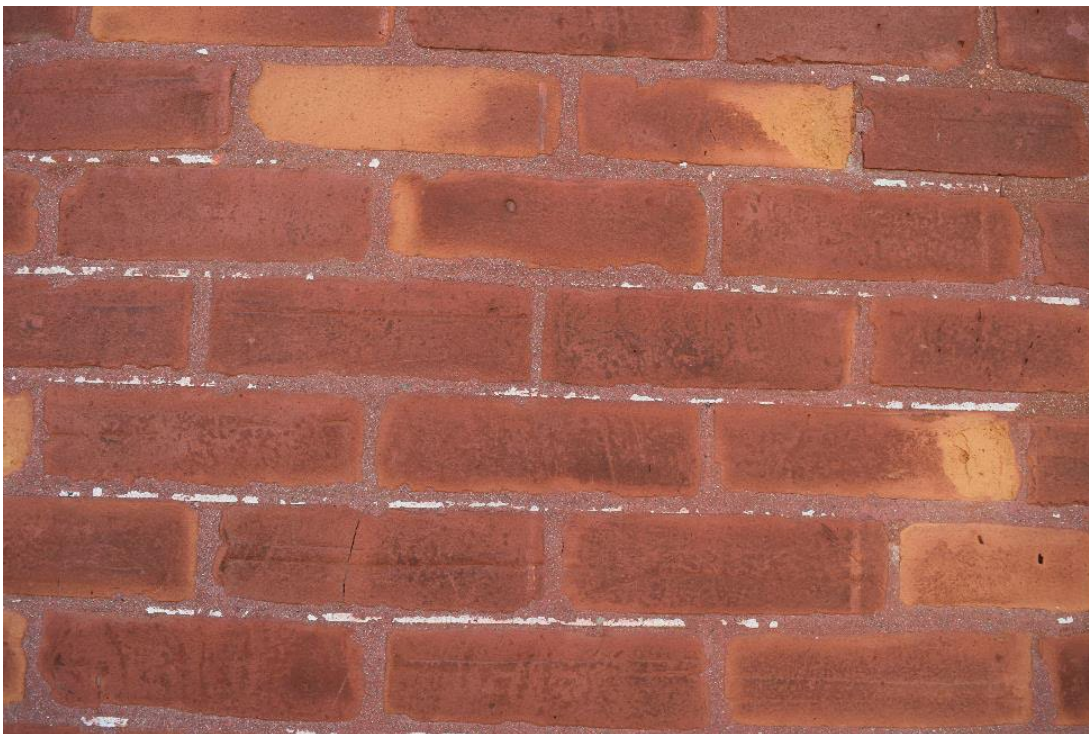
Image 18: Closeup of remaining ribbon pointing in brick façade

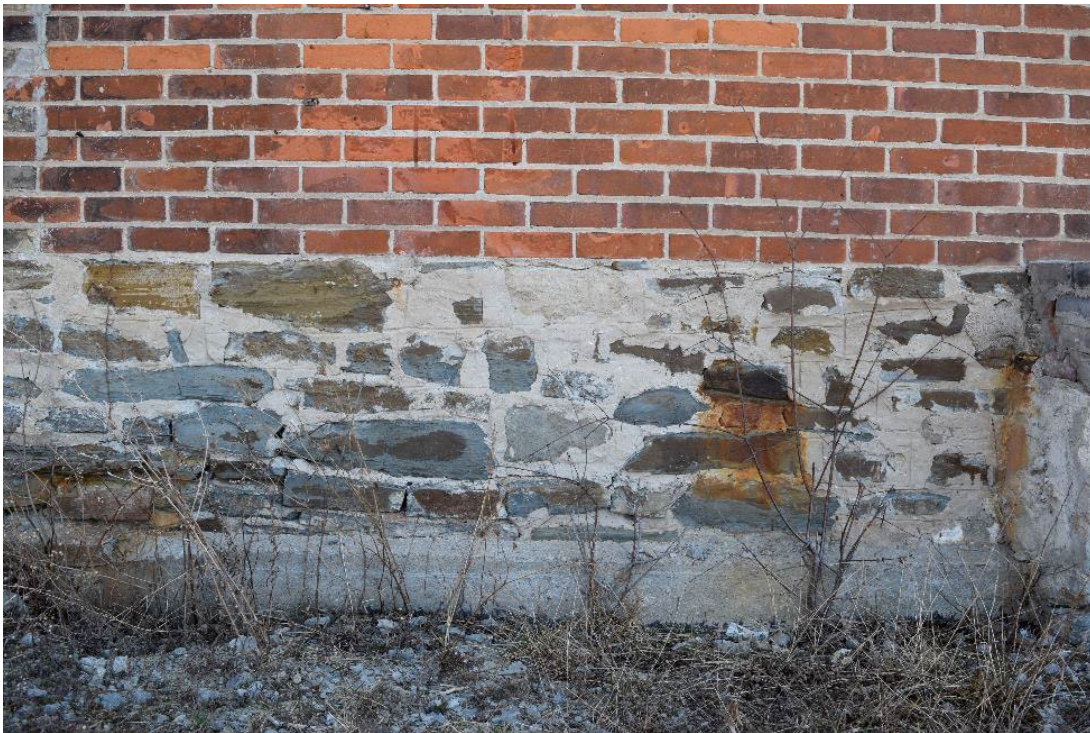
Image 20: Example of field stone foundation with flush bond mortar

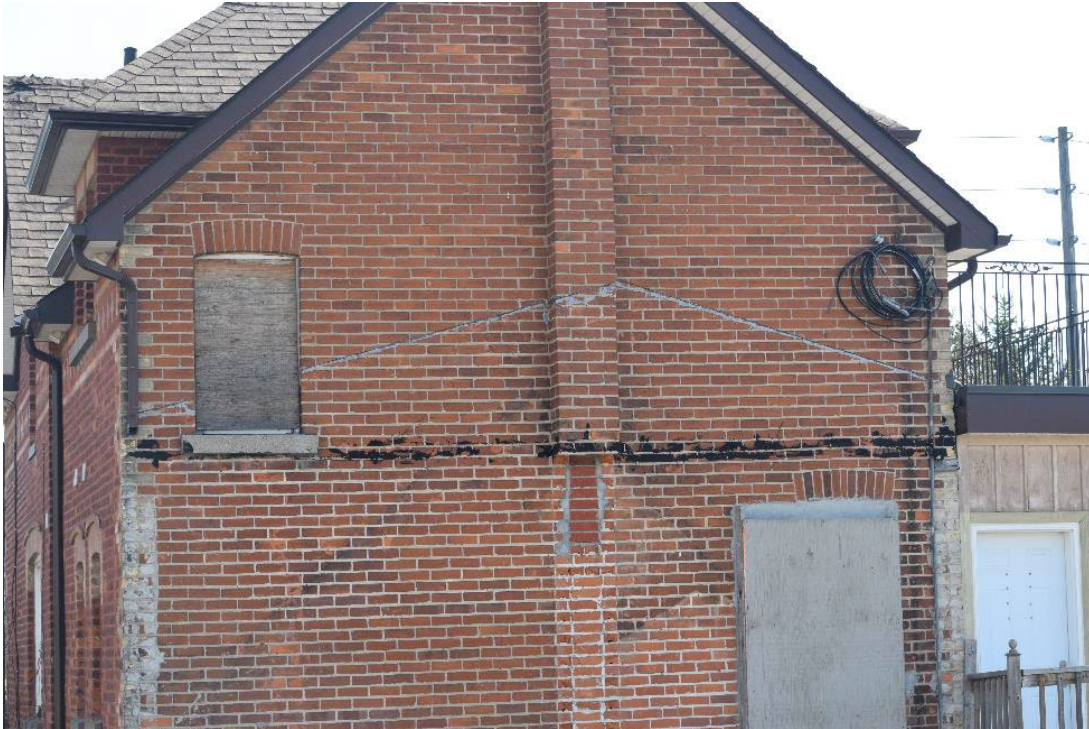
Image 21: Rear of structure showing signs of removal of previous rear addition

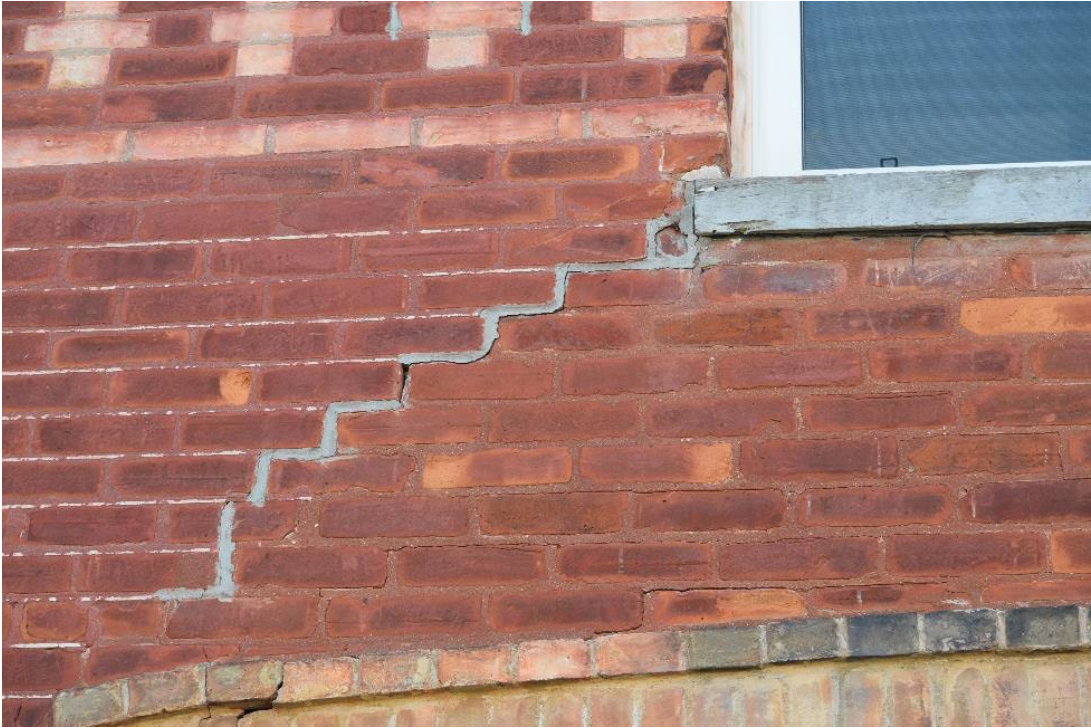
Image 26: Example of cracking in brick veneer

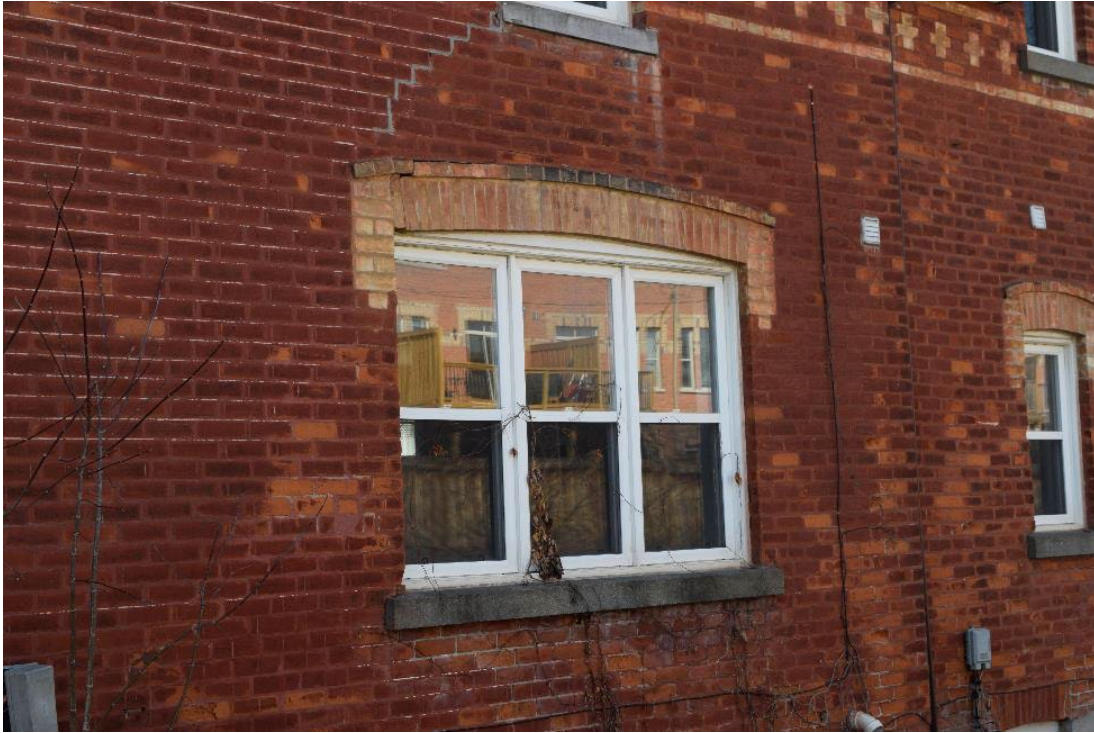
Image 27: Large window on north face of structure, sill has been replaced with cast concrete and voussoir shows signs of deformation

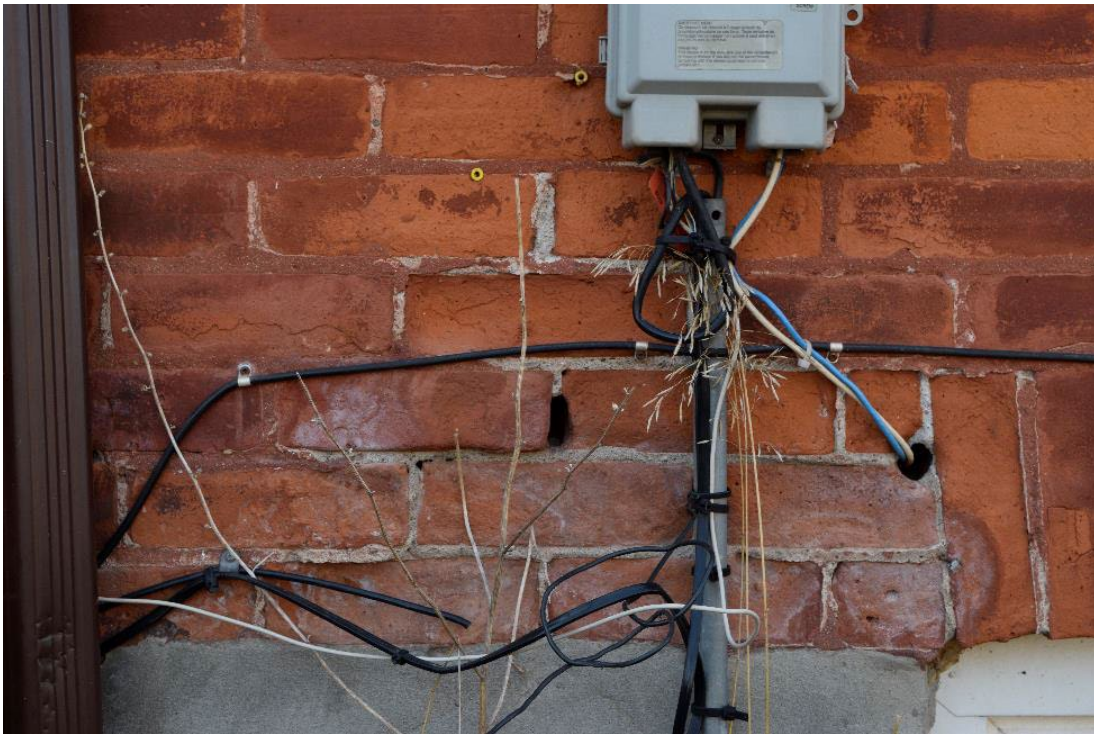
Image 28: Example of typical brick exfoliation resulting from poor water management

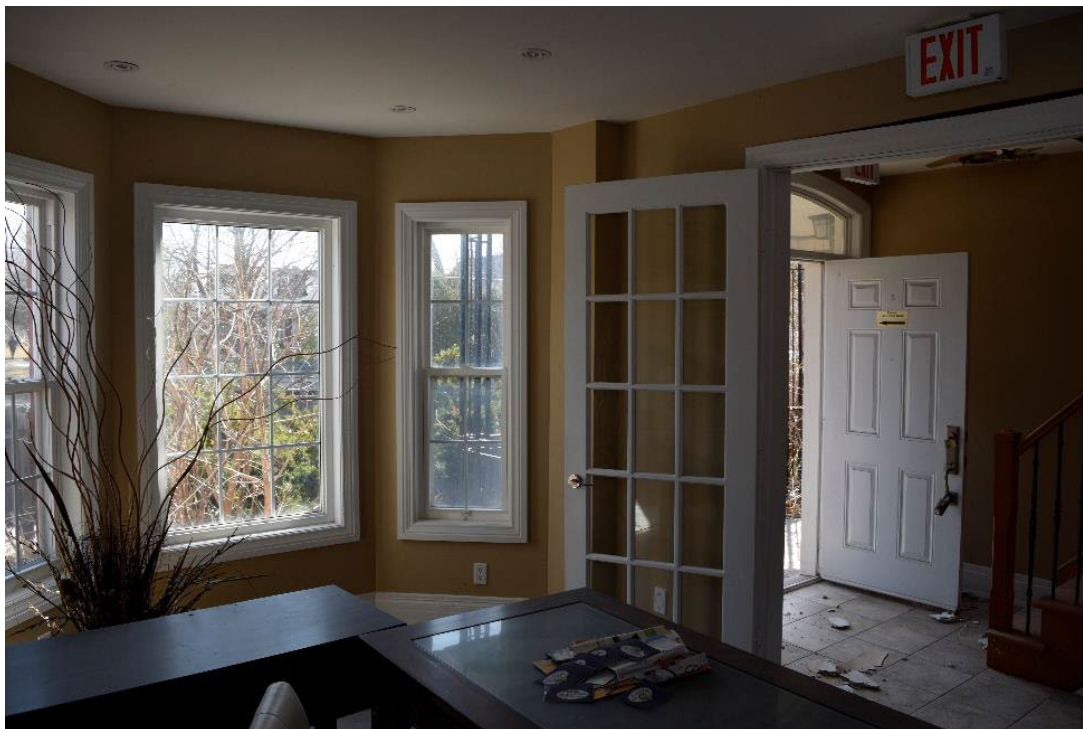
Image 29: Interior of bay on front of home

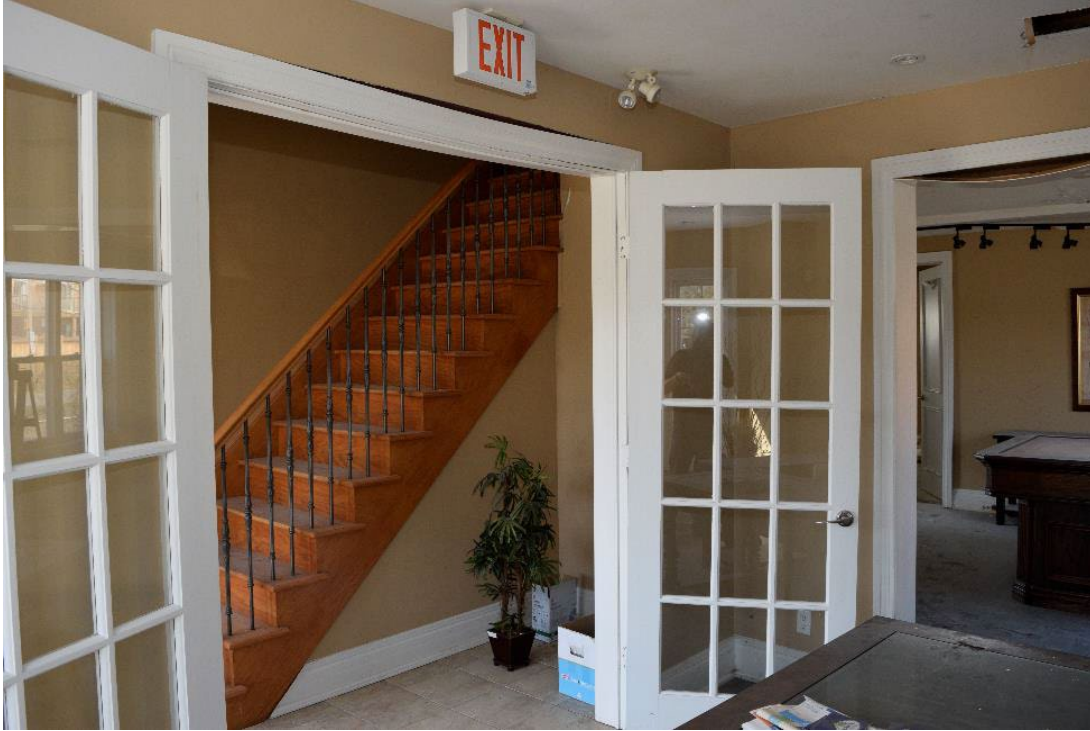
Image 30: Extant stairs, note deformation of trim around door resulting from water infiltration

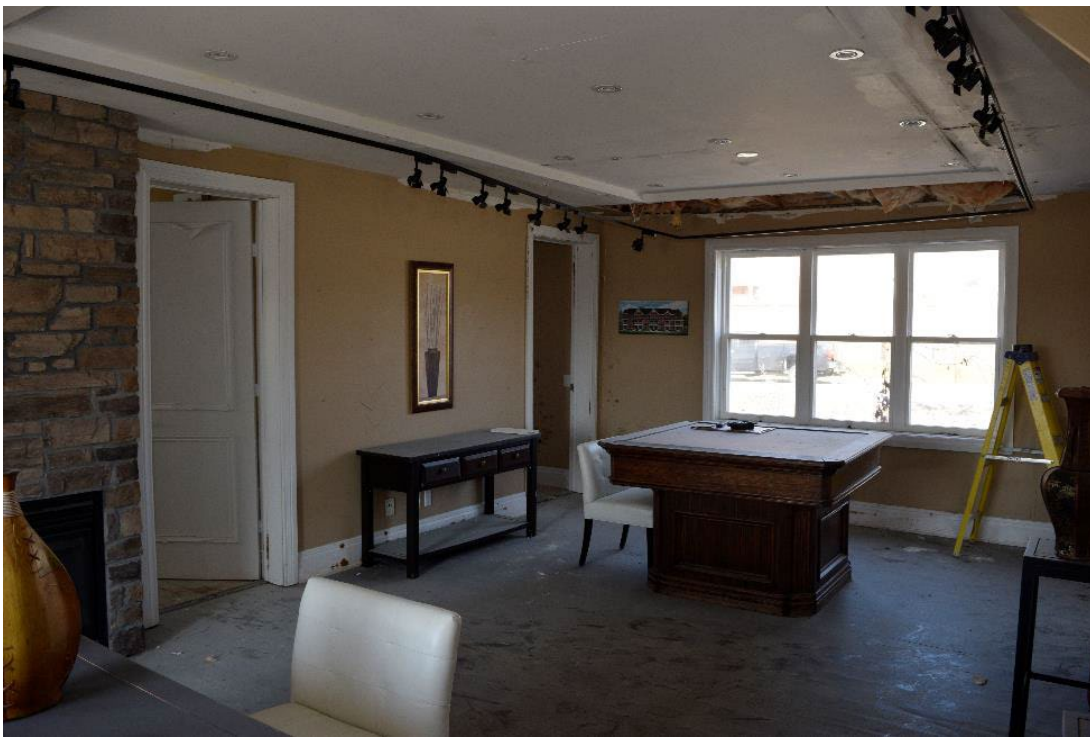
Image 31: Typical example of the interior of structure, facing north

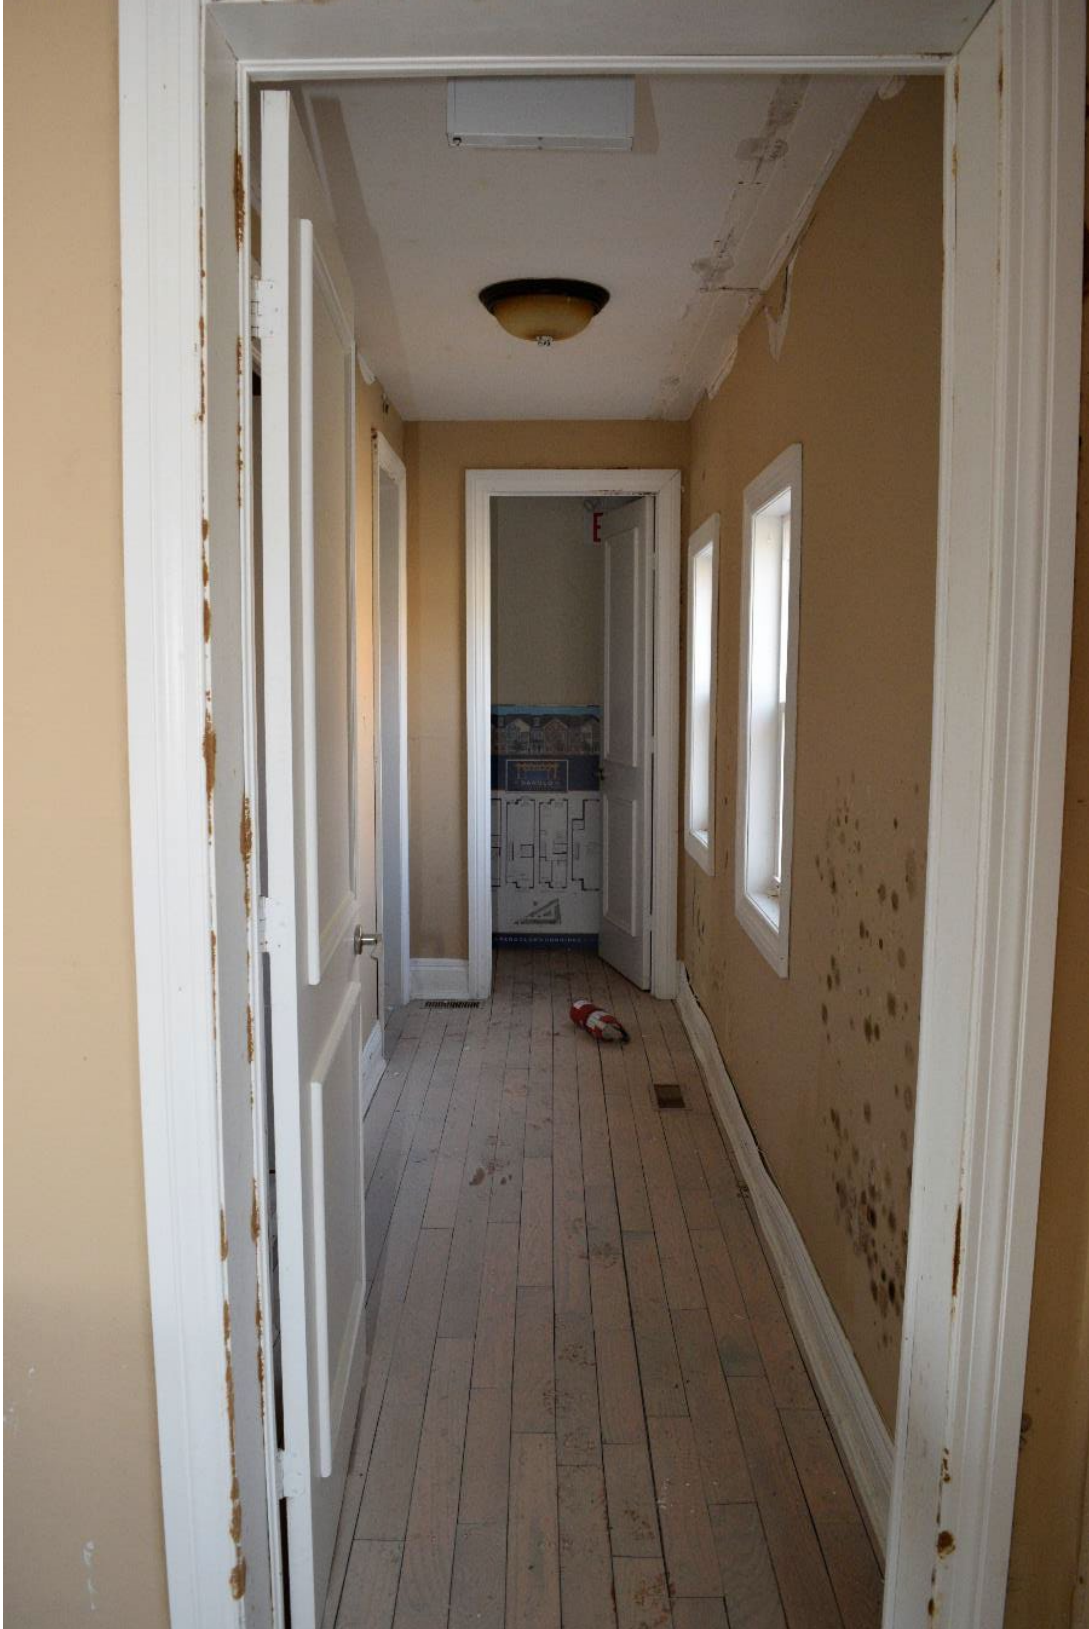
Image 34: Rear hall on first floor, note mould growth and floor damage indicative of extensive water damage, facing west

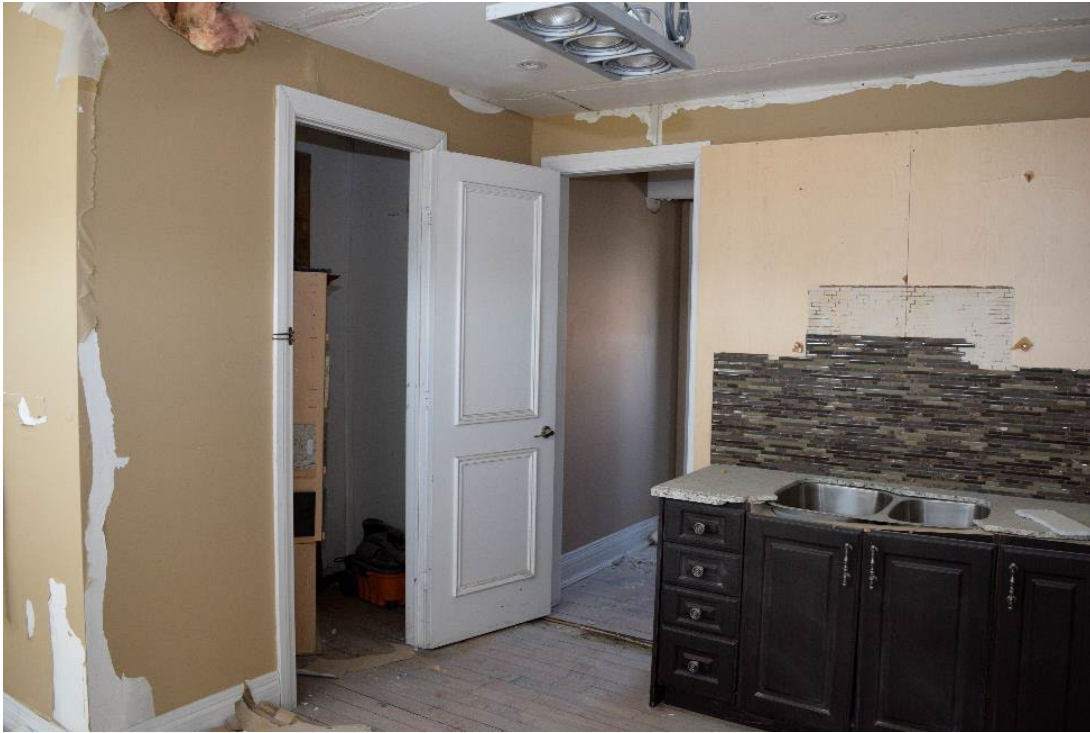
Image 35: Kitchen on first floor, facing southwest

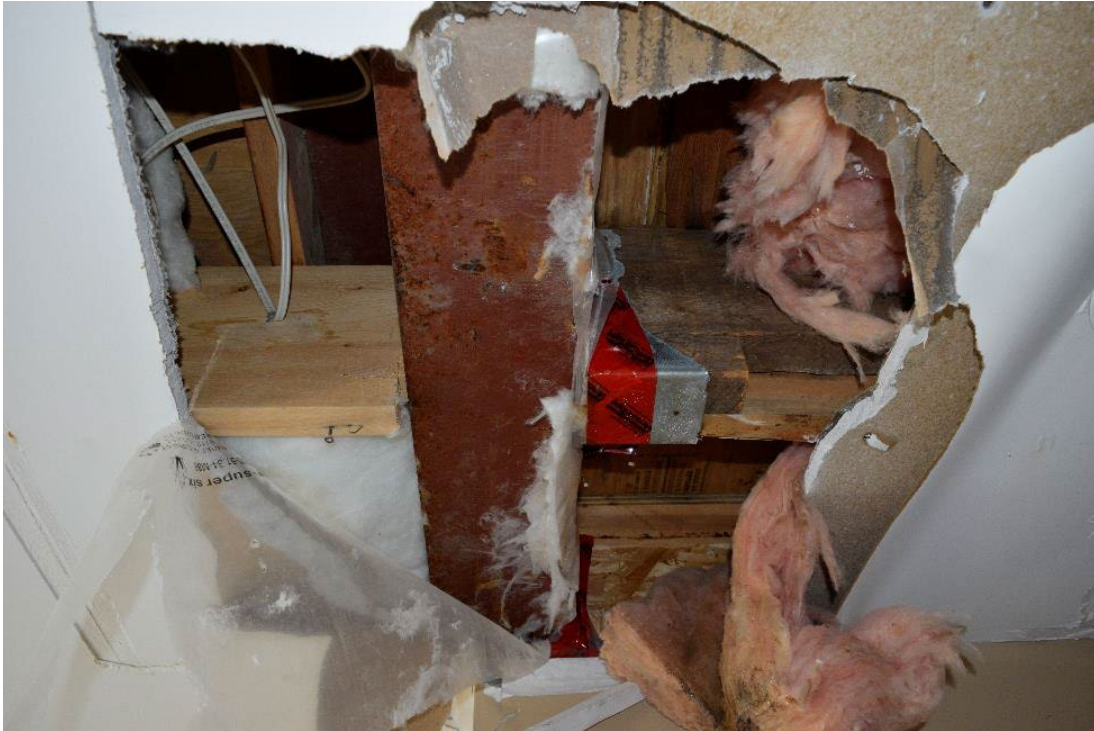
Image 37: Steel I-beam used to replace structure where wall has been removed

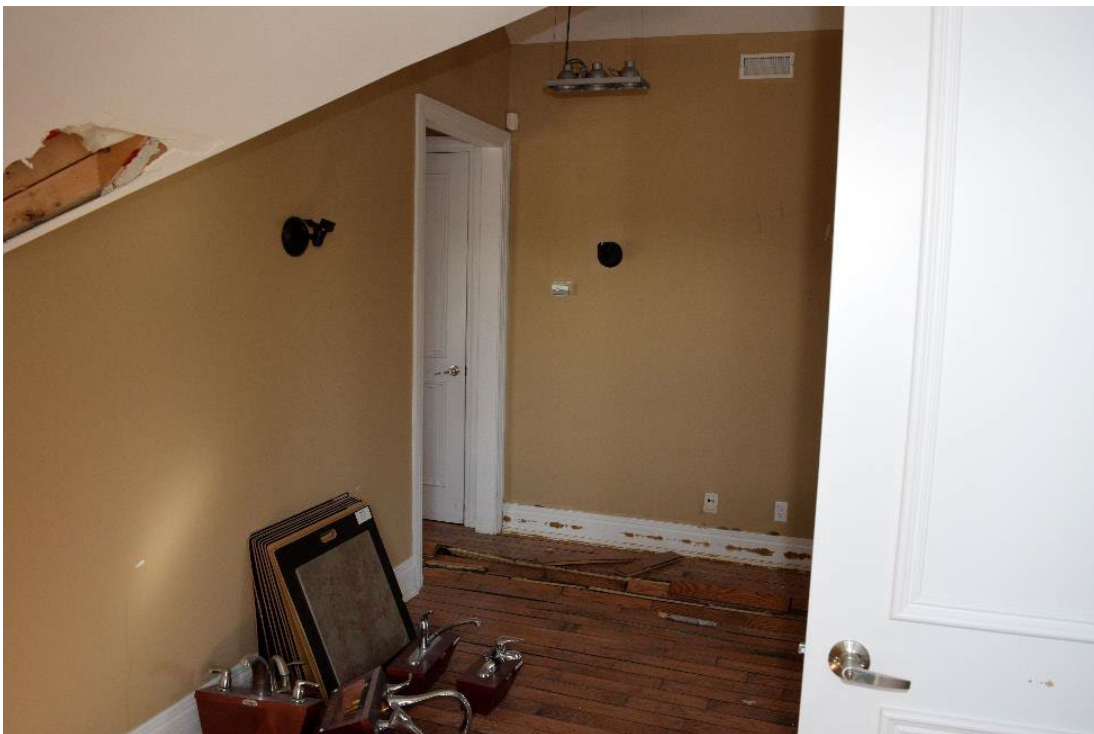
Image 38: Landing on second floor at top of stairs

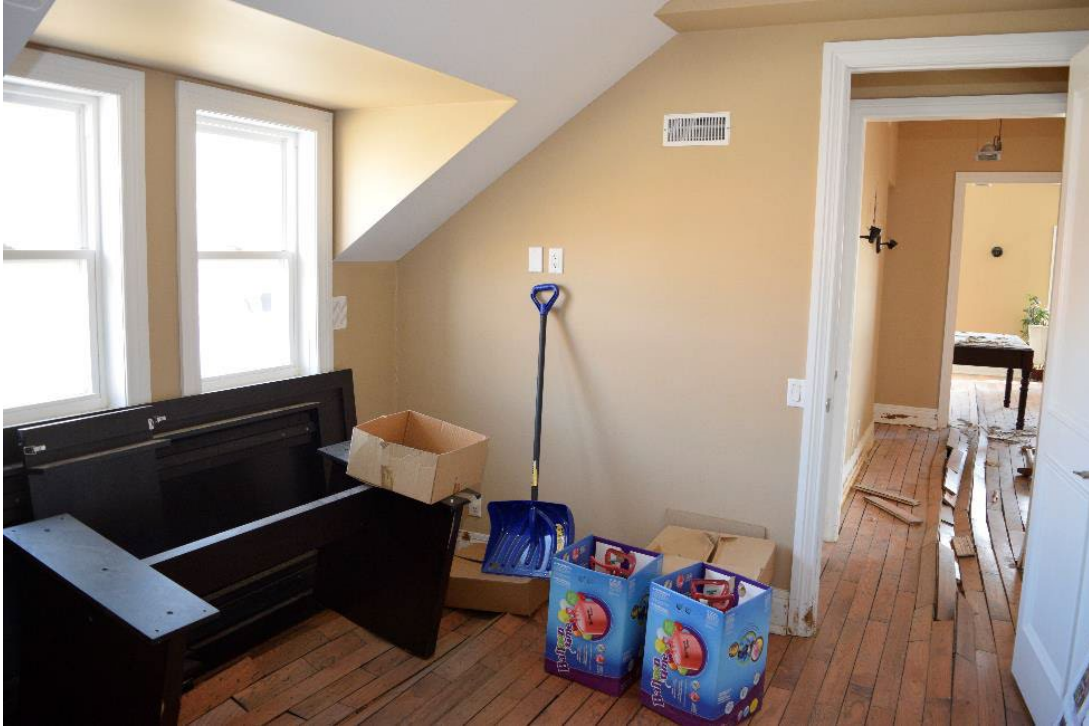
Image 41: Rear room on second floor, facing north, windows are located in hip dormer depicted in Image 25, note water damage to flooring

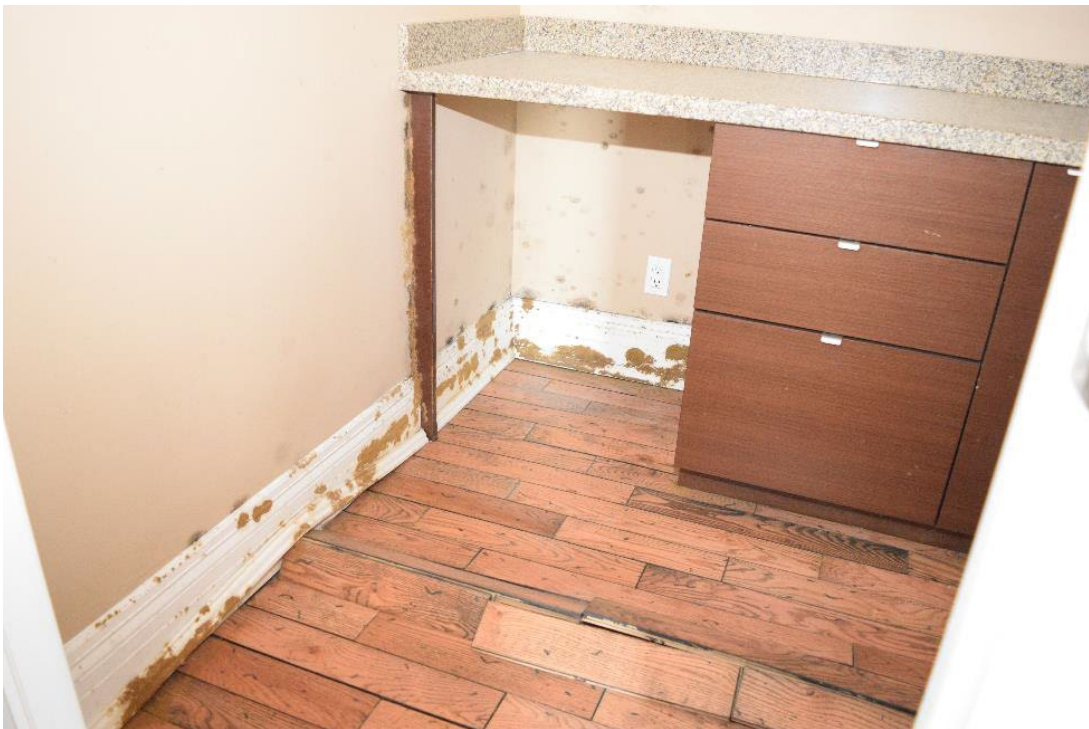
Image 42: Water damage typical of that observed on second floor

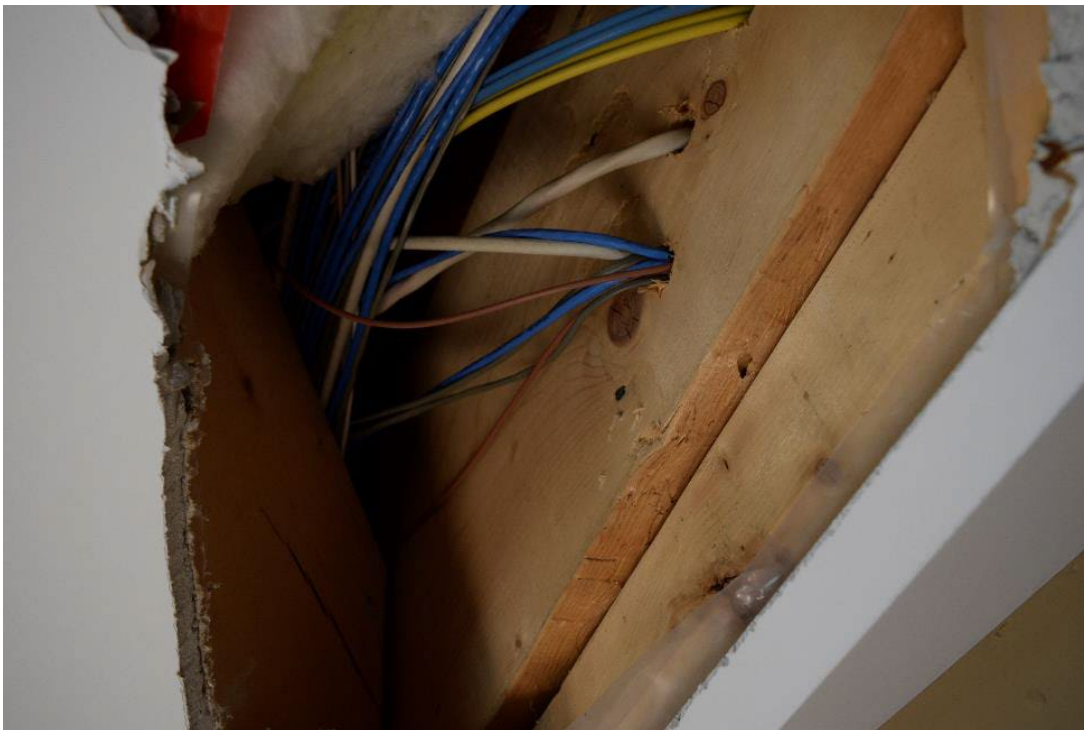
Image 43: Example of new roof framing

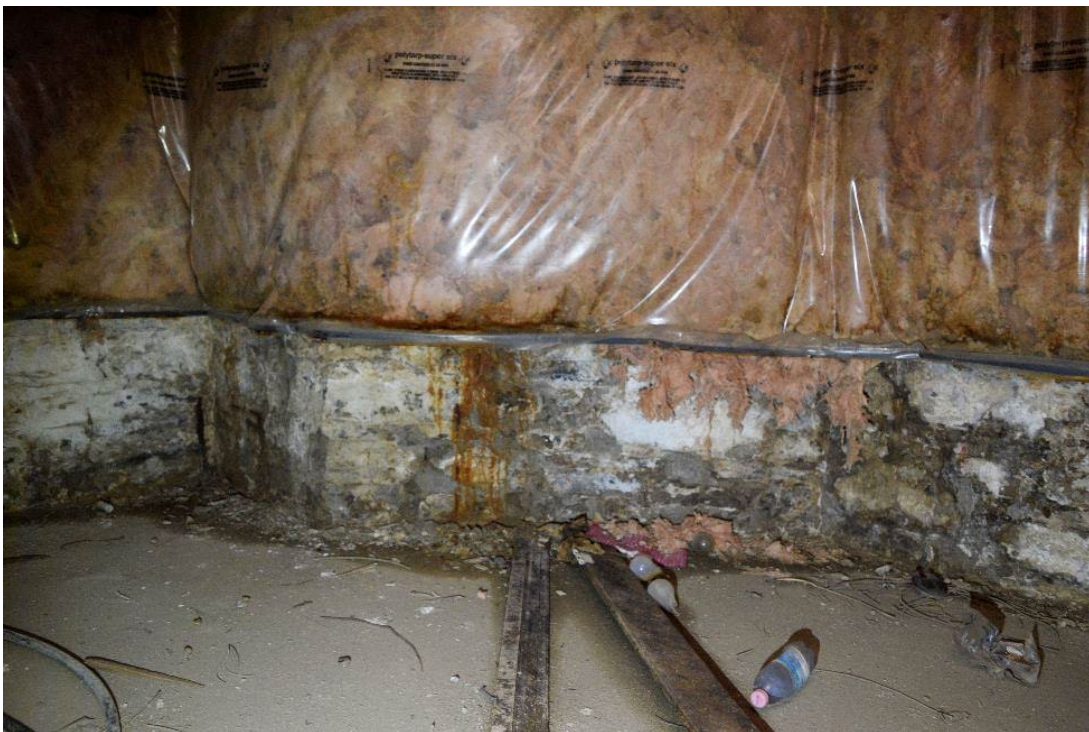
Image 48: Typical example of water damage and mould growth in basement

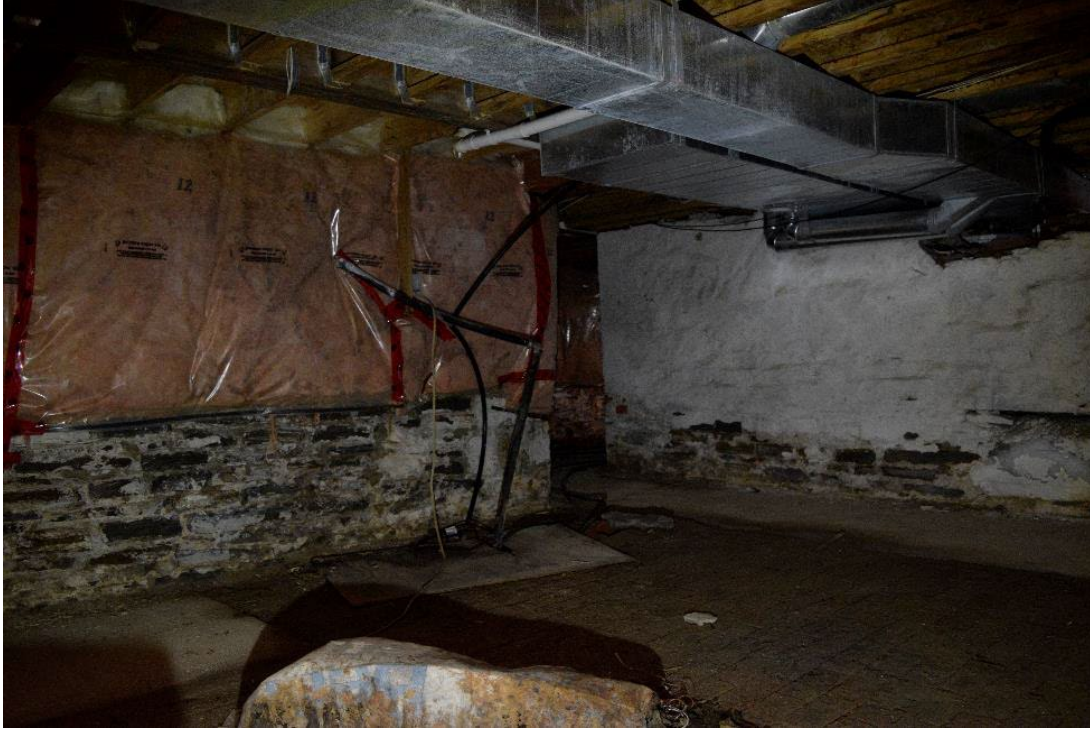
Image 49: Overview of basement

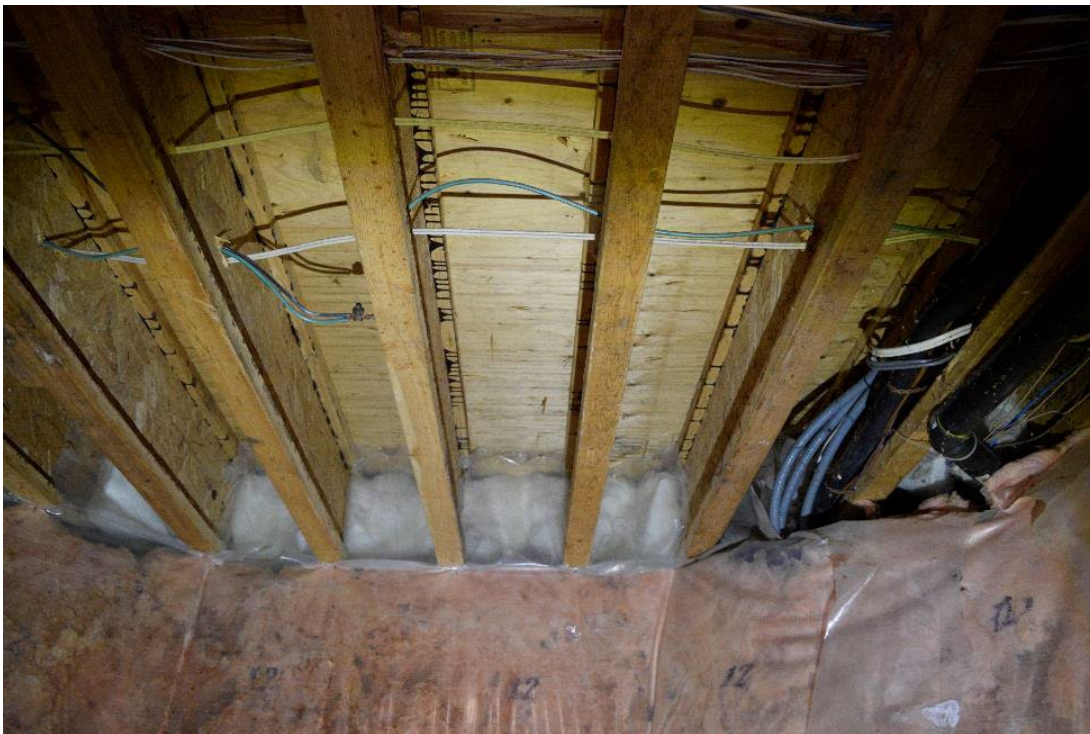
Image 50: I-joists used to replace original floor joists, typical of entire first floor as seen from basement

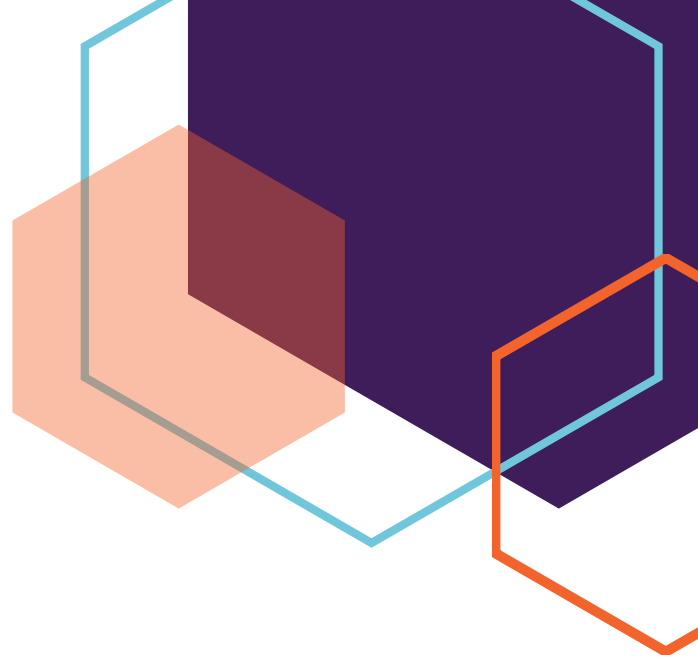
- GENERAL MASONRY NOTES:**
1. STABILIZE STRUCTURAL CRACKS
 2. REPOINT THE BRICK WORK
 3. REPLACE DAMAGED AND MISSING BRICKS
 4. REPAIR MASONRY AT STRUCTURAL OPENINGS
 5. RESTORE DICHROMATIC BRICKWORK IN FRONT GABLE IMPACTED BY MODERN VENT INSTALLATION
 6. STABILIZE AND REPAIR CHIMNEYS

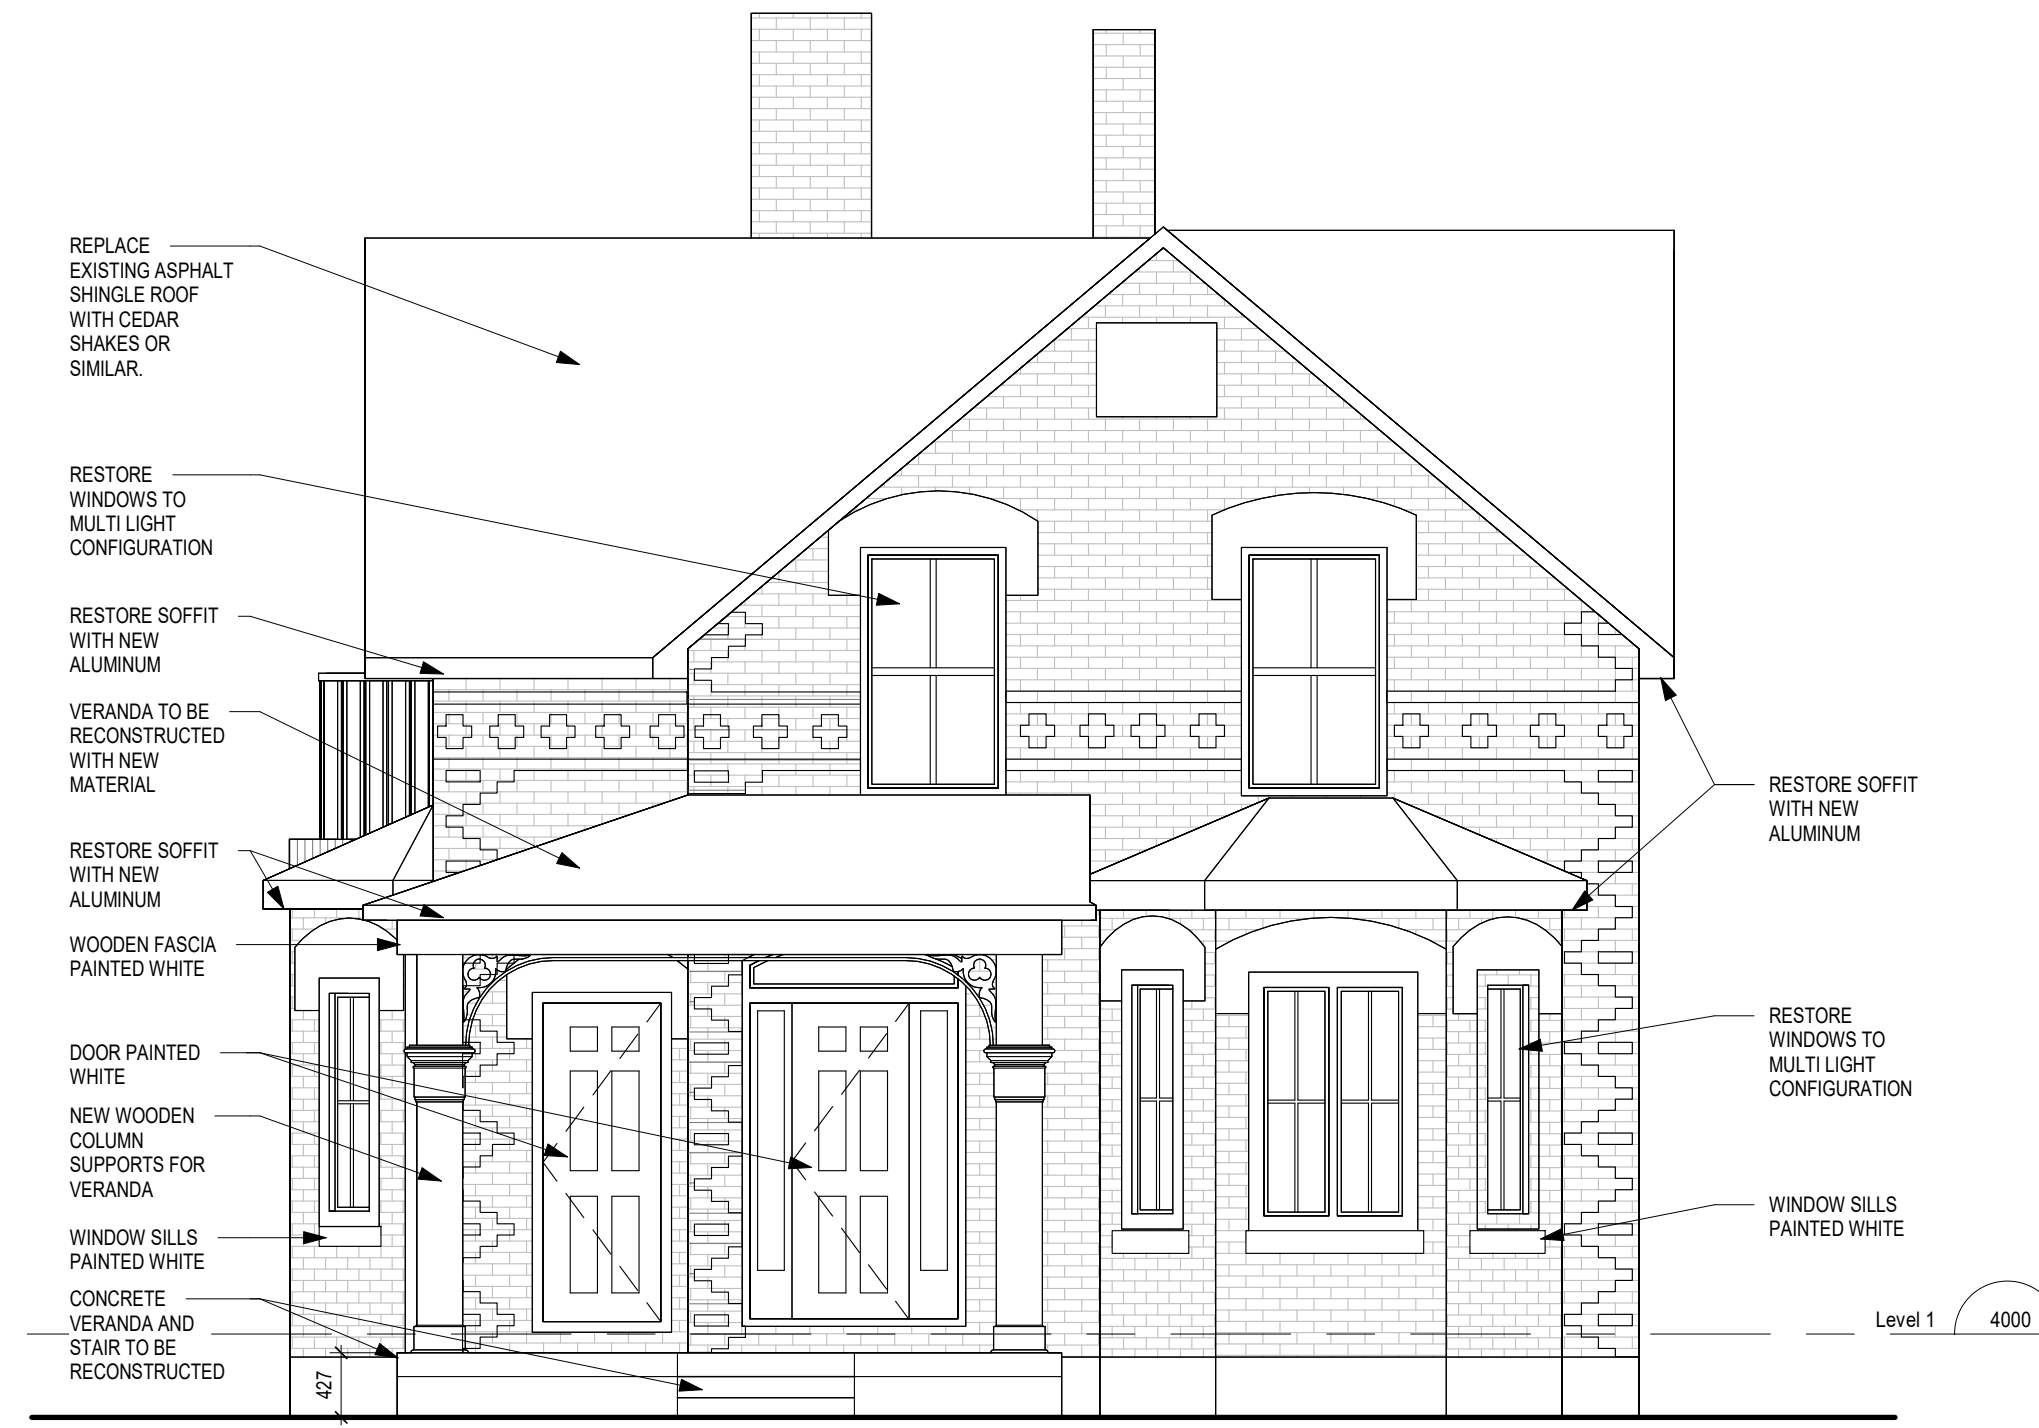
4 EAST ELEVATION
A402 1:50
