Conservation Plan for Heritage Resources - 8204 Kipling Avenue, Part of Lot 9, Concession 8, Township of Vaughan, now City of Vaughan, Regional Municipality of York, Ontario

Project number: PHC-2021-026

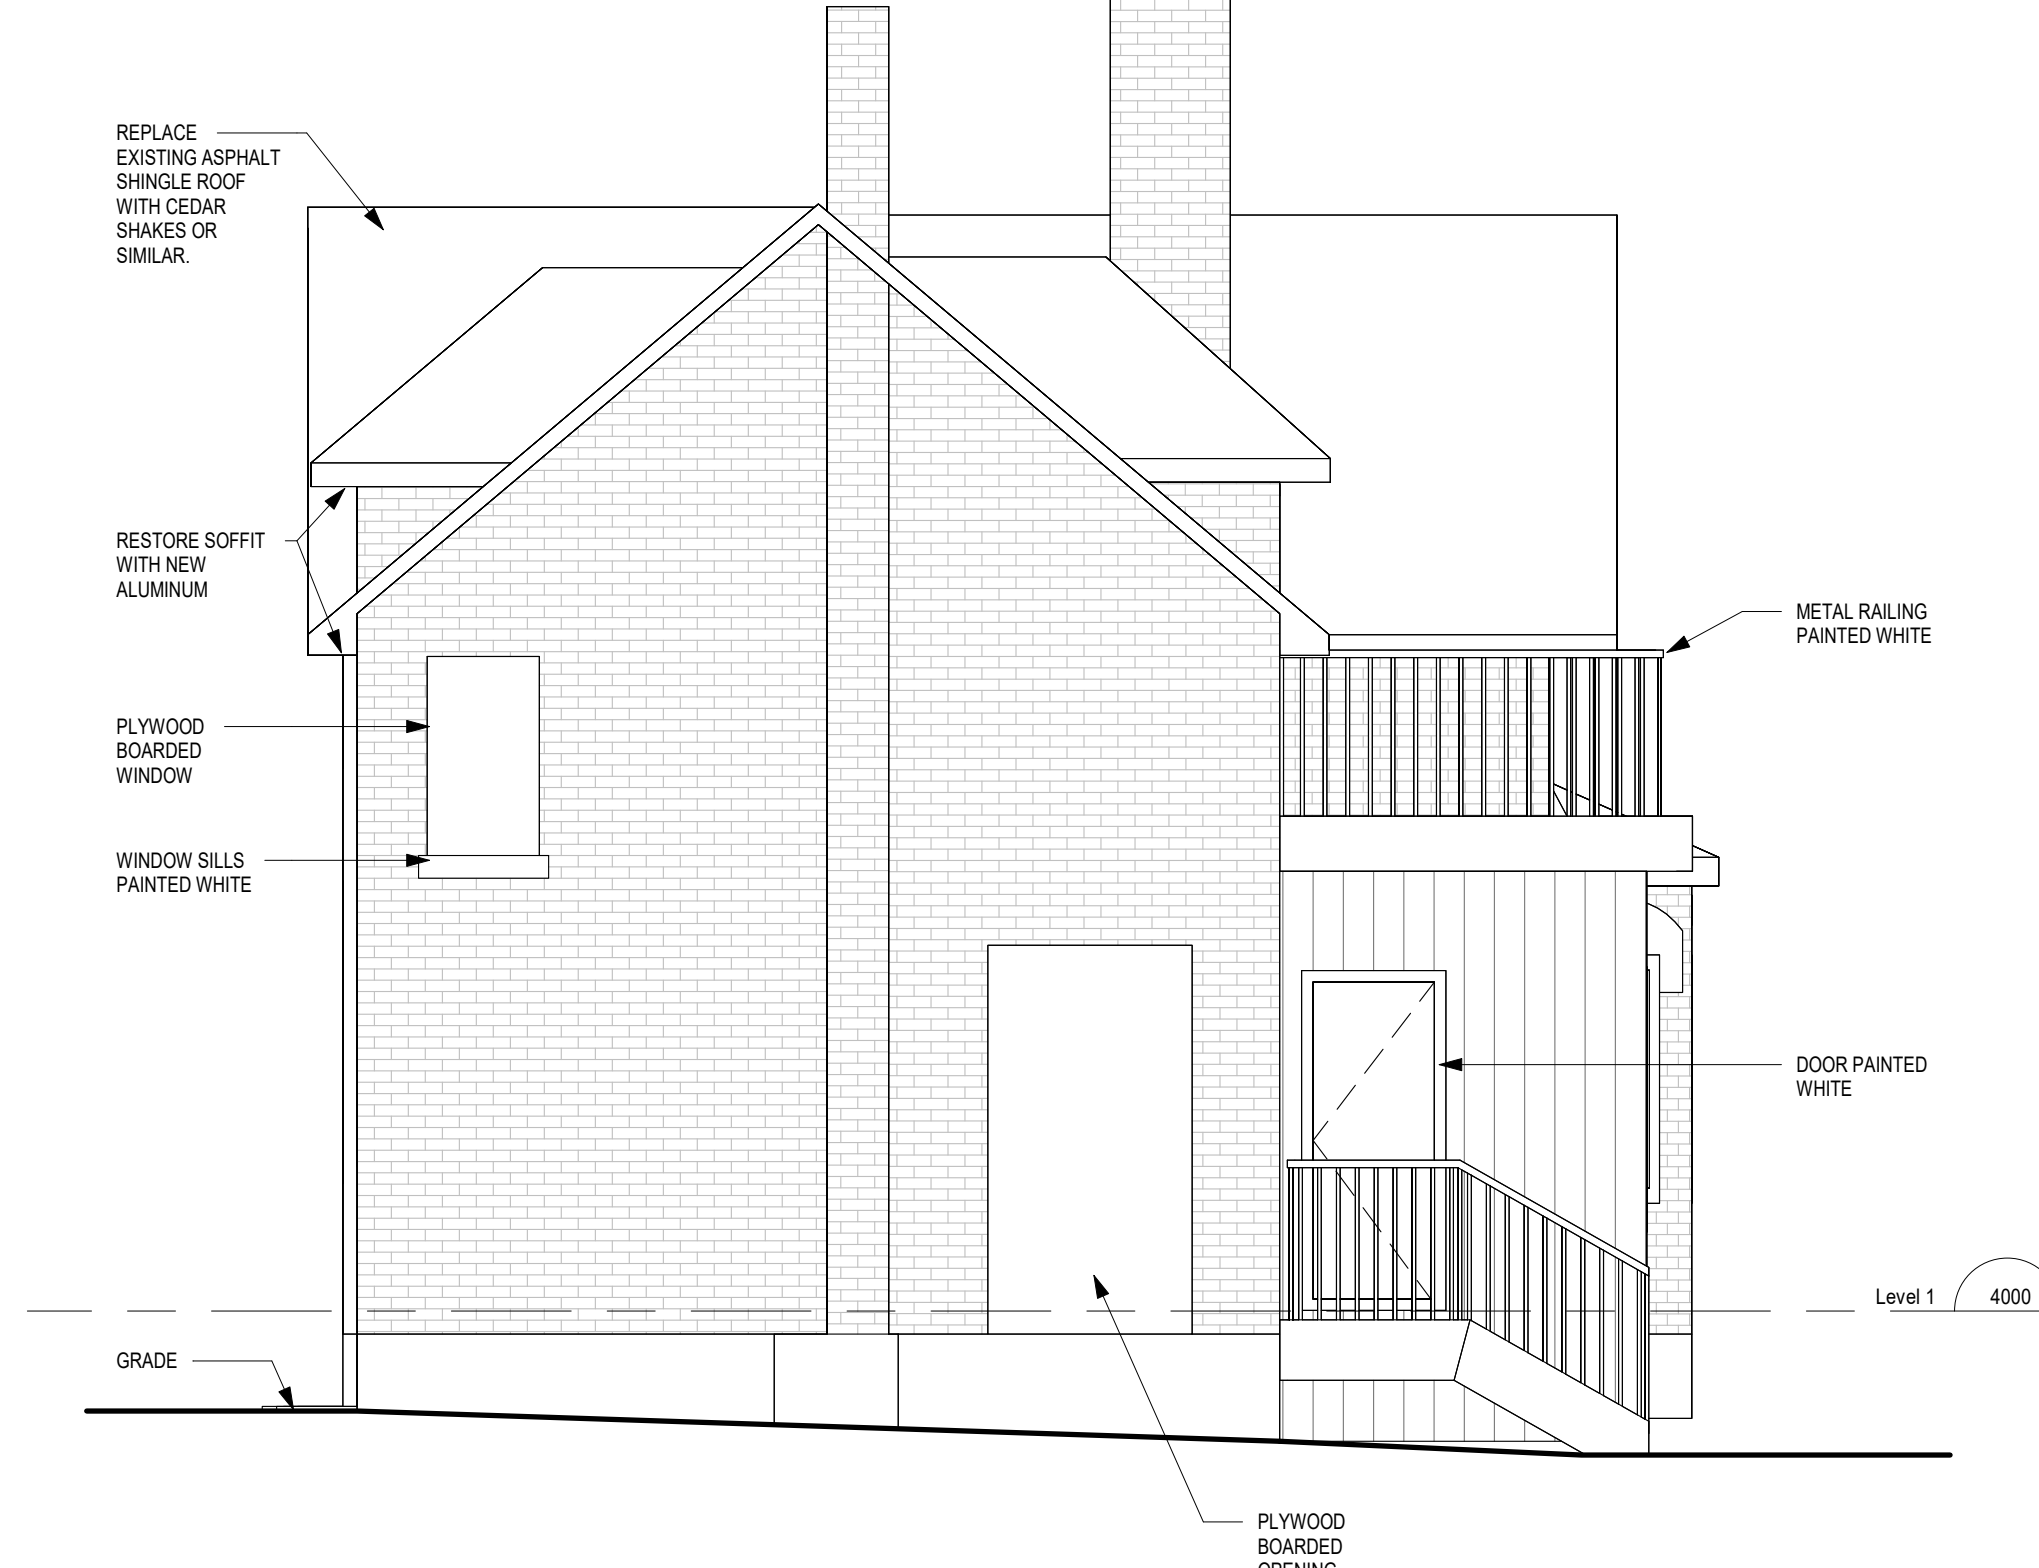
2 WEST ELEVATION
A402 1:50

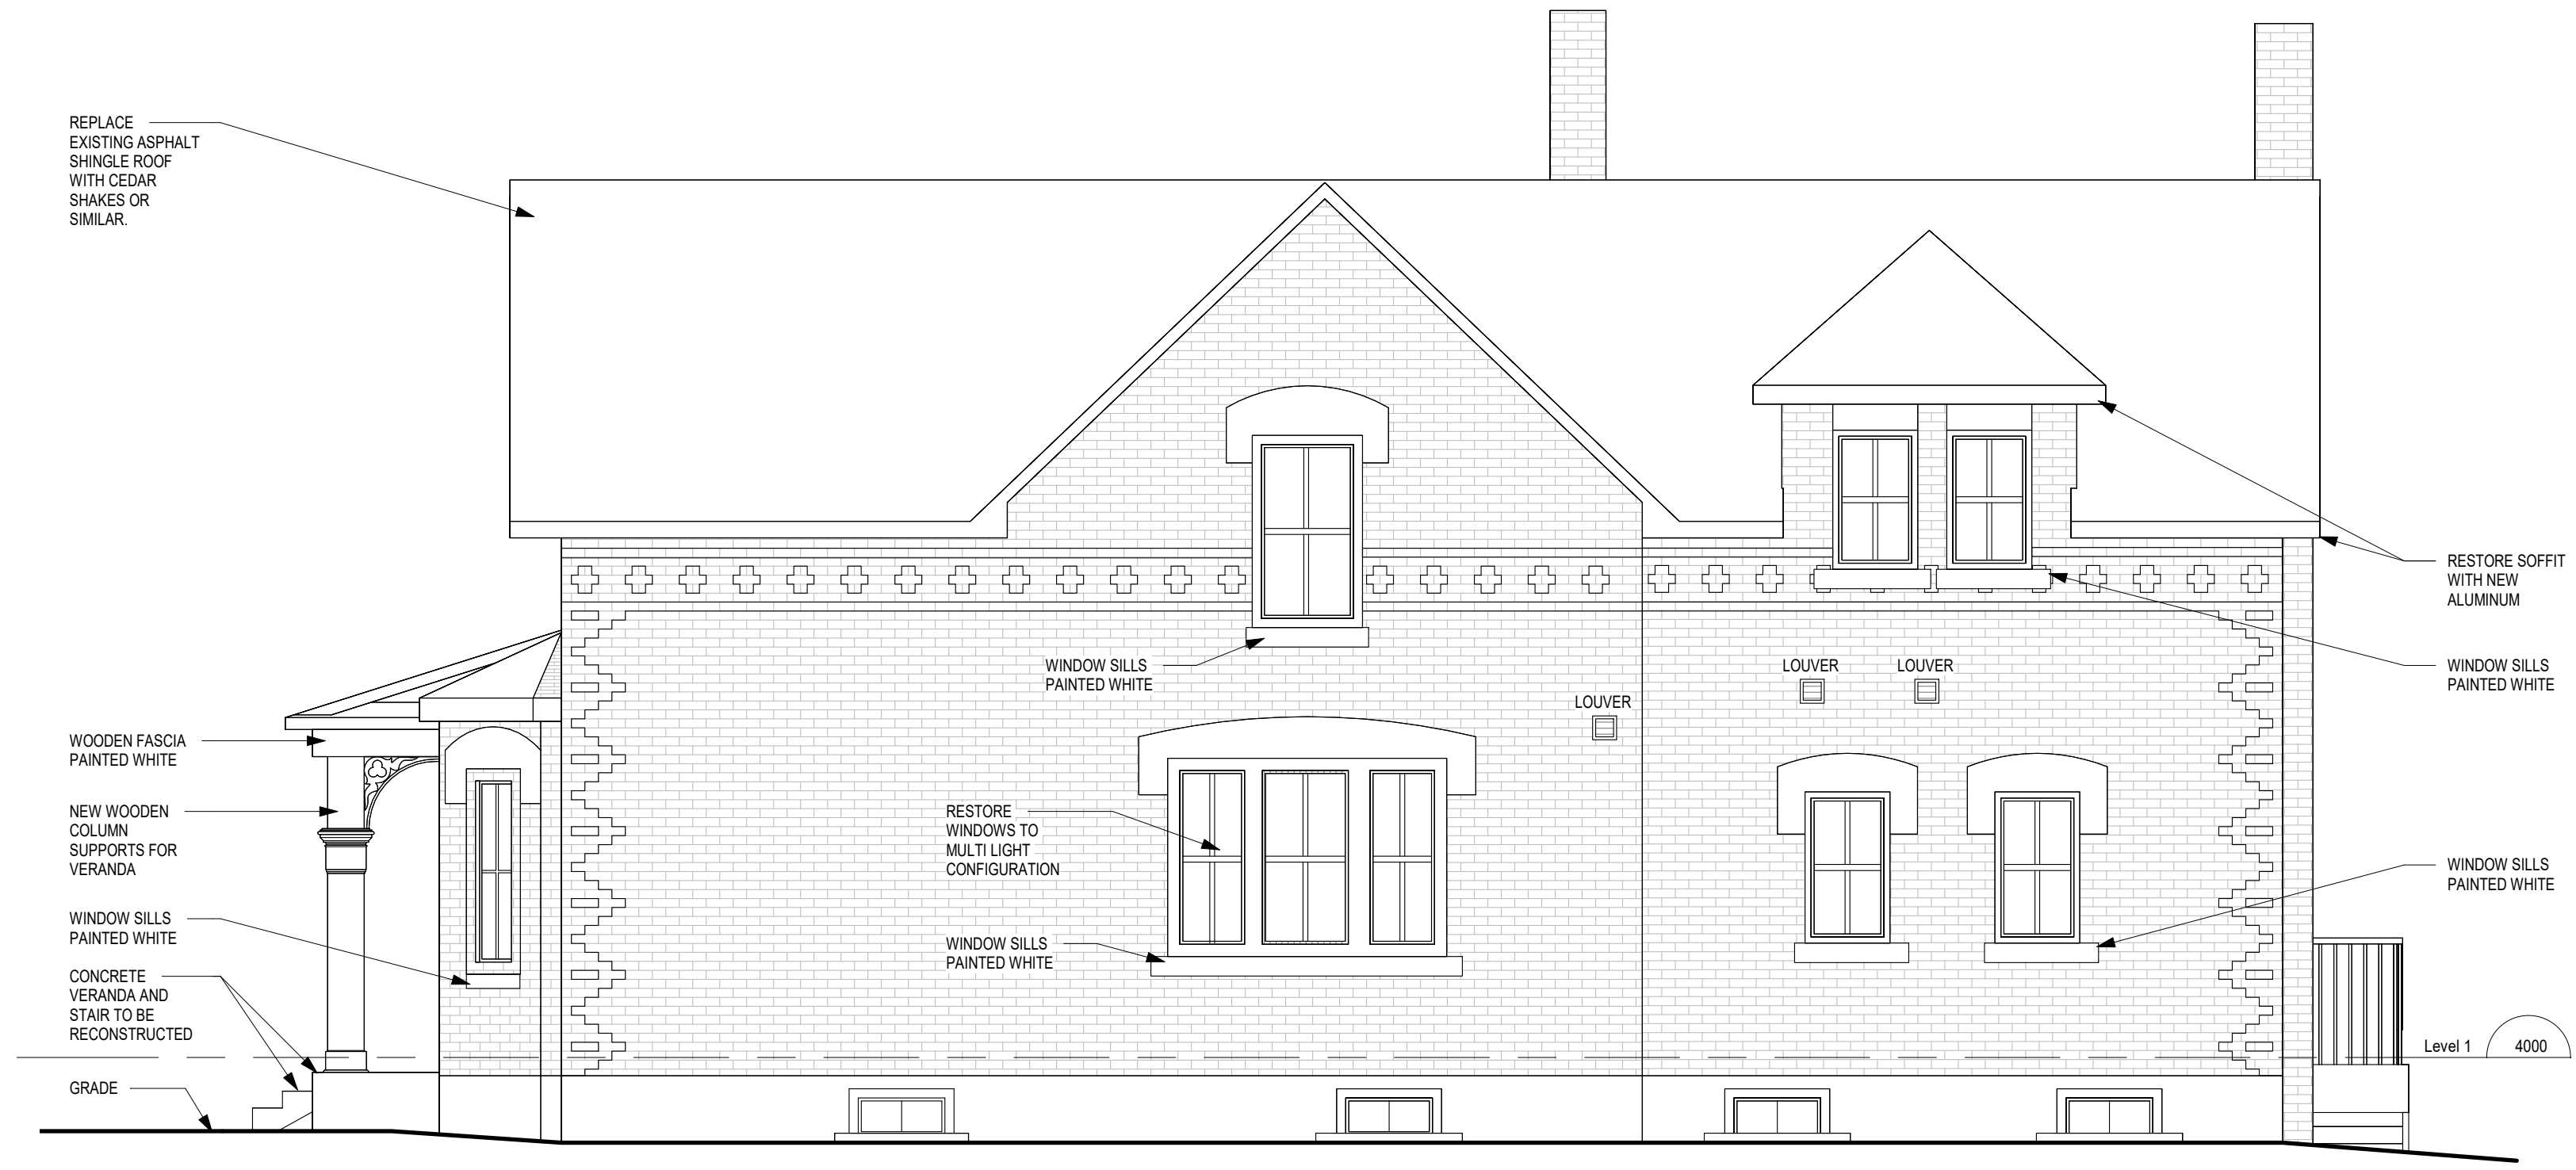
3 NORTH ELEVATION
A402 1:50

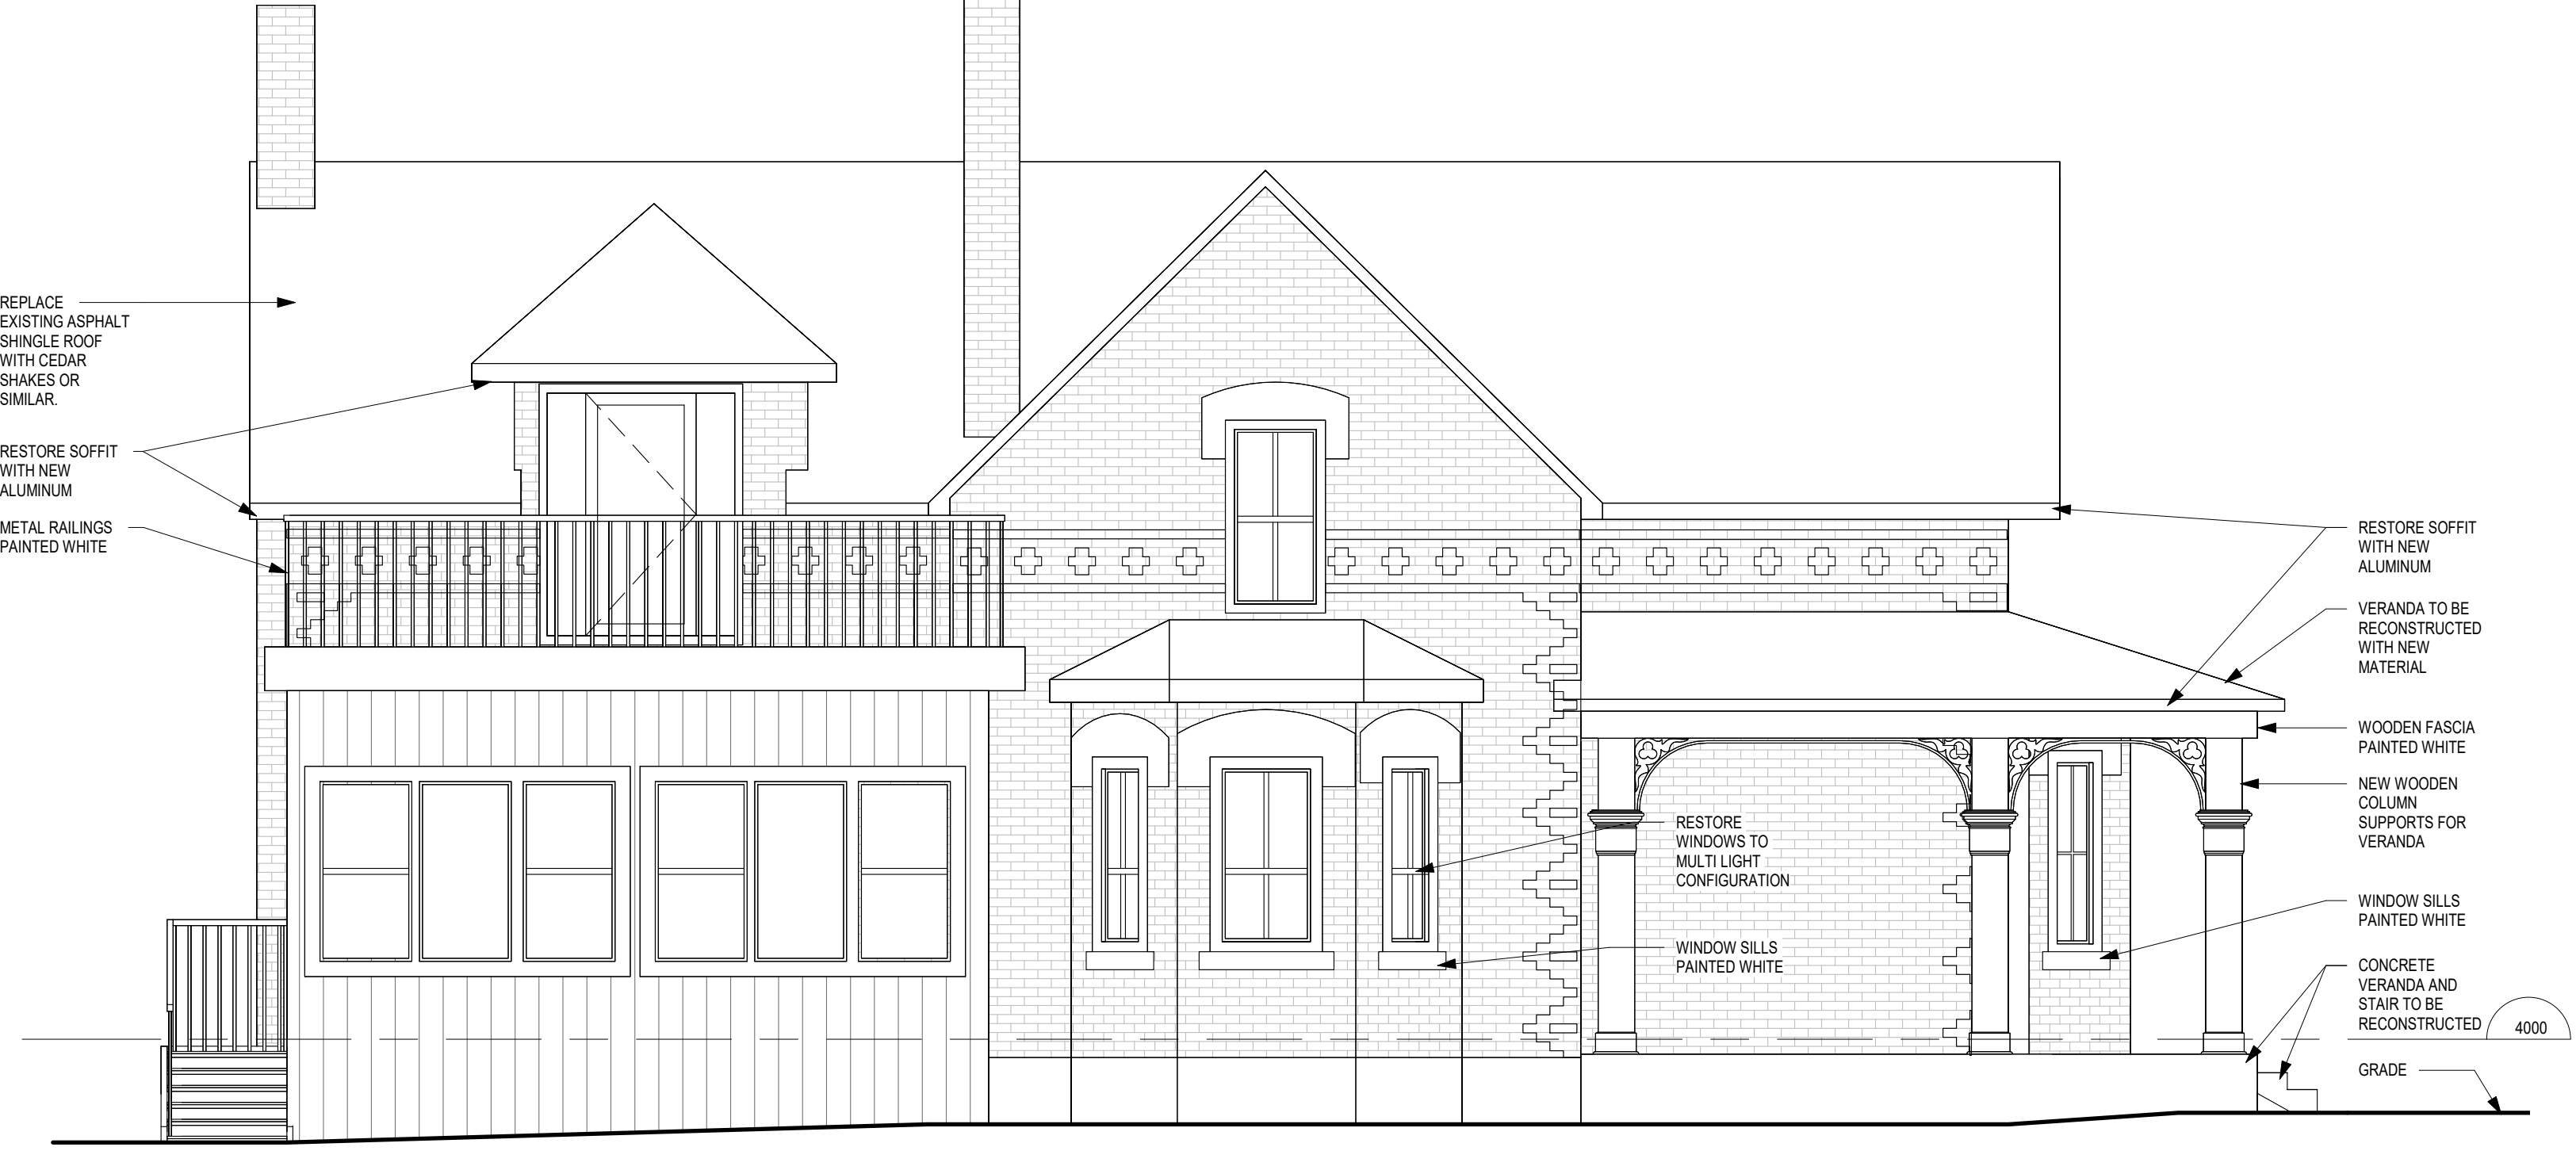
1 SOUTH ELEVATION
A402 1:50
