CONDITION SURVEY

8204 KIPLING AVENUE, WOODBRIDGE, ONTARIO

KEA Report #20071

July 22, 2020

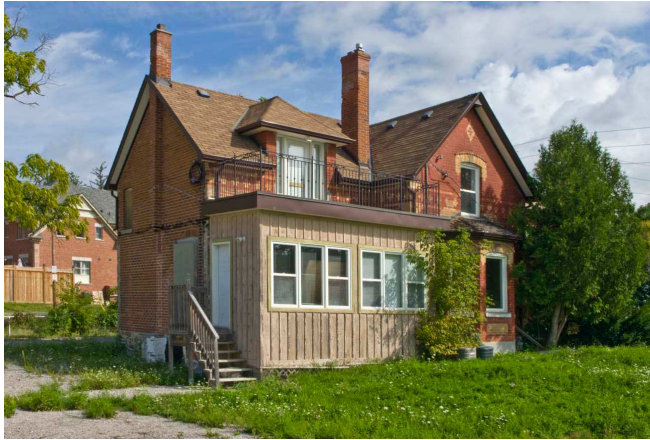
Perimeter Walls -It was noted that all the perimeter walls above ground are of red brick veneered construction with buff brick trim quoined decorative detailing around corners with arches over the windows. See photos 1 to 4

Photo 1 Looking To South-West Corner

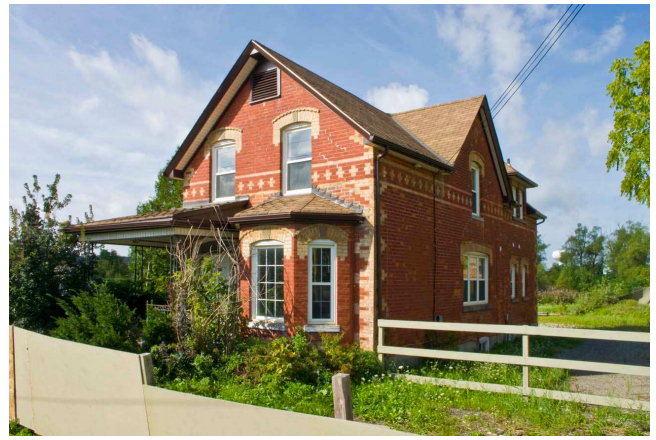
Photo 2 Looking To North-East Corner

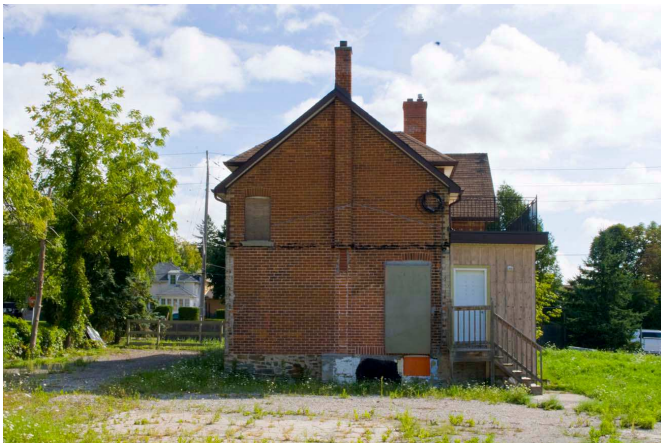
Photo 3 Looking To West Side

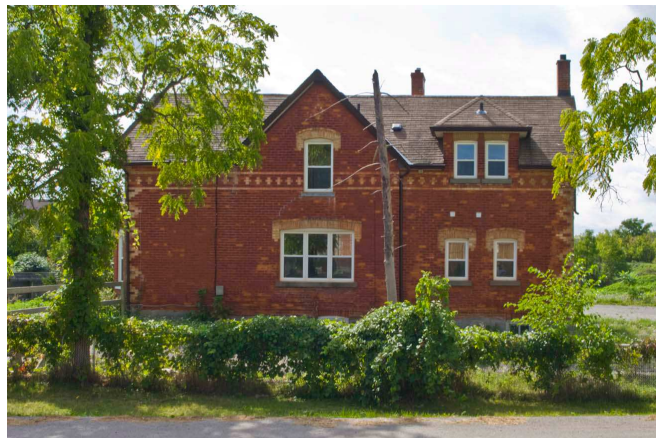
Photo 4 Looking To West Side

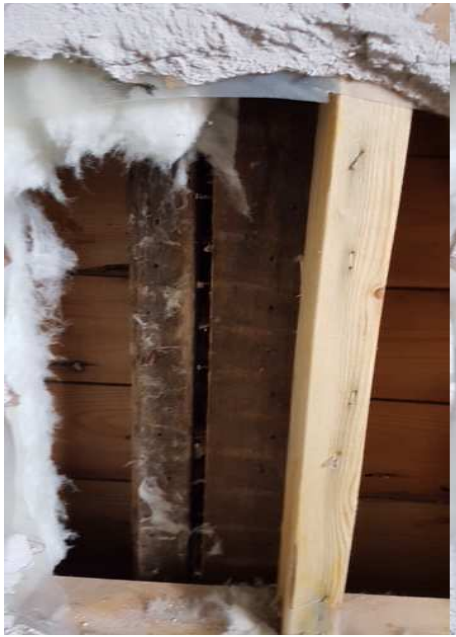
2nd Floor Framing - The existing 2nd floor construction was finished with gypsum board finish. We removed portions of the drywall in a few locations to observe the structural framing. It was seen that the joists for the 2nd floor above the dining room / reception area were seen to be the original 2x8 @ 16" o/c spanning east-west supported on interior walls. See photo 5. The joists above the front entry / reception room on the east side had been removed and replaced with new 9 ½" deep fabricated I- joists spanning north-south and supported on the north exterior wall and the intermediate wall. In the west side portion of the building, we observed that the original 2x8 joists spanned north-south supported on two intermediate beams spanning east-west. We exposed the south side steel beam to confirm it to be 12" deep with 7 ½" wide x ½" thick flange. See photos 6 & 7

Photo 5 - 2x8 Joists 2nd Floor - Living/Dining/Reception

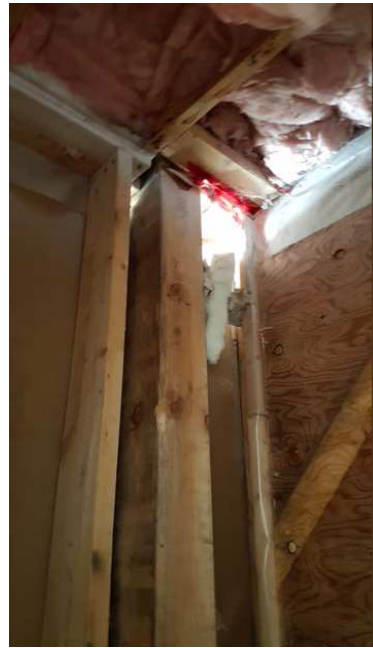
The beam was supported on a 6" x 6" wood post at each end bearing on the foundation wall on the west side and on the fireplace masonry wall on the east side. The same beam was continued above the fireplace in the dining room with steel column supports. The beam on the north side was noted to be 3 ply 2"x10" deep supported on 4 ply 2x4 wood studs.

Photo 6 6x6 Wd Post Supporting Steel Beam Storage Room (Main Flr)

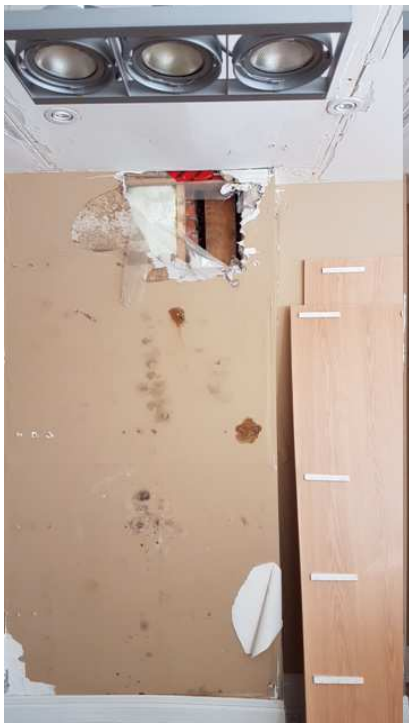
Photo 7 - Steel Beam South side Kitchen

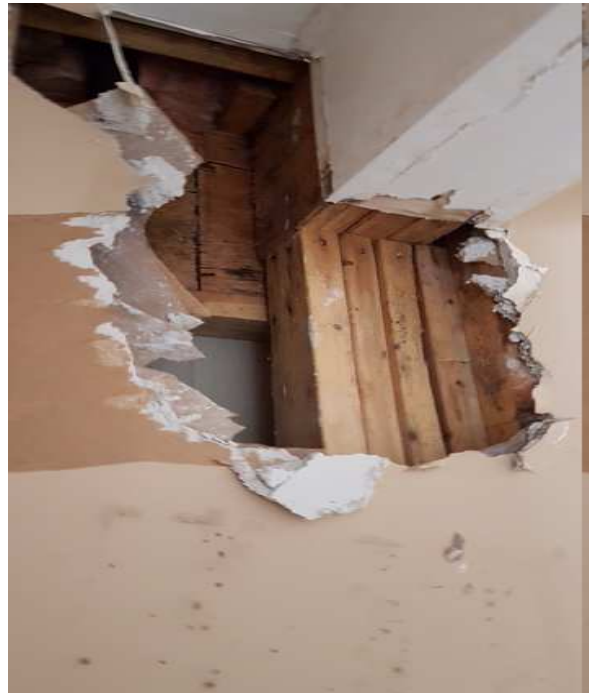
Photo 8 - 4 ply 2x10 Beam Main Floor Powder Room

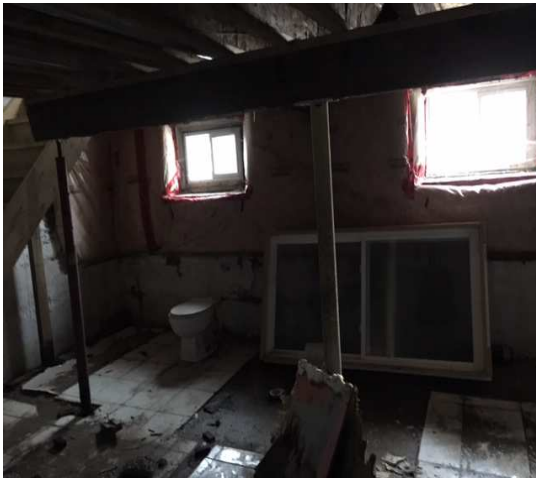
Main Floor Framing - It was noted that all original joists for the main floor framing had been removed and replaced with 12" deep fabricated I- joists spanning north-south supported on an intermediate wood beam. However, we were not able to find any stamped description eg name of the manufacturer or strength grade located on the joists to assess its capacity. No mid-span blocking was seen for the main floor framing. See photos 9 & 10.

Photo 9 12" Deep Main Floor I joists on Wood Bm & Post View Looking North

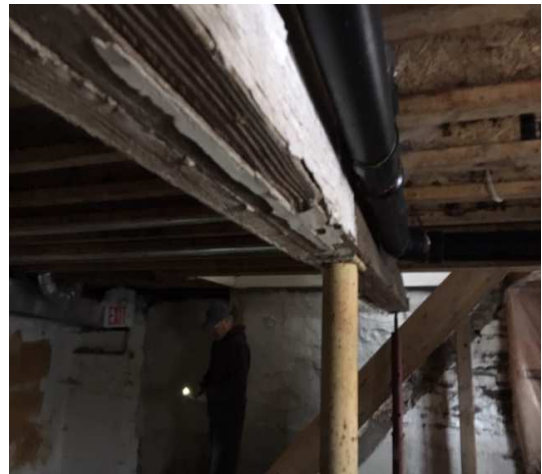
Photo 10 12" deep Main Floor I joists on Wood Bm & Post View Looking West

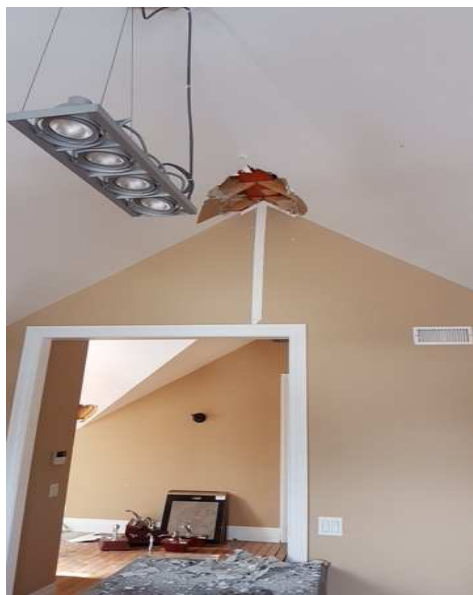
Roof Construction - The building has gable ends on all 4 sides with the main ridge running east - west. However, the interior of the roof framing was concealed with gypsum board finish. The rafters are supported on approximately 4' high perimeter walls on the north and south sides with no collar ties. We exposed the roof framing at two locations to find new 2x8 rafters @ 16" o/c spanning east-west. The ridge was noted to be 2 ply 12" deep LVLs - see photo 11. While we could not confirm it on site, we assume that the ridge was supported on 2-2x4 vertical studs at the east and west gable ends as well as on 2-2x4 vertical studs at the 2 interior walls. The southside valley beam was noted to be 2 ply 12" deep LVL (photo 12) and assumed to be supported on 2-2x4 studs.

Photo 11 2x8 Rafters on 12" Ridge Beam

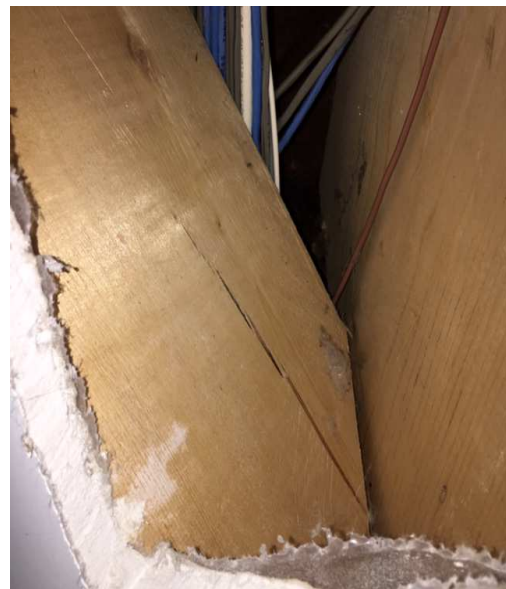
Photo 12 2x8 Rafters on 12" Valley Beam
