BRUCE CORLEY HERITAGE DOCUMENTATION

John Lawrie Farm

8262 Highway 27 Vaughan Ontario

15/07/2015

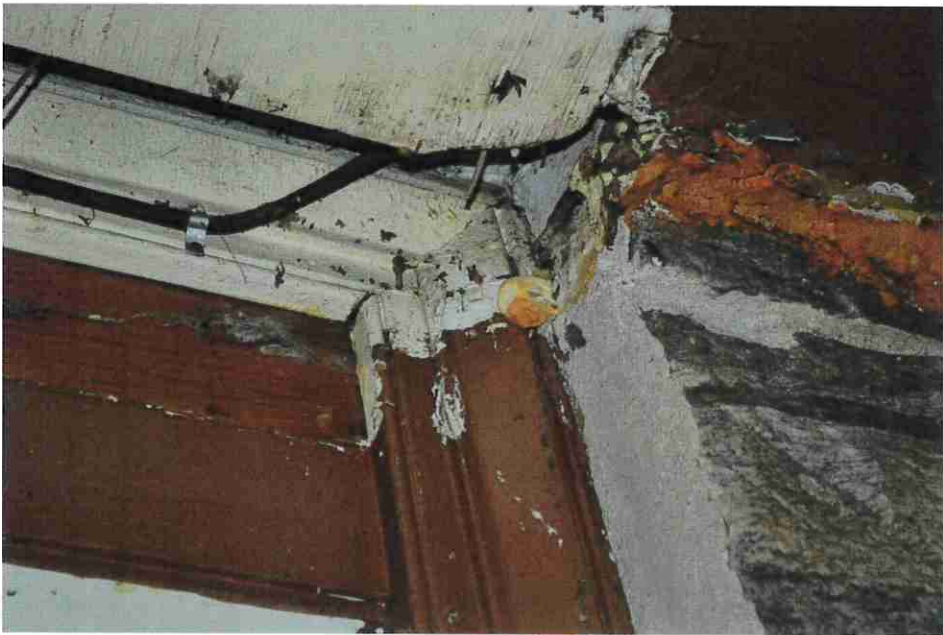
Figure 13: Original Front door casing. Typical exterior trim at all openings.

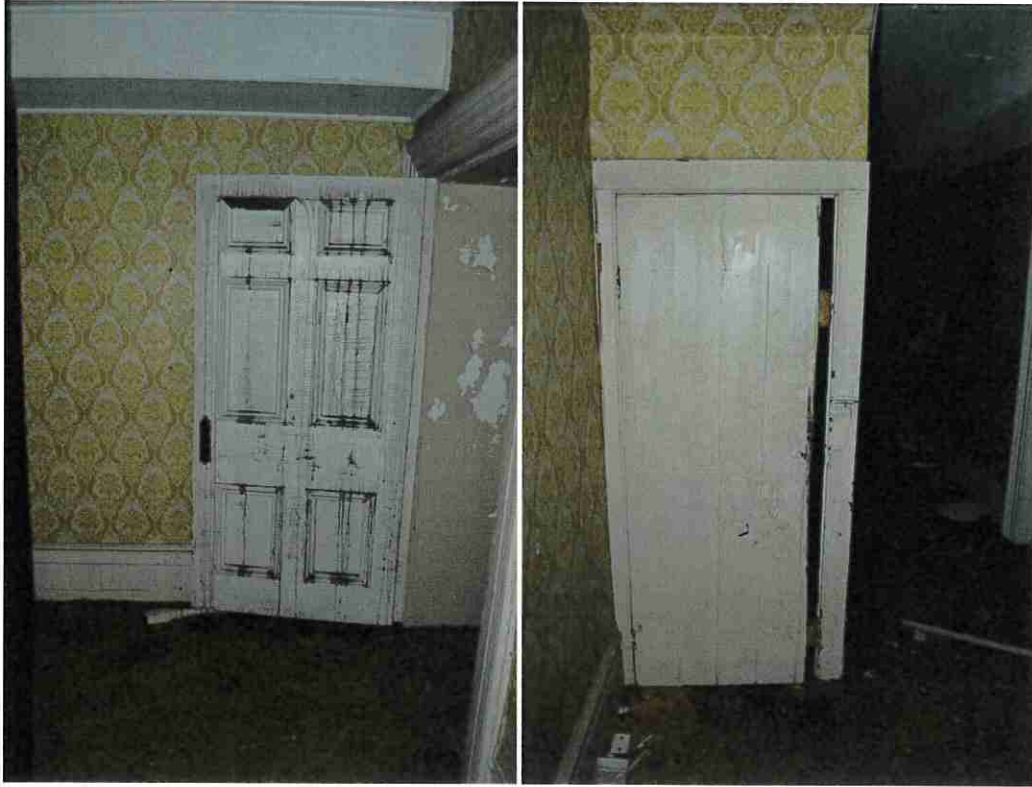
The building retains its basic form and much of the original trim including baseboards, casings, wainscoting and window paneling. Much of the front door is missing and the door at the rear of the hall may be the original front door. Many of the interior panel doors have been destroyed but the pattern remains. The cellar windows are undamaged but all the other windows have been badly damaged. The interior configuration of the rear of the building on the ground floor has been repeatedly altered over the life of the building. The house may have originally been parged all over except the quoins and east lintels. The rear ground floor window is closed off in the wall as a cupboard. The exterior is visible through the broken plaster and is in very exceptionally good condition. The surrounding wall is parged.

Figures 18 and 22: Original front door at rear of hall and door to cellar.

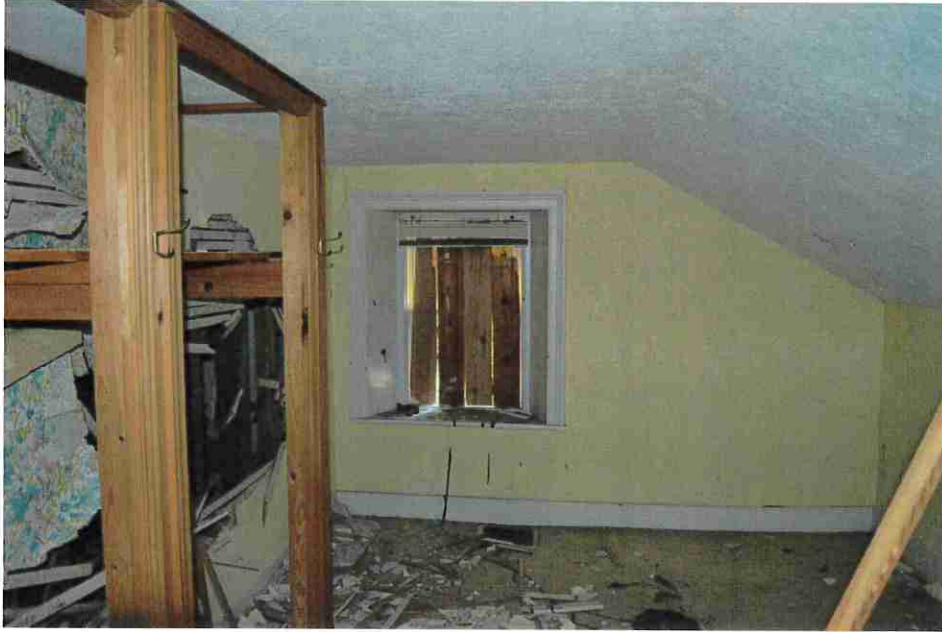
Figure 27: North West Bedroom Note sawn lath. The north two bedrooms were originally combined.

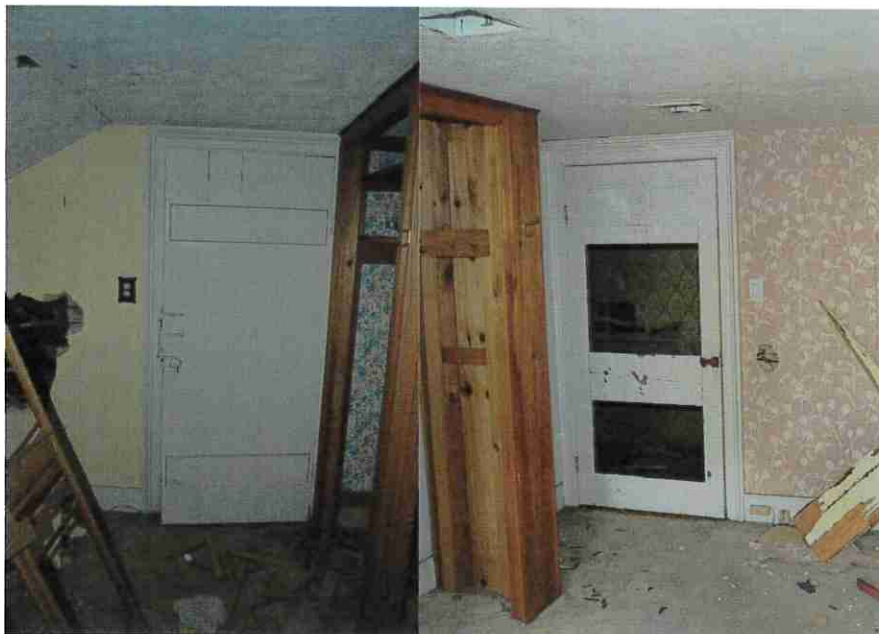
Figure 30: North and south bedroom doors. Note plank north doors compared to six panel south bedroom doors.

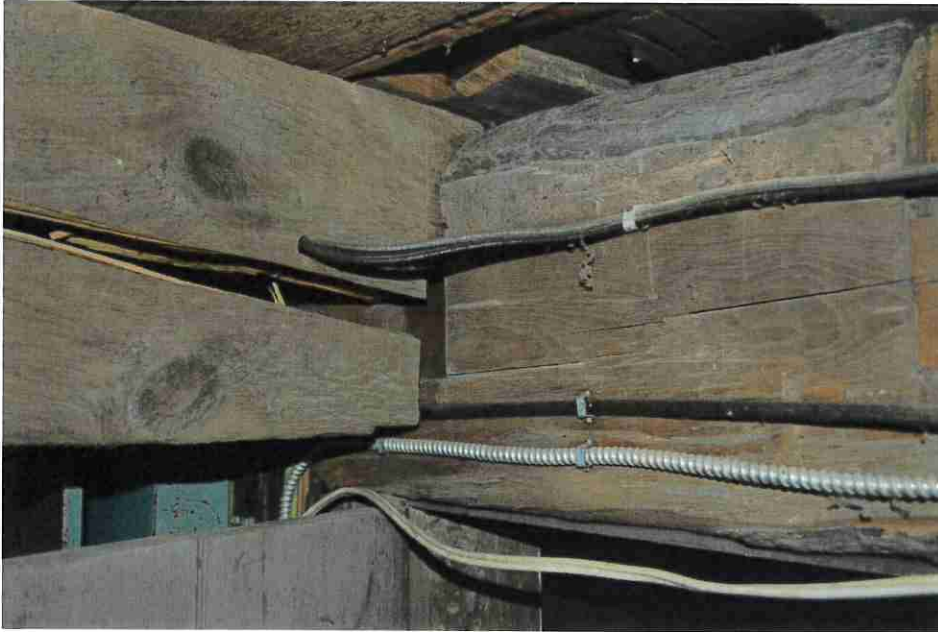
Figure 39: Cellar summer beam on a later brick wall. Note typical joist split because of the insufficient bearing.

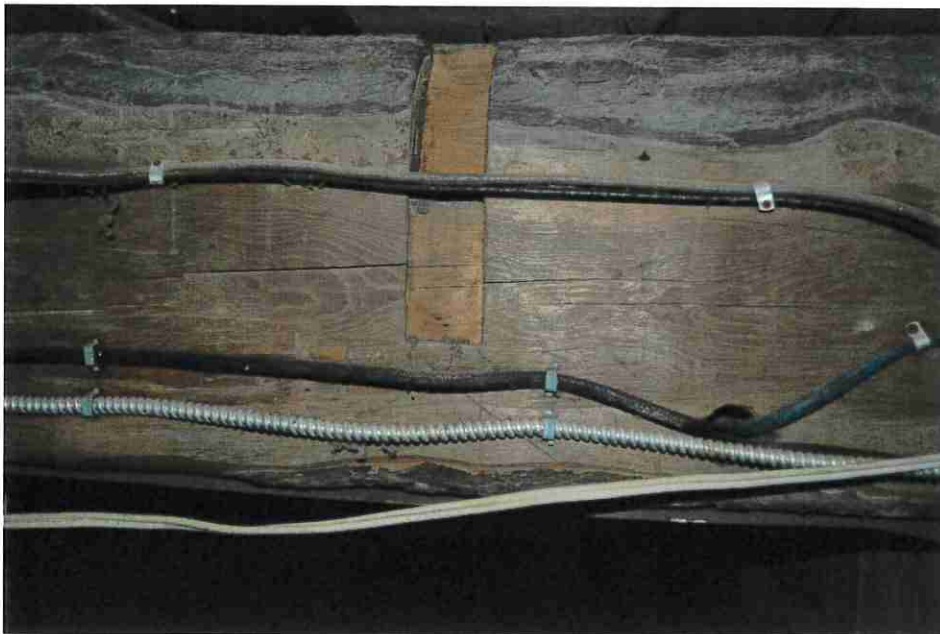
Figure 40: Beam pocket with one and four inch bearing.

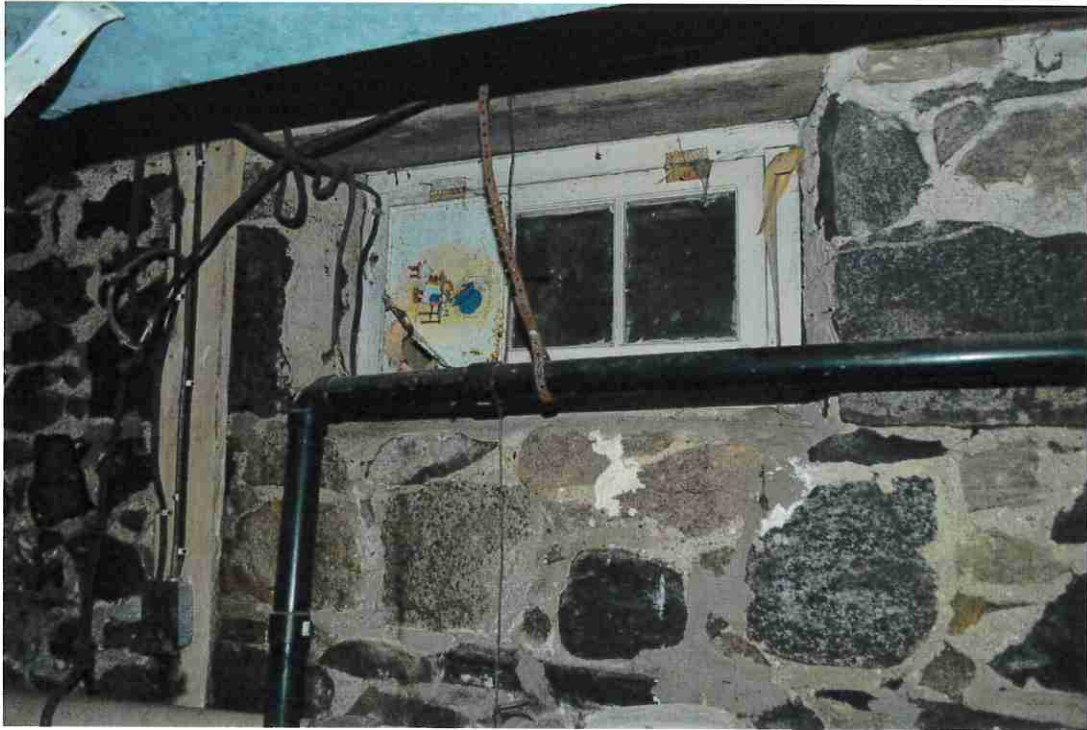
Figure 43: Cellar window south room Note lack of parging on granite walls.

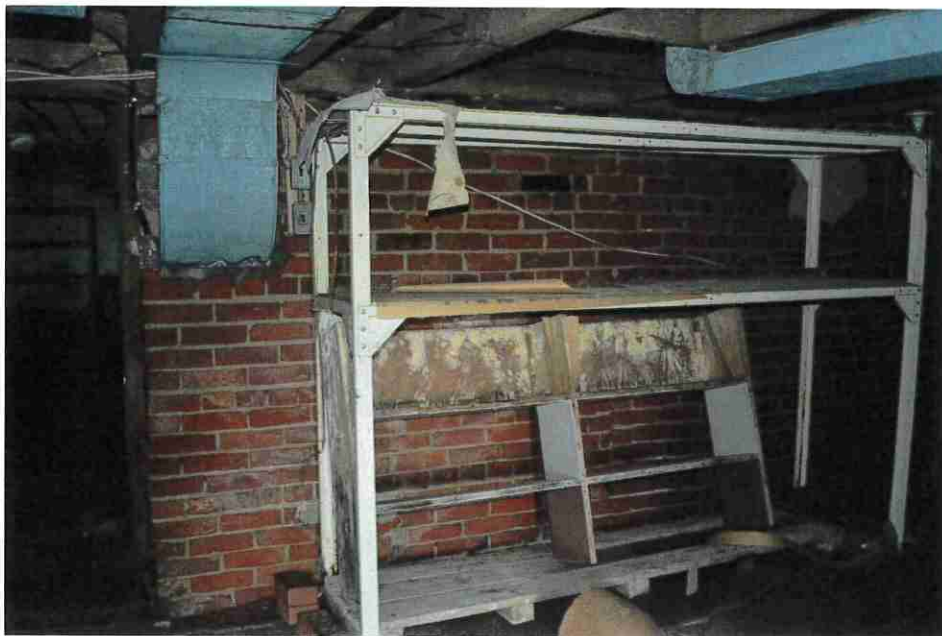
Figure 44: Brick wall under summer beam note attached to stone walls.

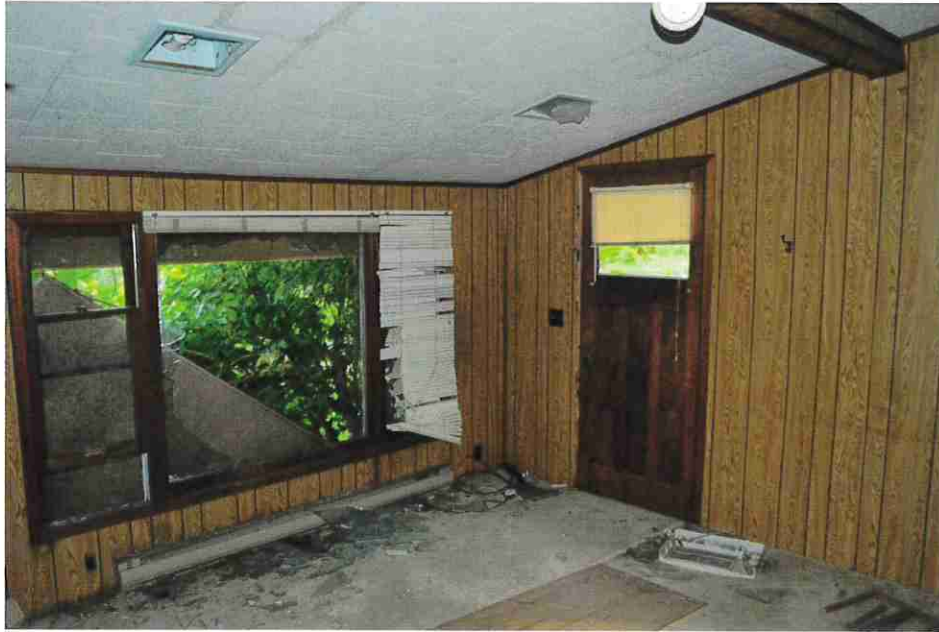
All evidence of the original porch design was lost when they were enclosed. A double wythe brick garage with a room in the rear may have originally been a carriage house. It may have been built when the addition was bricked. The west wall is badly heaved and bowed from frost and structurally unsound.

Figure 49: Enclosed south porch.

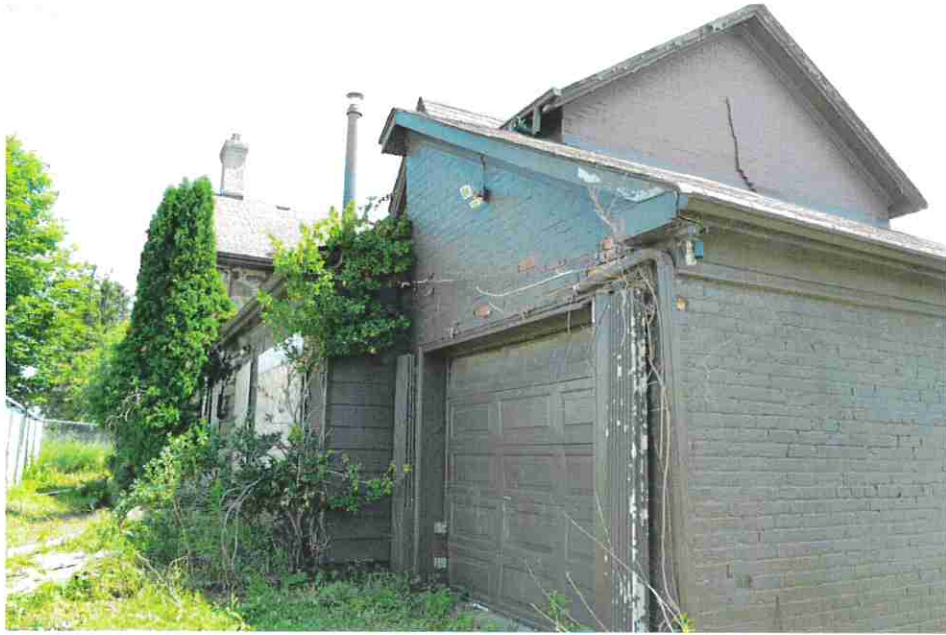
A single solid wood column was found on site along with two wood pilasters placed later on either side of the garage door. The pilasters are quite old and may have been placed originally at the front of the house. The column may have come from the rear porch.

Figure 55 and 56: Garage. Note pilasters attached later.
