CULTURAL HERITAGE IMPACT ASSESSMENT REPORT (DRAFT)

DEVLIN HOUSE

11151 KEELE ST, VAUGHAN, ON

APRIL 10, 2023

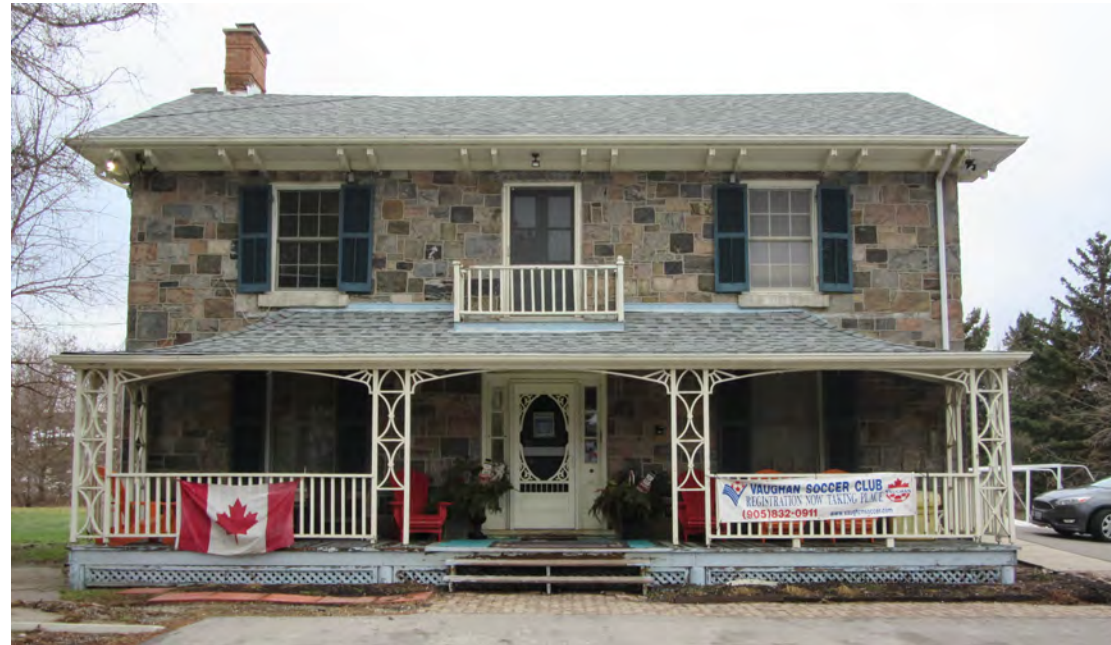
Figure 4:: view of front/west (street) face.

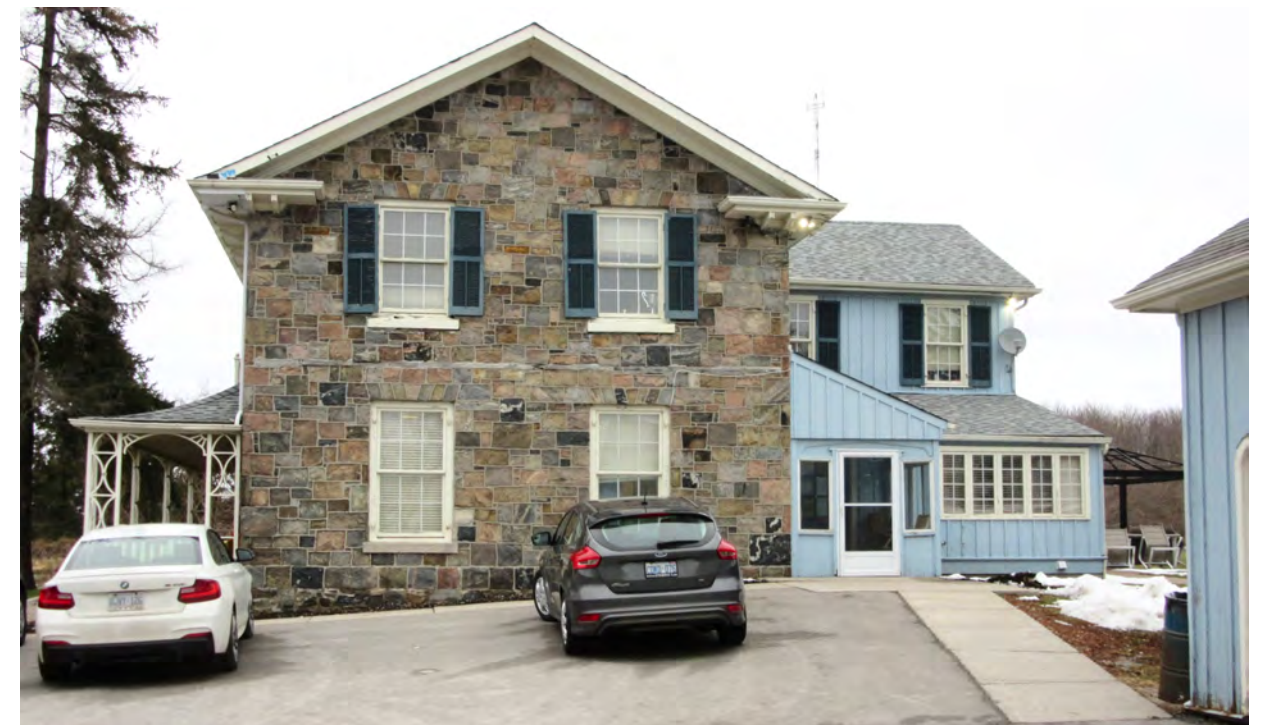
Figure 7: view of side/south face with squared stone, raised pointing, wood nailer for removed wrap-around porch.

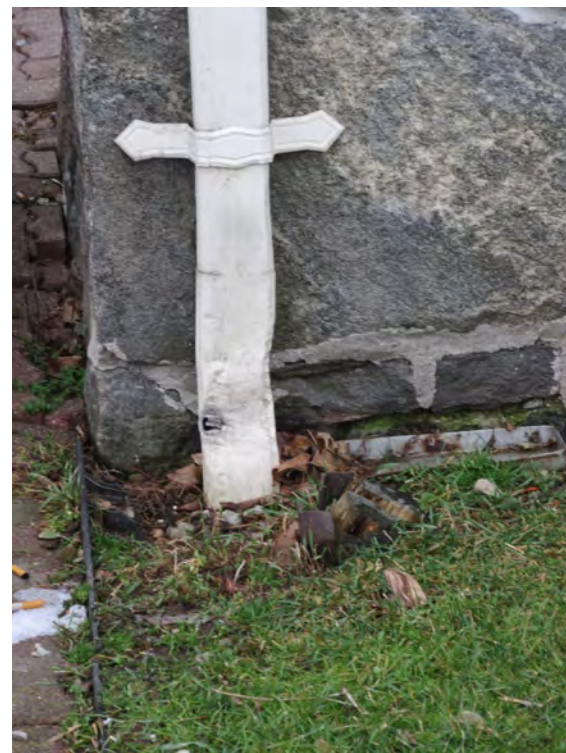
Figure 10: damaged aluminum RWL, too close to masonry. Figure 11: temporary animal infiltration screen

- 6.1.6 Rainwater leaders need to be offset from masonry, directed away from foundation & window wells; Rainwater leaders need to be offset from masonry, directed away from foundation & window wells; typical for all rainwater leaders (RWL): rework rainwater leader & straps so that off-set 1.5 " away from brick quoins; also insert inspection hole (or leaf interceptor) at top & bottom of vertical pipes.

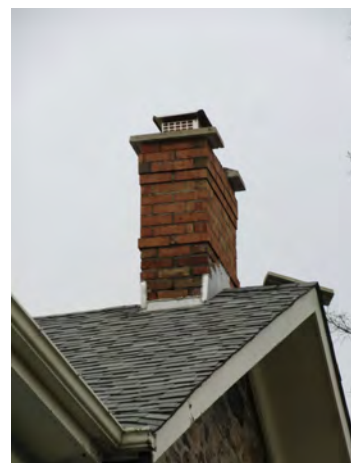
Figure 12

- 6.3 Reinstate chimney cap (figure 12) visible at north gable roof; anchor, seal around flues, flash.
- 6.4 Rear painted wood balcony requires temporary shoring, investigation for and original or sound components, re-securing to building structure in appropriate, understated manner, repair or replacement of wood elements, treatment with appropriate paint finish.
