**ARBORIST REPORT
Site Tree Inventory & Tree Preservation Plan**

**Residence:
Marilu Abreu
8 Lester B. Pearson Street
Kleinburg ON
LOG 1C0**

Project No. 24-10182023

October 18, 2023

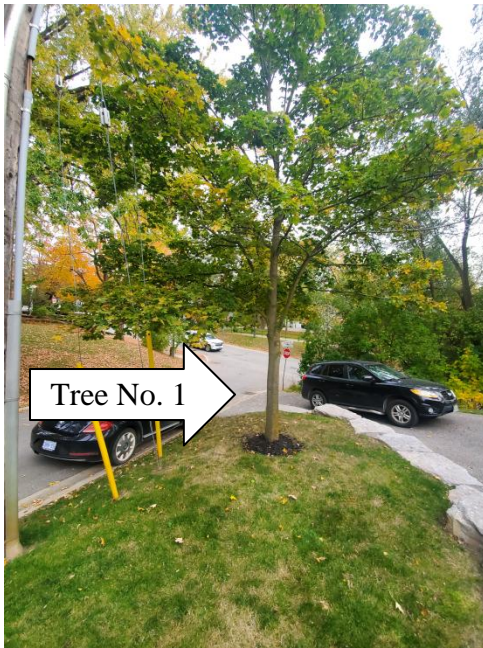
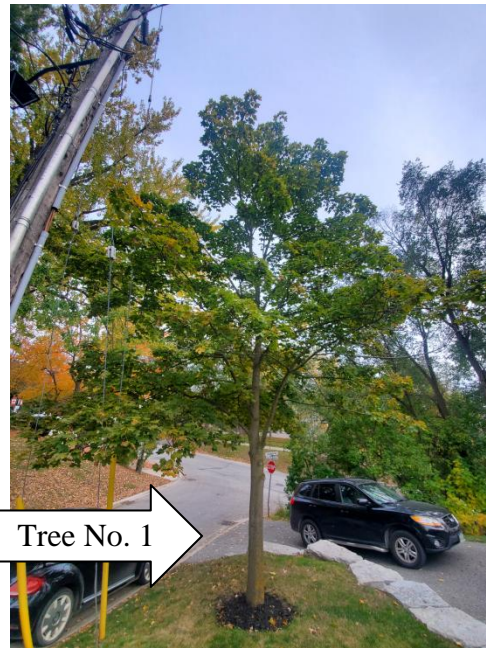
TREE NO. 1 - Norway Maple

This Norway Maple is located on the applicant's property.

This tree is in fair condition with a living crown ratio of 80%.

This tree will not be affected by construction.

This tree will be preserved and protected before and during construction.

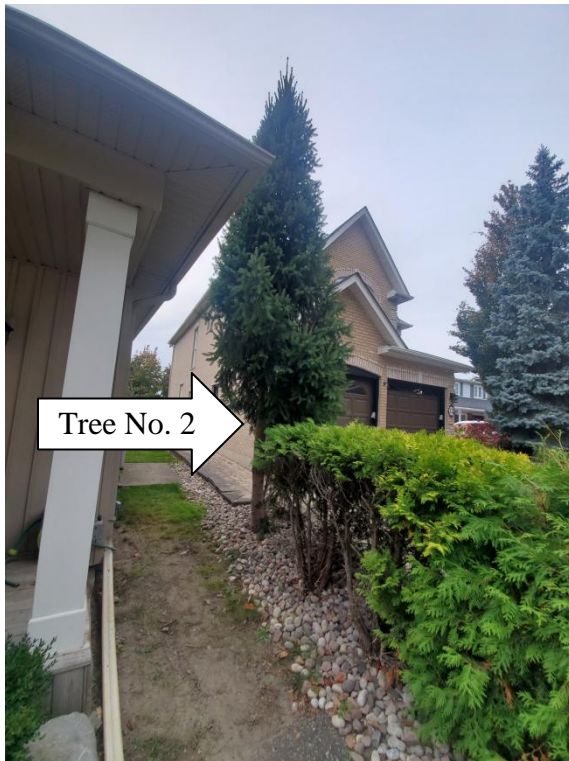
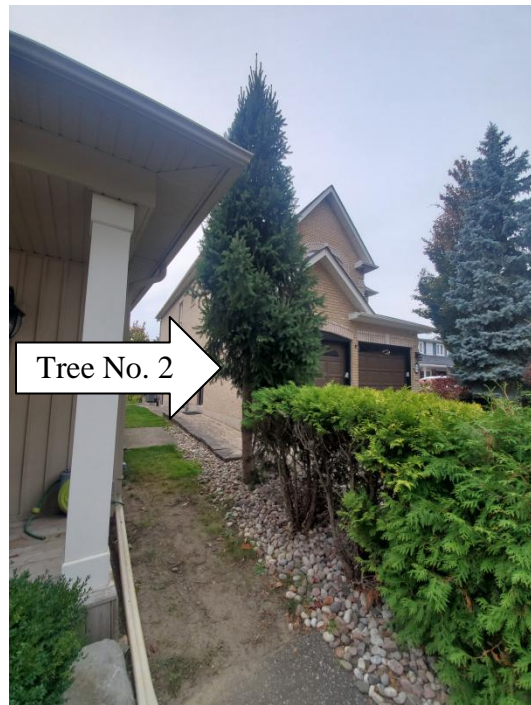
TREE NO. 2 – White Spruce

This White Spruce is located on the neighbouring property to the north.

This tree is in fair condition but has been aggressively elevated due to lack of grown space.

The living crown ratio is 70%.

This tree will not be affected by construction.

This tree will be preserved and protected before and during construction.

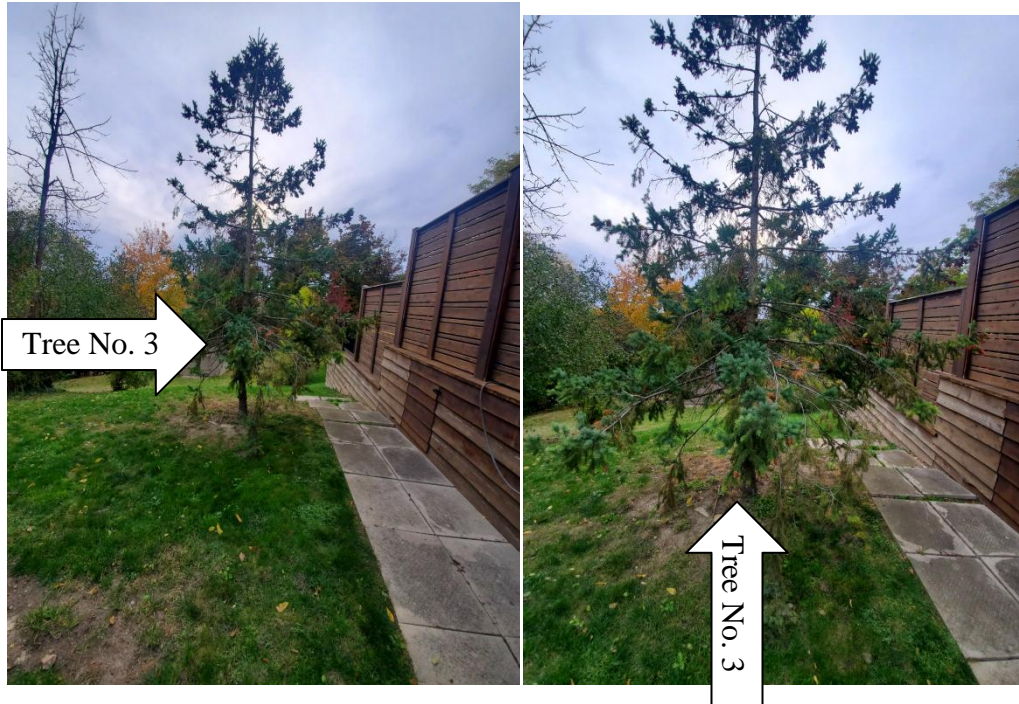
TREE NO. 3 – White Spruce

This White Spruce is located on the applicant's property.

This tree is poor condition and has a living crown ratio of 40%.

This tree will be removed to accommodate the construction of a new dwelling and landscaping plan.

A tree removal permit is not required due to its DBH size. The replanting obligations are not applicable.

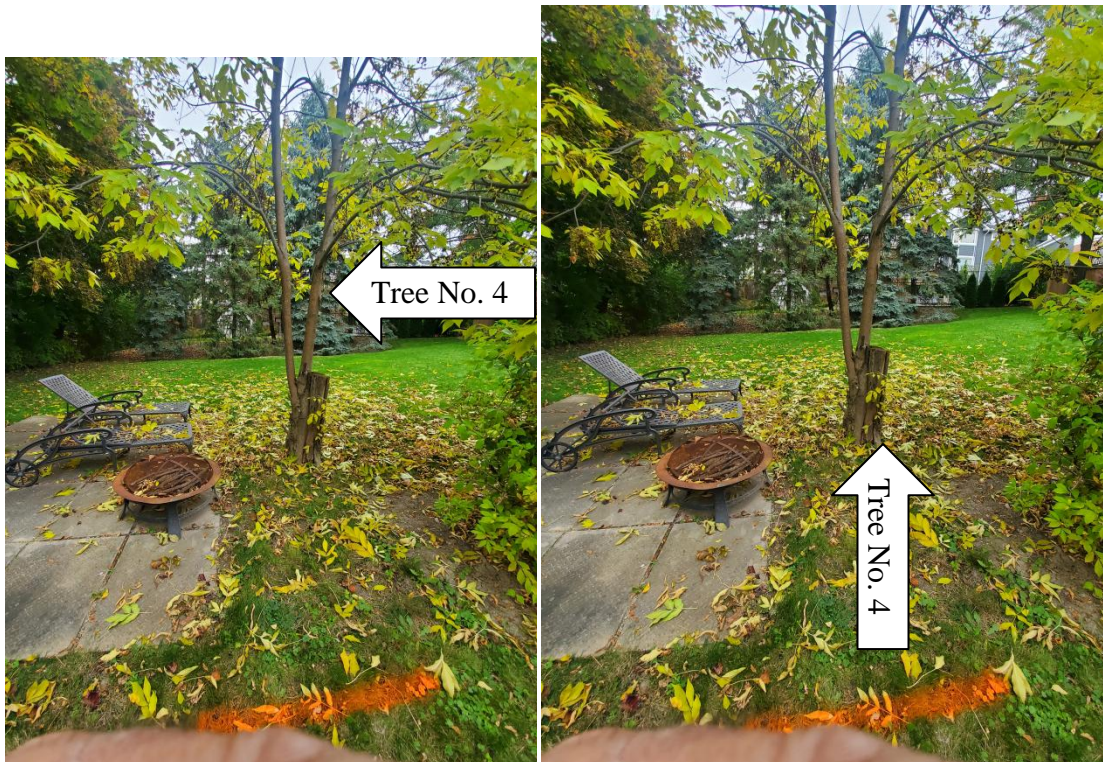
TREE NO. 4 – White Ash

This White Ash tree is located 2.4 m from the property line on the neighbouring property to the north. The orange marker indicates property line.

This tree is in poor condition with a living crown ratio is 20%. The two stems in the canopy are essentially sucker growth regenerated from a failed ash tree, due to “emerald ash borer disease”. Given this tree’s DBH size, distant from property line and species, protection with TPZ hoarding is not required.

This tree will not be affected by construction.

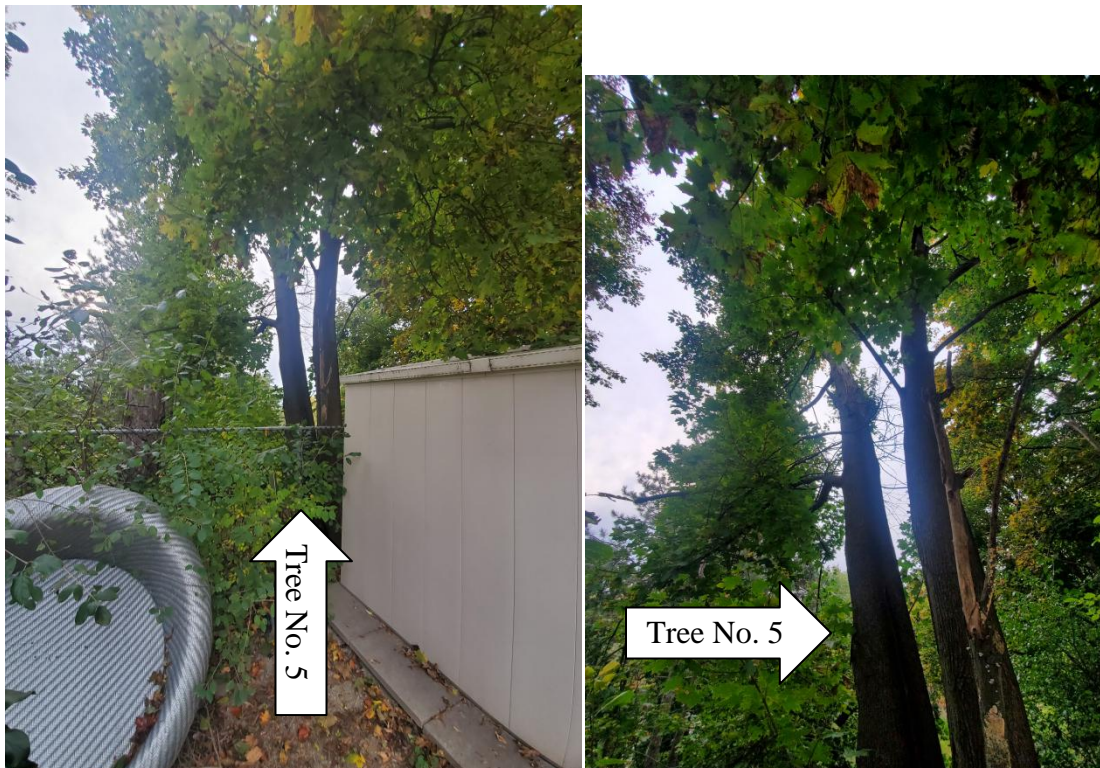
TREE NO. 5 – Norway Maple – 2 stem

This Norway Maple is in poor condition and located on the neighbouring property to the west, 0.7m from the property line (fence).

The living crown ratio is approximately 40% due to crowded growing conditions.

This tree will not be affected by construction.

This tree will be preserved and protected before and during construction of the new dwelling and landscape plan with “Heavy Duty Hoarding” ...refer to drawing ULA110A.

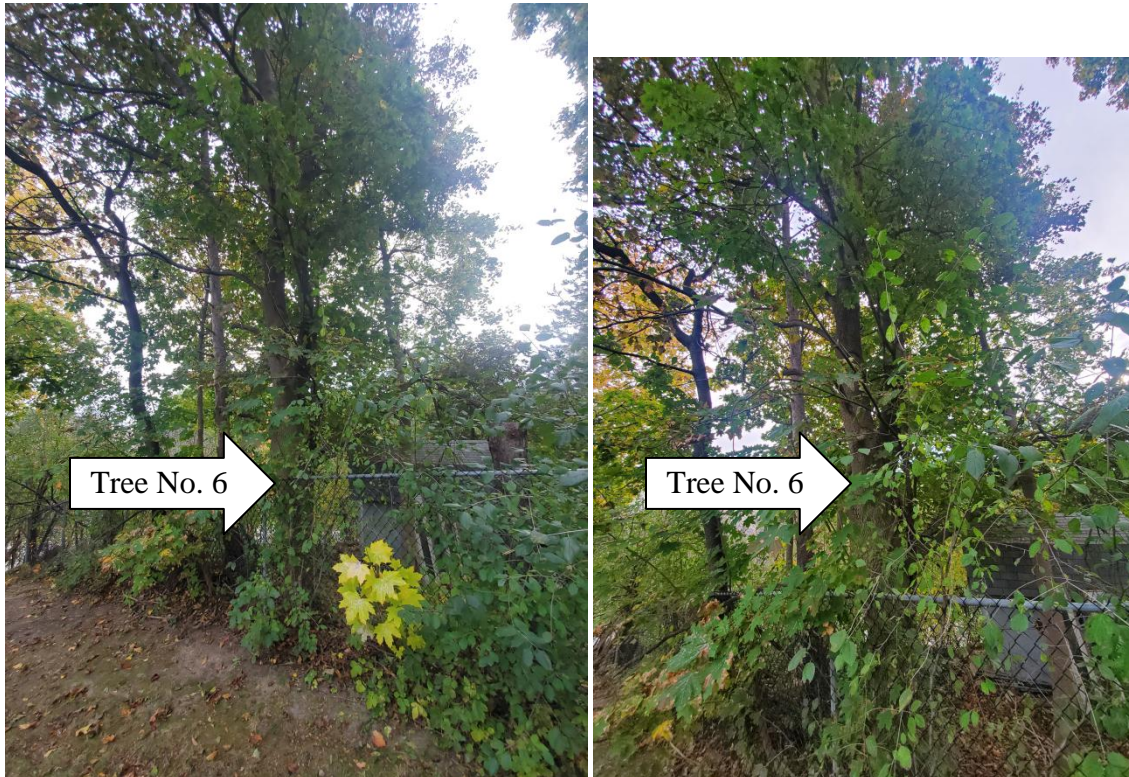
TREE NO. 6 – Norway Maple

This Norway Maple is in fair condition and located on the neighbouring property to the west, 0.5m from the property line (fence)..

The living crown ratio is approximately 50% due to crowded growing conditions.

This tree will not be affected by construction.

This tree will be preserved and protected before and during construction of the new dwelling and landscape plan with “Heavy Duty Hoarding” ...refer to drawing ULA110A.

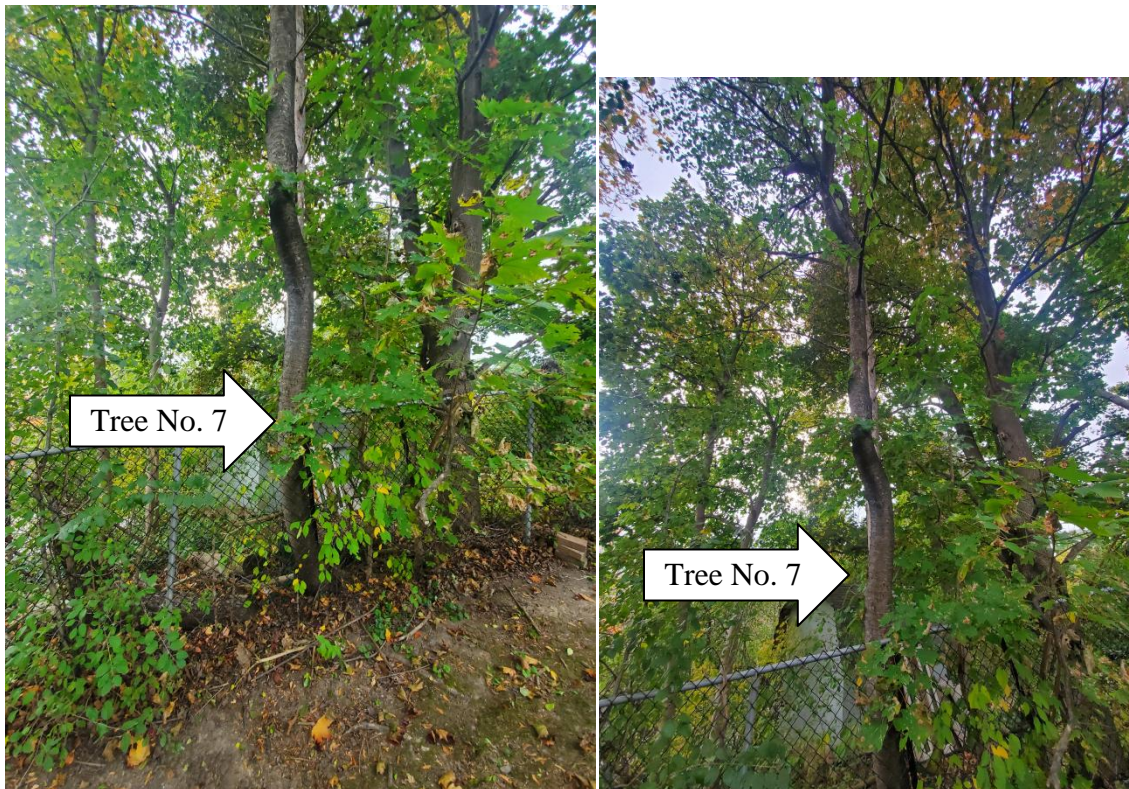
TREE NO. 7 - Cherry

This Cherry tree is in poor condition and located on the neighbouring property to the west, 0.3m from the property line (fence).

The living crown ratio is approximately 40% due to crowded growing conditions.

This tree will not be affected by construction.

Due to this tree DBH size, TPZ hoarding is not a requirement. As a courtesy to the neighbouring property to the west, the tree will be protected with vertical Heavy Duty Hoarding...refer to drawing ULA110A.

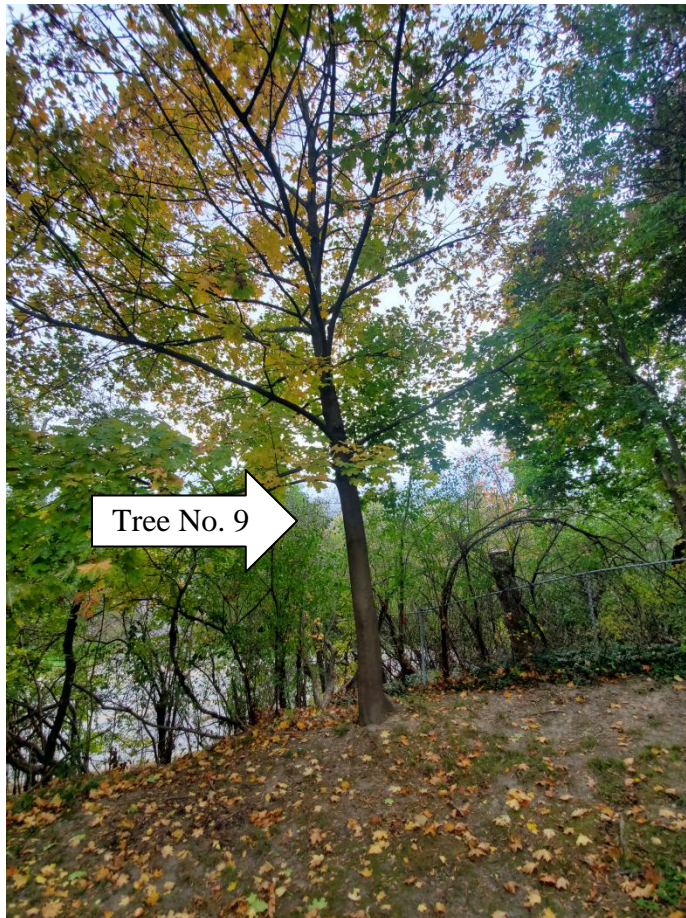
TREE NO. 9 – Norway Maple

This Norway Maple is in fair condition and located on the applicants property.

The living crown ratio is 60%.

This tree will not be affected by construction.

This tree will preserved and protected before and during construction of new dwelling and landscaping plan with “Heavy Duty Hoarding”refer to drawing ULA110A.

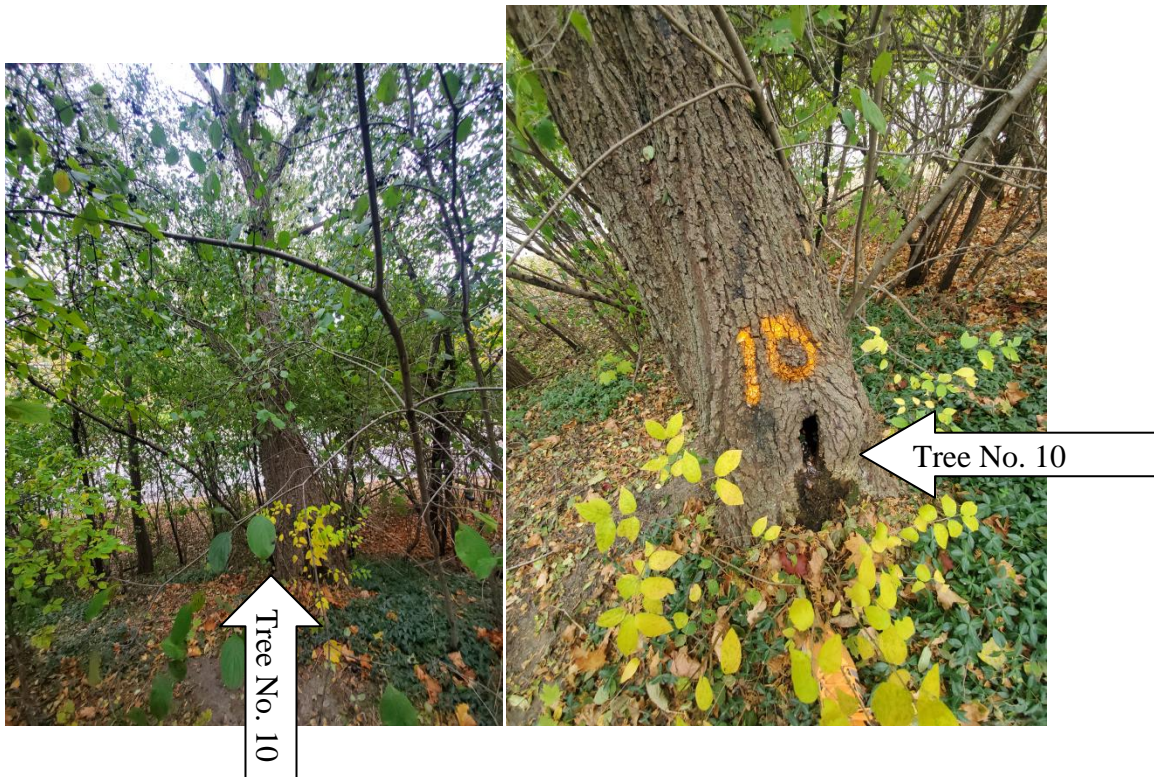
TREE NO. 10 – Black Willow

This Black Willow is in fair to poor condition and located on the applicant's property.

The living crown ratio is 50%. The tree has a large cavity at the base.

This tree will not be affected by construction.

This tree will be preserved and protected before and during construction of new dwelling and landscaping plan with "Heavy Duty Hoarding"refer to drawing ULA110A.

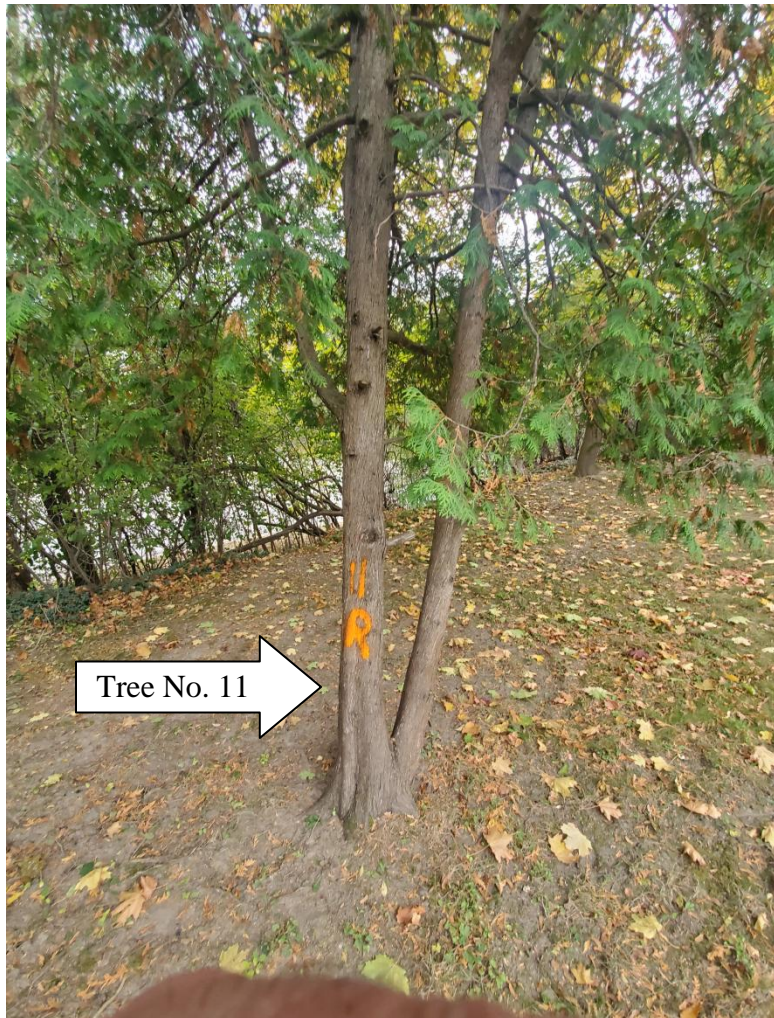
TREE NO. 11 – White Cedar – 2 Stem

This 2 stem White Cedar tree is in poor condition and located on the applicant's property. The living crown ratio is 30%.

This tree will be removed to accommodate the construction of a new dwelling and landscaping plan. The replanting of 1 tree is required within 2 years of permit issuance.

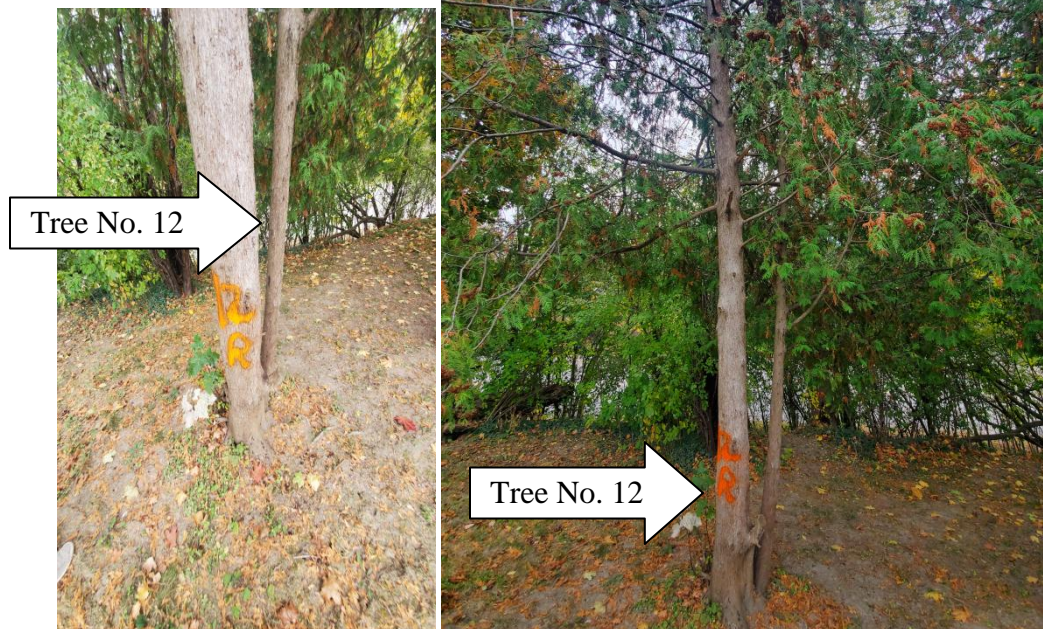
TREE NO. 12 – White Cedar – 2 stem

This 2 stem White Cedar tree is in poor condition and located on the applicant's property. The living crown ratio is 30%.

This tree will be removed to accommodate the construction of a new dwelling and landscaping plan. The replanting of 1 tree is required within 2 years of permit issuance.

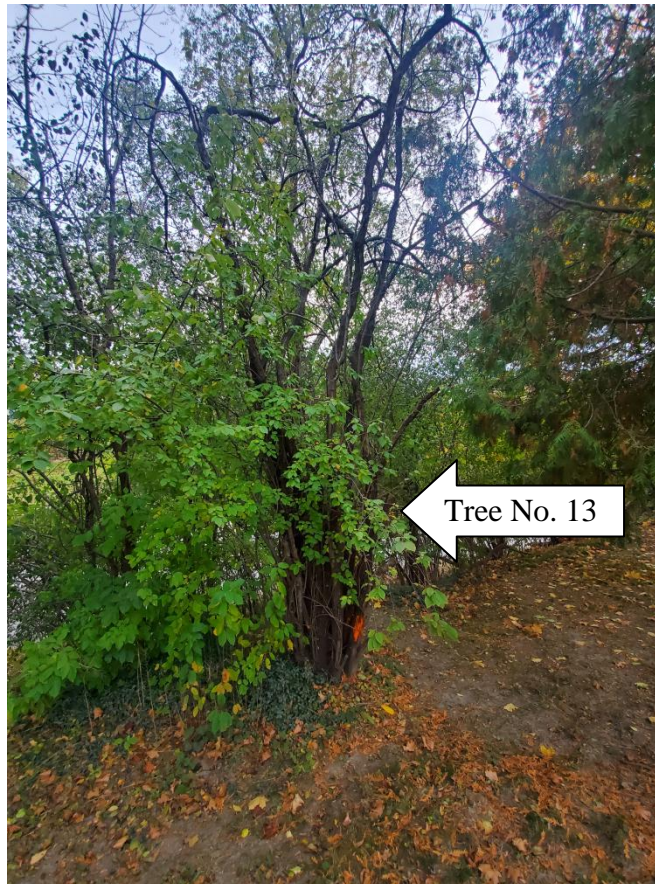
TREE NO. 13 – Buckthorn – multistem

This multistem Buckthorn tree is dead and located on the applicant's property.

This tree will be removed due to its condition.

No permit is required due to its condition. Replanting obligation does not apply.

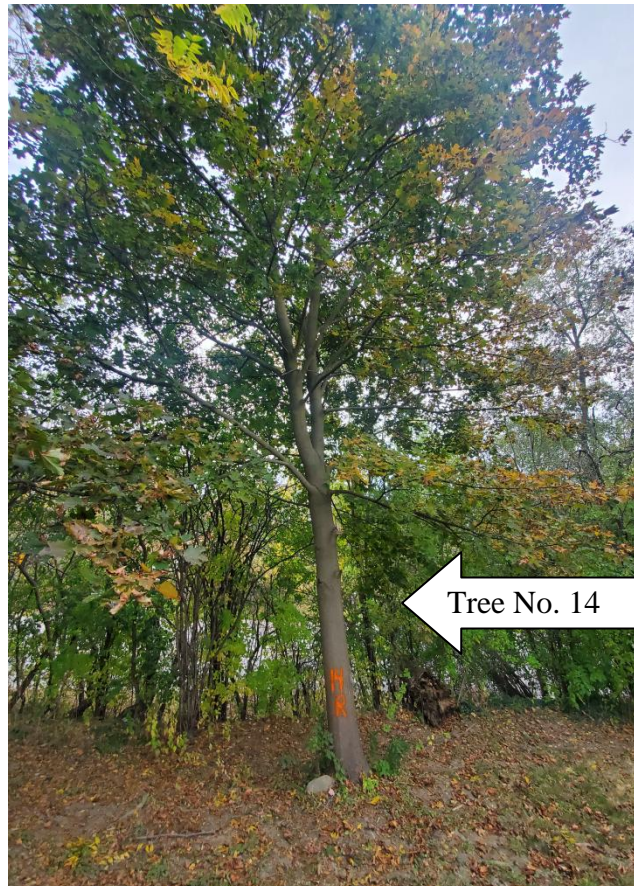
TREE NO. 14 – Norway Maple

This Norway Maple is in fair condition and located on the applicant's property.

The living crown ratio is 70%.

This tree will be removed to accommodate the construction of the new dwelling and landscape plan.

Permit is required for removal and the replanting of 2 trees is required within 2 years of permit issuance.

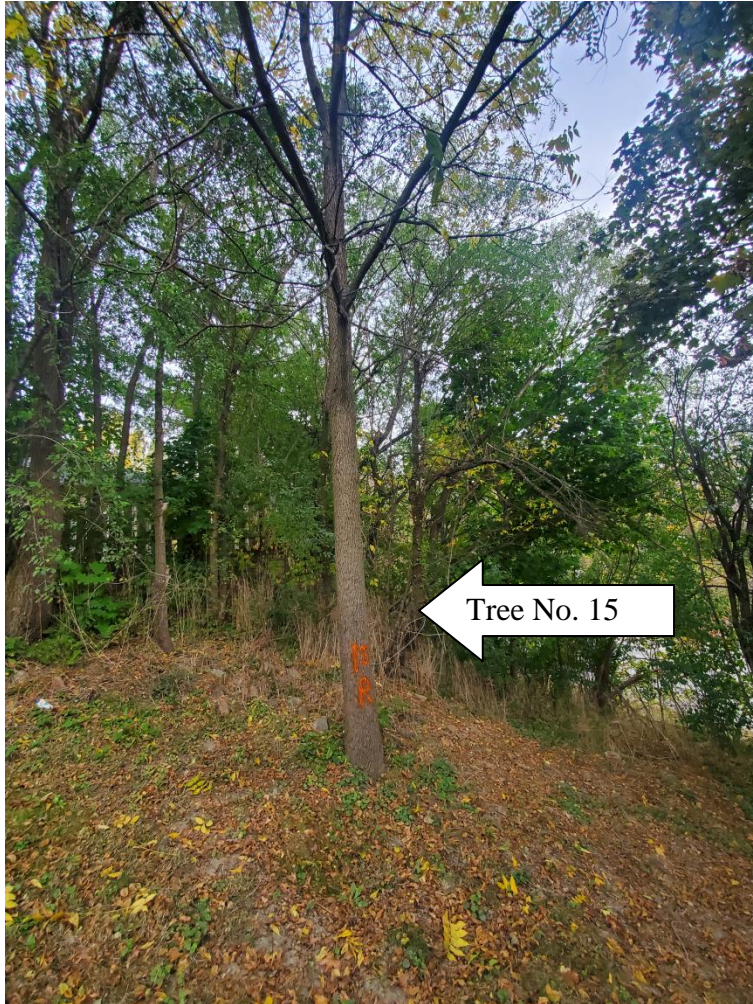
TREE NO. 15 – Black Walnut

This Black Walnut tree is in fair condition and located on the applicant's property.

The living crown ratio is 70%.

This tree will be removed to accommodate the construction of the new dwelling and landscape plan.

Permit is required for removal and the replanting of 1 tree is required within 2 years of permit issuance.

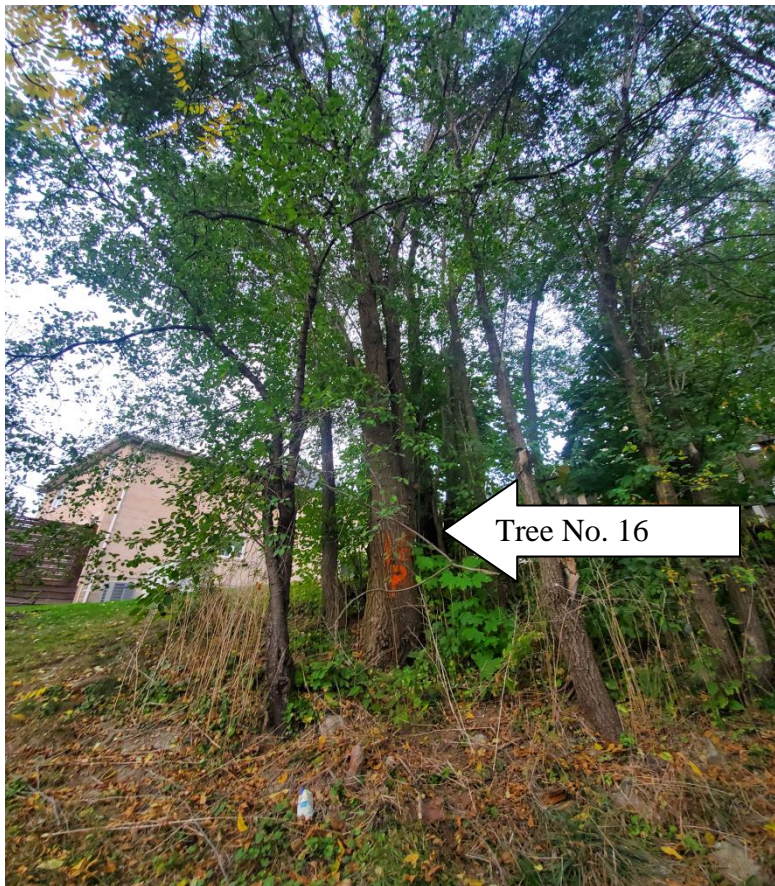
TREE NO. 16 – Siberian Elm

This Siberian Elm tree is in fair to poor condition and located on the applicant's property.

The living crown ratio is 60%.

This tree will be removed to accommodate the construction of the new dwelling and landscape plan.

Permit is required for removal and the replanting of 2 trees is required within 2 years of permit issuance.

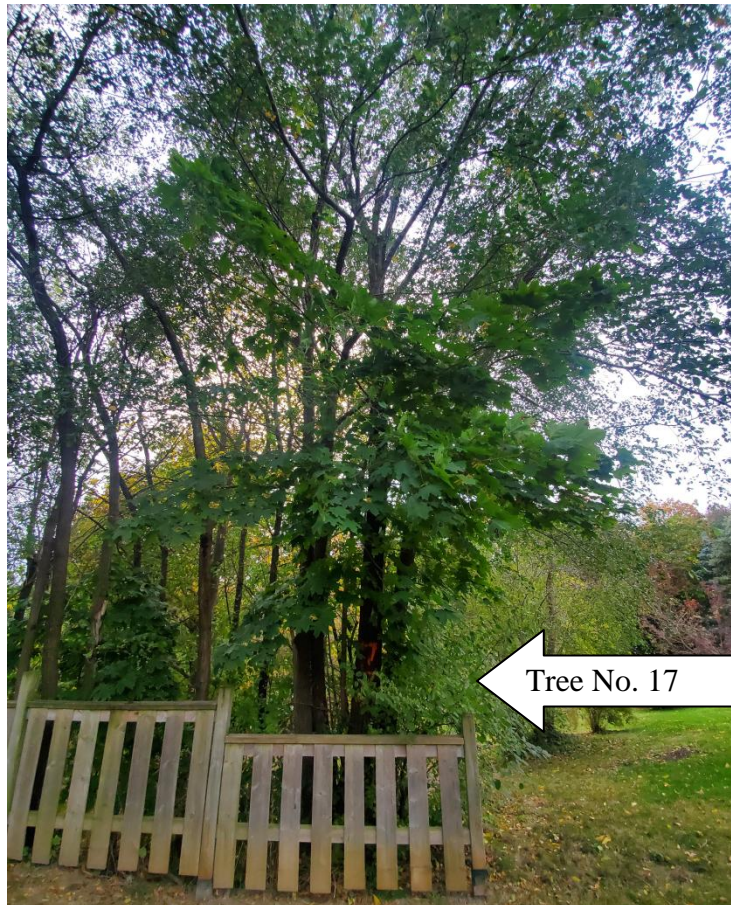
TREE NO. 17 – Siberian Elm – 4 stem

This 4 stem Siberian Elm tree is in poor condition and located on the applicant's property.

The living crown ratio is 50%.

This tree will be removed to accommodate the construction of the new dwelling and landscape plan.

Permit is required for removal and the replanting of 2 trees is required within 2 years of permit issuance.

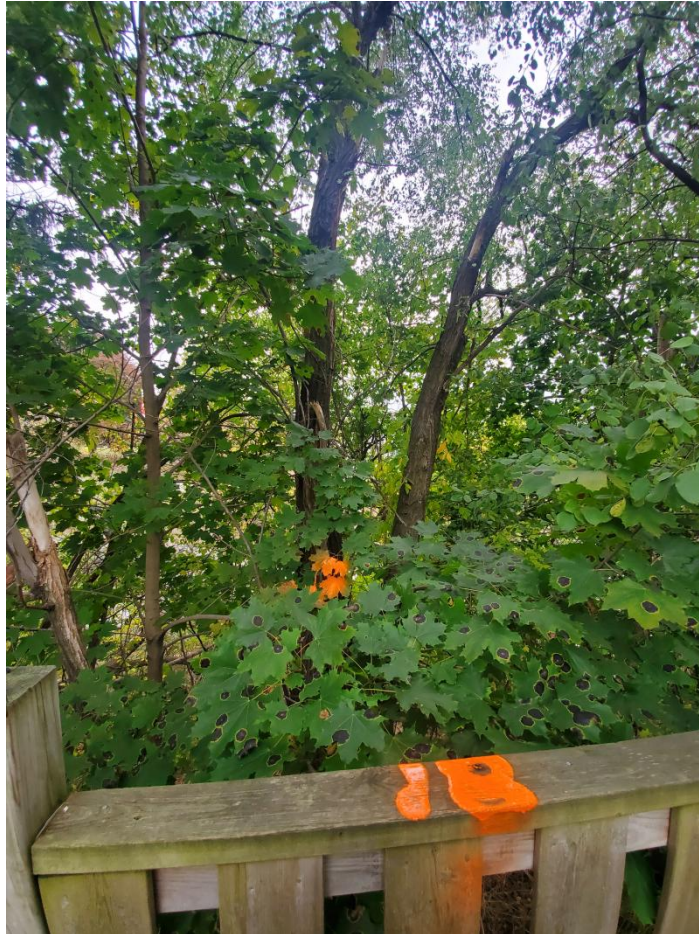
TREE NO. 18 – Siberian Elm – 3 stem

This 3 stem Siberian Elm tree is in fair to poor condition and located on the applicant's property.

The living crown ratio is 50%.

This tree will be removed to accommodate the construction of the new dwelling and landscape plan.

Permit is required for removal and the replanting of 2 trees is required within 2 years of permit issuance.

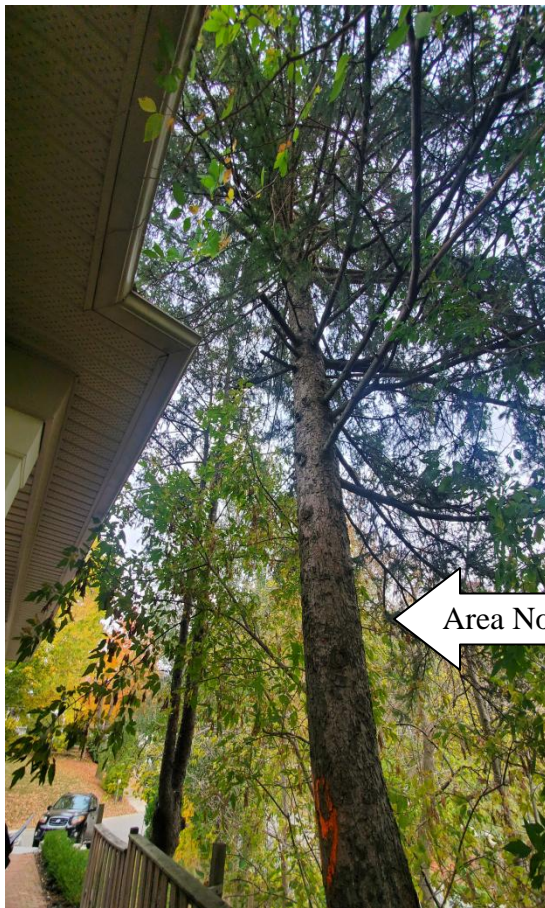
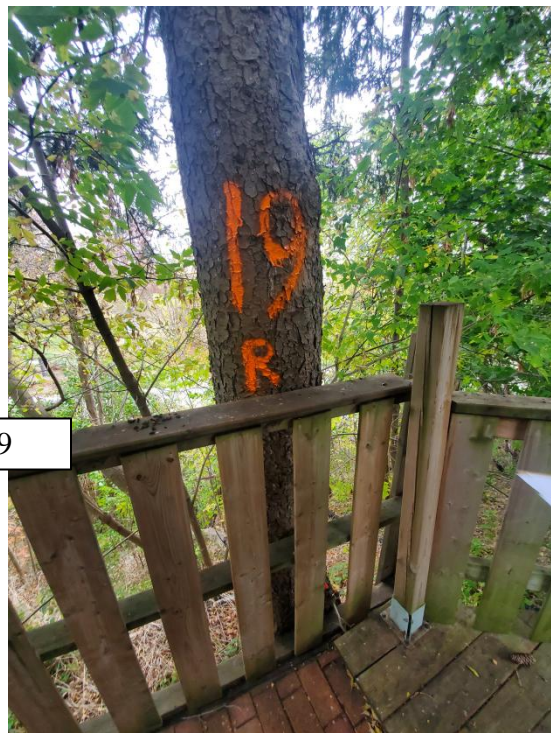
TREE NO. 19 – White Spruce

This White Spruce tree is in poor condition and located on the applicant's property.

The living crown ratio is 30%, due to very crowded growing conditions and Cytospora Fungal Infestation.

This tree will be removed to accommodate the construction of the new dwelling and landscape plan.

Permit is required for removal and the replanting of 3 trees is required within 2 years of permit issuance.

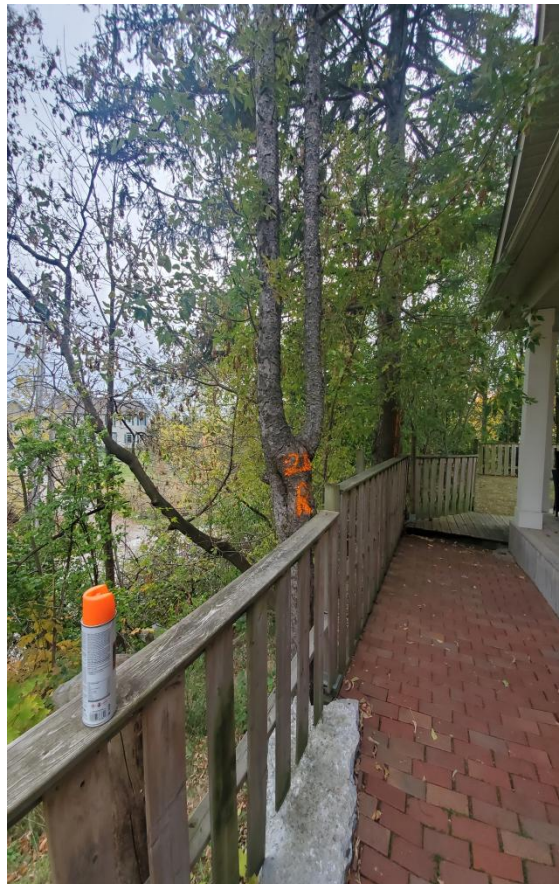
TREE NO. 20 – Black Cherry

This Black Cherry tree is in poor condition and located on the applicant's property.

The living crown ratio is 30%, due to very crowded growing conditions and Black Knot Fungus Infestation.

This tree will be removed to accommodate the construction of the new dwelling and landscape plan.

Permit is required for removal and the replanting of 1 tree is required within 2 years of permit issuance.

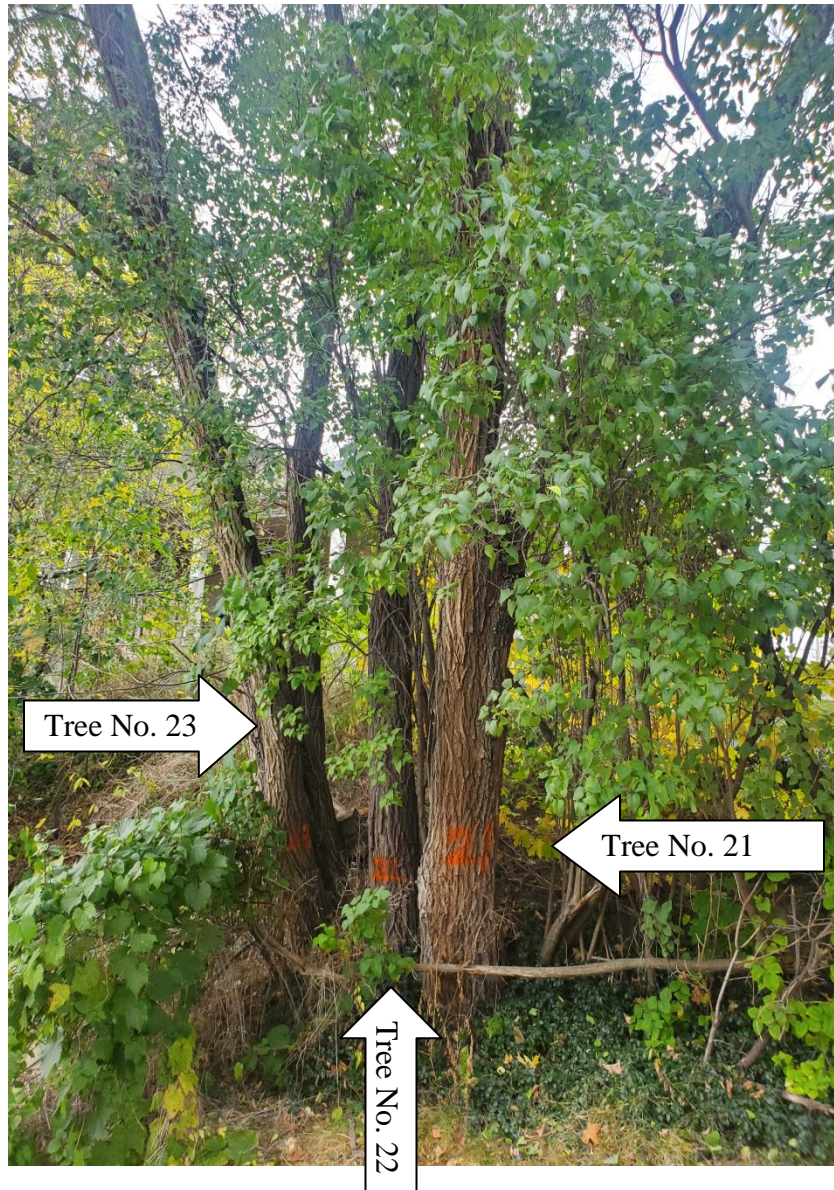
- TREE NO. 21 – Siberian Elm
- TREE NO. 22 – Siberian Elm
- TREE NO. 23 – Siberian Elm – 2 stem

This Siberian Elm is fair to poor condition and located on the City of Vaughan Right of Way, on the south side of the applicant's property.

This 2-stem Siberian Elm is fair to poor condition and located on the City of Vaughan Right of Way, on the south side of the applicant's property.

This tree will be preserved and protected before and during construction with "Light Duty Tree Hoarding"refer to drawing ULA110B.

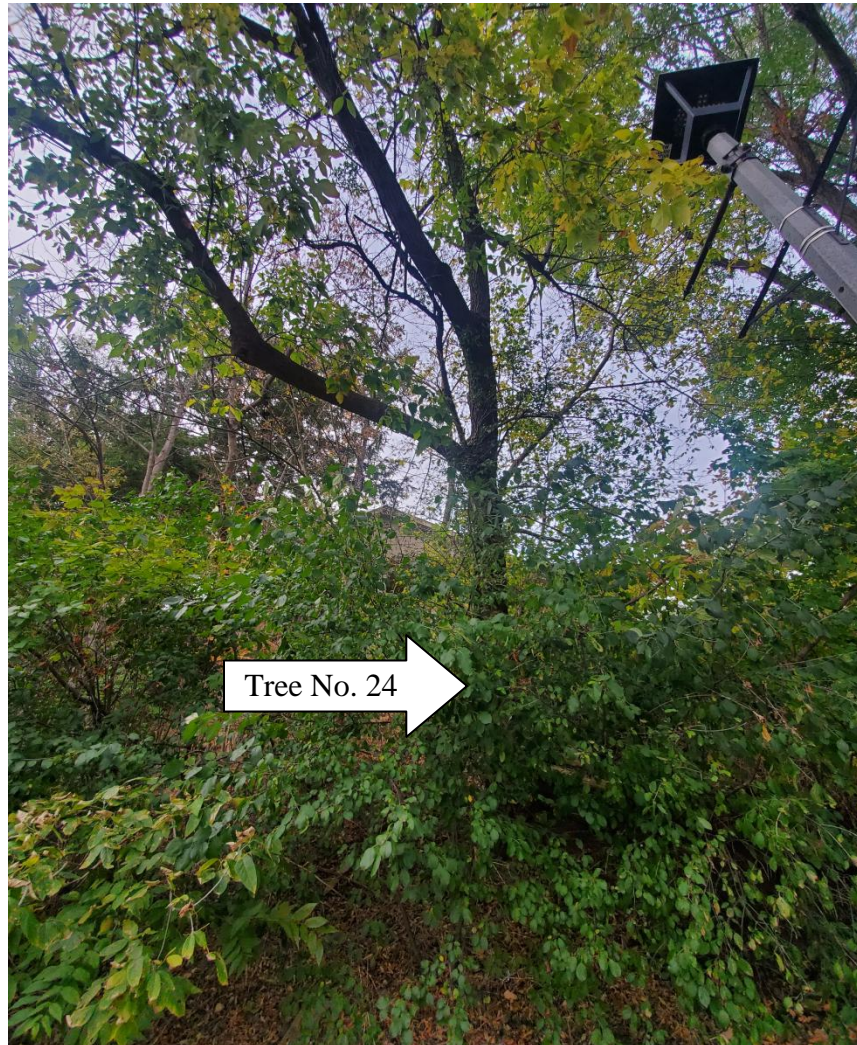
TREE NO. 24 – Manitoba Maple

This Manitoba Maple tree is poor condition and located on the City of Vaughan Right of Way, on the south side of the applicant's property.

This tree will be preserved and protected before and during construction with "Light Duty Tree Hoarding"refer to drawing ULA110B.

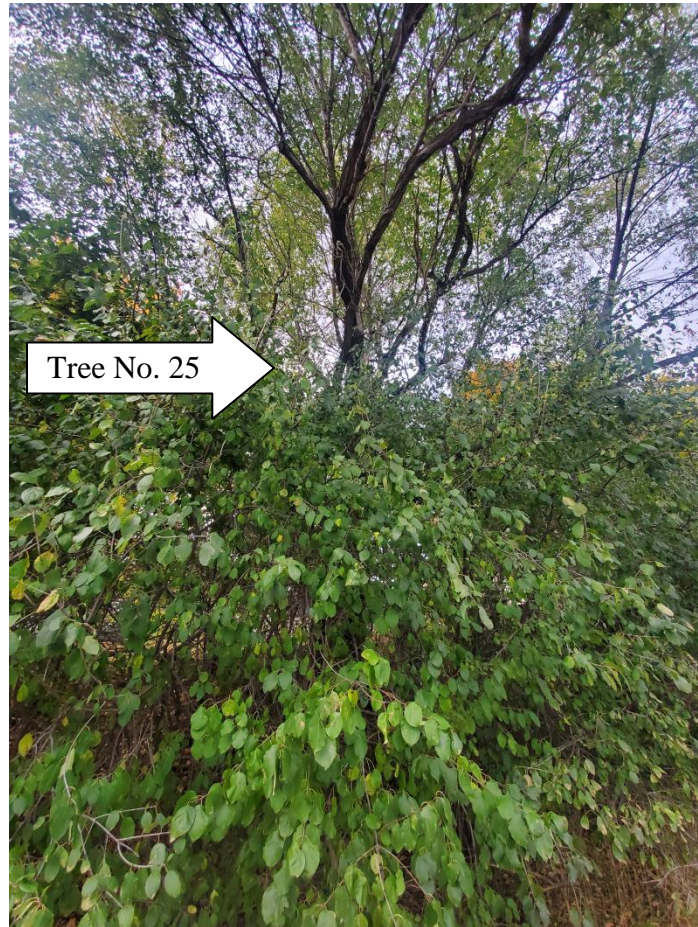
TREE NO. 25 – Siberian Elm – 2 stem

This 2 stem Siberian Elm tree is poor condition and located on the City of Vaughan Right of Way, on the south side of the applicant's property.

This tree will be preserved and protected before and during construction with "Light Duty Tree Hoarding"refer to drawing ULA110B.

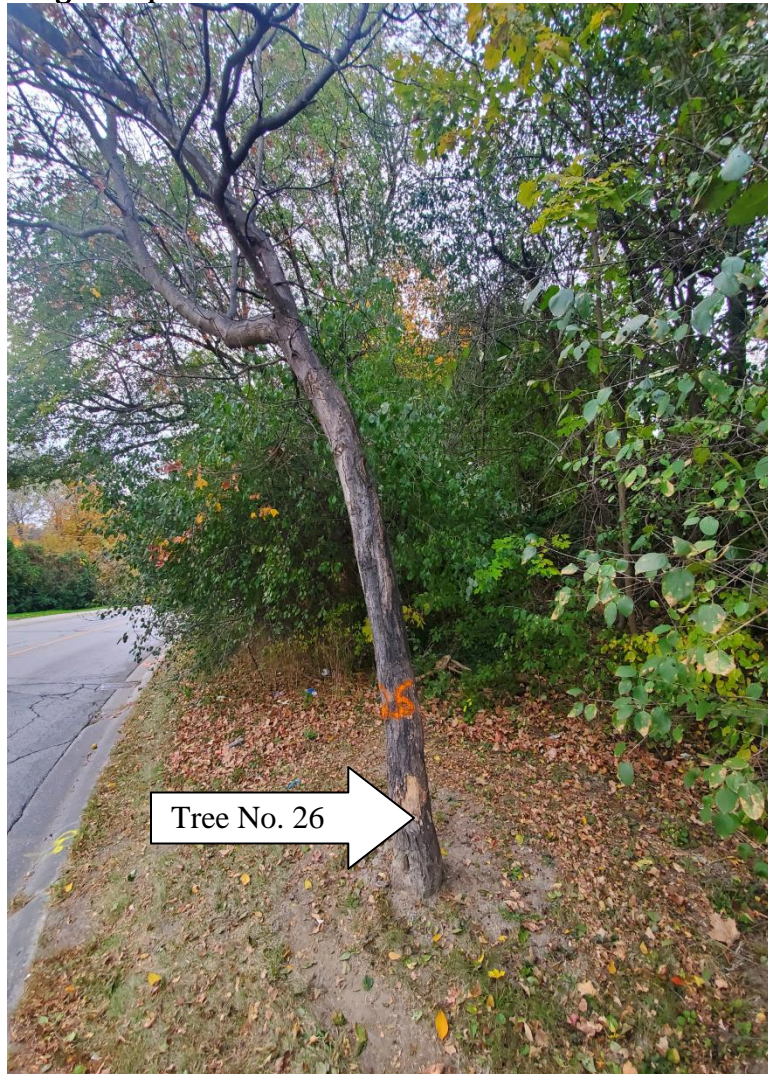
TREE NO. 26 – Sugar Maple

This Sugar Maple tree is in very poor condition and located on the City of Vaughan Right of Way, on the south side of the applicant's property.

This tree will be preserved and protected before and during construction with "Light Duty Tree Hoarding"refer to drawing ULA110B.
