**BUILDING CONDITION ASSESSMENT**

**Existing Heritage House**

4660 Kirby Road, Kleinburg, Vaughan

**File No. W23119**

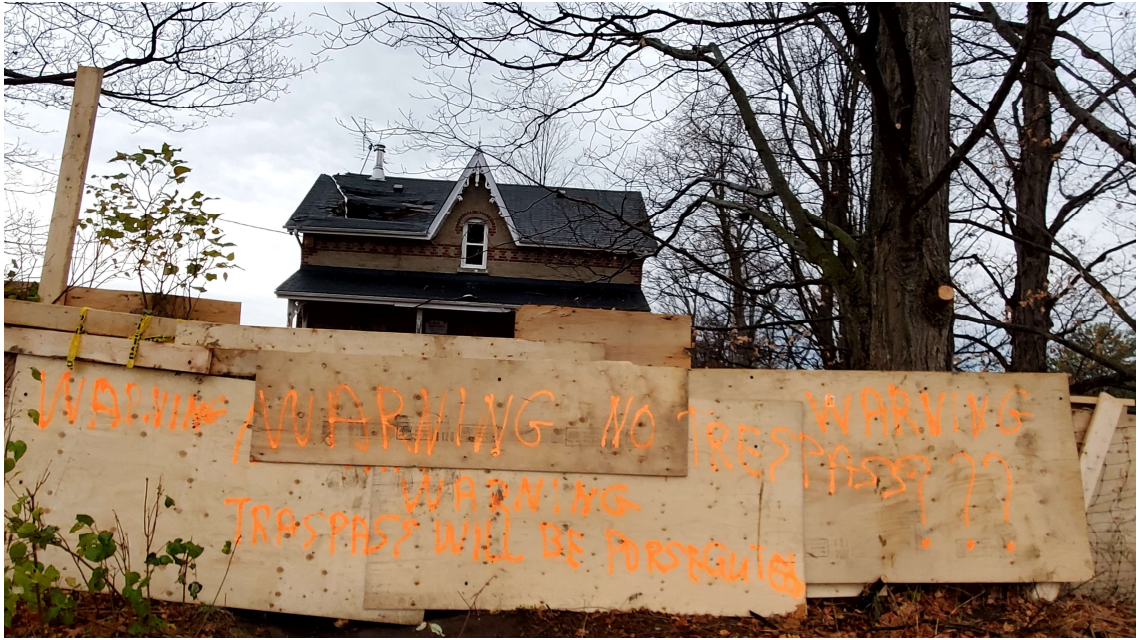
The building (house) is currently in a poor state and dilapidated. It is unoccupied and surrounded by scattered tall bushes, vegetation, and trees (Pic. 1 to Pic. 5). The perimeter wall foundations appear to consist of fieldstone walls. The depth of the fieldstone foundation walls is unknown. The Façade seems built with brown and red brick walls much of it is not in pristine condition.

Pic. 1: Entry Enclosed by Fence

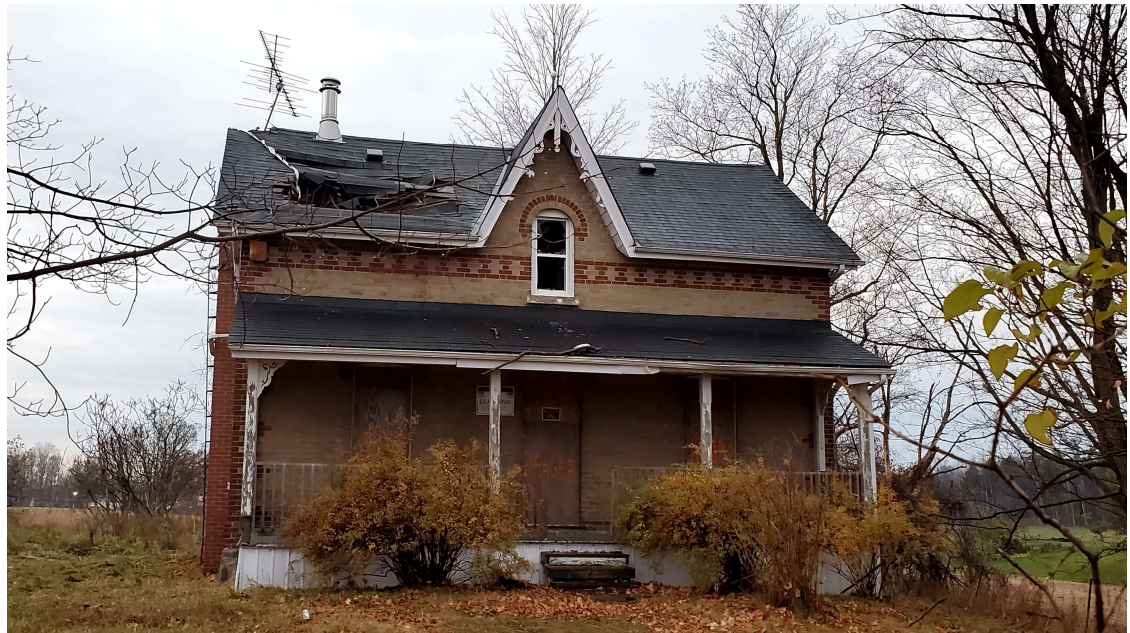
1. A significant portion of the roof was observed caved in. Evidence of extensive damage to the roof structures was seen (Pic. 2, Pic. 9, Pic. 10, Pic. 12 to Pic. 16).

3. The Chimney, built with red bricks, was broken above the roof line, and the successive heavy damage to the roof structure and floors/ceilings was noted at the location (Pic. 2, Pic. 9, Pic. 11, Pic. 14 to Pic. 16).

5. Wooden posts supporting the front verandah were observed degraded over time. (Pic. 2, Pic. 3); The windows appear damaged with shattered pane glazing, and many are covered with plywood sheathing (Pic. 2 to Pic. 5, Pic. 9, Pic. 11); a vertical sheathing encloses the entrance doorway into the house to prevent trespassing and safety issues (Pic. 2, Pic. 9). Further investigation from the inside would be required to fully determine the condition of the fieldstone foundation and other structural elements due to water damage.

Pic. 2: Heritage House-Northwest

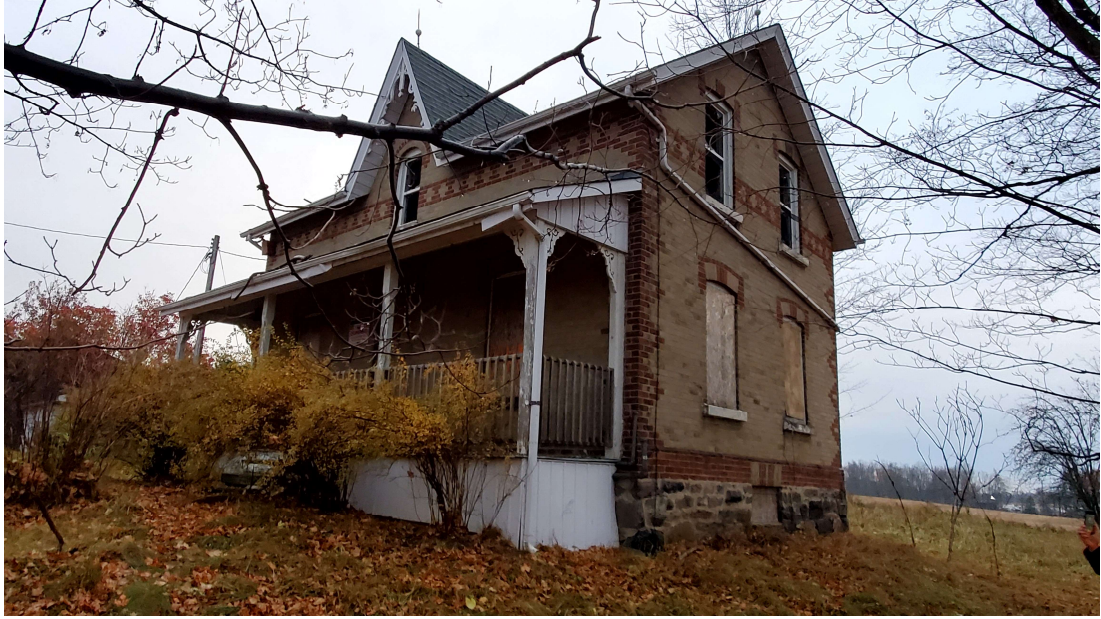
Pic. 3: Heritage House-Southwest

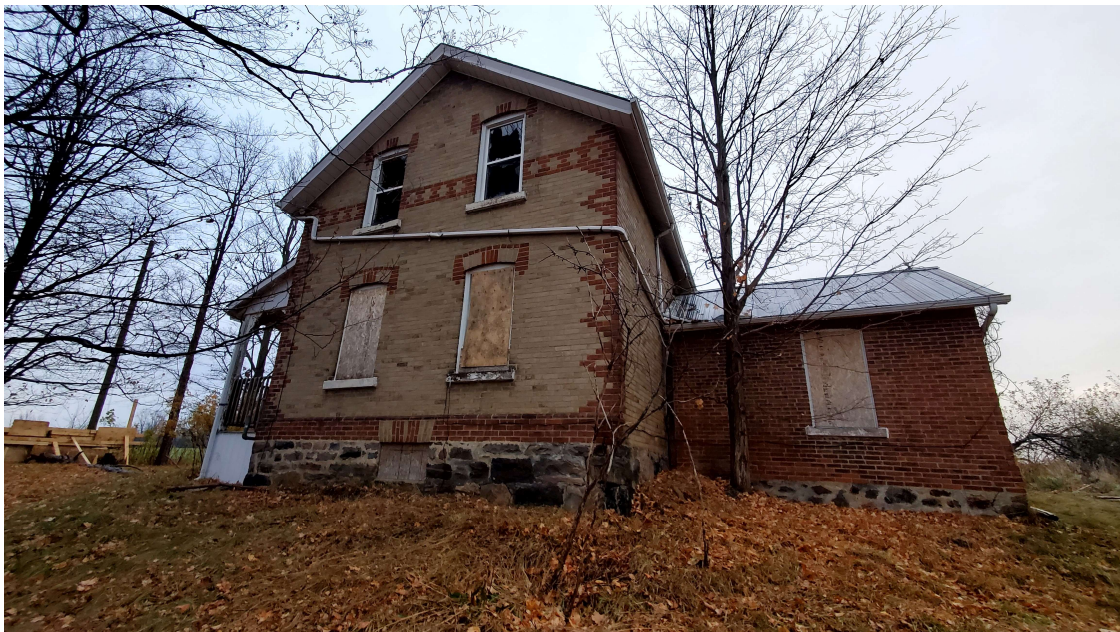
Pic. 4: Heritage House - Southside

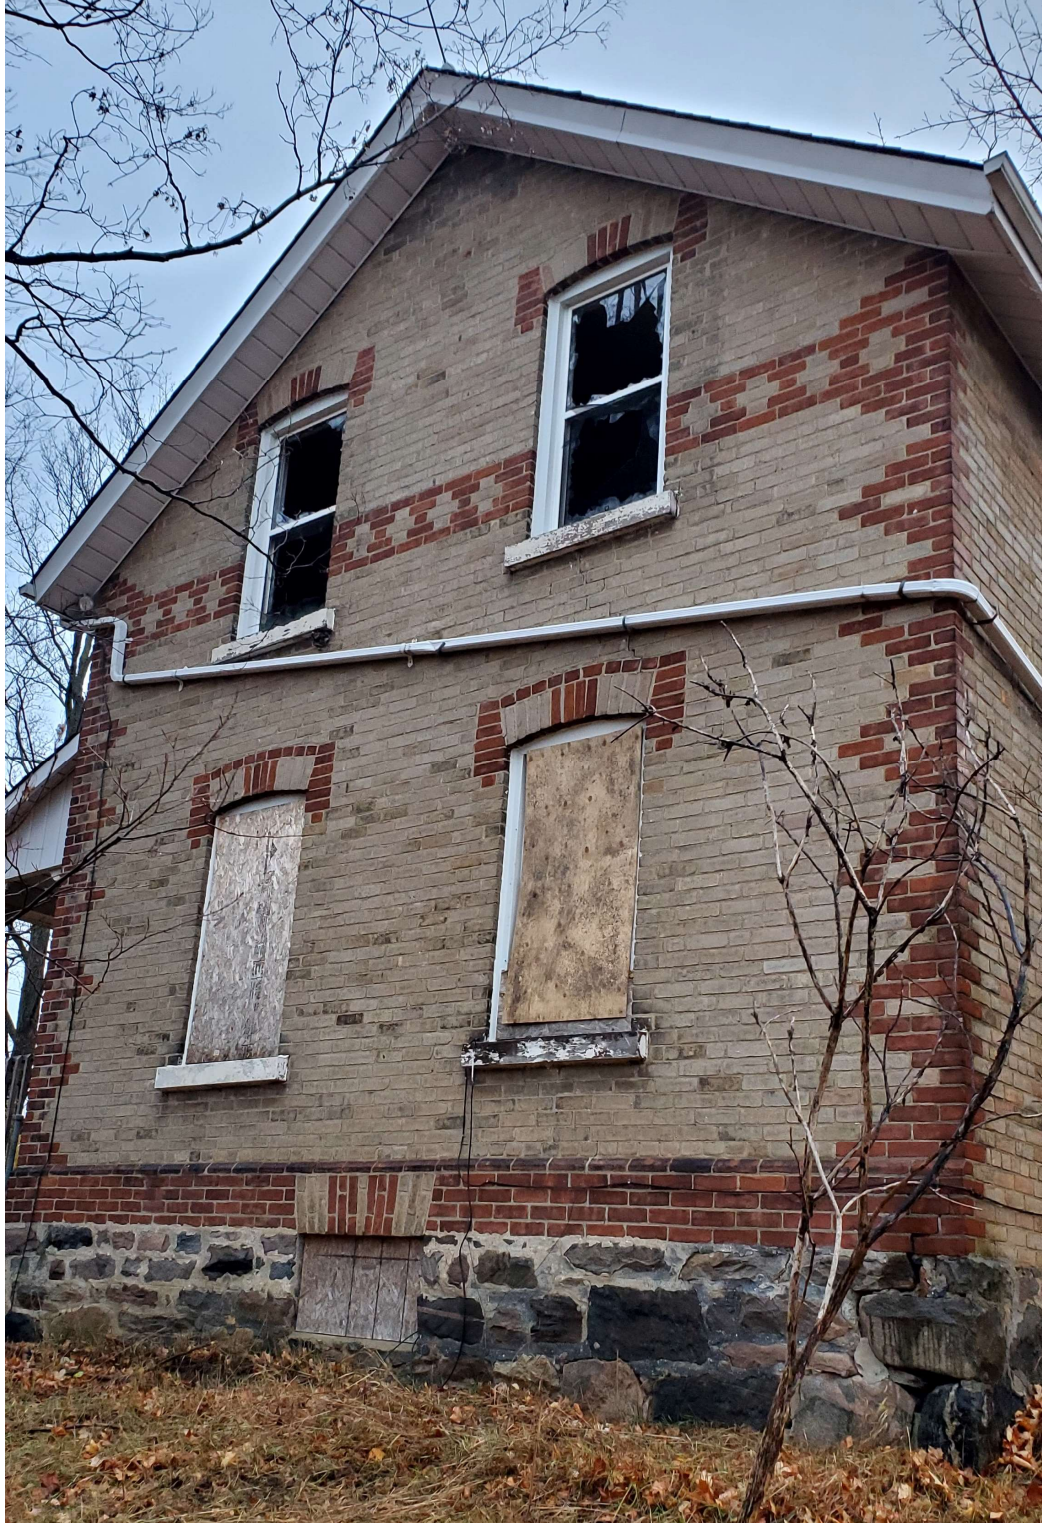
2. Wide and large vertically inclined cracks were observed in the field stone foundation walls, which travel up through the brick wall at the exterior southeast corner of the building (Pic. 5 to Pic. 8).

Wide and long, vertically inclined, two cracks on the fieldstone foundation walls at the back corners reveal the foundation settlement, which comprises the structural integrity.

Pic. 5: Wide Large Crack in the Field Stone Foundation Wall at Southeast Corner

Considering the above facts with the identified deficiencies, we strongly recommend that the building be demolished with proper permits obtained from the City.

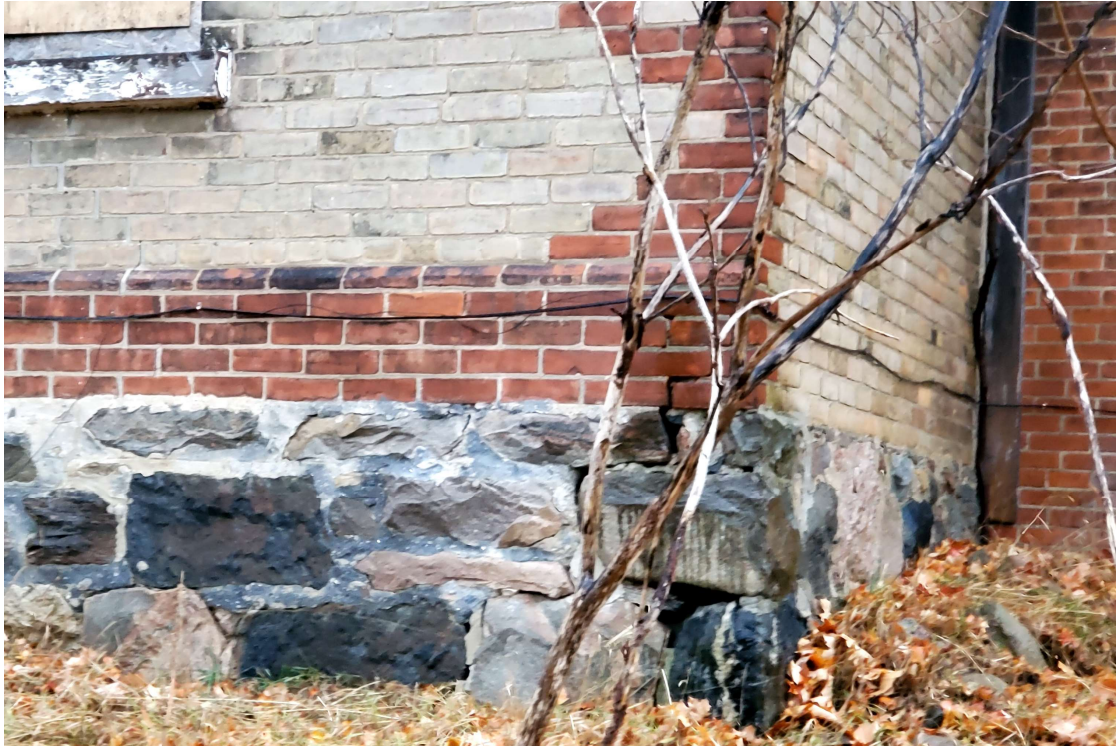
Pic. 6: Large and Wide Crack Closeup, Southeast Corner

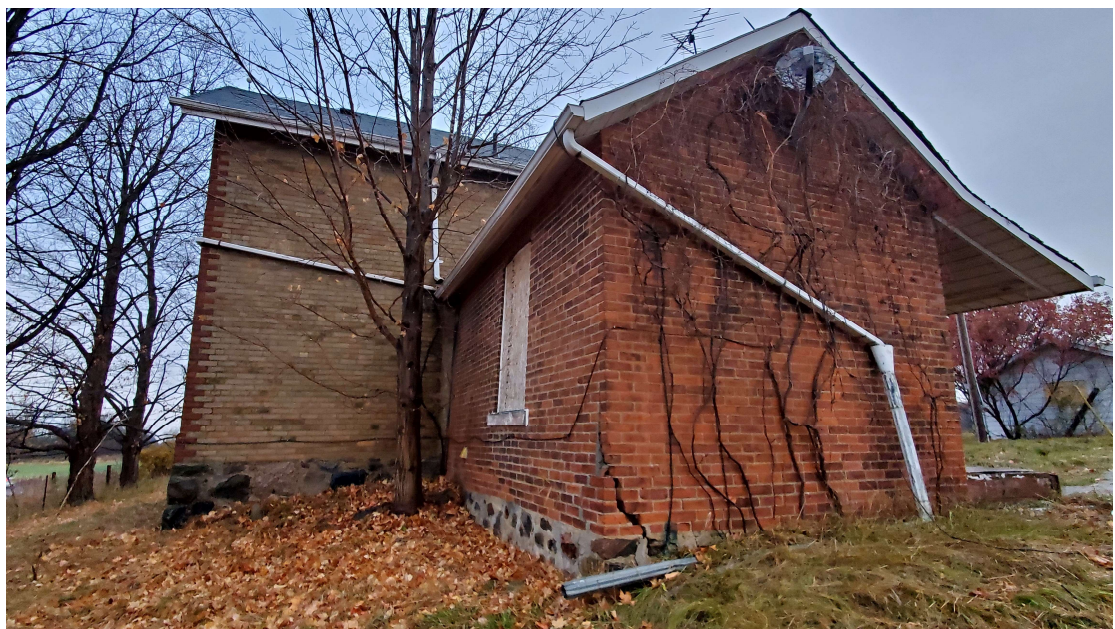
Pic. 7: Wide and large Vertically Inclined Crack in the Foundation and Brick Wall at Southeast Corner

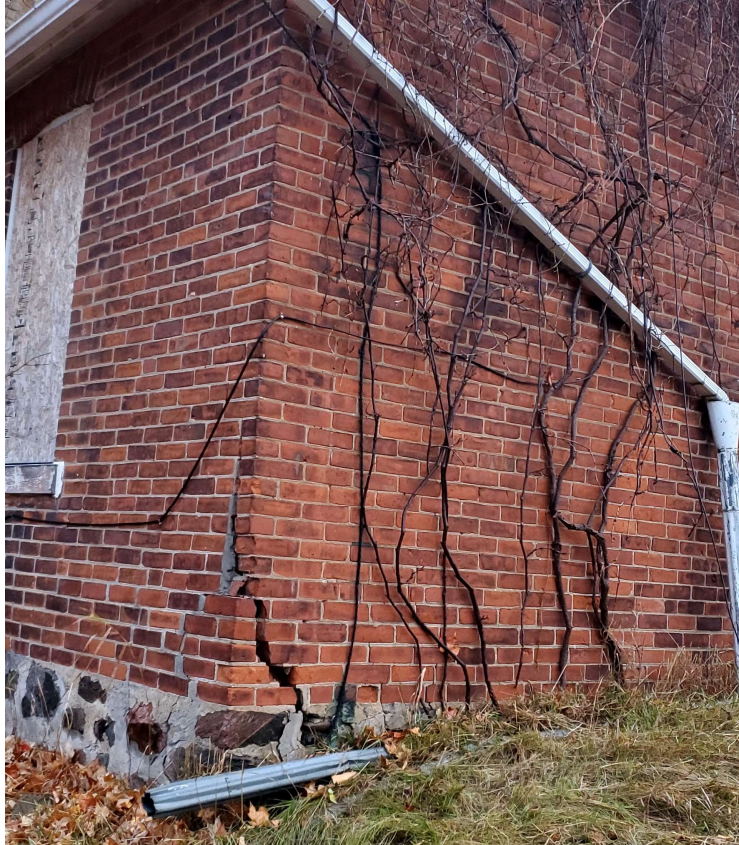
Pic. 8: Wide and Large Crack-Closeup

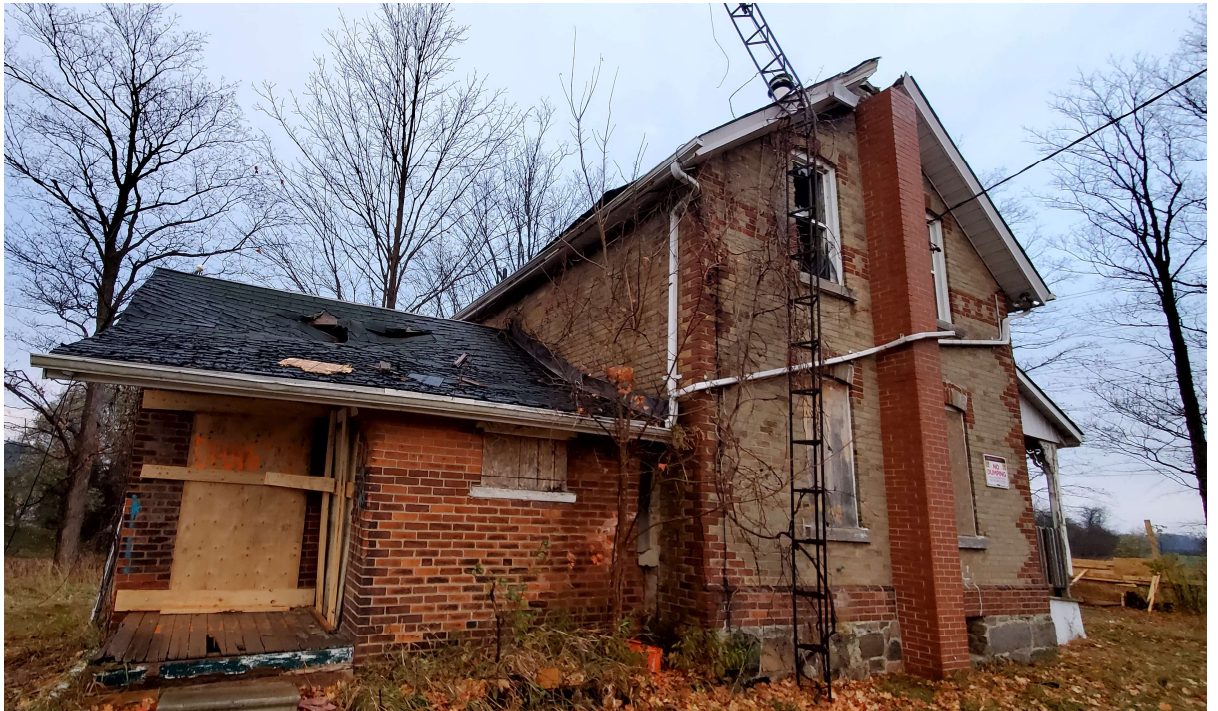
Pic. 9: Heritage House -Northside

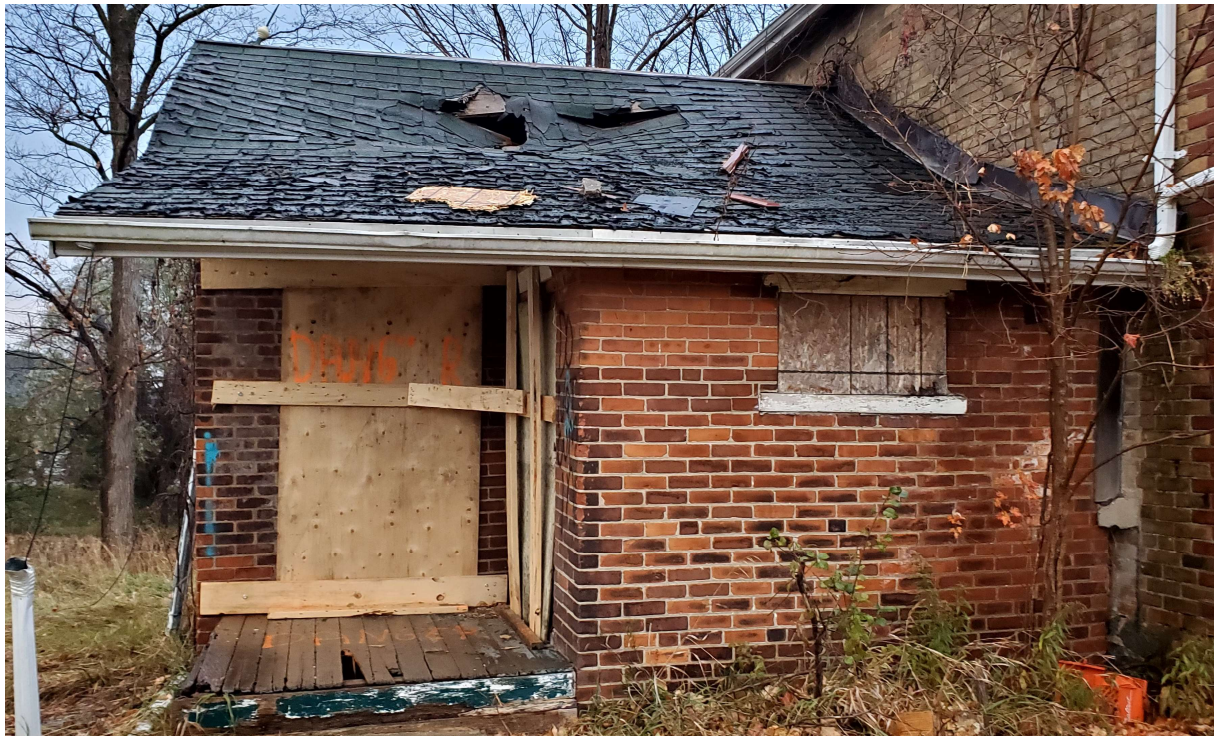
Pic. 10: Roof Caved In, Heritage House Backside- Part North face

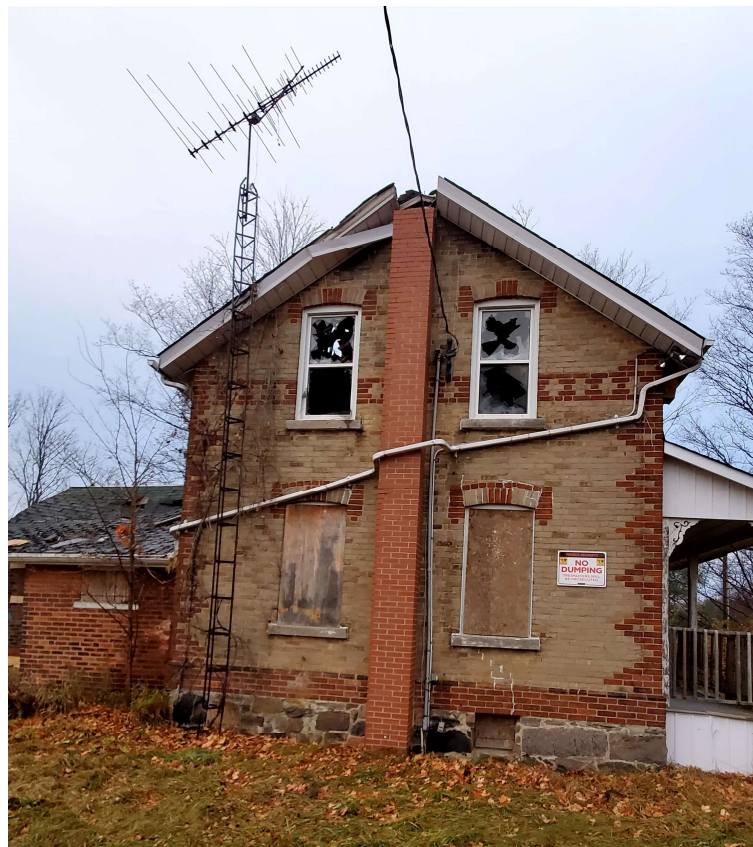
Pic. 11: Brick Chimney Broken from Top - North face

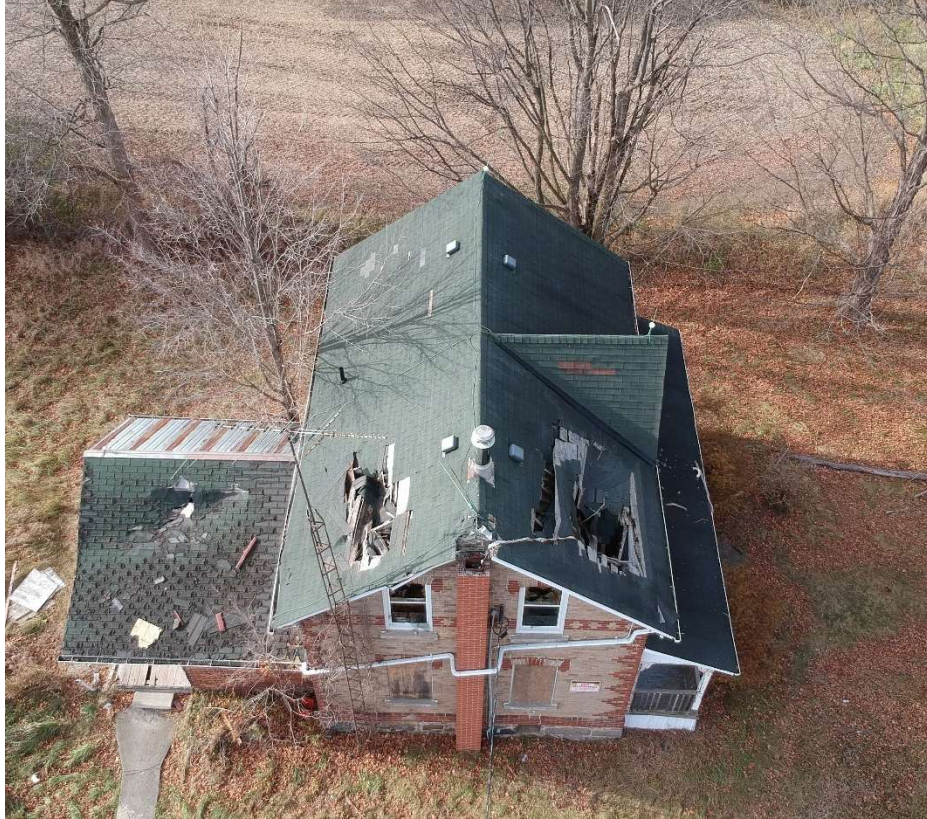
Pic. 12: Damaged Roof structure – Aerial View 1

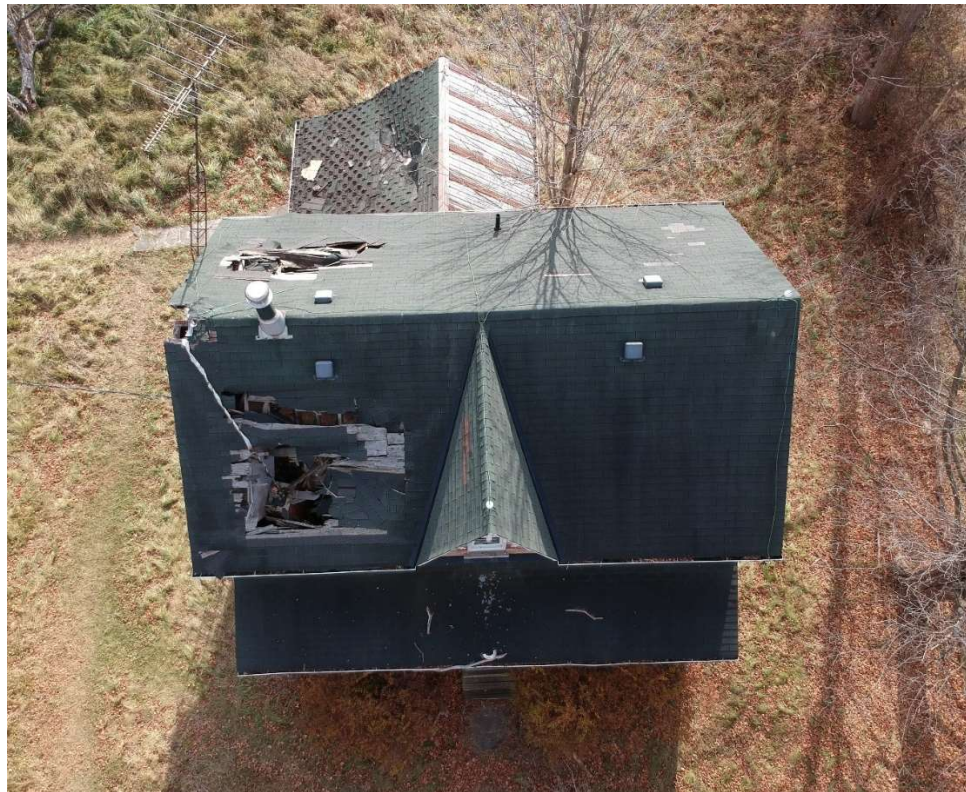
Pic. 13: Damaged Roof structure – Aerial View 2

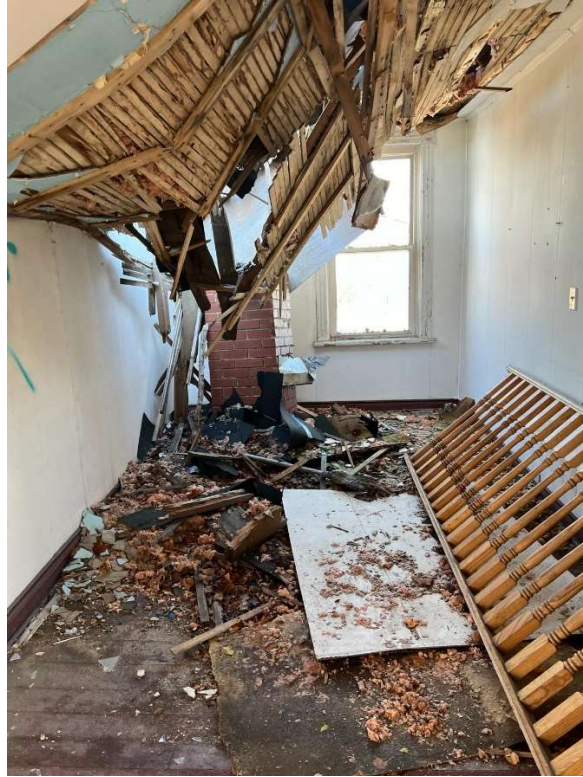
Pic. 14: Damaged Roof structure, Debris, Damp Wood Floor showing Decay and Deterioration

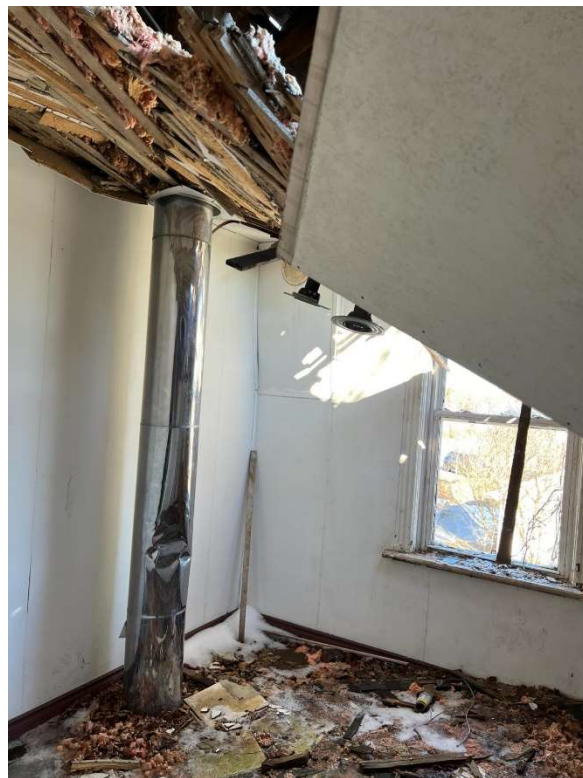
Pic. 15: Damaged Roof, Damp Wood Floor showing Decay and Deterioration

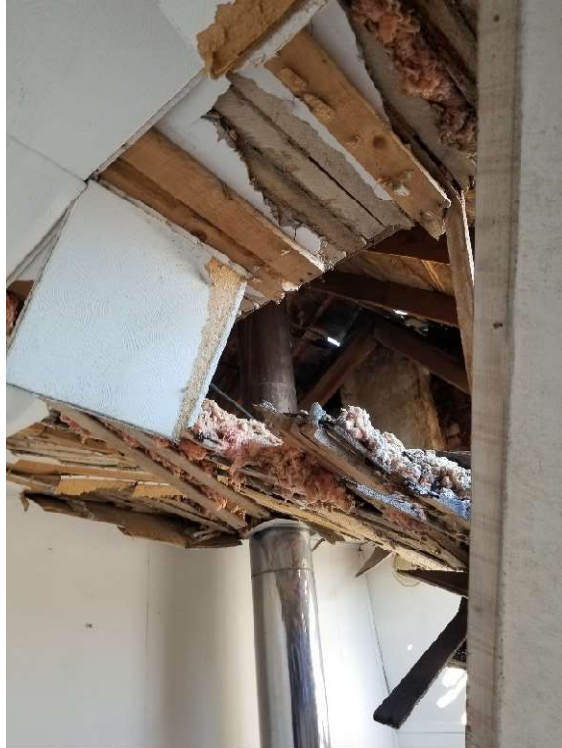
Pic. 16: Collapsed Ceiling with broken framing showing Deterioration

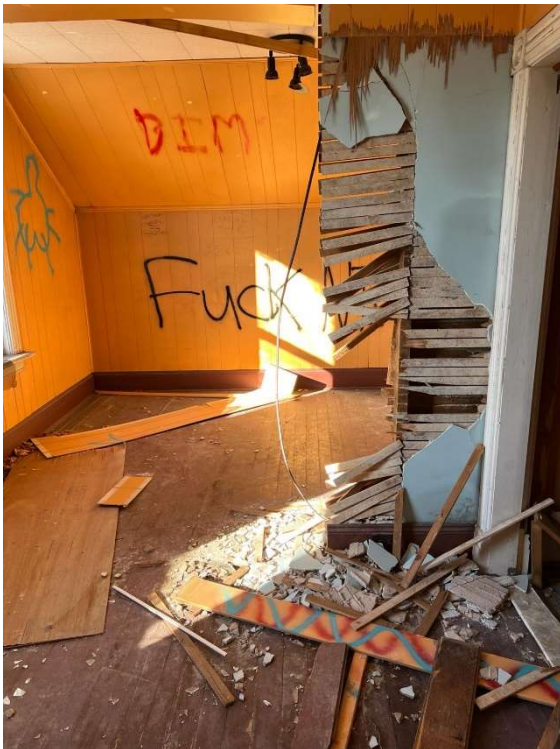
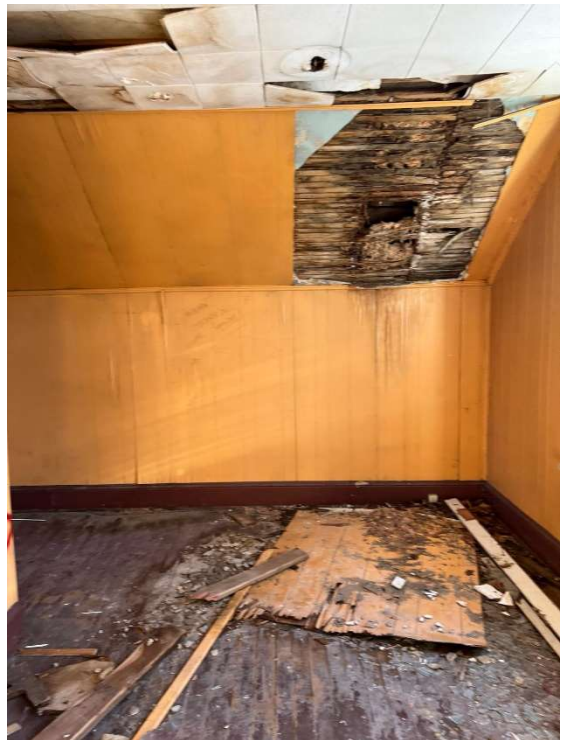
4. The hardwood floor displays signs of decay and deterioration, with several areas broken, making the house vulnerable. The stair guard rails are also broken (Pic. 17 to Pic. 24).

Pic. 17, Pic. 18: Broken and Deteriorated Ceiling, Damp and Decay wood floor and Debris

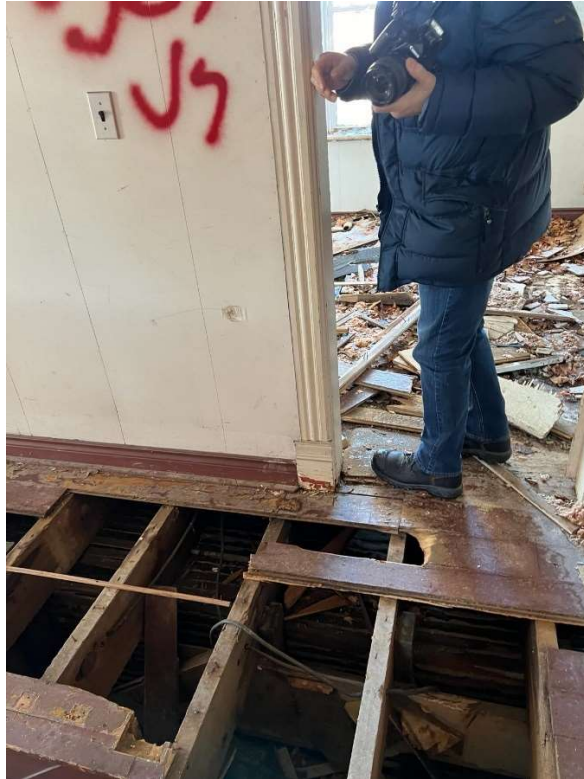
Pic. 19: Broken Floor, Debris, and Deterioration

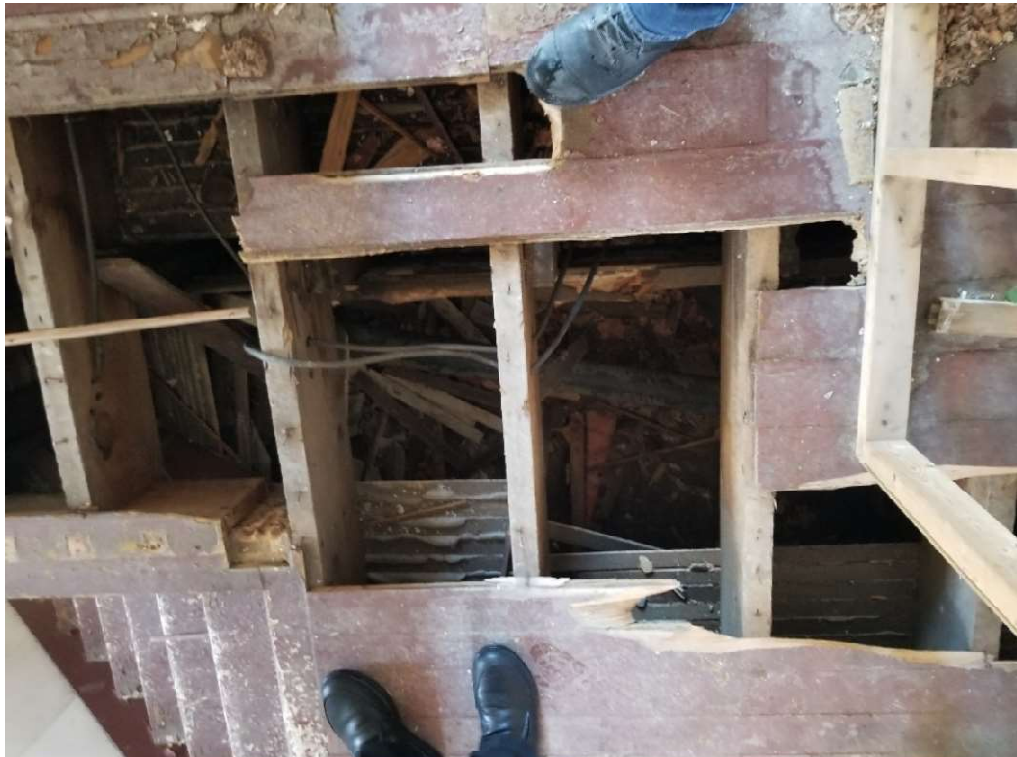
Pic. 20: Broken Floor, Debris, and Deterioration

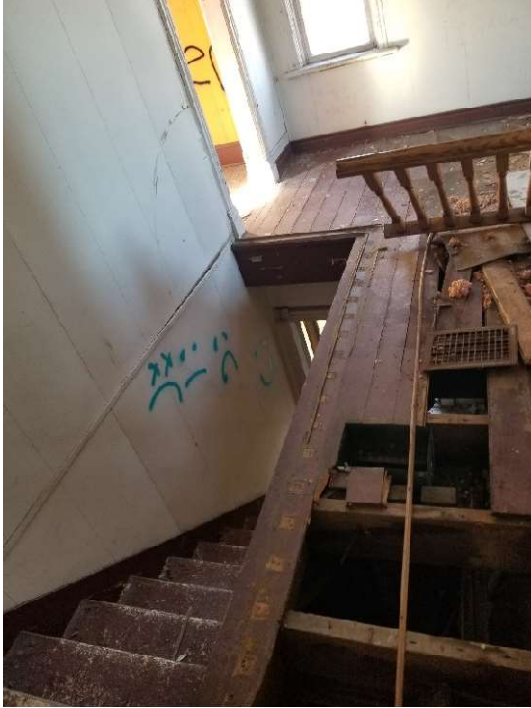
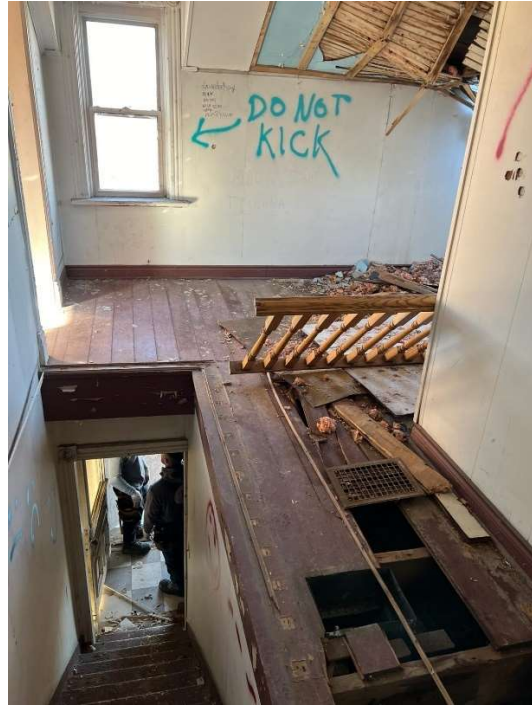
Pic. 21, Pic. 22: Broken Floor, Ceiling, and Stair Guard Rails

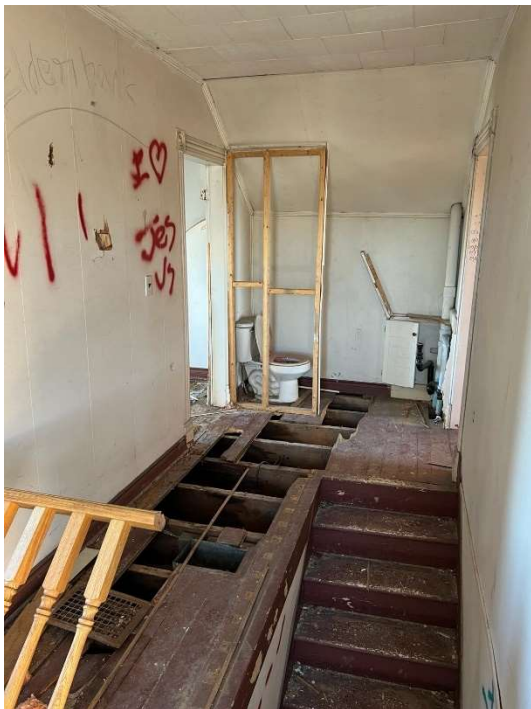
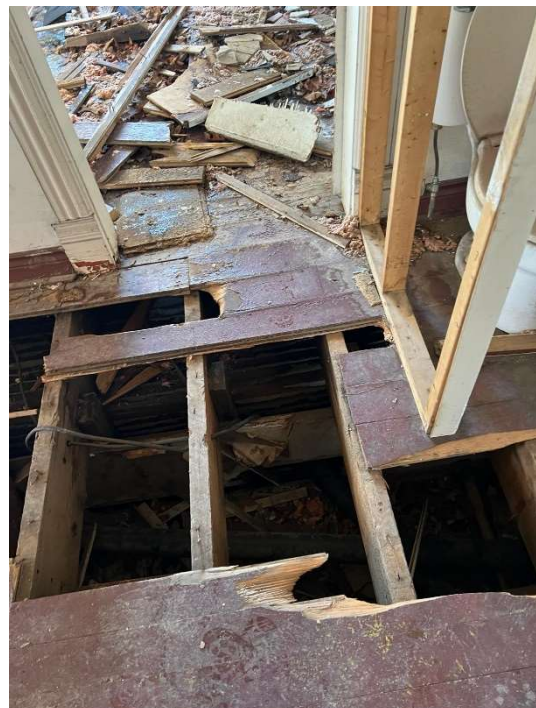
Pic. 23, Pic. 24: Broken Floor and Stair Guard Rails with Debris
