STRUCTURAL CONDITION ASSESSMENT

Existing Heritage House

6181 Major Mackenzie Drive West, Kleinburg, Vaughan

May 28, 2024

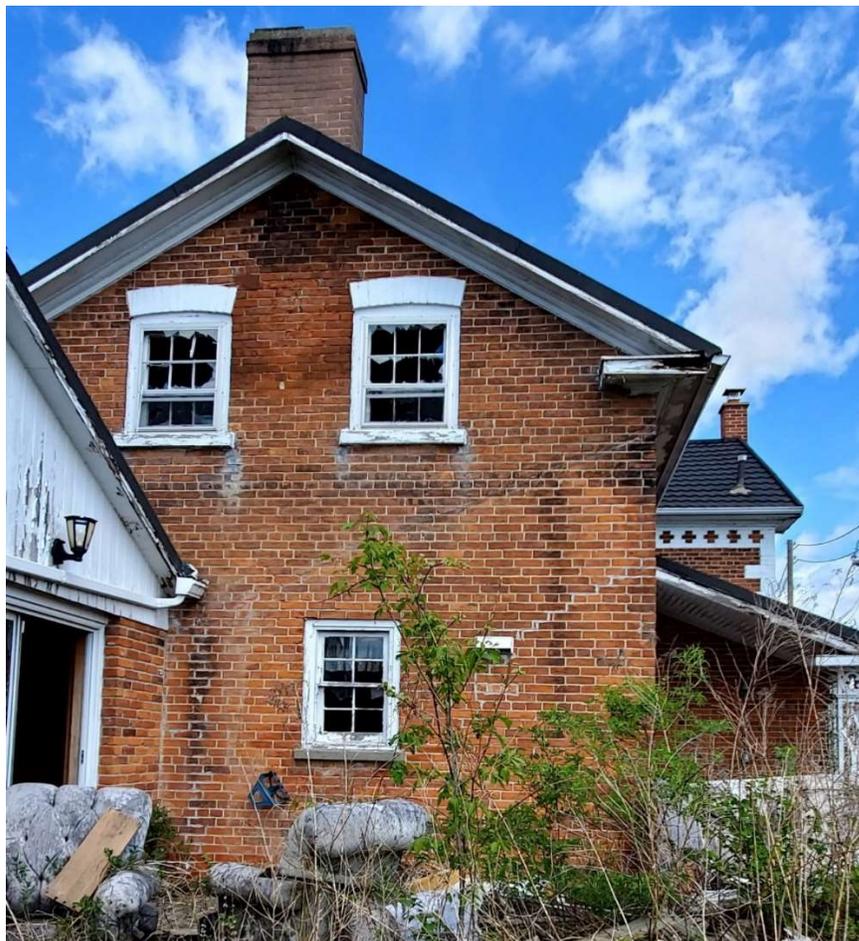
The exterior masonry walls seem to be in relatively good condition, except for signs of penetrating dampness at a few locations with watermarks on the gable end masonry wall on the south side. Evidence of previously repaired diagonal cracks was observed on the same brick masonry wall, which now appears to be dormant (Pic. 8). Decayed wood is also visible at the southeast roofing corner (Pic. 8).

Pic. 8: Southside View of Building 1B– Diagonal crack repairs, watermarks on Brick Masonry Wall, Broken Windows Pane and decayed wood at corner of the eave return.

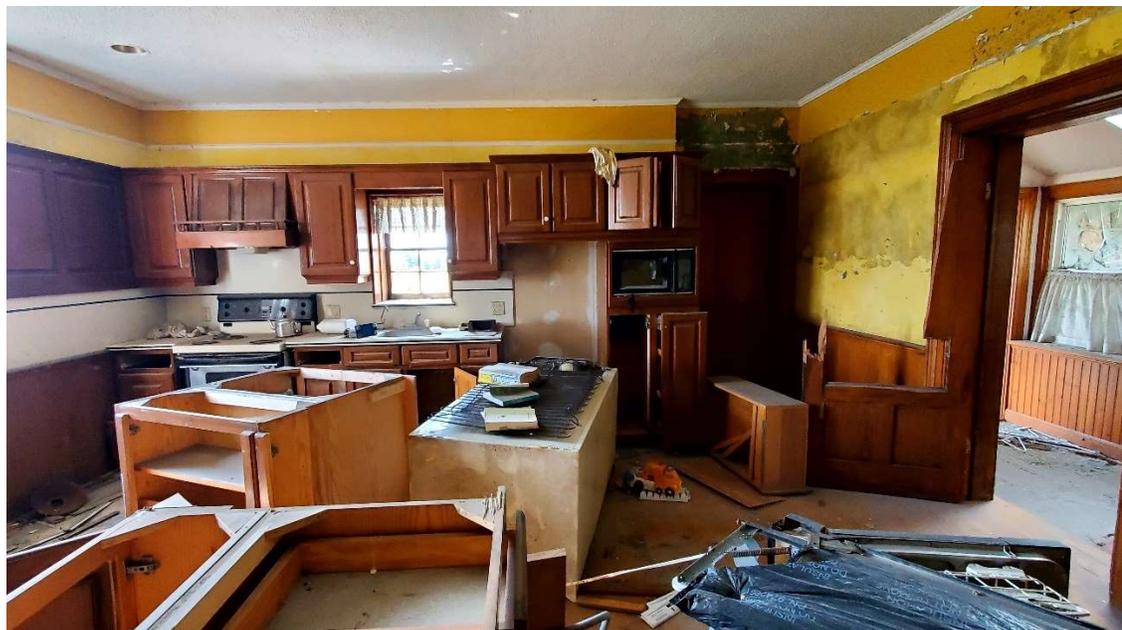
The interior structure was buried under finishes, including load-bearing walls, floor beams, and roof framing (Pic. 10 to Pic. 12, Pic. 15, Pic. 23). The interior side of the south and west walls in the kitchen exhibit substantial damp patches, discolouration, and peeled/flaked paints, which seem to result from the moisture caused by water ingress from the brick masonry wall (Pic. 10 to Pic. 12). Eastside wall and small laundry extension have water marks, discoloration, and peeled paints as well, which appears to be a result of moisture caused by water ingress (Pic. 13, Pic. 14); however, the brick masonry load-bearing wall elements appear in a stable and good condition structurally.

Pic. 10: Kitchen in Building 1B; Penetration Damp on the Walls

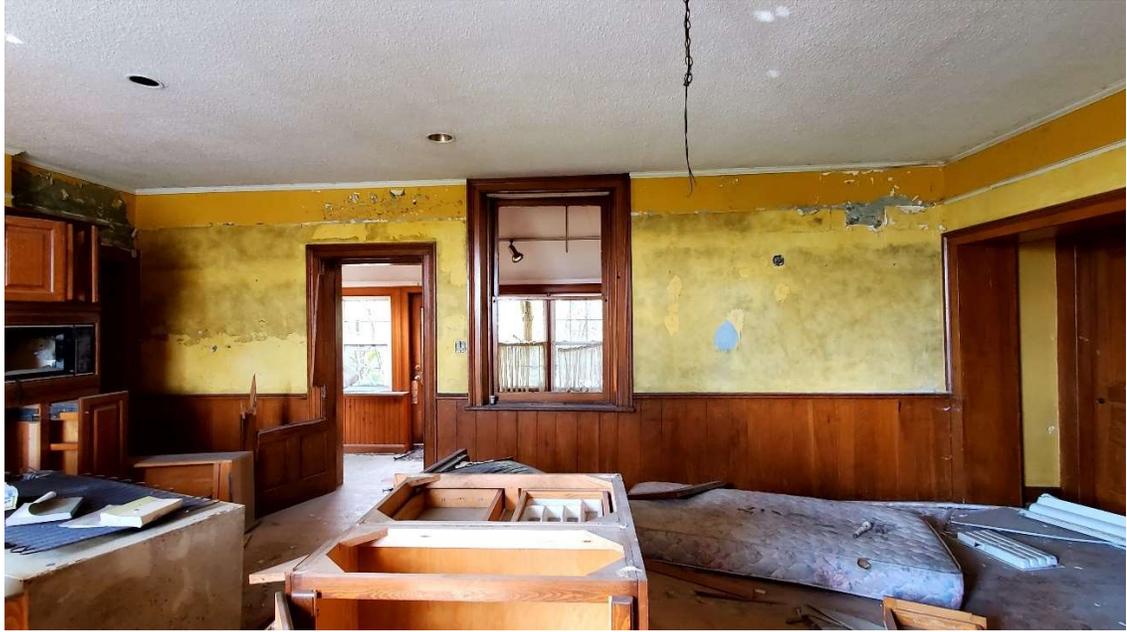
Pic. 11: Westside Wall in Kitchen; Penetration Damp-Building 1B

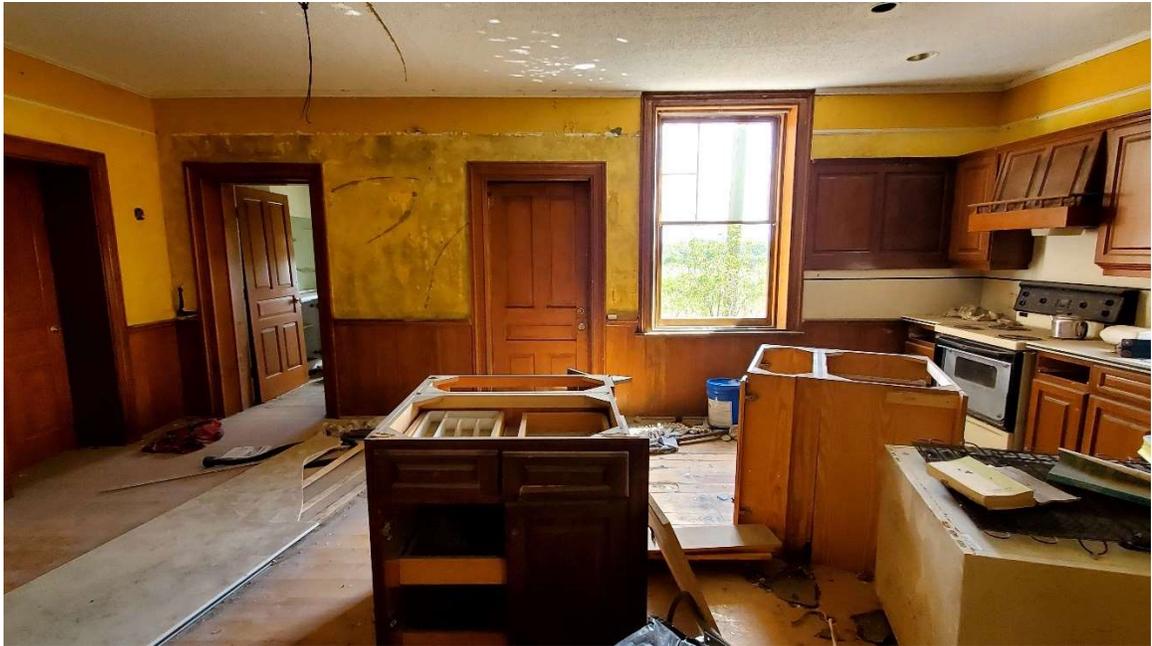
Pic. 12: Eastside Wall in Building B; Watermarks on the Wall-Building 1B

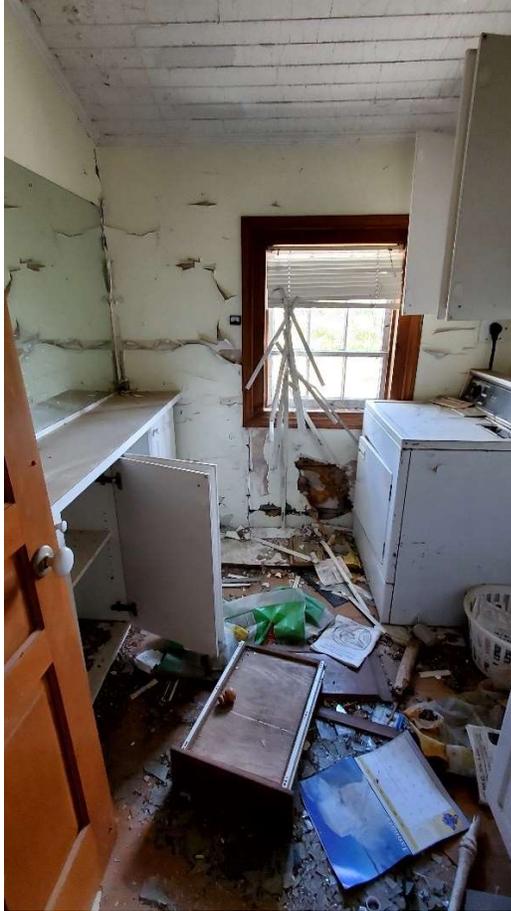
Pic. 13: Laundry in Building B; Debris, Peeling/flaking of Paint and Damaged Wall-Building 1B

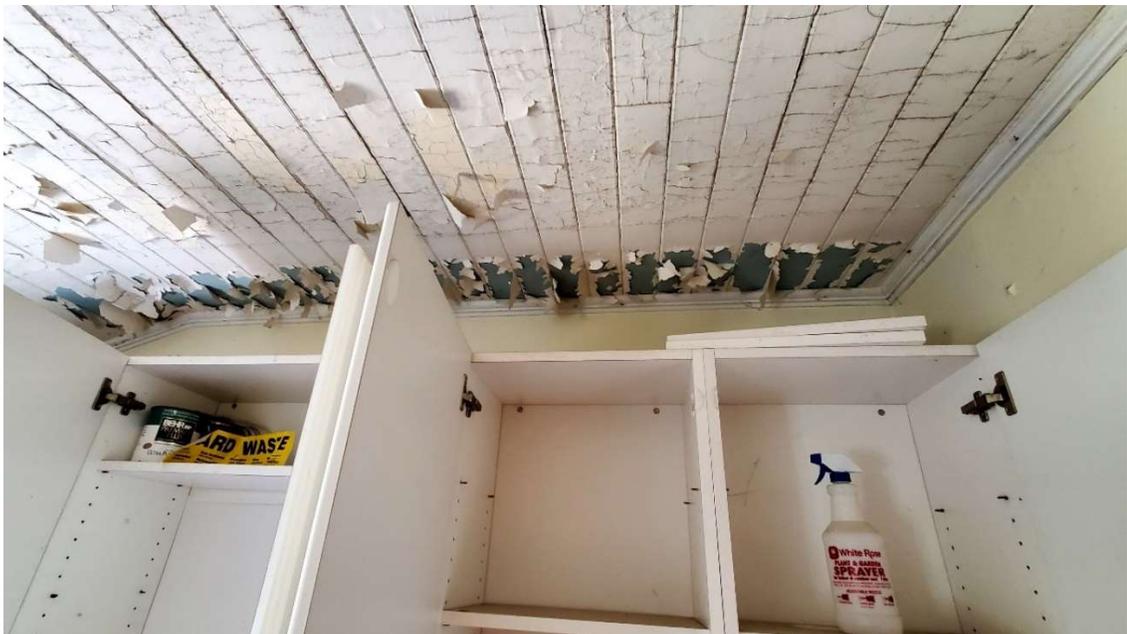
Pic. 14: Peeling/Flaking of Paint in Ceiling due to Moisture Penetration in Laundry room of Building 1B

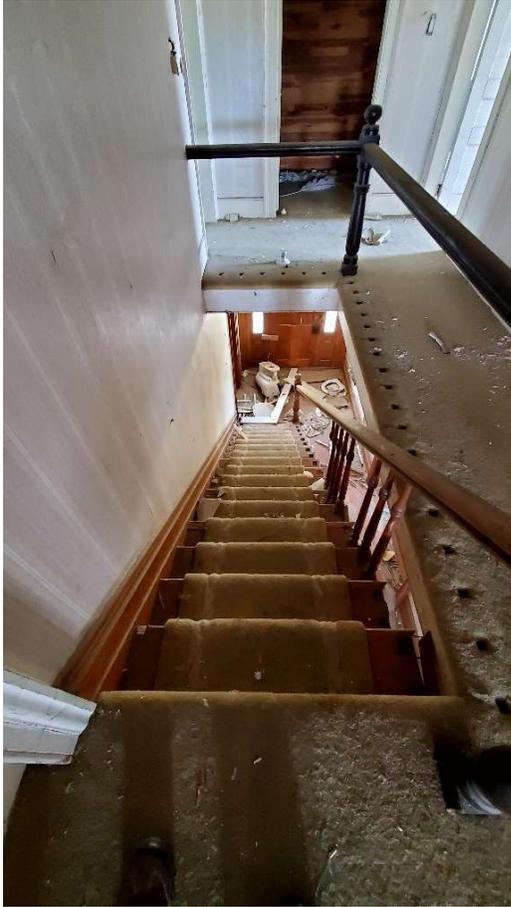
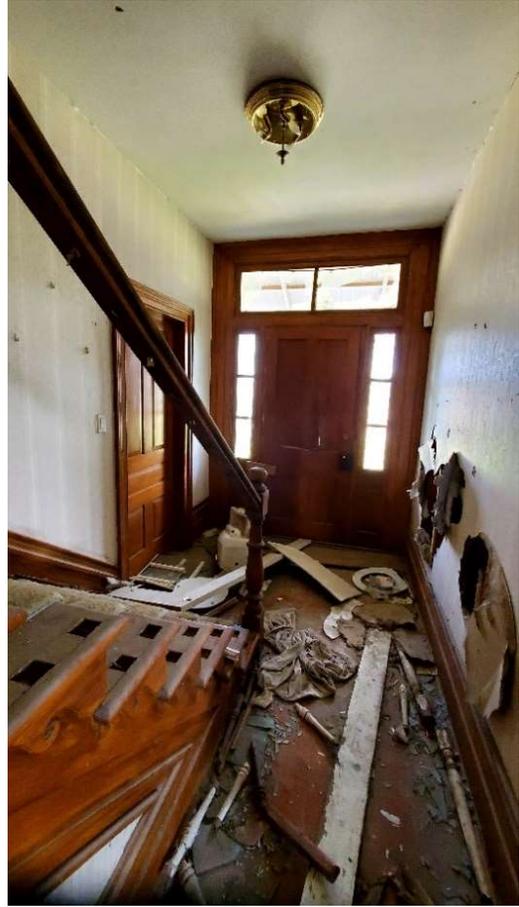
Pic. 21, Pic. 22: Central Corridor with Front Entrance, Stairs leading to the SF with Missing Balustrades-1A

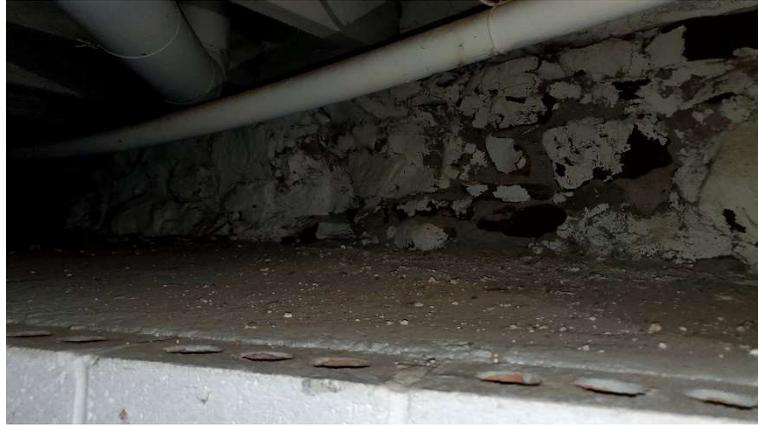
The foundation walls, although hidden, appear in good condition, concluding from no cracks, settlement, or bulge on the finishes of the walls observed in the basement except evidence of few repair patches to a partly exposed rubble masonry wall (Pic. 29), which can be seen from the crawl room of Building 1B; however, some water marks and mold growth were seen in some localized area of the walls.

Pic. 29: Patch Work on Rubble Masonry Foundation Wall-Building 1B Basement

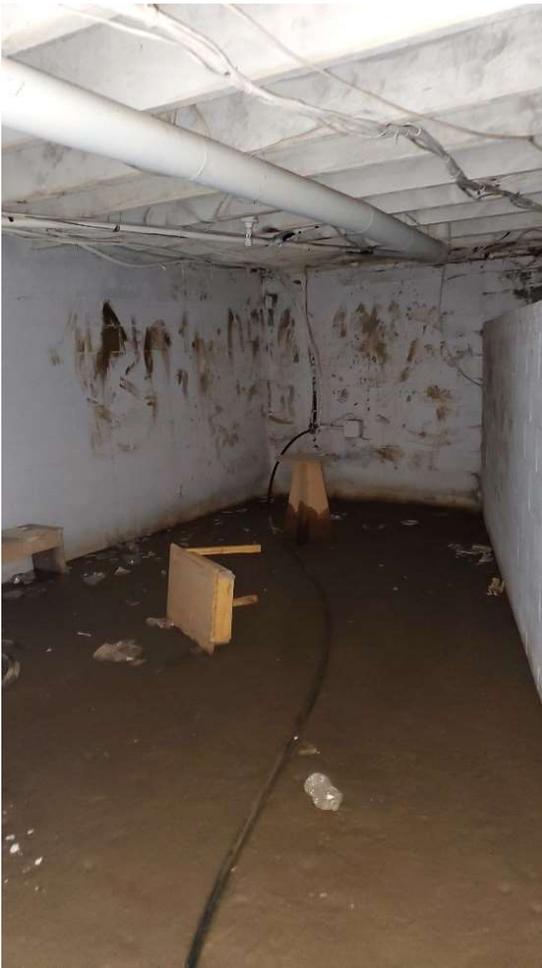
The muddy crawl room's entrance is in the main basement hall of Building 1A, next to the main door. The wooden floor structure, including wooden beams (approximately 3" x 10" at about 24" centers on each side), is supported on the concrete block and rubble stone foundation walls and appears to be in good condition (Pic. 30, Pic. 32). No settlement or cracks were observed in the foundation walls.

Pic. 30: Muddy, Crawl Space in Basement of Building 1B

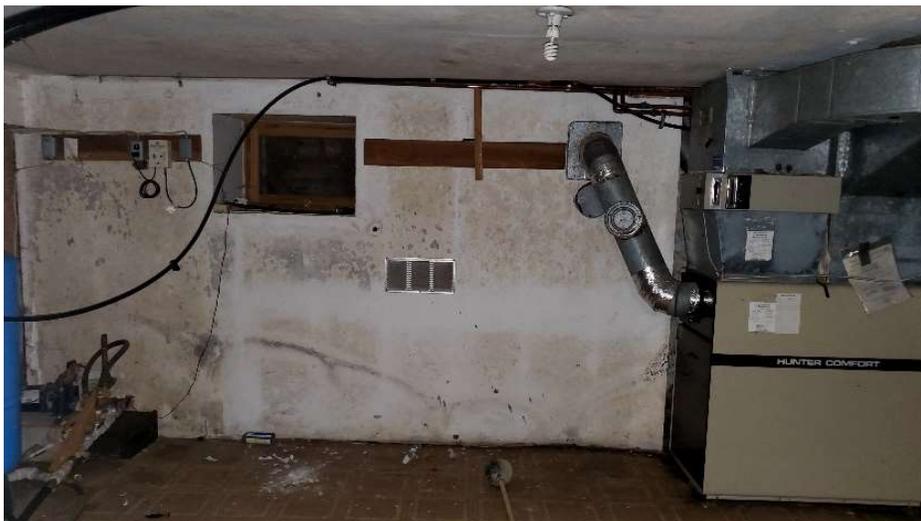
Pic 35: Basement Utility Room, Window, Damp Patches on Exterior Wall-Building 1A

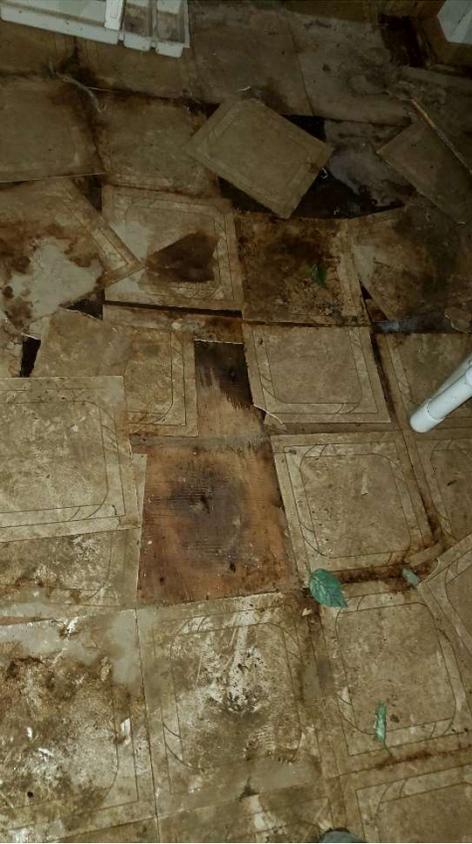
The basement floor consists of square vinyl tiles on wooden flooring, which are dirty, wet, stained, delaminated, damp, and showing mold growth in a few locations (Pic.36, Pic. 37); however, no cracking or settlement was observed.

Pic. 36: Wooden Floor underneath Water Damaged Delaminated Square Tiles in Basement-Building 1A

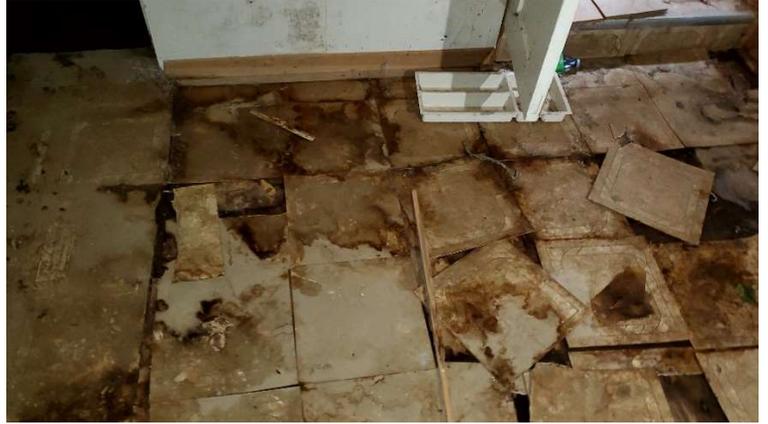
Pic. 37: Water Damaged Stained Flooring over Wooden Floor in Basement of Building 1A

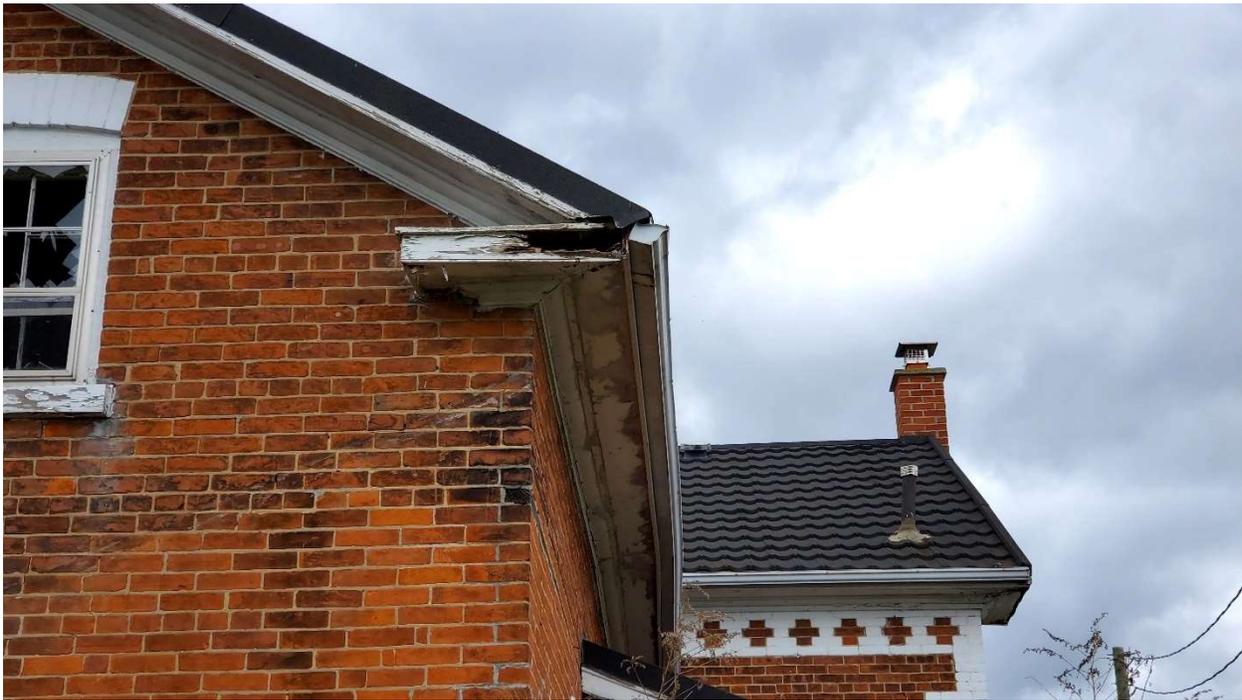
Pic. 38: Previously Repaired Diagonal Crack on Masonry Wall Southside of Building B and Rotten wood at the Eave Corner-Building 1B

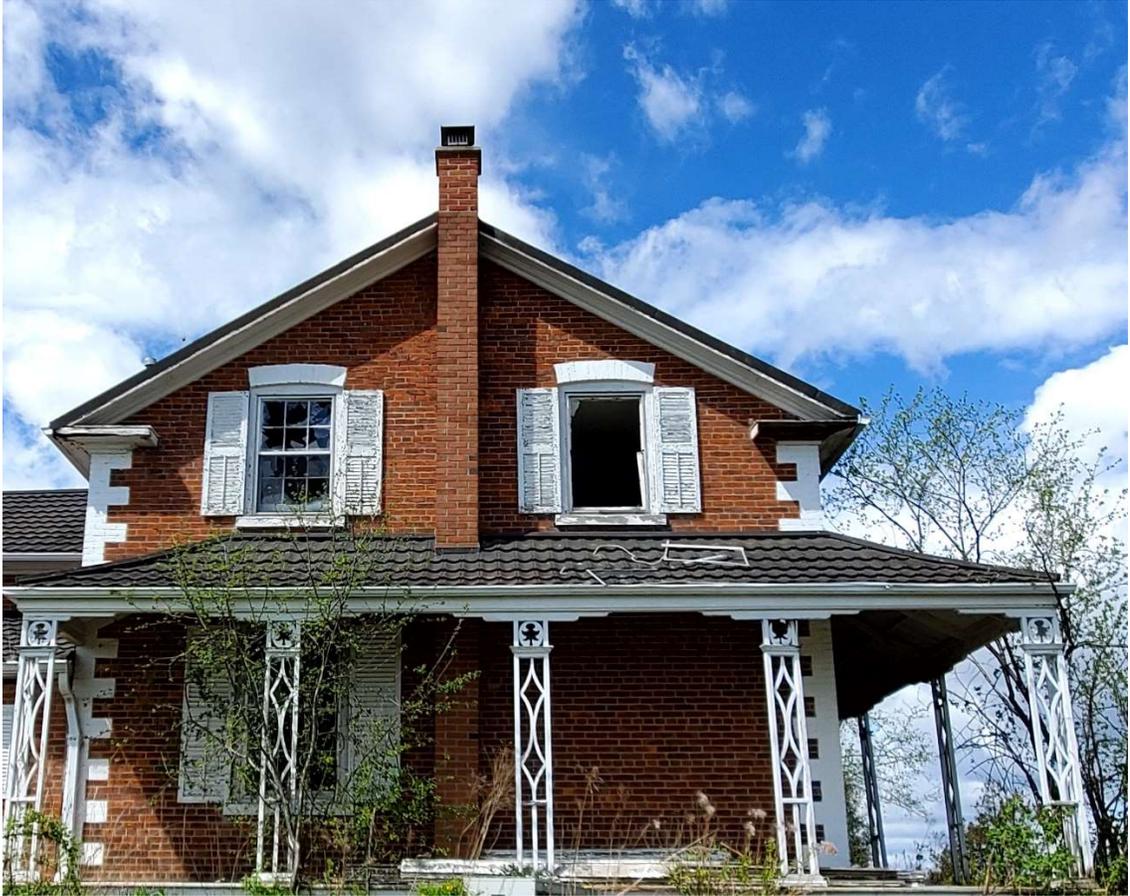
Pic. 39: Degraded Decorative Flat Wooden Posts Supporting Porch and Degraded wood at the Eaves Corner of Roof on Eastside-Building 1A.

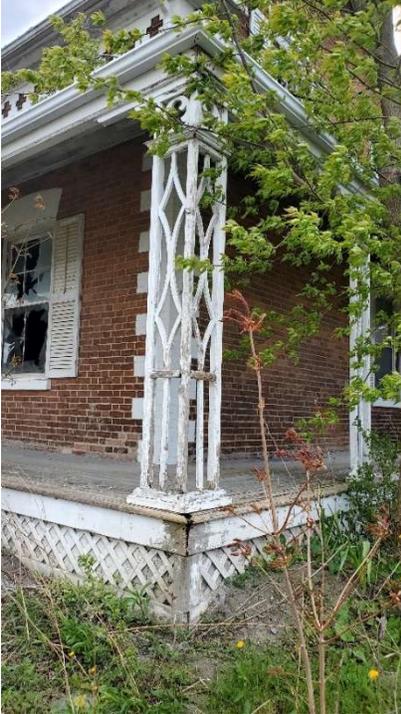
detached from the deck (Pic. 41, Pic. 42). The underside of the wooden structure is covered by a trellis on the wall, making it difficult to assess (Pic. 40, Pic. 41).

Pic. 40: Deteriorated Wooden Decorative Flat Post Supporting Deck – Building 1A

Based on our observation and structural assessment of Building 1A and Building 1B, the overall structural condition of the buildings appears to be relatively good, except for the porch. A few wooden posts supporting the porch and deck boards must be repaired or replaced as they are deteriorated or missing. It is recommended that Building 1A be relocated in a planned manner by carefully demolishing the adjoining Building 1B, as moving both buildings intact is a highly complex and impracticable task for the following reasons.

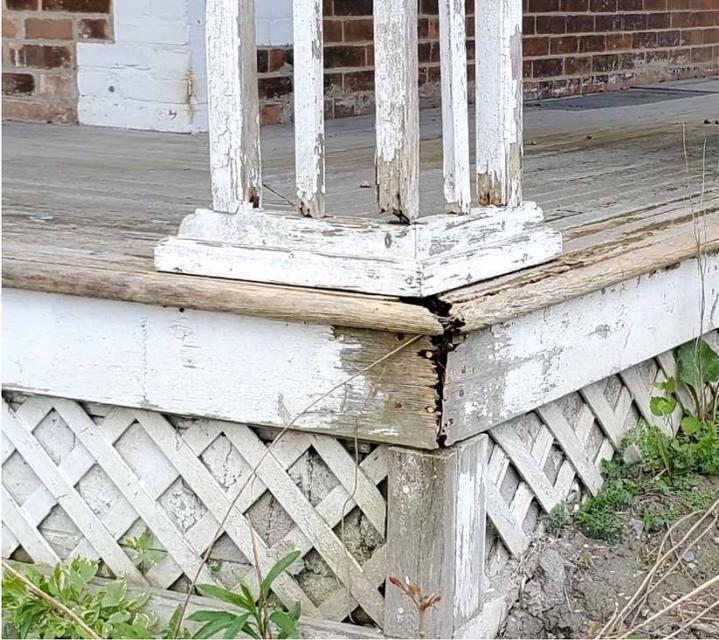
The wooden porch, covered with a mono-pitched roof on wooden framing, appears to be structurally in poor to fair condition. Two decorative flat wooden posts supporting the porch are missing. The porch also shows signs of degradation and deterioration of the wooden elements, including wooden posts and decking boards at a few locations (Pic. 44, Pic. 47). The wooden posts at the bottom are deteriorated, and a few are

Pic. 41: Compromised Post End, Degraded Perimeter Deck Board of Porch, Covered Deck Floor Structure – Building 1A

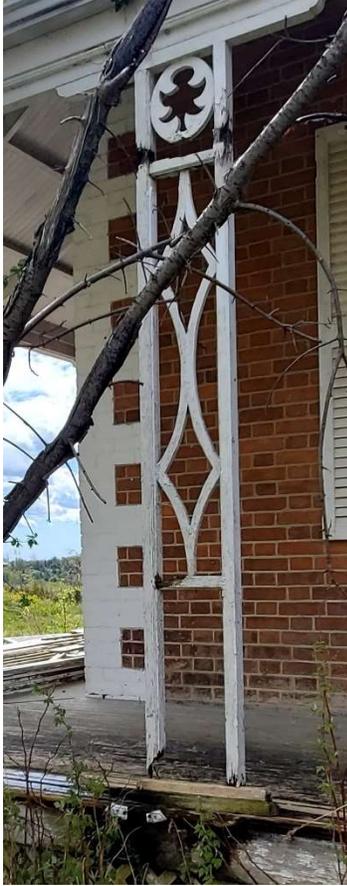
Pic. 42: Compromised Wooden Post at Top and Bottom-Building 1A

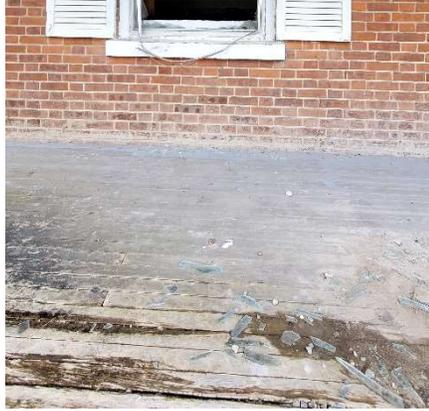
Pic. 43: Deteriorated Deck Floor

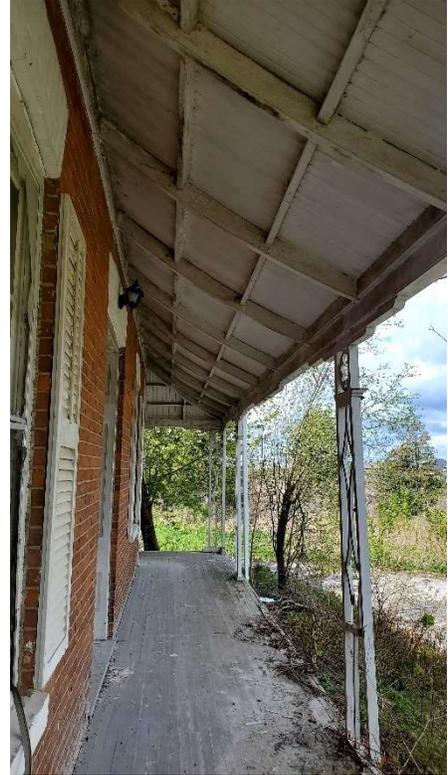
Pic. 44: Missing Post on Porch-Northside- 1A

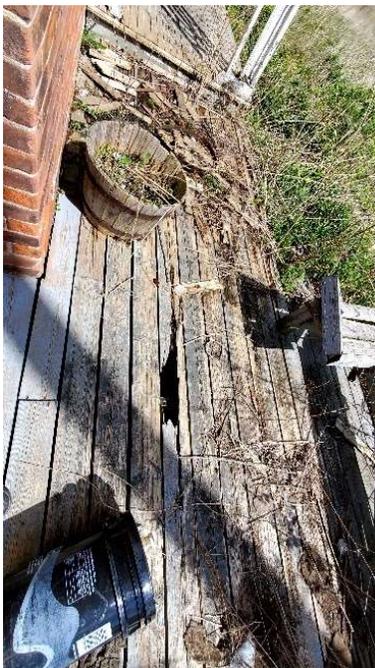
The wooden deck structure of the porch located on the Eastside entrance, structurally, appears to be in poor to fair condition which displays signs of degradation and deterioration occurred over time at few locations (Pic. 45). Deck floors are observed broken, decayed, and deteriorated. Underside structure of the deck is obscured by dumped debris and vegetation growth. Hence, it could not be assessed.

Pic. 45: Degraded Deck-Building 1B

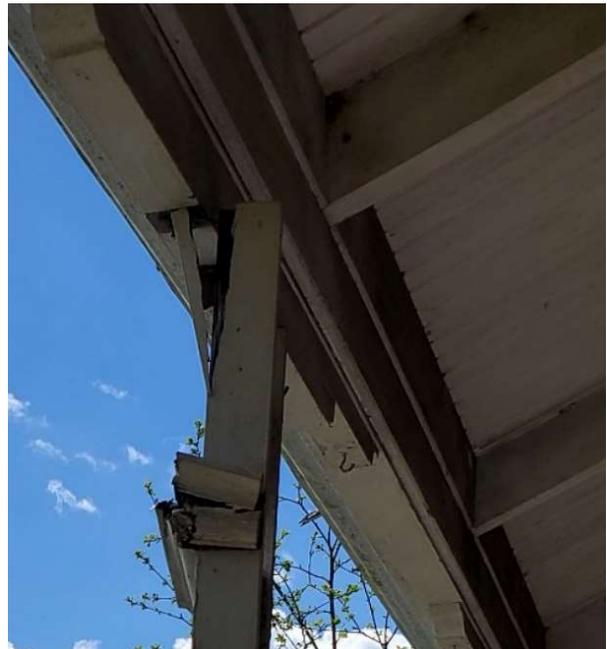
Pic. 46: Damaged Porch Post at Top-Building 1A

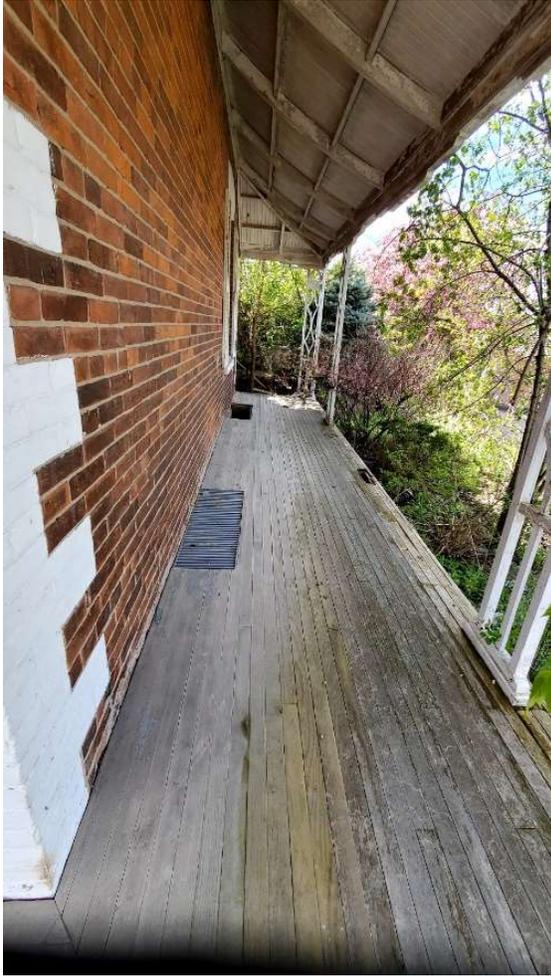
Pic. 47: Missing Post Supporting Porch – Westside 1A

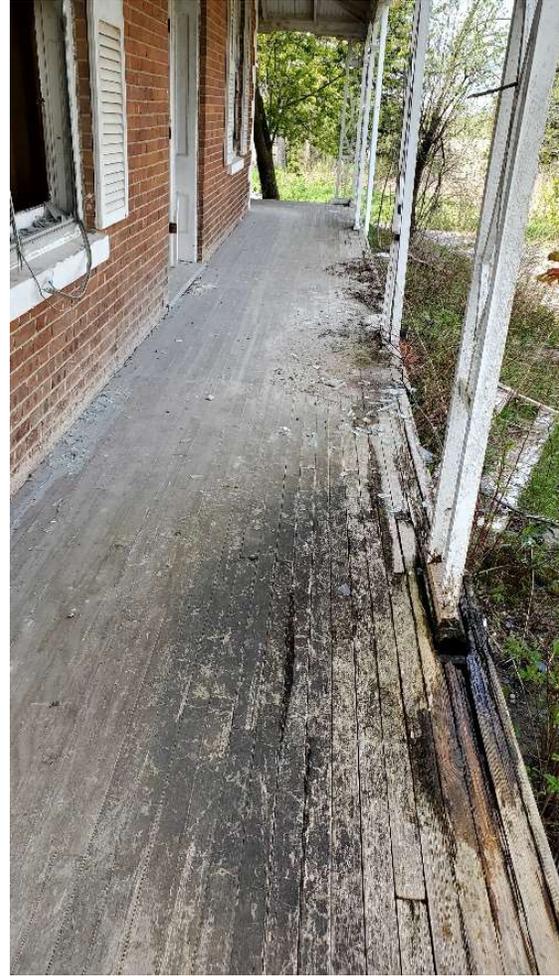
Pic. 48: Degraded Deck-1A

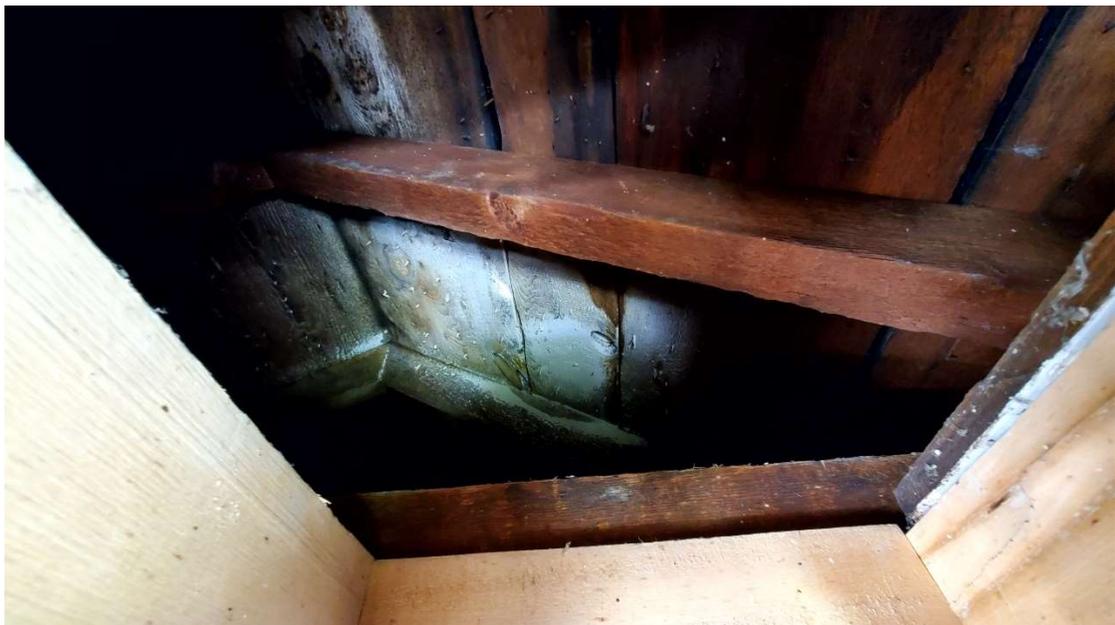
On the 2nd floor, the roof construction seems to consist of stone-coated metal roofing over wooden planks on the wooden rafters while looking into the attic opening (Pic. 49). It appears to be in good condition. The rafters are supported on load-bearing brick masonry walls.

Pic. 49: Wooden Planks on Wooden Rafter – Building 1B
