10376 Yonge Street • Suite 307 • Richmond Hill • Ontario • L4C 3B8 • T: 905•237•5410, F: 905•237•5413, E:ssoscia@sosciaeng.ca

BUILDING CONDITION ASSESSMENT

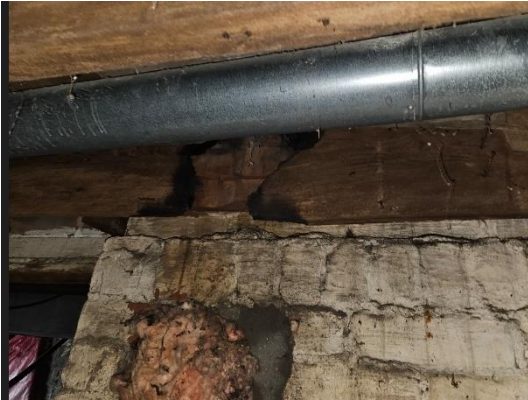
Figure 1: Evidence of Fire Damage impacting a ledger board carrying joists along basement foundation wall

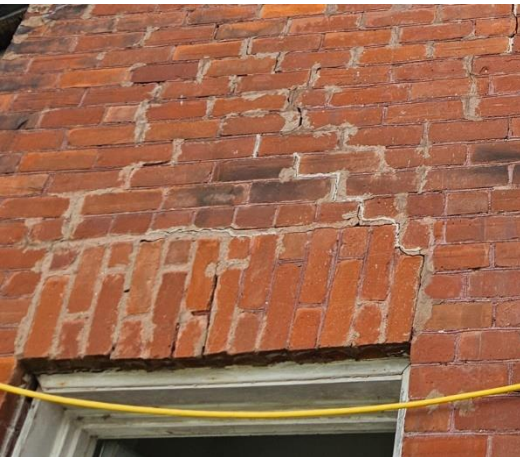
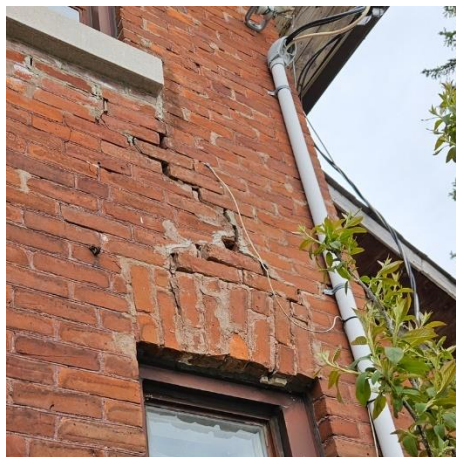
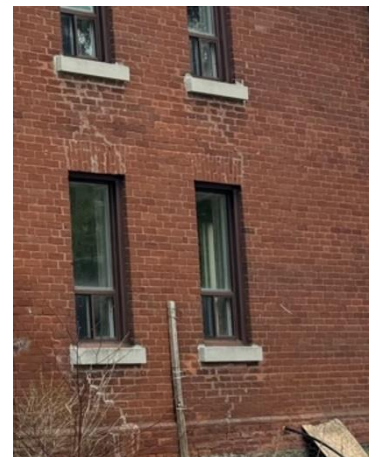
Figure 2: Diagonal cracking at high stress points (windows)

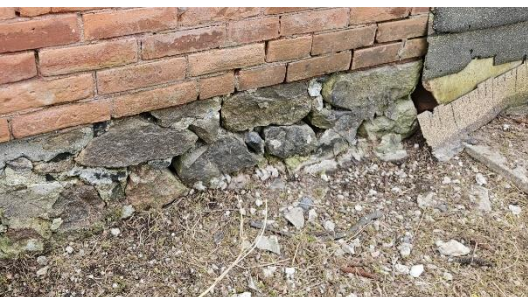
Figure 3: Load bearing foundation wall stones falling apart creating unsafe structural conditions and subject's basement to water leakage.

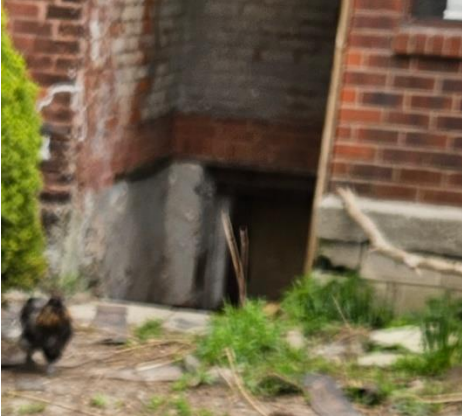
Figure 4: Walkout basement unreinforced wall subjected to lateral soil loading with soil beneath the slab addition on the south east corner of structure

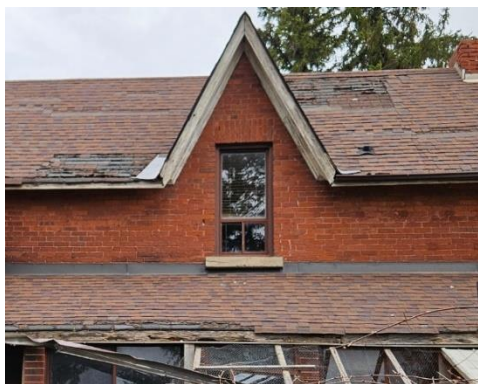
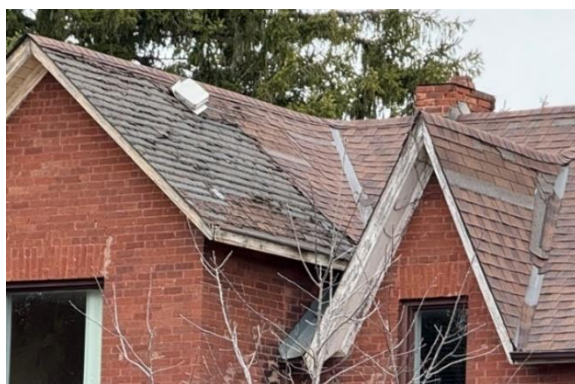
Figure 6: Roof shingles missing areas experiencing local rupturing

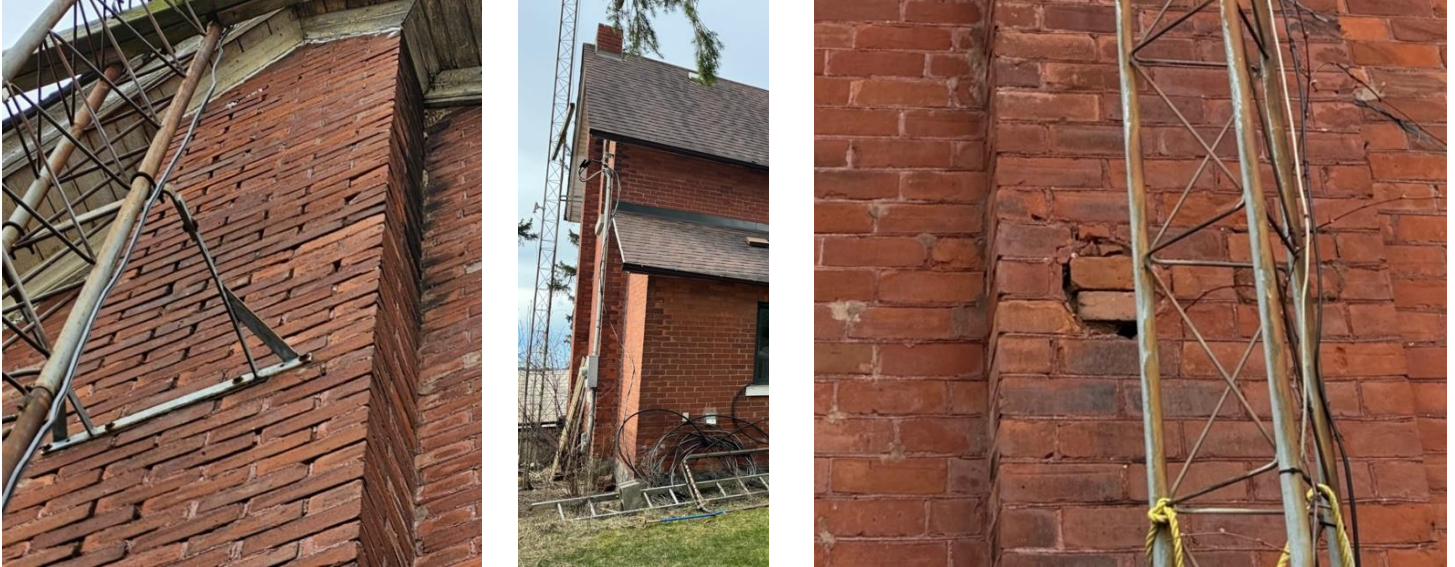
Figure 7: Chimney grouting between bricks eroded away with chimneys appearing to lean in-towards itself.

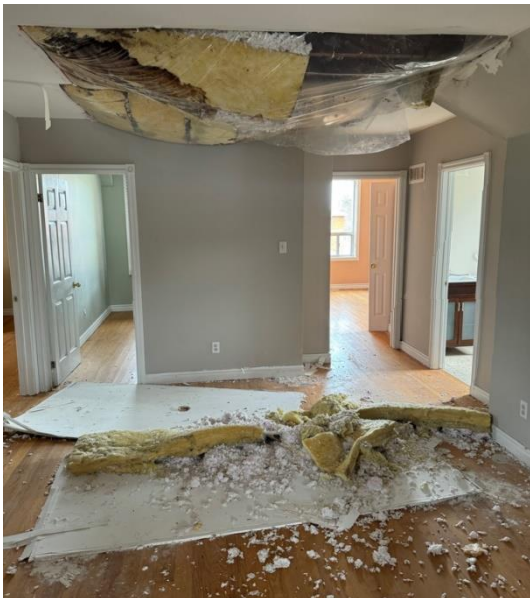
Figure 10: Ceiling collapsed due to possible excessive water wait from roof leakage.

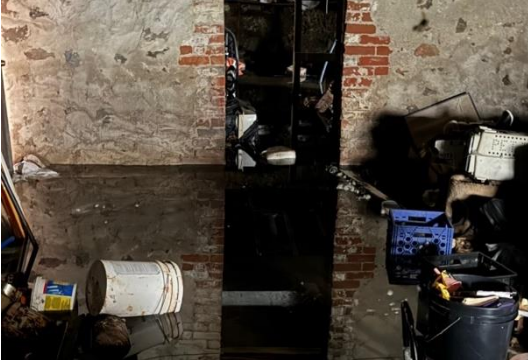
Figure. 11: Basement water leakage 1 to 2 feet high upon inspection.

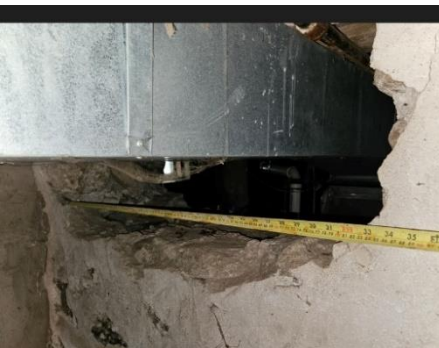
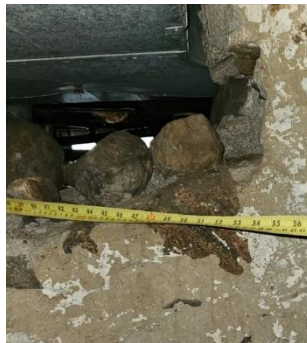
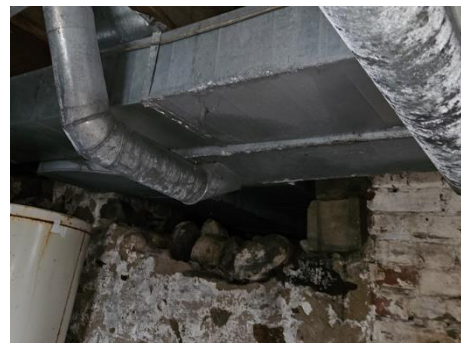
Figure. 12: Load bearing walls with large openings and is structurally unsafe with exterior load bearing walls and joists spanning up to 16.5 feet bearing on walls.

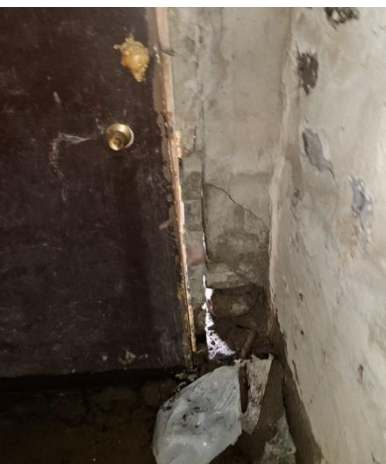
Figure 13: Gaps through to exterior in basement walls

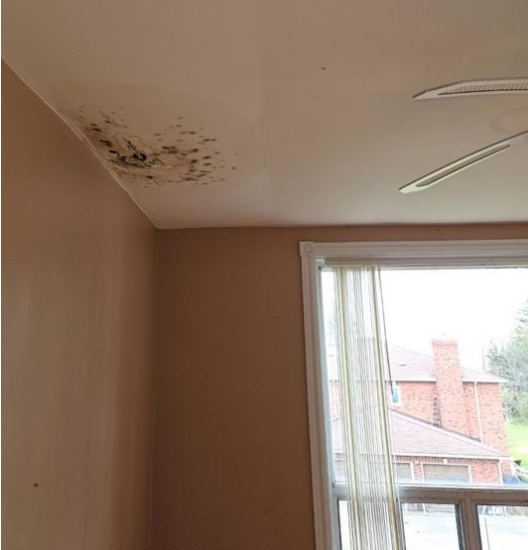
Figure. 16: Water damage/mold on the second-floor ceiling with fairly recent ceiling gypsum due to water leakage from roof.

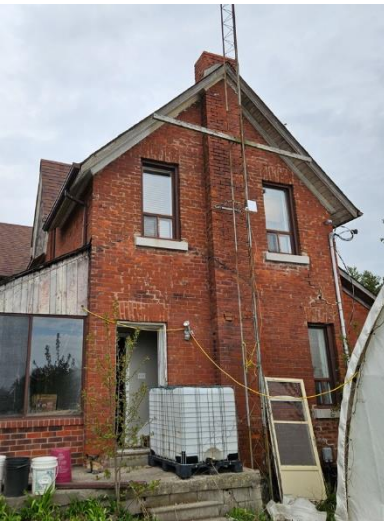
Figure. 17: East Chimney projected chimney with lack of interlocking and grouting to primary structure.
