FIELD REVIEW REPORT

Project:	Munshaw + Bassingthwaite House Relocation	Report #:	ERA-04
Project #:	13-106-05	Permit #:	(optional)
Contractor:	Danco House Raising & Moving Ltd. (House Relocation) Clear Construction and Design (Bassingthwaite house interior)	Location:	10090 Bathurst St
Weather:	Sunny, 25C	Review Date:	June 5, 2024
Prepared By:	Janice Quieta	Date Issued:	June 6, 2024

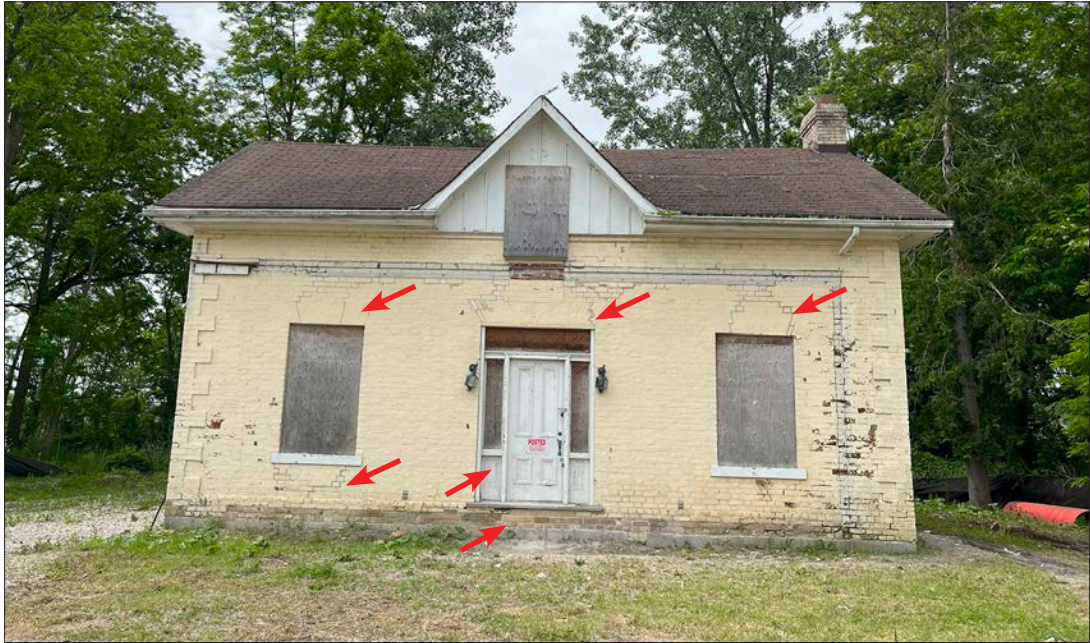
1. Bassingthwaite house, north elevation, on concrete block foundations and general site grading complete. New buff brick installed at the base, step cracking repairs and wood panel installation by DG Group.

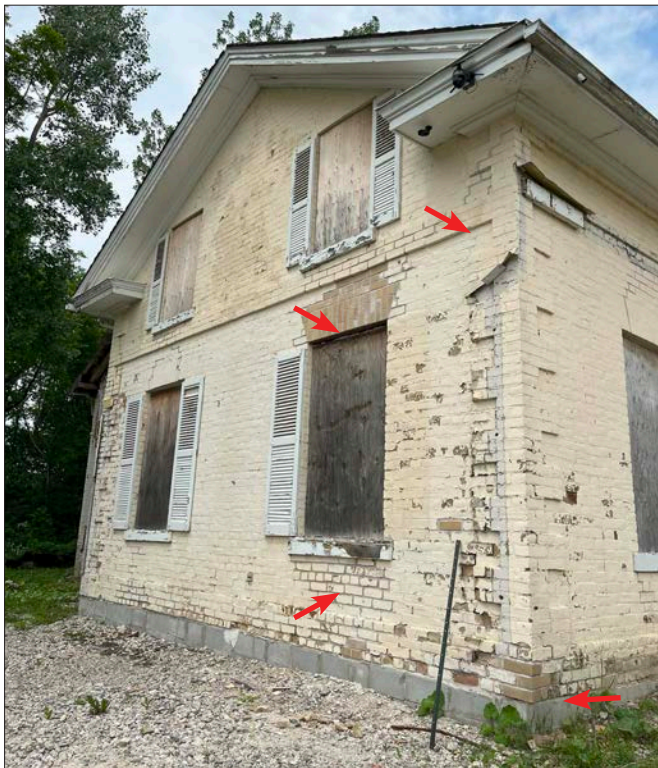
2. Bassingthwaite house, east elevation, on concrete block foundations and general site grading complete. New buff brick installed at the base and step cracking repairs by DG Group.

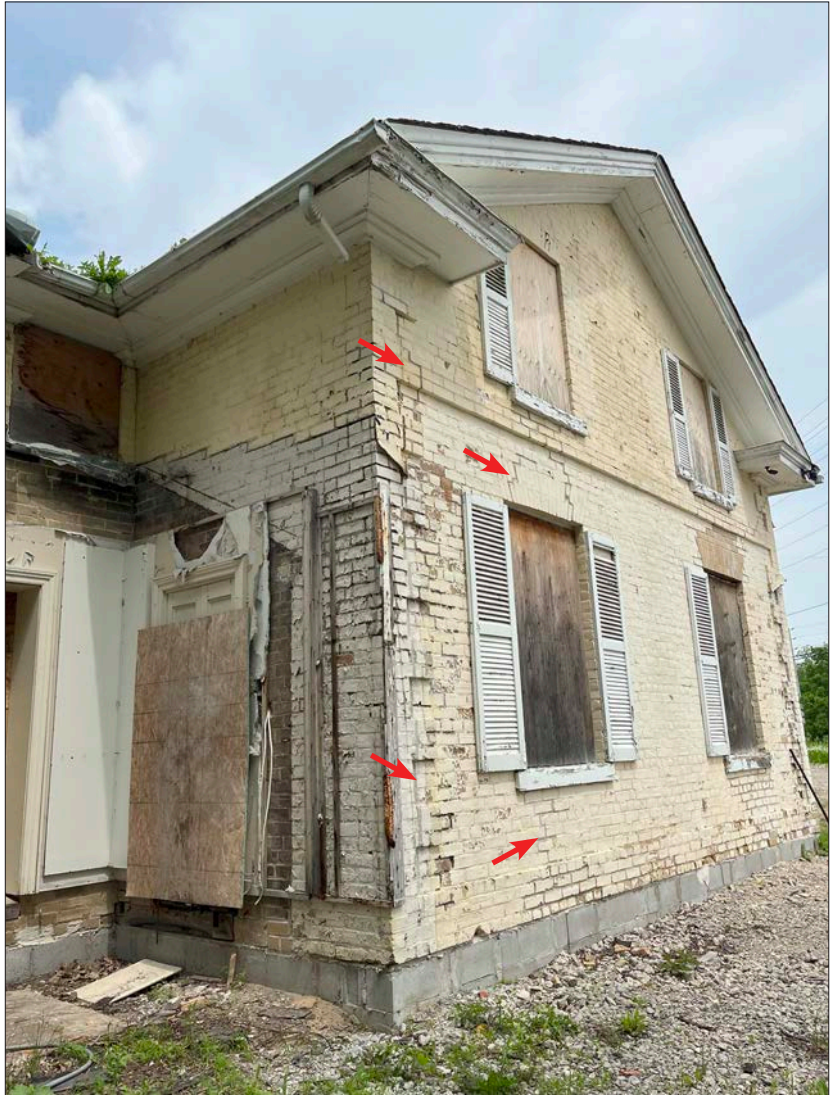
3. Bassingthwaite house, east and south elevation, on concrete block foundations and general site grading complete. East elevation brick and step cracking repairs by DG Group. No change to the south elevation.

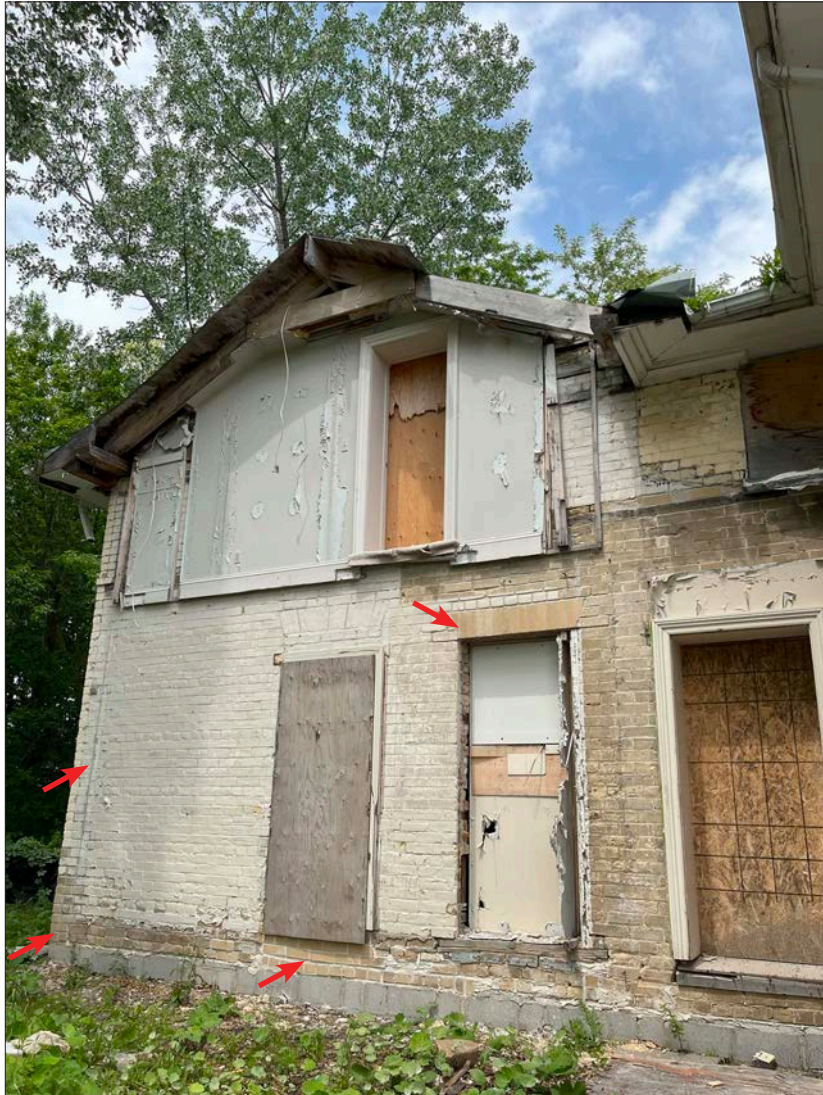
4. Bassingthwaite house, east elevation, on concrete block foundations and general site grading complete. New buff brick installed at the base and lintel, and brick repairs by DG Group.

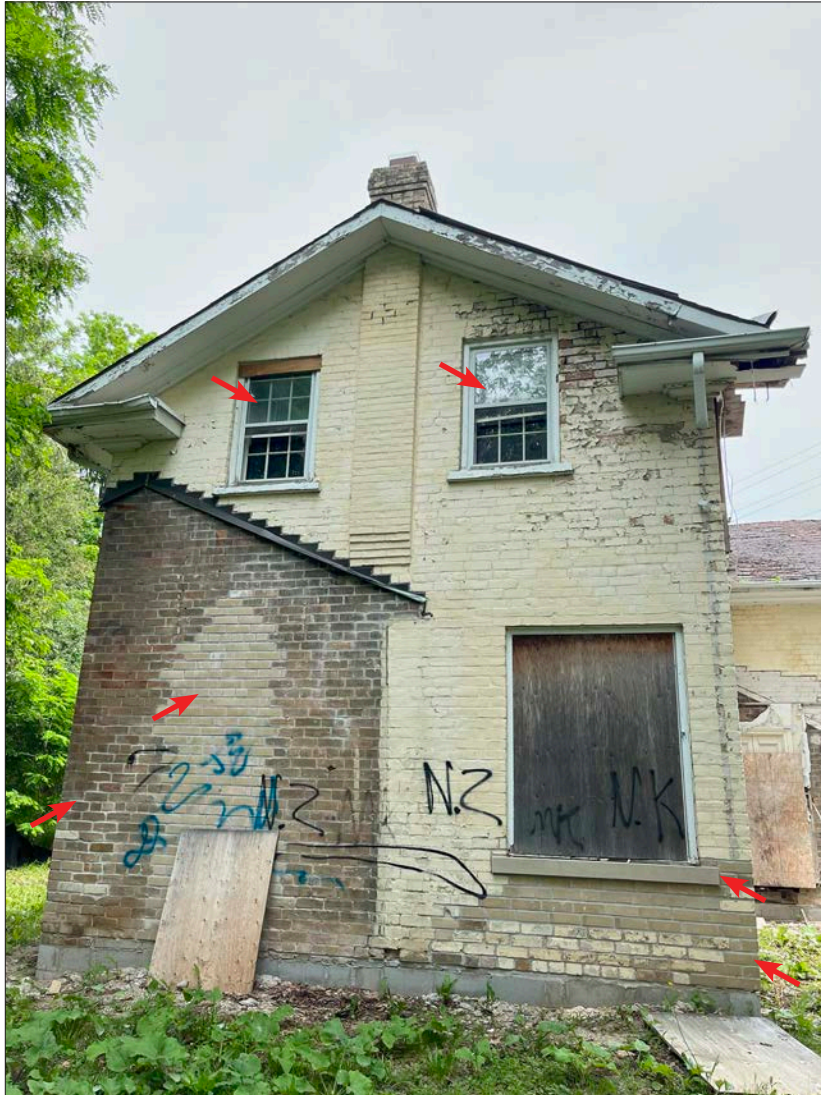
5. Bassingthwaite house, south elevation, on concrete block foundations and general site grading complete. New buff brick installed at the base, below the window, and existing opening, step cracking repairs, and new window sill installation by DG Group. Graffiti on the facade is noted. ERA recommends installing plywood covering at the second floor windows.

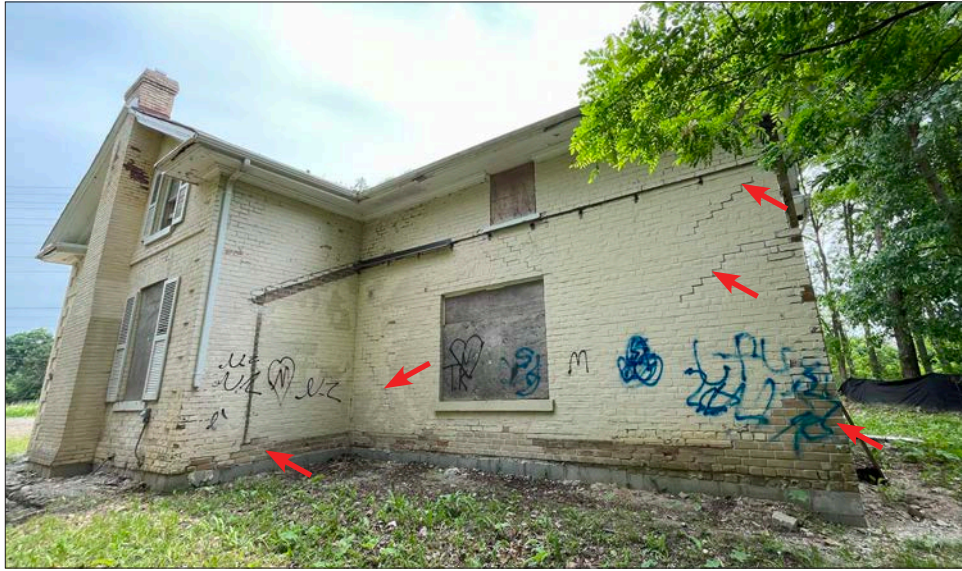
6. Basingthwaite house, west and south elevation, on concrete block foundations and general site grading complete. New buff brick installed at the base and step cracking repairs by DG Group. Graffiti on the facades is noted.

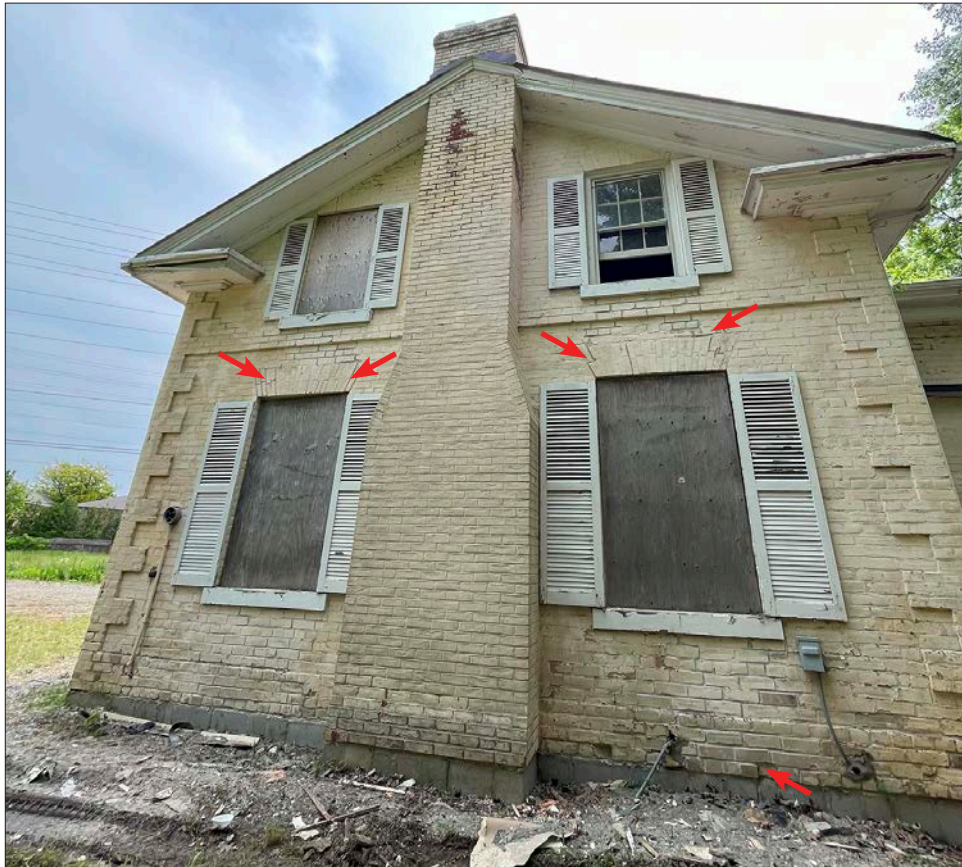
7. Basingthwaite house, west elevation, on concrete block foundations and general site grading complete. New buff brick installed at the base and step cracking repairs by DG Group.

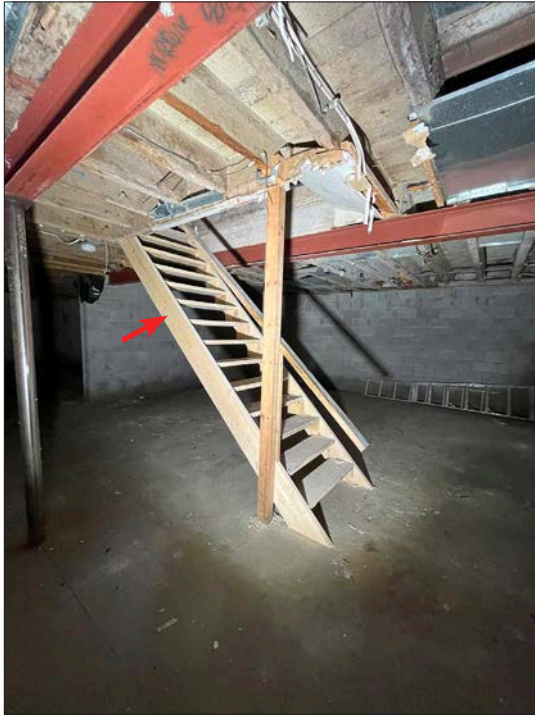
8. Bassingthwaite house, basement level, showing the concrete block foundation walls, concrete floor, steel structure and new wood frame stairs.

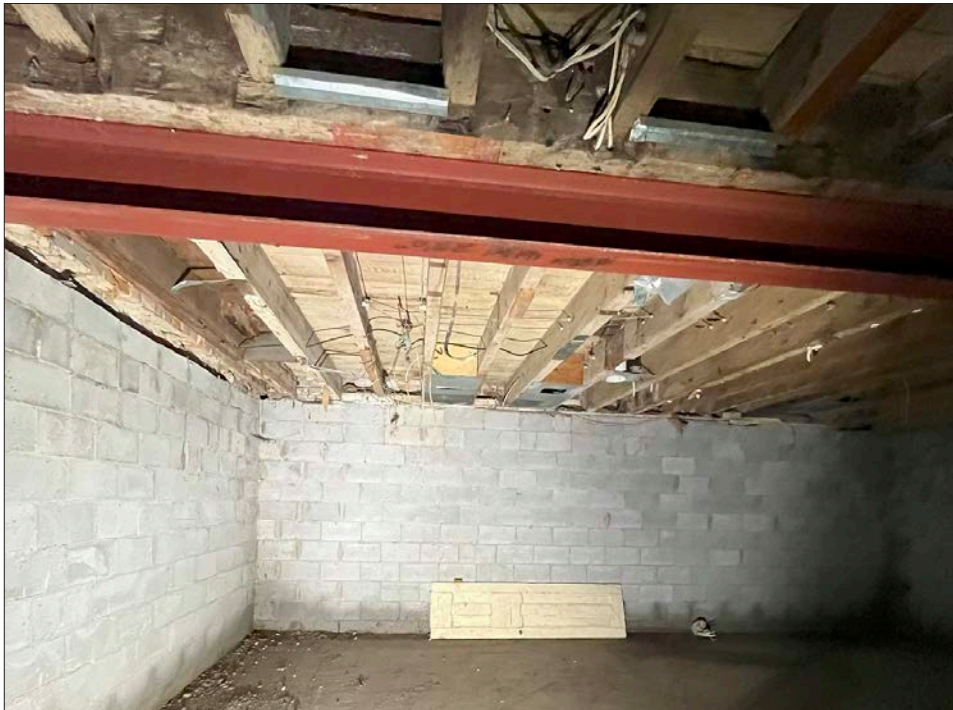
9. Bassingthwaite house, basement level, showing the concrete block foundation walls, concrete floor and steel structure.

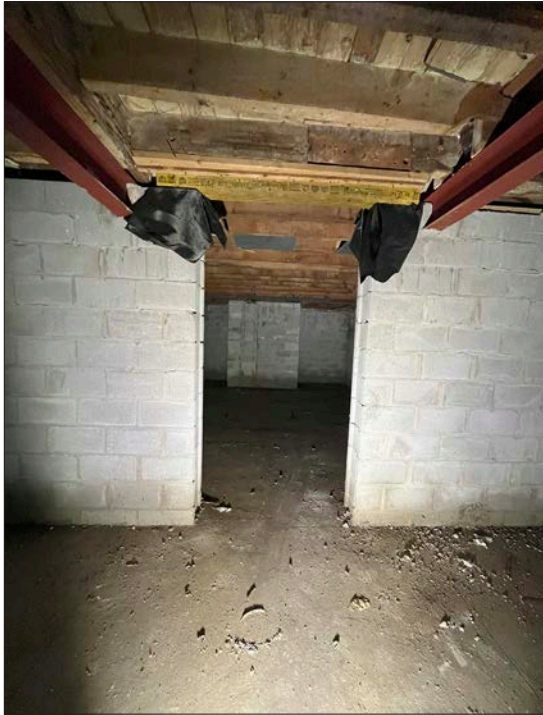
10. Basingthwaite house, basement level, showing the concrete block foundation walls, concrete floor and steel structure.

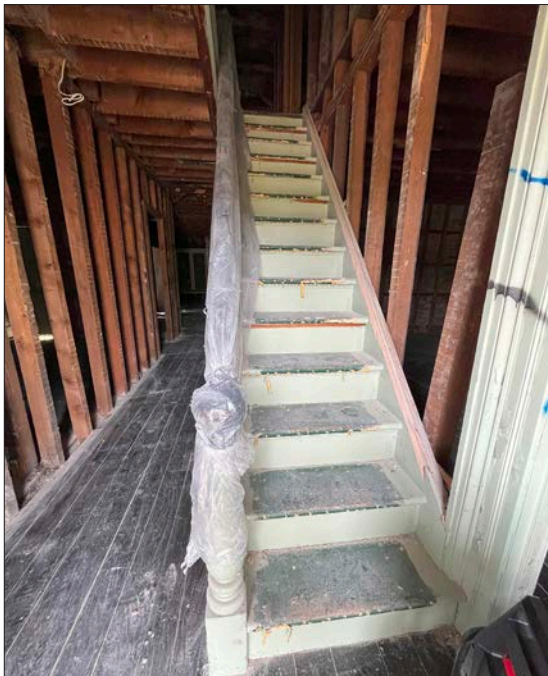
11. Basingthwaite house, ground level, the main stair newel post and handrails protected. The existing ceiling and wall finishes are demolished, the interior wall studs and floor joists are retained.

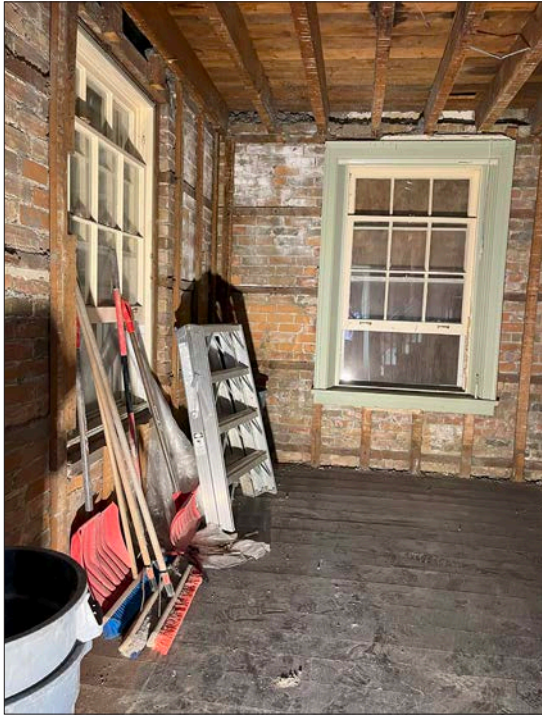
12. Bassingthwaite house, ground level, the existing ceiling and wall finishes are demolished, the perimeter brick wall, interior wall studs and floor joists are retained.

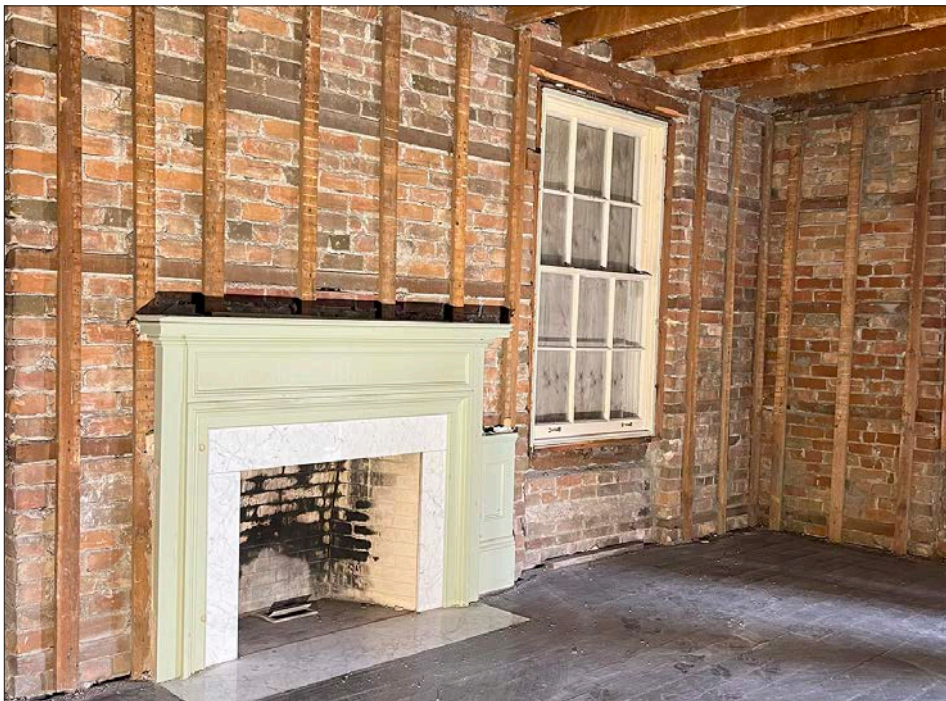
13. Bassingthwaite house, ground level, the existing floor and wall finishes are demolished, the perimeter brick wall, interior wall studs and floor joists are retained.

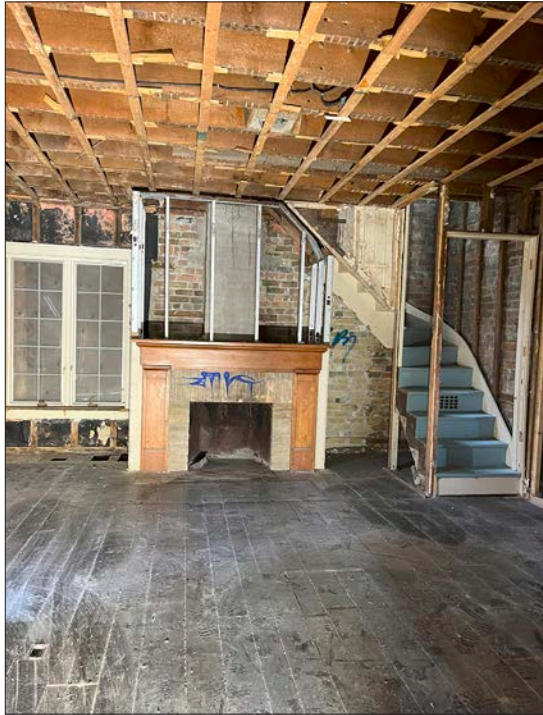
14. Basingthwaite house, ground level kitchen area, the ceiling and wall finishes are demolished, the perimeter brick wall, interior wall studs and floor joists are retained.

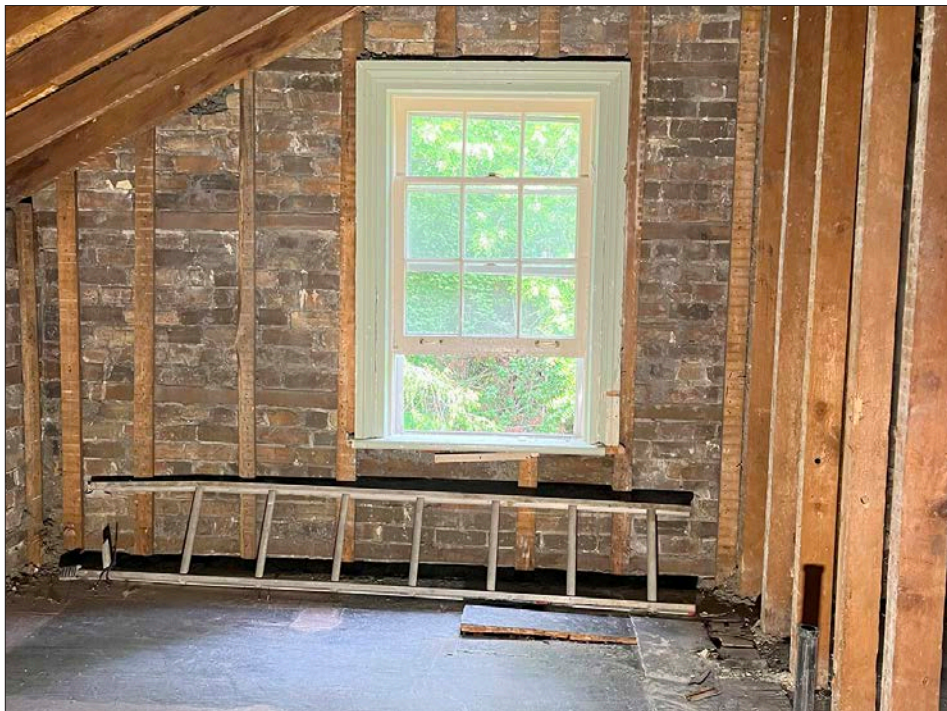
15. Basingthwaite house, second level, the existing roof and wall finishes are demolished, the perimeter brick wall, interior wall studs and roof joists are retained.

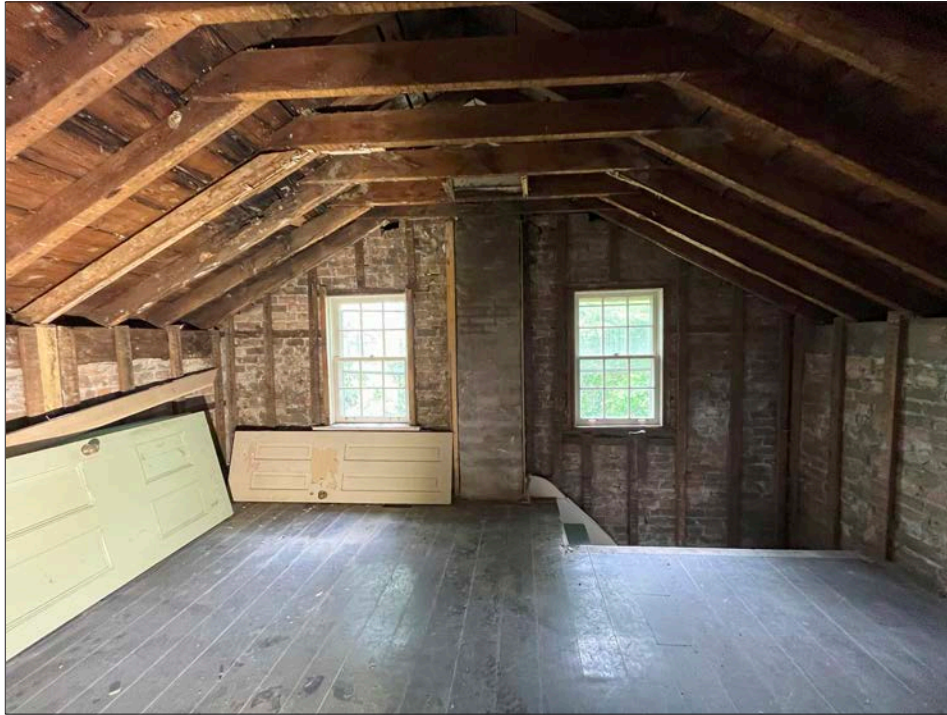
16. Bassingthwaite house, second level, showing the existing roof and wall finishes are demolished, the perimeter brick wall, interior wall studs and roof joists are retained. Original doors have been salvaged.

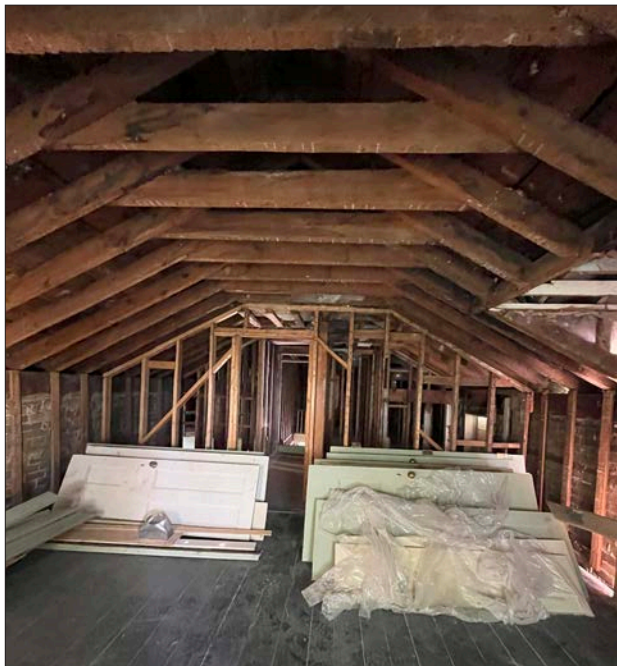
17. Bassingthwaite house, second level, showing the existing roof and wall finishes are demolished, the perimeter brick wall, interior wall studs and roof joists are retained. Original doors have been salvaged.

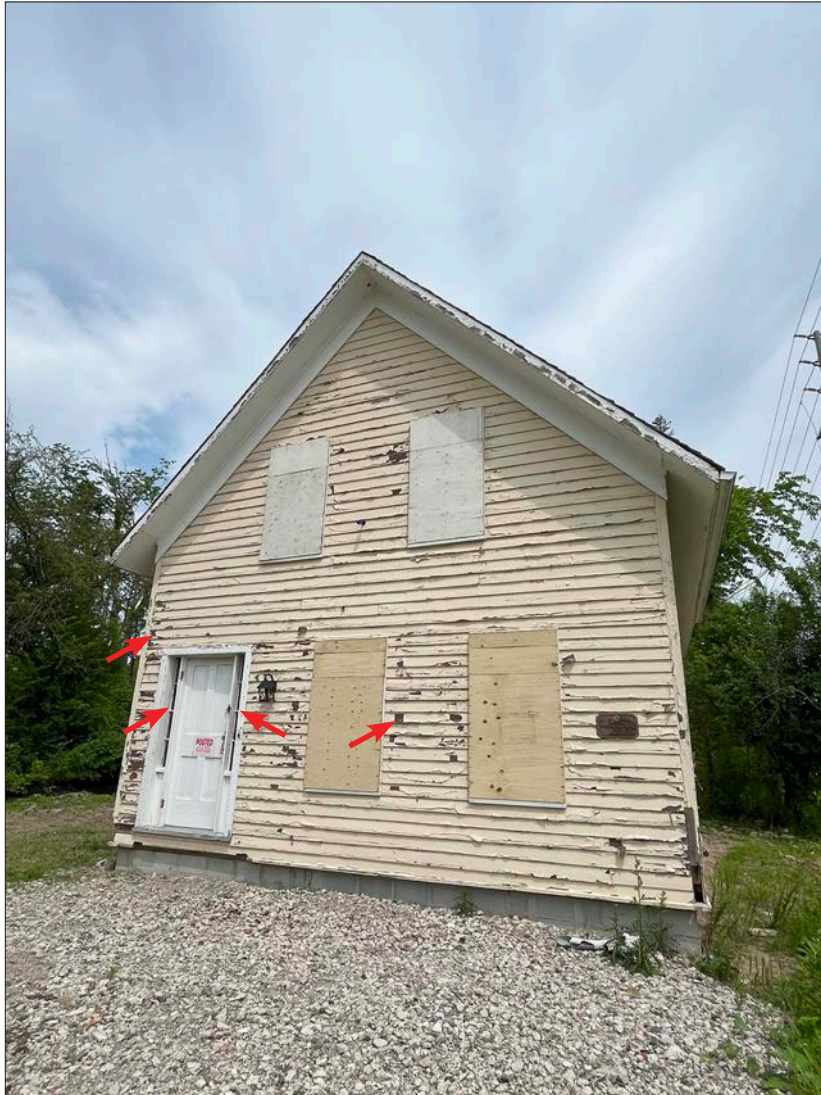
18. Munshaw house, south elevation, on concrete block foundations and general site grading complete. ERA noted broken glazing at the side lites and more paint flaking on the facade. ERA recommends installing plywood over side lite openings.

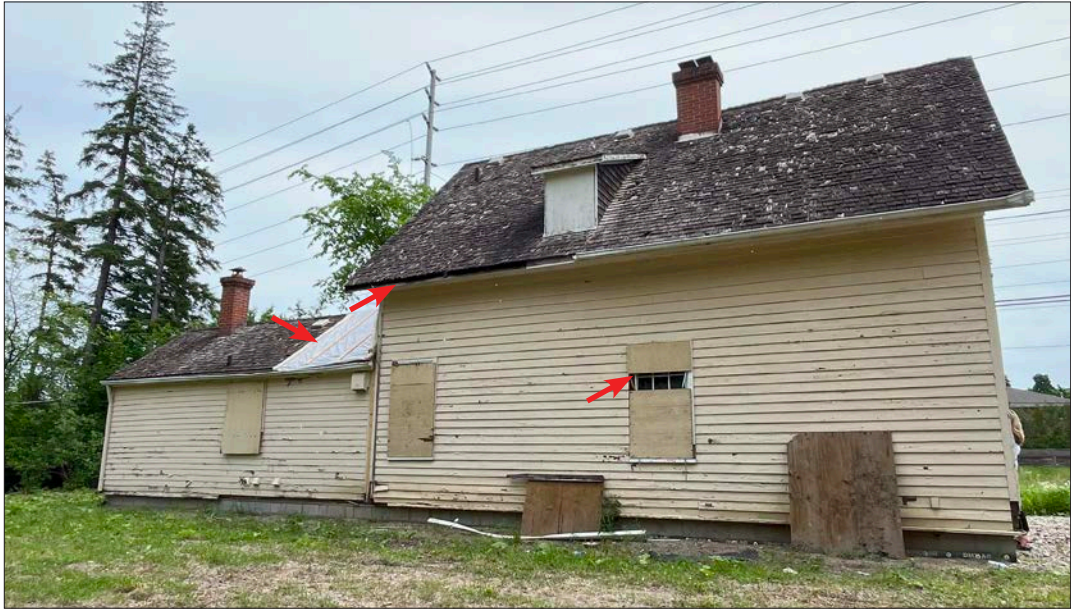
19. Munshaw house, west elevation, on concrete block foundations and general site grading complete. ERA noted the cedar shingles have deteriorated since the last site visit in 2021 and a section of the eaves-through has fallen off. ERA noted tarp protection installed at the roof and walls of the house. ERA recommends installing plywood over exposed opening.

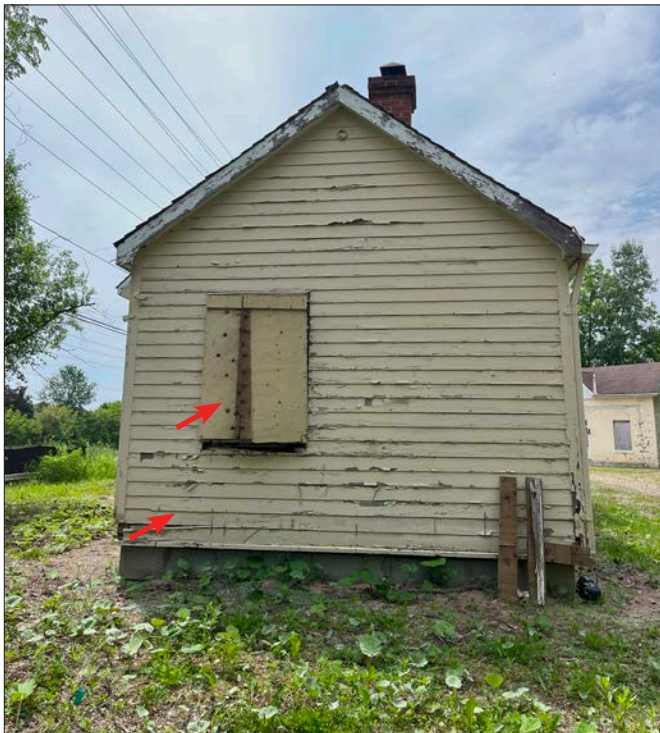
20. Munshaw house, north elevation, on concrete block foundations and general site grading complete. ERA noted more paint flaking on the facade. ERA noted the plywood installed over the opening is broken, ERA recommends installing new plywood.

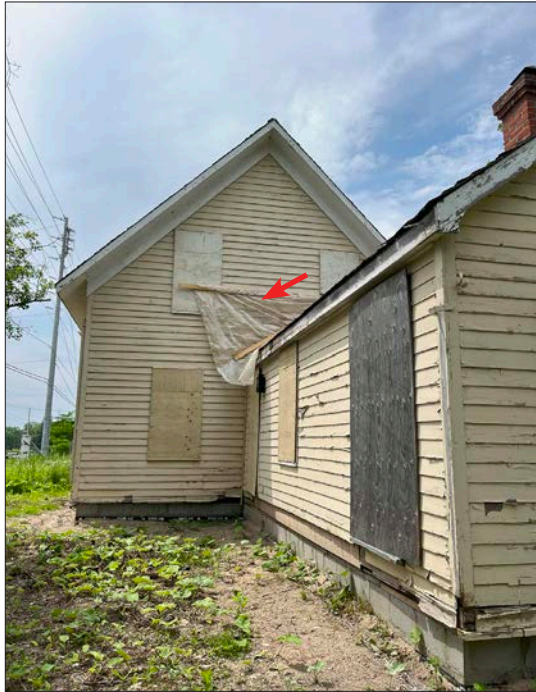
21. Munshaw house, north and east elevation, on concrete block foundations and general site grading complete. ERA noted tarp protection installed at the roof and wall of the house.

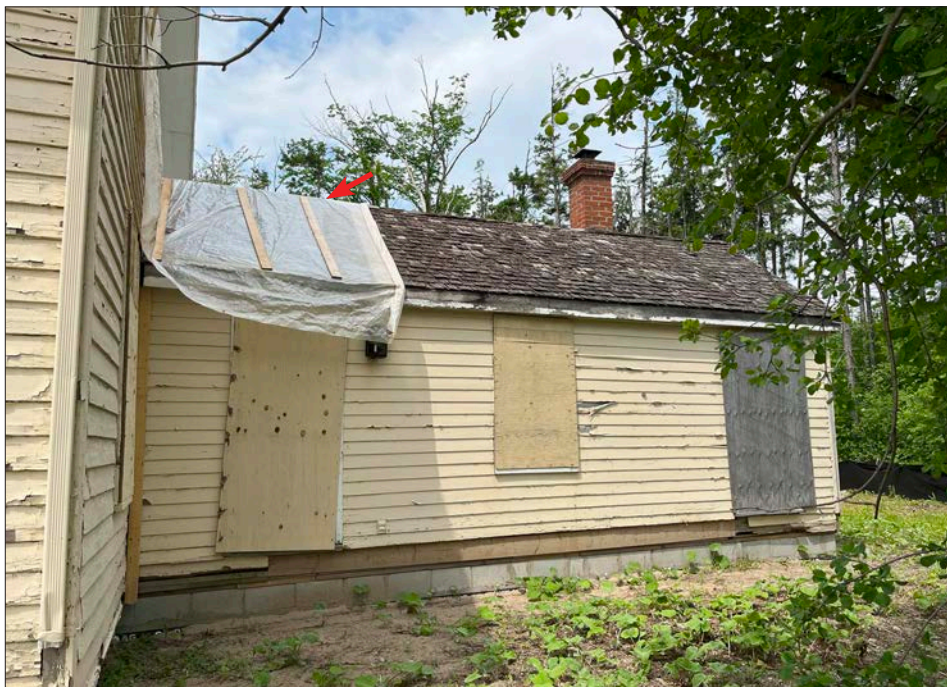
22. Munshaw house, east elevation, on concrete block foundations and general site grading complete. ERA noted the cedar shingles have deteriorated since the last site visit in 2021. ERA noted tarp protection installed at the roof and walls of the house.

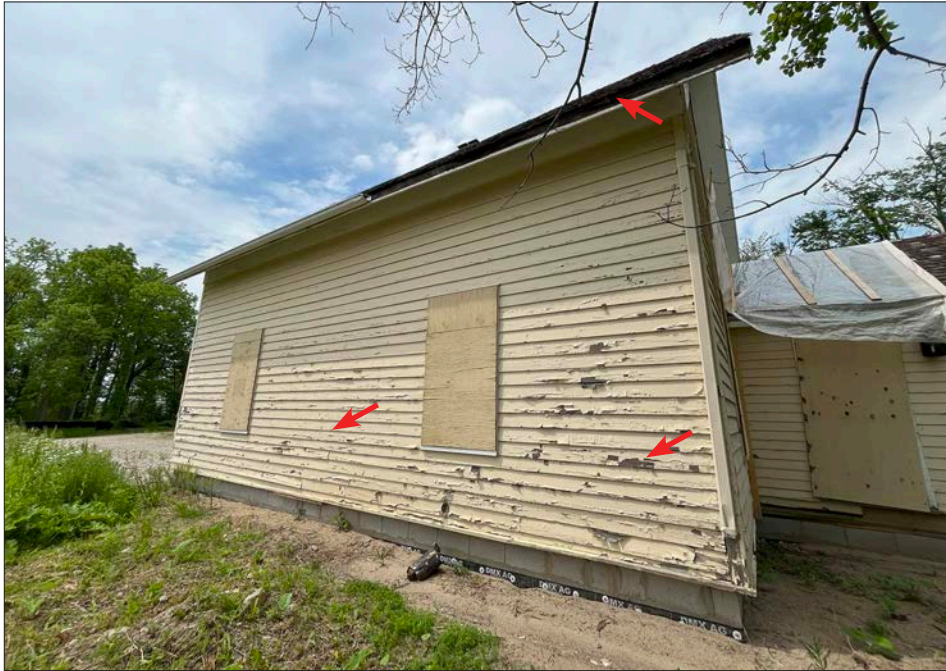
23. Munshaw house, east elevation, on concrete block foundations and general site grading complete. ERA noted that a section of the eaves-through has fallen off and more paint flaking on the facade.

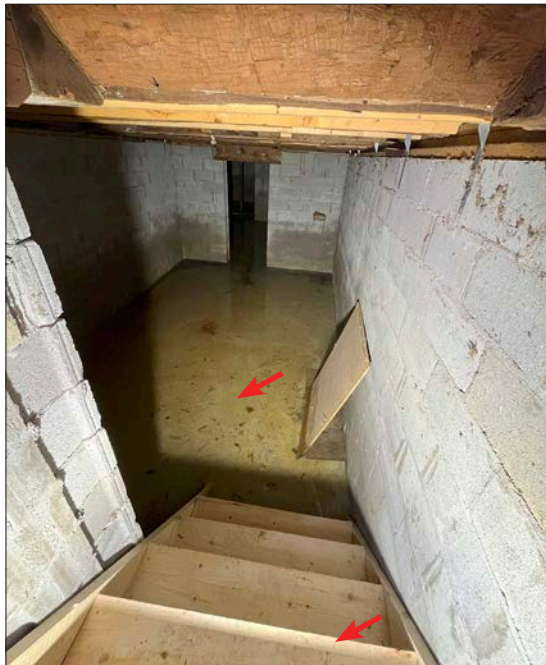
24. Munshaw house, basement level, showing the concrete block foundation, concrete floor, and new wood frame stairs. ERA noted 150mm high water accumulation in the basement. ERA recommends water removal.

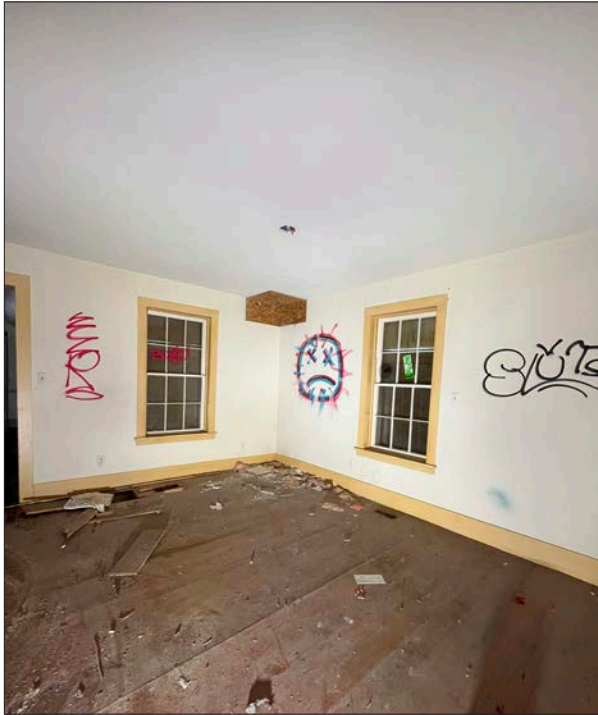
25. Munshaw house, ground level, no interior work completed. Graffiti on the walls is noted.

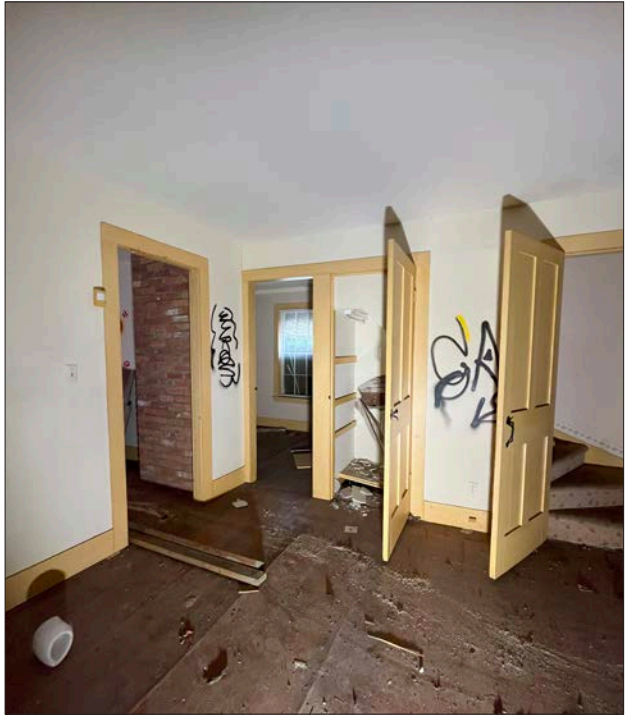
26. Munshaw house, ground level, no interior work completed. Graffiti on the walls is noted.

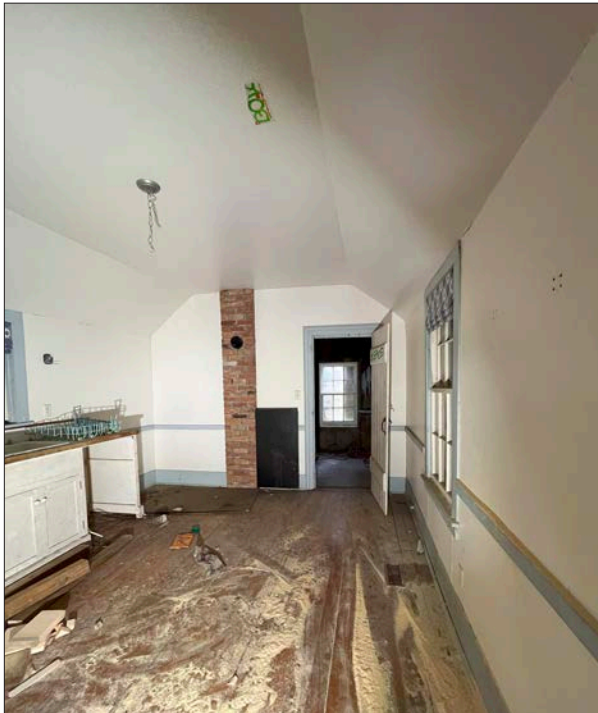
27. Munshaw house, ground level, no interior work completed.

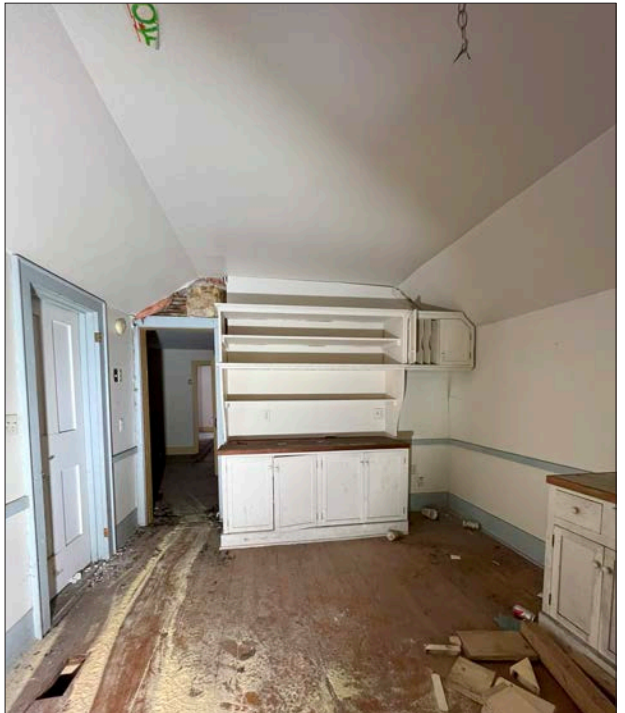
28. Munshaw house, ground level, no interior work completed.

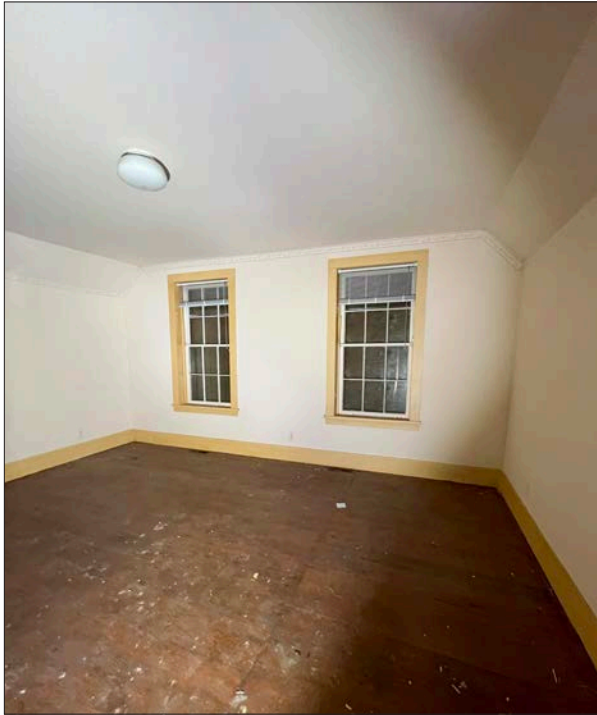
29. Munshaw house, second level, no interior work completed.

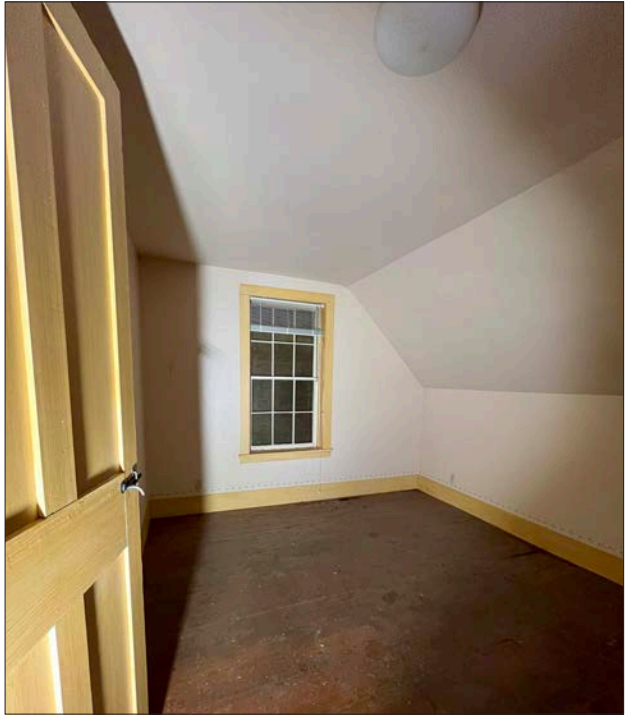
30. Munshaw house, second level, no interior work completed.

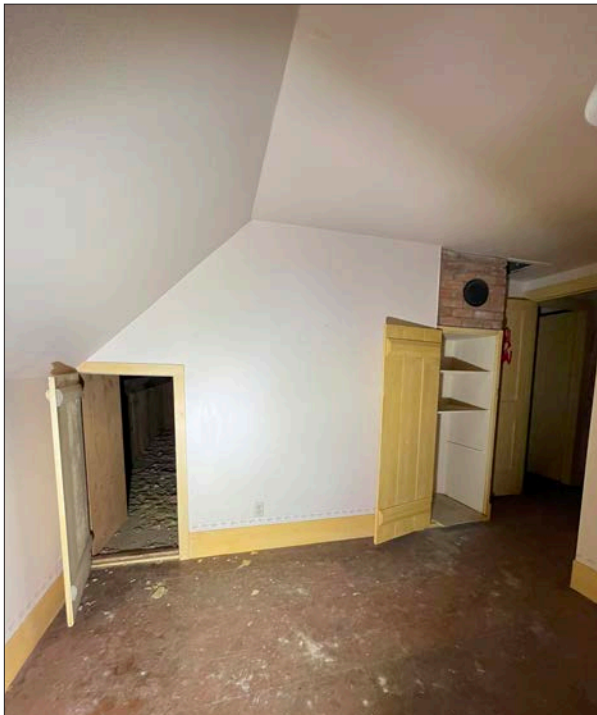
31. Munshaw house, second level, no interior work completed.

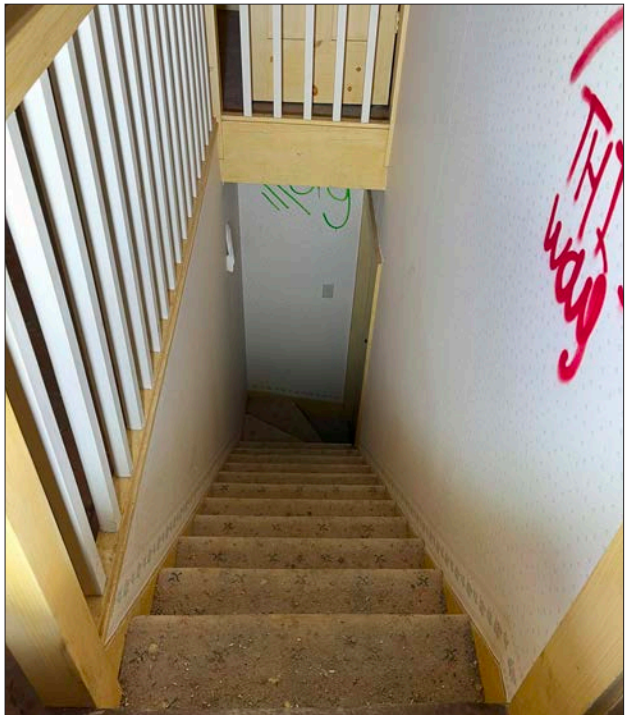
32. Munshaw house, second level, no interior work completed. Graffiti on the walls is noted.
