REPORT

10489 Islington Avenue, City of Vaughan, Ontario
Maintenance Plan

1668503-R02

September 24, 2020

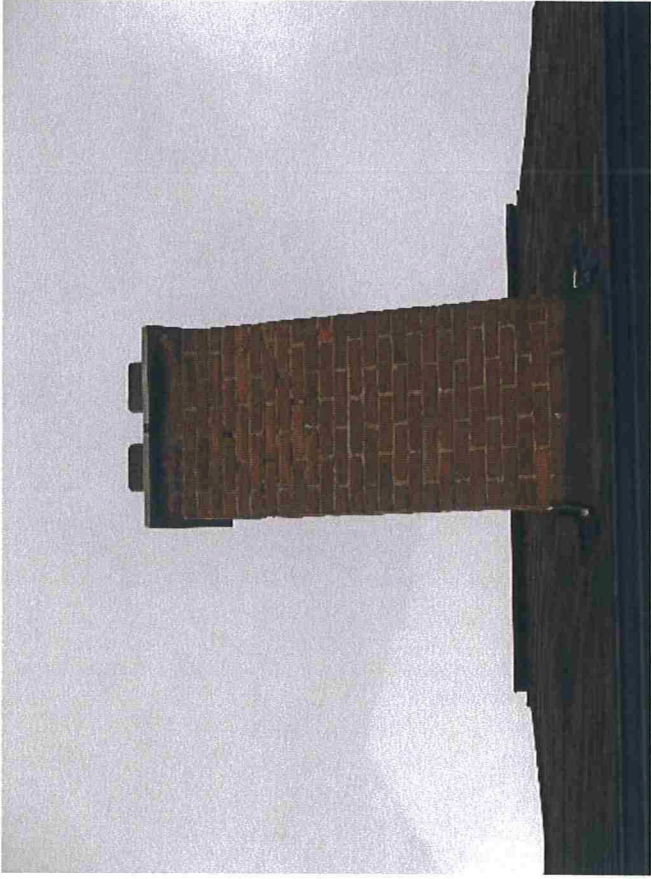
Element	Observed Conditions	Documentation
General structure	<ul style="list-style-type: none"> ■ Overall good condition based on the state of interior and exterior fabric (see below). 	See below.
Roofs	<ul style="list-style-type: none"> ■ No visible rot on the fascias or soffits, and the flashing and gutters appear sound ■ The roof covering for the house is in good condition ■ No tilting or mortar deterioration seen in the chimney masonry. Minor mortar washout is visible.

<p><i>Minor mortar washout visible on the main block chimney.</i></p>

- Repoint chimneys and walls.
 - Although intact, there are areas of the chimney and exterior walls which requires repointing due to mortar washout. As mentioned above, repointing should use lime mortar. The mortar mix should be durable enough to survive the weather yet soft enough not to damage masonry. Patching the chimney render instead of total replacement is preferred.

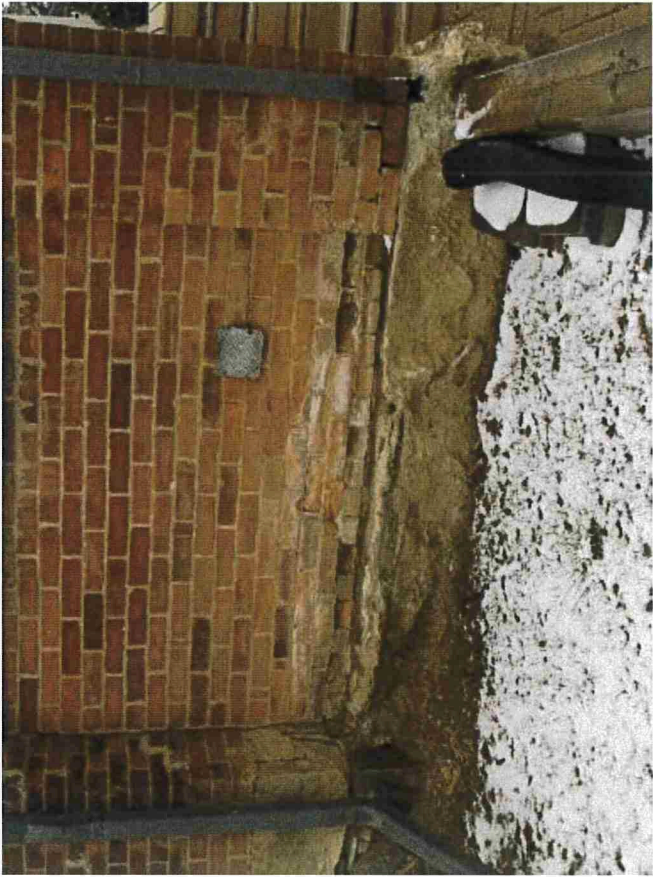
Element	Observed Conditions	Documentation
Walls, foundations and exterior features	<ul style="list-style-type: none">■ House walls appear to be sound with no evidence of bowing■ No evidence of water infiltration or efflorescence■ Areas of the exterior walls display mortar washout■ Some areas of the foundation need to be repointed

<p data-bbox="1024 394 1052 779"><i>Mortar washout on exterior bricks.</i></p>

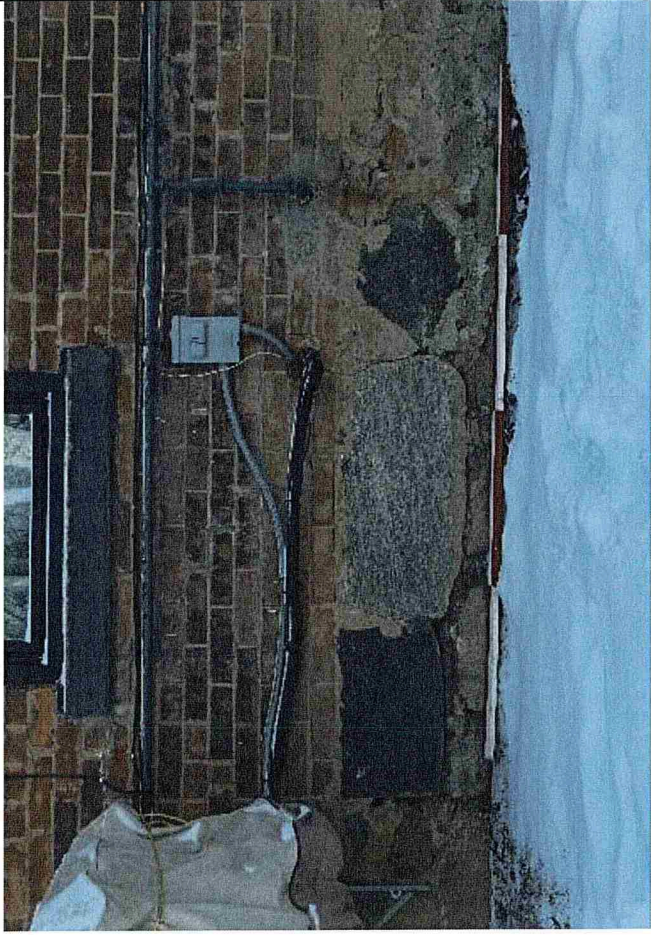
<p data-bbox="1040 289 1073 892"><i>Mortar requiring repointing as visible on north façade.</i></p>

- Repoint the Foundation; and,
 - Field investigations noted evidence of mortar washout, which will need to be repointed using lime mortar. A heritage mason can advise on the mortar mixture, but it should be slightly weaker than the stones in the wall (Weaver 1993:134).

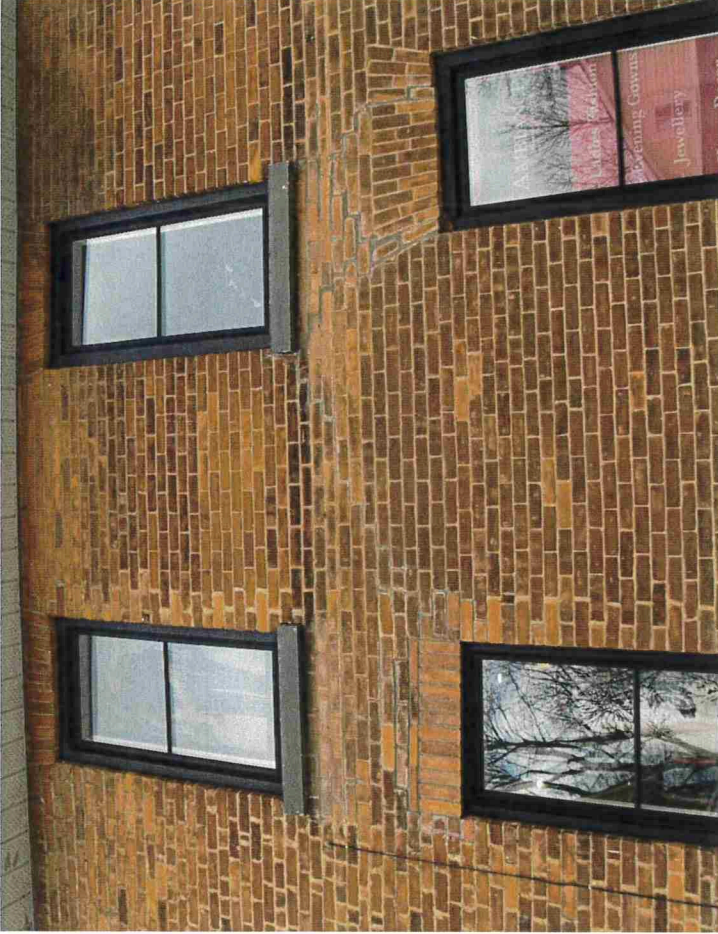
Element	Observed Conditions	Documentation
Windows and Doors	<ul style="list-style-type: none">■ Windows, doors, and glazing appear to be in good condition throughout

<p><i>Windows on the north façade.</i></p>

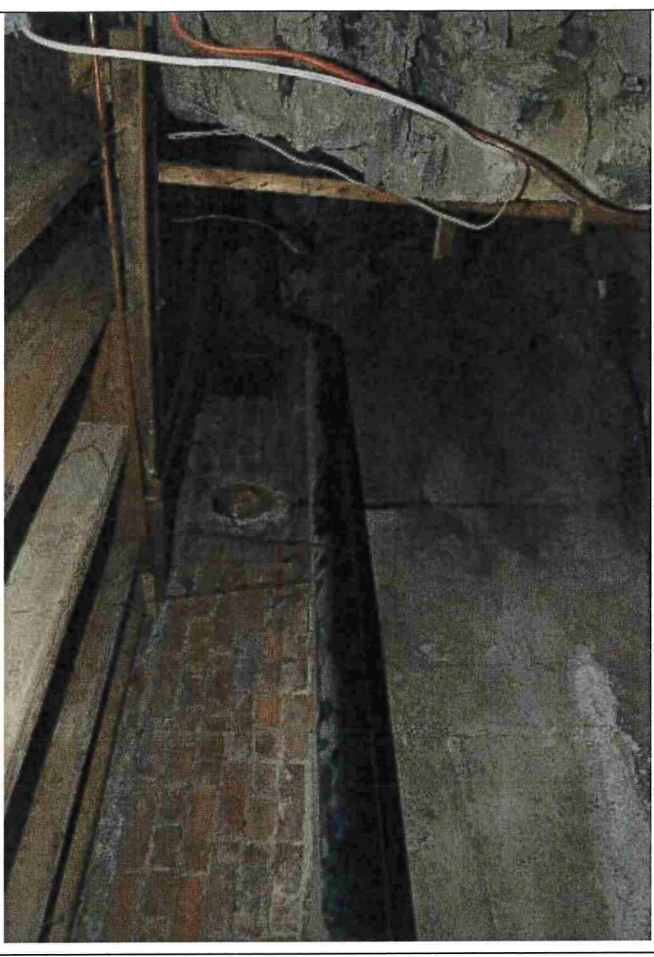
Element	Observed Conditions	Documentation
Basements	<ul style="list-style-type: none">■ No evidence of efflorescence or dampness in the basement■ Debris (i.e. boxes, storage) blocking views of wall conditions

<p><i>Interior condition of the basement.</i></p>

- Inspect quarterly for insect, pests and other infestation;
- Debris in basement should be removed to ensure leaks can be more easily detected. Consider installing dehumidifier to prevent moisture build up;

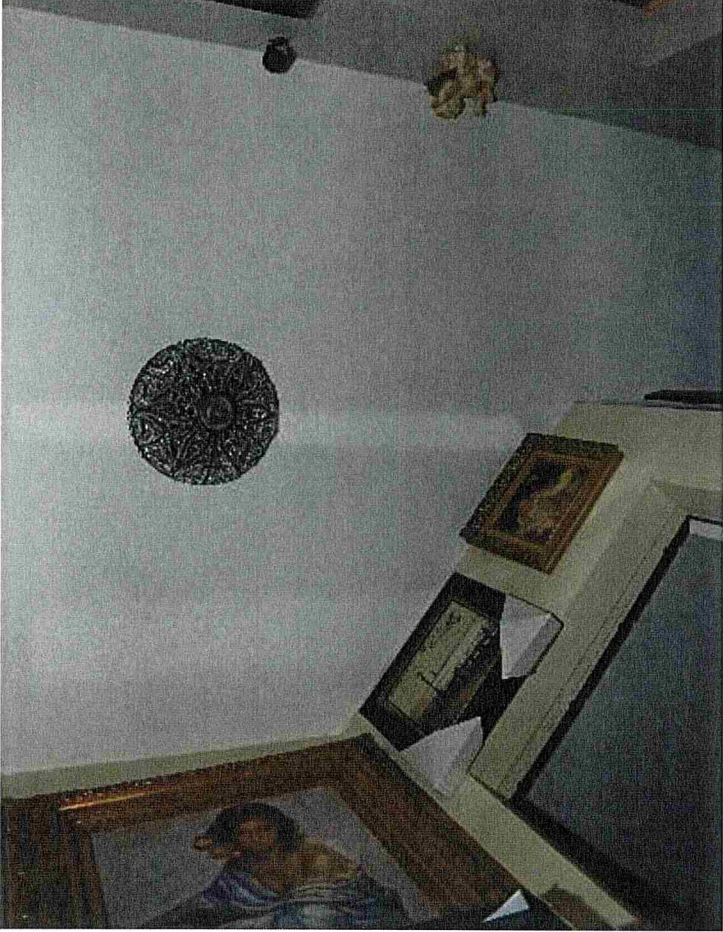
Element	Observed Conditions	Documentation
<p>Living and working spaces</p>	<ul style="list-style-type: none">■ No areas of paint exfoliation and plaster damage suggesting moisture infiltration

<p><i>Interior condition of second storey hallway and ceiling</i></p>

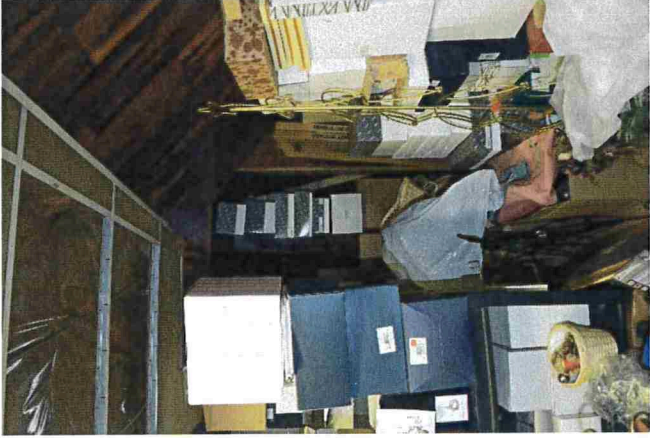
Element	Observed Conditions	Documentation
<p>Attics, shafts, and concealed spaces</p>	<ul style="list-style-type: none">■ There is evidence of water infiltration in the attic which has stained fibreglass batts.

<p><i>Water infiltration evident on the ceiling of the attic.</i></p>

- Clear out all gutters and downspouts and ensure these shed water away from the foundations;
- Inspect roof for leaks and replace damaged fibreglass batts and flashings;
