HERITAGE UPDATE LETTER

ATTACHMENT 2 15 MILL STREET

RE: HERITAGE UPDATE LETTER, 15 MILL STREET

HERITAGE IMPACT STATEMENT
THE MILL COTTAGE
15 MILL STREET, THORNHILL
CITY OF VAUGHAN, ONTARIO

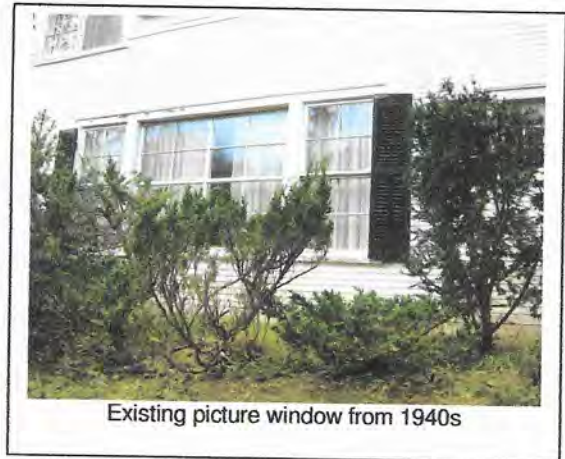
In the 1940s, a large picture window was installed between the two existing flanking windows, replacing the chimney which was removed at that time. While these renovations were accomplished with some sensitivity, they nonetheless destroyed the simplicity and formality of the original symmetrical Georgian façade.

Existing picture window from 1940s

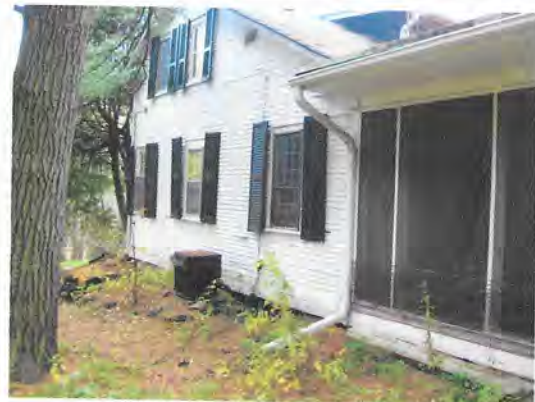
In the 1940's a screened porch was added to the south with a flat roof and this addition partially disguises the "salt box" form.

1940s porch at rear of salt box

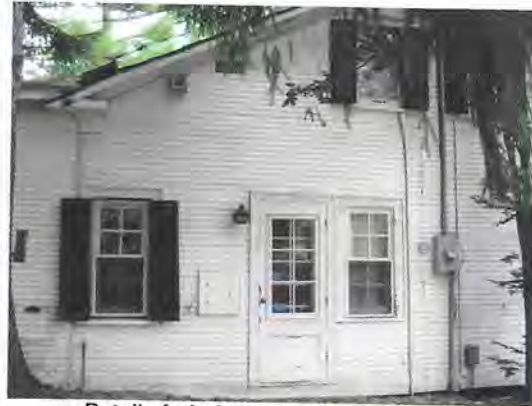
The upper windows have operable shutters while only some of the lower windows have been equipped with shutters, again evidence of later changes to the lower window configuration.

Detail of windows and door, east side

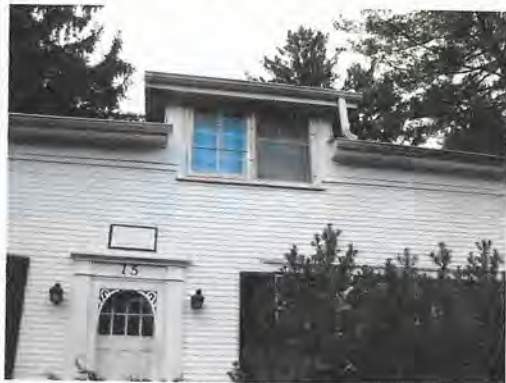
1910 north dormer

The new shed dormer, added to the north elevation, cuts into the existing roof and siding and is not a particularly attractive addition to this simple Georgian vernacular cottage.

2. The existing dormer will be replaced with a new central dormer to reinforce the symmetry of the original house.
3. The west elevation windows will be restored and relocated to original location if it is determined that those locations differ from the existing locations.

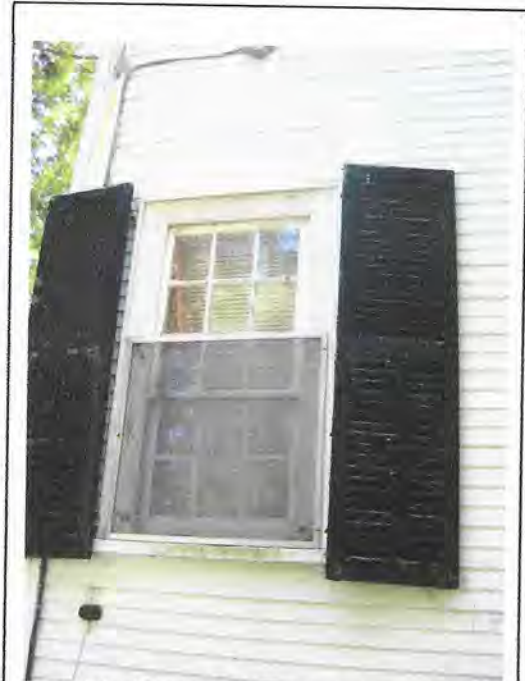
All the windows on the 1825 portion of the house are wood frames and sash, and are equipped with storm windows. They are in poor repair and require extensive restoration.

Original 9 over 6 window, west elevation

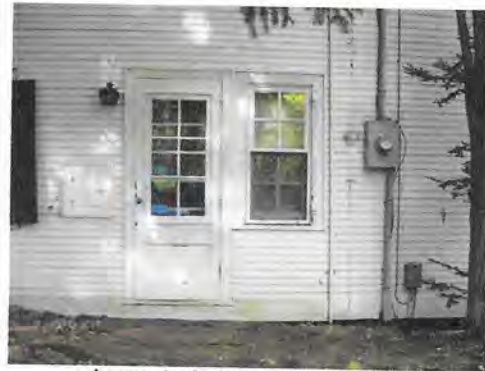
The windows on the east elevation have been altered from the original. The lower windows are 4-over-4 windows and one appears to be missing on the north. The upper windows are 2-over-2 windows. A new door has been added to this façade.

4 over 4 window, east elevation

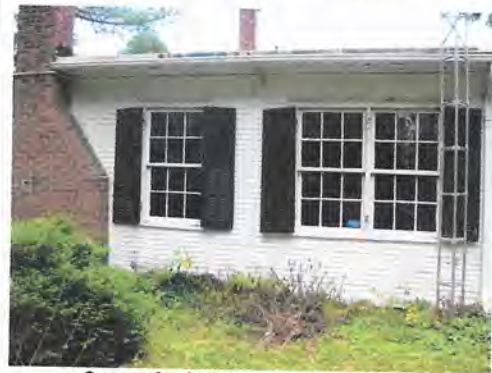
6 over 6 windows, south addition

The windows on the addition are 6-over-6 wood windows with operable shutters. There are four windows on the south elevation and one window and a door to the east porch and two windows and a door to the west screened-in porch. These windows are single-glazed, in relatively good condition. New "picture windows light the kitchen area and are nine paned windows, added as part of the 1950's kitchen renovation. The roof of the 1910 addition is a low sloped roof and shows signs of sagging and the fascia requires repair. The new dormer window, installed to bring light to the second floor of the 1825 house, has three pairs of two six-paned windows, set in the shed roof dormer.

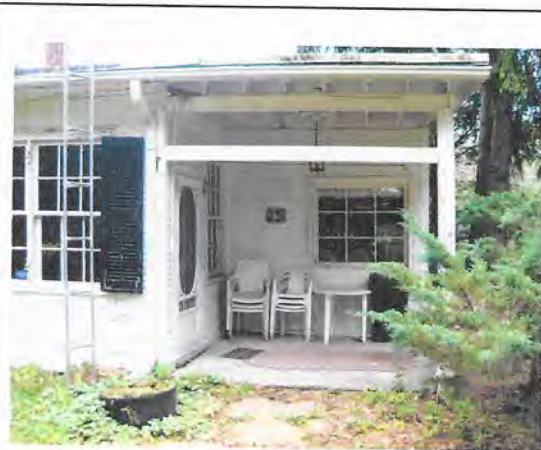
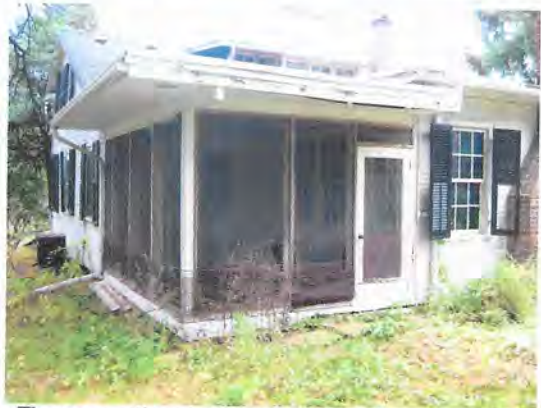
While the 1910 addition has a certain charm, its form and its junction with the 1825 house is unsympathetic to the original building and the new addition on its own has little architectural pedigree. The sun porch is an awkward addition and the later kitchen renovation denigrates any pedigree the addition may possess.

The connections between the 1825 house and later additions are not very sympathetic. Note deteriorated finishes.

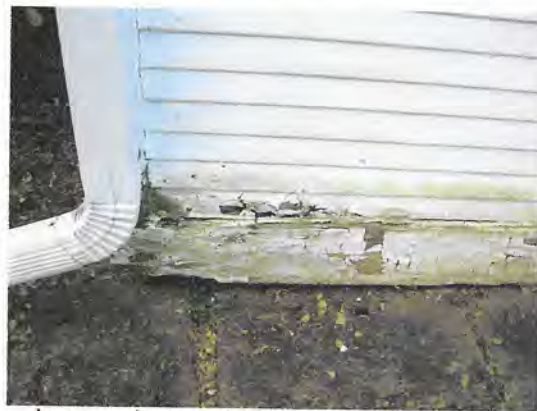
In some places at the base of building, there are signs of deterioration in the wood.

5. The wood siding will be repaired and deteriorated wood replaced.
6. A new cedar shingle roof will be installed, replacing more recent asphalt shingles.
