THOMSON WATSON CONSULTING ARBORISTS Inc.

RE: Tree Inventory and Preservation Plan for 65 Wallace Street, Vaughan

TREE INVENTORY 65 Wallace Street, Vaughan, Ontario

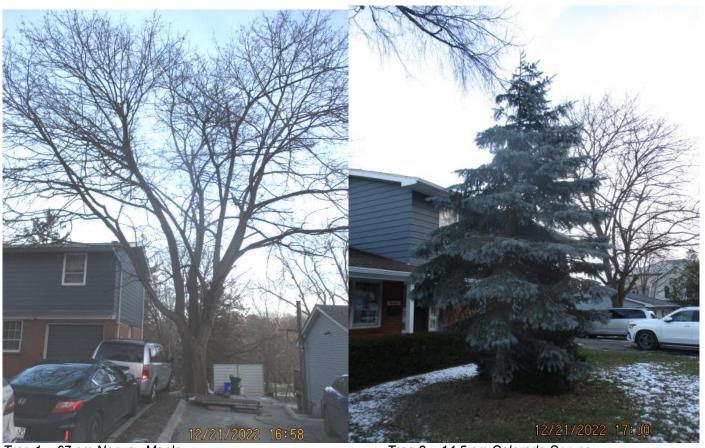
Tree 1 – 67 cm Norway Maple

| | | | | ¥ |
|---|---|---|---|--|
| | | | | gravel driveway to north, underground girdling roots to east and south, tree |
| | | | | splits into three stems at 2 metres with included bark in union, storm breaks |
| 1 | Norway Maple | 67 | fair | in canopy, poorly pruned to north over driveway and house |

To allow adequate construction access around the house and foundation excavation overdig, it is proposed to remove Trees 1, 2, 4, 24 and 25. Tree 1 is located on the south neighbour's property and its removal will require permission of the tree's owner.

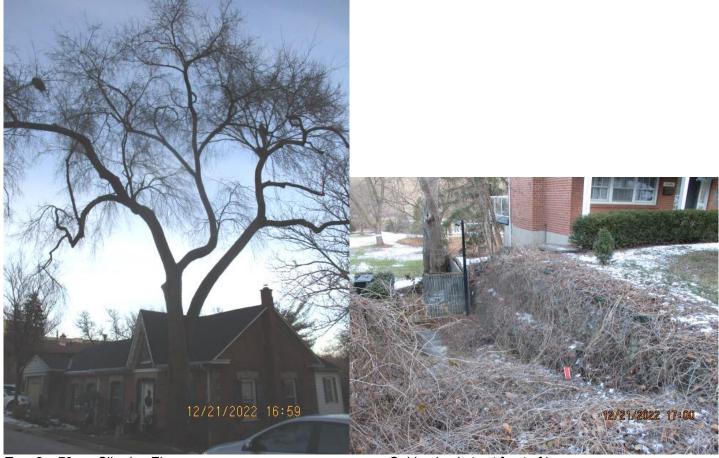
Tree 3 – 73 cm Siberian Elm

Gabion baskets at front of house

| | | | | ¥ |
|---|---|---|---|--|
| _ | O:1 : | 70 | | topped and tipped back, tree splits into two stems at 4 m with included bark |
| 3 | Siberian Elm Manitoba | 73 | fair | in union - open crack at union, slime flux infection in wounds |

Tree 3 is a 73 cm Siberian Elm (*Ulmus pumila*) growing in front of 57 Wallace Avenue. The tree requires a 4.8 metre Tree Protection Zone. A Tree Protection Fence must be placed 4.8 metres to the south of the tree on the subject property. It is expected that this Fence will be placed on the gabion baskets that hold up the grade on the north side of the property.

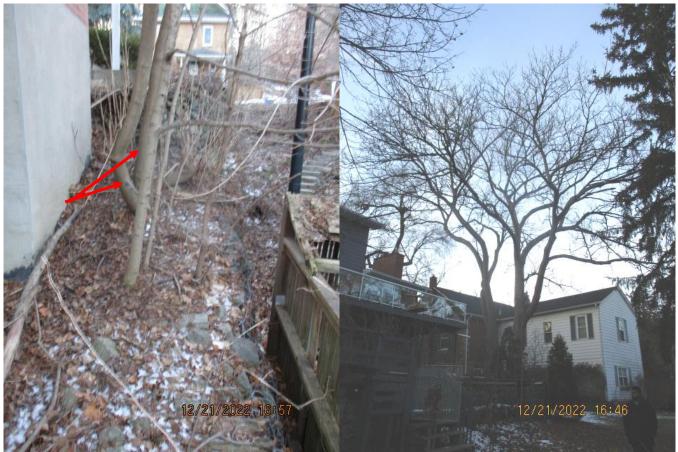
Tree 4 – Manitoba Maple

| | | | | ¥ |
|---|---|---|---|--|
| 4 | Maple | 17, 11 | fair | basal diameter of 20 cm + |

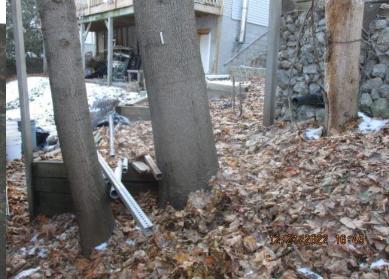
Base of Tree 5 with gabion basket supported patio to south

| | | | | ¥ |
|---|---|---|---|--|
| | | | | tree splits into three stems at 80 cm with south stem cut and decayed |
| 5 | Buttornut | 100 90 | foir | (wound could not be seen due to fence), branch wounds with some wound |
| 5 | Butternut | 100, 80 | fair | decay, few black spots on trunk |

It is proposed to preserve Tree 5 but the tree will be injured as foundation excavation and limited construction access will occur within its 6.0 metre Tree Protection Zone. The following seven paragraphs describe how to protect the tree during the separate portions of the construction process.

Branches in Tree 5 within 2.0 metres of the proposed house and roof will need to be pruned for clearance. A tree care company which is acceptable to the owner of Tree 5 should be hired to prune the tree. A minimum amount of canopy should be removed to avoid excessive injury to the tree.

When the existing house is demolished, the house foundation within 6.0 metres of Tree 5 can be pulled into the footprint of the house but no additional excavation beyond the foundation can occur. Under the direct supervision of a qualified Arborist, the raised soil deck area and stones within the gabion baskets will be pulled into the footprint of the house. The soil will be removed in layers and the Arborist will stop of soil removal once the grade of the backyard is reached or significant roots are exposed within the soil.
