**Re: Request for Consideration to Lift Conservation Easement and Demolition
9151 Huntington Road, Vaughan, Ontario
John Fleming House**

Project No. 2406581

**Re: Building Relocation Review
Existing Heritage Building – John Fleming House
9151 Huntington Road, Vaughan, Ontario**

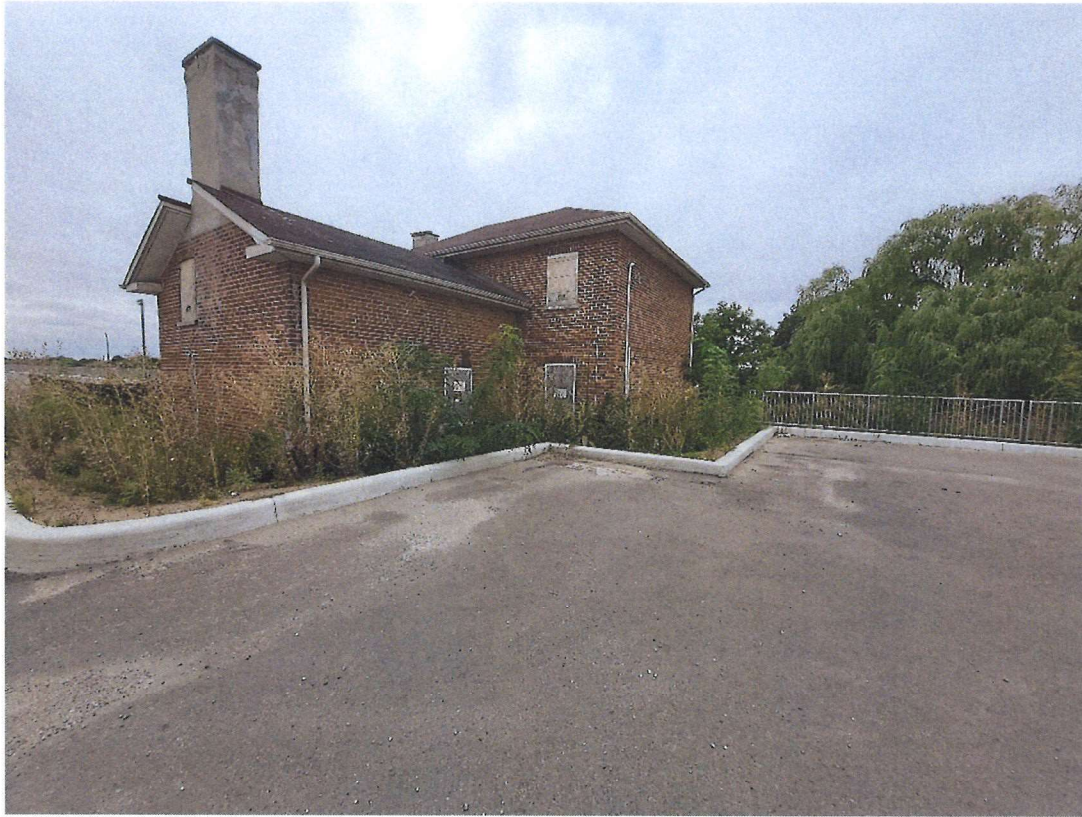
Photo 1 – View of House from Northeast

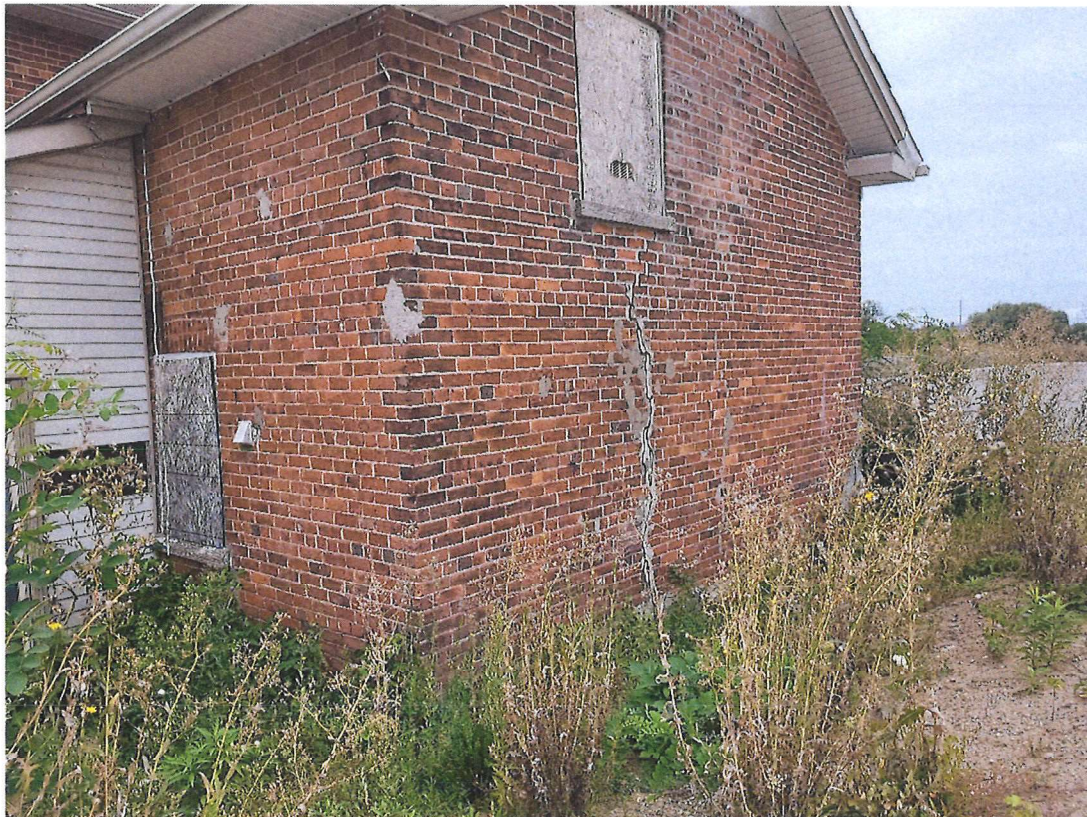
The walls have significant cracking throughout, especially on the east side, highlighted by a large vertical crack running all the way from the foundation up to the window (refer to Photo 2). These cracks have been previously patched, but these patches appear to have been made with modern mortars which are incompatible with older masonry and may cause further damage as the materials expand and contract at different rates.

Photo 2 - View of East side showing large vertical cracks between foundation and window

1. Routing of mortar joints to remove the Portland cement mortars that have been used in recent repairs.
2. Reinforcement of mortar joints at crack locations with helical ties.
3. Replacement of cracked brick units.
4. Repointing of all mortar joints with appropriate mortar for the brick units.
5. Deteriorated floor joists may have to be sistered with new material. Existing mechanical, electrical, and plumbing services will have to be removed and reinstalled in affected areas (these systems will likely have to be replaced anyways).

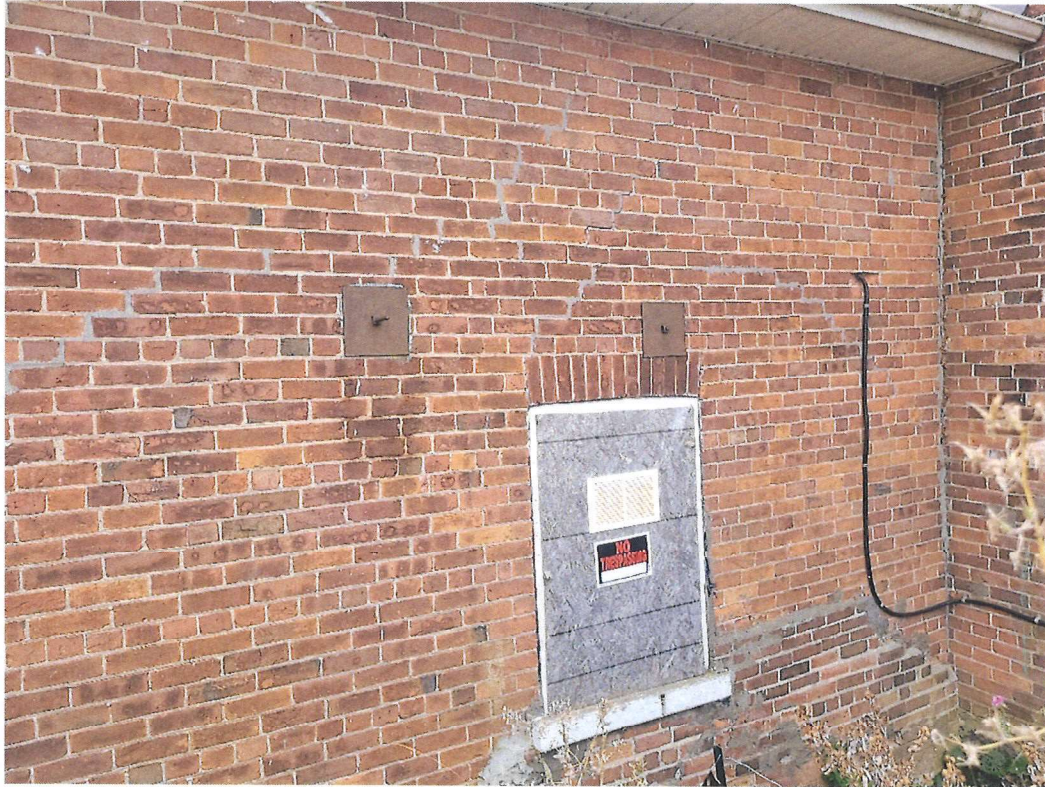
It was also noted that there are two steel rods with plates on the ends running through the second-floor structure in the north-south direction of the east wing. These steel rods were likely installed to support the north and south walls of this area, as they may have been bowing out. The cracking around these steel rods also supports this conclusion (refer to Photo 3).

Photo 3 - View of North side showing steel plates and ends of steel cross ties at second floor, also cracking

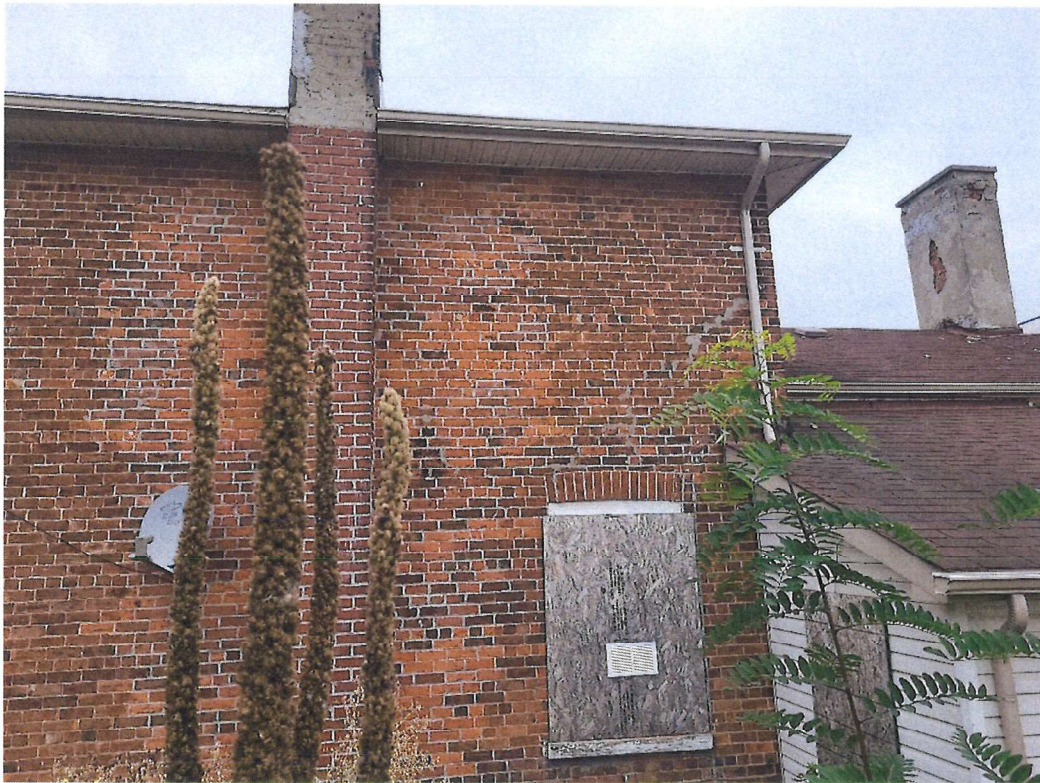
The chimneys have been parged, likely due to deterioration of the masonry. That parging is now cracking and disintegrating throughout (refer to photo 4).

It appears that large portions of the masonry walls have been replaced with different bricks and newer mortars, especially notable on the south wall, as shown in Photo 4. The newer mortars, again, are a concern as they may be incompatible with the older masonry.

Photo 4 - View of South side showing cracking and evidence of repairs
