**Communication**

**Council – November 19, 2024**

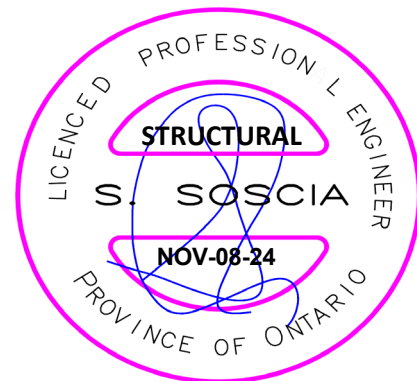
We further conclude that the non-compliance with the Ontario Building Codes, and the Ontario Occupational Health and Safety Acts overrides any historical and cultural value that this dwelling is said to contain. We recommend, that this house undergo demolition because of its inhabitable condition.

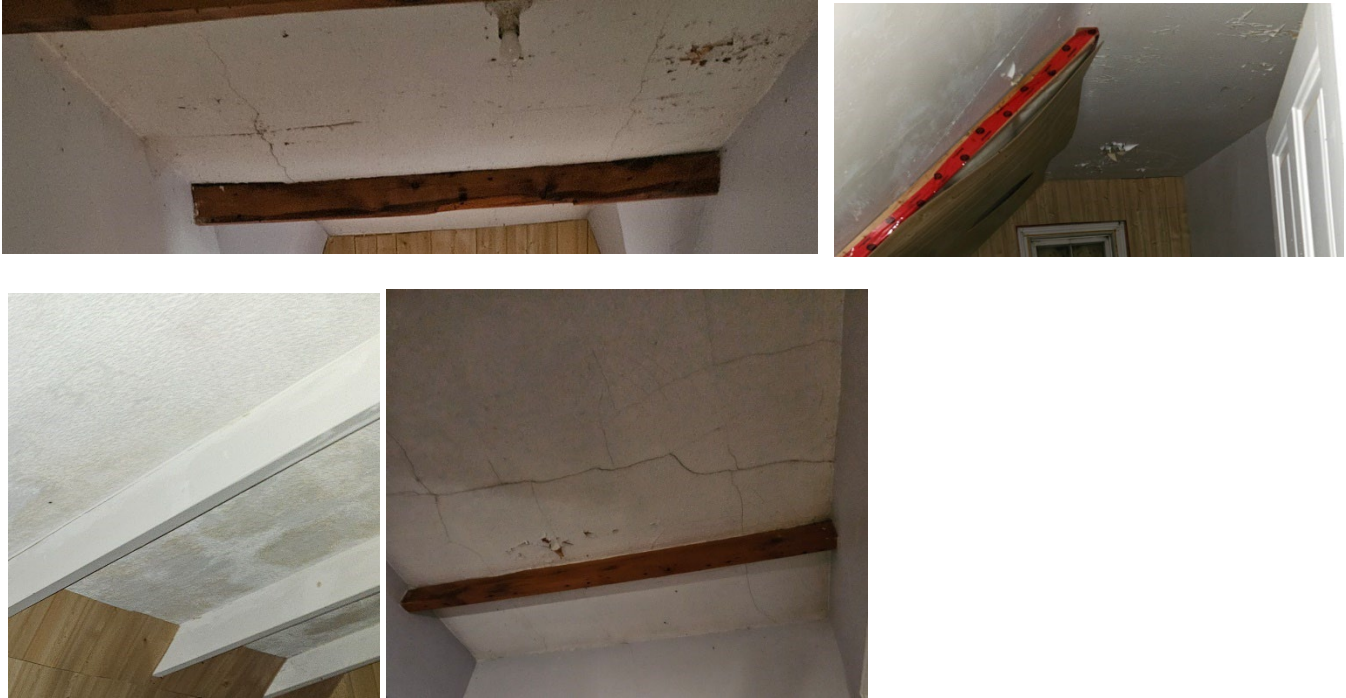
**Figure 1:** Cracking shown throughout the second floor ceiling and discolouring due to water penetration through roof.

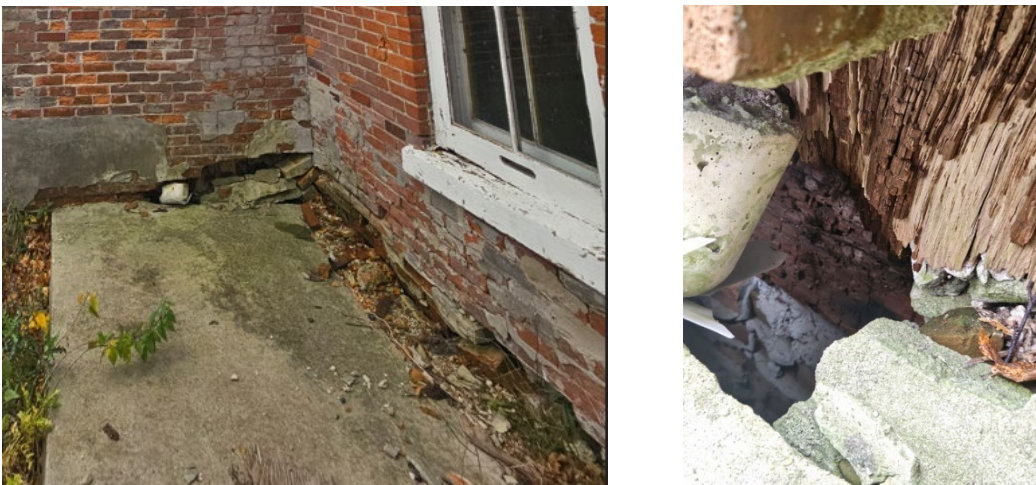
**Figure 2:** Exterior brick is crumbling throughout the building where openings as shown exposes the building to water infiltration and infestation.

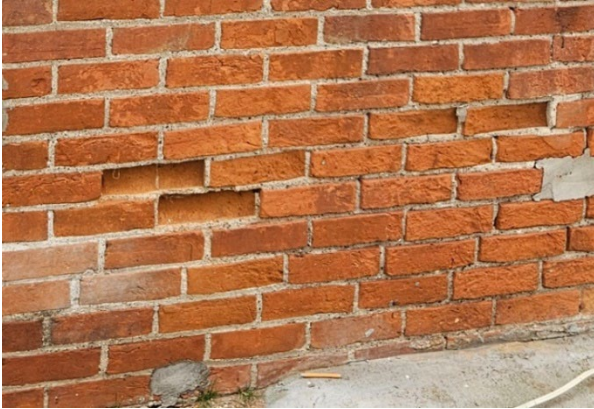
**Figure 3:** Section loss of brick systematic throughout exterior wall that are shown to be porous included with the mortar subjecting to freeze and thaw.

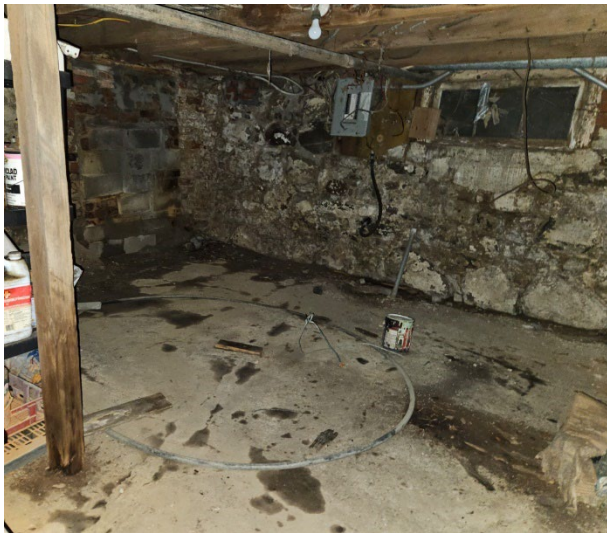
**Figure 4:** Water infiltration visible with discolouring of the slab due to water absorption throughout the basement.

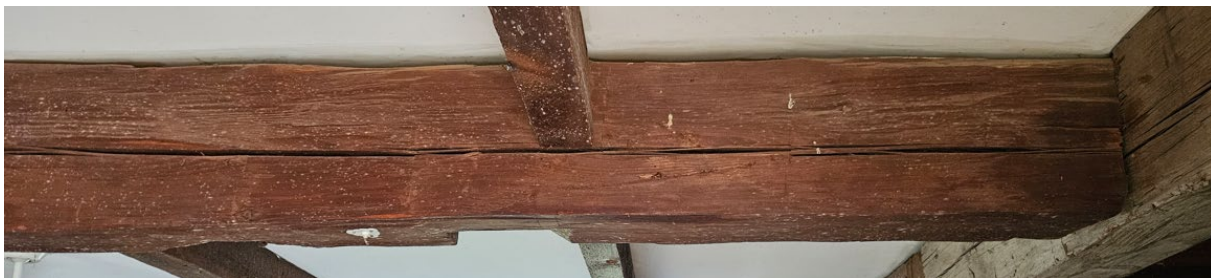
**Figure 5:** Structural main supporting beam undergone flexural bending failure with splitting from end-to-end.

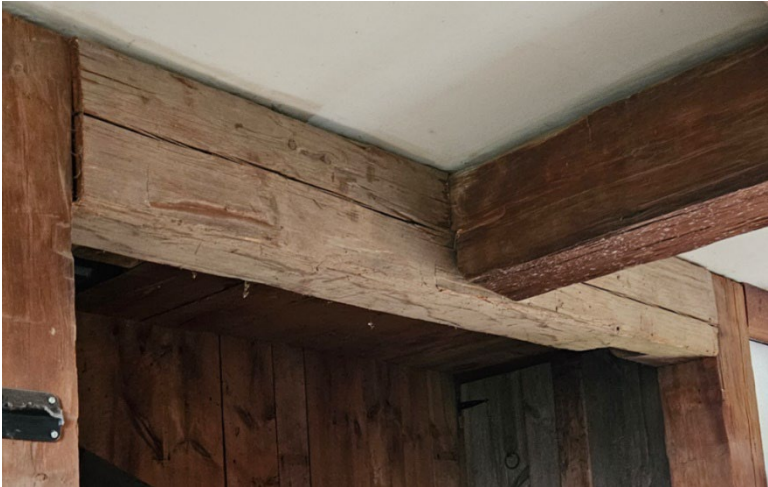
**Figure 6:** Main structural member undergoing flexural failure with splitting of member from end-to-end.

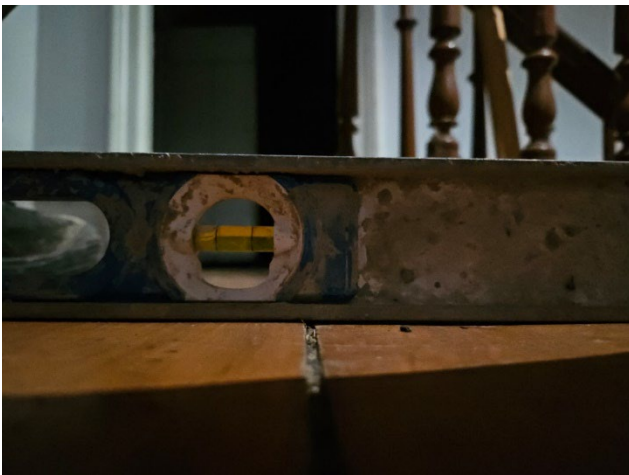
**Figure 7:** Leveler taken from top of stairwell on second floor.

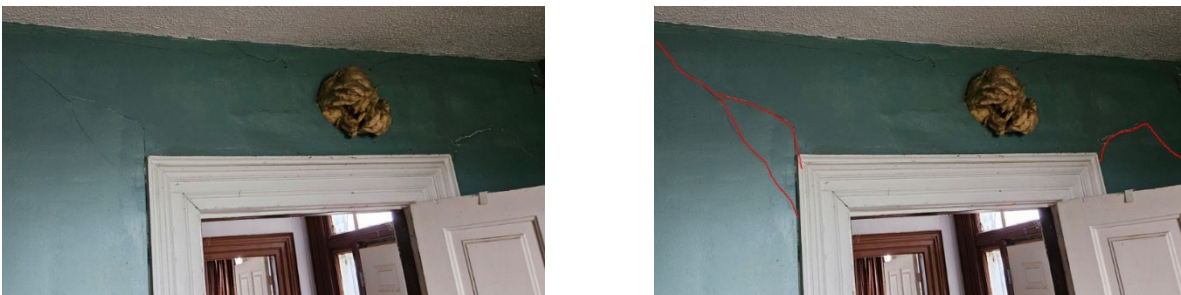
**Figure 8:** Floor beneath is deflecting considerably where partition walls are sinking and cracking as shown in red.

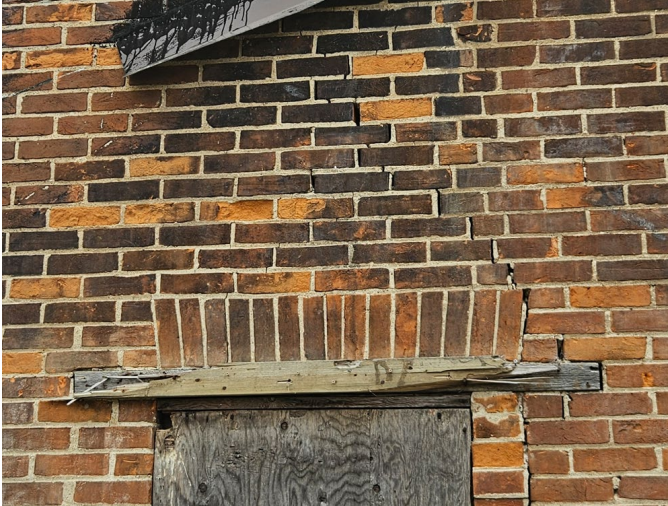
**Figure 9:** Diagonal cracking at openings.

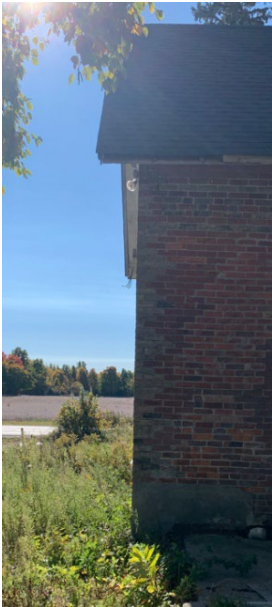
**Figure 10:** The east wall appears to not be plumb.

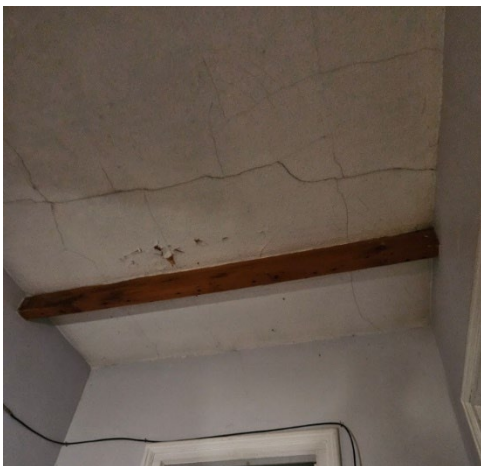
**Figure 15:** Parallel cracks to collar ties.

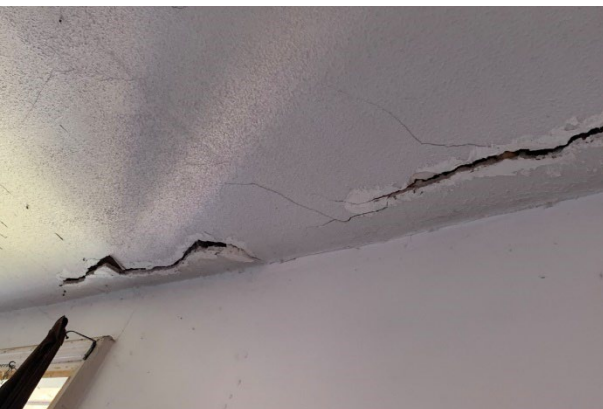
**Figure 16:** Ceiling tears at wall interface due to lateral displacement and walls pushing outwards out of plumb due to potential roof instability.

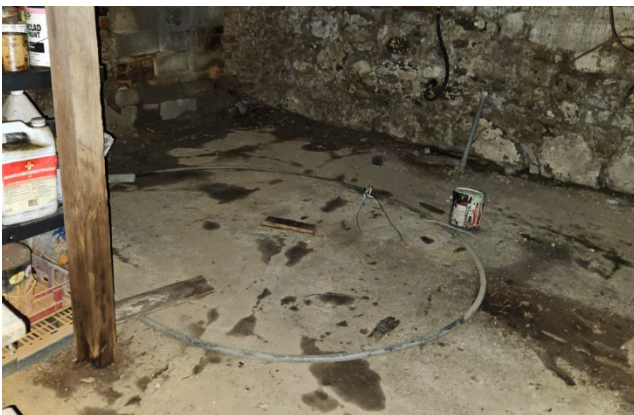
**Figure 19:** Discoloring of slab due to water absorption and infiltration.

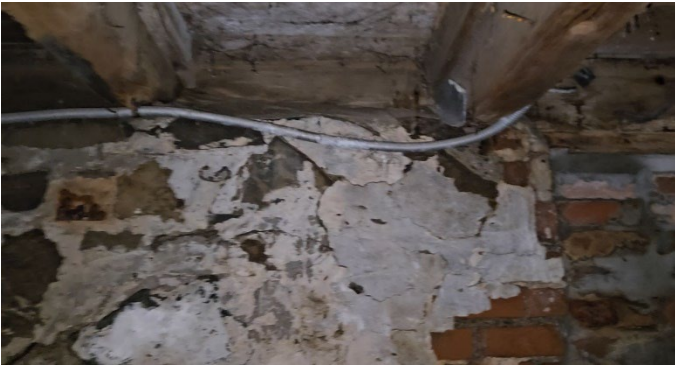
**Figure 20:** Spalling.

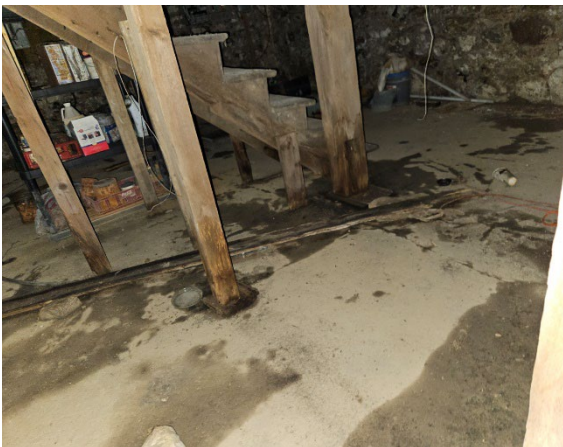
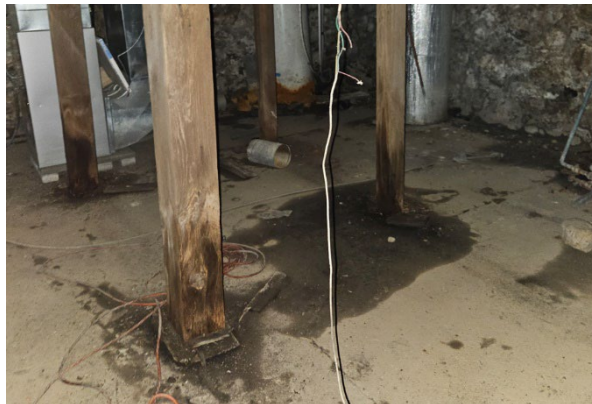
**Figure 21:** Water penetration through slab and seen on posts without adequate bearing.

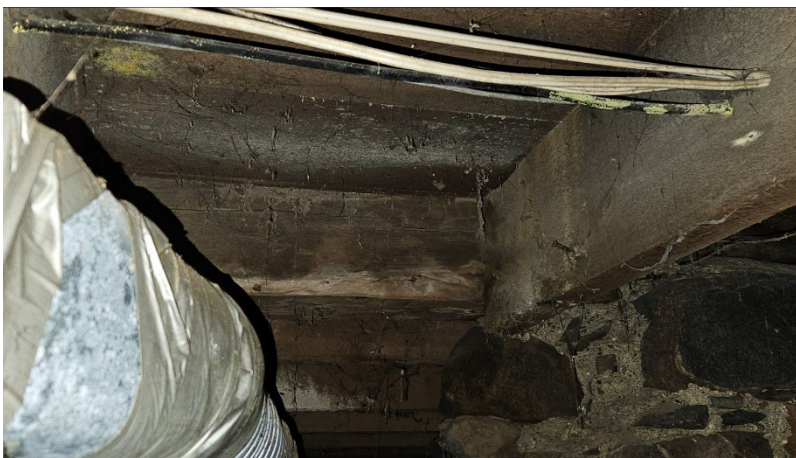
**Figure 22:** White mold and water discoloration due to water moisture and penetration.

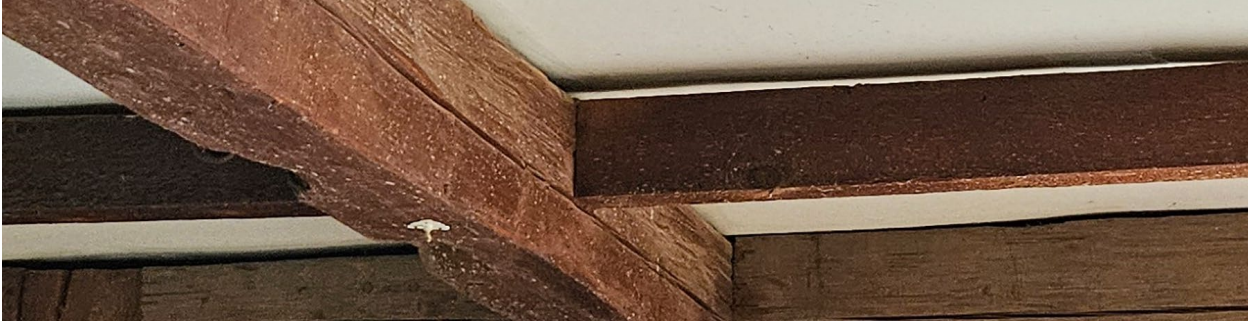
**Figure 23:** Deflection between ceiling and joists.

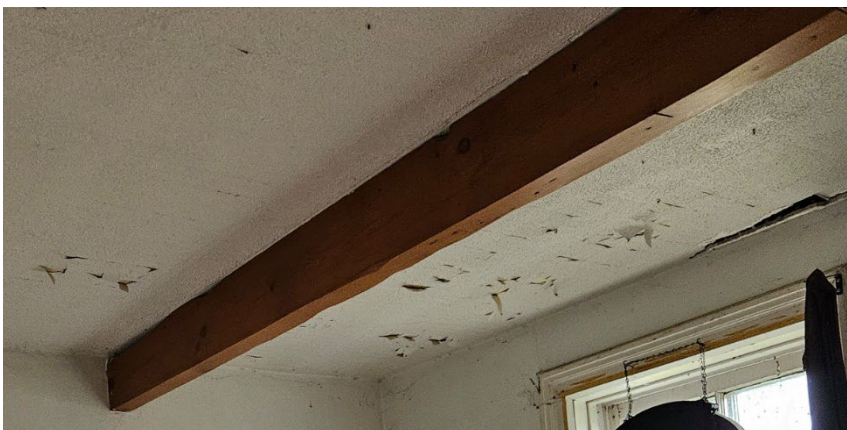
**Figure 25:** Paint peeling due to moisture.

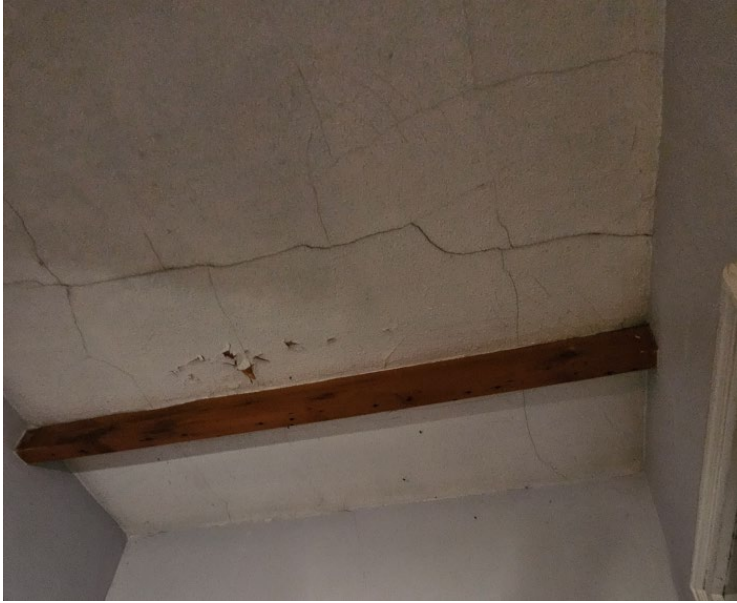
**Figure 26:** Long ceiling splits due to tearing from lateral deflection.

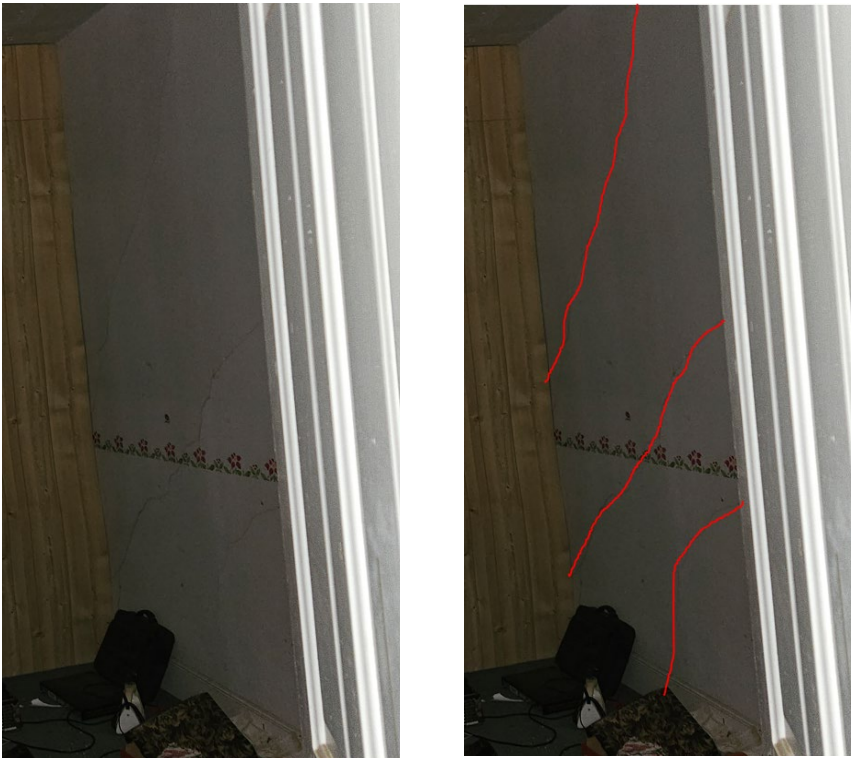
**Figure 27:** Diagonal cracking seen and may be from one side of building settling more than other side.

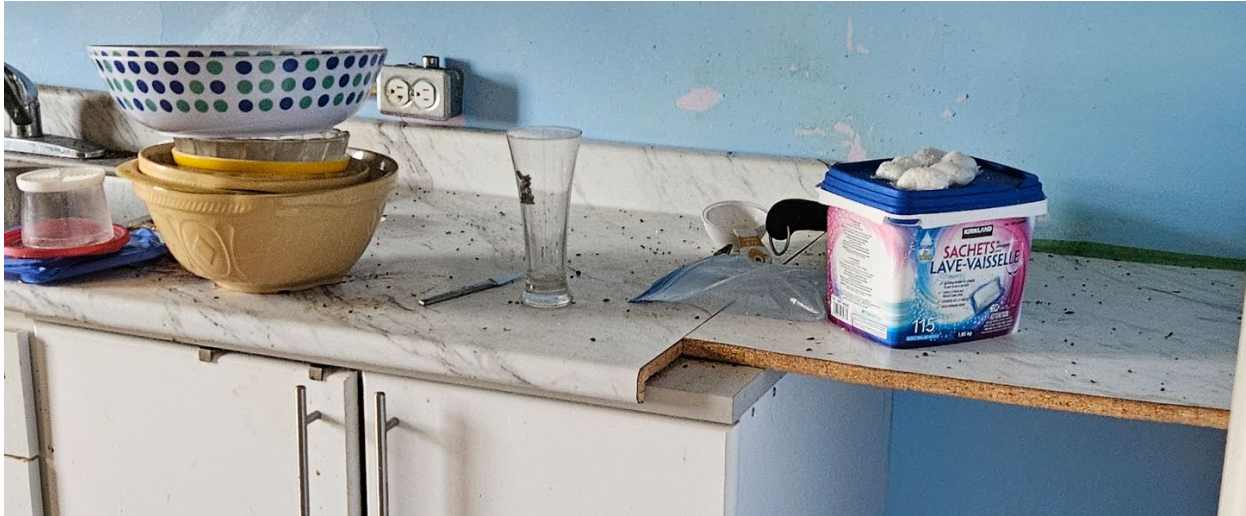
**Figure 28:** Droppings seen throughout the structure indicating infestation of rodent or wildlife.
