**Arkiform Construction Inc.**  
2900 Langstaff Rd Unit 7  
Concord, Ontario  
L4K 4R9

## **HERITAGE REPORT**

Inspection done on July 4<sup>th</sup>, 2024 @ 9:00 am

The property on 7230 Nashville Road, Vaughan Ontario is Listed to the Municipal Heritage Inventory.  
Construction date circa 1890s -1940

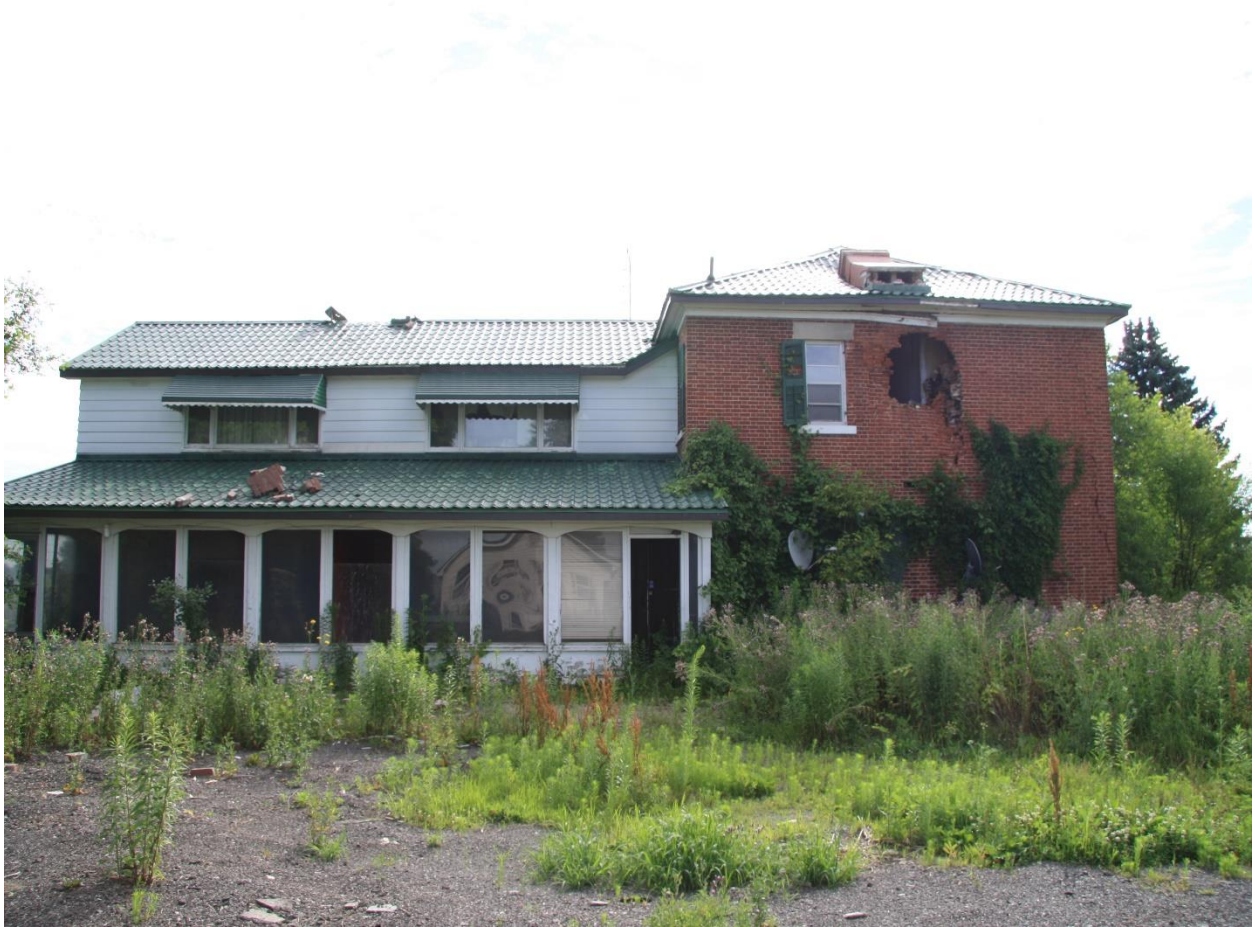
WEST ELEVATION

- **West Elevation** we have a new window that is not in the context of the house, and the major chimney has fallen and resting on the roof. This created a displacement on the wall having a major hole on the façade. Also, evident vertical cracks on the RH of the house **(Photo attached)**

- All the walls all around the house are compromised with noted major cracks on brick façade this is an indication of major foundation problems.
- The interior: is impossible to enter due to the house's dangerous condition. The house must be protected by a temporary fence for non-trespassing, this should be addressed immediately.
- Most of the windows and doors that are missing will also require restoration or replacement.

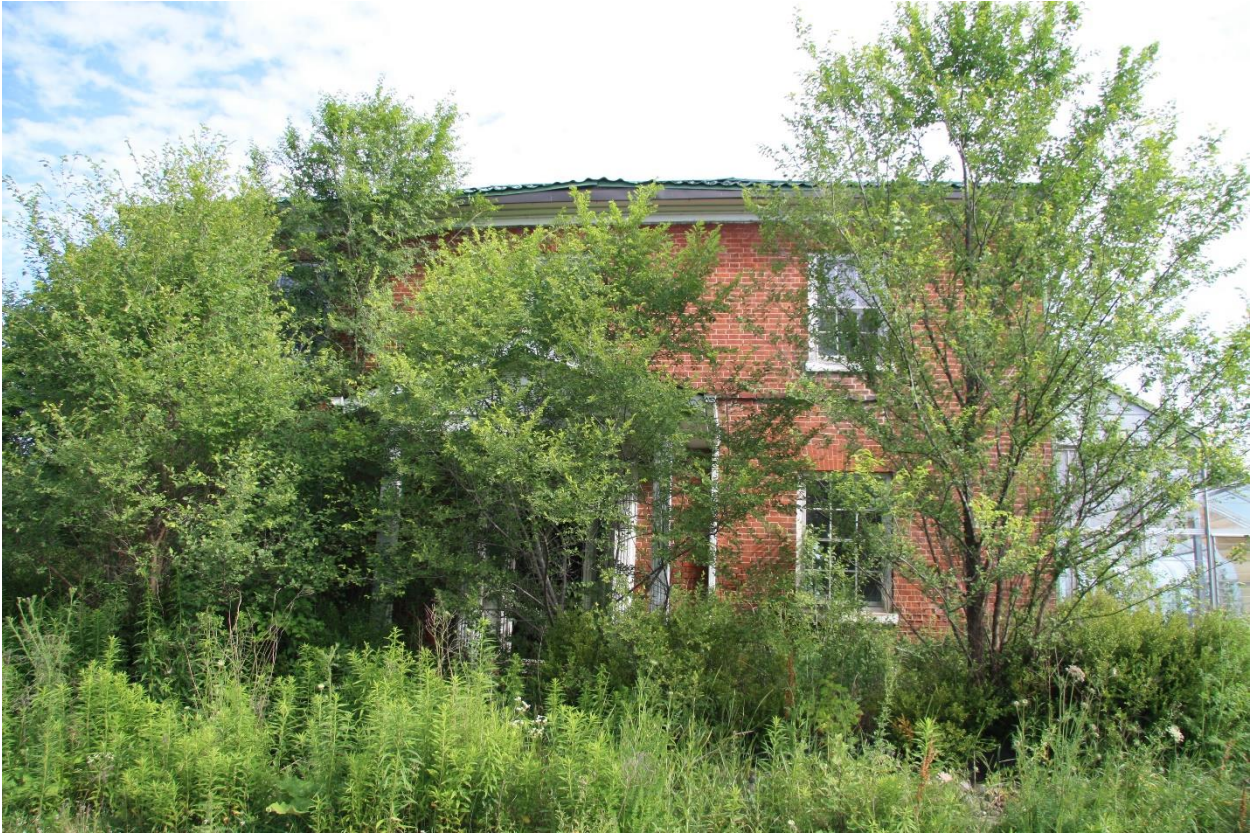
SOUTH ELEVATION

- The **South Elevation** is evident only the area that is currently visible, on major vertical cracks on the RH. and LH of the house.
- The **East Elevation** brick work pattern has been changed to a common bond due to a large green house on the full length of the house up to the second-floor line .and chimney is completely down on the roof creating a major crater on the roof. **(Photo attached)**
