STRUCTURAL CONDITION ASSESSMENT

Existing House

7230 Nashville Road, Kleinburg, Vaughan

July 17, 2024

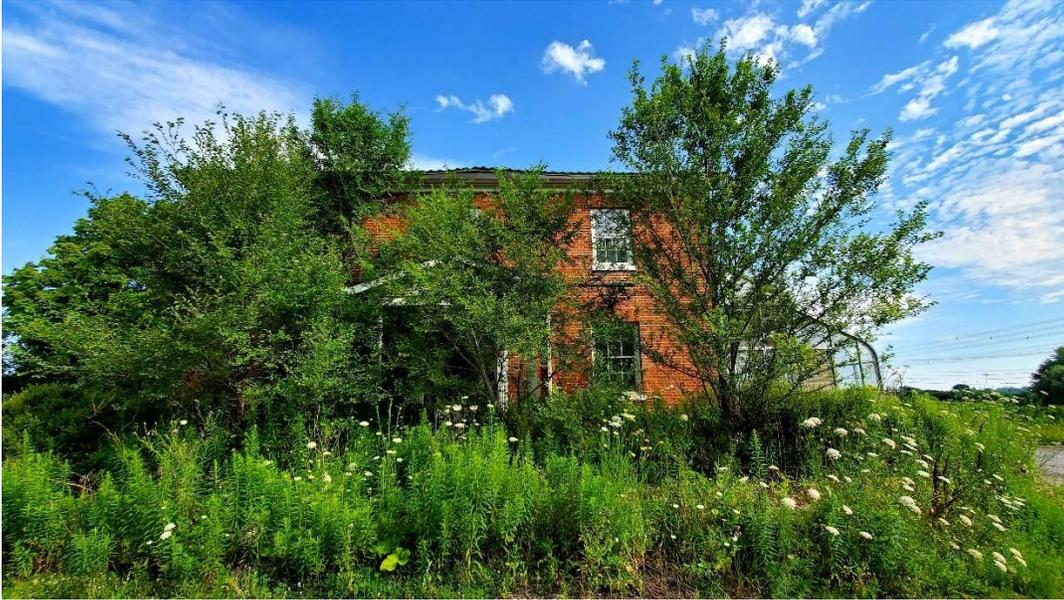
The building (house) is currently vacant, abandoned, damaged, and in a severely deteriorated condition. The west and south exterior walls, including the entrance to the house, are surrounded by dense vegetation and tall bushes. (Pic. 1 to Pic. 5). The projected porch at the house is supported by wooden posts and has a partially glazed main entrance door. The main house features an exterior brick façade, and a green-coloured metal roof. There are two chimneys, one at either end, which are damaged and have fallen over and lying on top of the existing metal roof. The metal roof is damaged in several areas and severely damaged at the location of the previously noted fallen chimneys.

Pic. 1: Southview of the House-Front Entrance

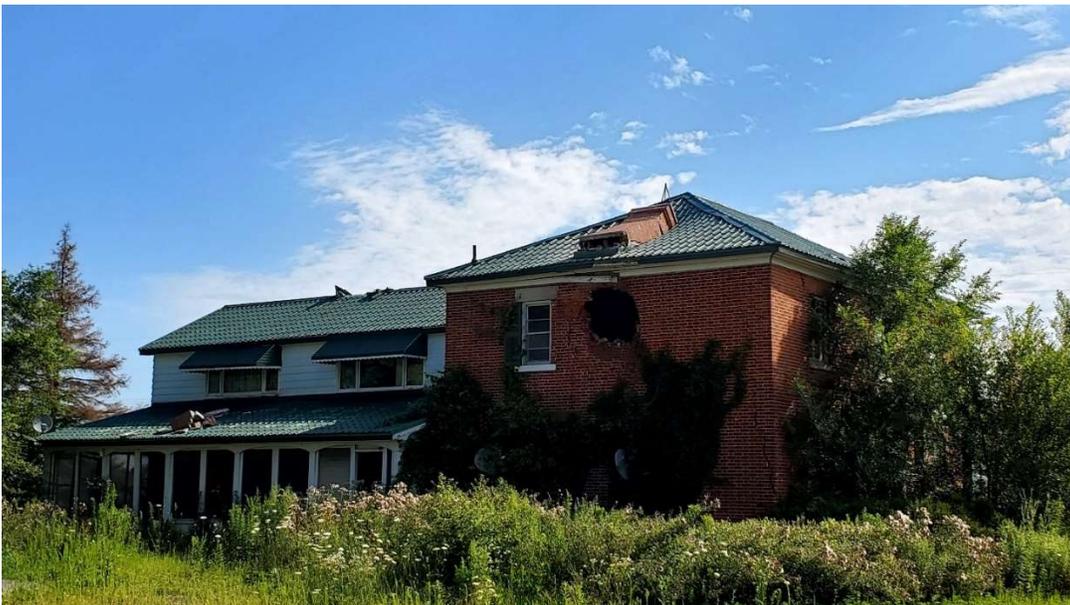
The existing building addition (Pic. 2, Pic. 9) along the north side of the main building (house) has a rectangular footprint and is one-and-a-half-storey with a basement. It has a side-gable roof, a chimney in the center, which is damaged/broken and fallen over onto the existing roof, and a concrete block wall foundation with wooden floors. The building addition has an exterior brick facade on the first floor and wooden siding on the second floor. There are two fully glazed windows on the front and back of the second floor, each with a chajja on top. The first floor has glazed windows on the north and east sides. The building has a one-story front verandah with wood-framed glazed windows and doors at both ends. The shed roof is green metal. Currently, the building addition is abandoned and unoccupied.

1. Extensive vertically inclined crack, wide at the bottom and narrow at the top, was observed on the exterior load-bearing masonry wall on the west side from the southwest corner, travelling up from the bottom to the top of the building (Pic. 2, Pic. 3, Pic. 5). Another sizable fissure was also observed on the same wall some distance away from the long crack (Pic. 5).

4. The Chimneys were broken above the roof line and damaged the roof structure, including the metal edge, fascia, and soffit (Pic. 2, Pic. 3, Pic. 7).
5. The metal roof was damaged and lifted in many areas including at the locations of the fallen chimneys (Pic. 2, Pic. 3, Pic. 7). The damaged roof offers no protection to the interior of the building from the elements (rain, snow etc.) resulting in further deterioration of the interior of the building, including flooding, rotting and damage to flooring, walls and ceilings, and environmental issues such as mold.

Pic. 2: Westview of the House showing Northside Addition

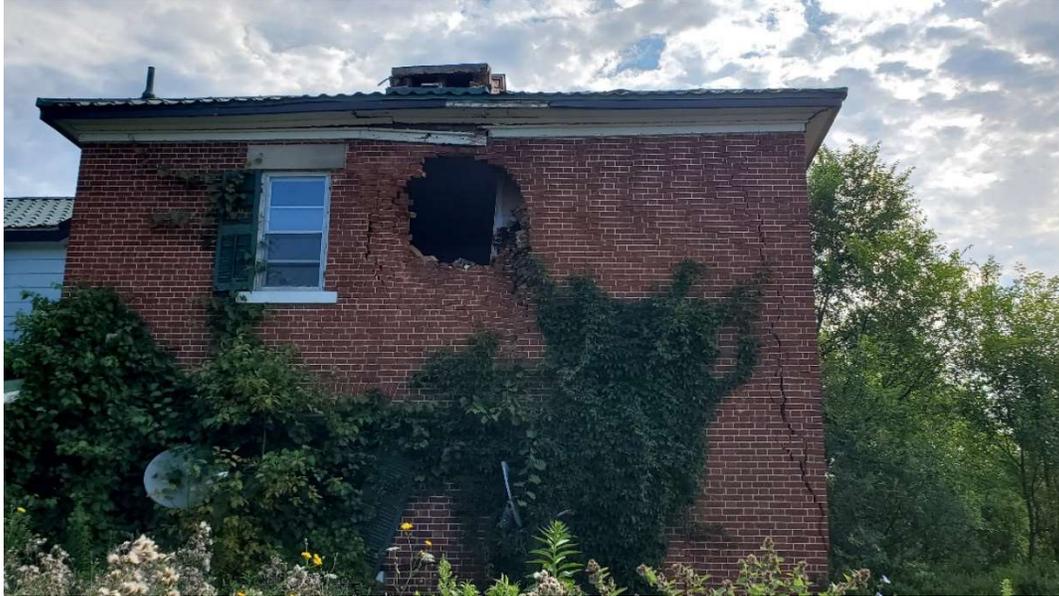
2. A very large round collapsed area on the load-bearing masonry wall was observed on the west side near the top center of the wall, wide and large cracks surrounding the fallen section. It appears this fallen section caved in towards the inside of the building. (Pic. 3, Pic. 5).

6. The wooden steps leading up to the entrance porch were observed to be degraded. The windows on the west side appear damaged with shattered panes and a broken shutter hung on the exterior wall (Pic. 3).

Pic. 3: Westview showing Cracks on the Masonry Wall, Part Caved In and Broken Chimney

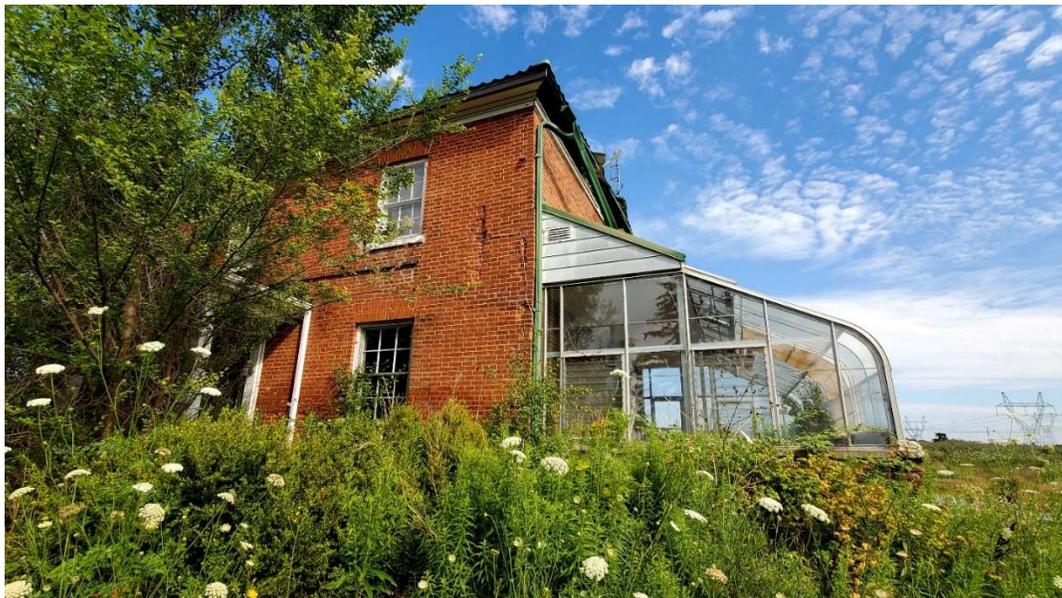
There is a Greenhouse addition on the east side of the main building. Which is supported by the exterior brick wall. (Pic. 4, Pic. 7 and Pic. 8)

Pic. 4: Southside view showing Greenhouse Addition on Eastside

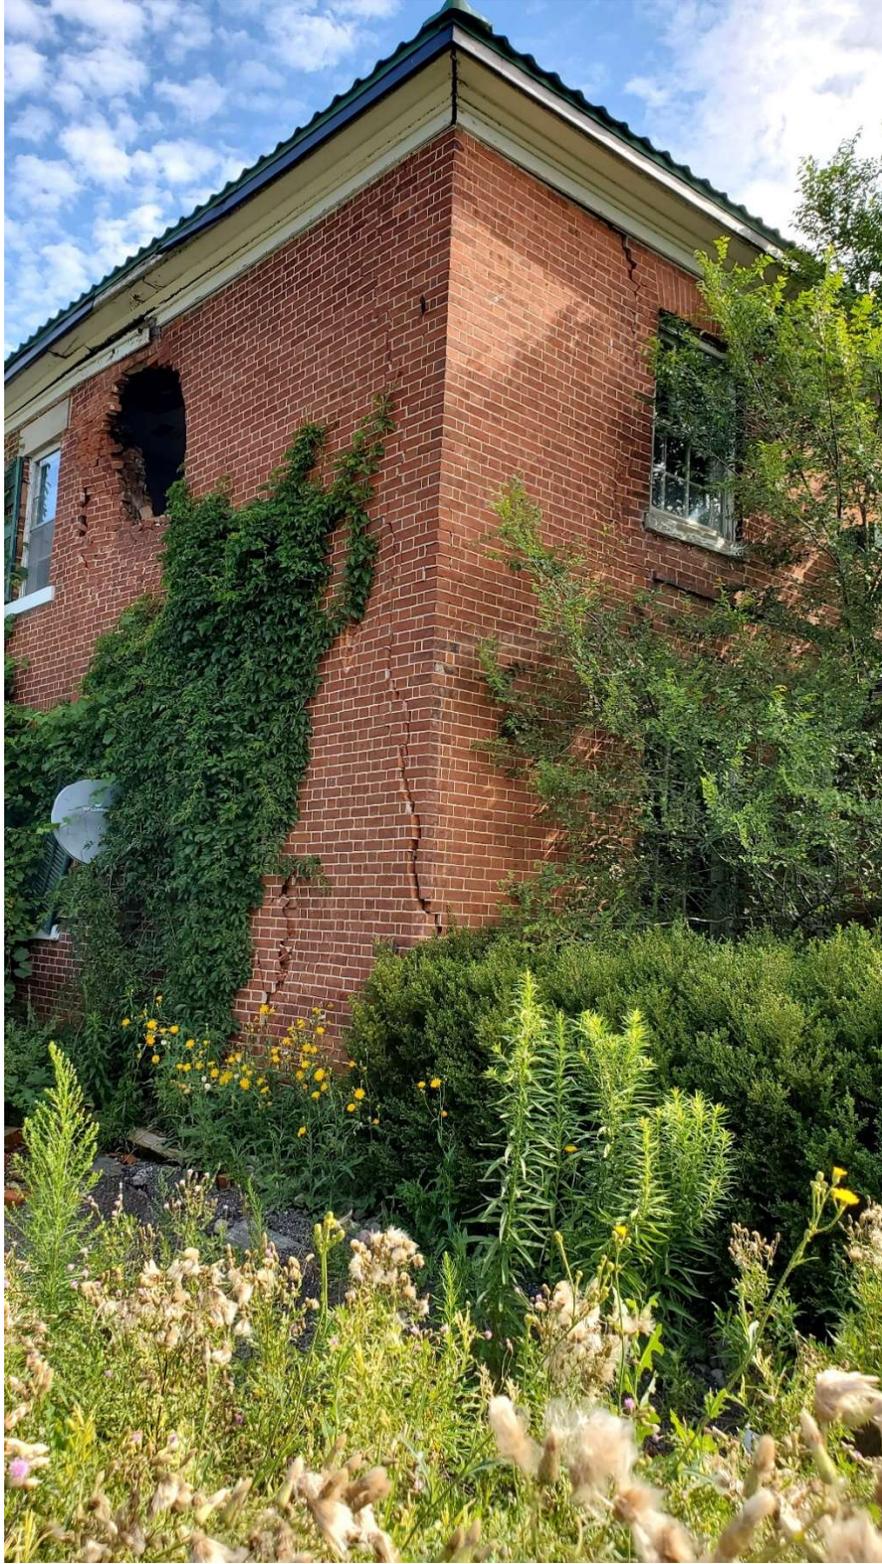
3. A wide vertical crack was noticed on the left side, near the window, from the top of the load-bearing masonry wall on the southside (Pic. 5). Some disintegrated bricks with long vertical cracks were also seen on the same wall on the right side at the southeast corner (Pic. 6).

Pic. 5: Southwest view of the House-Cracks and Damage in the Load-bearing Masonry Wall

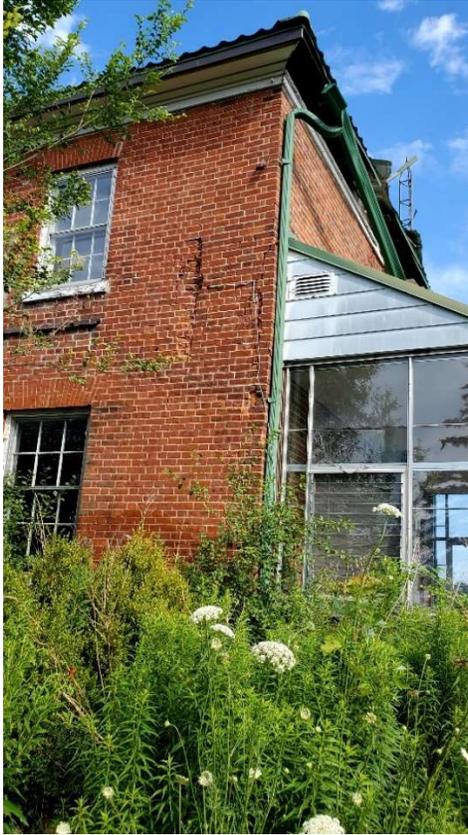
Pic. 6: Cracks and Damage on the Southside Masonry Wall of the House

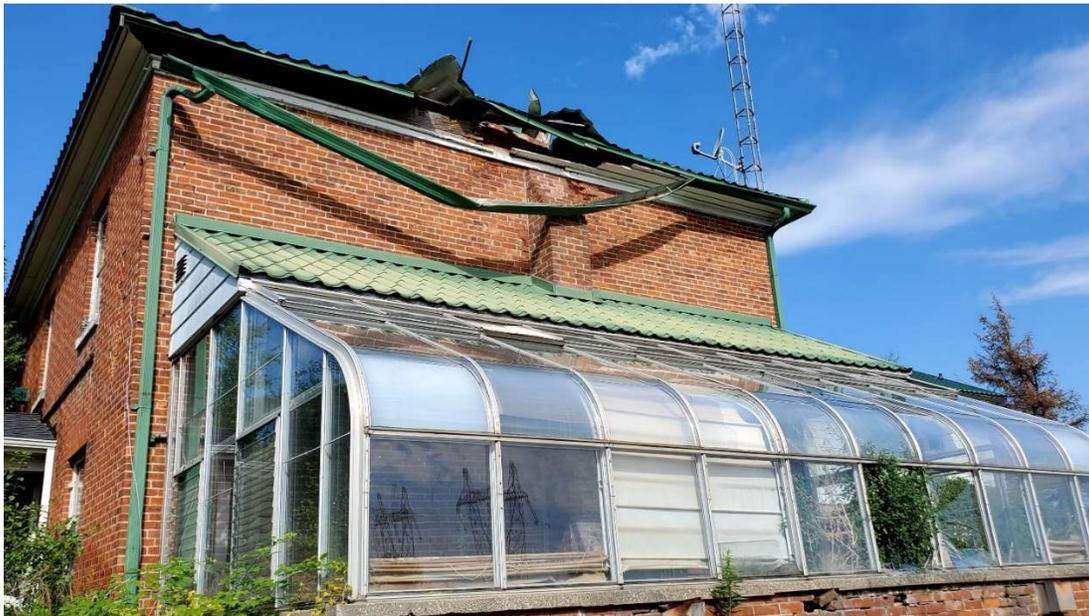
Pic. 7: Eastside View of the House showing Damaged Roof at Broken Chimney and Greenhouse Addition

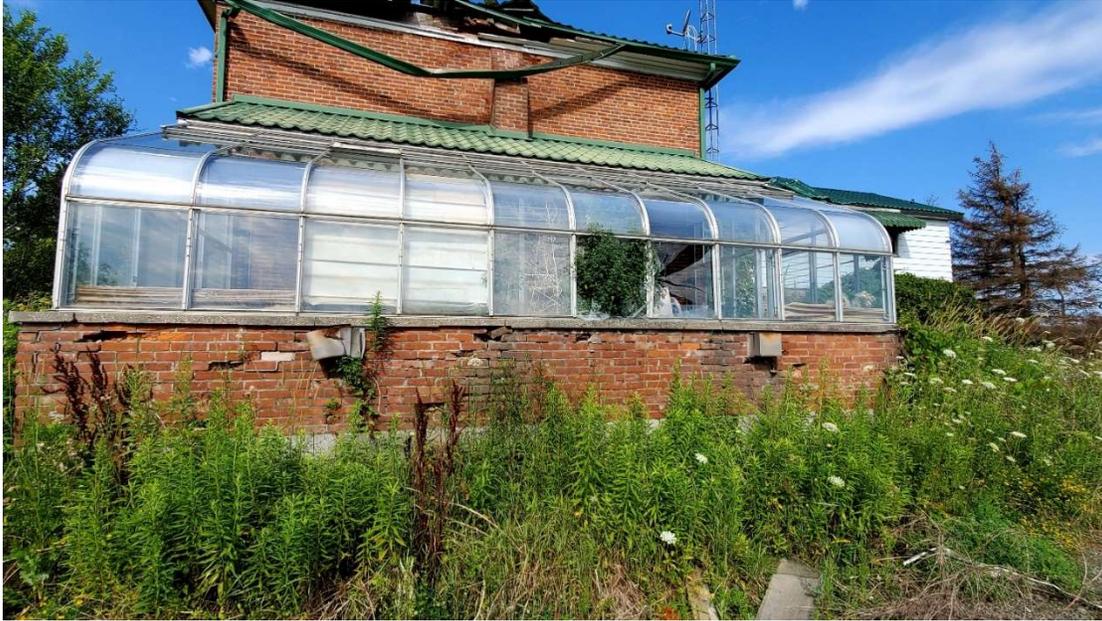
7. The brick masonry wall of the greenhouse addition appeared disintegrated, and vegetation growth was observed in the greenhouse with a broken few pane (Pic. 8).

Pic. 8: Eastview showing disintegrated Masonry Wall, Vegetation growth in the Greenhouse with Broken Panes

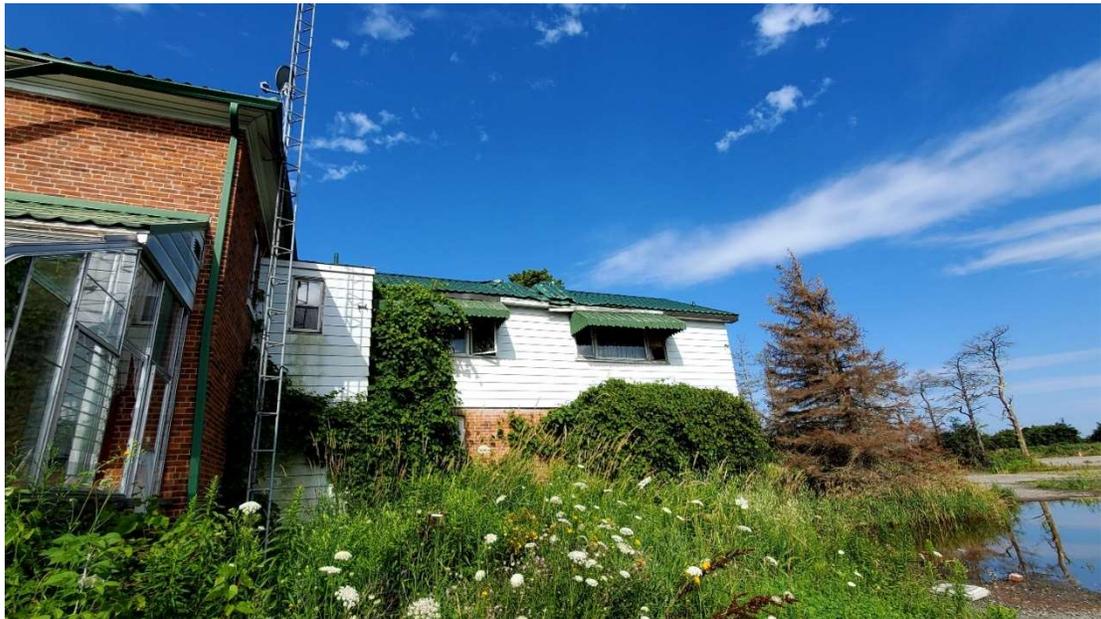
Pic. 9: House Addition on Northside

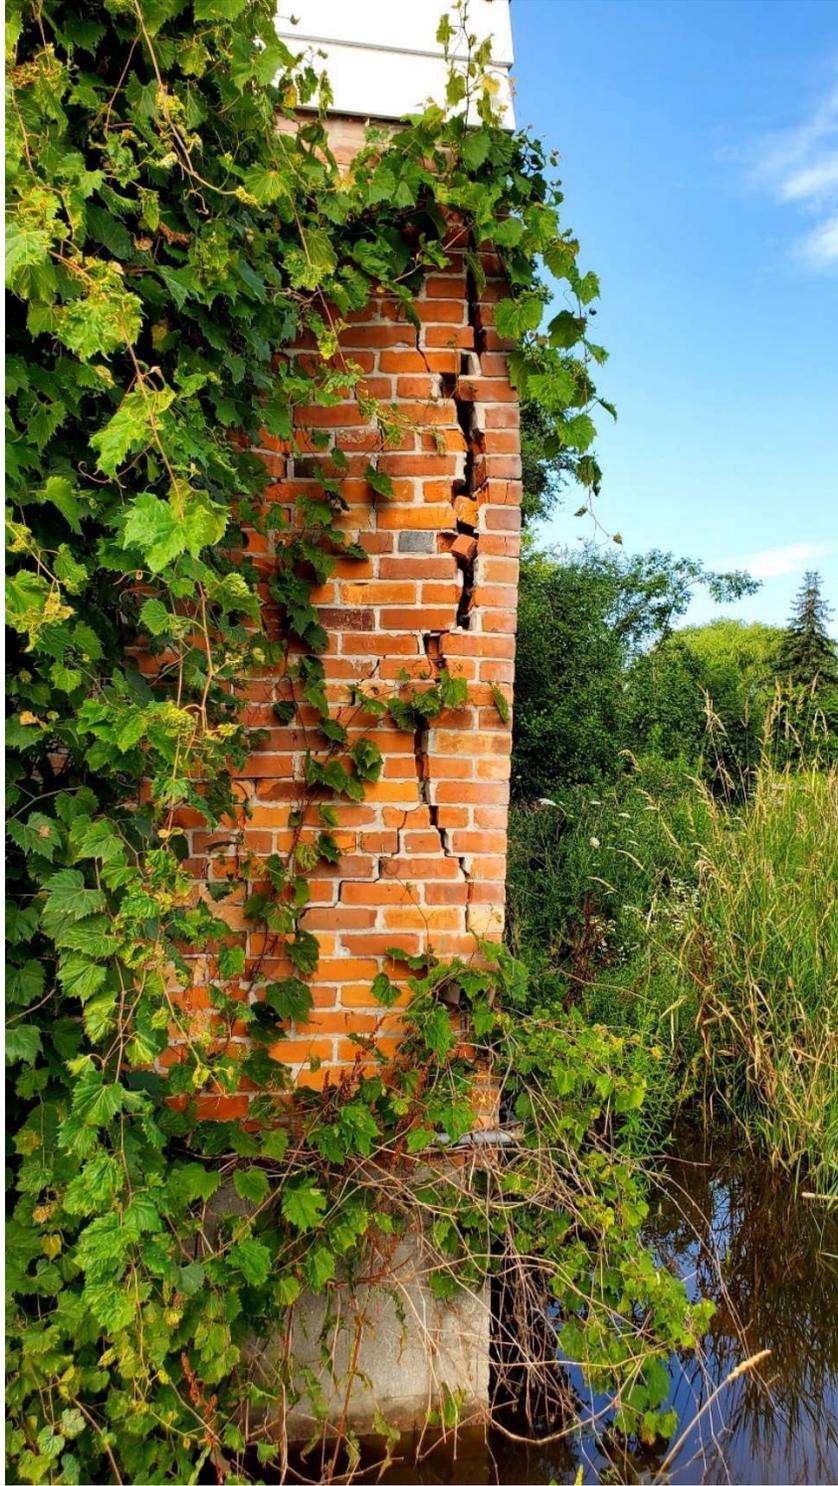
8. Wide and long vertical cracks were also observed in the load-bearing masonry wall at the northeast corner of the house addition on the northside (Pic. 10).

Pic. 10: Wide and Long Vertical Crack on the Northside House Addition and Water Pool Outside

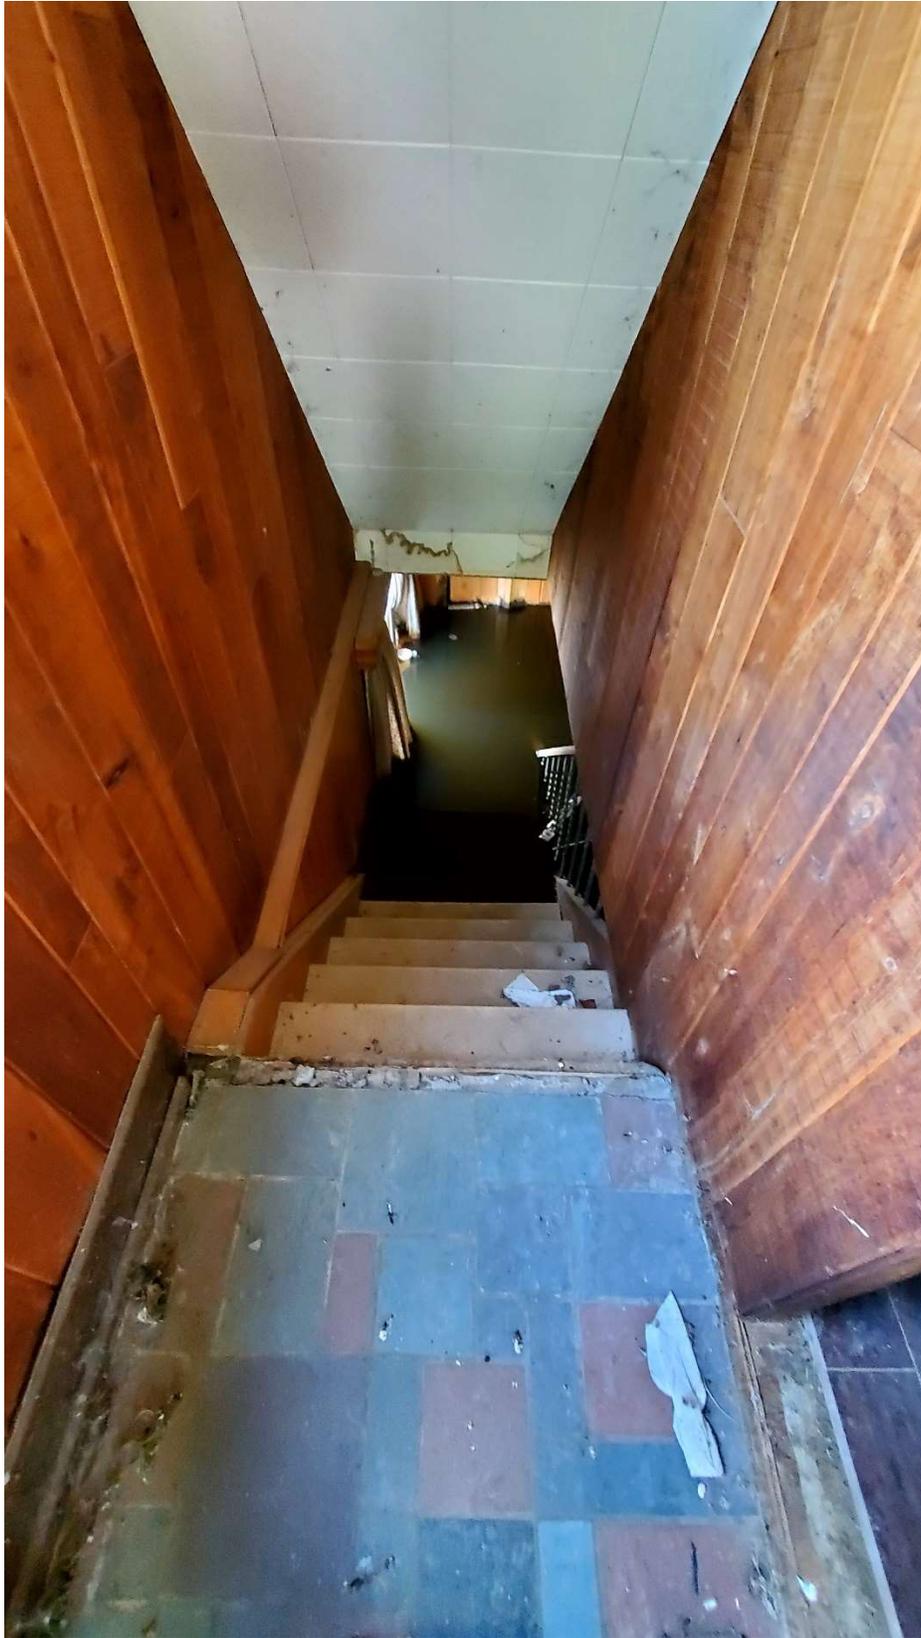
9. The house's crawl space was not inspected due to safety concerns and health hazards; however, the basement of the house addition on the north side is visible from the ground floor and is fully submerged in dirty water up to the windowsill (Pic. 11). That makes it inaccessible to inspect the structure's foundation condition from the basement.

Pic. 11: Submerged Basement of the House Addition on the Northside
