19. NOTICE OF APPLICATION TO REPEAL THE HERITAGE DESIGNATION BY-LAW OF JAMES DALZIEL HERITAGE HOUSE AT 7230 NASHVILLE ROAD IN KLEINBURG (TRANSMITTAL REPORT)

HERITAGE REPORT

STRUCTURAL CONDITION ASSESSMENT

7230 Nashville Road, Kleinburg, Vaughan

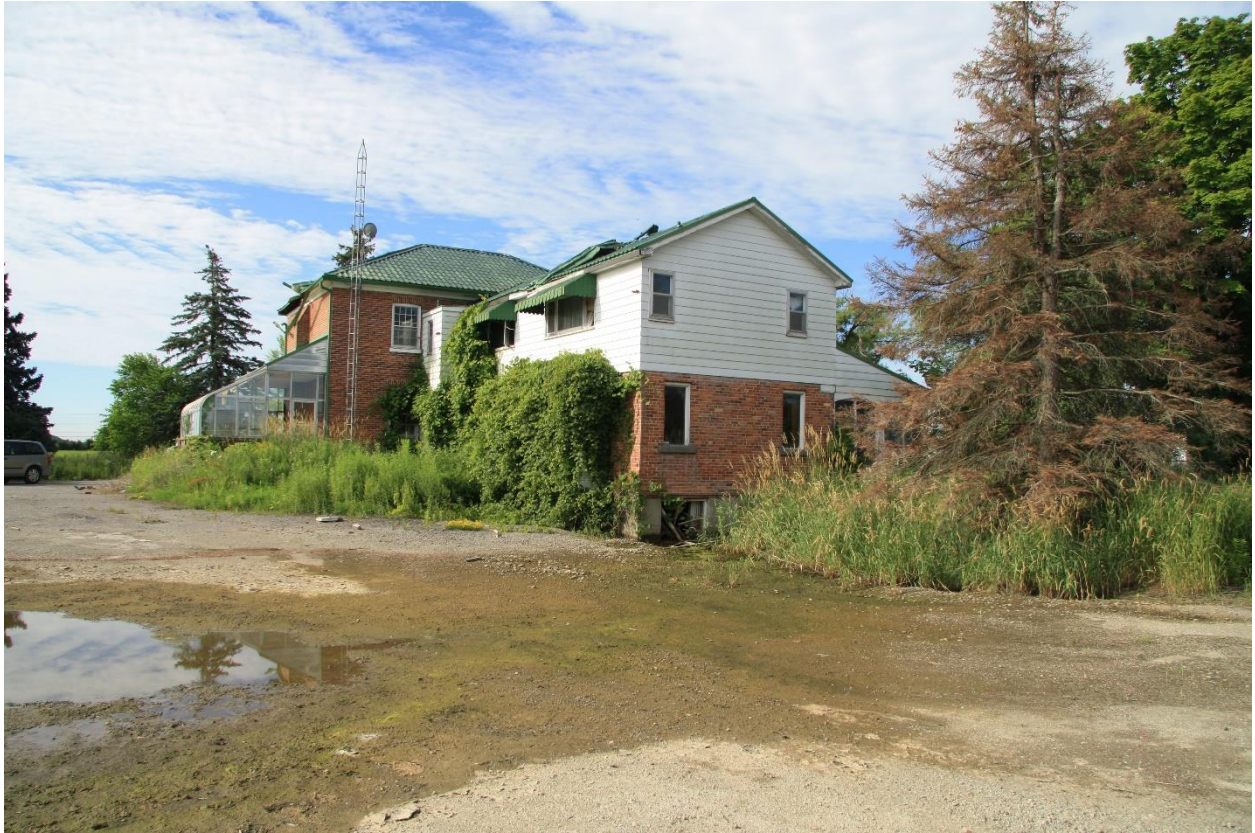
NORTH ELEVATION

- Some windows and doors have been changed.
- All the aluminum cladding and metal roof.
- The **North Elevation** is mostly occupied by a new construction attached to the farmhouse as a brick and block and aluminum siding on the second floor.

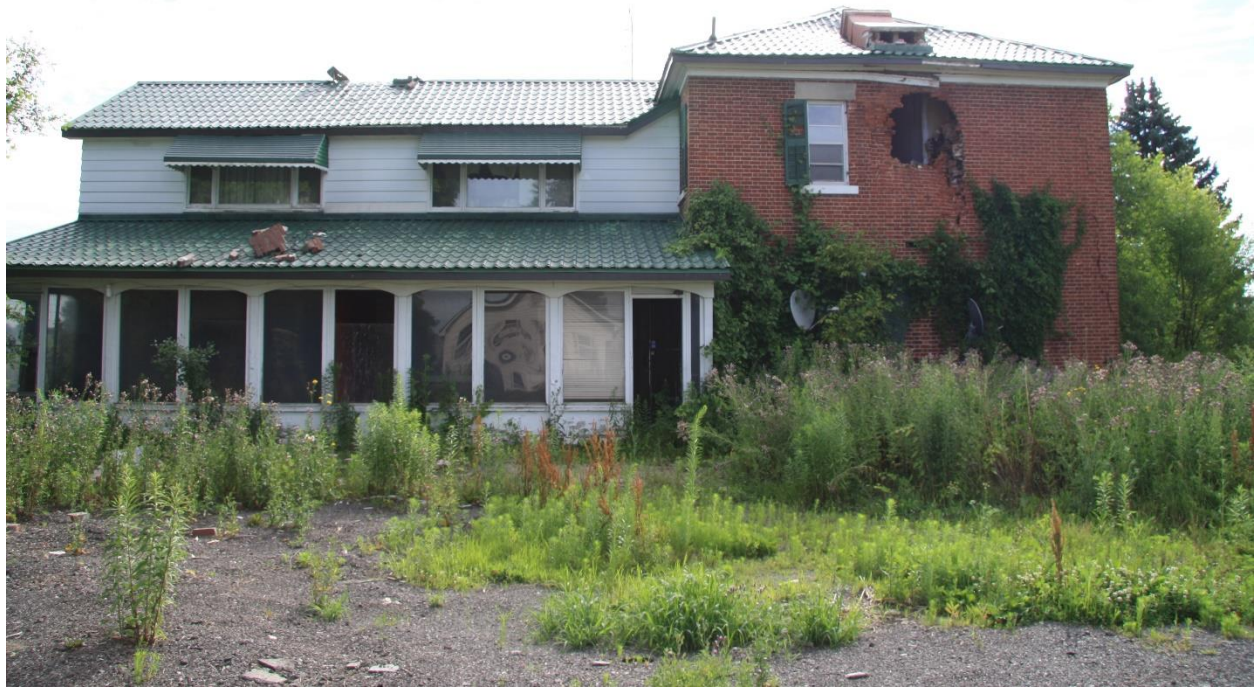
WEST ELEVATION

- **West Elevation** we have a new window that is not in the context of the house, and the major chimney has fallen and resting on the roof. This created a displacement on the wall having a major hole on the façade. Also, evident vertical cracks on the RH of the house **(Photo attached)**

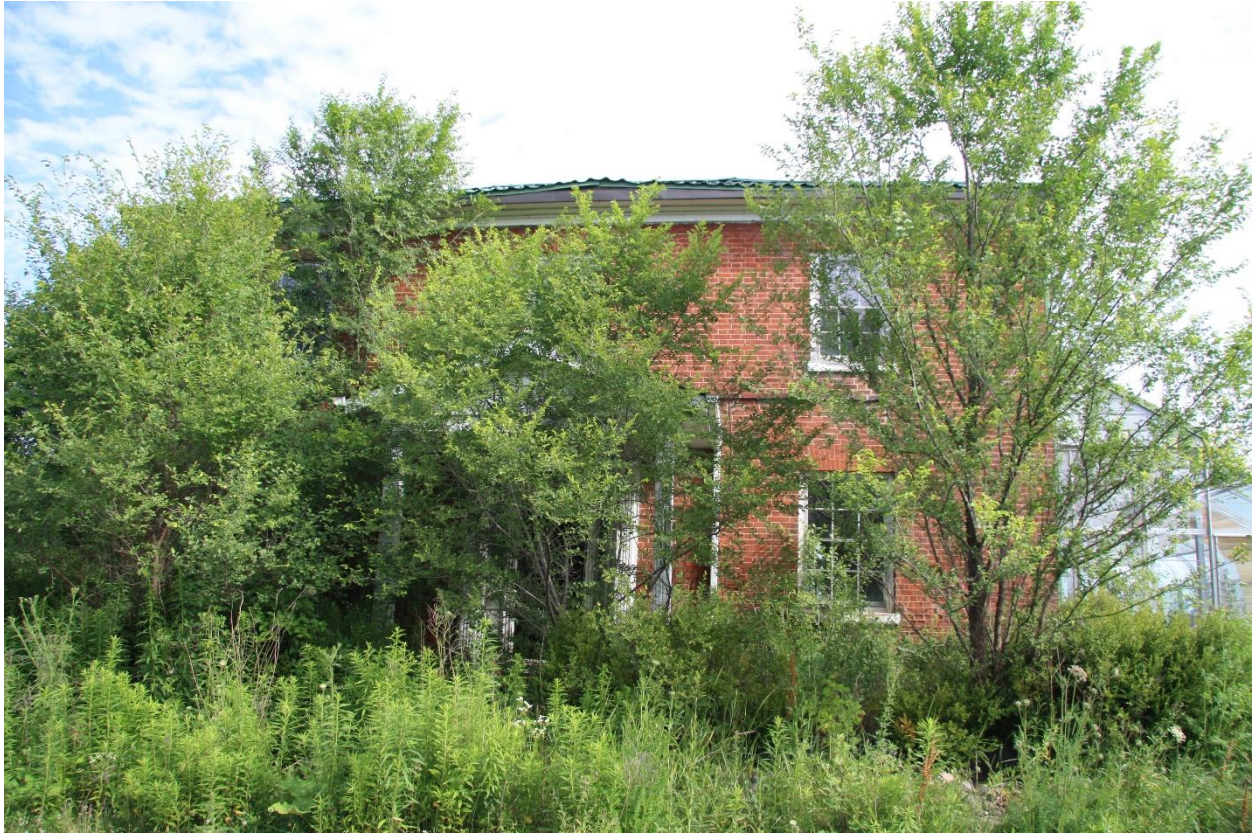
SOUTH ELEVATION

- The **South Elevation** is evident only the area that is currently visible, on major vertical cracks on the RH. and LH of the house.
- The **East Elevation** brick work pattern has been changed to a common bond due to a large green house on the full length of the house up to the second-floor line .and chimney is completely down on the roof creating a major crater on the roof. **(Photo attached)**

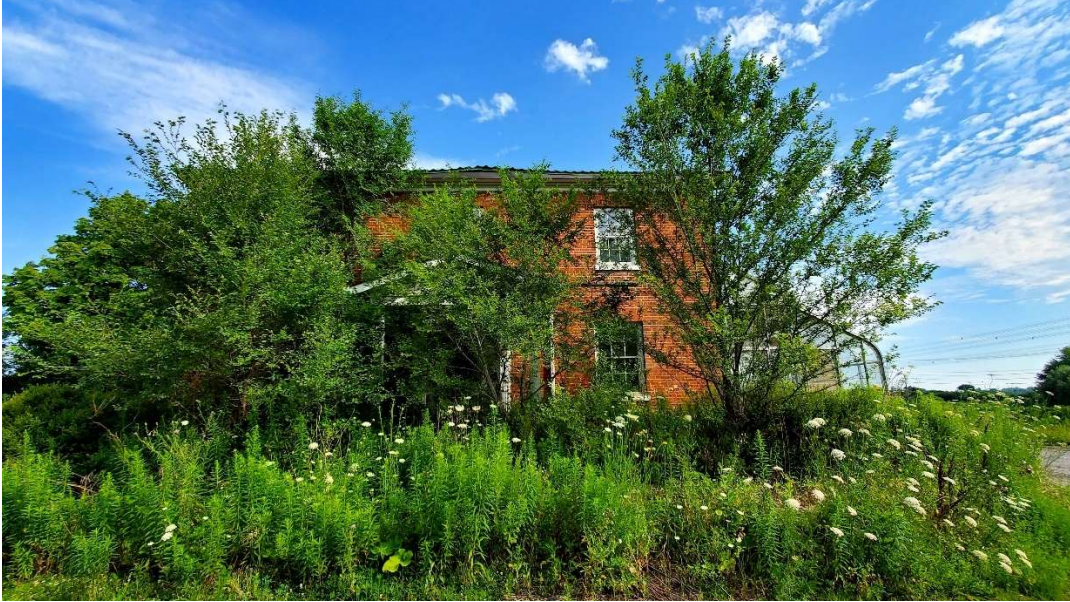
The building (house) is currently vacant, abandoned, damaged, and in a severely deteriorated condition. The west and south exterior walls, including the entrance to the house, are surrounded by dense vegetation and tall bushes. (Pic. 1 to Pic. 5). The projected porch at the house is supported by wooden posts and has a partially glazed main entrance door. The main house features an exterior brick façade, and a green-coloured metal roof. There are two chimneys, one at either end, which are damaged and have fallen over and lying on top of the existing metal roof. The metal roof is damaged in several areas and severely damaged at the location of the previously noted fallen chimneys.

Pic. 1: Southview of the House-Front Entrance

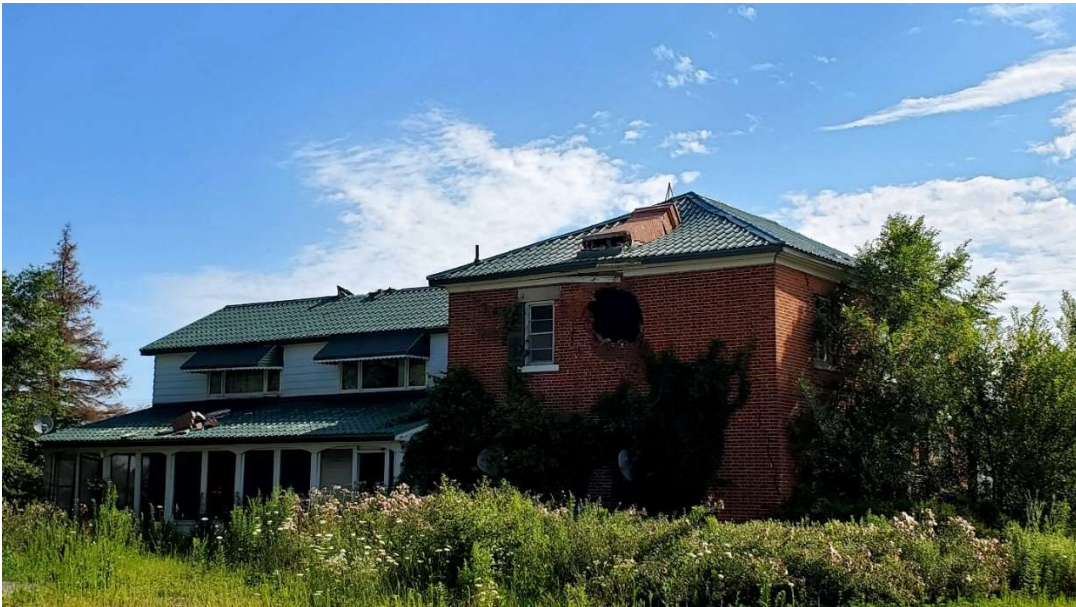
The existing building addition (Pic. 2, Pic. 9) along the north side of the main building (house) has a rectangular footprint and is one-and-a-half-storey with a basement. It has a side-gable roof, a chimney in the center, which is damaged/broken and fallen over onto the existing roof, and a concrete block wall foundation with wooden floors. The building addition has an exterior brick facade on the first floor and wooden siding on the second floor. There are two fully glazed windows on the front and back of the second floor, each with a chajja on top. The first floor has glazed windows on the north and east sides. The building has a one-story front verandah with wood-framed glazed windows and doors at both ends. The shed roof is green metal. Currently, the building addition is abandoned and unoccupied.

4. The Chimneys were broken above the roof line and damaged the roof structure, including the metal edge, fascia, and soffit (Pic. 2, Pic. 3, Pic. 7).
5. The metal roof was damaged and lifted in many areas including at the locations of the fallen chimneys (Pic. 2, Pic. 3, Pic. 7). The damaged roof offers no protection to the interior of the building from the elements (rain, snow etc.) resulting in further deterioration of the interior of the building, including flooding, rotting and damage to flooring, walls and ceilings, and environmental issues such as mold.

Pic. 2: Westview of the House showing Northside Addition

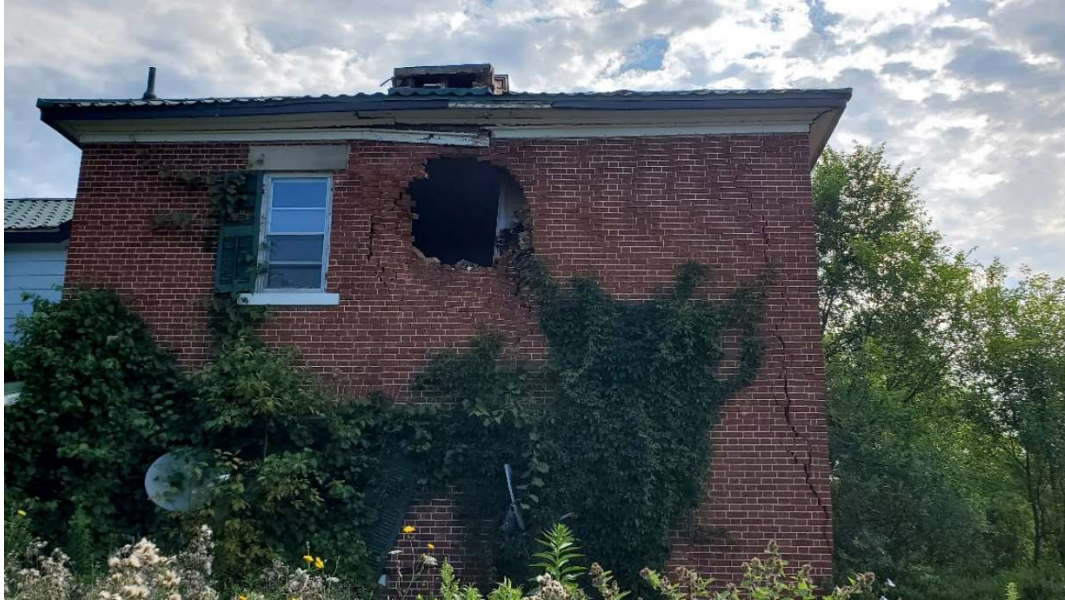
2. A very large round collapsed area on the load-bearing masonry wall was observed on the west side near the top center of the wall, wide and large cracks surrounding the fallen section. It appears this fallen section caved in towards the inside of the building. (Pic. 3, Pic. 5).

6. The wooden steps leading up to the entrance porch were observed to be degraded. The windows on the west side appear damaged with shattered panes and a broken shutter hung on the exterior wall (Pic. 3).

Pic. 3: Westview showing Cracks on the Masonry Wall, Part Caved In and Broken Chimney

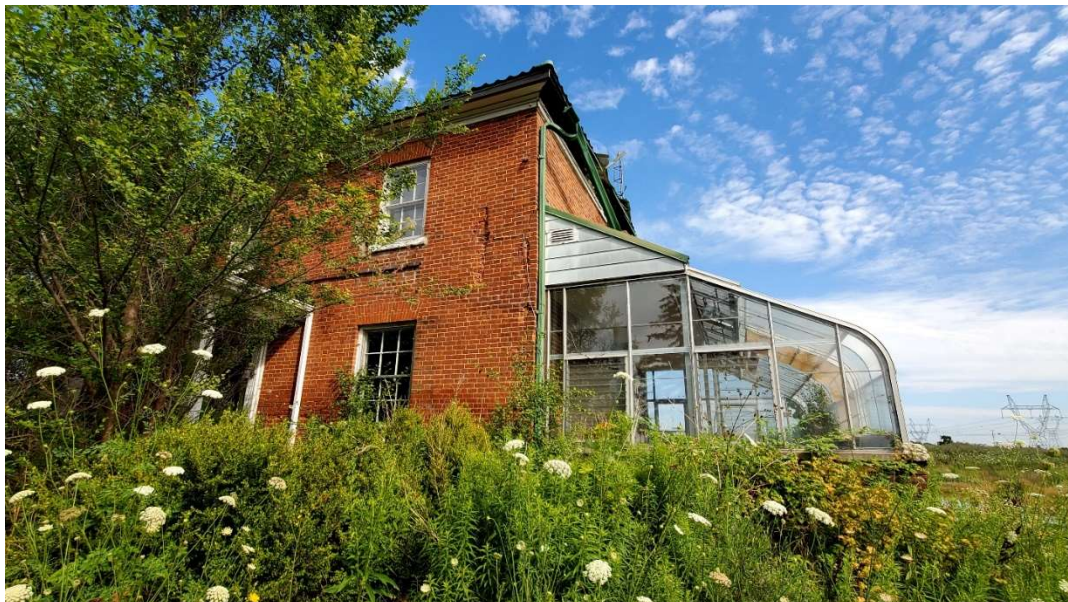
There is a Greenhouse addition on the east side of the main building. Which is supported by the exterior brick wall. (Pic. 4, Pic. 7 and Pic. 8)

Pic. 4: Southside view showing Greenhouse Addition on Eastside

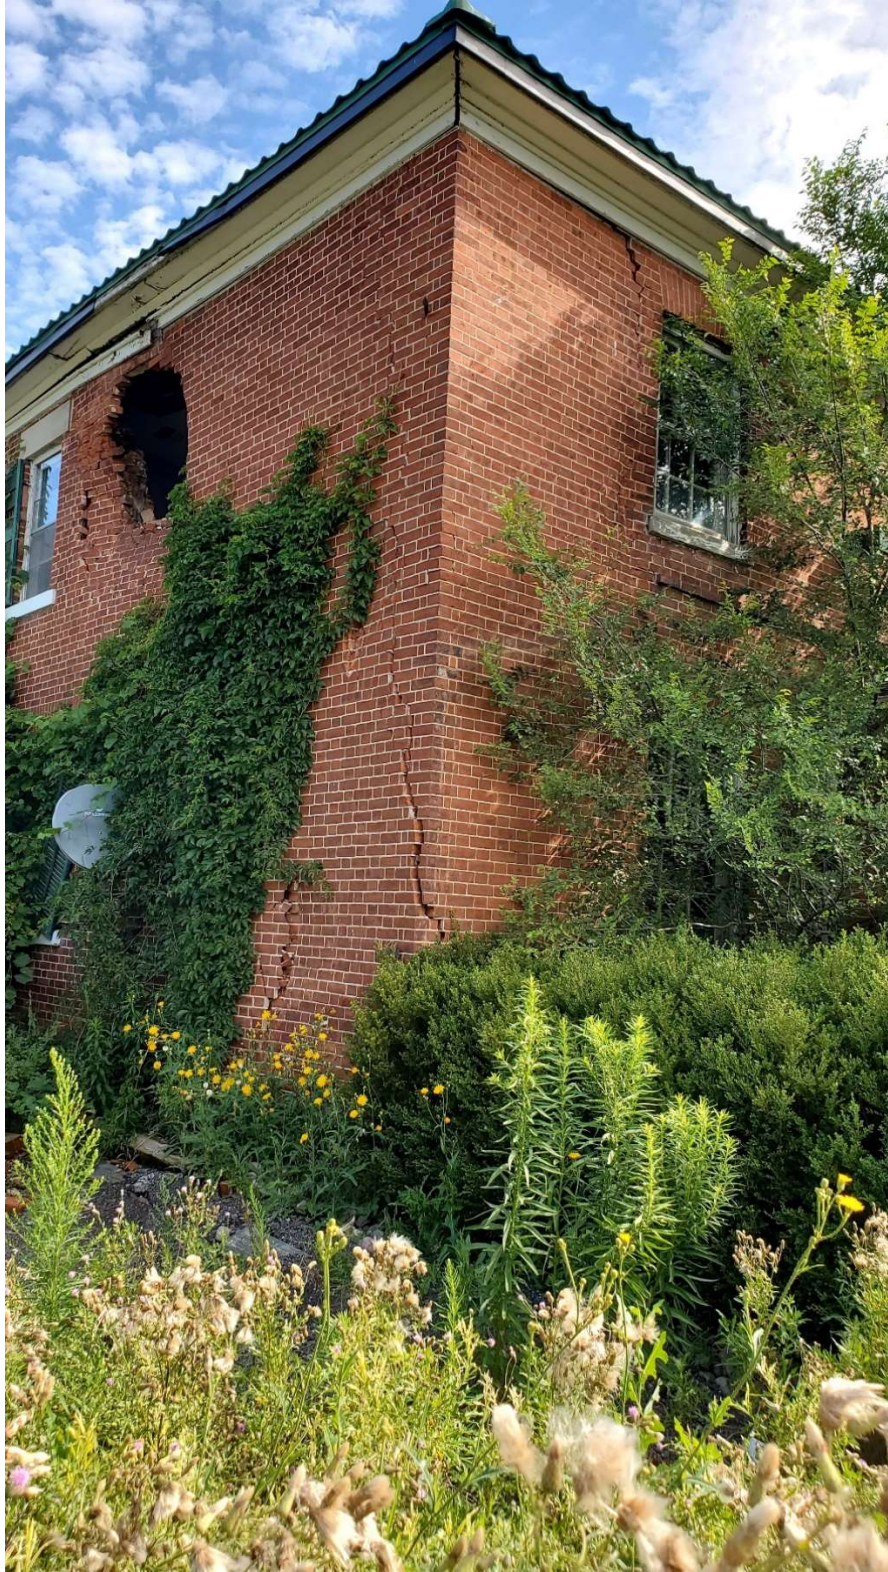
1. Extensive vertically inclined crack, wide at the bottom and narrow at the top, was observed on the exterior load-bearing masonry wall on the west side from the southwest corner, travelling up from the bottom to the top of the building (Pic. 2, Pic. 3, Pic. 5). Another sizable fissure was also observed on the same wall some distance away from the long crack (Pic. 5).

3. A wide vertical crack was noticed on the left side, near the window, from the top of the load-bearing masonry wall on the southside (Pic. 5). Some disintegrated bricks with long vertical cracks were also seen on the same wall on the right side at the southeast corner (Pic. 6).

Pic. 5: Southwest view of the House-Cracks and Damage in the Load-bearing Masonry Wall

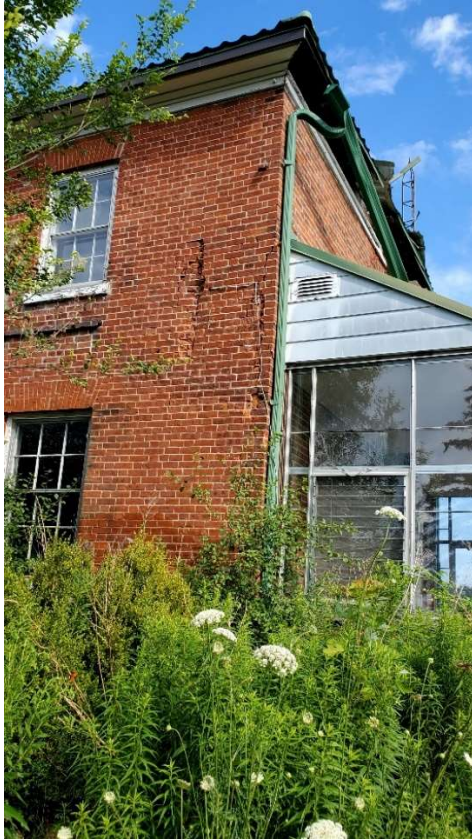
Pic. 6: Cracks and Damage on the Southside Masonry Wall of the House

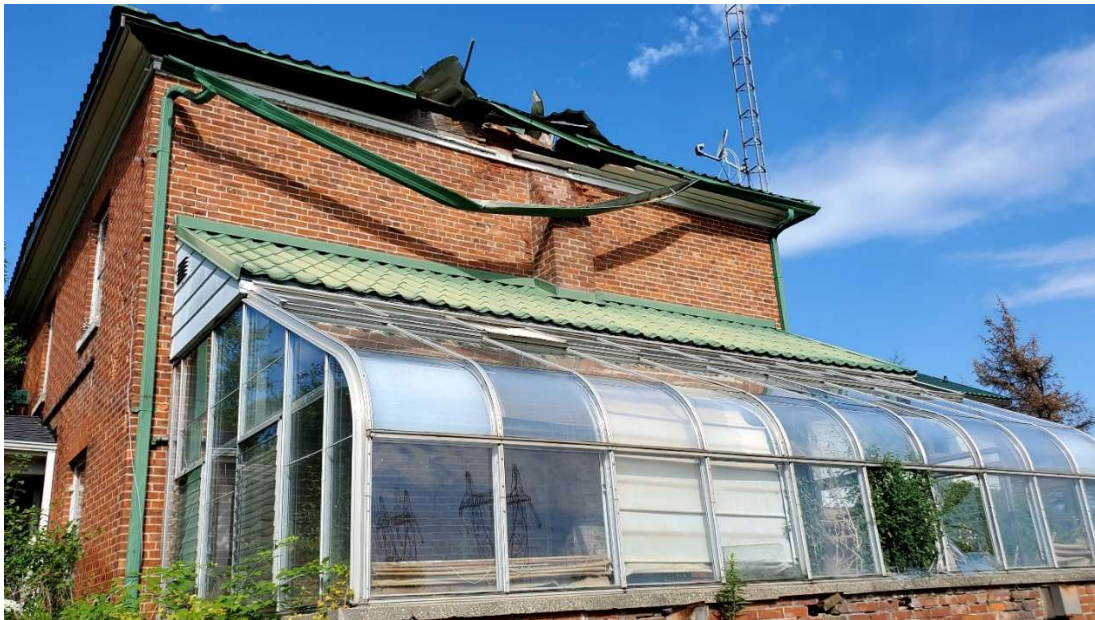
Pic. 7: Eastside View of the House showing Damaged Roof at Broken Chimney and Greenhouse Addition

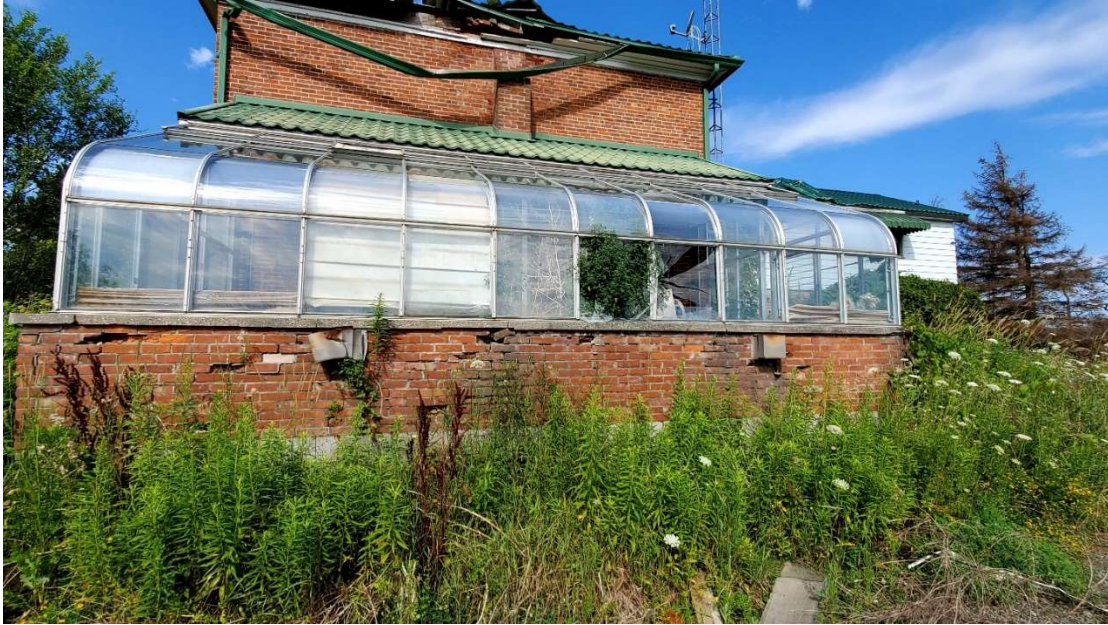
7. The brick masonry wall of the greenhouse addition appeared disintegrated, and vegetation growth was observed in the greenhouse with a broken few pane (Pic. 8).

Pic. 8: Eastview showing disintegrated Masonry Wall, Vegetation growth in the Greenhouse with Broken Panes

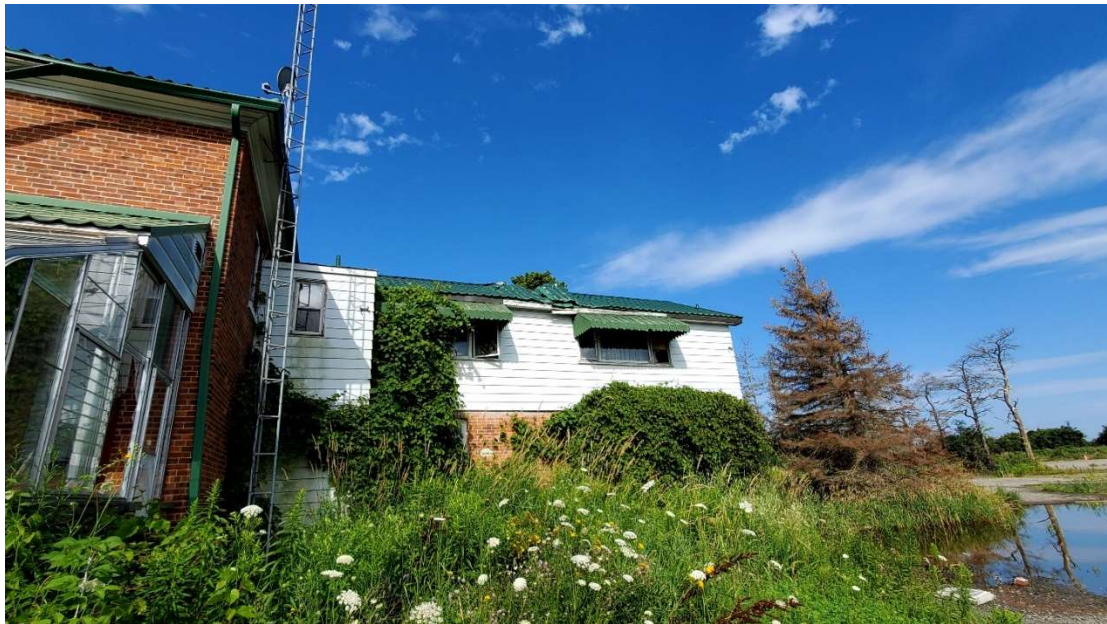
Pic. 9: House Addition on Northside

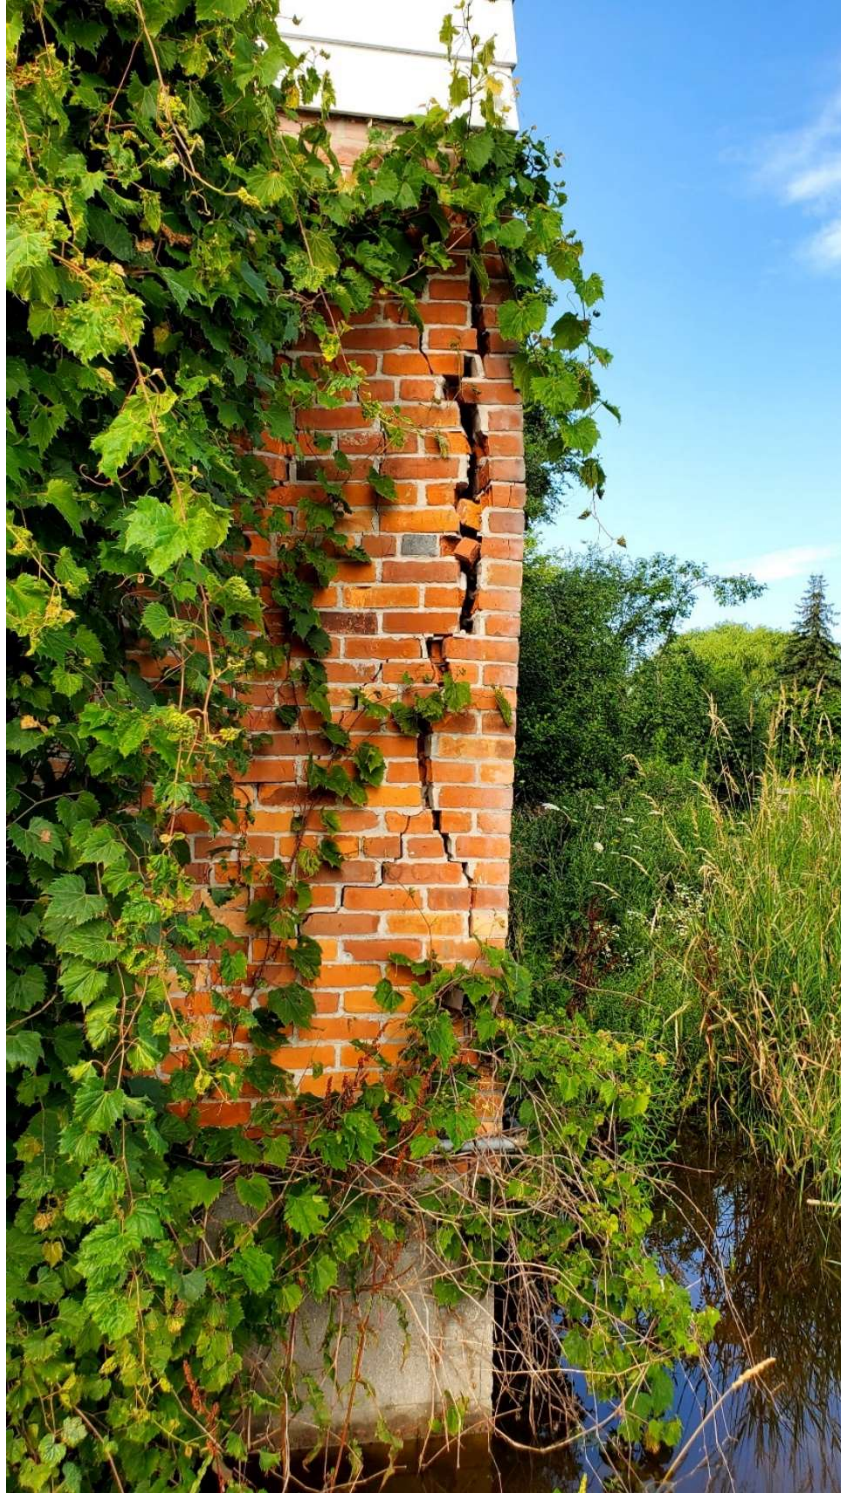
8. Wide and long vertical cracks were also observed in the load-bearing masonry wall at the northeast corner of the house addition on the northside (Pic. 10).

Pic. 10: Wide and Long Vertical Crack on the Northside House Addition and Water Pool Outside

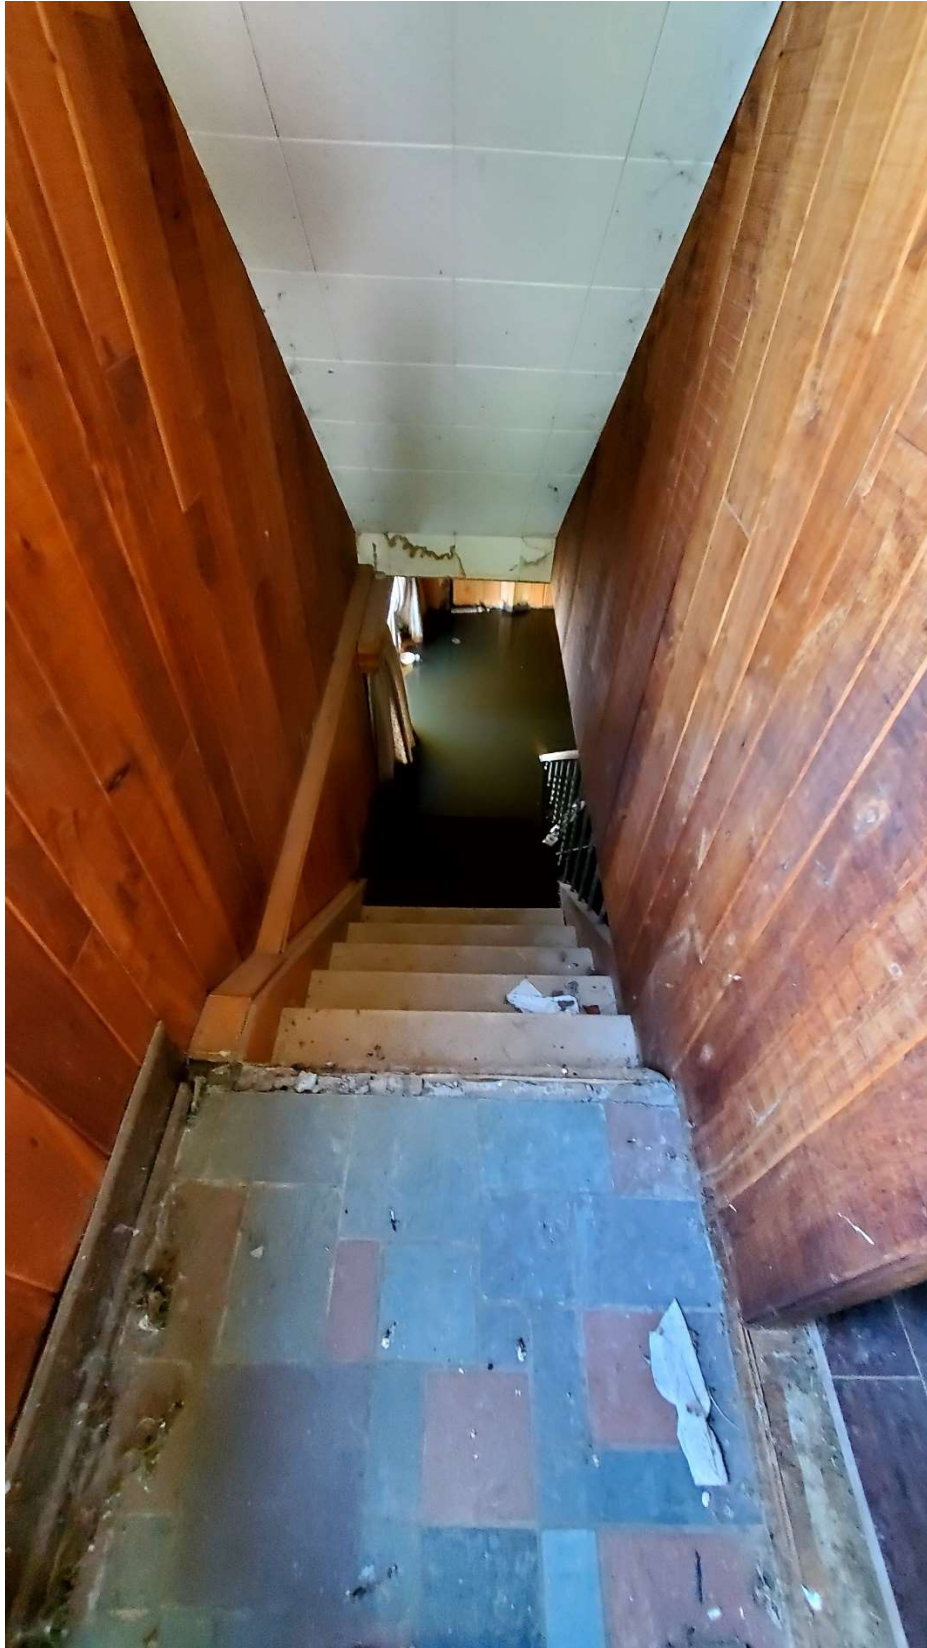
9. The house's crawl space was not inspected due to safety concerns and health hazards; however, the basement of the house addition on the north side is visible from the ground floor and is fully submerged in dirty water up to the windowsill (Pic. 11). That makes it inaccessible to inspect the structure's foundation condition from the basement.

Pic. 11: Submerged Basement of the House Addition on the Northside
