TREE IMPACT & EVALUATION REPORT for **TREE #8** at **8 Main Street, Vaughan, ON L4H 3N5**

Date: April 22nd, 2025

Prepared by: **Ivan Mitev**, M.Sc. Ecologist

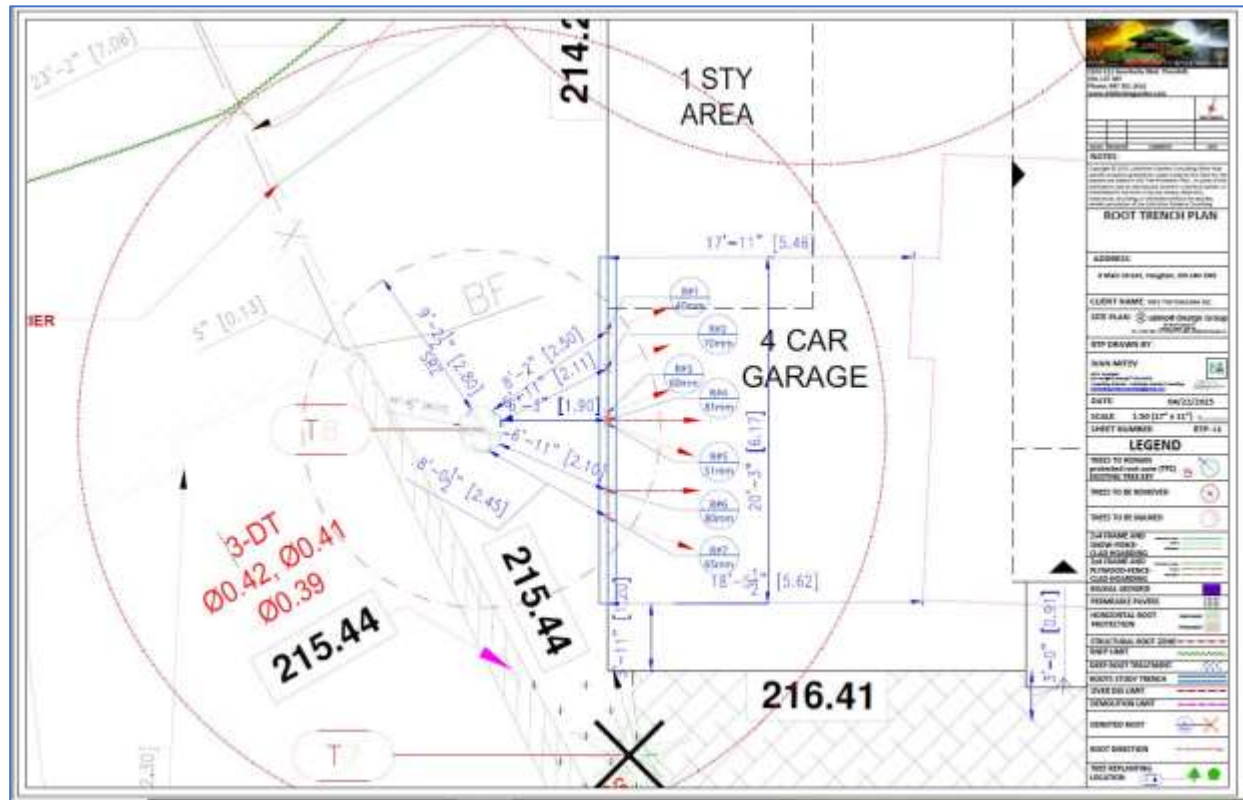
Figure 2: illustrates roots found in root exploratory trench. Roots are labelled with the corresponding diameter sizes; Please review Root Trench Plan-L1 for more details

Roots Sensitive excavation was performed by Air Spade to a depth of **0.60 m** along with the westerly limit of the proposed new foundation. The exploratory trench is marked in blue colour, as indicated in the cut-out from the Root Trench Plan L1 (Fig.2).

roots associated with **T8** with individual diameter i.e., **R#1: ø 40mm/450mm depth; R#2: ø 70mm/300mm depth; R#3: ø 60mm/600mm depth, R#4: ø 81mm/600mm depth, R#5: ø 51mm/600mm depth, R#6: ø 80mm/600mm depth, and R#7: ø 65mm/600mm depth**, were carefully exposed, mapped and documented on the provided Root Trench Plan. Please review RTP-L1 for more details. These roots were revealed within first 60cm of the soil level. The largest found root is associated with **T8: R#4: ø 81mm** was found at a distance of **1.90 m**, east from the base of the tree.

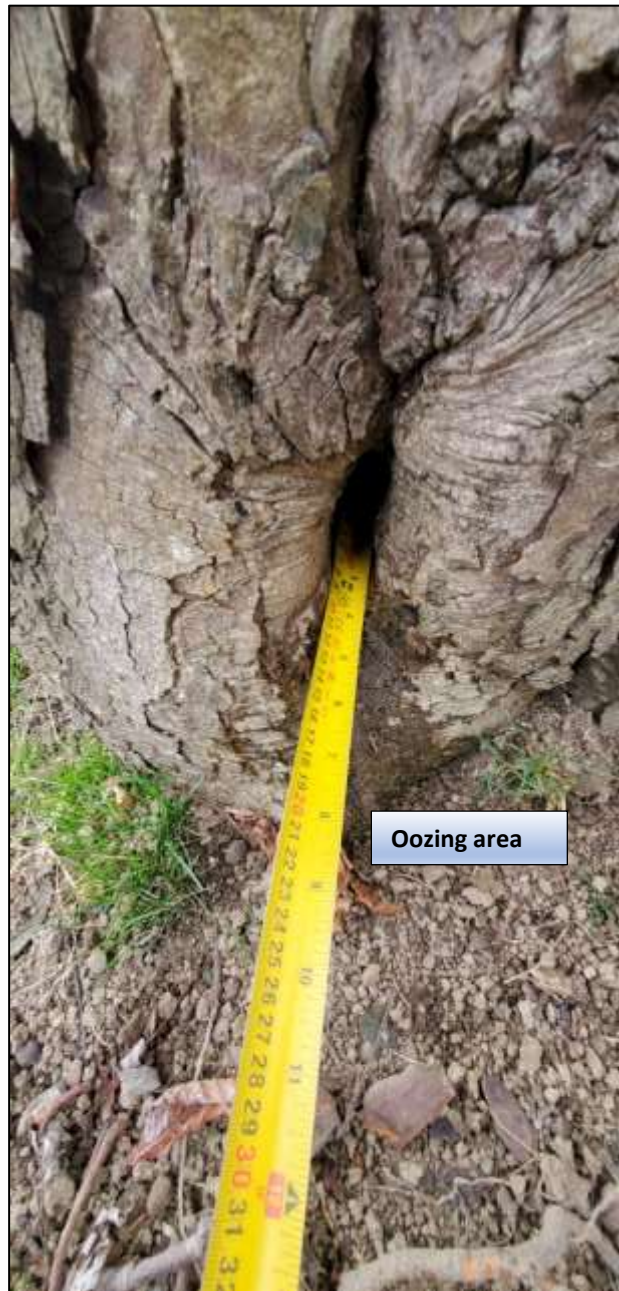
Another cause of concern is the small hollow found close to the base of the tree, just below trunk bifurcation. It has an approximate depth of 10cm and width of 5 cm. Oozing was noted during the conducted site assessment. Oozing on the subject tree may be an early symptom of bleeding canker, a disease caused by the bacterium *Pseudomonas syringae pathovar aesculi*. An additional laboratory analysis including culturing the bacterium, DNA analysis (PCR), and/or microscopic examination of the affected tissues must be conducted in order to confirm the presence of specific genes in *P. syringae pv. aesculi* or *Phytophthora*.

Fig.4: Basal cavity, close up

The property owner is not willing to accept any site risks and would like to see the tree removed in order to eliminate any hazard to property the safety of the residents, and the neighbour's property. Given the very low-risk tolerance of the property owner, as well as taking into consideration the above arborist's findings, we recommend that the tree be removed and replaced.

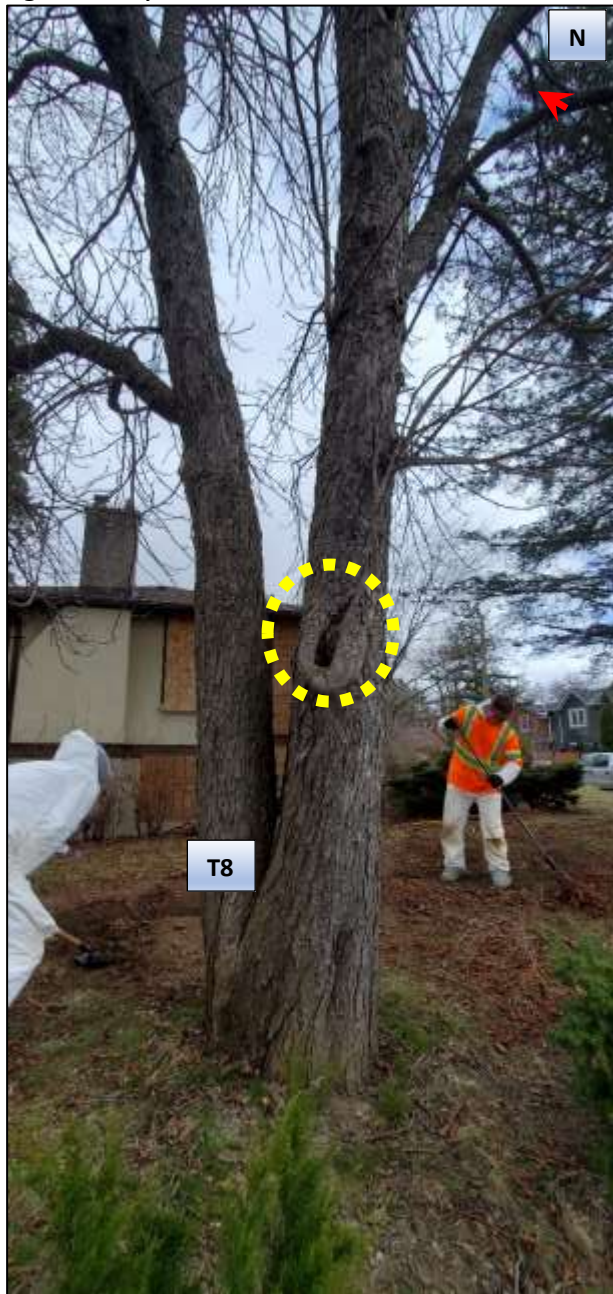
A total of three (3) small to medium size cavities were documented during the provided tree assessment. Two of them have formed at the site of the former western and northern leaders, whose lateral branches have fallen some time ago. Although the tree has produced a significant response growth that almost enclosed the cavities, the size of the inner hollow remains large. The cavity of the western leader is visible from the west side of the tree, roughly 2m above the existing grade. It has an approximate depth of 30cm and width of 8.5 cm. Given that the size of the cavity exceeds 30% of the inner circumference, with sound shell less than 70 %, we may conclude that the mechanical strengths of the western stem is reduced.

Fig.5: Cavity on the western leader

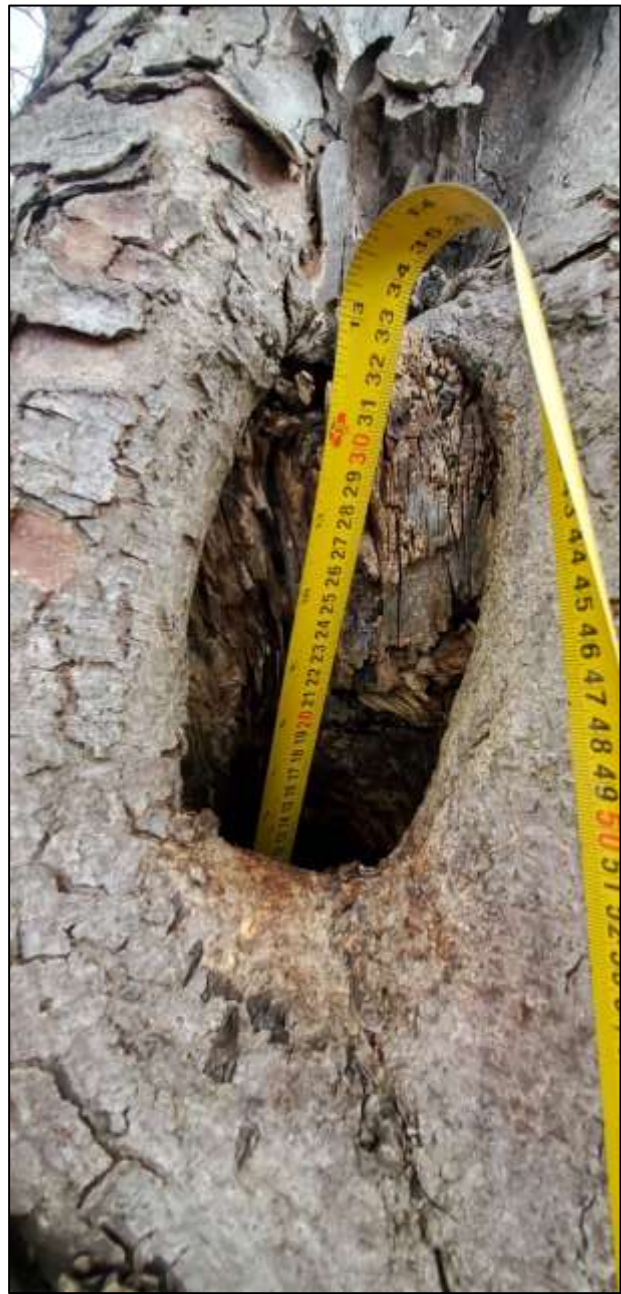
Fig.6: Associated depth, close up

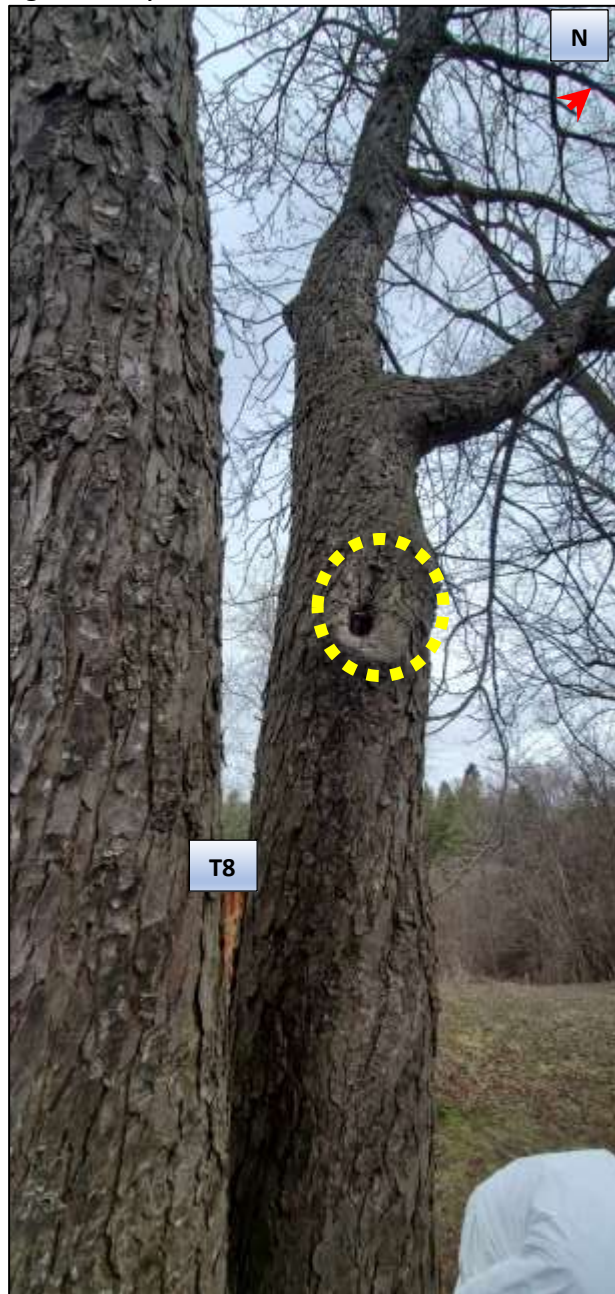
Fig.7: Cavity on the northern leader

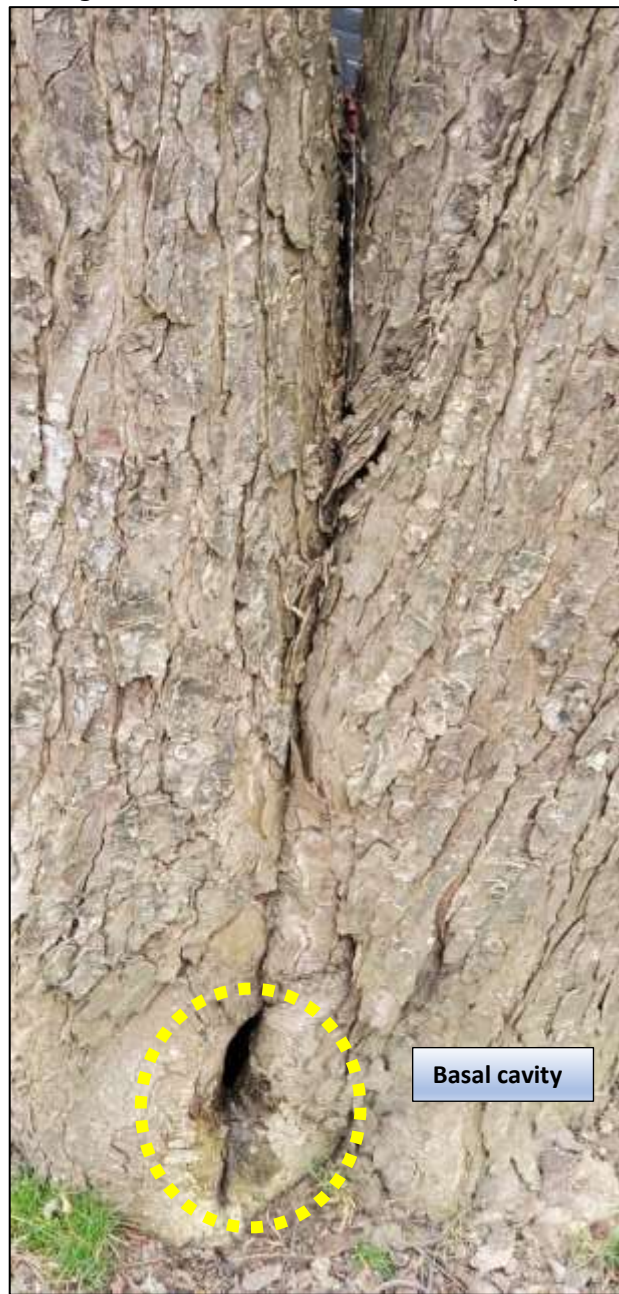
The forked trunk bifurcation signals a potential weakness, especially on the side where the leader grows outward on a lean. A narrow-angled fork like this can also be prone to infection. The seam creates a crevice for insects and disease pathogens and increases the likelihood of tree failure.

Fig.8: Included bark section, close up

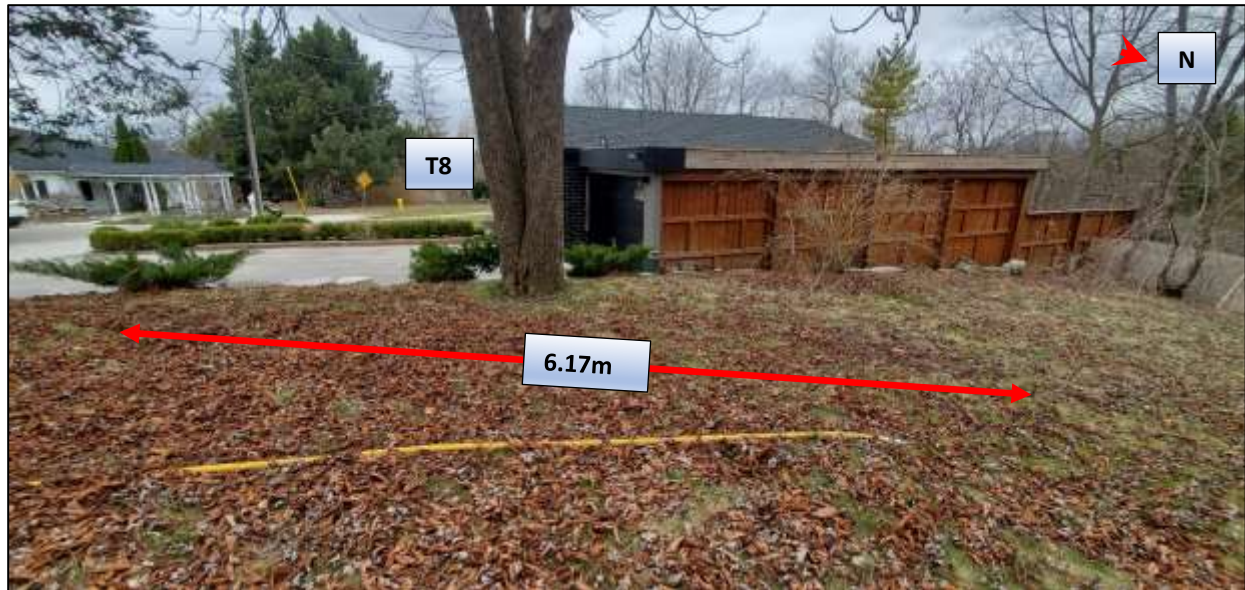
Fig.9: The root study area viewed from the east. The red arrows mark the total limit of the proposed exploratory excavation trench

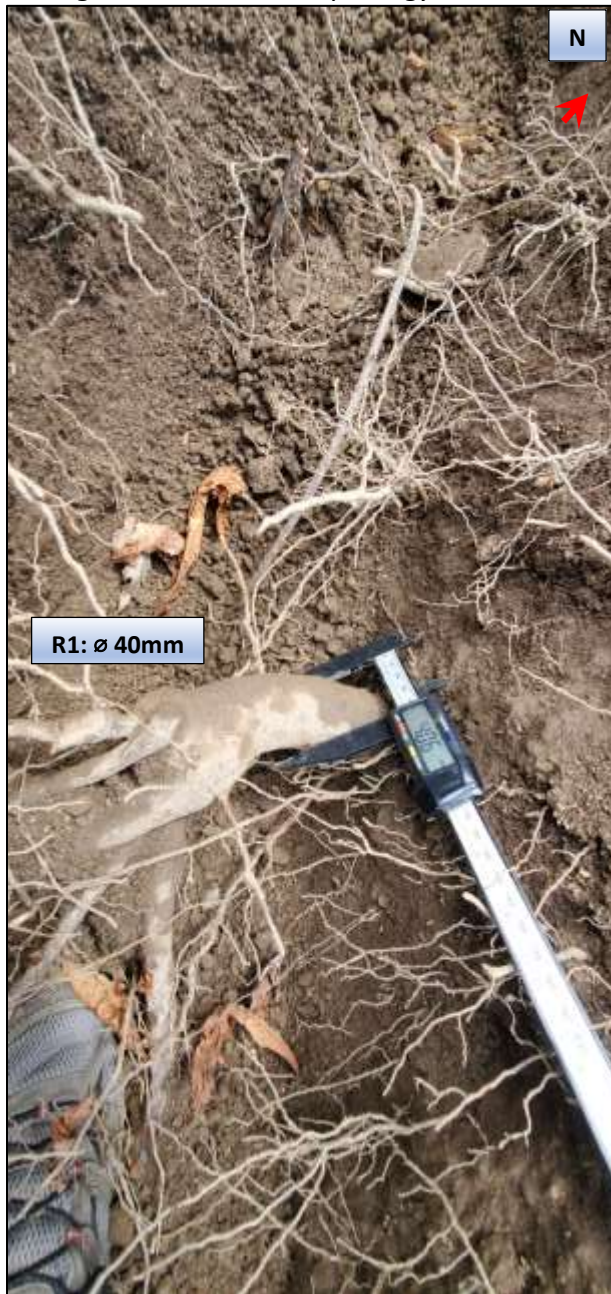
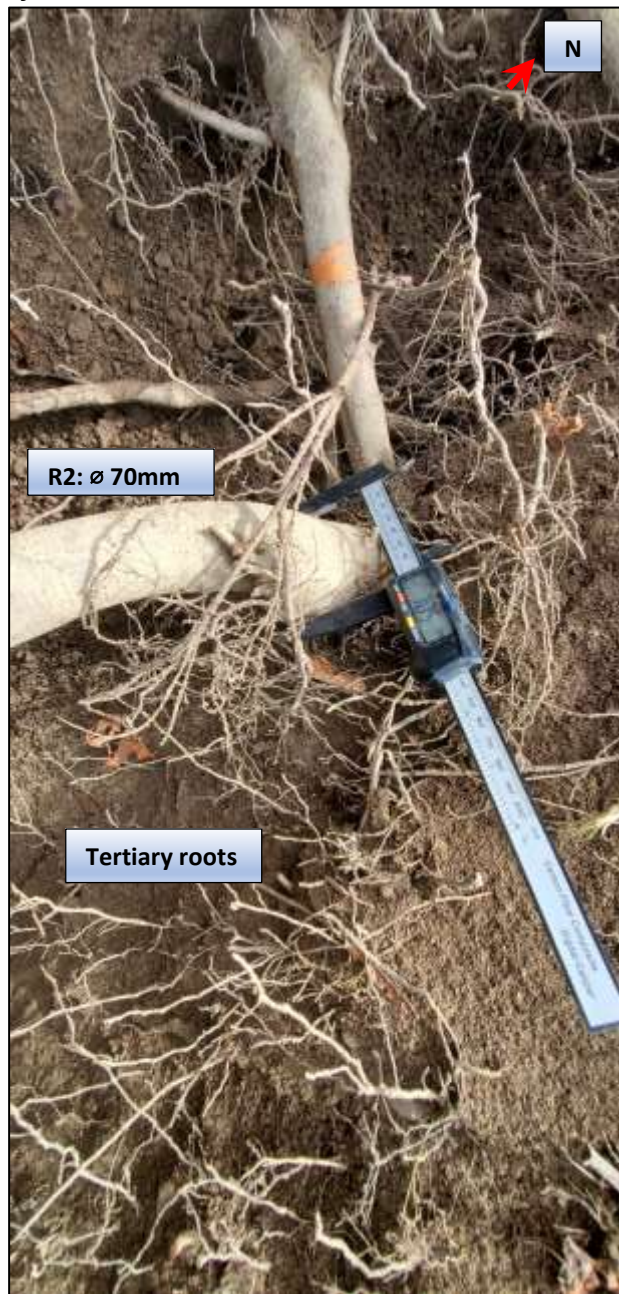
Fig. 11&12: Root morphology and directions of the main lateral roots associated with T8

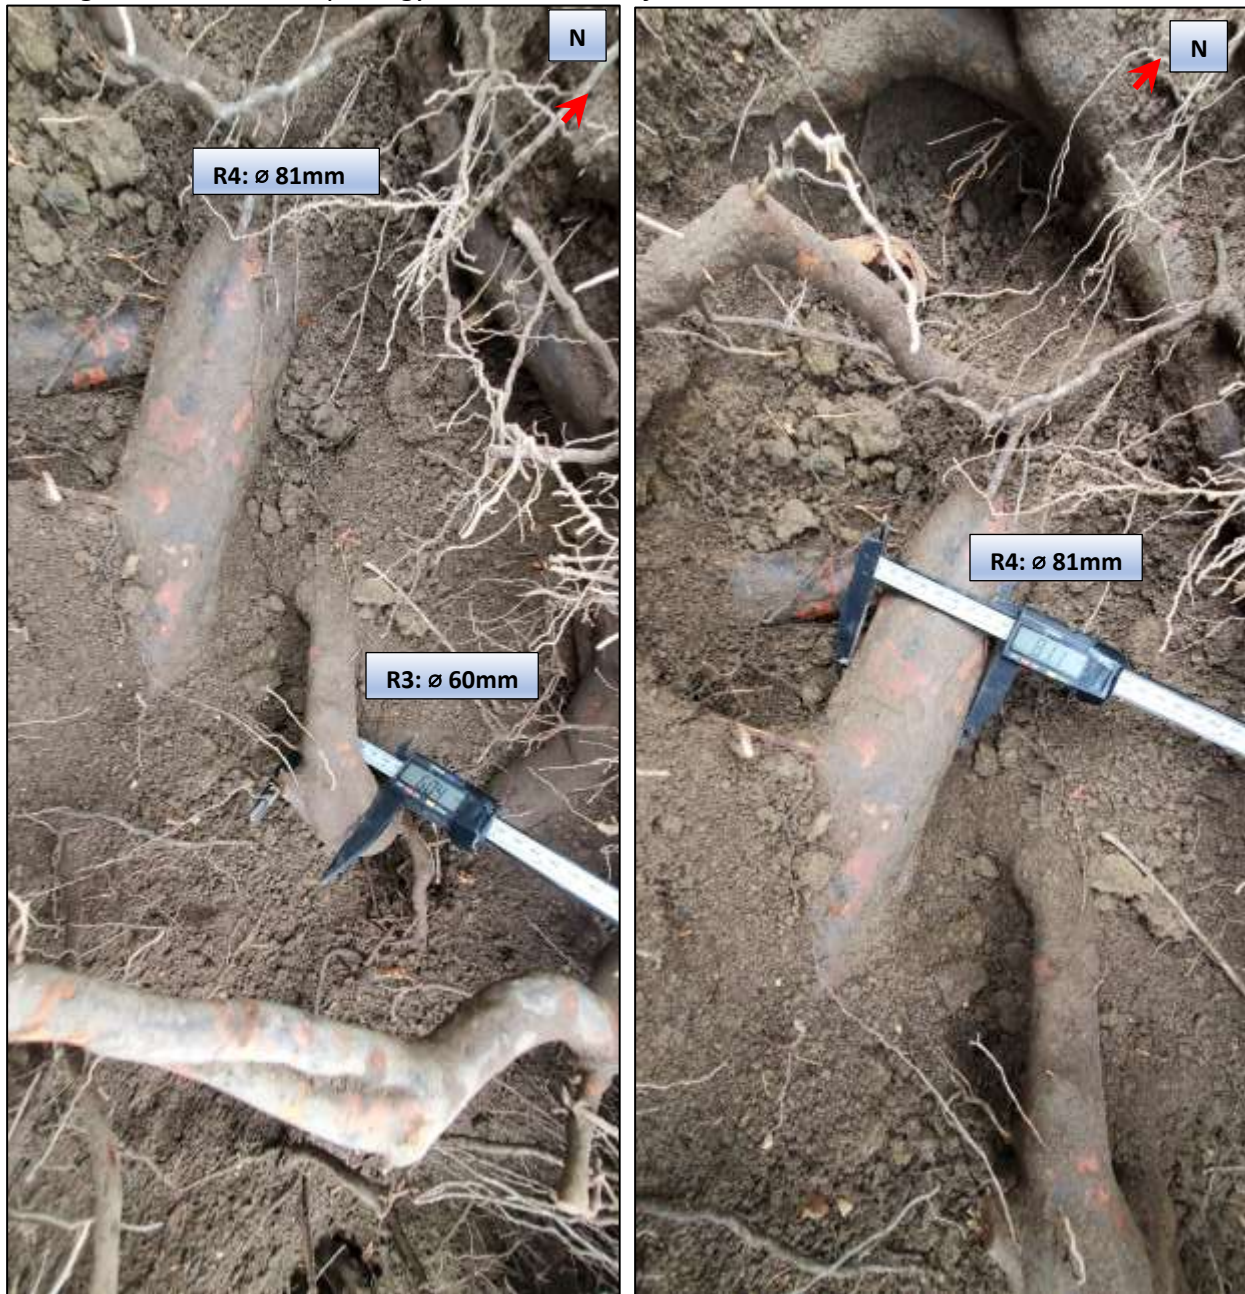
Fig.13&14: Root morphology and directions of the main lateral roots associated with T8

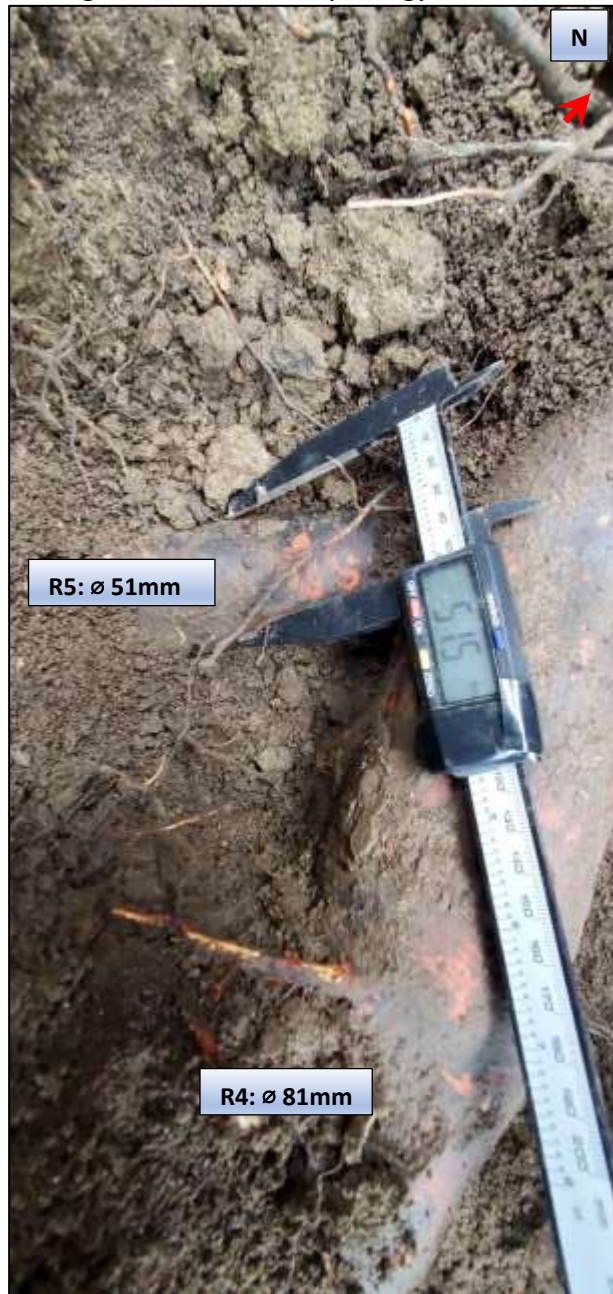
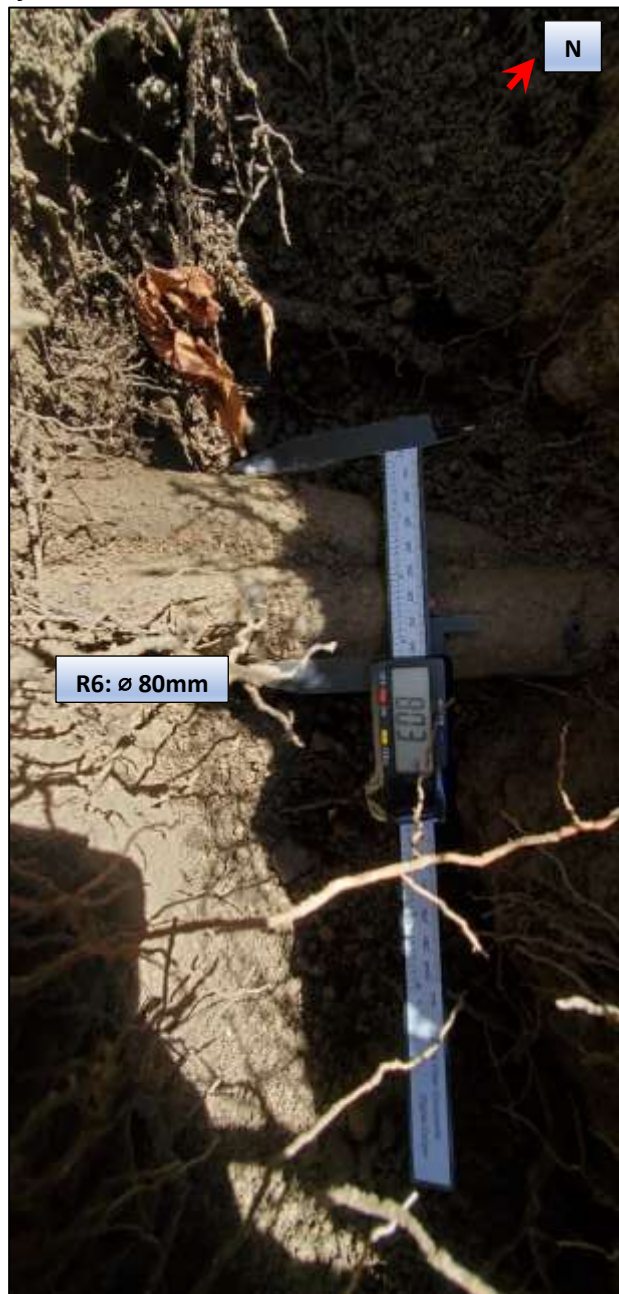
Fig.15&16: Root morphology and directions of the main lateral roots associated with T8

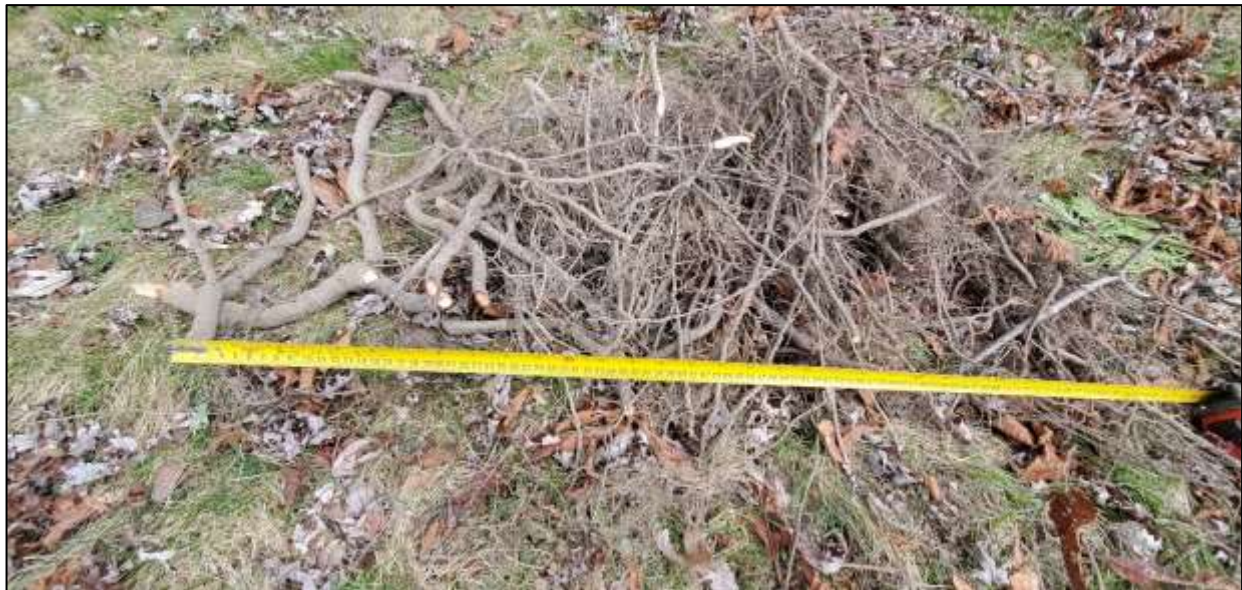
Soil composition of the first 60cm soil surface was largely loam. Below that depth, the soil composition significantly declines and clay particles and buried construction debris are prevalent in the B horizon. A small number of fibrous roots were severed cleanly on the west side of the excavation trench in order to allow Air Spade access only.

Fig. 22: A small number of fibrous roots were severed cleanly on the west side of the trench in order to allow Air Spade access.
