STRUCTURAL INSPECTION REPORT

Property Address: 10911 Jane Street East
Vaughan, Ontario
L6A 1S1

Inspection Date: 2026-04-27

File No.: 2026-076

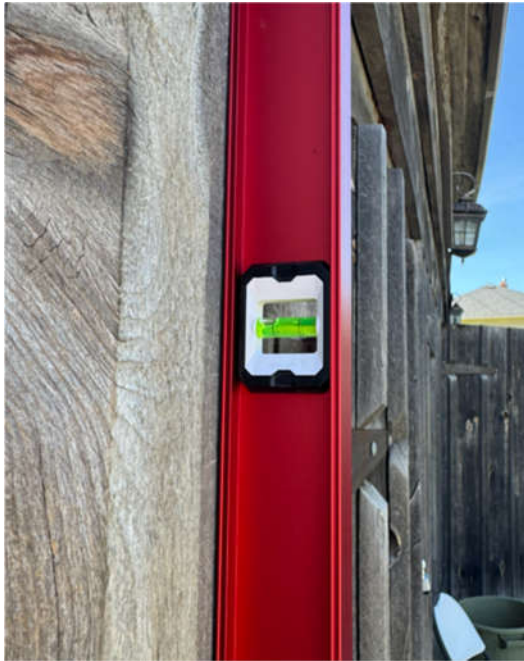
Fig. 1

Using a 6'-0" level, the structure was found to be significantly out of plumb. See Fig. 1.

- **Lateral Instability:** The bubble level indicates a severe tilt away from the roadway/public right-of-way.
- **Stress:** Since the structure is leaning, the gravity loads are no longer transferred vertically through the posts. Instead, they create "eccentric loading," which generates forces on old joints that were never designed to hold them.

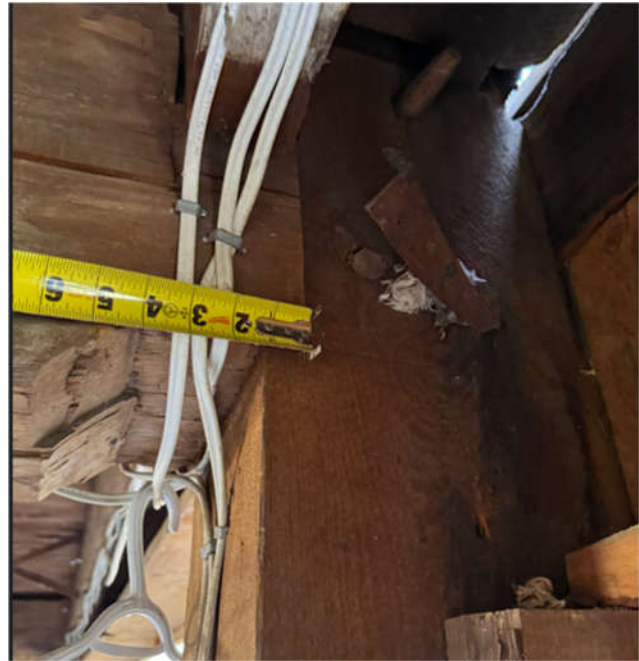
- **Rot and Degradation:** Moisture infiltration at the base of the posts has compromised the wood fibers, leading to a loss of compressive strength. See Fig. 2 & 8.
- **Improvised Shimming:** Observations show the use of non-structural wood scraps (shims) to compensate for post-shortening and settlement. This is an inadequate measure that provides no lateral or vertical stability.

The internal skeletal system shows signs of "checked" timber and joint separation. See Fig. 2 & 6.

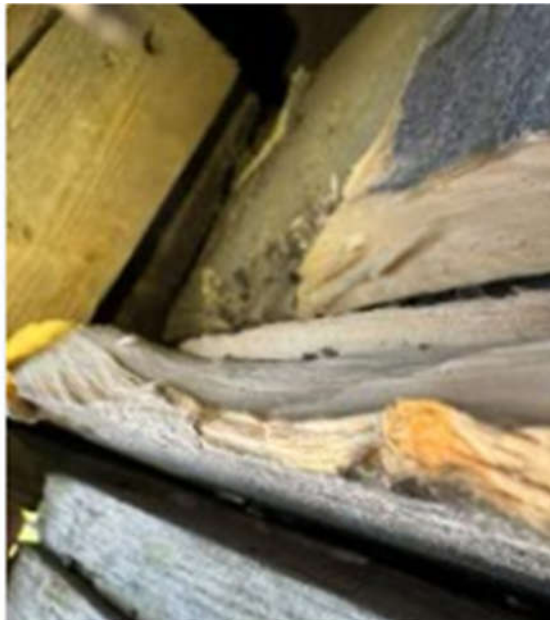
Fig. 3

- **Beam Deflection:** The horizontal spans show visible deflection, which has caused the secondary floor joists to pull away from their primary seats. See Fig. 5 & 6.
- **Crushing at Bearings:** In several areas, the horizontal beams are crushing the tops of the vertical posts due to moisture-softened wood and over-stressing. See Fig. 3.

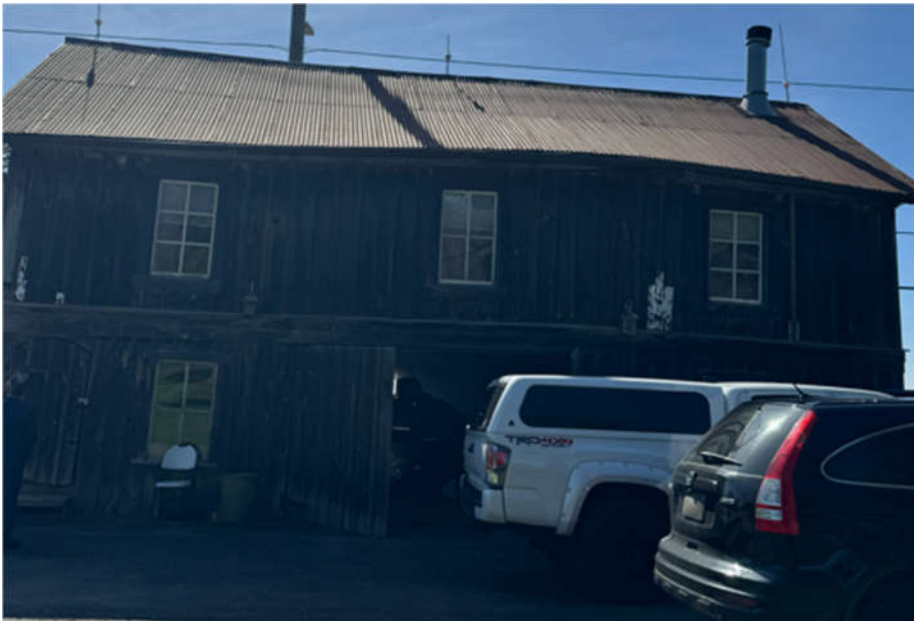
Fig. 7

A visual inspection of the roofline reveals that the primary ridge and rafter system have suffered significant deformation. See Fig. 7.

- **Sagging and Arching:** The roof plane is no longer linear, exhibiting pronounced sagging (deflection) between support points and "arching" in specific bays. This suggests that the internal purlins or rafters have either fractured or have lost their structural bearing due to the shifting of the exterior walls.
- **Possible Frost Heaving:** There are localized areas of the roof deck that appear pushed upward, or "heaved." This is likely the result of frost penetration to the building's frame; as one section of the building settles or leans, it forces opposing members upward, creating an arched profile that compromises the water-shedding capabilities of the roofing material.
- **Load Path Failure:** The distorted geometry of the roof indicates that the upper frame has failed, and the roof is no longer capable of safely distributing snow or wind loads to the foundation.

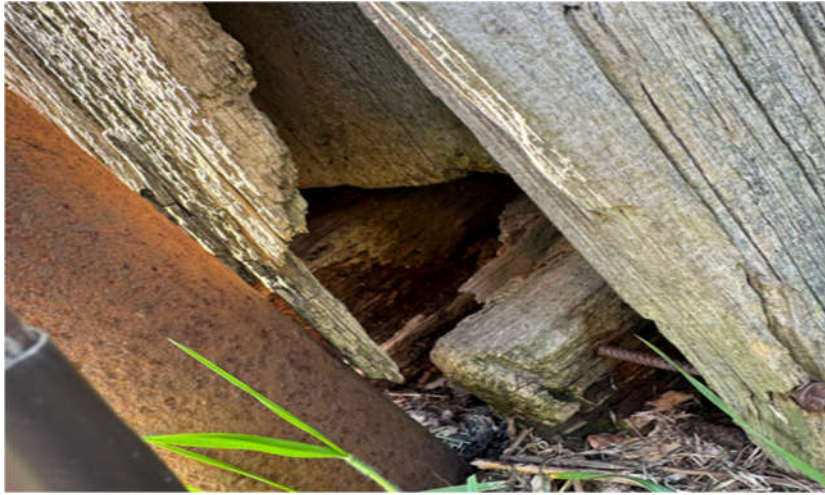
Fig. 8

The primary vertical support members (timber posts) show evidence of advanced rot, heaving, and crushing at the ground-contact level.

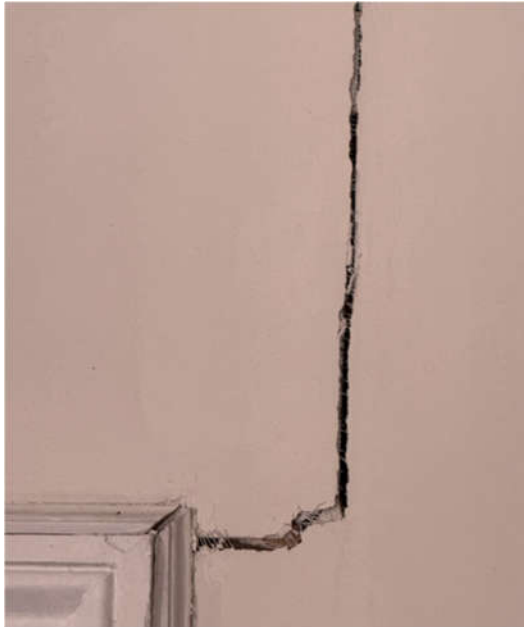
Fig. 9

- **Stress Cracking:** Large, vertical, and diagonal "stair-step" cracks have appeared in interior plaster/drywall. See Fig. 9.
- **Separation at Openings:** The cracking around window indicates that the building frame is twisting (torsion), which is a precursor to structural failure of the envelope. See Fig 10.
