# BASSINGTHWAITE HOUSE

# **Conservation Plan**

10244 BATHURST STREET, VAUGHAN

September 11, 2019

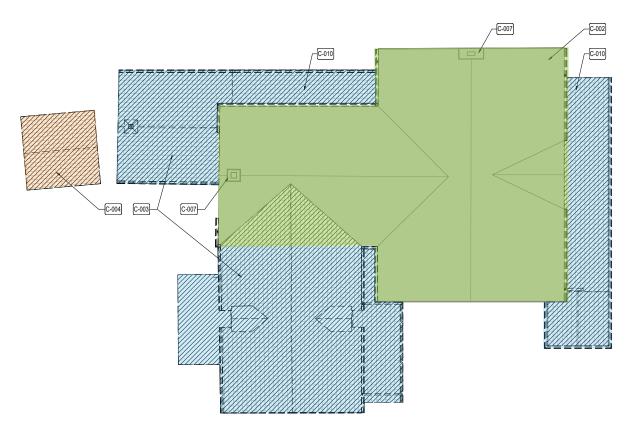
Prior to relocation, stabilization measures will be taken, which include protecting all windows, doors and chimneys to ensure they are not damaged during relocation. Additionally, removal of later additions to the house (post-1860) and the smoke house are proposed. Stone from the smoke house and the original basement foundation will be salvaged. The smoke house structure will be thoroughly documented before removal.

- Cut 2 inches in to the brickline where the house will be removed from its old foundation:
- Install 2-1/2 foot angle iron around the perimeter of the house;
- Cut 4 holes for the 2 main beams (in old foundation);
- Cut holes every 4 inches in the foundation in order to install crosser beams on top of the main beams;
- Shim up all floor joists and support beams off crosser beams;
- Pressure up the grid of steel to 50% of the weight of the house:
- Pressure up each one of the crosser beams off of the main beams to the load each crosser beam will support (preload crossers);
- Raise house off of old foundation;
- Set rollers up on cribs and roll house off of old foundation;
- Set house on firm ground and remove pressures off the jacks, calculating where each hydraulic dolly will be placed under the 2 main beams; and
- Set house on power dollies to be moved to Proposed Site.

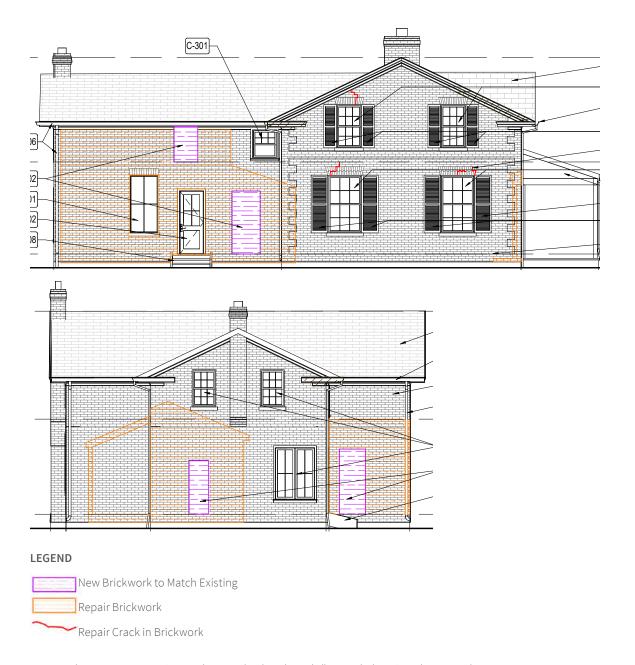
Proposed masonry restoration on the west (top) and south (bottom) elevations (ERA, 2019).
