**STRUCTURAL CONDITION ASSESSMENT FOR  
89 NASHVILLE ROAD, KLEINBERG, ONTARIO**

November, 2019  
Project ID: AS19-145

Re: 89 Nashville Road, Kleinberg, Ontario  
Structural Assessment  
Project ID: AS19-145

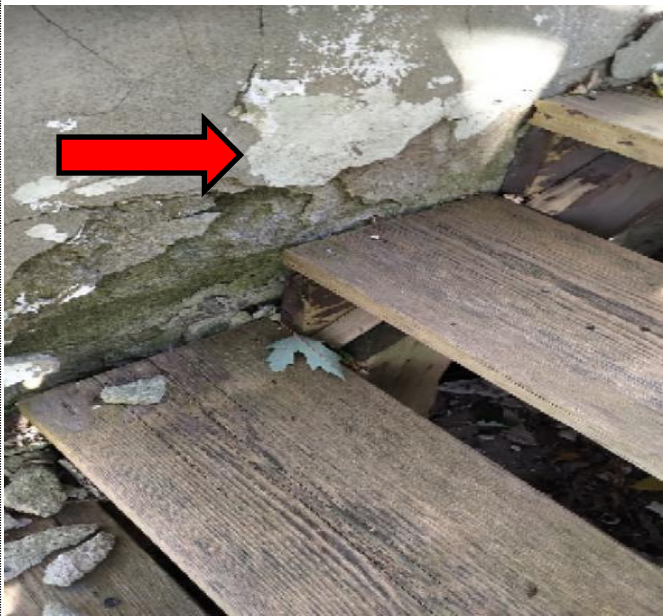
Evidence of spalling and concrete delamination concealing the original loose field stone foundations at the south west corner.

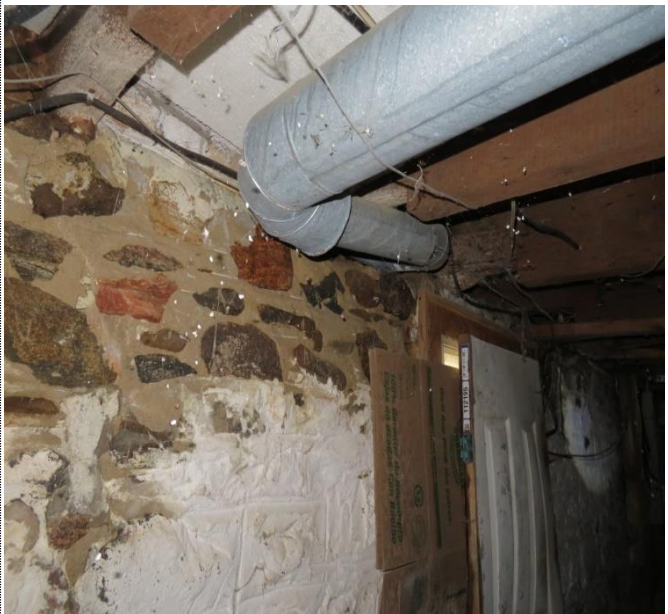
Extensive structural damage to the exposed original field stone. Several stones were found to be concealed and painted with cementitious repair materials, as shown.

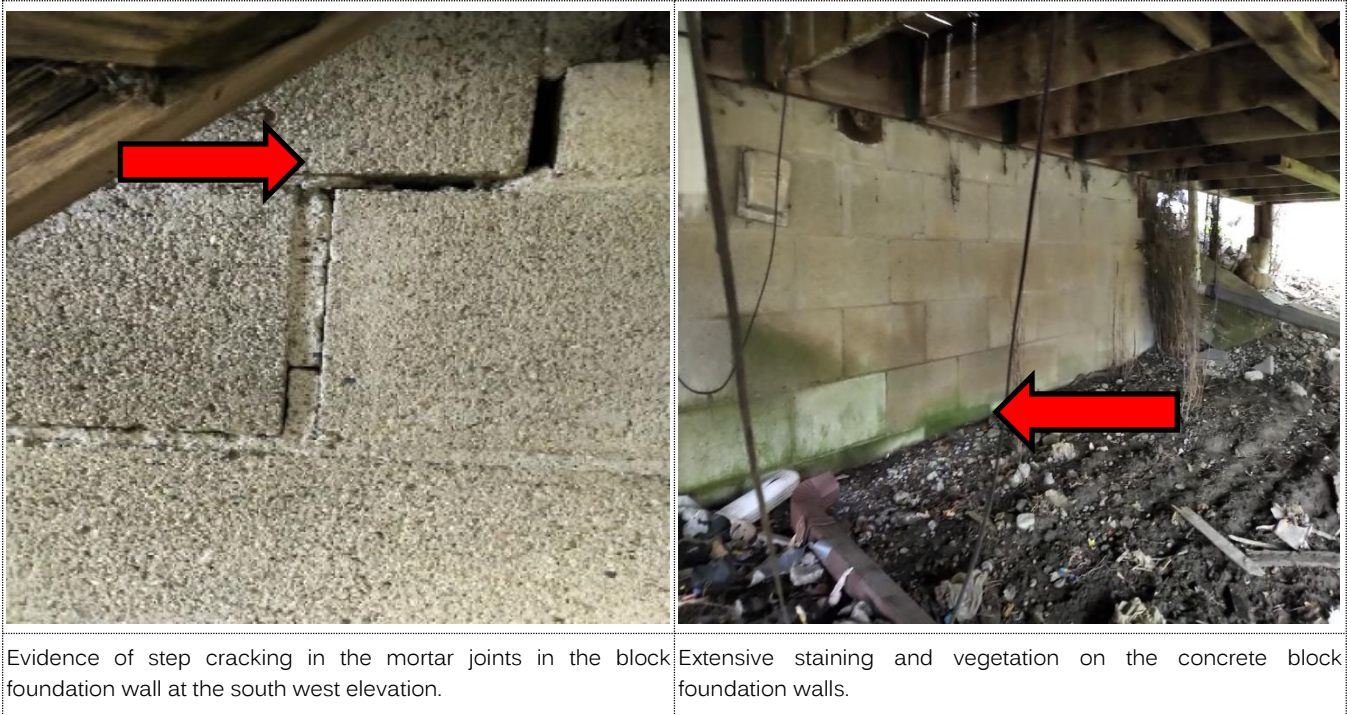
Evidence of step cracking in the mortar joints in the block foundation wall at the south west elevation. Extensive staining and vegetation on the concrete block foundation walls.

The block foundation walls were constructed years ago and form part of the pre 1970's addition. The block foundation walls at locations made accessible were visually reviewed. The south west corner of the addition was found to exhibit step cracking and heaving of the block. The cementitious repair materials at this location was found to be extensively delaminated and unsound. This location appears to be structurally unsound. The original fieldstone foundation walls forming the basement of the mid to late 1800's dwelling unit appear to be structurally unsound and have been repaired over the years with cementitious repair materials and masonry brick. It was also observed that the basement flooded commonly during raining periods. The external field stone walls are generally bowing outwards. The stonework is suffering from erosion of the mortar joints close to defective gutters or flashings. The stonework has been pointed with cement mortar, and this has resulted in water becoming entrapped in the stone and subsequent frost damage. There is evidence of laterally and differential movement in the foundation walls indicating that this is creating unsafe condition structurally.

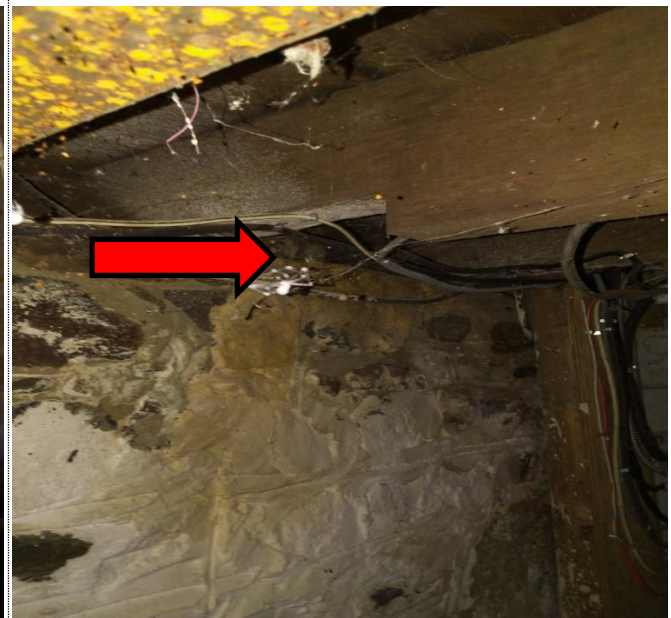
Several framing members are deteriorated and have been notched out, split and have also warped. Alterations can weaken members. This type of modification can severely weaken the joists.

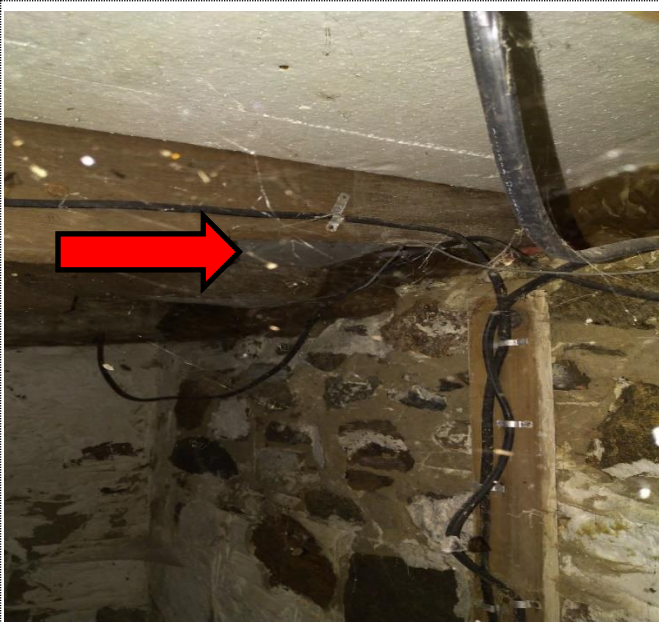
Heavy timber framing is split and rotting in several locations. The staining or discoloration of the wood members indicates that it has been subjected to water and potentially has a high moisture content suitable to support decay.

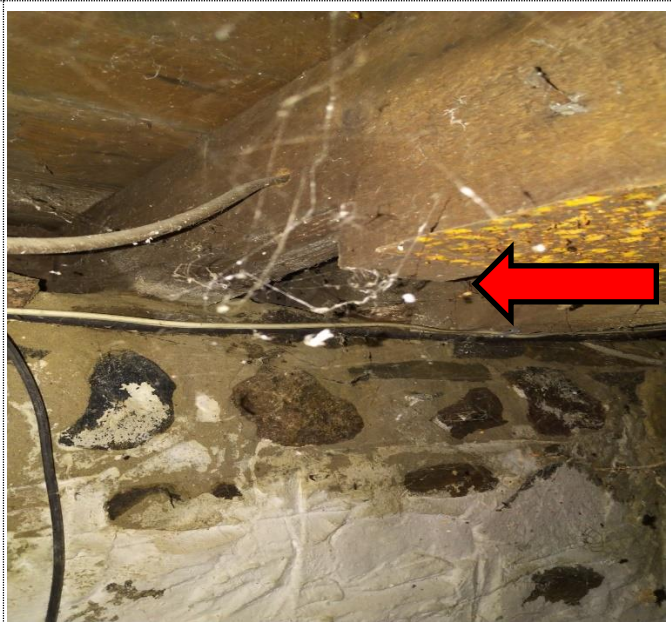
Several framing members have been notched out and have split and have also warped.

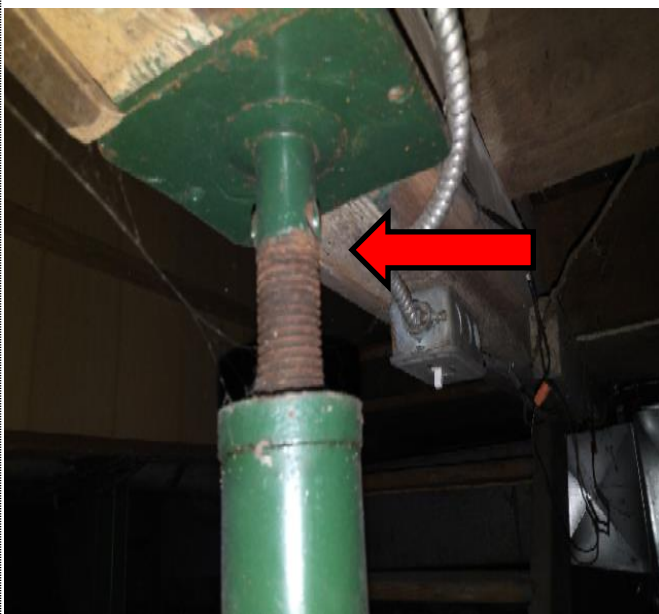
Temporary post shores and 6x6 timber have been placed to support the timber floor framing and summer beams.

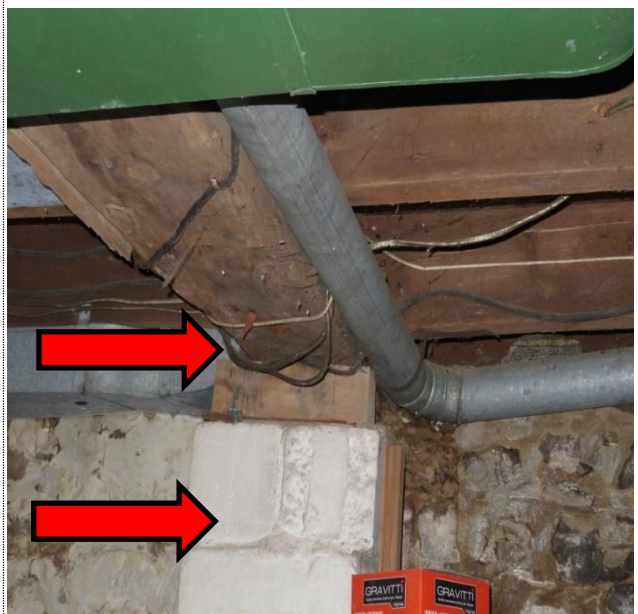
Concrete pilasters have been installed with 4x4 wood blocks to support the heavy timber summer beam. The concrete block pilaster appears to have moved with the slab on grade. The summer beam was found to be degraded and rot in several areas.

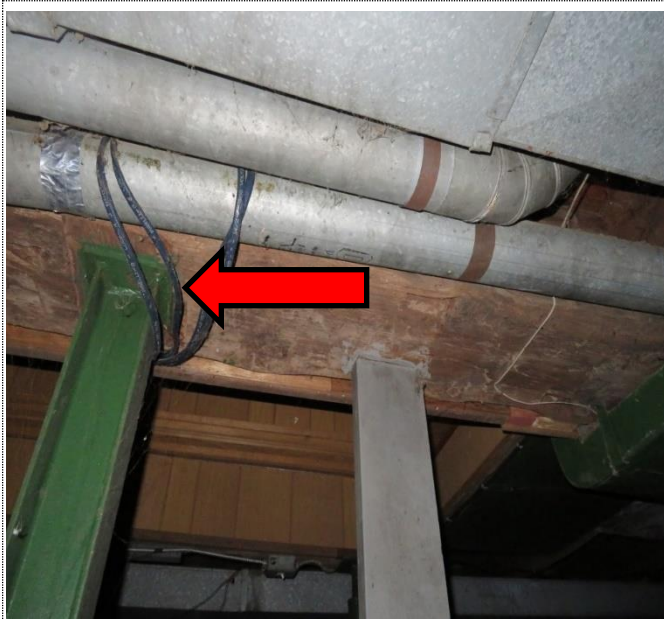
Undersized steel columns placed on the slab on grade below the summer beam. It appears that no footings were created for the steel columns. It appears that the slab on grade is heaving creating an upward punching shear force through the timber wood summer beam.

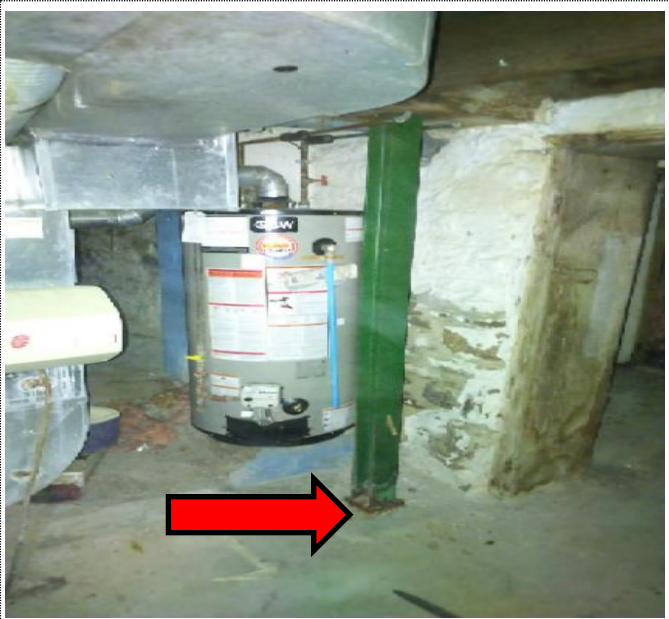
There is extensive corrosion on the base plates forming the steel columns supporting the summer beam.

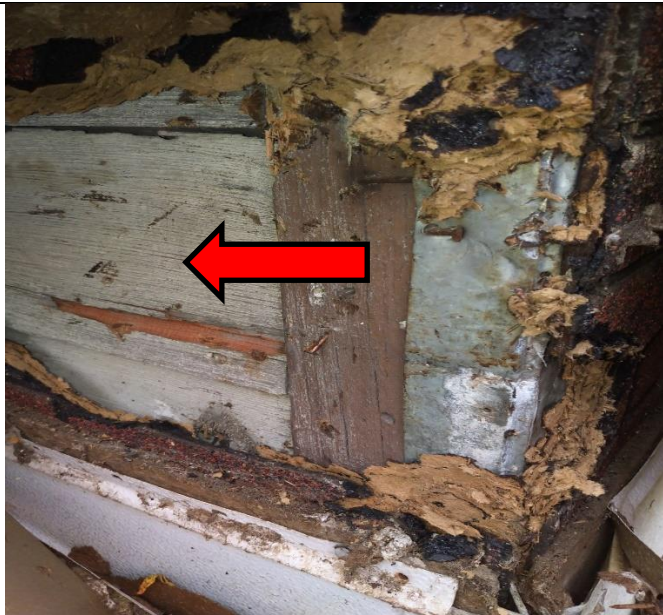
The exterior framing and simple wide plank boards that have been locally replaced are currently degraded and show evidence of wood rot. These framing members are concealed with insulbrick and metal siding.

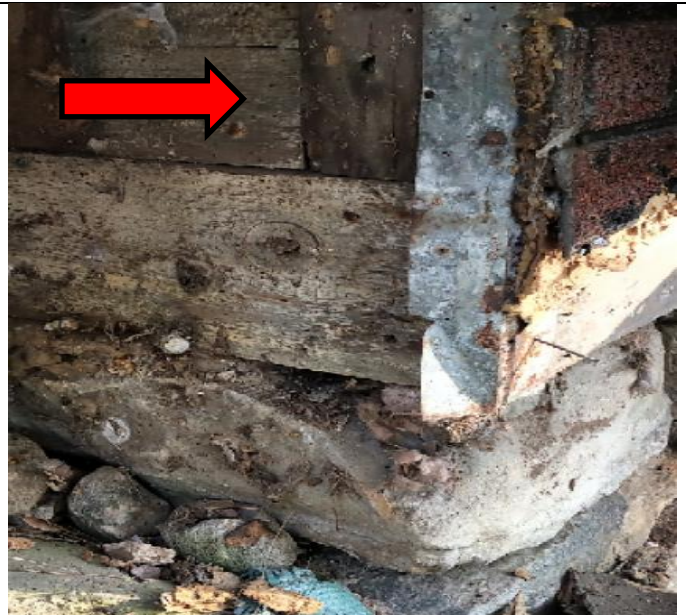
The exterior framing and simple wide plank boards that have been locally replaced are currently locally exposed to the elements, however it appears that it was concealed with insulbrick and metal siding.

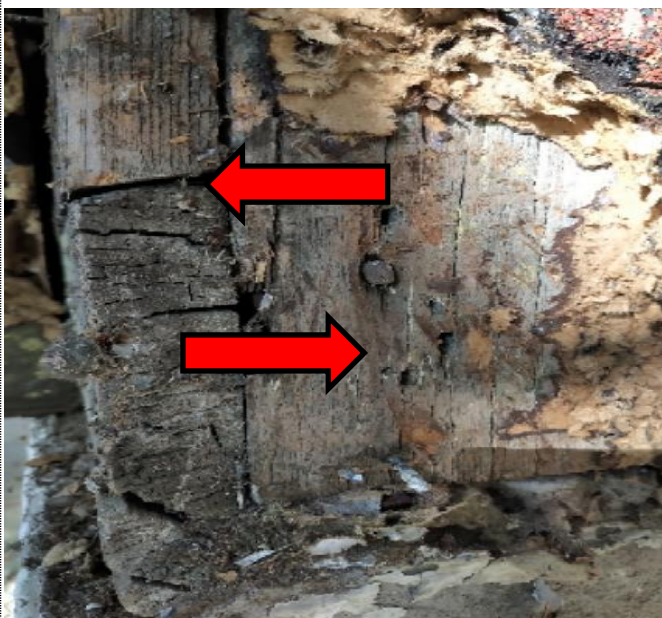
The South West section was exposed and reviewed. The exterior framing and simple wide plank boards that have been locally replaced. Several boards and framing members were found to exhibit extensive wood rot.

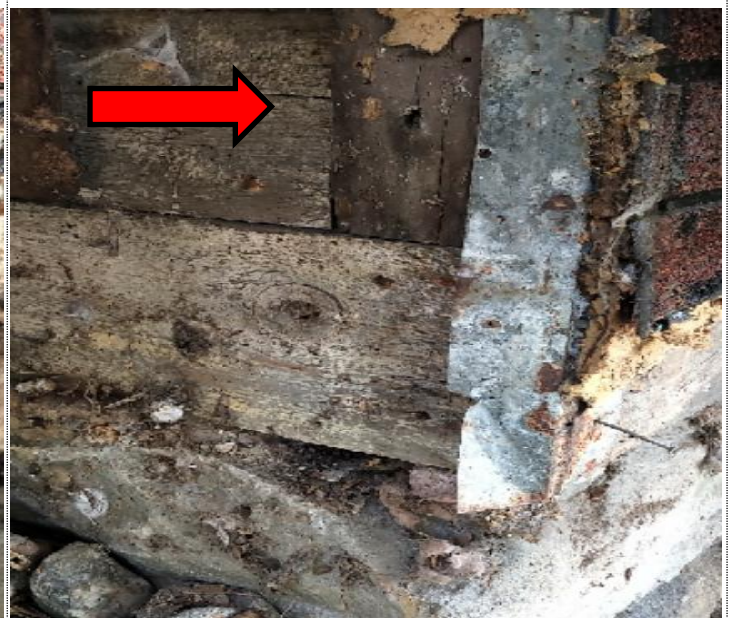
The North East section was exposed and reviewed. The exterior framing and simple wide plank boards that have been locally replaced. Several boards and framing members were found to split and exhibit extensive wood rot.

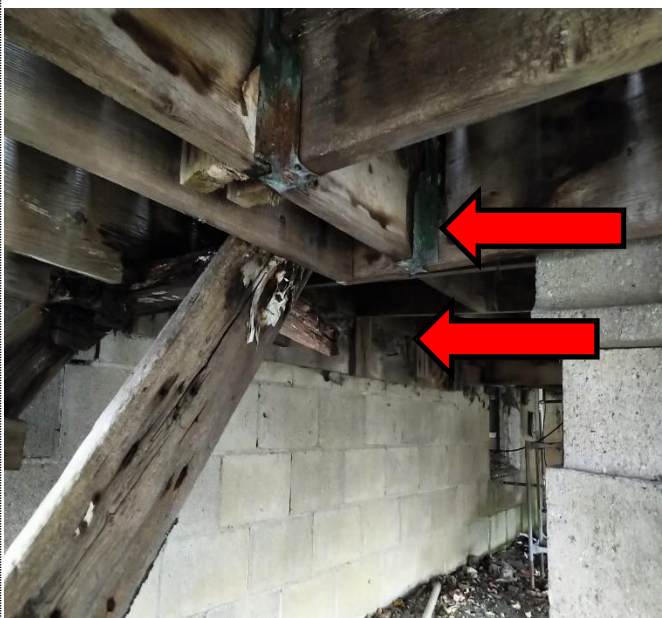
There is evidence of wood rot and wood decay on several joists supporting the rear addition.

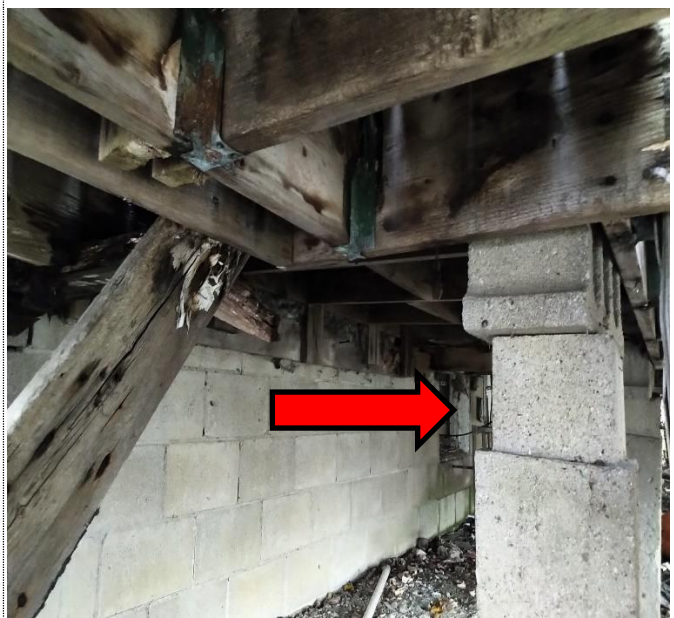
The concrete blocks are temporary supports for the rear addition. The rear addition has settled and is structurally unsafe and in an unsound condition.

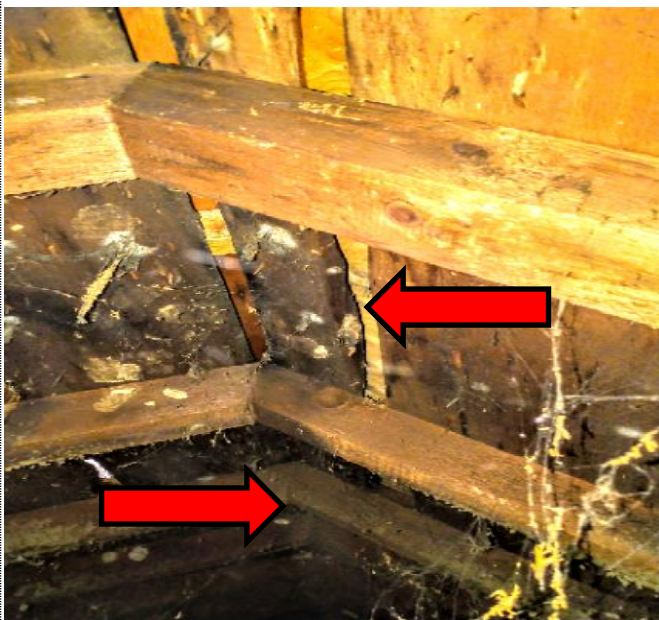
The peak of the roof assembly was found to be moist and damp with extensive mold growth.

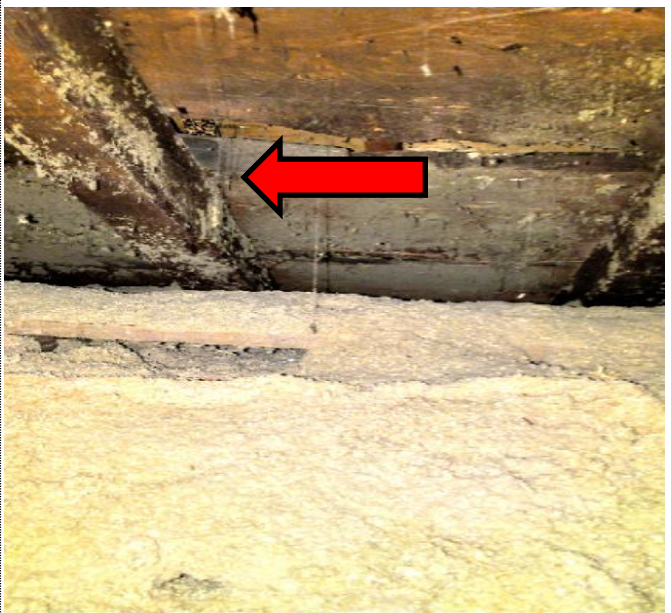
Several timber roof members were found to be split, and warped at several areas made accessible.

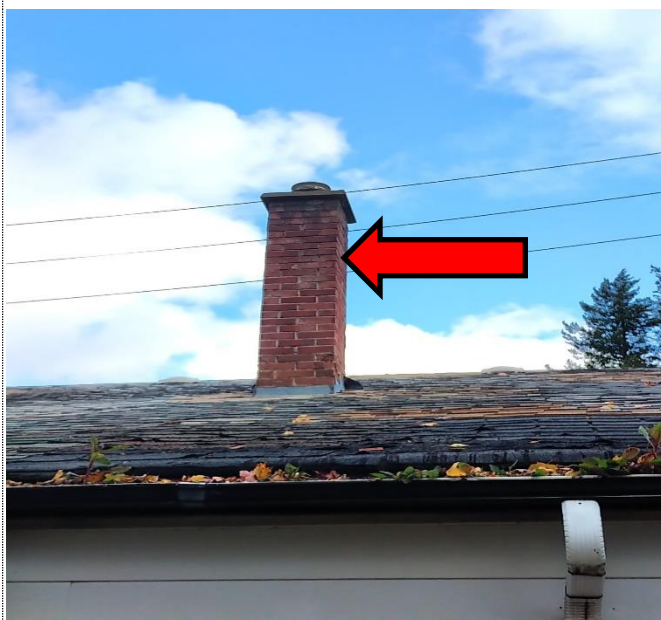
There are several spalled and deteriorated bricks including loose mortar joints. The precast coping stone above the bricks was also found to be delaminated and cracked.

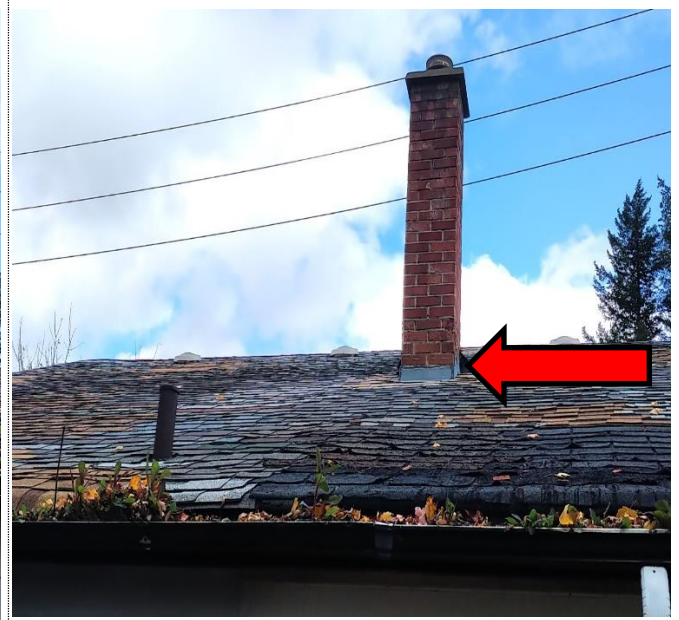
The metal flashing appears to have been installed incorrectly. The lower portion of the chimney also shows evidence of brick spalls and loose mortar joints
