**STRUCTURAL CONDITION ASSESSMENT FOR
99 NASHVILLE ROAD, KLEINBERG, ONTARIO**

Prepared for
STATEVIEW HOMES

November, 2019
Project ID: AS19-146

Re: 99 Nashville Road, Kleinberg, Ontario
Structural Assessment
Project ID: AS19-146

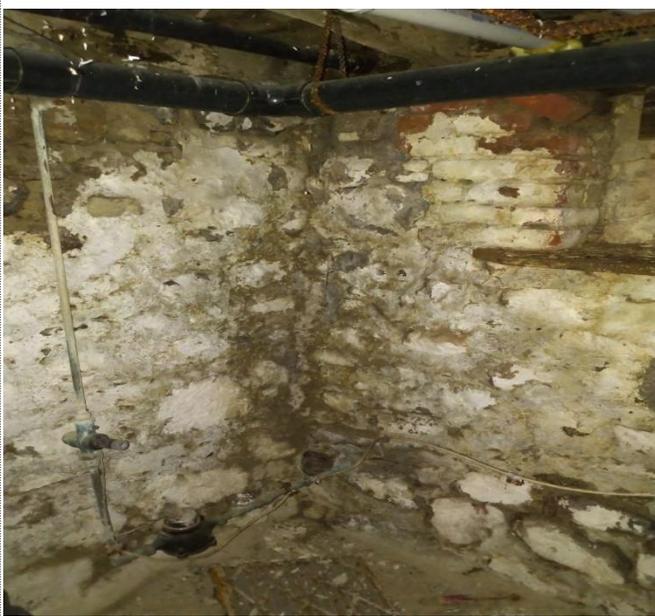
There is extensive water damage and deterioration to the field stone forming the perimeter foundation walls at several locations.

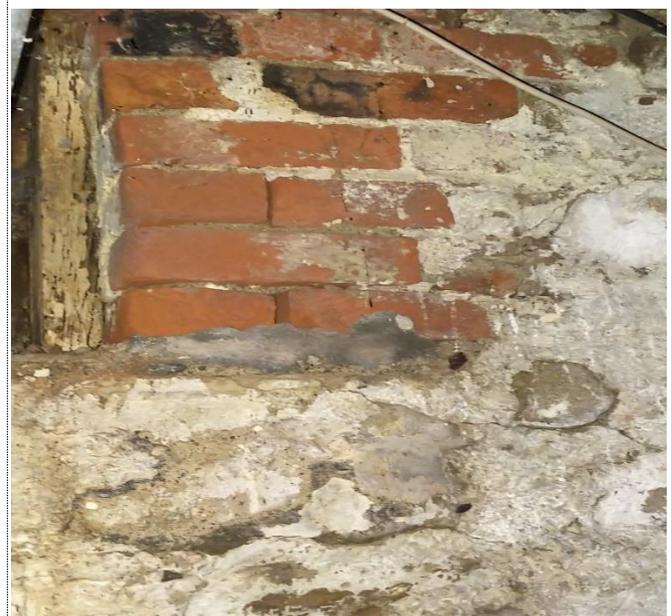
Several areas of deteriorated field stone have been replaced with masonry brick and cementitious repair materials.

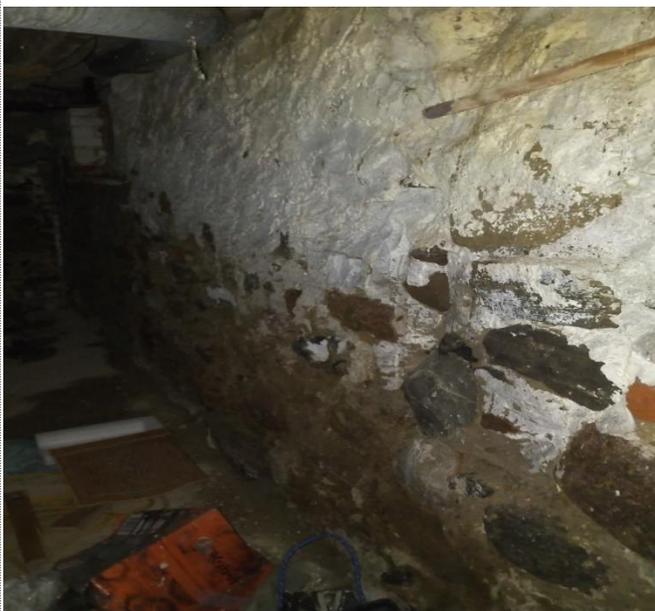
The field stone foundation walls concealed with cementitious repair materials is bowing outwards.

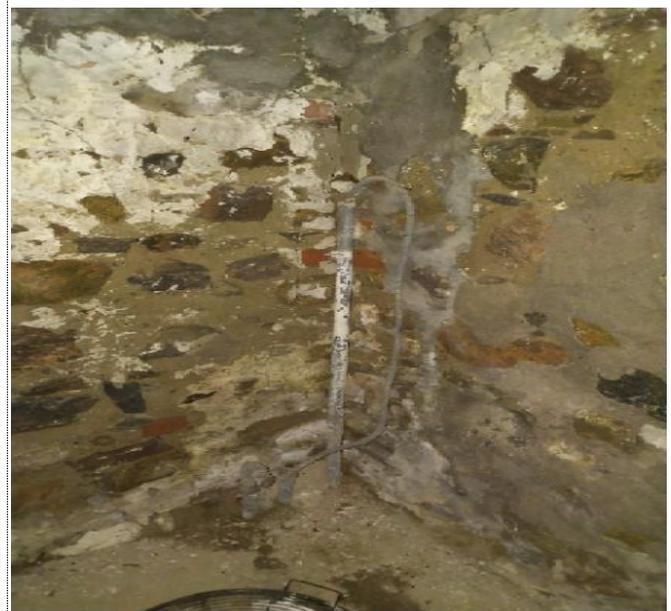
Numerous loose field stone have been concealed with cementitious materials.

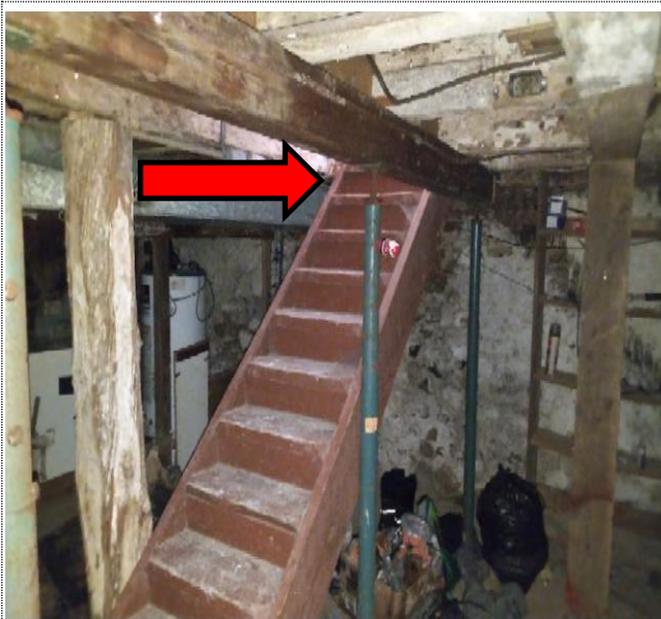
Temporary post shores and 6x6 timber have been placed to support the timber floor framing and summer beams.

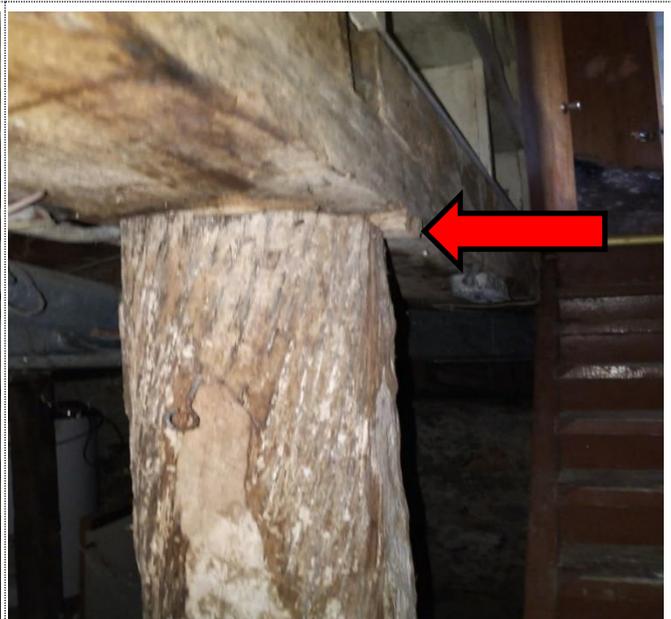
Evidence of water staining and moisture damage to the original summer beam and timber column. There are wood shims in place below the beam and column, as shown in the photograph.

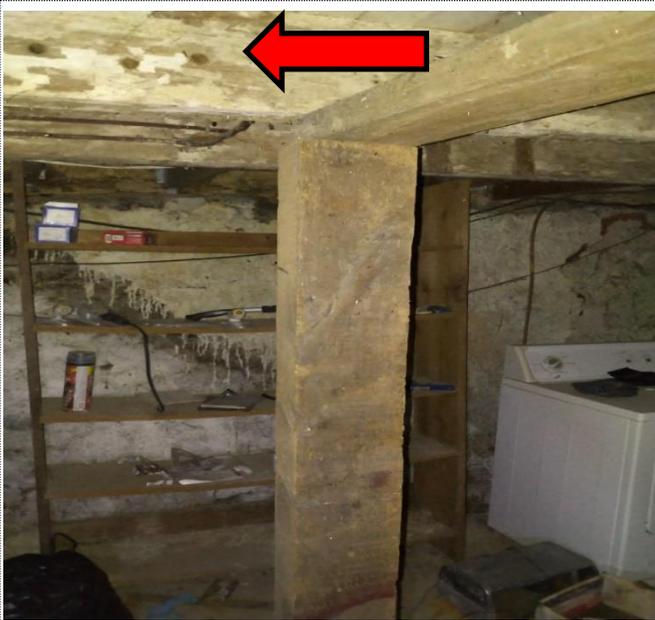
Staining or discoloration of wood indicates that it has been subjected to water and potentially has a high moisture content suitable to support decay.

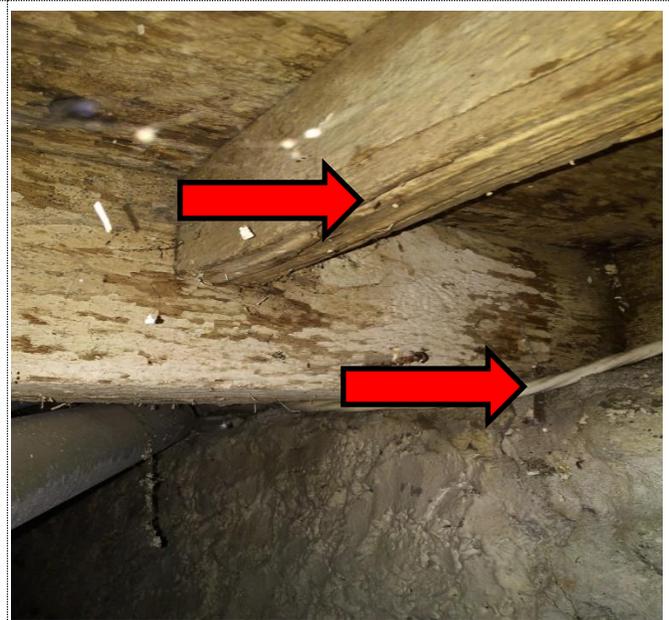
Several framing members are deteriorated and have been notched out, split and have also warped. Alterations can weaken members. This type of modification can severely weaken the joists.

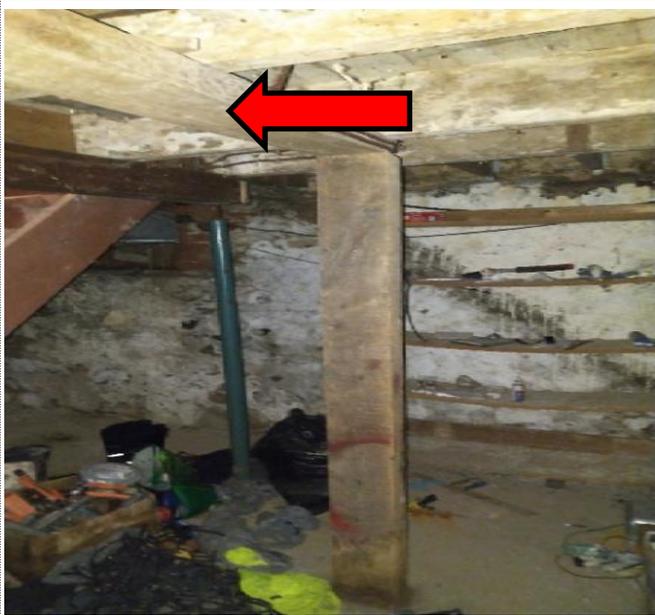
Undersized support framing that is deteriorated and deflecting at mid span. The built-up wood beams down the centre of the building show significant sag, likely due to long-term creep wood under the load of the multiple floor finishes. The beams also exhibit ineffective load-sharing between the inner plies and outer ledgers.

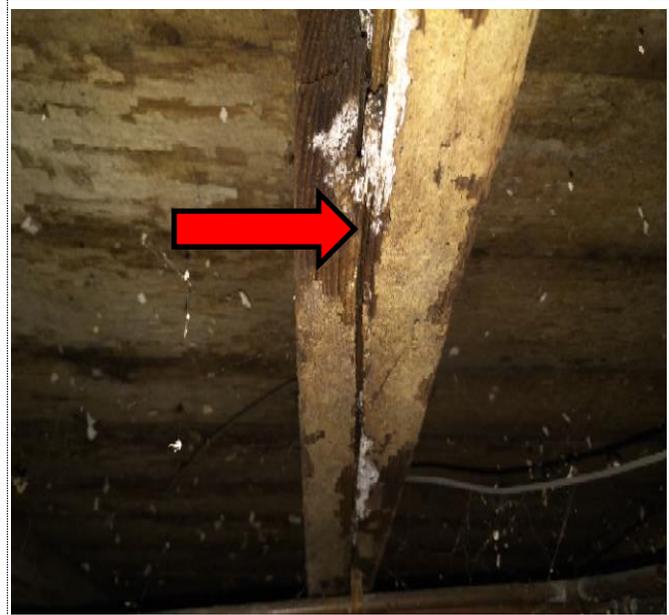
Heavy timber framing is split and rotting in several locations. The staining or discoloration of the wood members indicates that it has been subjected to water and potentially has a high moisture content suitable to support decay.

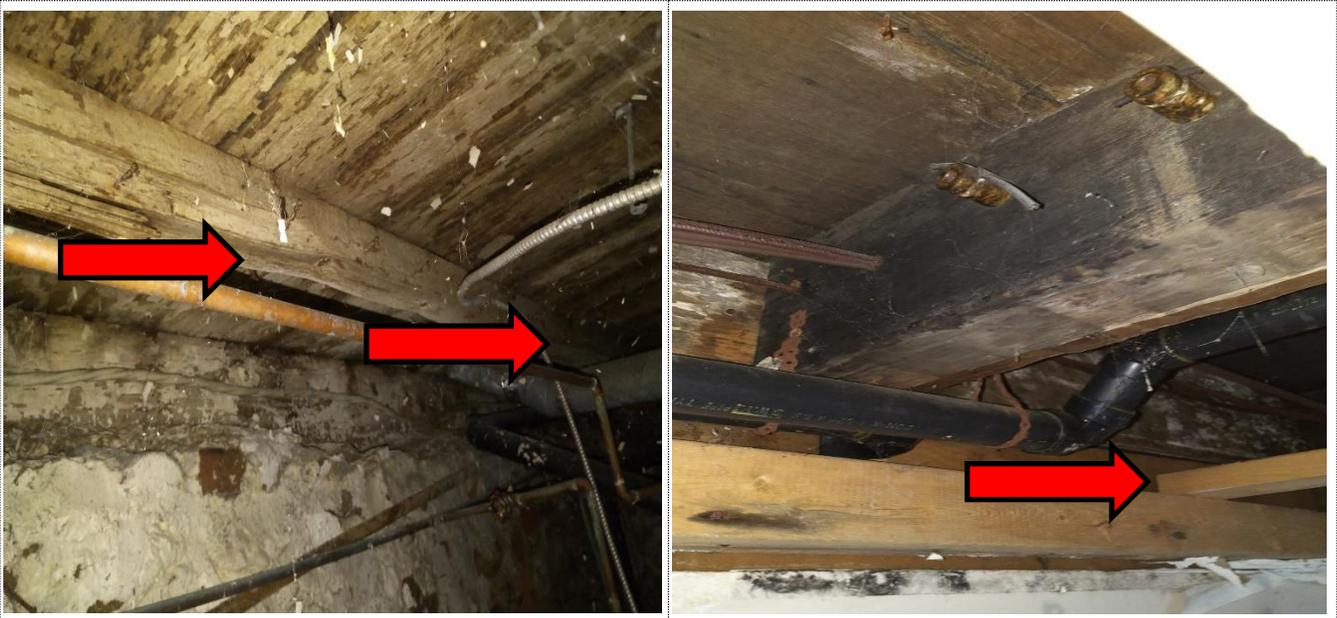
Extensive cross-sectional loss through several timber framing and mold spores were identified. There is also knob and tub wiring through the old timber members.

Several additional support joists and lightwood bracing have been placed in order to support some of the old deteriorated timber,

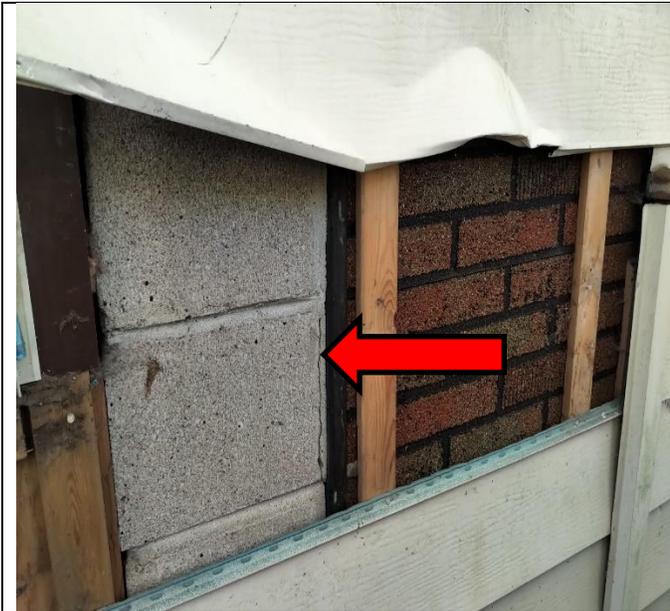
The transition between new addition and old structure. Original timber framing and simple plank boards have been locally replaced and have been concealed with insulbrick and metal siding.

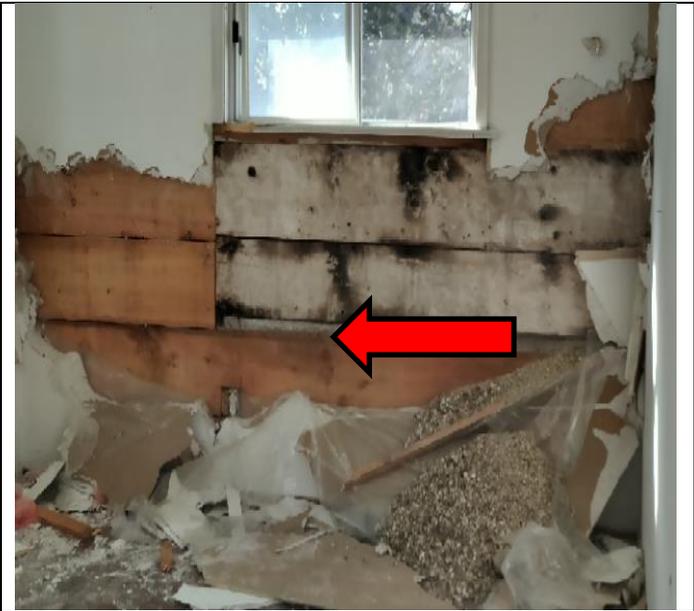
Several simple plank boards and framing have been locally replaced, as shown in the above photograph.

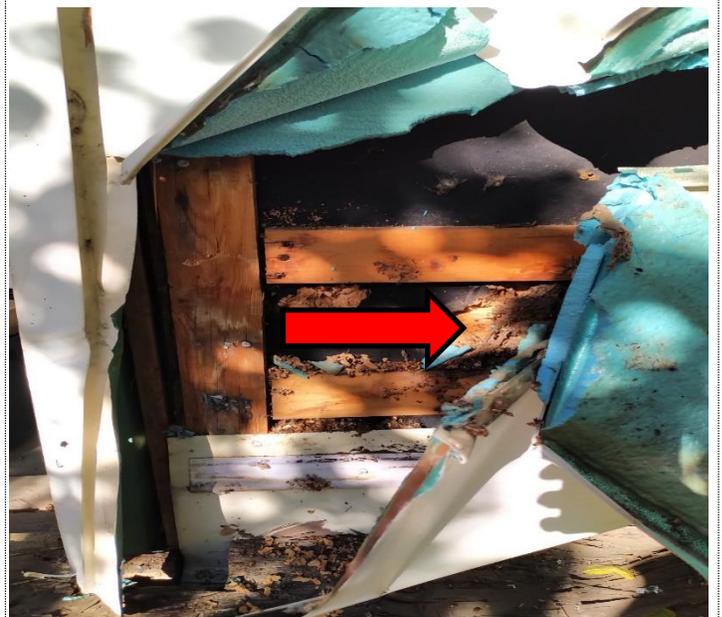
The metal siding and insulbrick was removed locally and revealed that several timber framing and simple plank boards have been altered or locally removed and replaced.

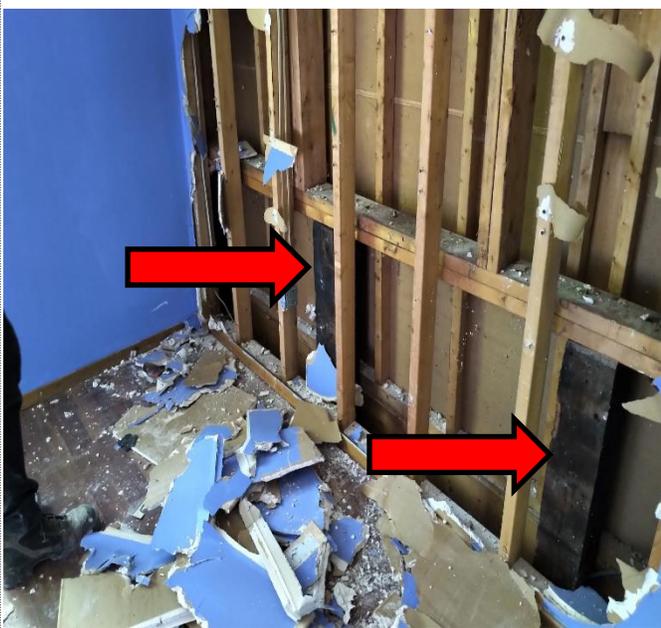
Double wall system forming the newer addition forming the e east elevation. Note, the original timber framing that was found to be extensively charred.

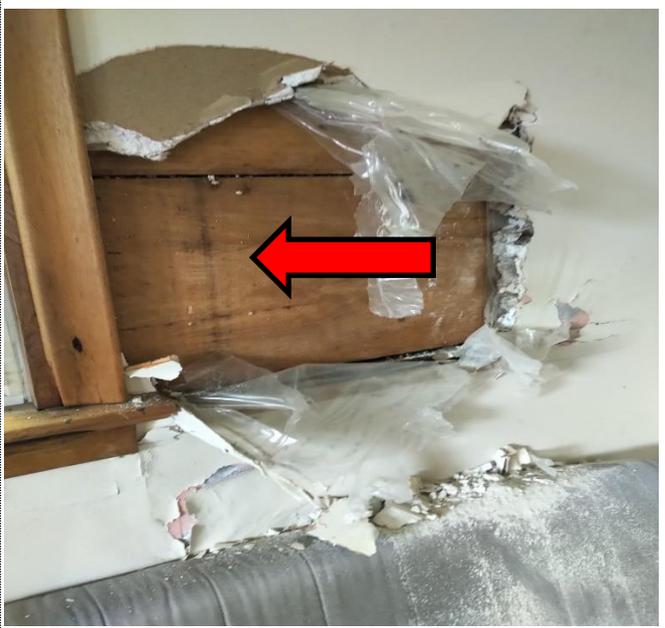
Locally replaced simple plank board forming the exterior walls along the north and west elevations.

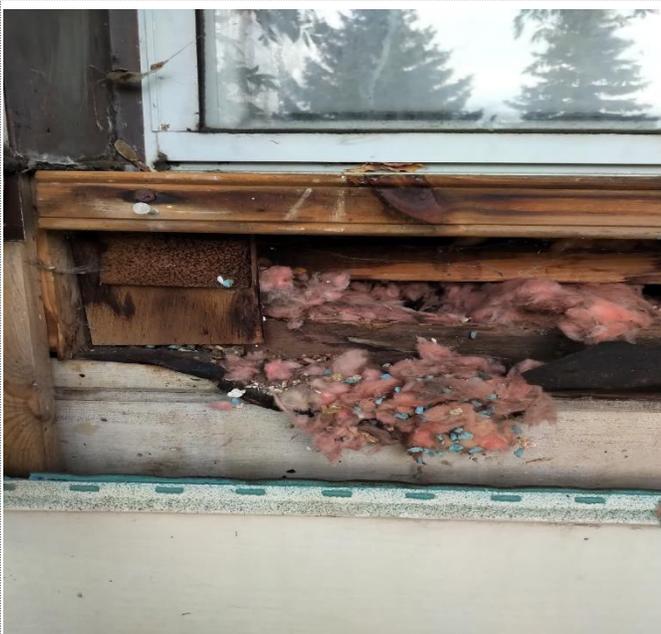
The original sills were removed and replaced. There is water damage and extensive mold growth to the newer lumber and batt insulation. The batt insulation was found to be wet.

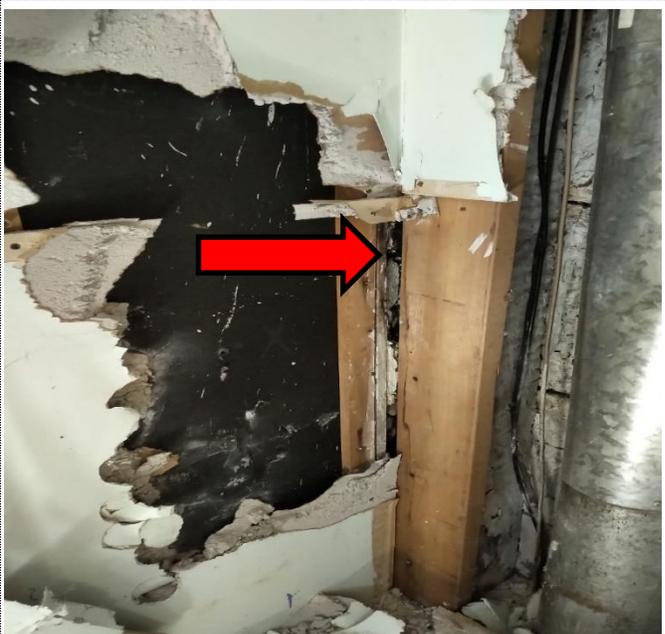
Several alterations have been made to the interior corner connection.

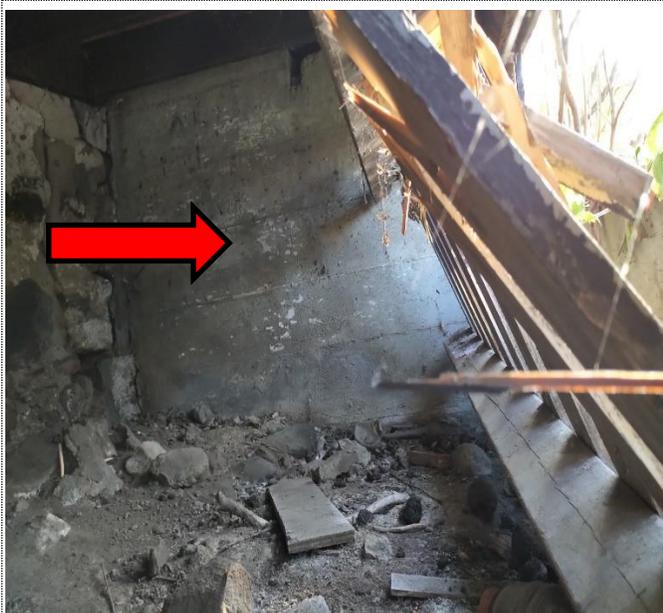
Porch decking supported on cast in place concrete knee wall. Portion of the field stone supporting the porch decking is loose and deteriorated.

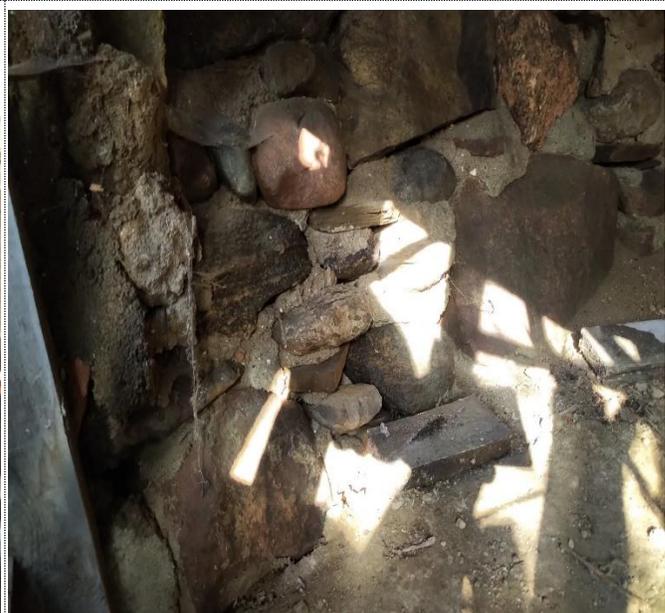
Exterior wood porch supported by loose and deteriorated field stone foundations.

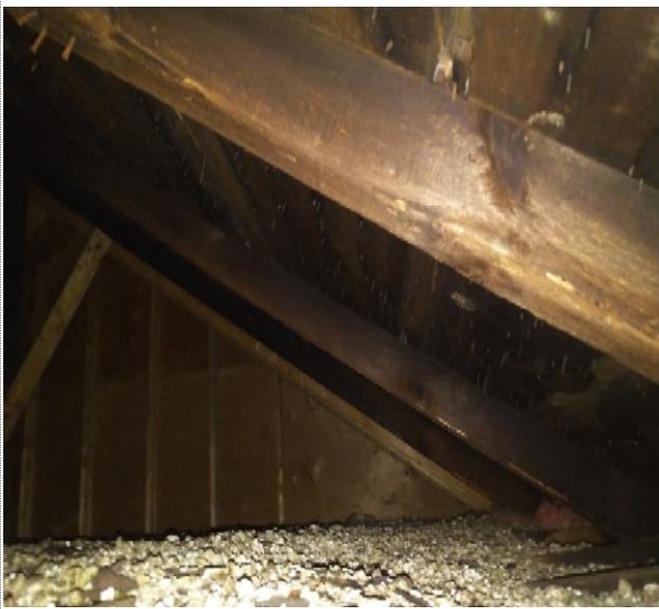
Original timber rafters appear to be stained with soot. Several structural wood trusses that had its webs removed by previous homeowners may have had the intent of creating living space in the attic.

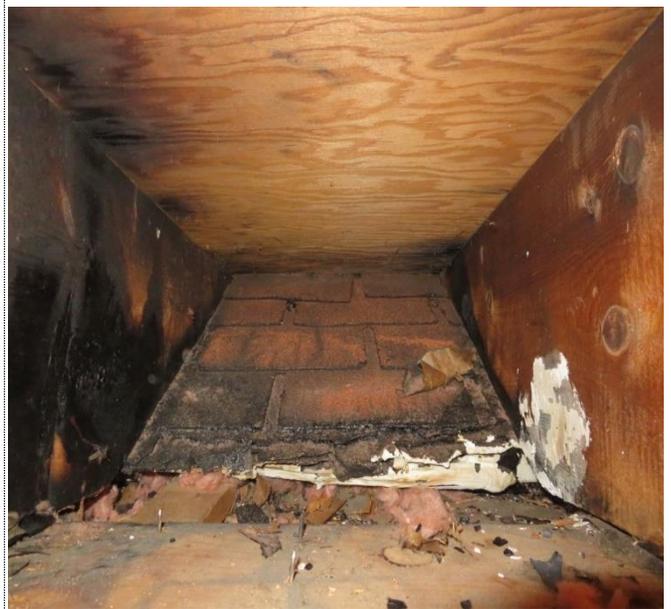
Transition between new and original structure. There appears to be soot stains on the new addition and roofing shingles that appear to have fire damage.

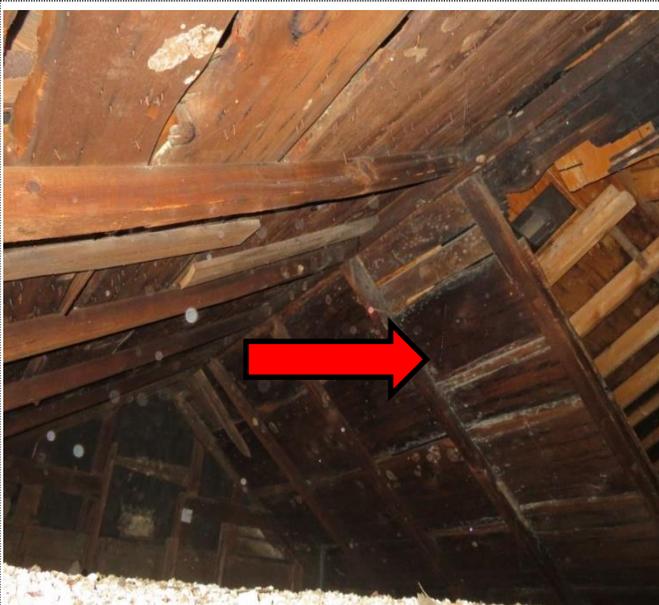
Original timber rafters and simple plank board that have extensive water damage and mold. Several plank boards were covered in soot. As a consequence of the moisture exposure, wood members in the roof also contained areas of deterioration

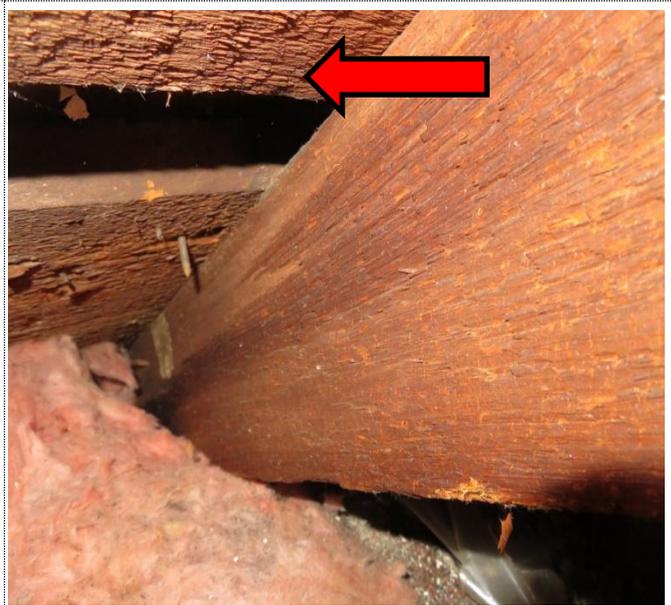
Several plank boards were found to exhibit extensive wood rot.

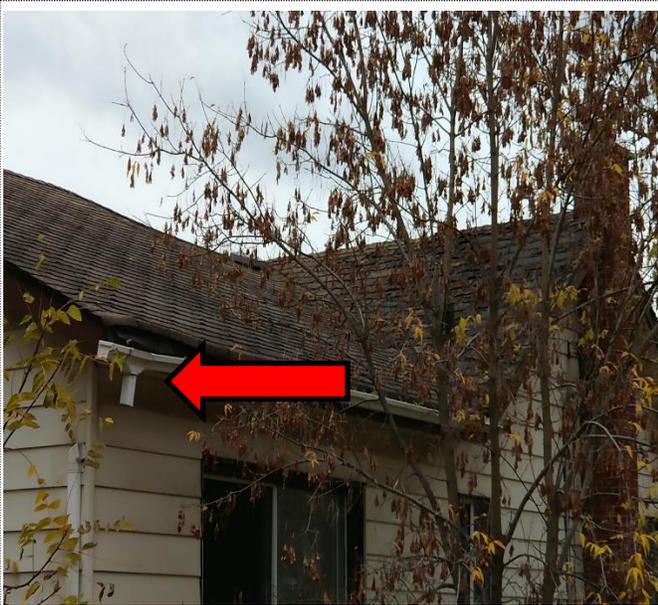
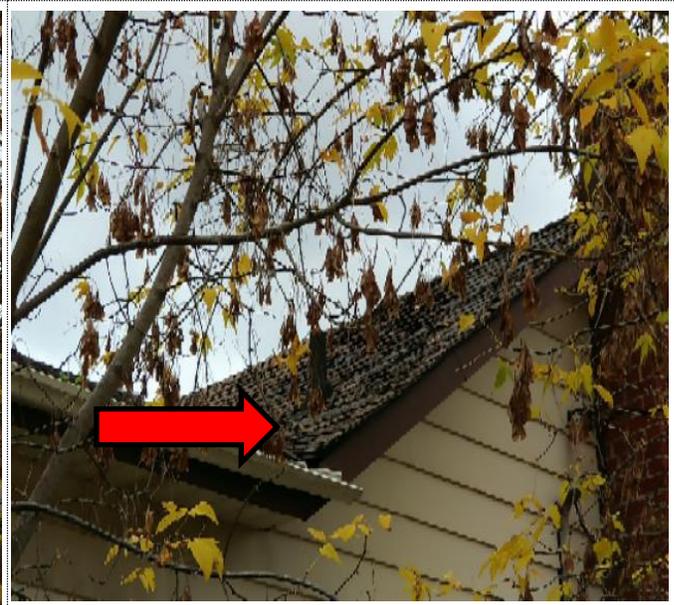
The roof has been re-covered relatively recently, and provided with new rafters and felt. The shingles and plywood sheathing concealing the roof appears to be in effective in several areas. The metal troughs and downspouts are disconnected and damaged in several areas.

The original timber trusses have been locally removed and replaced. Signs of serious wet-rot decay were noted in the timber. There are numerous dips in the roof line. Several areas of shingles have curled and deteriorated.

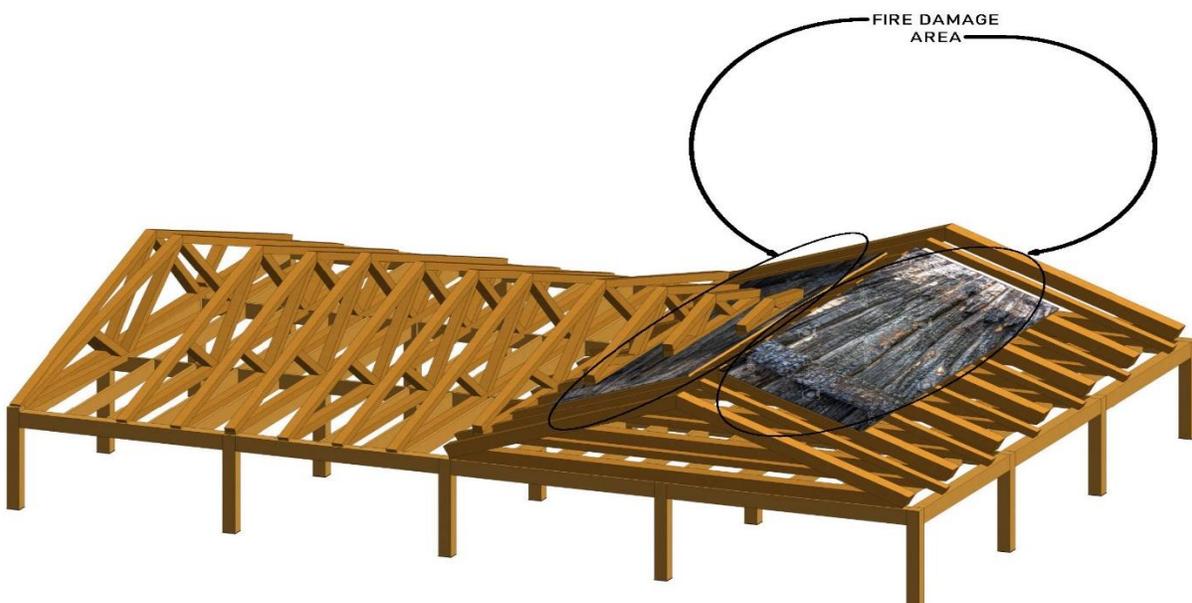
Detail Identifying Extent of Fire Damage to the Roof Assembly

The wood members that have been damaged from fire appear to be significantly charred. The char layer could be scrapped off however, any charred portion of fire exposed wood member has no residual load capacity. The wood beneath the char layer may have some residual load capacity, but this residual capacity will be less than the load capacity prior to the fire.

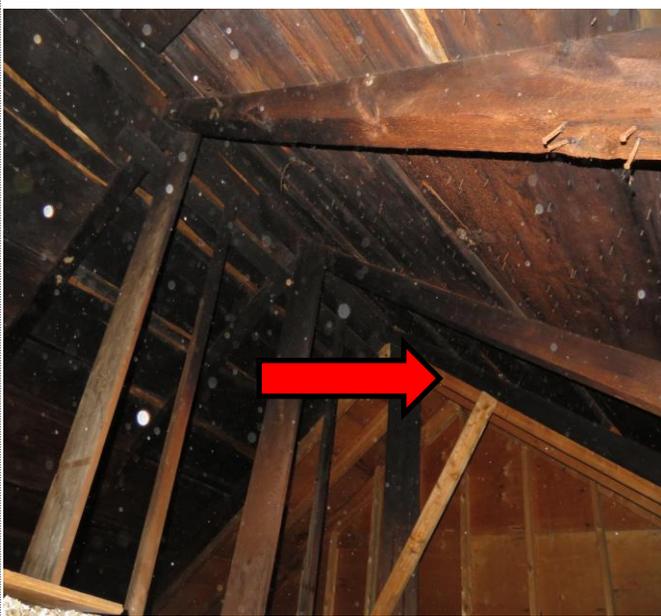
Several wood timber framing and light wood framing have been damaged with fire.

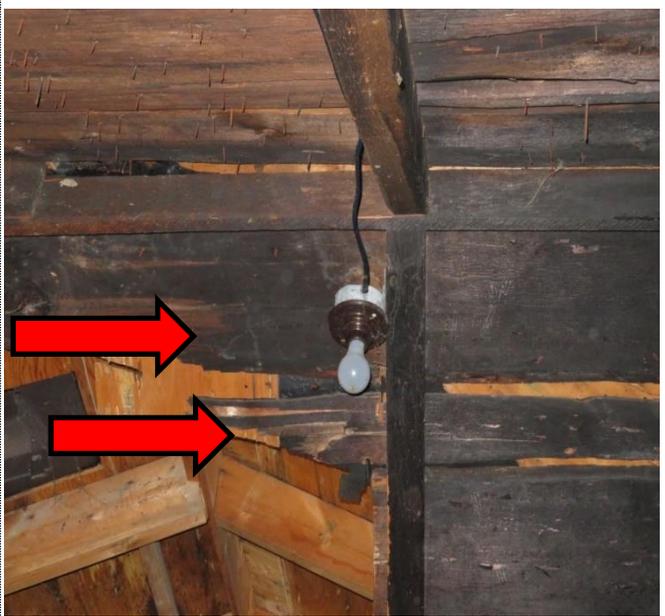
There is extensive fire damage to the original timber rafters and simple plank boards. It appears that there is visible shrinkage to the timber framing.

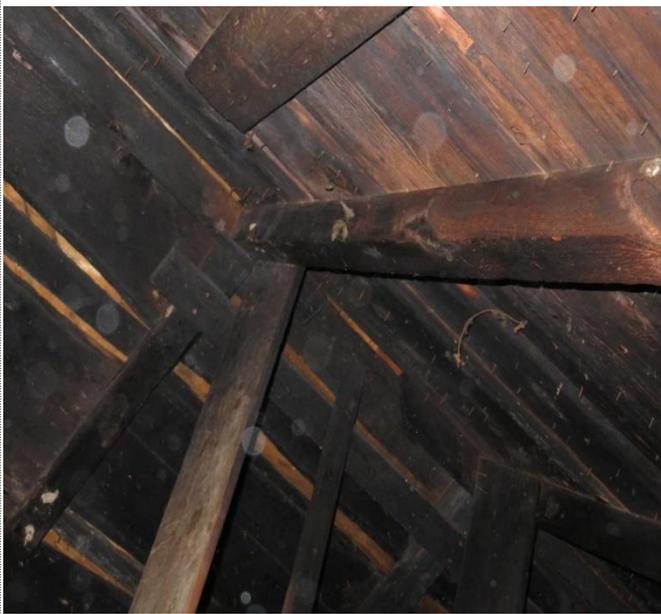
There is extensive fire damage to the original timber rafters and simple plank boards.

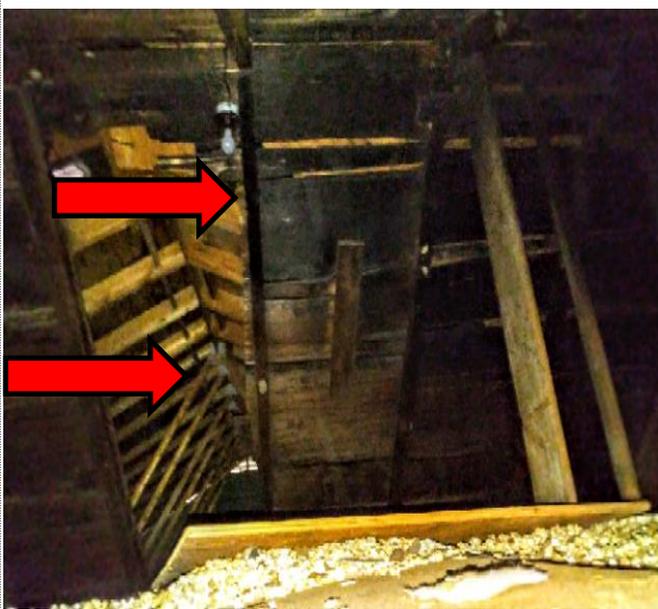
Several wood timber framing and light wood framing have been damaged with fire. It appears that there is visible shrinkage to the timber framing.

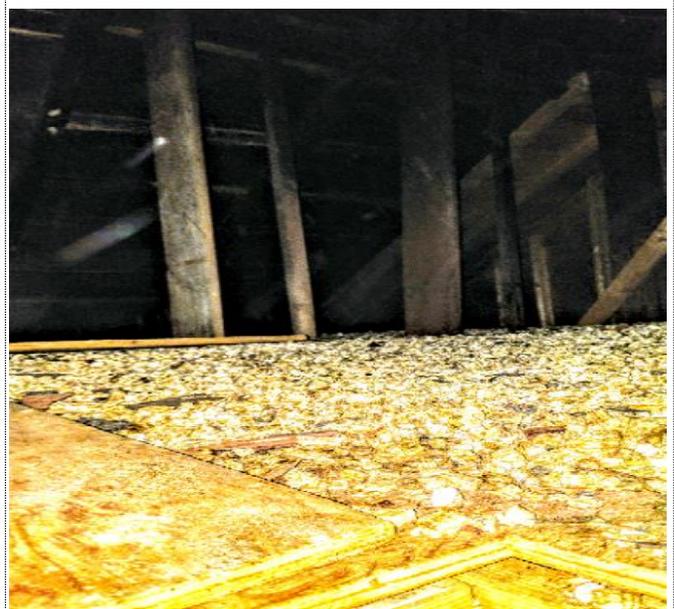
Several wood timber framing and light wood framing have been damaged with fire.

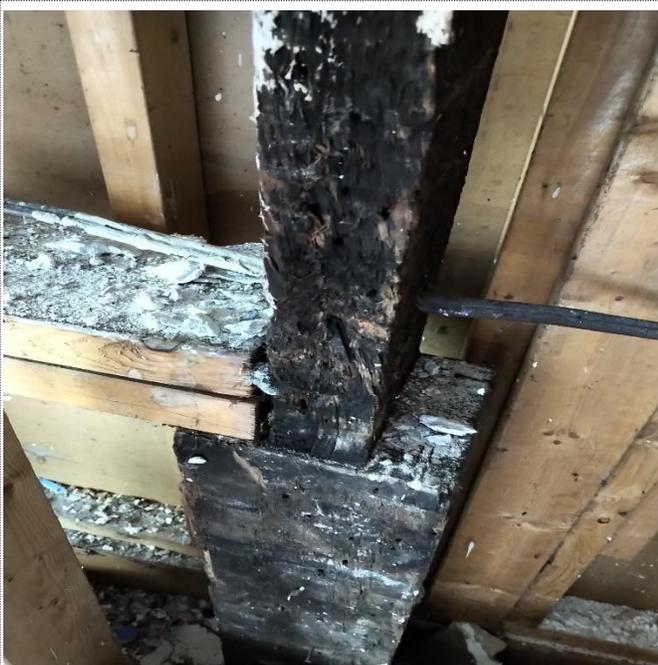
Extensive fire damage and wood rot to the original exterior wall framing that was partial removed.

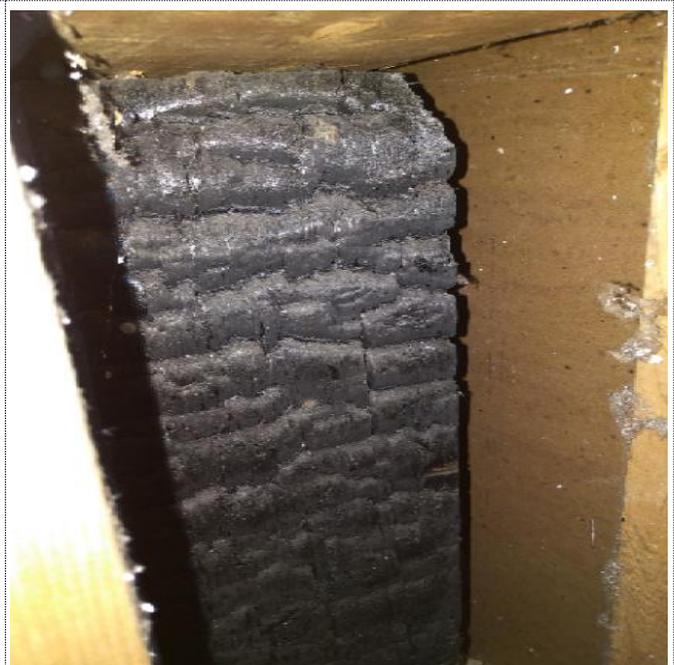
Extensive fire damage to the original exterior wall framing that was partial removed.

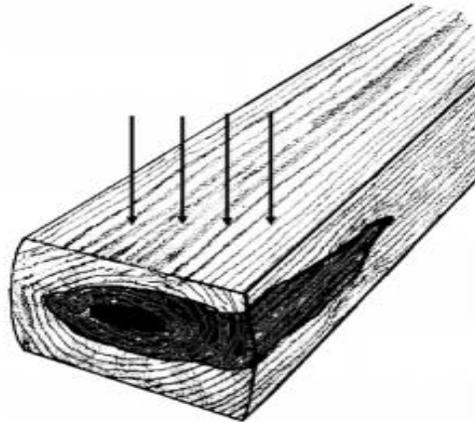
Because of interior deterioration the outer shell can collapse when the timber is stressed in bearing.
