19. DEMOLITION OF EXISTING BUILDING AND CONSTRUCTION OF IDENTICAL REPLICA BUILDING AT 89 NASHVILLE ROAD, KLEINBURG-NASHVILLE HERITAGE CONSERVATION DISTRICT

**STRUCTURAL CONDITION ASSESSMENT FOR
89 NASHVILLE ROAD, KLEINBERG, ONTARIO**

November, 2019
Project ID: AS19-145

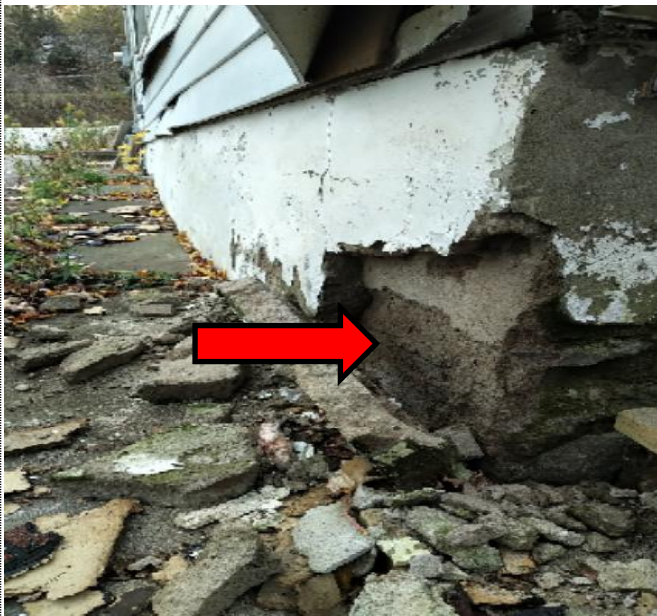
Evidence of extensive concrete deterioration and spalling concrete concealing the original loose field stone foundations. Portions of the foundation walls appear to be bowing outwards.

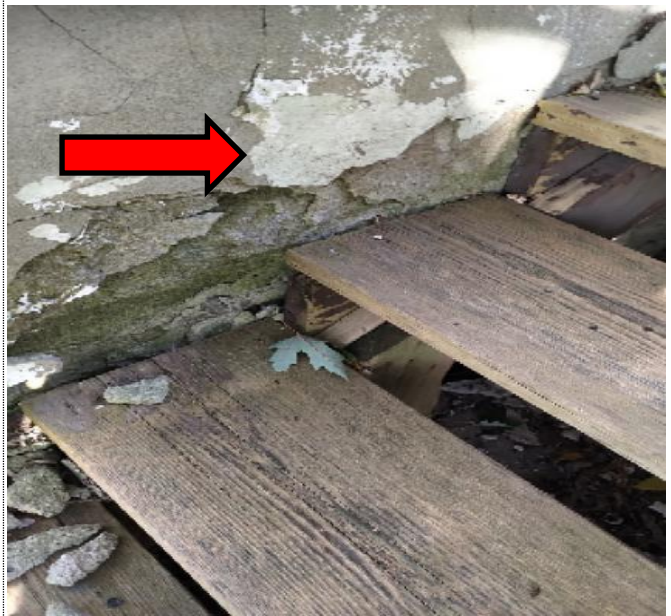
Evidence of spalling and concrete delamination concealing the original loose field stone foundations at the south west corner.

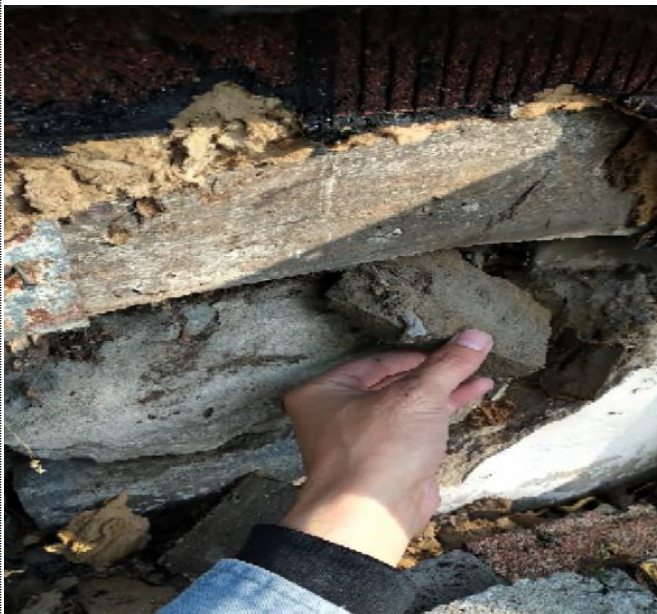
Extensive structural damage to the exposed original field stone. Several stones were found to be loose, as shown.

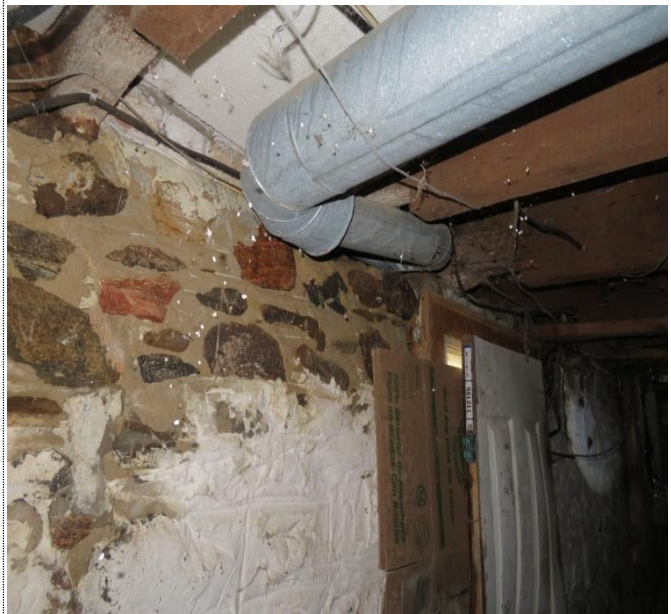
Extensive structural damage to the exposed original field stone. Several stones were found to be concealed and painted with cementitious repair materials, as shown.

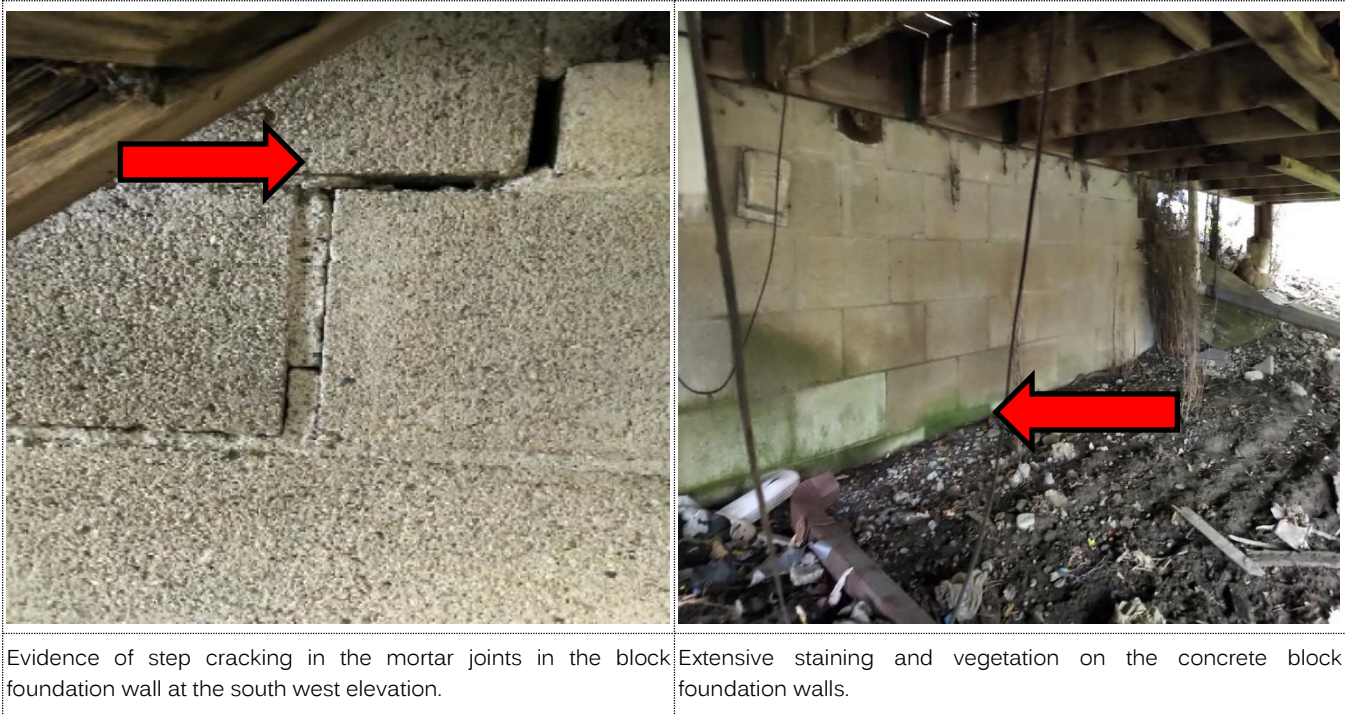
Evidence of step cracking in the mortar joints in the block foundation wall at the south west elevation.

Extensive staining and vegetation on the concrete block foundation walls.

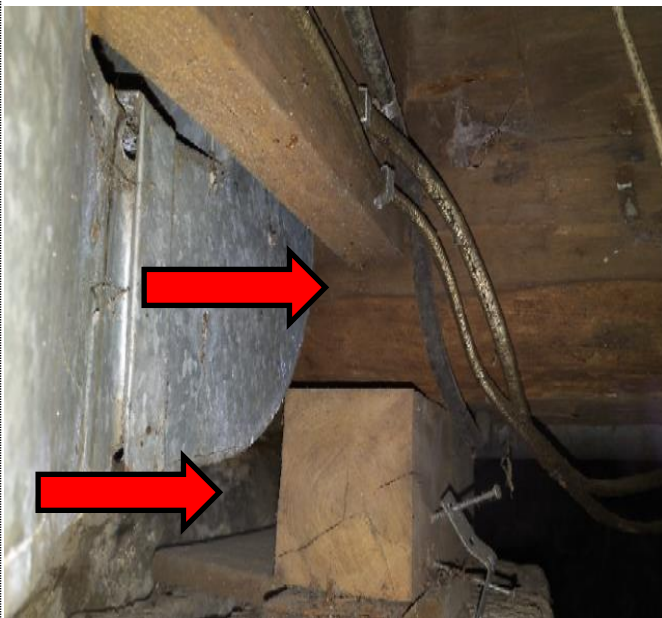
Several framing members were found to be split and degraded and were supported on structurally unsound concrete block pilasters with 4x4 blocks.

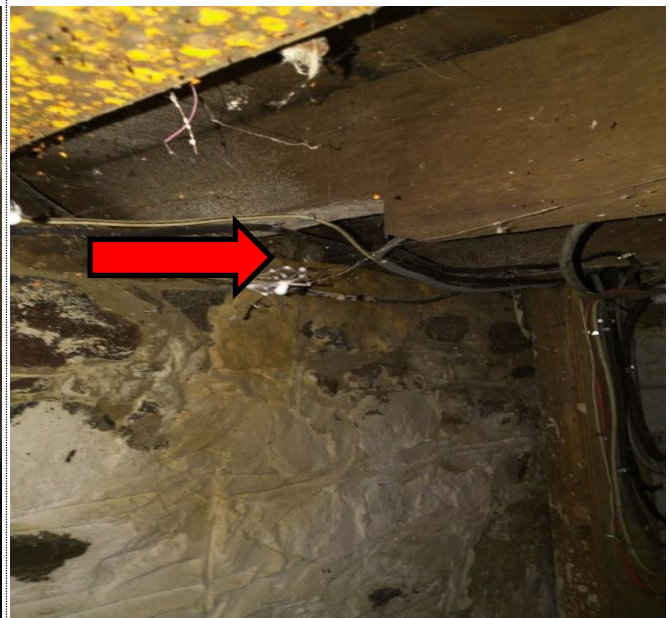
Several framing members are deteriorated and have been notched out, split and have also warped. Alterations can weaken members. This type of modification can severely weaken the joists.

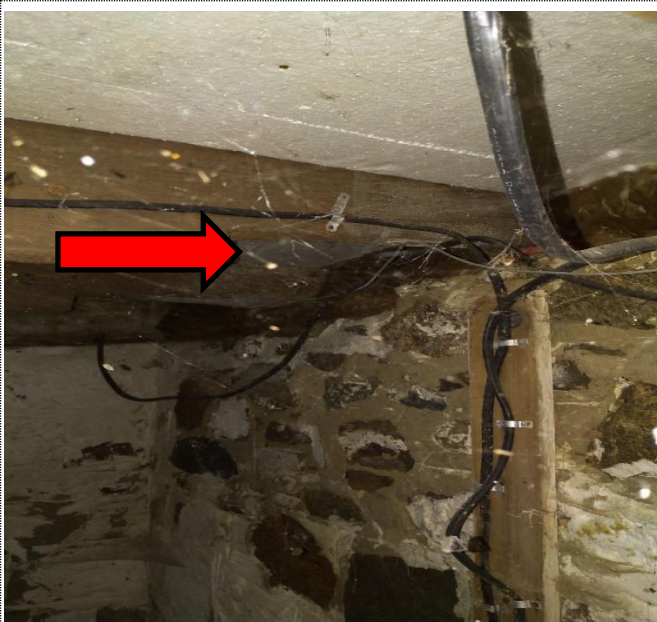
Heavy timber framing is split and rotting in several locations. The staining or discoloration of the wood members indicates that it has been subjected to water and potentially has a high moisture content suitable to support decay.

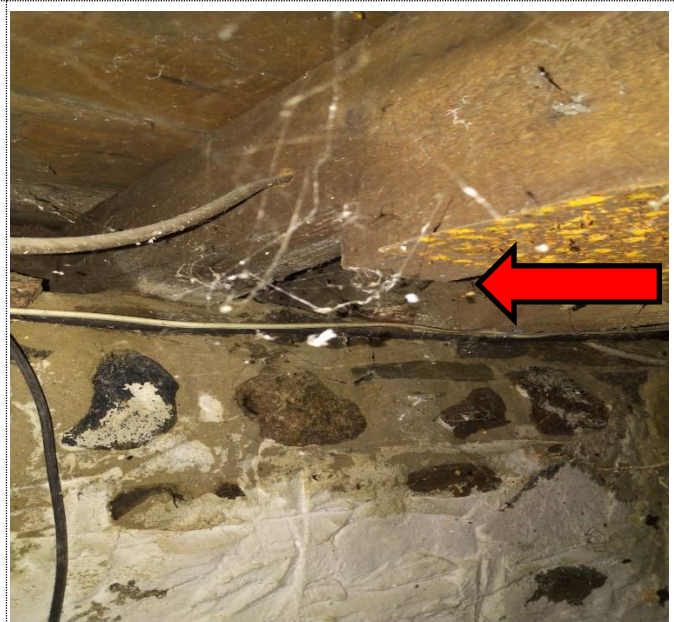
Several framing members have been notched out and have split and have also warped.

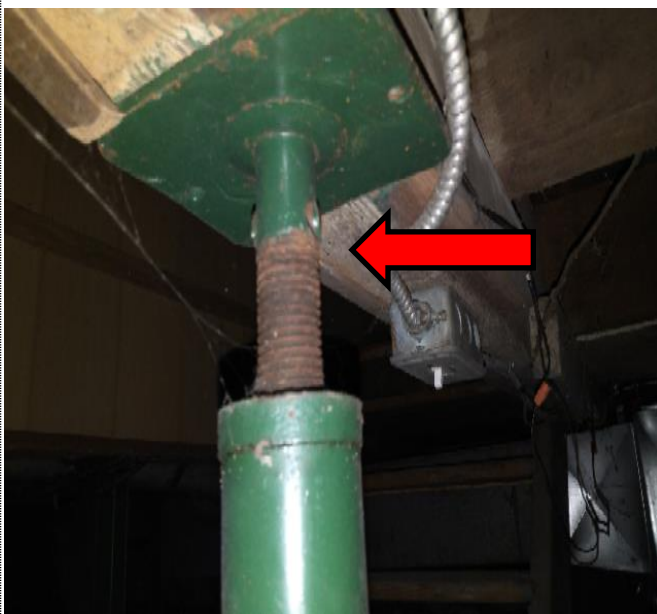
Temporary post shores and 6x6 timber have been placed to support the timber floor framing and summer beams.

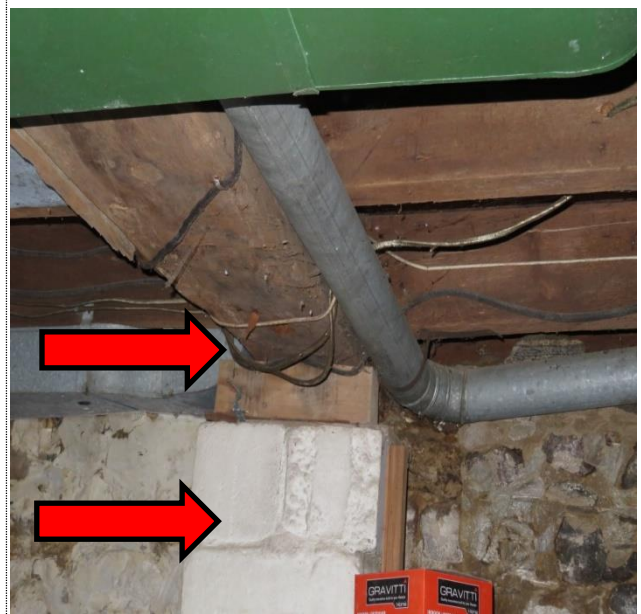
Concrete pilasters have been installed with 4x4 wood blocks to support the heavy timber summer beam. The concrete block pilaster appears to have moved with the slab on grade. The summer beam was found to be degraded and rot in several areas.

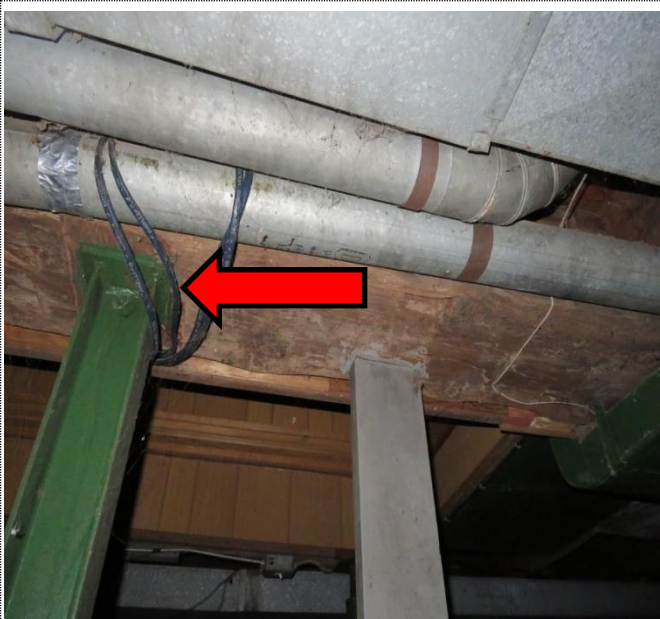
Undersized steel columns placed on the slab on grade below the summer beam. It appears that no footings were created for the steel columns. It appears that the slab on grade is heaving creating an upward punching shear force through the timber wood summer beam.

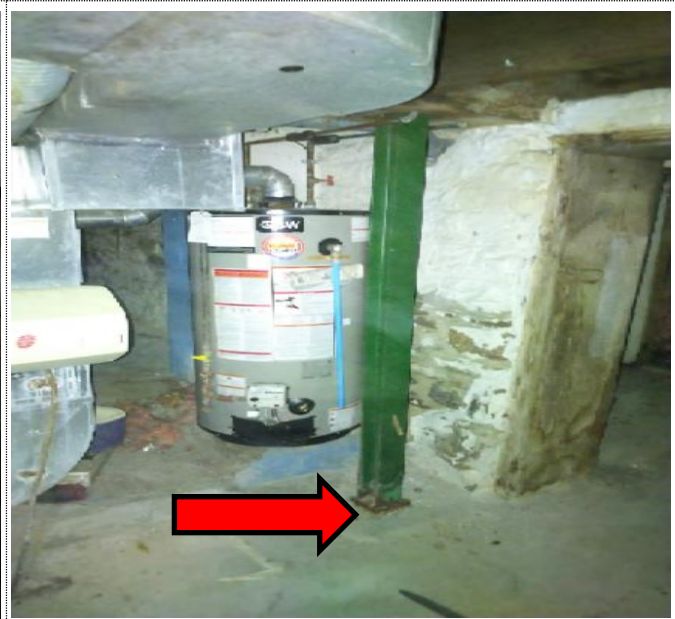
There is extensive corrosion on the base plates forming the steel columns supporting the summer beam.

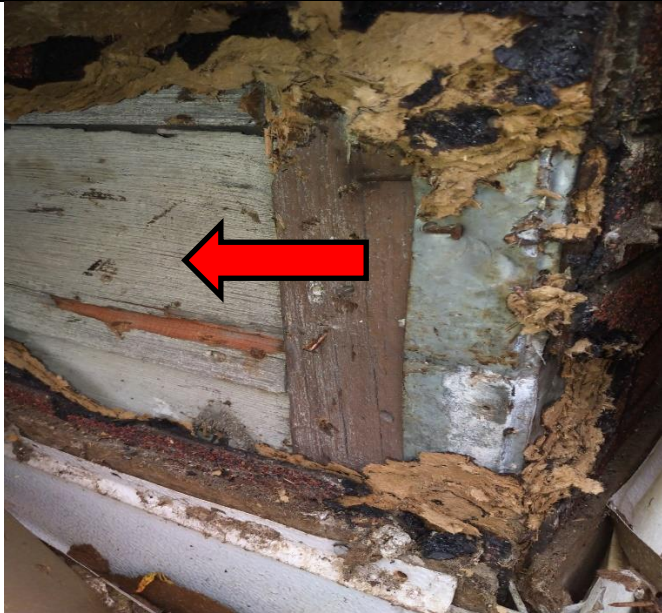
The exterior framing and simple wide plank boards that have been locally replaced are currently degraded and show evidence of wood rot. These framing members are concealed with insulbrick and metal siding.

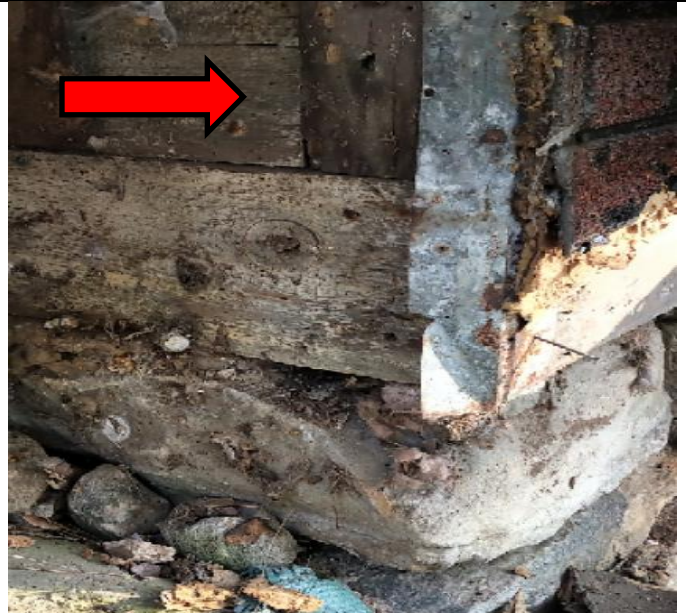
The exterior framing and simple wide plank boards that have been locally replaced are currently locally exposed to the elements, however it appears that it was concealed with insulbrick and metal siding.

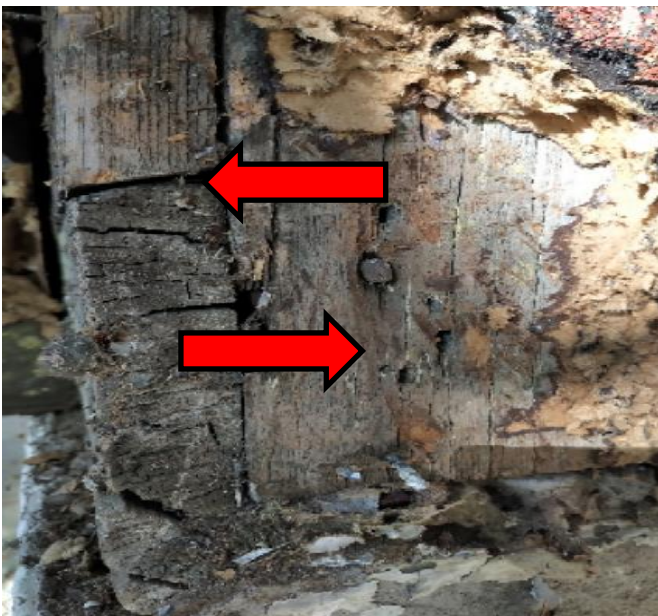
The South West section was exposed and reviewed. The exterior framing and simple wide plank boards that have been locally replaced. Several boards and framing members were found to exhibit extensive wood rot.

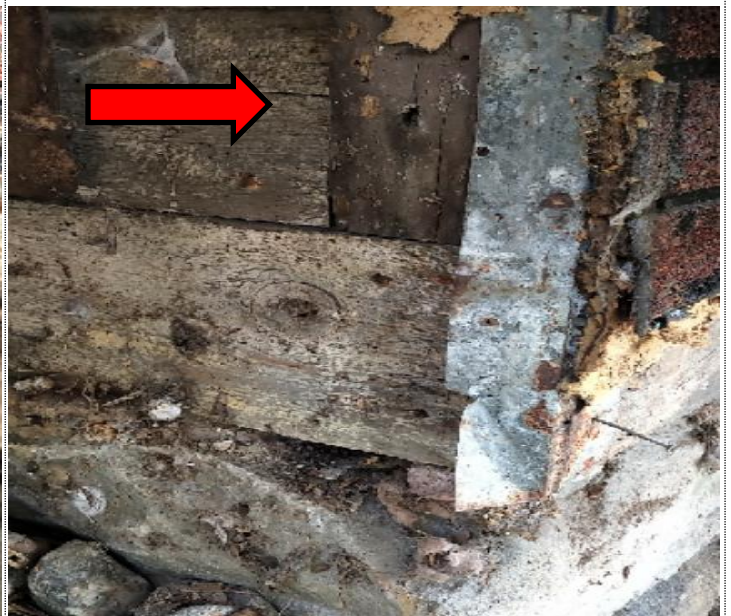
The North East section was exposed and reviewed. The exterior framing and simple wide plank boards that have been locally replaced. Several boards and framing members were found to split and exhibit extensive wood rot.

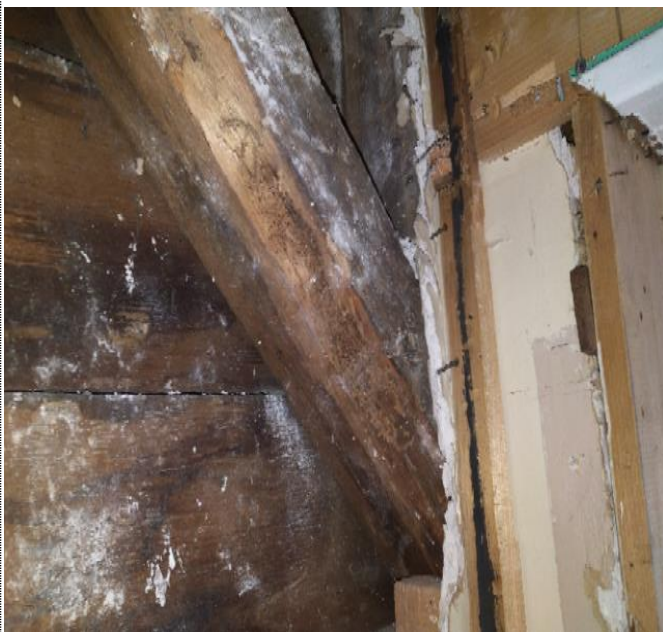
The corner location was exposed and found to contain diagonal bracing. The bracing members found to be moist and damp with evidence of mold. The upper portion of the timber bracing was found to be deteriorated and split.

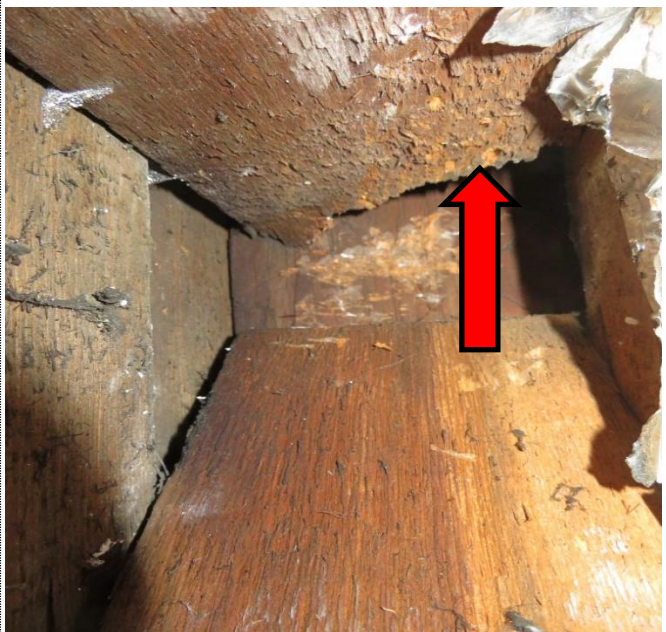
The upper portion of the timber bracing found to be disengaged and deteriorated, as shown in the photo above.

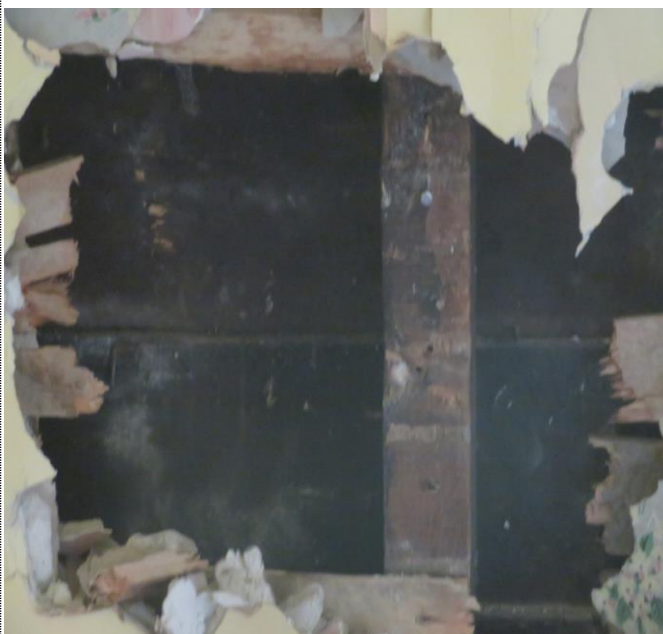
Several simple plank boards and timber framing were found to exhibit extensive mold growth. Several exterior boards between the original dwelling unit and the salt box tail have been locally replaced.

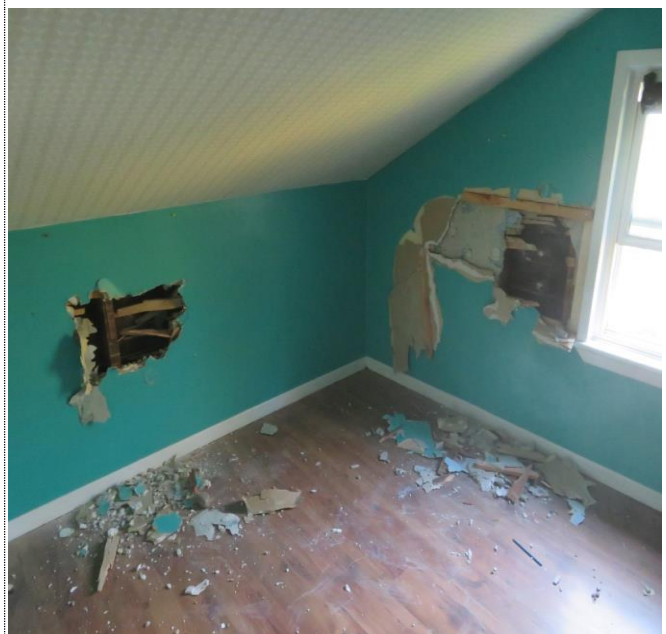
The exterior wall and interior wall between the original structure and the salt box addition have been vandalized. The walls are concealed with plaster lath.

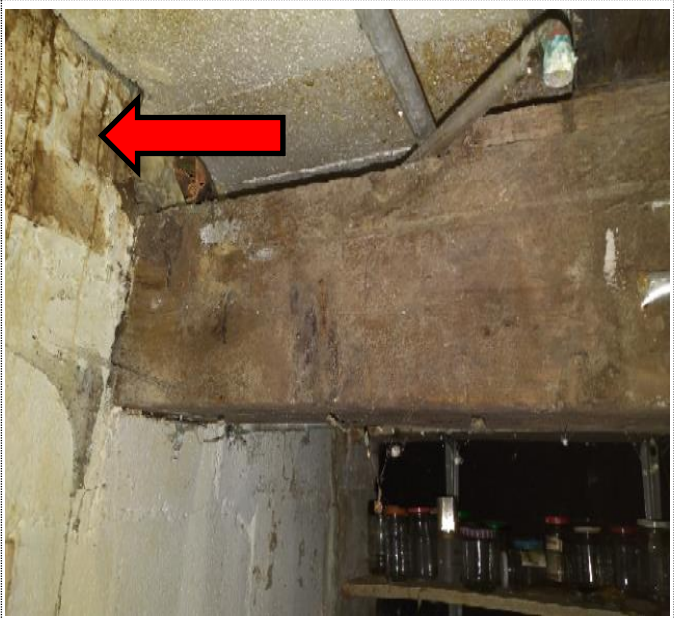
Timber wood beams bearing on block foundation walls below the saltbox addition. Note, evidence of water staining along the upper portion of the foundation walls.

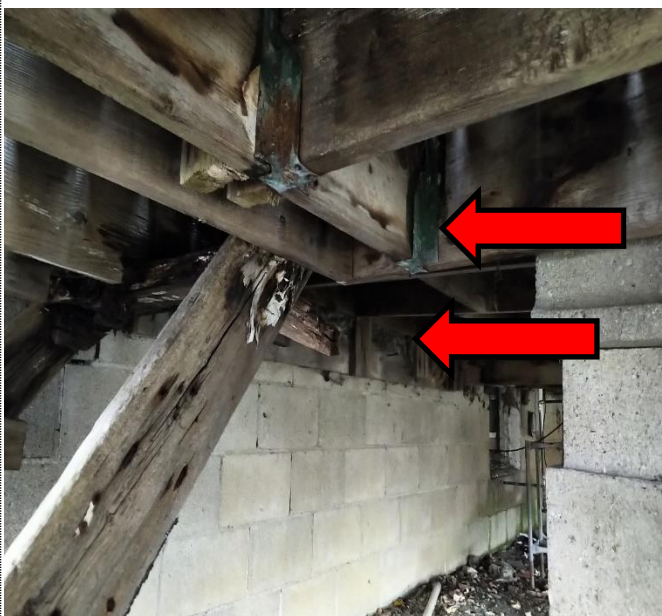
There is evidence of wood rot and wood decay on several joists supporting the rear addition.

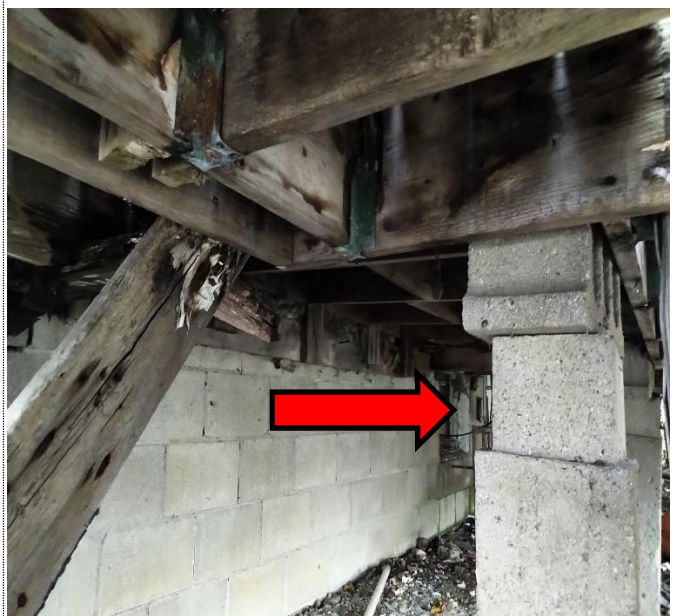
The concrete blocks are temporary supports for the rear addition. The rear addition has settled and is structurally unsafe and in an unsound condition.

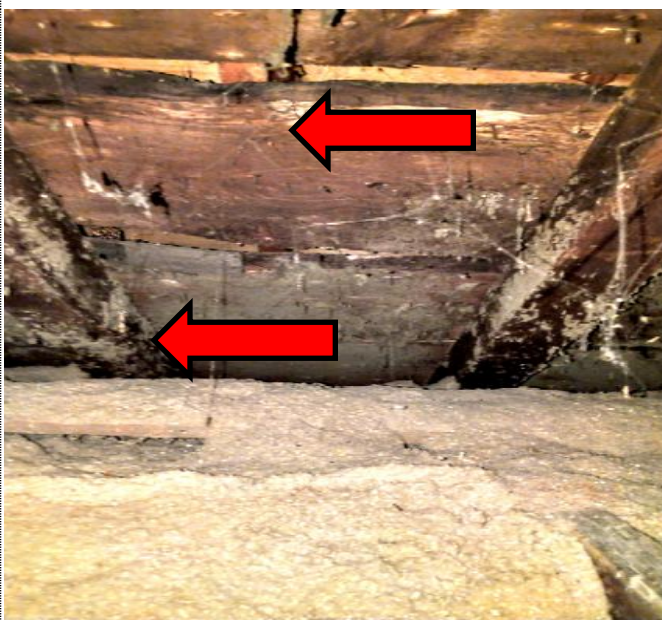
There is extensive wood deterioration forming the simple plank board sheathing and timber wood trusses. The timber framing would be wet and deteriorated at locations made visible.

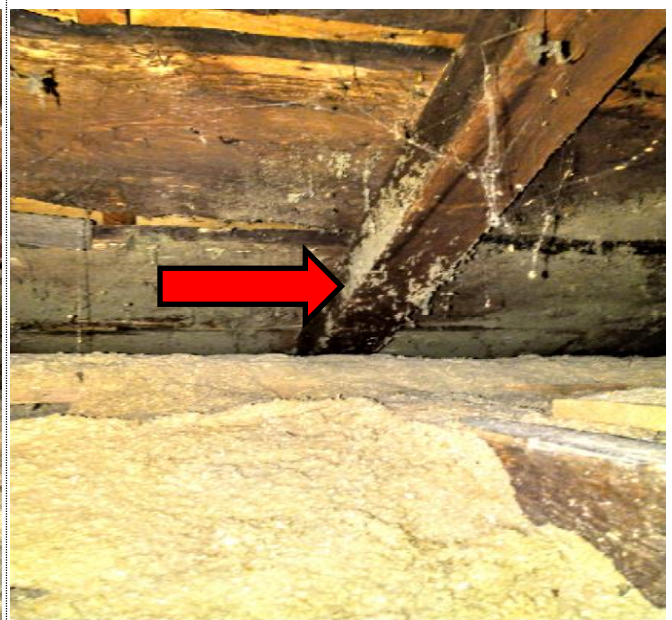
Several timber roof frames were found to have extensive decay and mold, as shown in the above photograph.

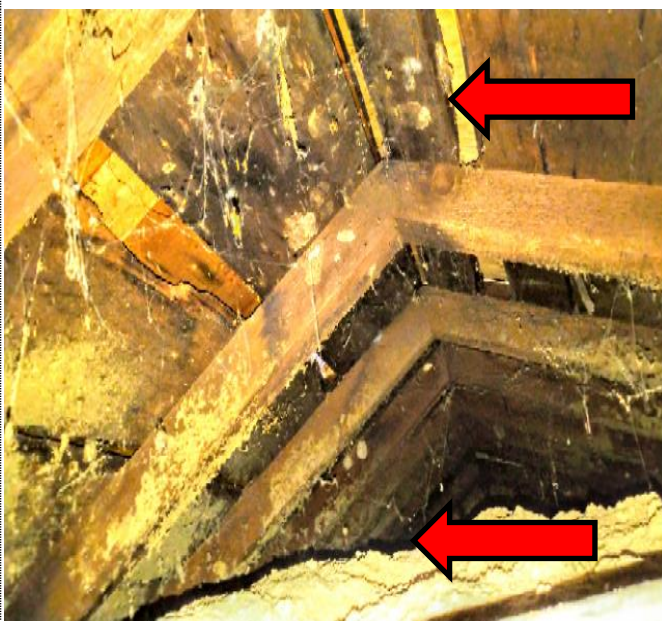
Timber wood simple plank boards and timber roof assembly found to exhibit deterioration and in a general state of decay.

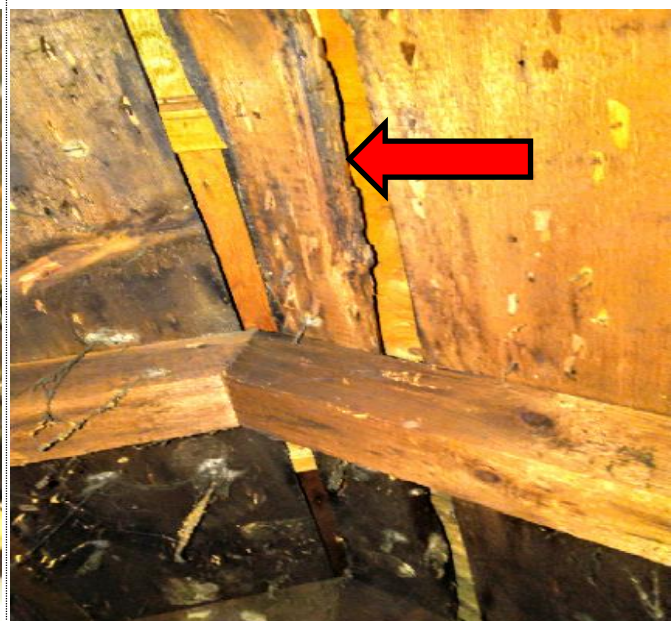
Several timber plank boards were found to exhibit extensive deterioration as well as mold.

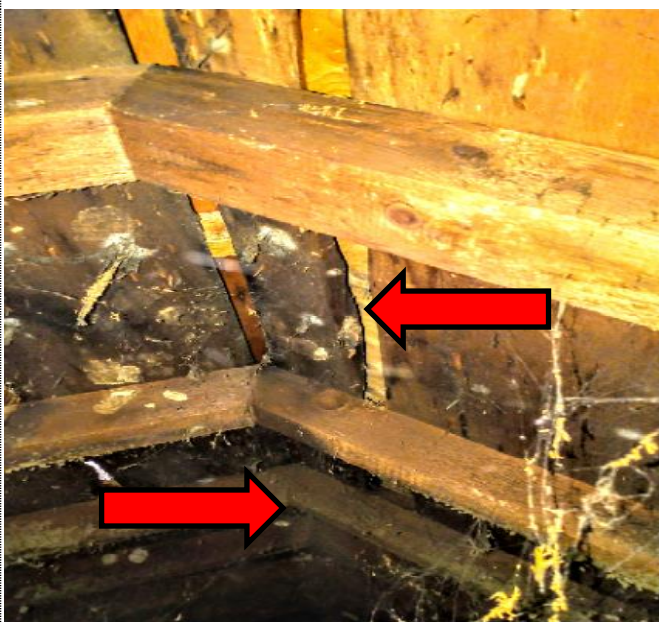
The peak of the roof assembly was found to be moist and damp with extensive mold growth.

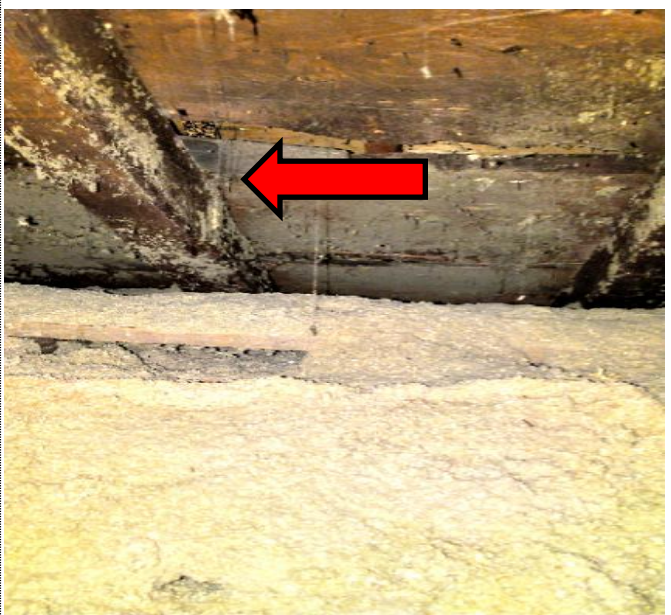
Several timber roof members were found to be split, and warped at several areas made accessible.

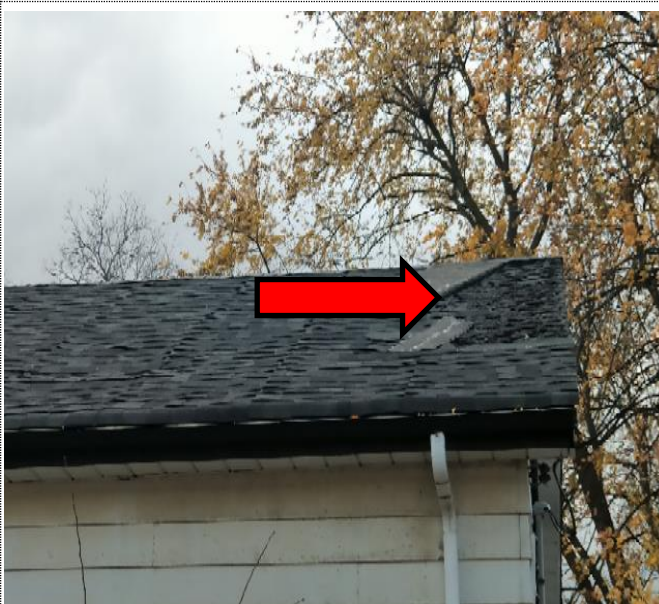
There is an overlay of shingles. The shingles and plywood sheathing where made accessible were found to be deteriorated.

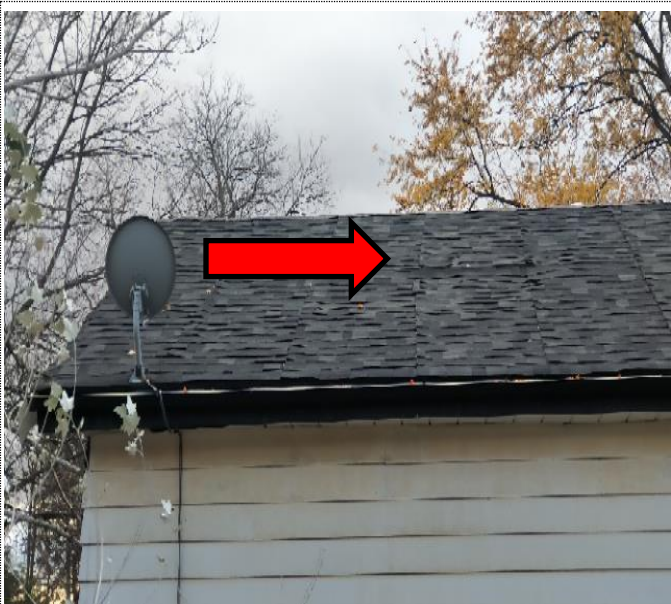
There are obvious sags evident in the roof framing on the north east elevation.

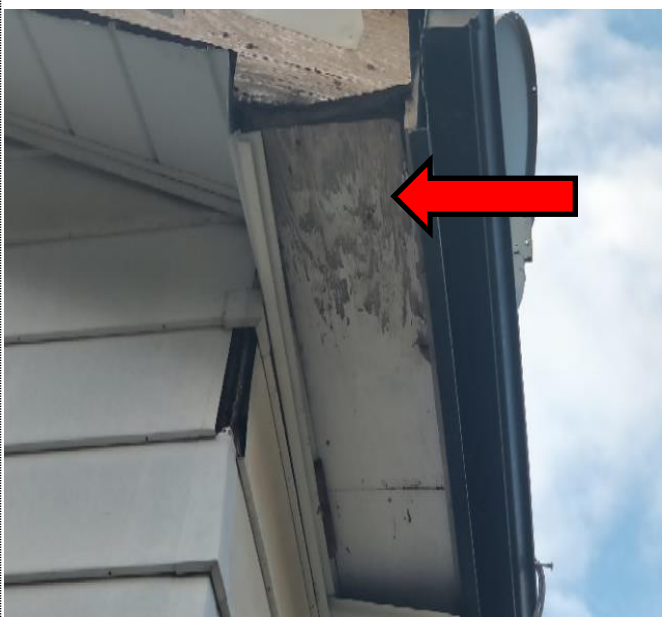
The wood soffits appear to have water stains and some wood deterioration, as shown in the photograph. No vents were provided in the soffits.

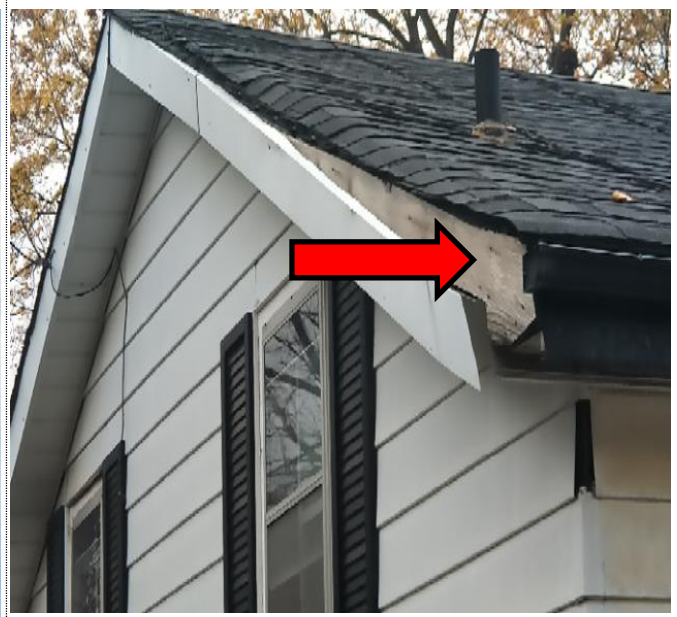
The metal siding concealing the wood framing for the roof has separated leaving the wood elements exposed to the elements.

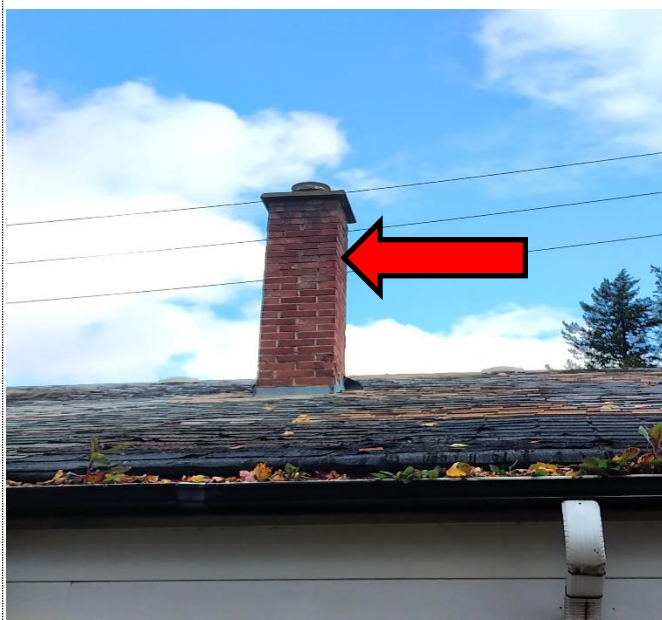
There are several spalled and deteriorated bricks including loose mortar joints. The precast coping stone above the bricks was also found to be delaminated and cracked.

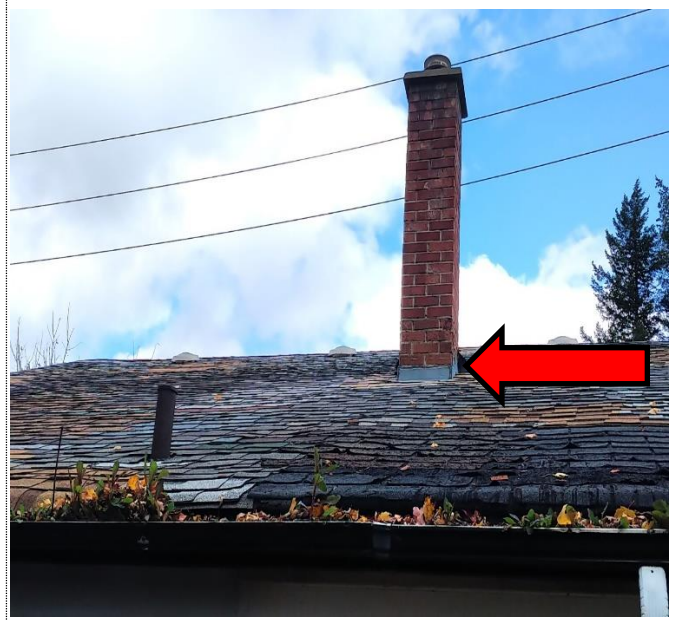
The metal flashing appears to have been installed incorrectly. The lower portion of the chimney also shows evidence of brick spalls and loose mortar joints

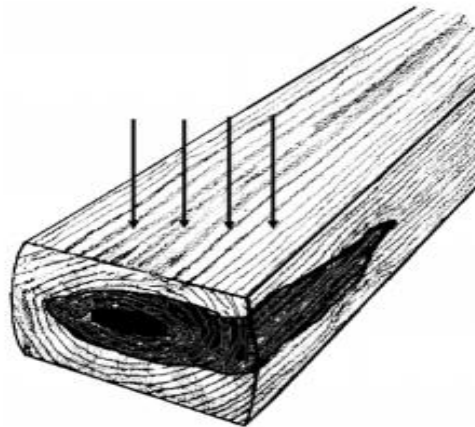
Because of interior deterioration the outer shell can collapse when the timber is stressed in bearing.
