20. DEMOLITION OF EXISTING BUILDING AND CONSTRUCTION OF IDENTICAL REPLICA BUILDING AT 99 NASHVILLE ROAD, KLEINBURG-NASHVILLE HERITAGE CONSERVATION DISTRICT

**STRUCTURAL CONDITION ASSESSMENT FOR
99 NASHVILLE ROAD, KLEINBERG, ONTARIO**

November, 2019
Project ID: AS19-146

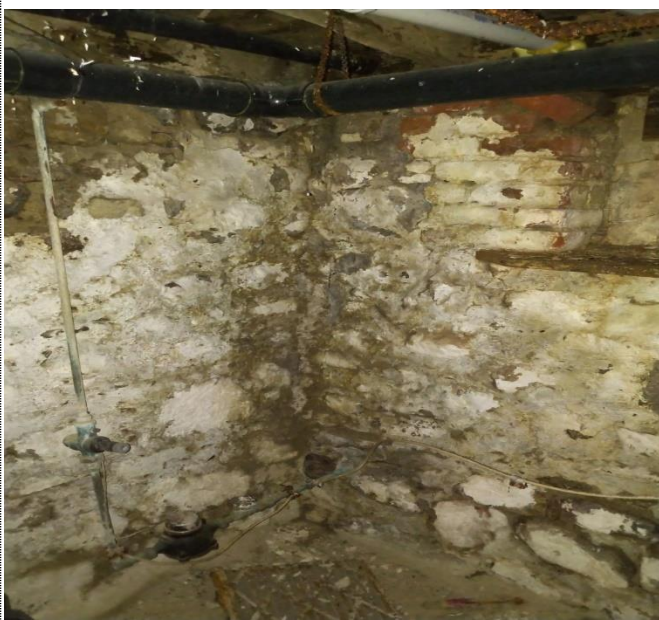
There is extensive water damage and deterioration to the field stone forming the perimeter foundation walls at several locations.

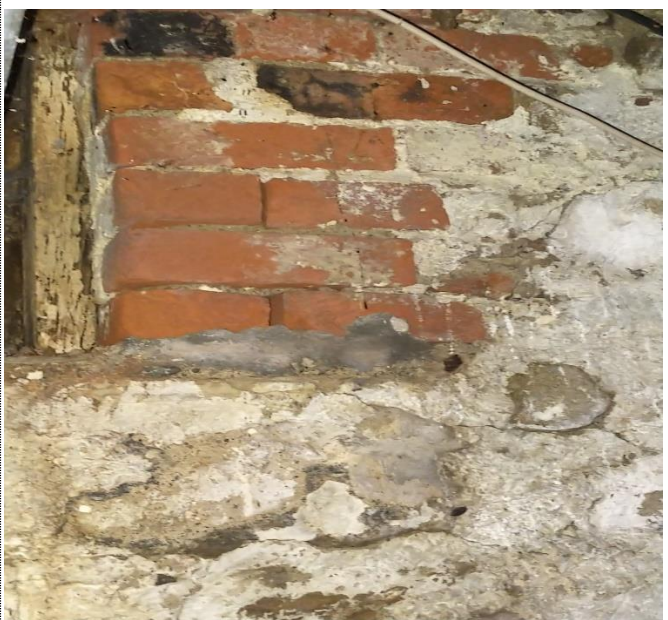
Several areas of deteriorated field stone have been replaced with masonry brick and cementitious repair materials.

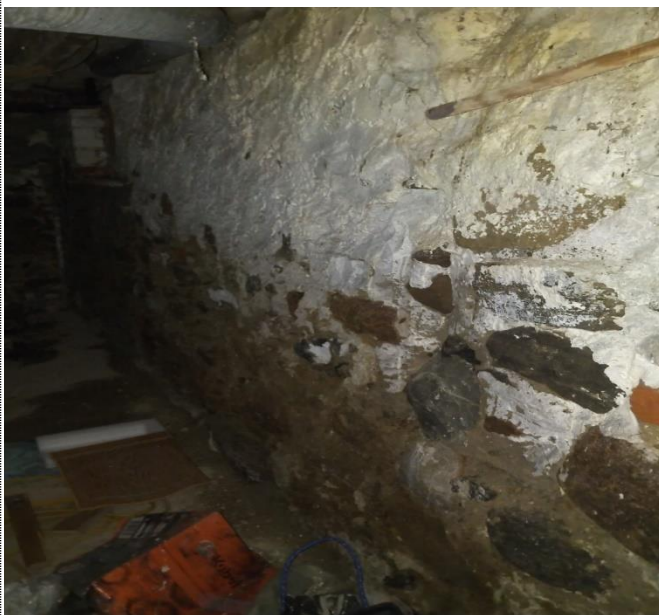
The field stone foundation walls concealed with cementitious repair materials is bowing outwards.

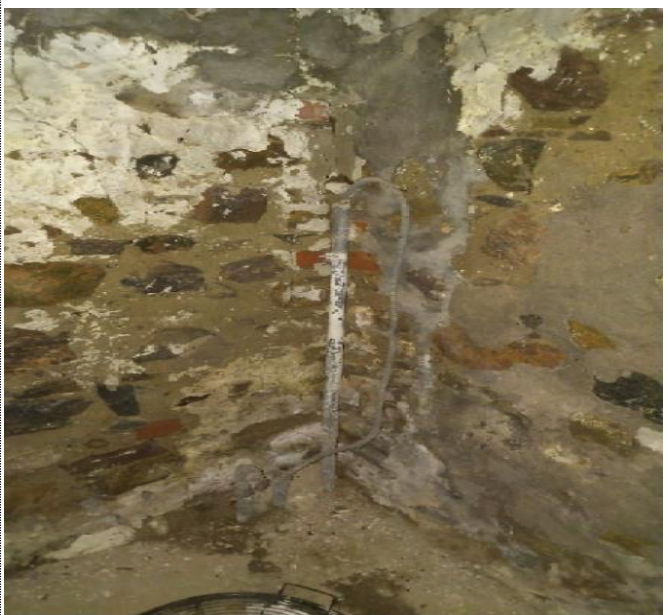
Numerous loose field stone have been concealed with cementitious materials.

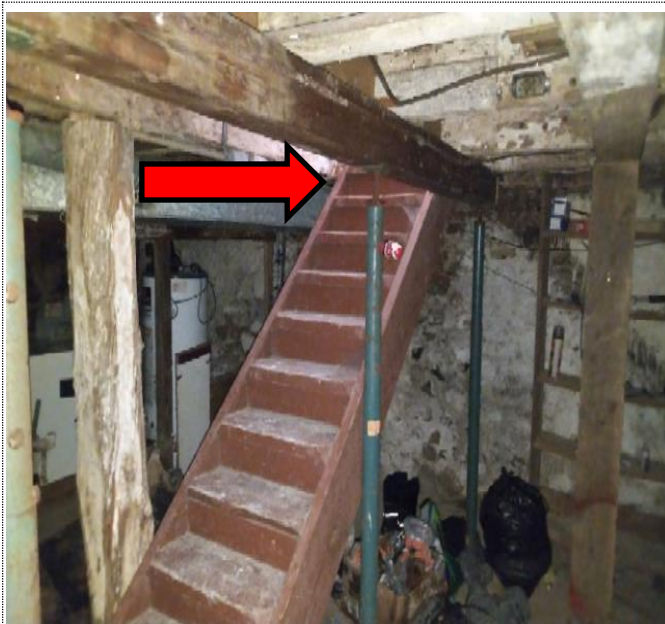
Temporary post shores and 6x6 timber have been placed to support the timber floor framing and summer beams.

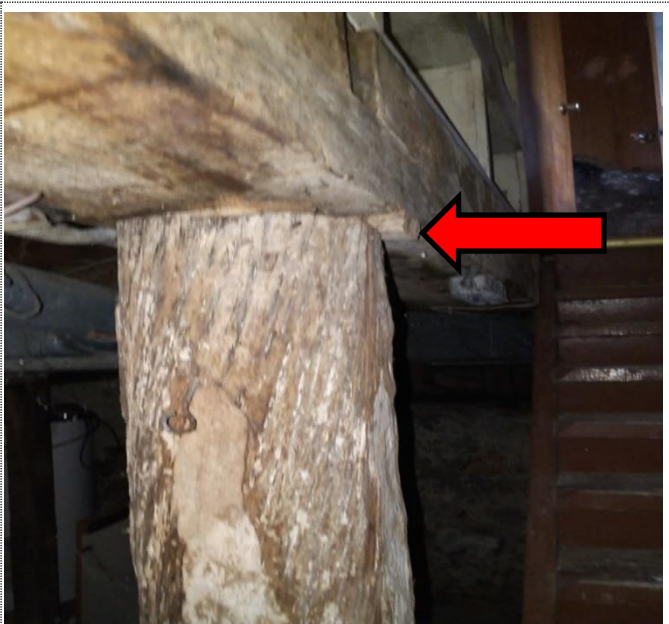
Evidence of water staining and moisture damage to the original summer beam and timber column. There are wood shims in place below the beam and column, as shown in the photograph.

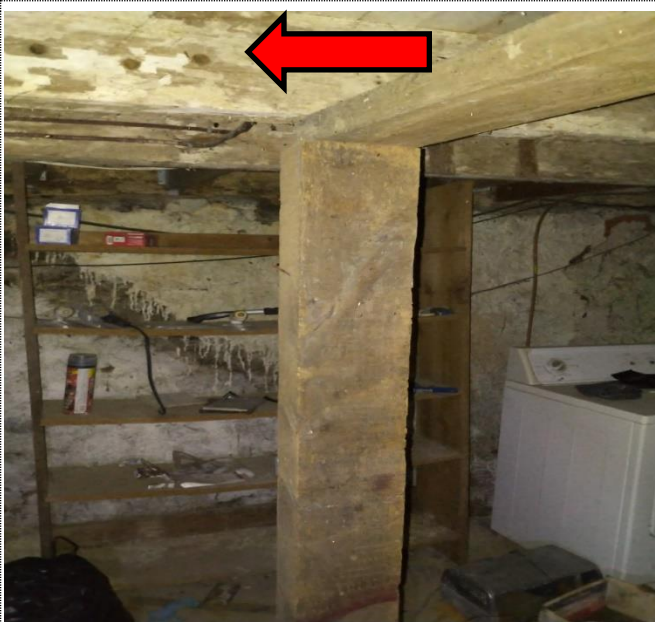
Staining or discoloration of wood indicates that it has been subjected to water and potentially has a high moisture content suitable to support decay.

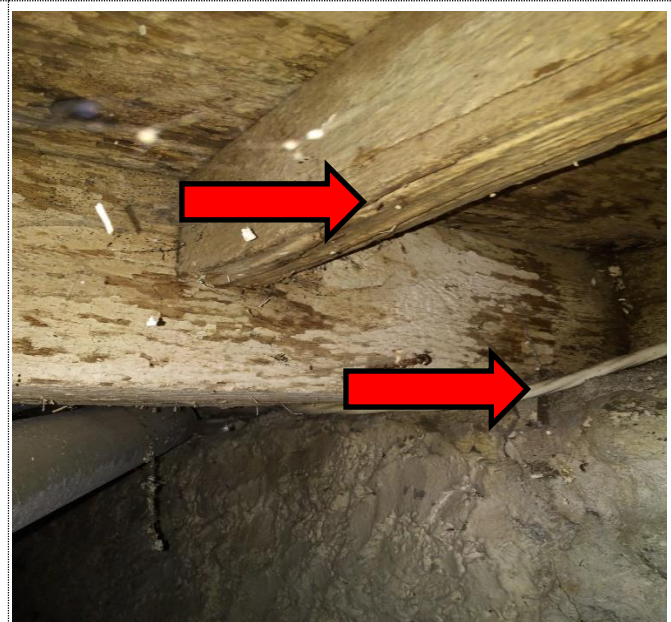
Several framing members are deteriorated and have been notched out, split and have also warped. Alterations can weaken members. This type of modification can severely weaken the joists.

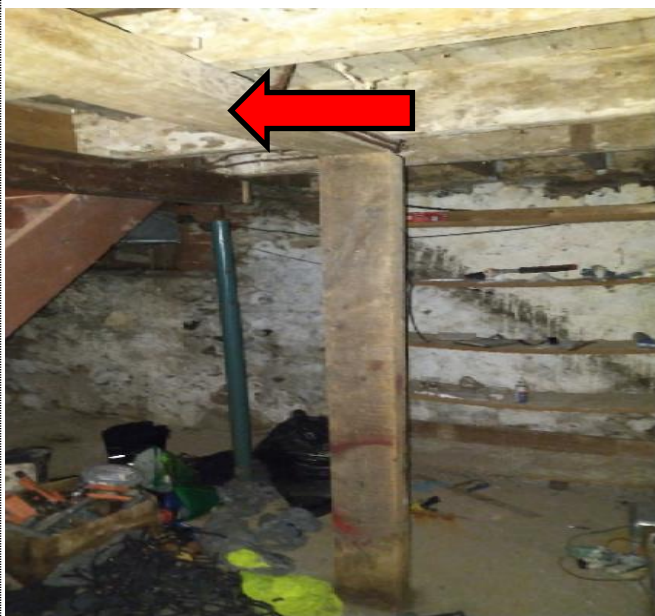
Undersized support framing that is deteriorated and deflecting at mid span. The built-up wood beams down the centre of the building show significant sag, likely due to long-term creep wood under the load of the multiple floor finishes. The beams also exhibit ineffective load-sharing between the inner plies and outer ledgers.

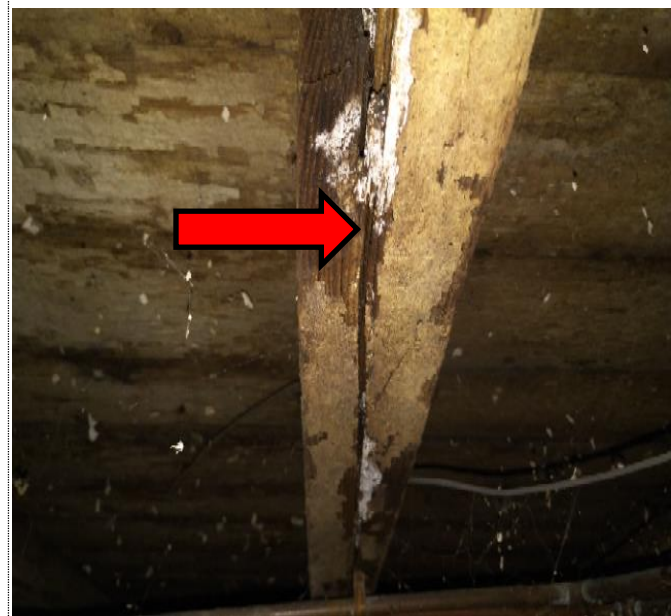
Heavy timber framing is split and rotting in several locations. The staining or discoloration of the wood members indicates that it has been subjected to water and potentially has a high moisture content suitable to support decay.

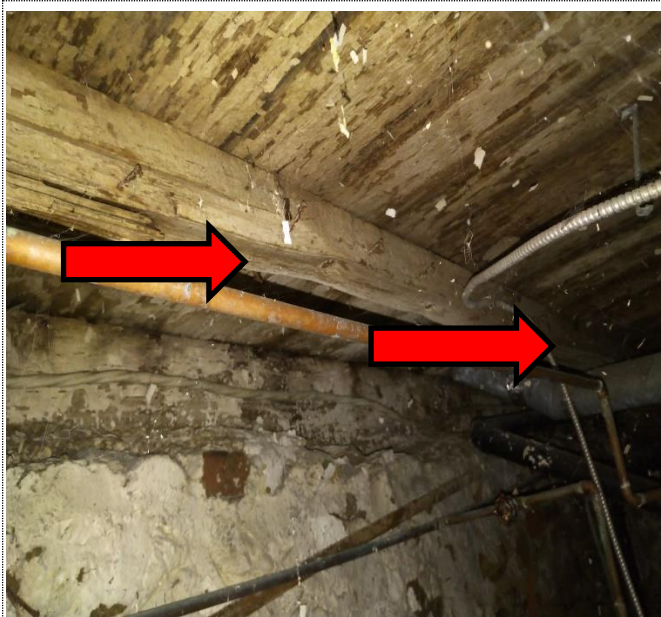
Extensive cross-sectional loss through several timber framing and mold spores were identified. There is also knob and tub wiring through the old timber members.

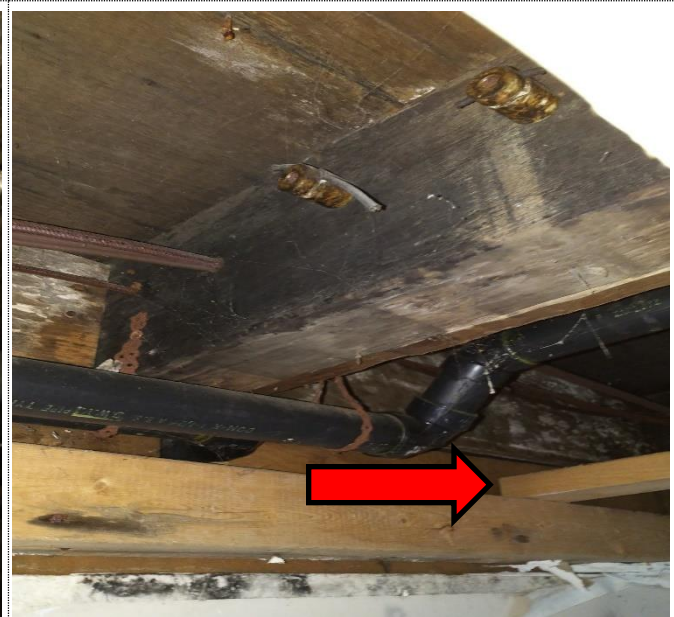
Several additional support joists and lightwood bracing have been placed in order to support some of the old deteriorated timber,

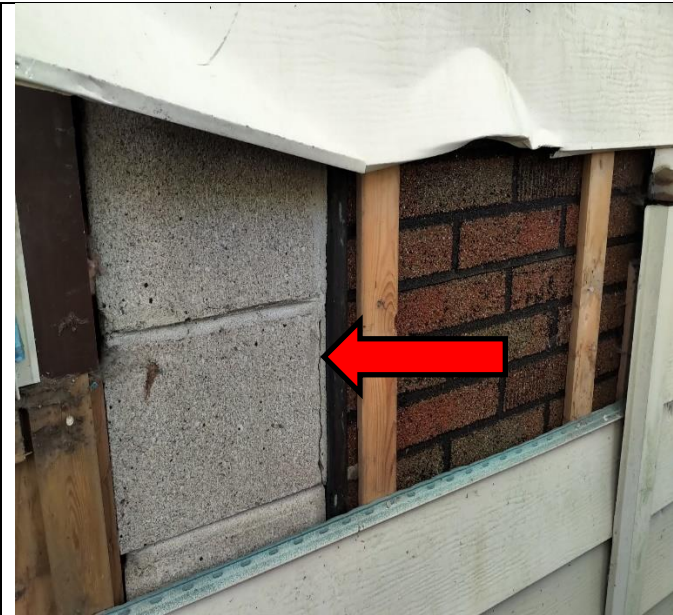
The transition between new addition and old structure. Original timber framing and simple plank boards have been locally replaced and have been concealed with insulbrick and metal siding.

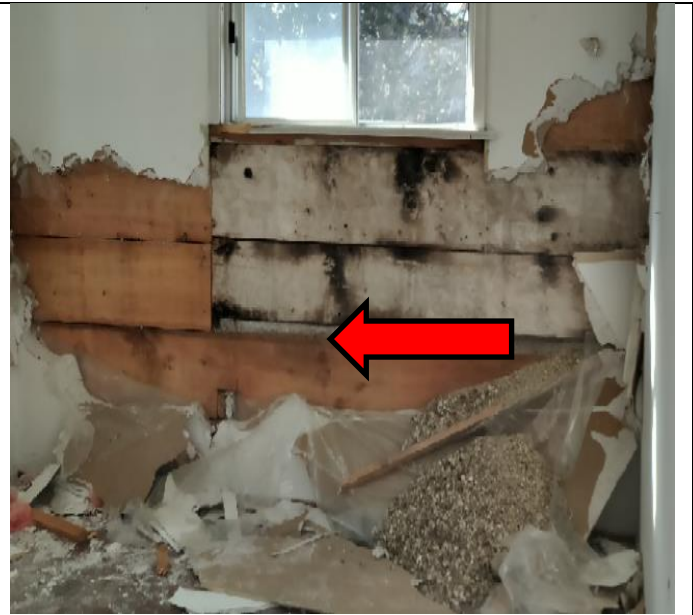
Several simple plank boards and framing have been locally replaced, as shown in the above photograph.

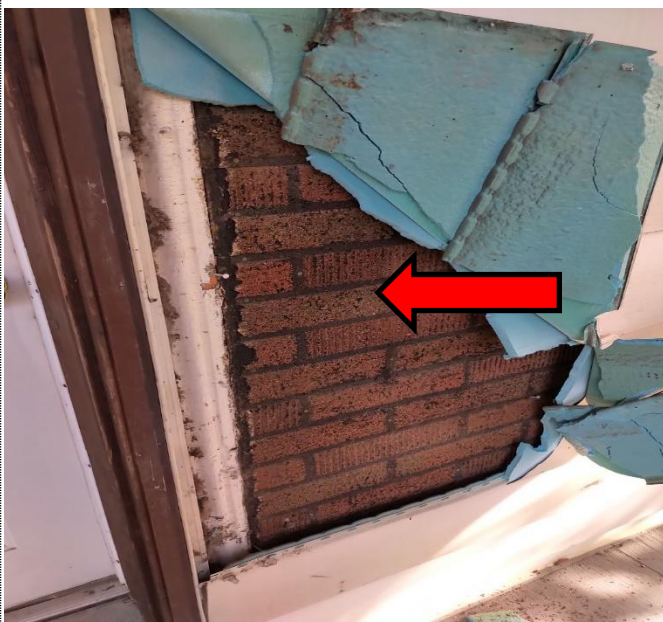
The exterior framing was concealed with insulbrick, as shown in the above photograph.

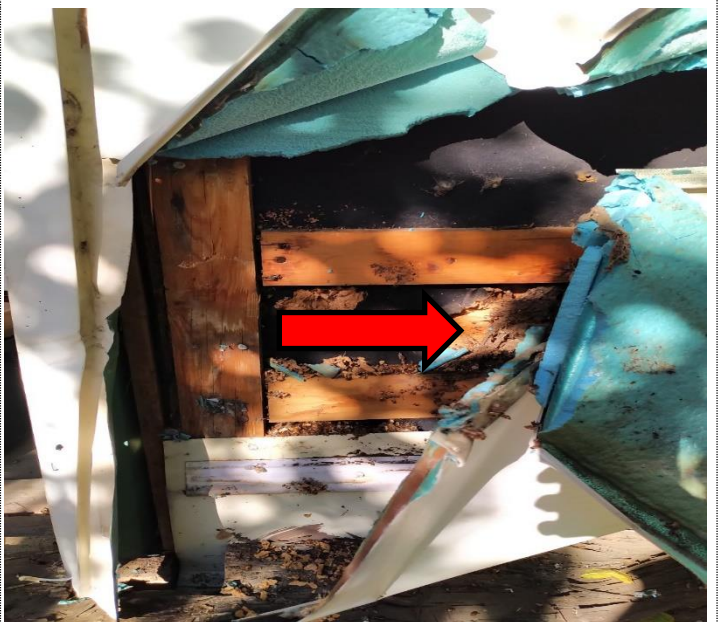
The metal siding and insulbrick was removed locally and revealed that several timber framing and simple plank boards have been altered or locally removed and replaced.

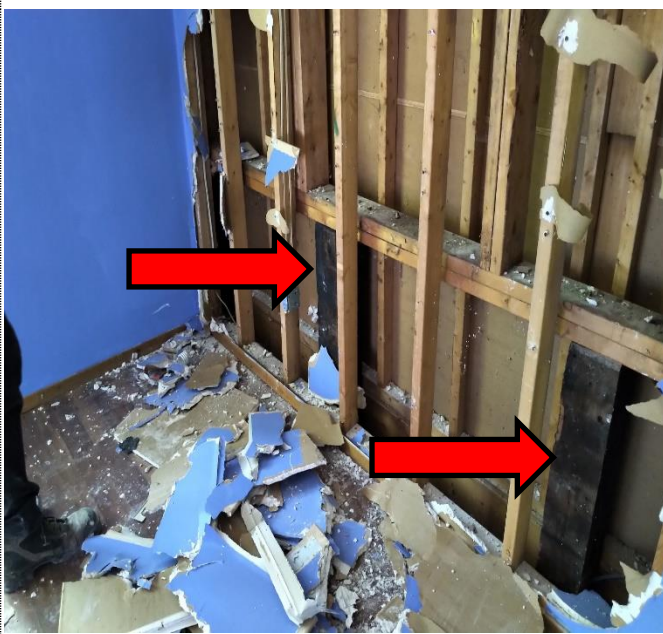
Double wall system forming the newer addition forming the e east elevation. Note, the original timber framing that was found to be extensively charred.

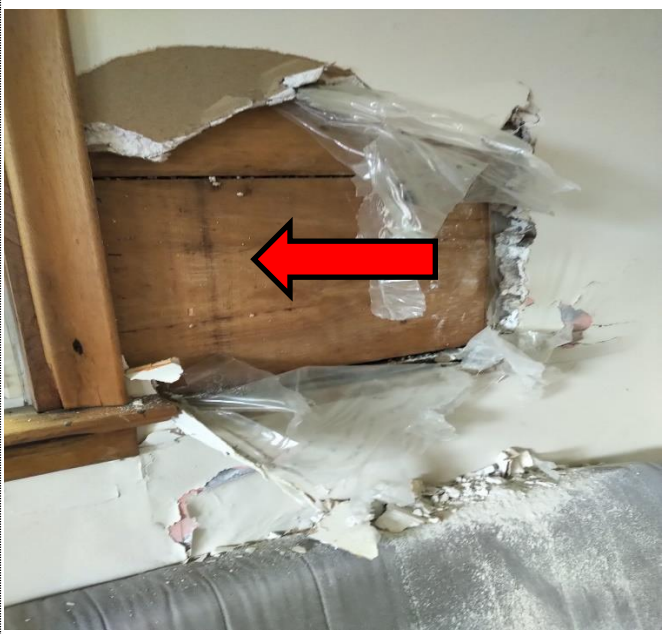
Locally replaced simple plank board forming the exterior walls along the north and west elevations.

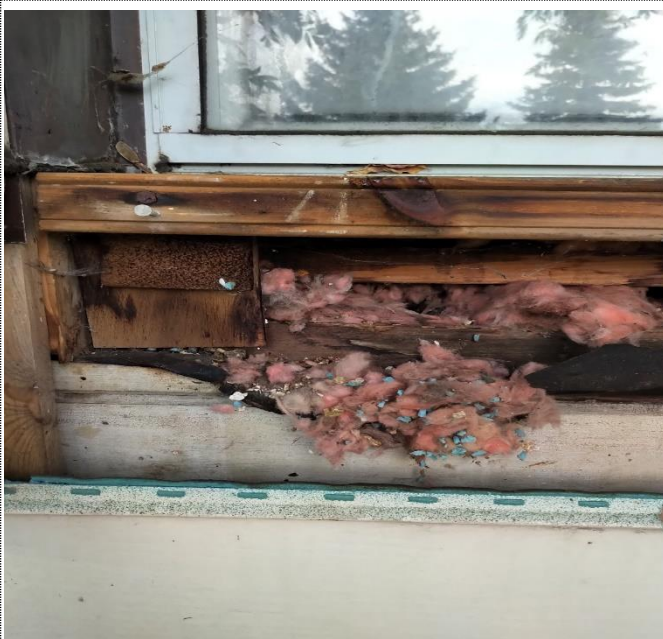
The original sills were removed and replaced. There is water damage and extensive mold growth to the newer lumber and batt insulation. The batt insulation was found to be wet.

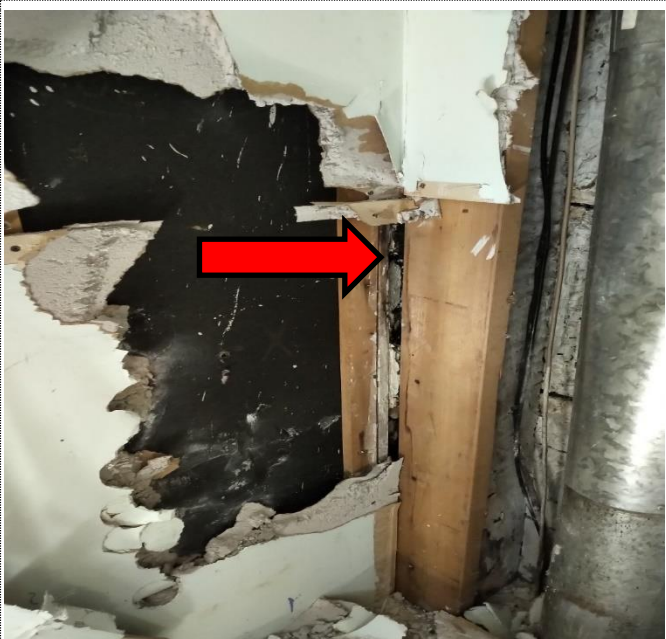
Several alterations have been made to the interior corner connection.

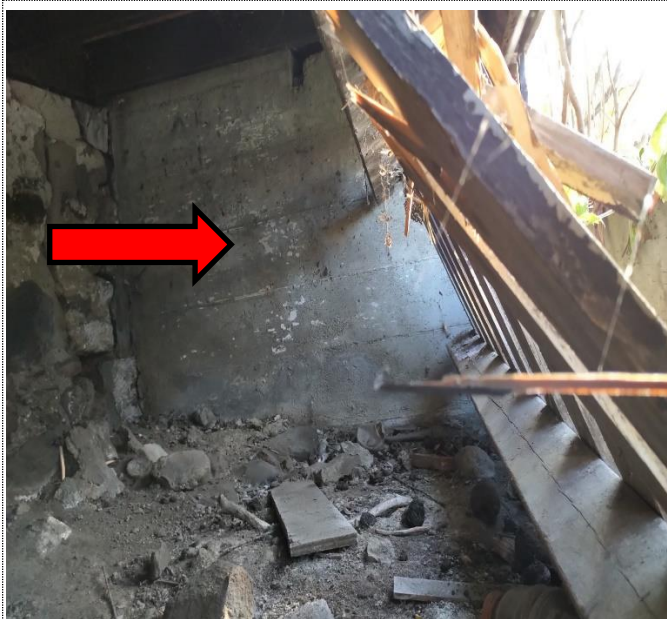
Porch decking supported on cast in place concrete knee wall. Portion of the field stone supporting the porch decking is loose and deteriorated.

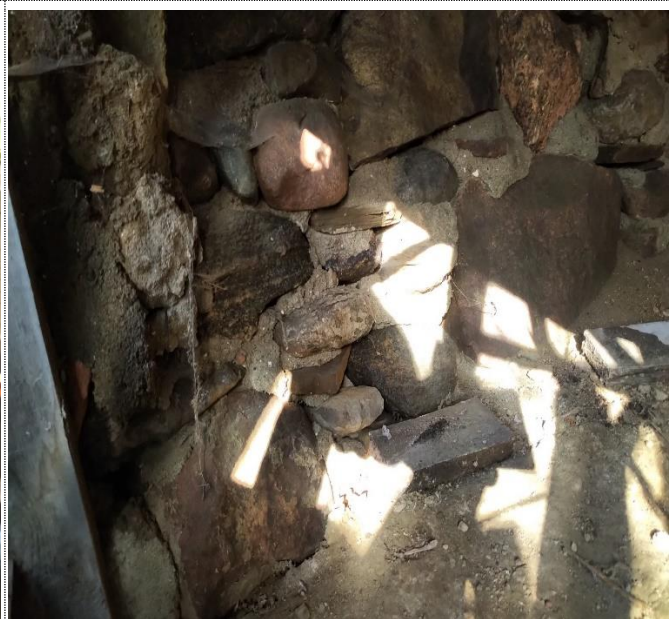
Exterior wood porch supported by loose and deteriorated field stone foundations.

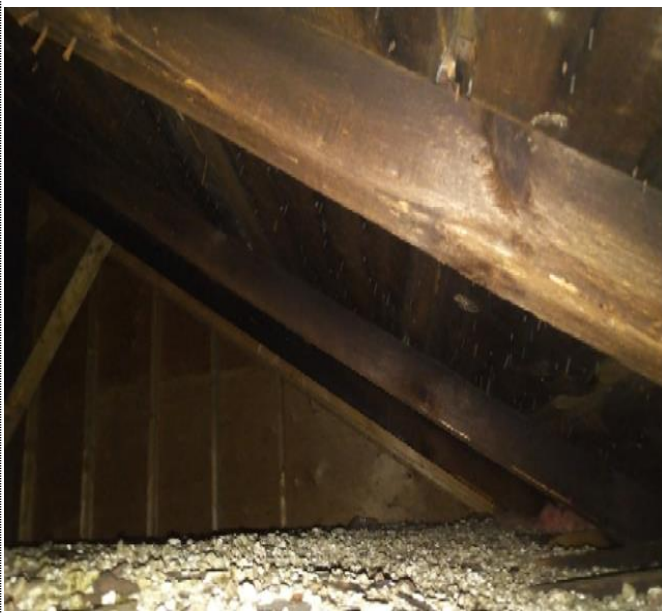
Original timber rafters appear to be stained with soot. Several structural wood trusses that had its webs removed by previous homeowners may have had the intent of creating living space in the attic.

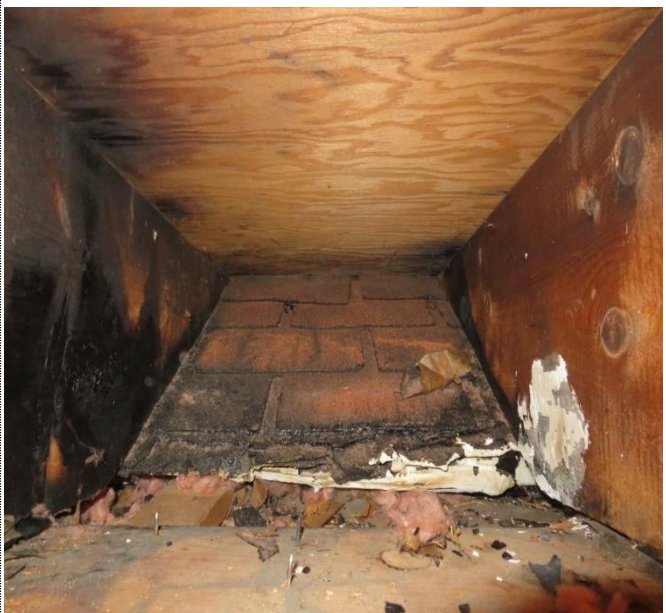
Transition between new and original structure. There appears to be soot stains on the new addition and roofing shingles that appear to have fire damage.

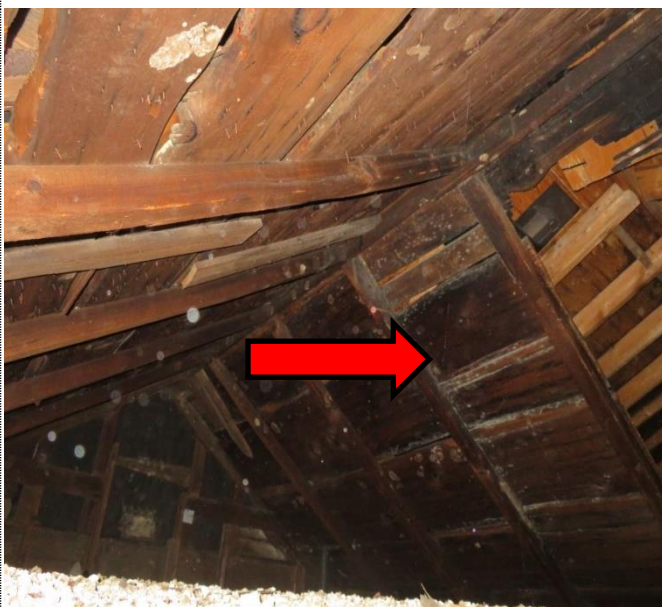
Original timber rafters and simple plank board that have extensive water damage and mold. Several plank boards were covered in soot. As a consequence of the moisture exposure, wood members in the roof also contained areas of deterioration

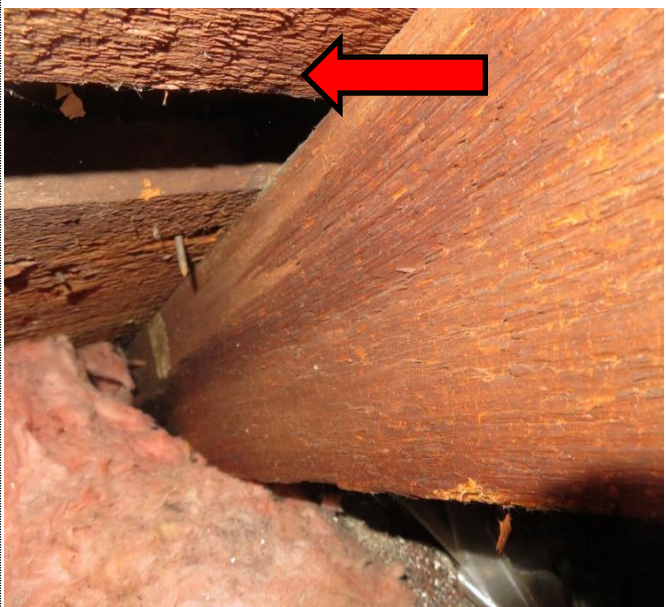
Several plank boards were found to exhibit extensive wood rot.

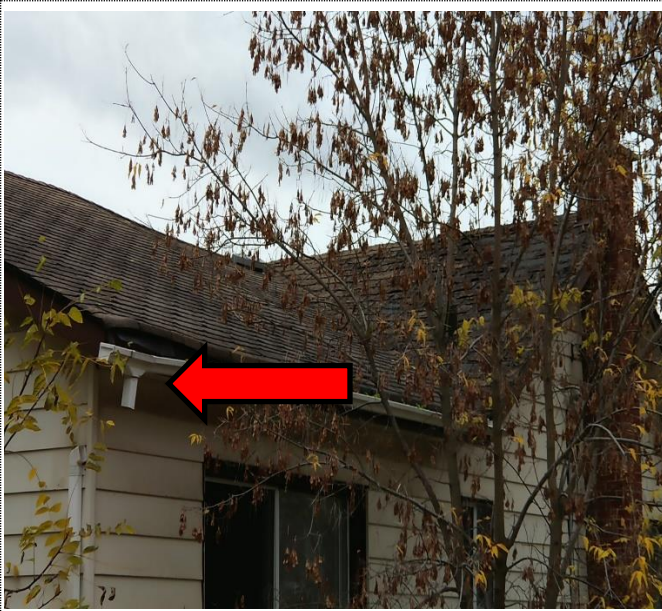
The roof has been re-covered relatively recently, and provided with new rafters and felt. The shingles and plywood sheathing concealing the roof appears to be in effective in several areas. The metal troughs and downspouts are disconnected and damaged in several areas.

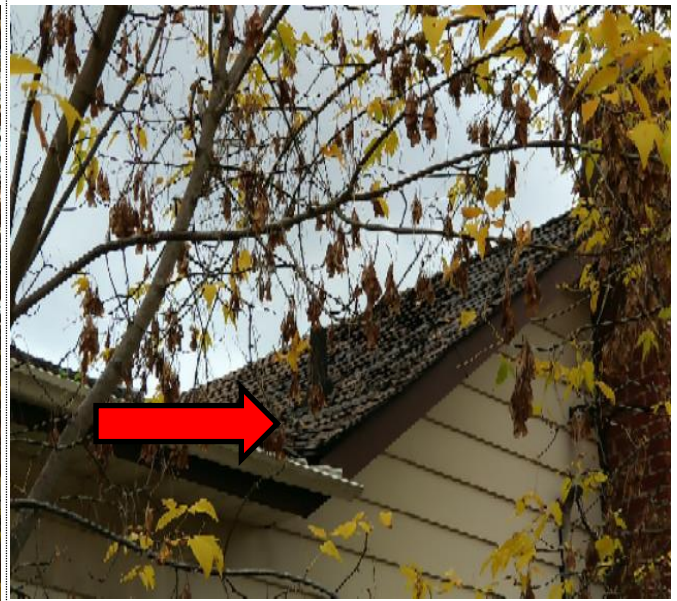
The original timber trusses have been locally removed and replaced. Signs of serious wet-rot decay were noted in the timber. There are numerous dips in the roof line. Several areas of shingles have curled and deteriorated.

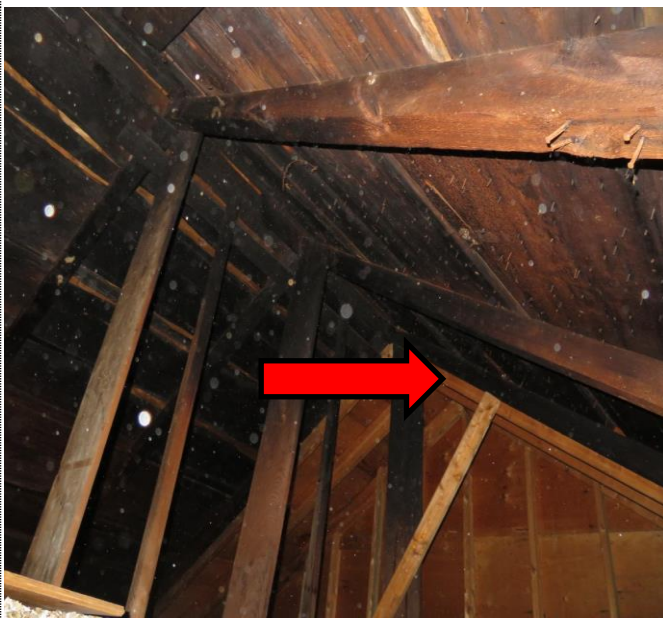
Several wood timber framing and light wood framing have been damaged with fire.

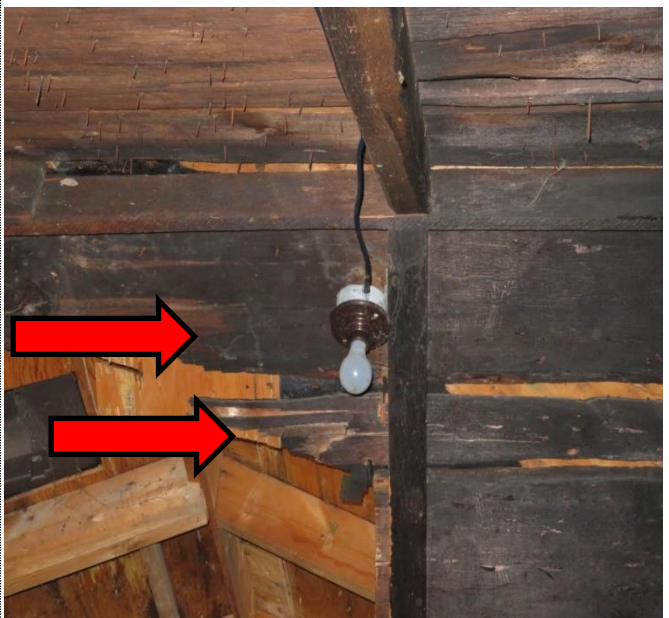
There is extensive fire damage to the original timber rafters and simple plank boards. It appears that there is visible shrinkage to the timber framing.

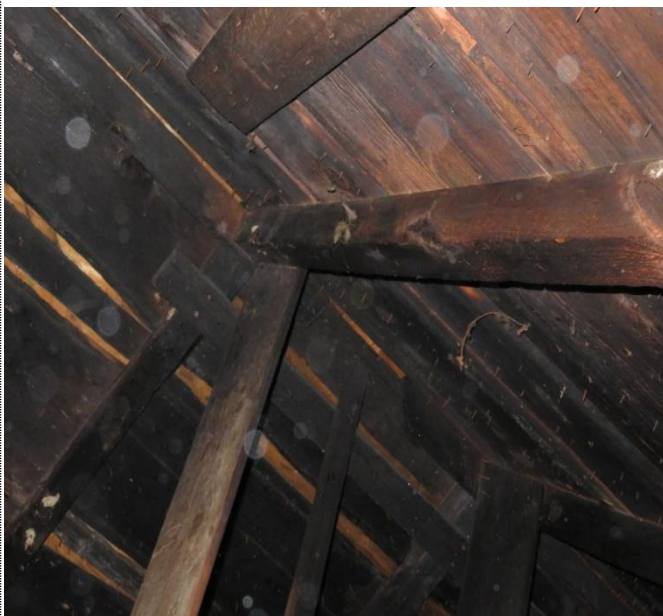
There is extensive fire damage to the original timber rafters and simple plank boards.

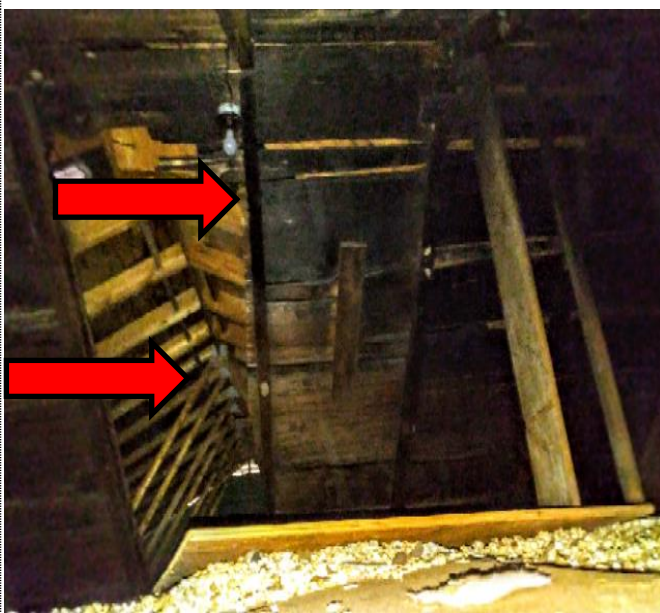
Several wood timber framing and light wood framing have been damaged with fire. It appears that there is visible shrinkage to the timber framing.

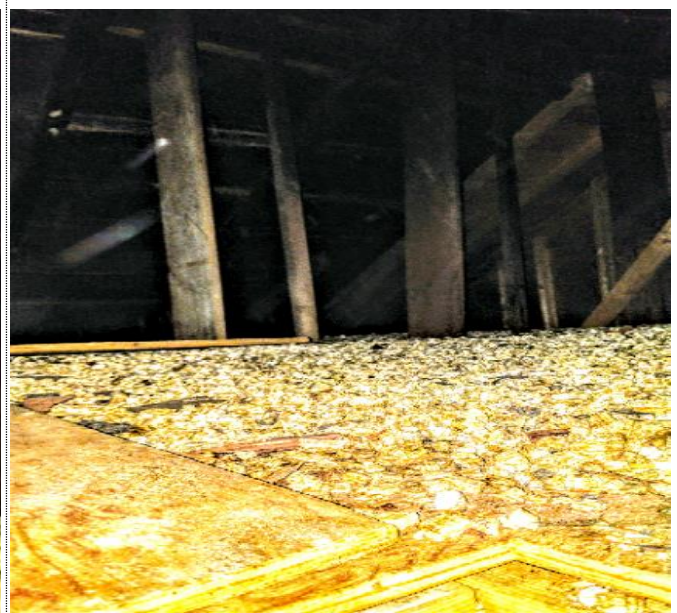
Several wood timber framing and light wood framing have been damaged with fire.

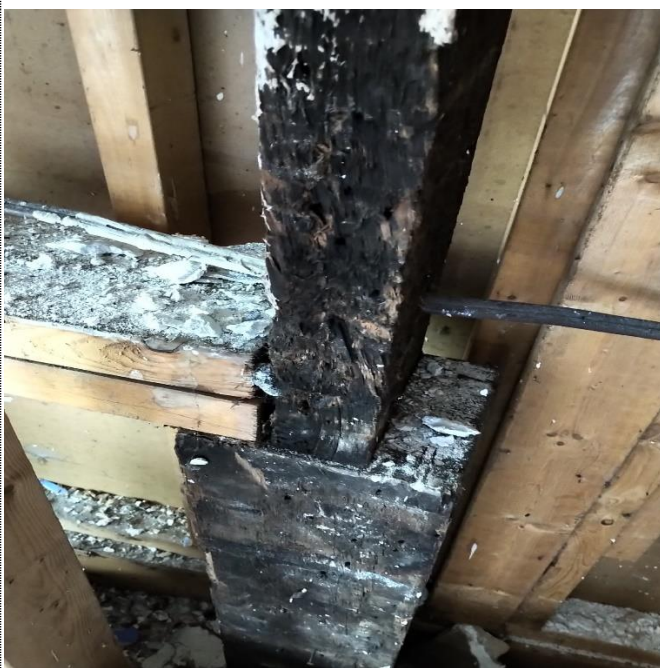
Extensive fire damage and wood rot to the original exterior wall framing that was partial removed.

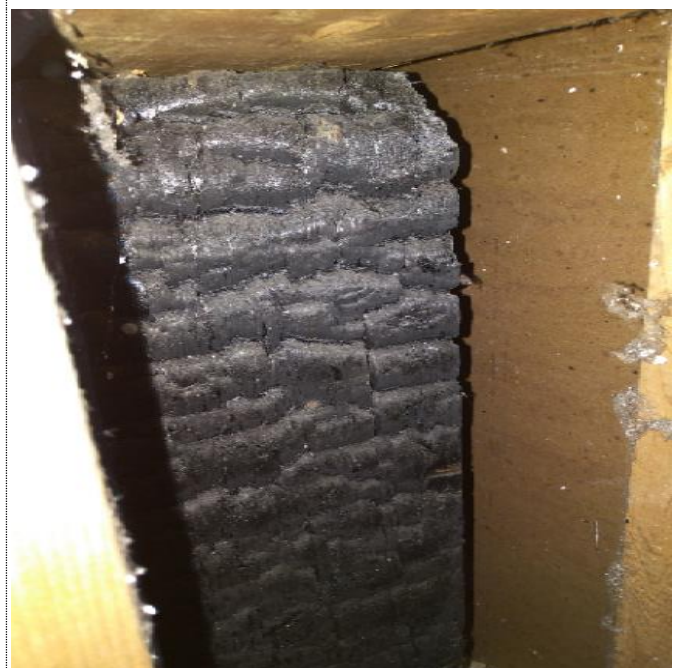
Extensive fire damage to the original exterior wall framing that was partial removed.

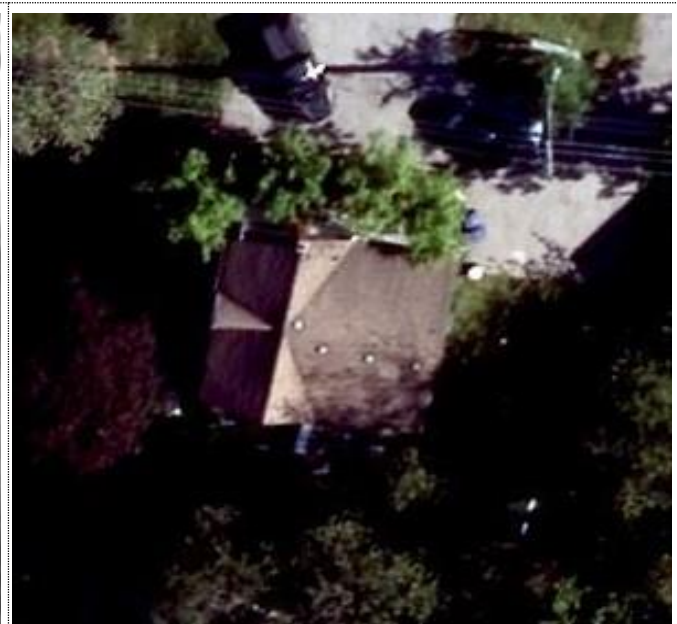
Photographic image of 99 Nashville Road in (2016). Note, east addition as well as the south extension to the original structure has been extensively altered including roof lines and the addition of a false dormer.
