05 May 2020

**ATTACHMENT 3**

Re: Beaverbrook Heritage Home, Vaughan  
Load Review Report

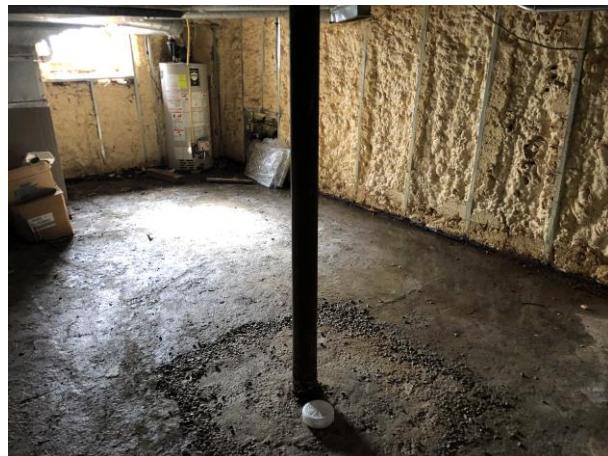
- The basement floor was observed to be a concrete slab on grade. Refer to photo 3.
- It was observed at the basement that the existing floor structure above was exposed to view. Refer to photo 4.

- It was observed on site that at the basement, the existing floor joist above were typically 2"x10" wood joists spaced at 16" on centre, supported by a centre 10"x10" wood beam. There was also observed a timber posts and several steel posts, and it appeared that concrete footings were previously installed below grade (as per the change in concrete surface immediately around the steel posts). Refer to photos 3-5.

Photo 3- Basement Level

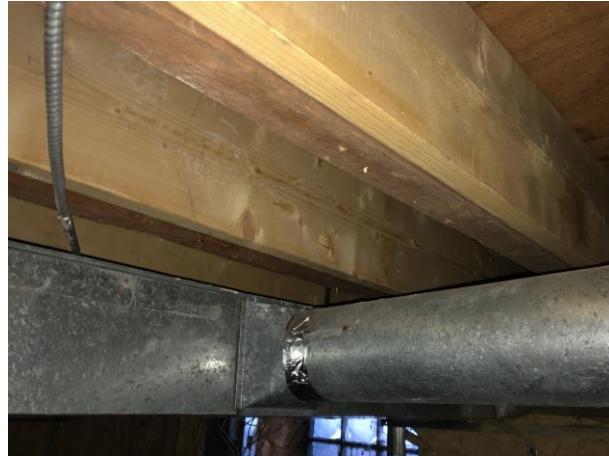
- It was observed that there was standing water and high humidity in the basement.
- It was observed that in certain sections of the basement, the floor joists above were sistered full length. Refer to photo 4.

Photo 4- Sistered Basement Joists

Based on the above information, it is our opinion that the base building ground floor structure requires reinforcement for the proposed office usage. The existing floor joists where not sistered are undersized for the proposed live loads or are currently showing signs of wood creep and excessive deflection. We recommend that all the existing floor joists and stair beams be sistered. We also recommend that the existing wooden post is to be replaced by a new steel posts, and the existing damaged steel post bases be removed and repaired. New concrete footings are to be poured atop the existing

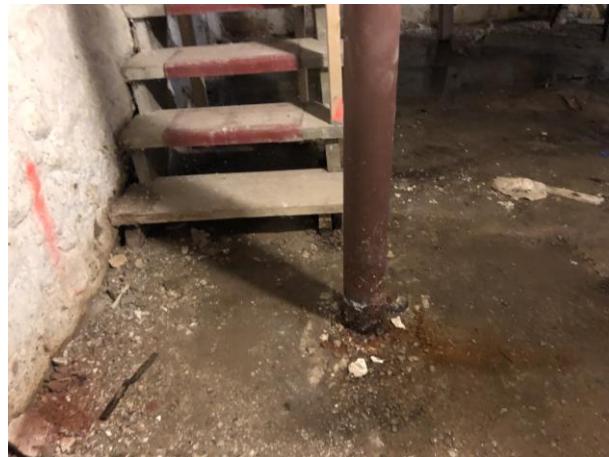
- It was observed on site that there appeared to be significant corrosion at the base of the steel posts at the basement. Refer to photos 5 & 6.
- At the ground floor there was observed to be cracking in the wall finishes and the ground floor appeared to be visually sagging. Refer to photo 7.

Photo 5- Existing Basement Steel Posts

slab on grade to give standoff from the standing water, with all new and existing steel coated with a zinc rich paint primer system to protect from further moisture damage.

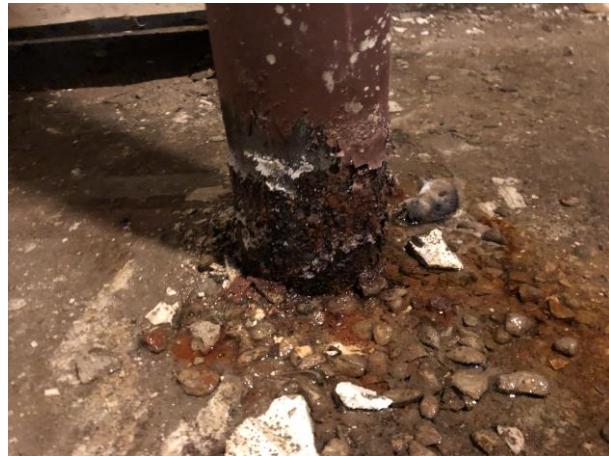
Photo 6- Corrosion at Base of Steel Posts

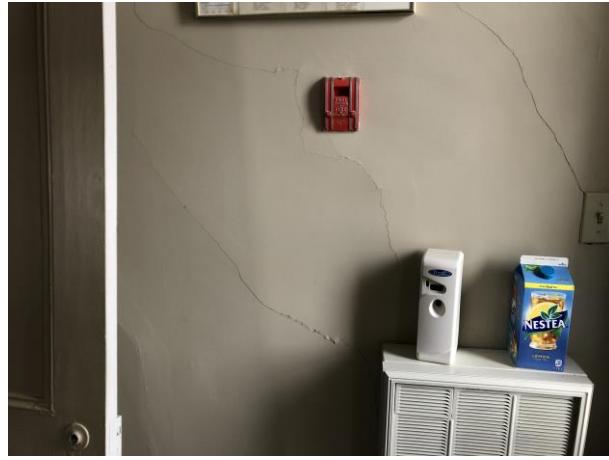
Photo 7- Ground Floor Wall Finish Cracking

Based on the above information, it is our opinion that the base building 2<sup>nd</sup> floor structure can safely sustain the loads imposed by the proposed office usage. Once the ground floor structure has been retrofit, all damaged wall finishes, or are to be repaired. The existing finishes are to be monitored for future cracking; if cracking is observed they should be reviewed by a qualified structural consultant.

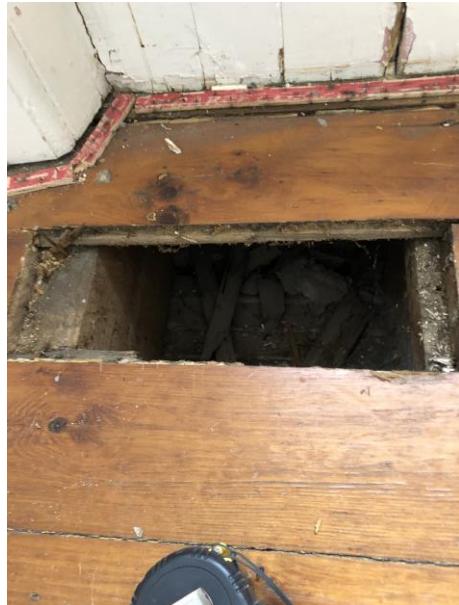
- At the 2<sup>nd</sup> floor, there was observed to be several localized openings in the floor to view the existing structure below. Refer to photo 8.
- It was observed that at the 2<sup>nd</sup> floor that the existing floor structure was typically constructed of 2"x10" timber joists spaced at 16" on centre.
- The 2<sup>nd</sup> floor joists were observed to be supported by timber and masonry load bearing walls below.
- The existing 2<sup>nd</sup> floor walls were observed to be 2"x4" stud walls with plaster and lathe finishing.
- There was cracking observed in the wall finishes at the existing 2<sup>nd</sup> floor. Refer to photo 9.

Photo 8- 2<sup>nd</sup> Floor Discrete Opening

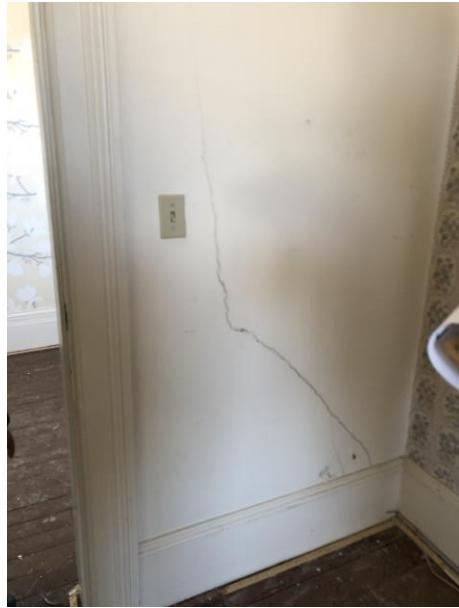
Photo 9- 2<sup>nd</sup> Floor Wall Finish Cracking

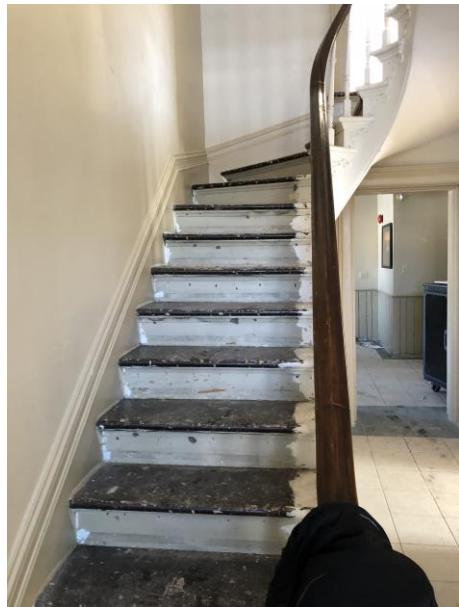
- The existing main stair was observed to be a timber framed straight flight that curved at the top. Refer to photo 10 & 11.
- The structure of the existing stair was observed through discrete openings at the underside plaster finish of the stair soffit.
- The lower straight section of the stair was observed to be supported by 2"x4" stud walls on each edge of the stair. At the curved upper portion, the stair was observed to be constructed of a curved centre timber joist.
- The existing stair was observed to be in a poor condition, with noticeable bouncing when walking up and down the stairs.
- We understand that the main stair is a listed heritage component.

Photo 10- Main Staircase

Based on the above information, it is our opinion that the existing main stair requires significant retrofit to be usable, as replacement may not be an option due to heritage concerns. Retrofit may require installation of curve steel supports and may also require installation of new steel beams and posts at the ground and 2<sup>nd</sup> floor to accommodate the stair retrofit. Alternatively, we recommend that the stair be closed off from pedestrian/egress access and usage.

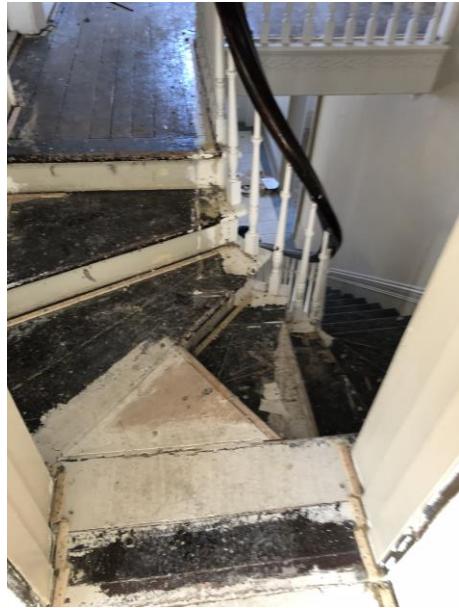
Photo 11- Top Landing Main Staircase

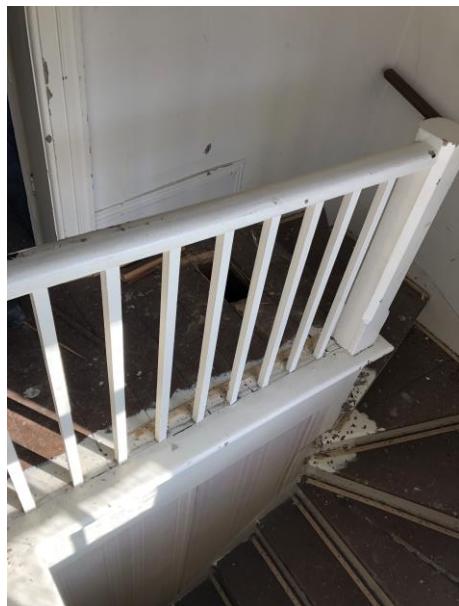
- The existing rear stair was observed to be a timber framed straight flight stair with a 180 degree turn at the top. Refer to photo 12.
- The stair was observed to be supported at each side by timber framed stud walls.
- The stair was observed to be in good condition, with no noticeable sagging or excessive bounce.

Based on the above information, it is our opinion that the existing rear stair can safely sustain the loads imposed by the proposed corridor/egress usage without reinforcement.

Photo 12- Rear Staircase
