Revised
Heritage Evaluation of Existing Structures
10568 Islington Avenue, Kleinburg, ON
In the City of Vaughan

Phillip H. Carter Architect and Planner
And
Paul Oberst Architect

December 2019

This document is a preliminary heritage evaluation in preparation for a Heritage Impact Assessment to be completed at a later date.

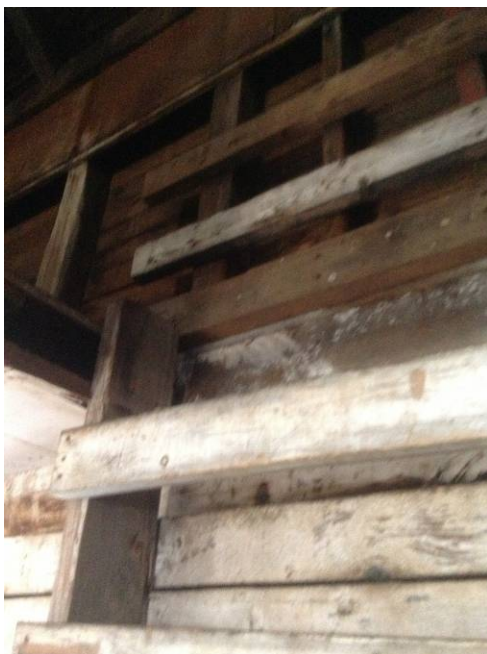
Figure 12. Top of the ladder shows large header on top of lower plank on plank wall, supporting frame of loft level. It's possible that the loft was added later.

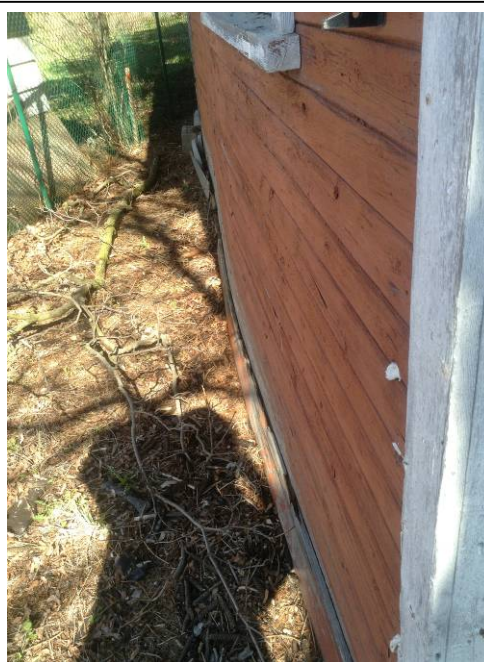
The siding on the garage and the shed-roof extension on the drive shed being 1x6 v-joint material in contrast to the 1x4 boards on the drive shed. This suggests that the extension is contemporaneous with the garage. The uniform exterior of the drive shed conceals the construction beneath, where the lower level appears to be of plank-on-plank construction, while the upper level is barn framed with posts, braces, and infill studding, resting on a header on top of the lower wall. Our timber specialist, Vic Snow, tells us that there are some similarly constructed barns in King Township. There is no stone foundation evident, and the lower boards on the south end of the west wall are bowed and deteriorated (see Figure 13).

Figure 13. There is a significant bow at the base of the west wall near the south corner.

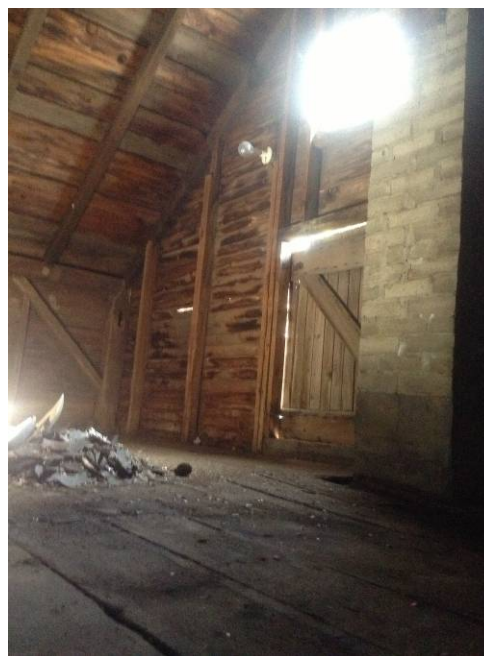
Figure 14. The upper level is barn framed with corner posts, braces, and infill studding. Brick chimney is visible on the right. It is at the centre of the south gable. Water damage to the sheathing boards is visible. Daylight is coming through one gap to the left. Note brick chimney to right of loading door.

1. Except for a side view of its gable roof, the drive shed is concealed by the large three-car garage set in front of it, as seen from Islington Avenue. The garage in front, and the contemporaneous extension to the north are without heritage value. The sheathing appears to have suffered some damage from water infiltration. Additionally, the bowing of the wall which is in contact with the soil, and the removal of the siding adjacent to the garage makes it an unlikely candidate for conservation or re-use.

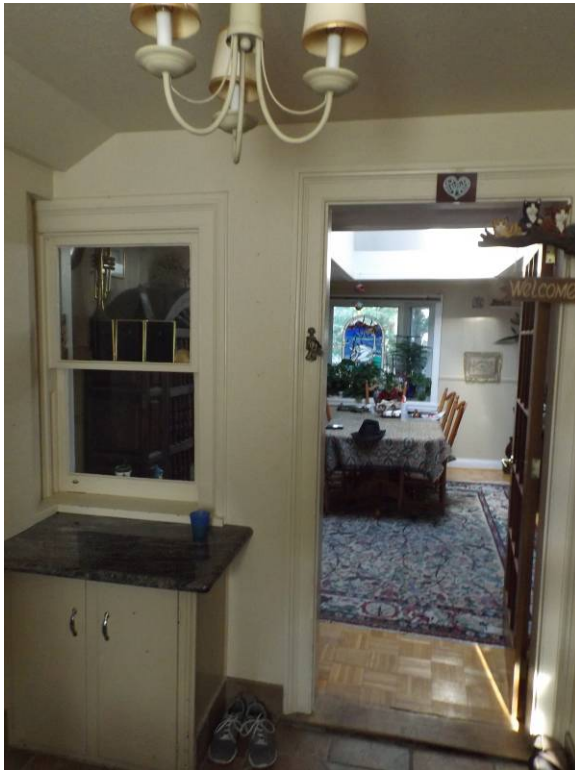
Figure 20. Looking from the entry door into the central 1-storey dining room. We believe this window and door openings were once in the exterior wall of the tail of the house.

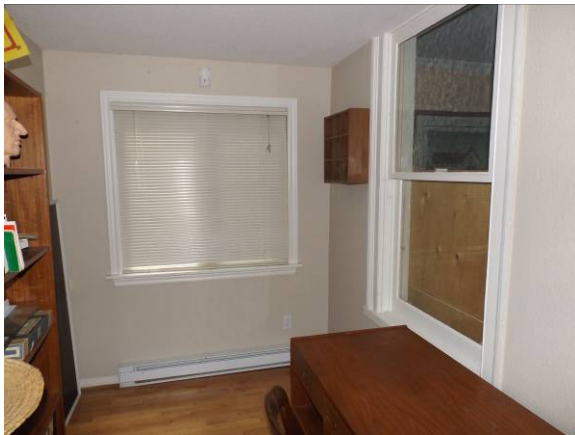
Figure 21. Ground floor, verandah, looking south. The window on the right looks into the front room. We believe it is in an original exterior opening, left from the previous version of the house. Being interior, it didn't require a thermal upgrade when the last alterations occurred. This window and the matching one behind us are the only surviving exterior elements of the mid-20th century iteration of the building.

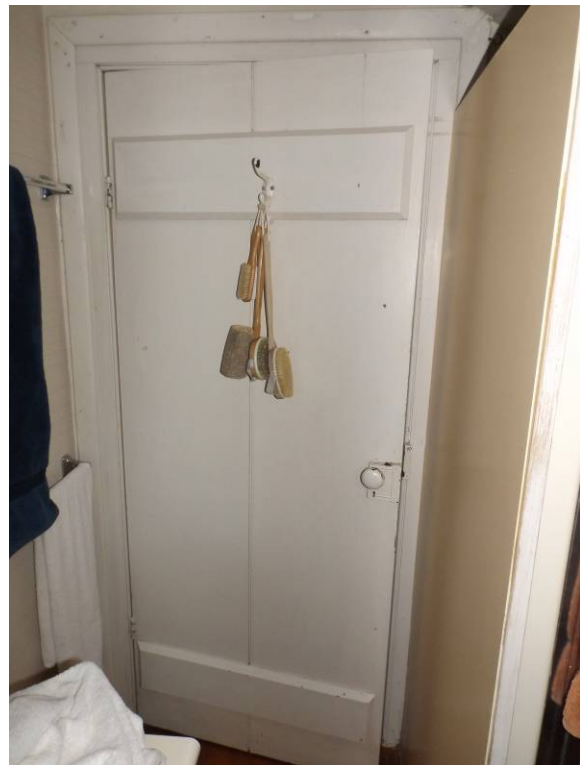
Figure 28. Second floor, very wide plank door. The bathroom and the tiny bedroom are the only two rooms that retain these doors.

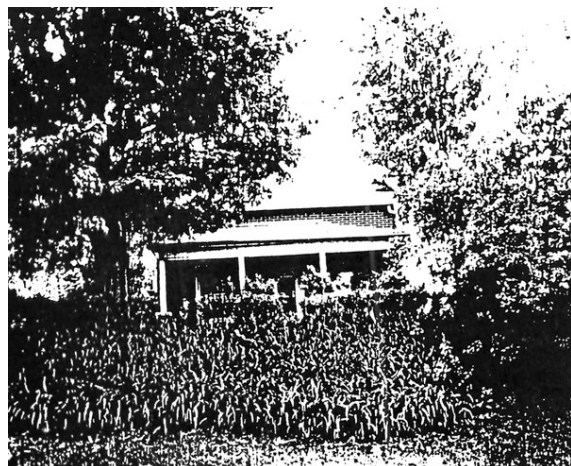
Figure 42. Image from 1993 Preliminary Study for a Kleinburg HCD, showing insulbrick siding which was removed to install the current stucco finish..

There is a very poor photograph in a 1993 study, which is shown in Figure 42. This seems to show a brick house, but the current owner was told by the prior owner that the house was once clad in insulbrick-type asphalt siding.

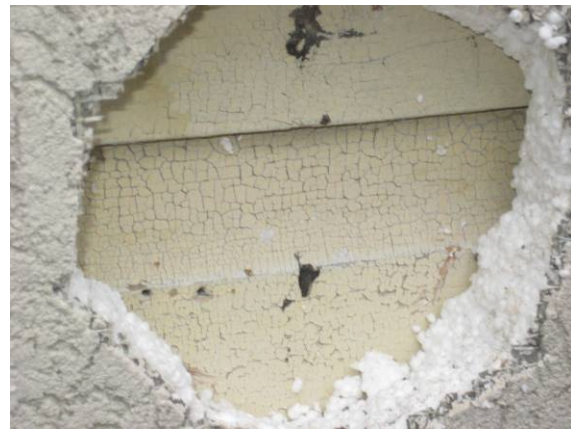
We removed a patch of the recent EIFS stucco finish on the north side of the house, as seen in Figure 43. It is evident that the insulbrick was removed prior to the application of the stucco which was installed over the prior wood siding. We found wood siding under the stucco. The siding is milled to a drop channel pattern profile, which became popular around 1880, although it had originally appeared earlier. The rabbetted channel of the upper part of the board is unusually wide. The same siding profile is found on 10454 Islington across the street, and a similar profile, though with narrower channel, is found in the house immediately to the north at 10576 Islington Avenue. The front verandah on 10576 is similar to that on 10454.

Figure 43. Cut out of recent EIFS stucco over Styrofoam, showing underlying wood drop channel shiplap siding. We believe the nail holes once secured the insulbrick siding.

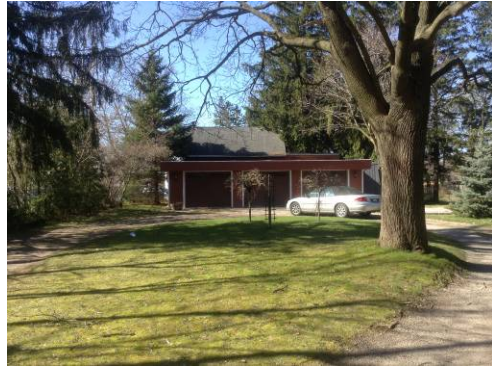
Figure 47. From Islington Avenue, the drive shed is almost entirely concealed by the 1957 garage addition.

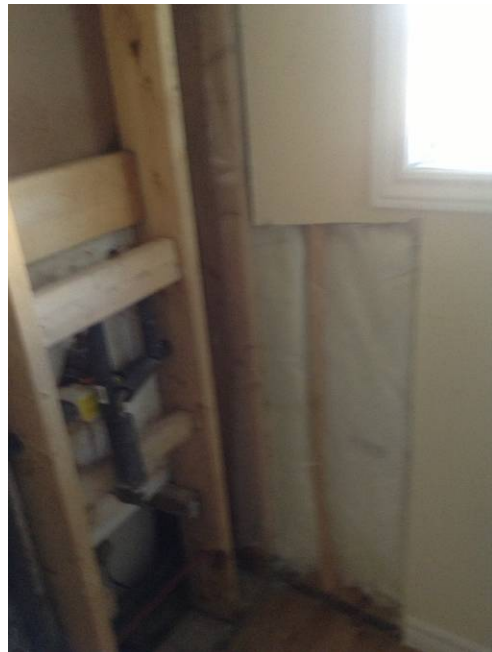
2. The north end wing of the secondary dwelling is recent and has no heritage value as shown by exposed construction. Whatever character the larger southern portion may have had is no longer recoverable. It not possible to know what the original use of this building was. In our professional opinion it is unlikely to have been a blacksmith shop.

Figure 48. Modern framing in the north wing of the secondary dwelling.

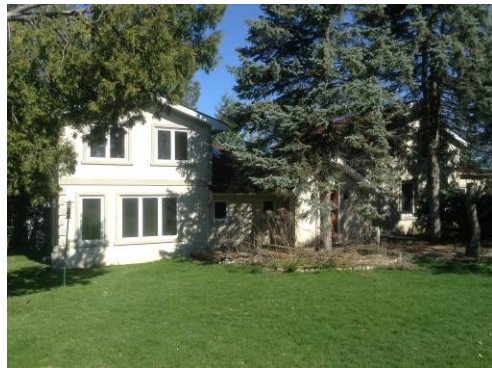
3. The original architectural character of the principal dwelling has also been concealed by its recent EIFS stucco finish, the erection of additions in the middle and back of the building, and the fitting of modern replacement doors and windows and their trim. There are no longer any heritage-defining characteristics on the exterior of the building other than the basic shape of the main front portion of the original house. The original tail is buried in the later additions, and no longer legible.

Figure 49. The original attributes of the principal dwelling have been removed or concealed by 20th century alterations.
