# STRUCTURAL REVIEW REPORT

*8811 HUNTINGDON ROAD (HENRY BURTON HOUSE), WOODBRIDGE, ON*

18107463

July 28, 2020

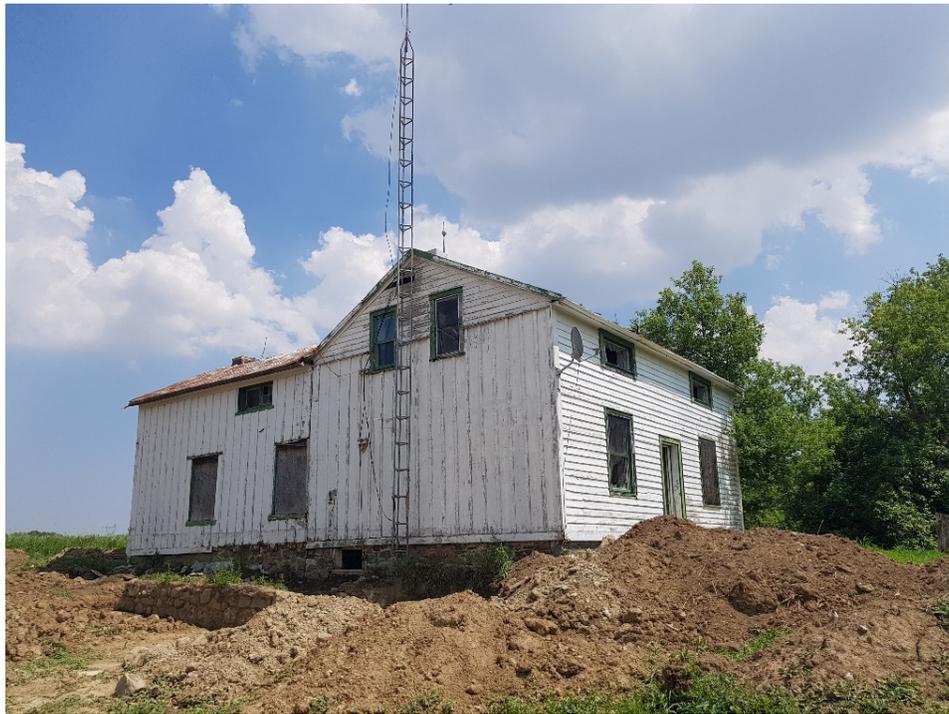
Figure 1: West and north façades.

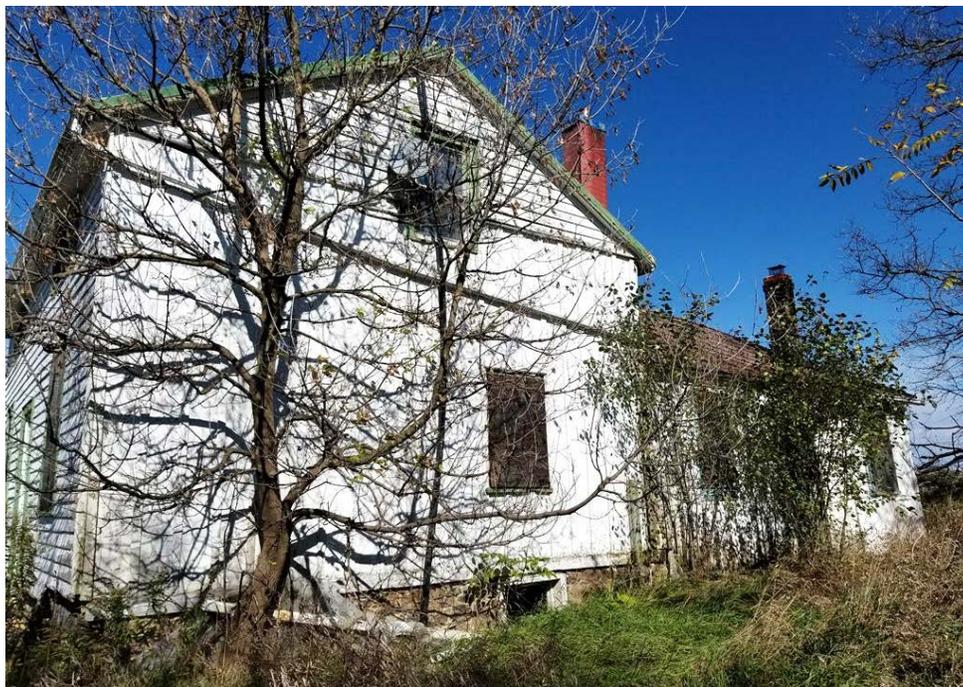
Figure 2: South façade.

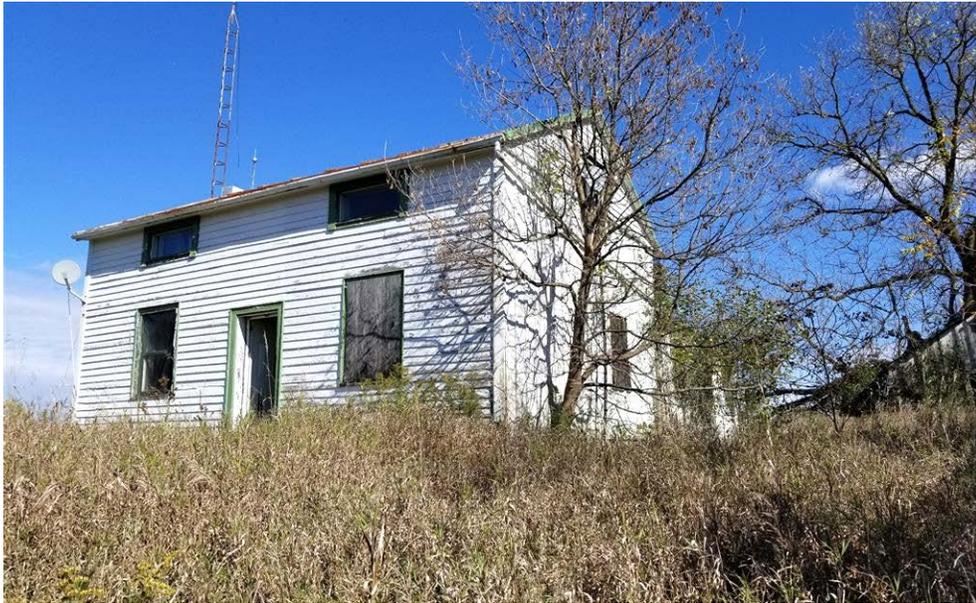
Figure 3: South and west façades.

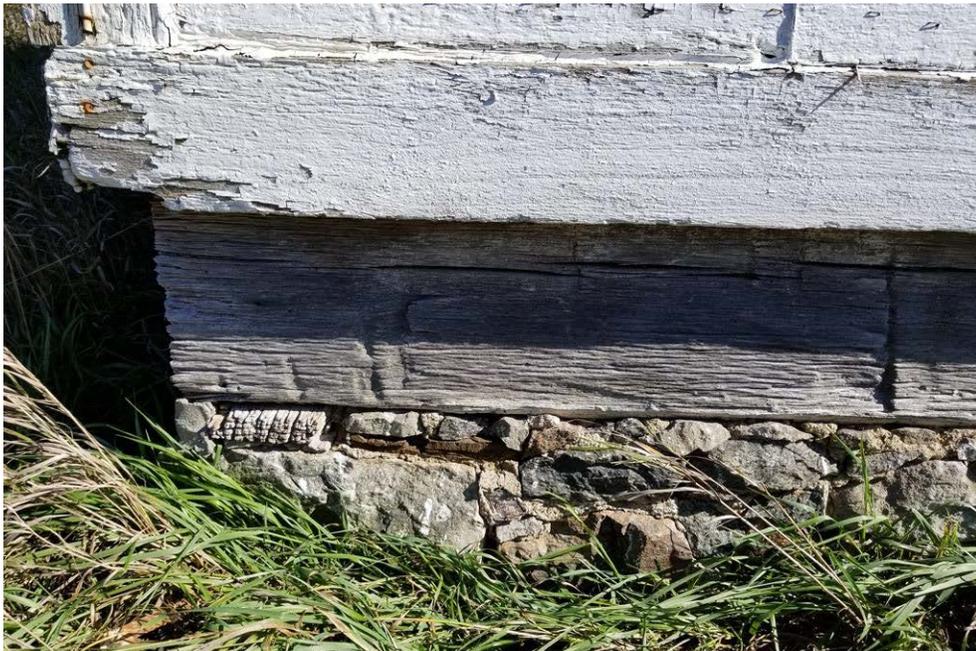
Figure 4: Coursed rubble foundation of the Main Block.

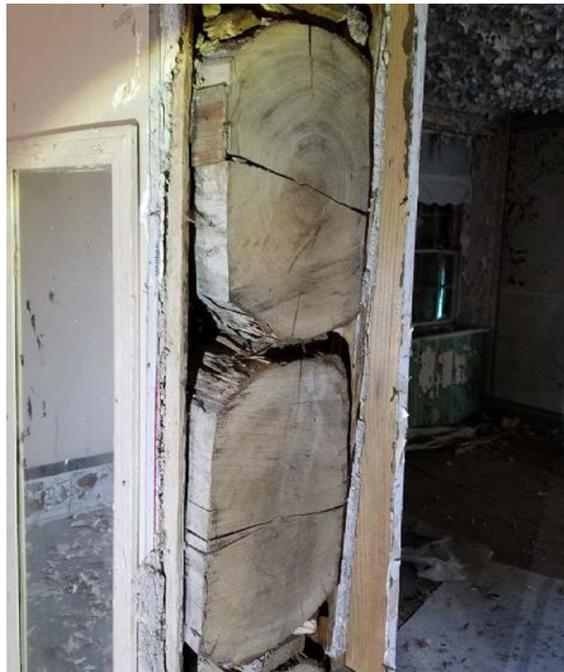
The doorway that opens into the East Wing exposes the interior construction of the Main Block walls: partially shaped logs, indicating that a portion of the structure is a log house covered by siding (Figure 6). These logs were felled and cut using a crosscut hand saw, based on the non-parallel straight lines, which suggest hand sawing over a band saw, and are present on the exposed end surfaces of the wood, and did not have the bark removed from the upper and lower sides of the log before shaping and construction of the house (Figure 7). Plaster is visible on both sides of the logs, indicating plasters walls in both the Main Block and the East Wing. The large lintel over the doorway shows evidence of drill or wedge marks and split in order to create the flat beam. Vertical hand-split lath is present on the Main Block side of the doorframe (Figure 8).

**Figure 6: Interior east log wall on the Main Block.**

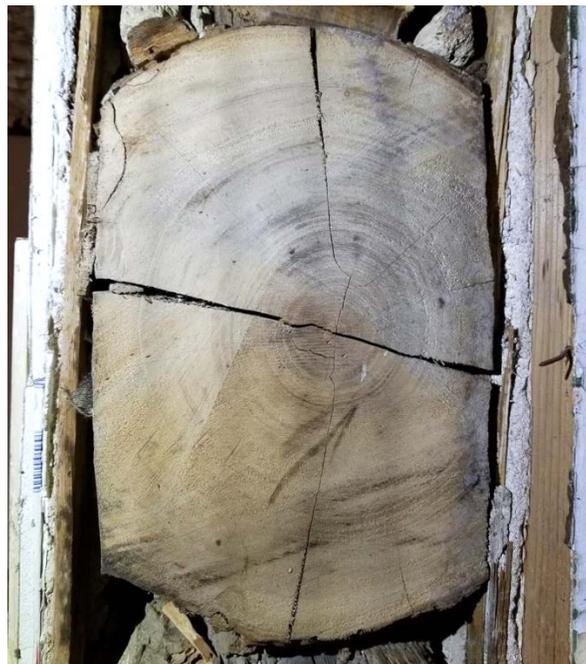
**Figure 7: Cross-cut saw marks.**

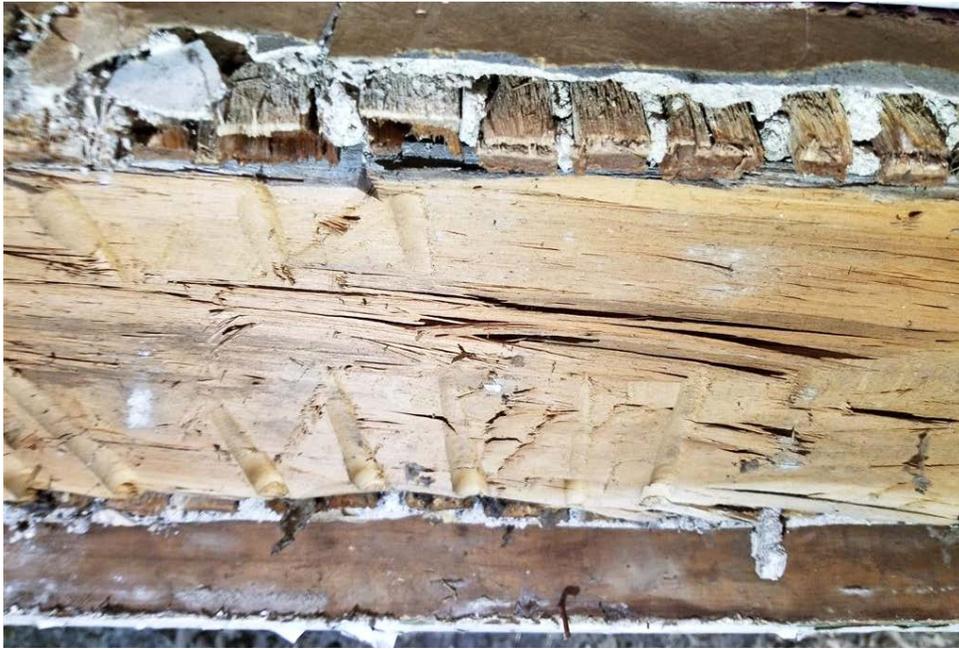
**Figure 8: Detail of top of the doorway, showing split log and vertical lath and plaster.**

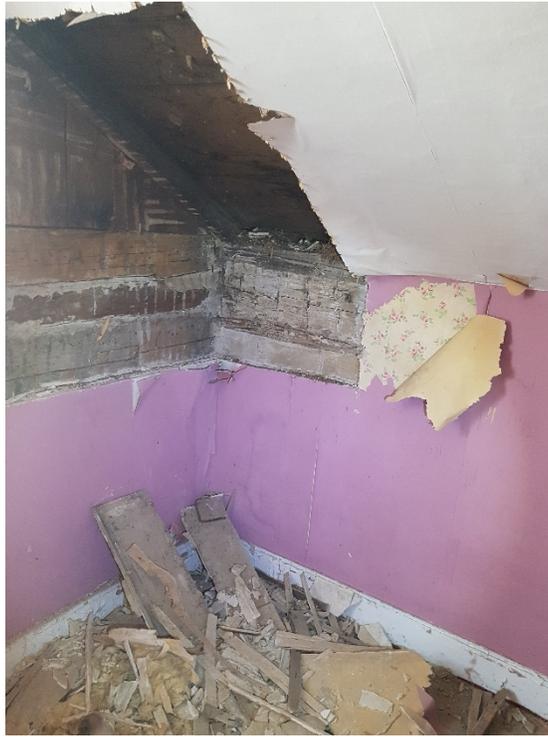
The second storey of the Main Block is separated into three rooms. A wall running through the middle of the space sections off two identically sized bedrooms, each with a window at the north wall. Floorboards on the second storey are very wide hardwood planks that likely date to the original construction of the residence (Figure 12).

**Figure 12: Northeast bedroom, second storey. Note the wide baseboards.**

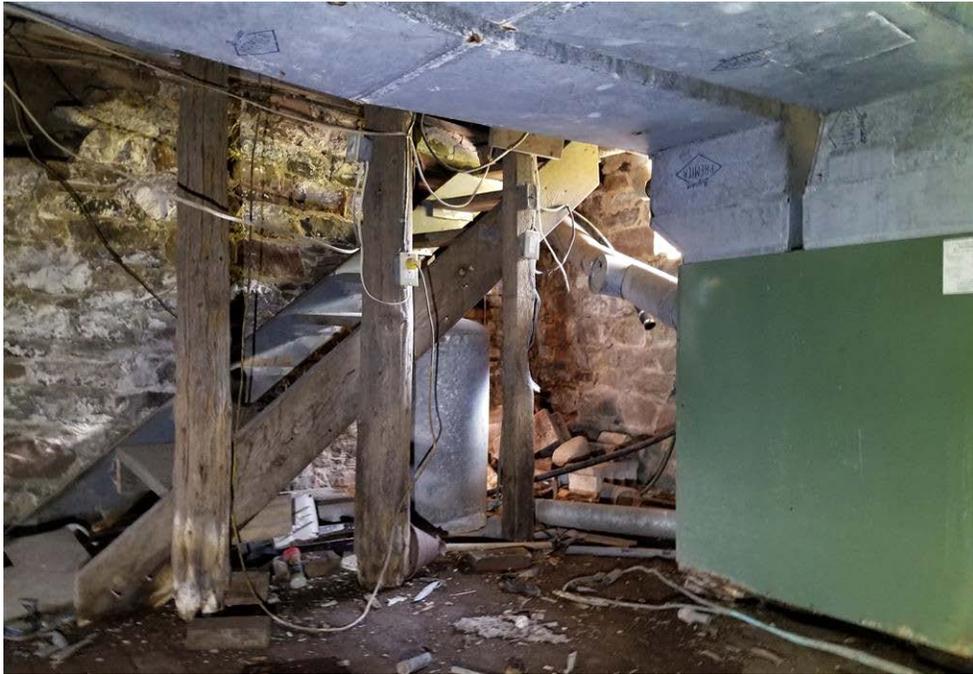
**Figure 13: Stairs in the southeast corner of the basement, with three support posts.**

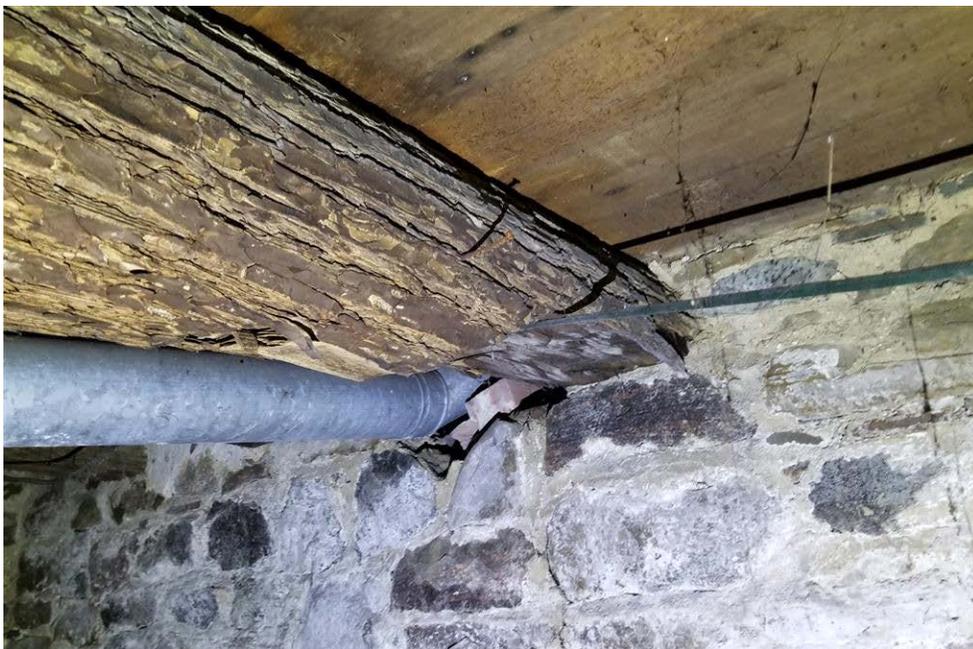
**Figure 16: Example of overhead sleeper.**

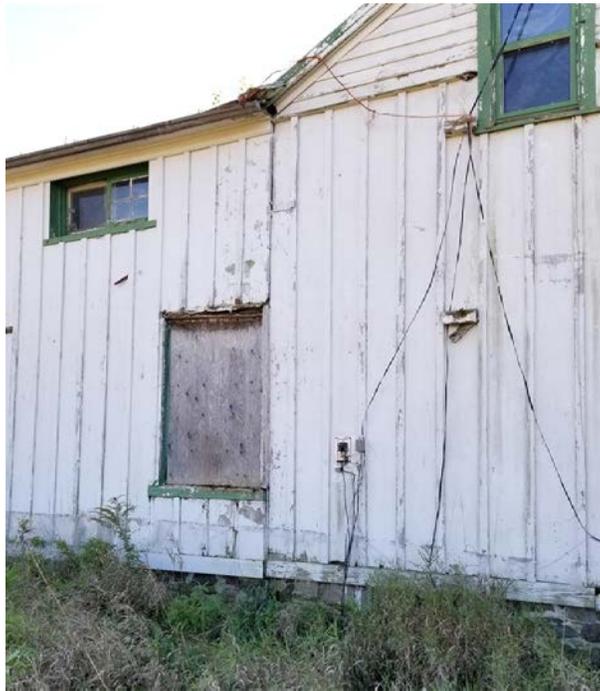
**Figure 20: Visible joint between East Wing and Main Block. Note the small horizontal sliding window.**

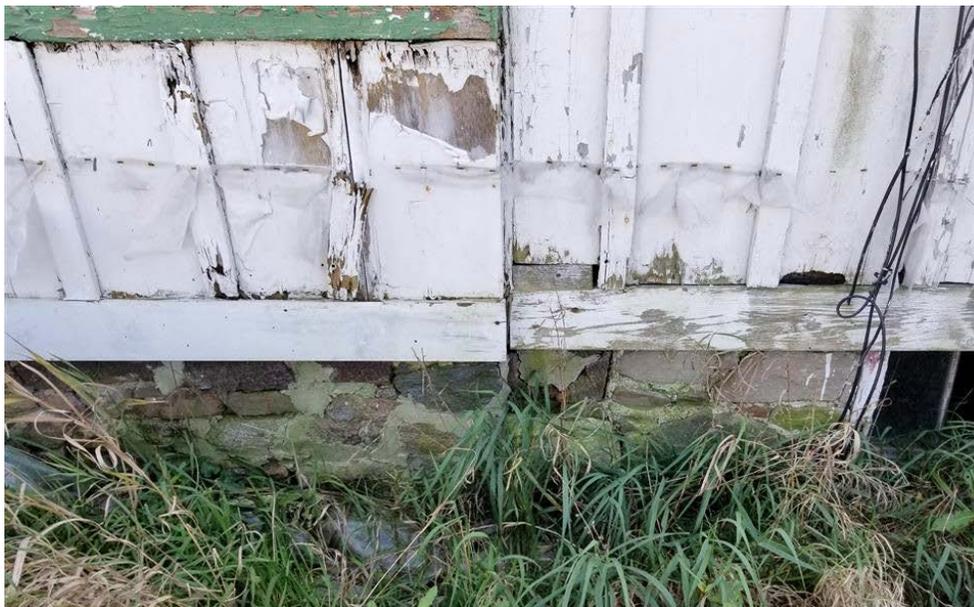
Sitting on a coursed rubble foundation similar to that of the Main Block, there is a visible joint between the two structures (Figure 20 and Figure 21). Only the north and east walls of the structure are visible from the exterior, due to its connections to the Main Block to the west and the South Addition to the south.

**Figure 21: Joint visible in foundation in East Wing and Main Block.**

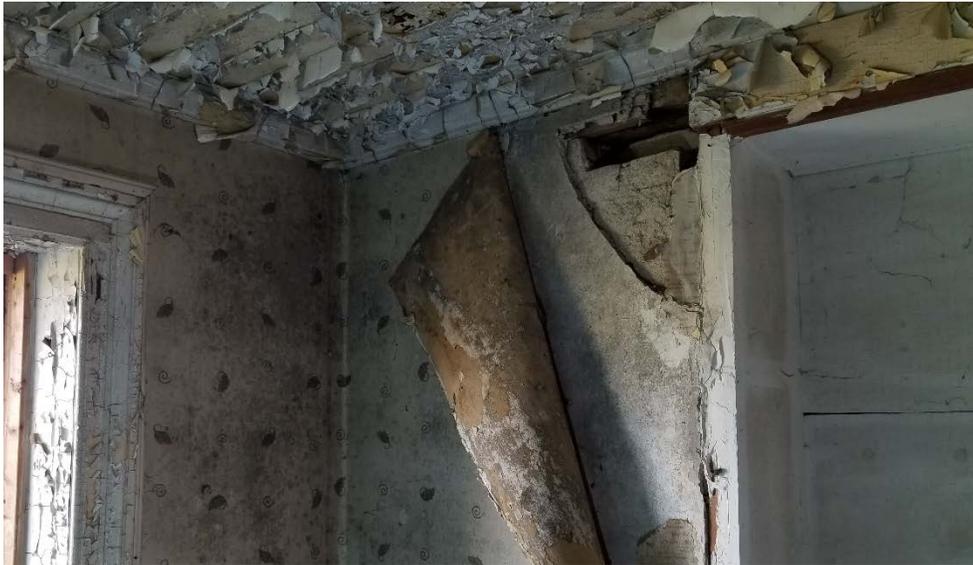
The East Wing can be entered from the exterior door on the east façade, or through the adjoined Main Block door on the west interior wall. The ground floor itself has only one, large room, and it was likely added as an extension for kitchen space to the structure. While the exterior walls of the Wing are covered by wood siding, brick is exposed around a blind window on the south interior wall, suggesting that the entire wing is likely constructed from brick (Figure 22).

**Figure 22: Bricks visible behind wallpaper and plaster, southeast corner of the ground floor room.**

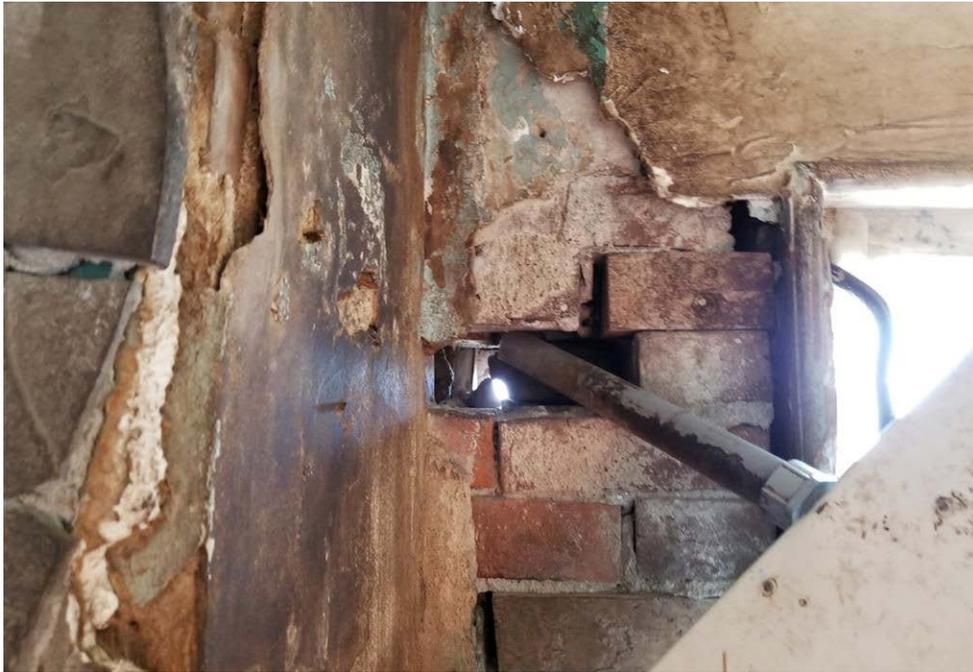
At the top of the north staircase (Figure 23), the East Wing's second storey does not connect to that of the Main Block. This level is divided into two rooms, an east and a west, that comprise the entire floor. Directly adjacent to the staircase on the east wall is a large brick chimney with a stove flashing near the roof, which has been covered over in stones and cement, but has since been decommissioned (Figure 24). Brick is visible beneath the plaster on the exterior walls as well, confirming the brick construction of the Wing (Figure 25).

Figure 25: Detail of brick wall on east side of the Wing.

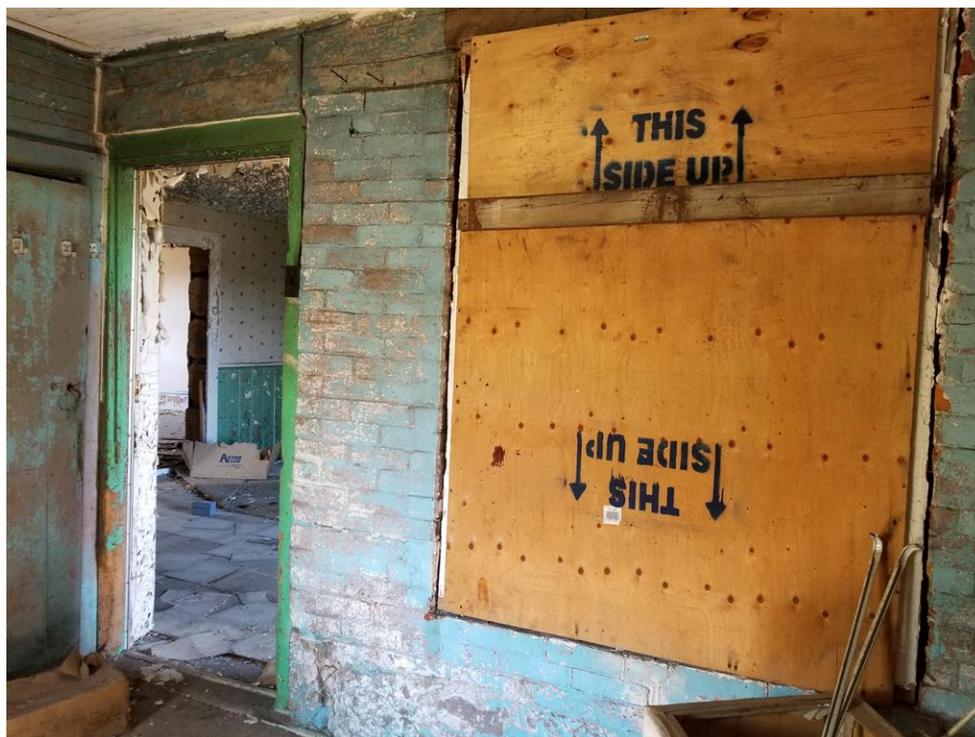
The South Addition has an east and a west room. Within the east room, a blind window and exposed brick wall suggest that the Addition was constructed as an extension of the East Wing (Figure 28). The east wall is covered with plaster and paint, and a stove flashing with a brick flue extends upwards from the centre of the wall (Figure 29). Rotten wood-panels on the ceiling have fallen away at the east end of the room, exposing wood framing above. A large wood beam extends between the East Wing and the South Addition with adze marks (Figure 30). This beam is likely part of the frame of the East Wing. Stretcher bond makes up the visible brick wall, which used to be an exterior wall.

Figure 28: Brick wall on north side of South Addition.
