## **Cultural Heritage Impact Assessment**

John Fleming House, 9151 Huntington Road, Lot 15, Concession 9, City of Vaughan, Regional Municipality of York, Ontario

18107463-R02-Rev1

13 March 2020

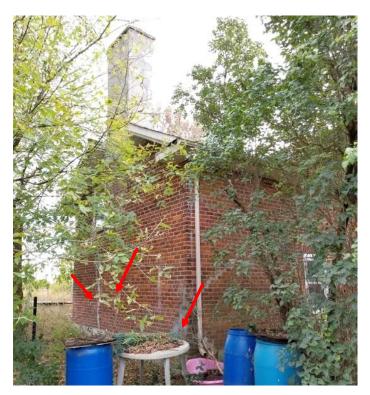
The north, east and west walls of the East Wing have experienced significant structural damage, as evidenced by the presence of tie rods, repaired cracking and patchy color of large brick areas (Figure 50). Thus, relocation of the East Wing may be difficult.

Figure 49: North and east façades of the East Wing. Note, extensive damage and repair to the east wall (red)

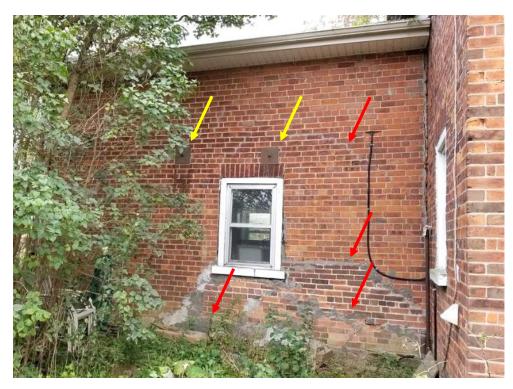
Figure 50: Extensive damage and repair to the north wall (red). Note the metal rods to secure the wall (yellow).

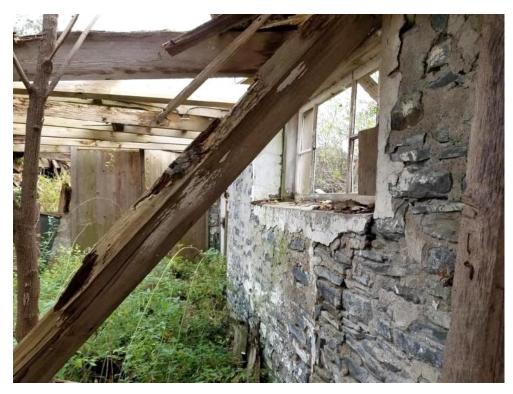
All that remains of the barn is a portion of the stone foundation. The coursed stone foundation presents asymmetrical fenestration with 10-pane fixed wood windows with flat head openings and no exterior decoration (Figure 60 and Figure 61). Exterior doors on the surviving west wall are plain wood. Interior beams which would have supported the floor above have decayed and cracked, and there is not much left inside the barn (Figure 62 to Figure 64).

Figure 62: Interior of the collapsed barn.

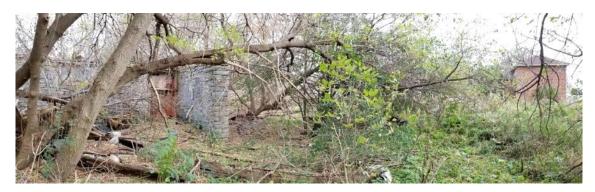
Figure 64: Panorama of the collapsed barn in relation to the farmhouse visible to the southwest.

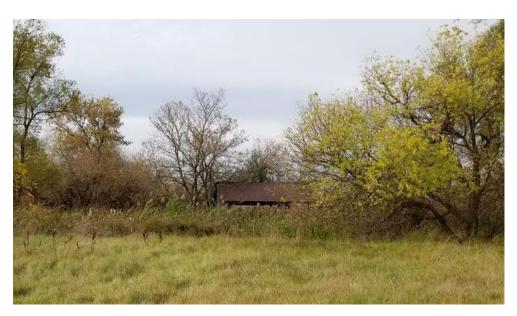
This 20<sup>th</sup>-century structure has a medium gable roof with a wood frame, currently in a state of collapse. Much of the wall material has rotted away, leaving the support posts in place (Figure 65). It was sided with vertical wood planks and is currently leaning to the east (Figure 66).

Figure 65: Northeast outbuilding, looking north.

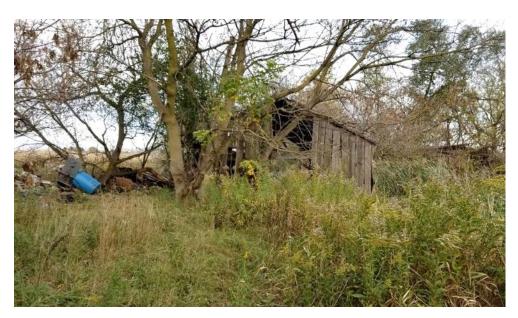
Figure 66: The west façade of the northeast outbuilding.

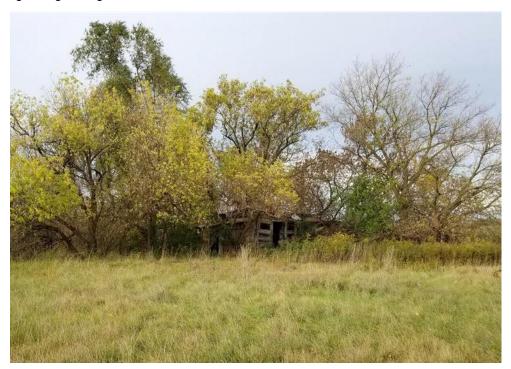
The mid-20<sup>th</sup> century East Outbuilding is a one-storey, wood frame structure with a low gable roof (Figure 67). It is currently surrounded by trees on the east side of the residential area and is barely visible within the trees and bushes that are growing through the structure.

Figure 67: East outbuilding.
