Revised  
Heritage Evaluation of Existing Structures  
10568 Islington Avenue, Kleinburg, ON  
In the City of Vaughan

Phillip H. Carter Architect and Planner  
And  
Paul Oberst Architect

December 2019

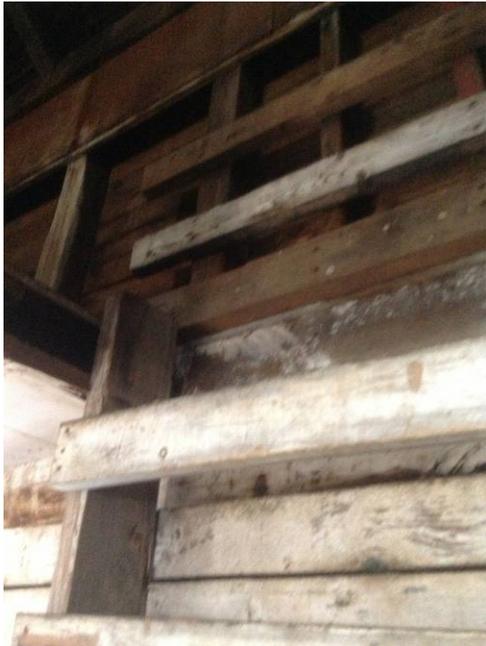
Figure 12. Top of the ladder shows large header on top of lower plank on plank wall, supporting frame of loft level. It's possible that the loft was added later.

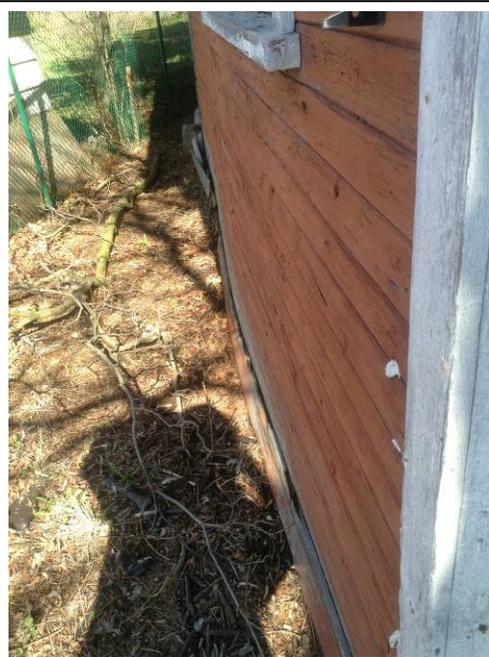
The siding on the garage and the shed-roof extension on the drive shed being 1x6 v-joint material in contrast to the 1x4 boards on the drive shed. This suggests that the extension is contemporaneous with the garage. The uniform exterior of the drive shed conceals the construction beneath, where the lower level appears to be of plank-on-plank construction, while the upper level is barn framed with posts, braces, and infill studding, resting on a header on top of the lower wall. Our timber specialist, Vic Snow, tells us that there are some similarly constructed barns in King Township. There is no stone foundation evident, and the lower boards on the south end of the west wall are bowed and deteriorated (see Figure 13).

Figure 13. There is a significant bow at the base of the west wall near the south corner.

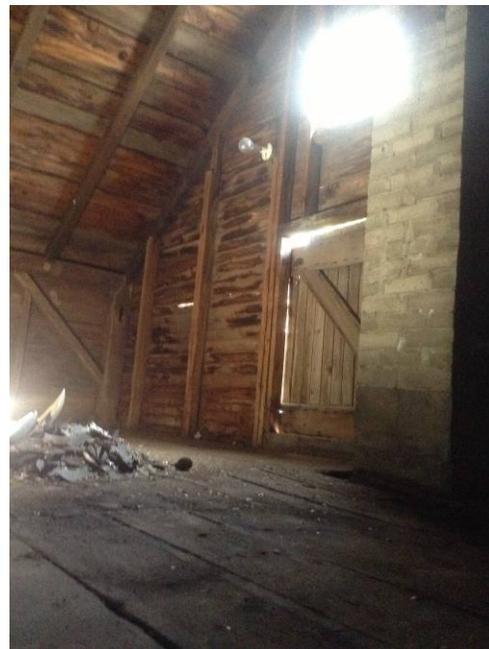
Figure 14. The upper level is barn framed with corner posts, braces, and infill studding. Brick chimney is visible on the right. It is at the centre of the south gable. Water damage to the sheathing boards is visible. Daylight is coming through one gap to the left. Note brick chimney to right of loading door.

1. Except for a side view of its gable roof, the drive shed is concealed by the large three-car garage set in front of it, as seen from Islington Avenue. The garage in front, and the contemporaneous extension to the north are without heritage value. The sheathing appears to have suffered some damage from water infiltration. Additionally, the bowing of the wall which is in contact with the soil, and the removal of the siding adjacent to the garage makes it an unlikely candidate for conservation or re-use.

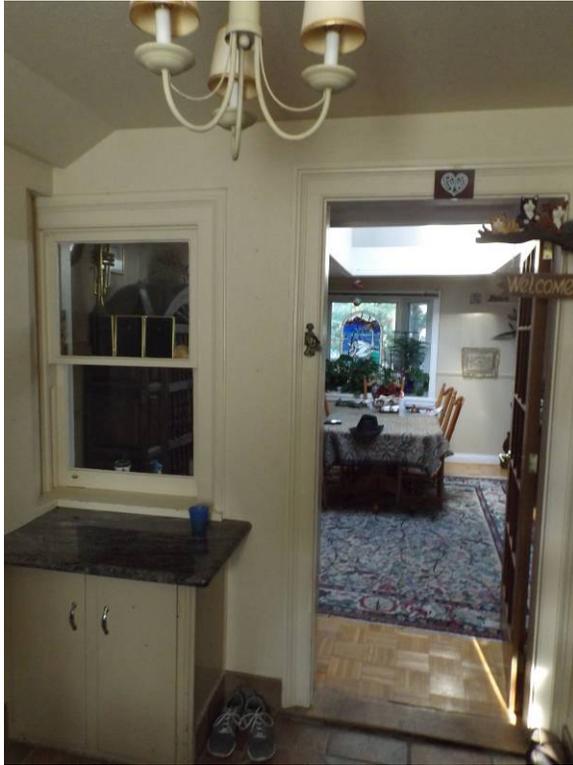
Figure 20. Looking from the entry door into the central 1-storey dining room. We believe this window and door openings were once in the exterior wall of the tail of the house.

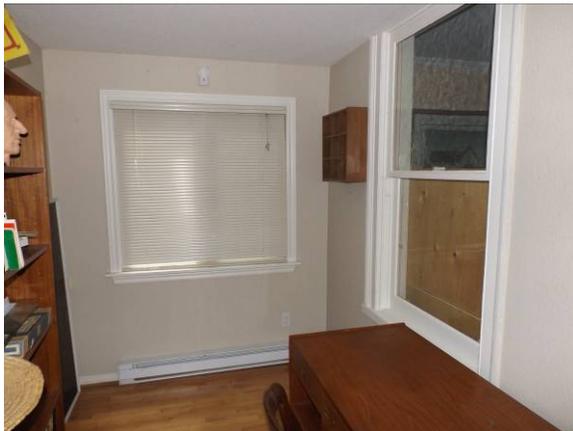
Figure 21. Ground floor, verandah, looking south. The window on the right looks into the front room. We believe it is in an original exterior opening, left from the previous version of the house. Being interior, it didn't require a thermal upgrade when the last alterations occurred. This window and the matching one behind us are the only surviving exterior elements of the mid-20<sup>th</sup> century iteration of the building.

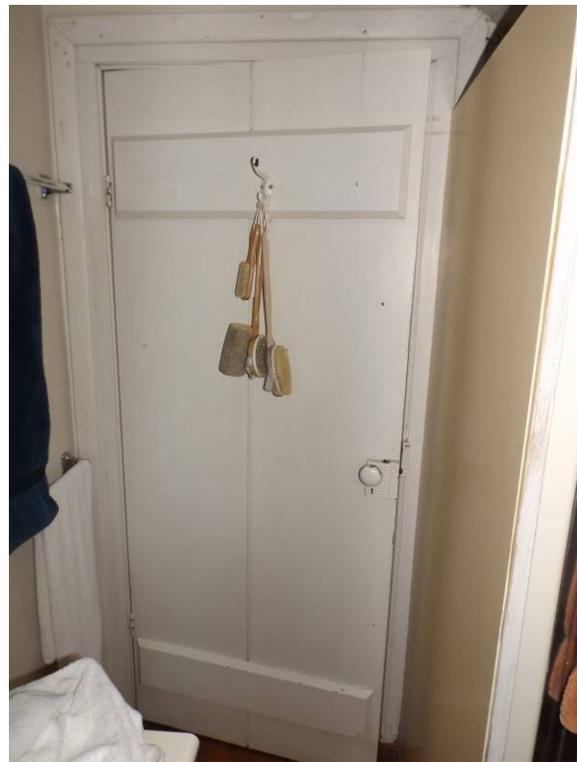
Figure 28. Second floor, very wide plank door. The bathroom and the tiny bedroom are the only two rooms that retain these doors.

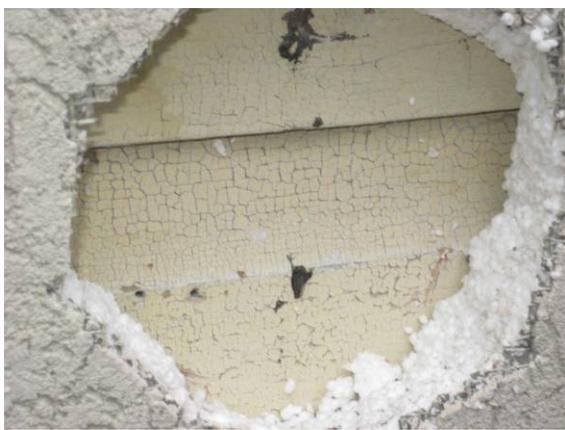
We removed a patch of the recent EIFS stucco finish on the north side of the house, as seen in Figure 43. It is evident that the insulbrick was removed prior to the application of the stucco which was installed over the prior wood siding. We found wood siding under the stucco. The siding is milled to a drop channel pattern profile, which became popular around 1880, although it had originally appeared earlier. The rabbetted channel of the upper part of the board is unusually wide. The same siding profile is found on 10454 Islington across the street, and a similar profile, though with narrower channel, is found in the house immediately to the north at 10576 Islington Avenue. The front verandah on 10576 is similar to that on 10454.

Figure 43. Cut out of recent EIFS stucco over Styrofoam, showing underlying wood drop channel shiplap siding. We believe the nail holes once secured the insulbrick siding.

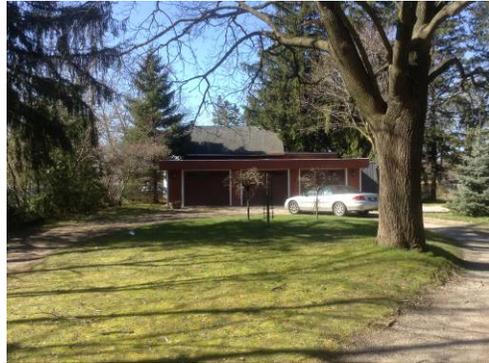
Figure 47. From Islington Avenue, the drive shed is almost entirely concealed by the 1957 garage addition.

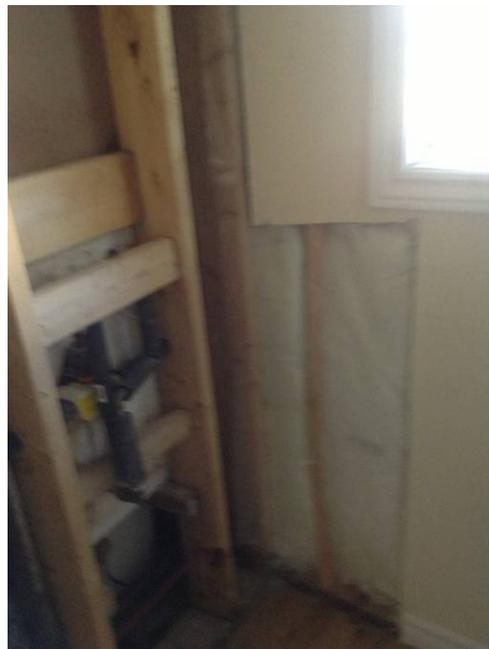
2. The north end wing of the secondary dwelling is recent and has no heritage value as shown by exposed construction. Whatever character the larger southern portion may have had is no longer recoverable. It not possible to know what the original use of this building was. In our professional opinion it is unlikely to have been a blacksmith shop.

Figure 48. Modern framing in the north wing of the secondary dwelling.

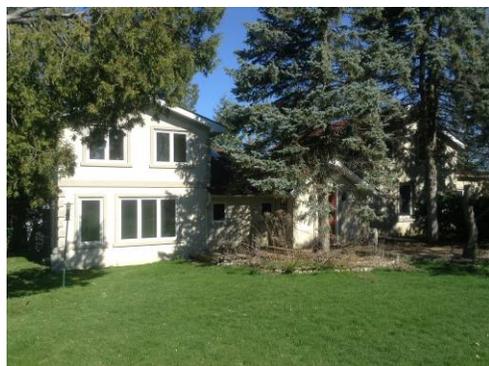
3. The original architectural character of the principal dwelling has also been concealed by its recent EIFS stucco finish, the erection of additions in the middle and back of the building, and the fitting of modern replacement doors and windows and their trim. There are no longer any heritage-defining characteristics on the exterior of the building other than the basic shape of the main front portion of the original house. The original tail is buried in the later additions, and no longer legible.

In our professional opinion, a successful restoration of the 19<sup>th</sup> century portion of the building is unlikely to be practical. Removal of the stucco encasement will likely reveal damaged siding and missing details of corner boards, fascias, trims and other details. The

Figure 49. The original attributes of the principal dwelling have been removed or concealed by 20<sup>th</sup> century alterations.
