46 CENTRE STREET, VAUGHAN CONSERVATION PLAN

REV. I - FINAL

AUGUST 13, 2020

COMMON
BOND
COLLECTIVE

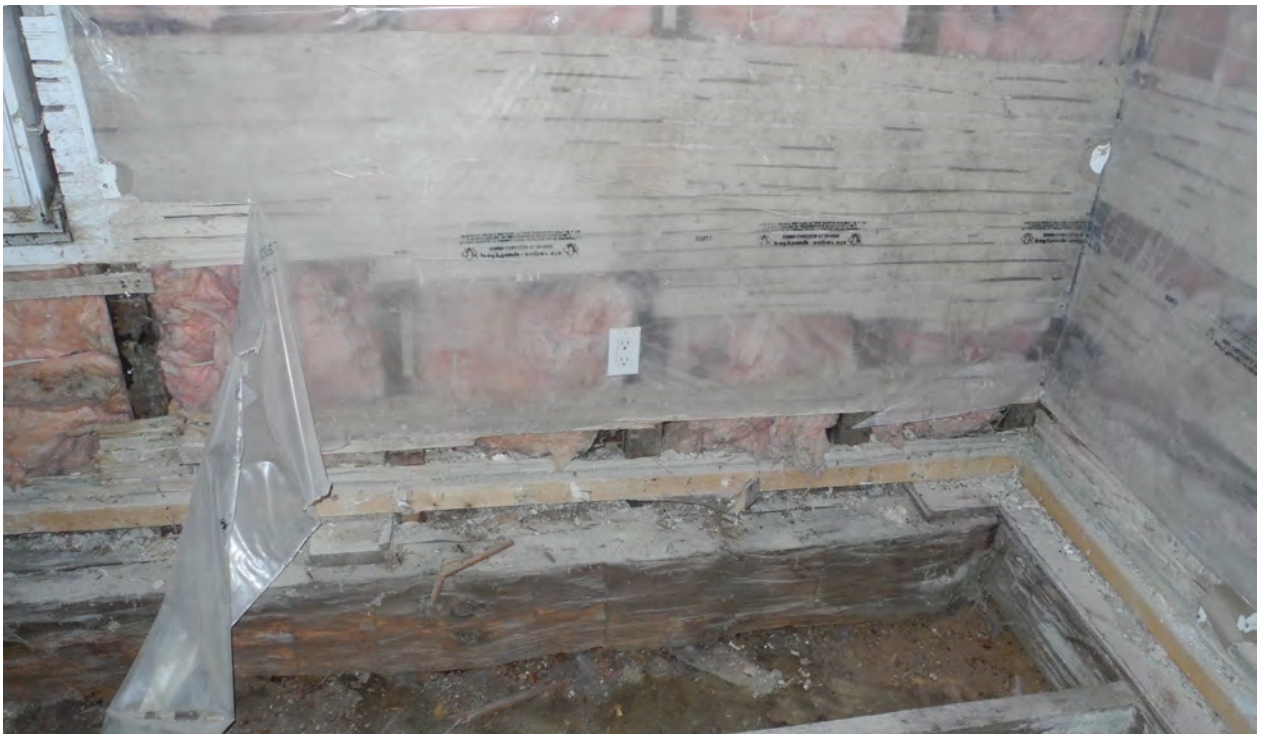
The main house walls are framed into a heavy timber sole plate set directly on soil a few inches below grade. There is no separate foundation, except on a portion of the north wall, where the brick wall of the partial basement under one of the additions underlies the timber sole plate.

Figure 6: South end of the Main House's east wall, showing sill plates set directly on the soil (CBCollective, 2020).

- The existing foundation consists of a heavy timber sole plate resting directly on soil a few inches below grade. While the timber sill has performed well for approximately 180 years, it is now severely deteriorated and has failed structurally in some locations. It is not considered practical to replace the existing timber with new material resting directly on grade. Instead, a poured concrete foundation wall extending below the frost line will be installed.

- The existing timber sole plates will be removed and replaced with a new dimension lumber sole plate supported on the new concrete foundation. It is anticipated that the bottom ends of the existing timber posts will be slightly trimmed to ensure that all remaining material is in good condition and the new sole plate installed a few inches above the level of the existing timber.

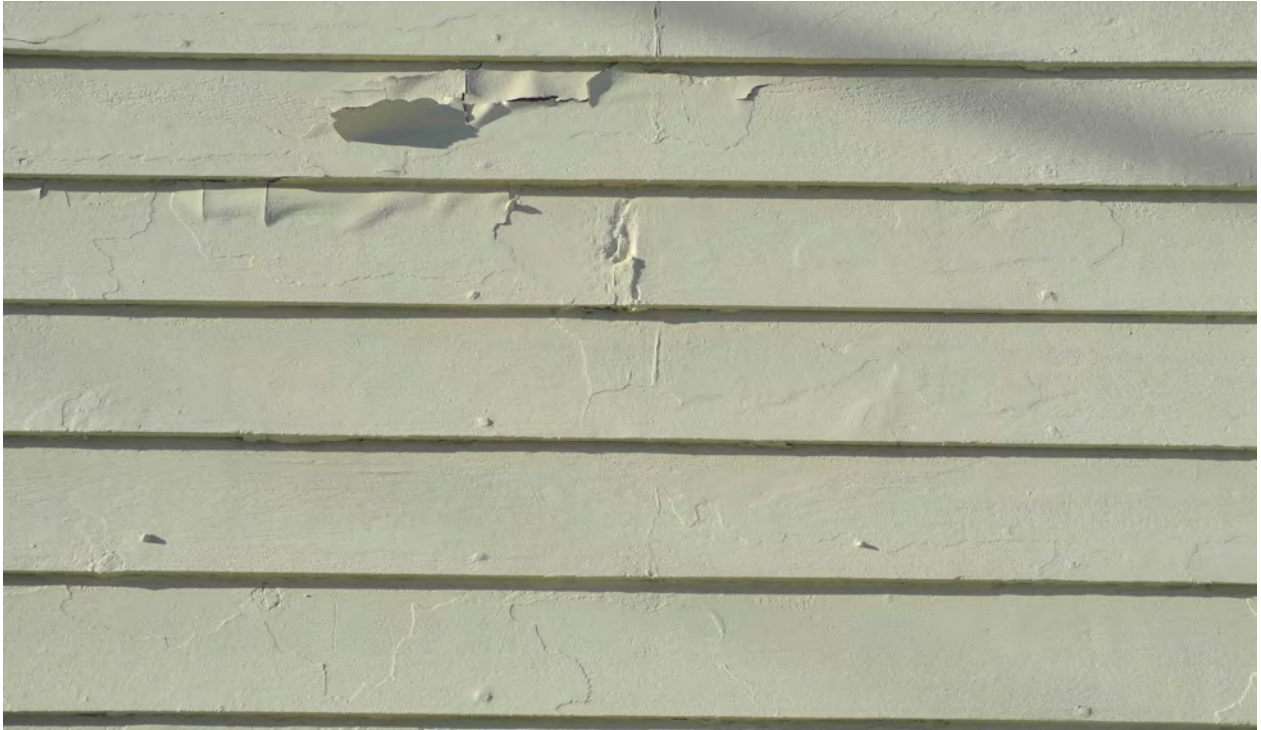
Wall cladding consists of painted clapboard siding affixed with machine cut wrought iron nails. The lowest three courses have been replaced with an aluminum siding of similar dimensions and finish to the wood. Exterior corners are finished with corner boards featuring a bead at the corner itself. Replacement material appears to have been used at the exposed portion of the main house's north elevation (metal or vinyl) and at the gable end of the tail addition. The siding is in worn but fair condition overall. Paint failure is found throughout, in some cases revealing older finishes below (Figure 13). The wood is weathered but sound where exposed with relatively little cracking or rot observed. A section of unrepaired nail holes with associated paint failure is found above the front door of the main house, likely related to previous signage. There is extensive splitting and cracking of board ends related to nails, typically near the outside corners and adjacent to windows (Figure 14). Numerous services penetrate or are mounted on the siding; in some cases penetrations are unsealed, likely resulting in water penetration.

Figure 7: Detail of typical cladding, with nails, paint failure, and previous paint visible (CBCollective, 2020).

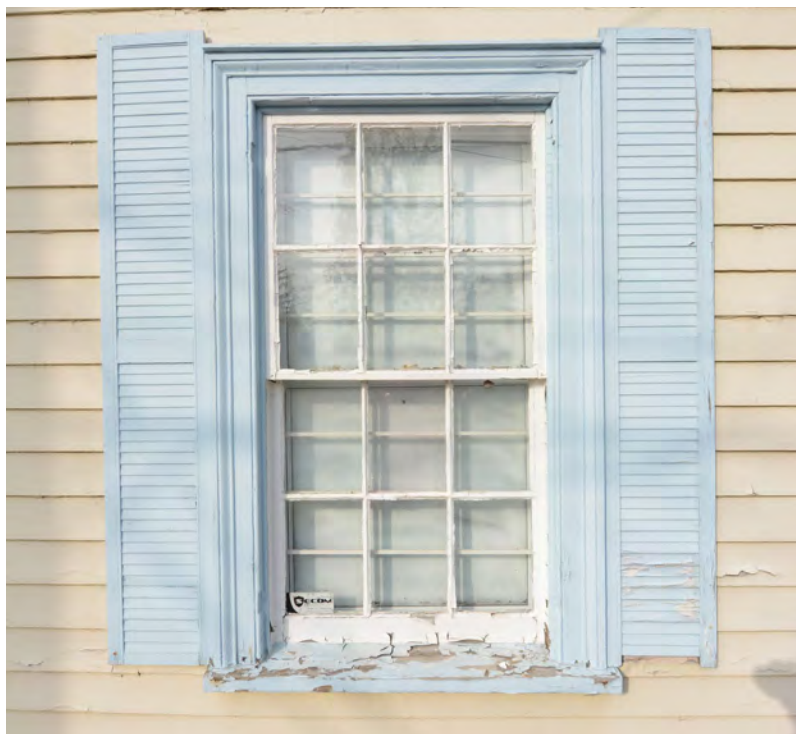
Figure 8: East window on the Main House's north elevation, showing typical configuration, casings, sill and shutters. Hinge mortises from earlier functional shutters can be seen on the inside of the left casing (Michael Scott Architect, 2020).

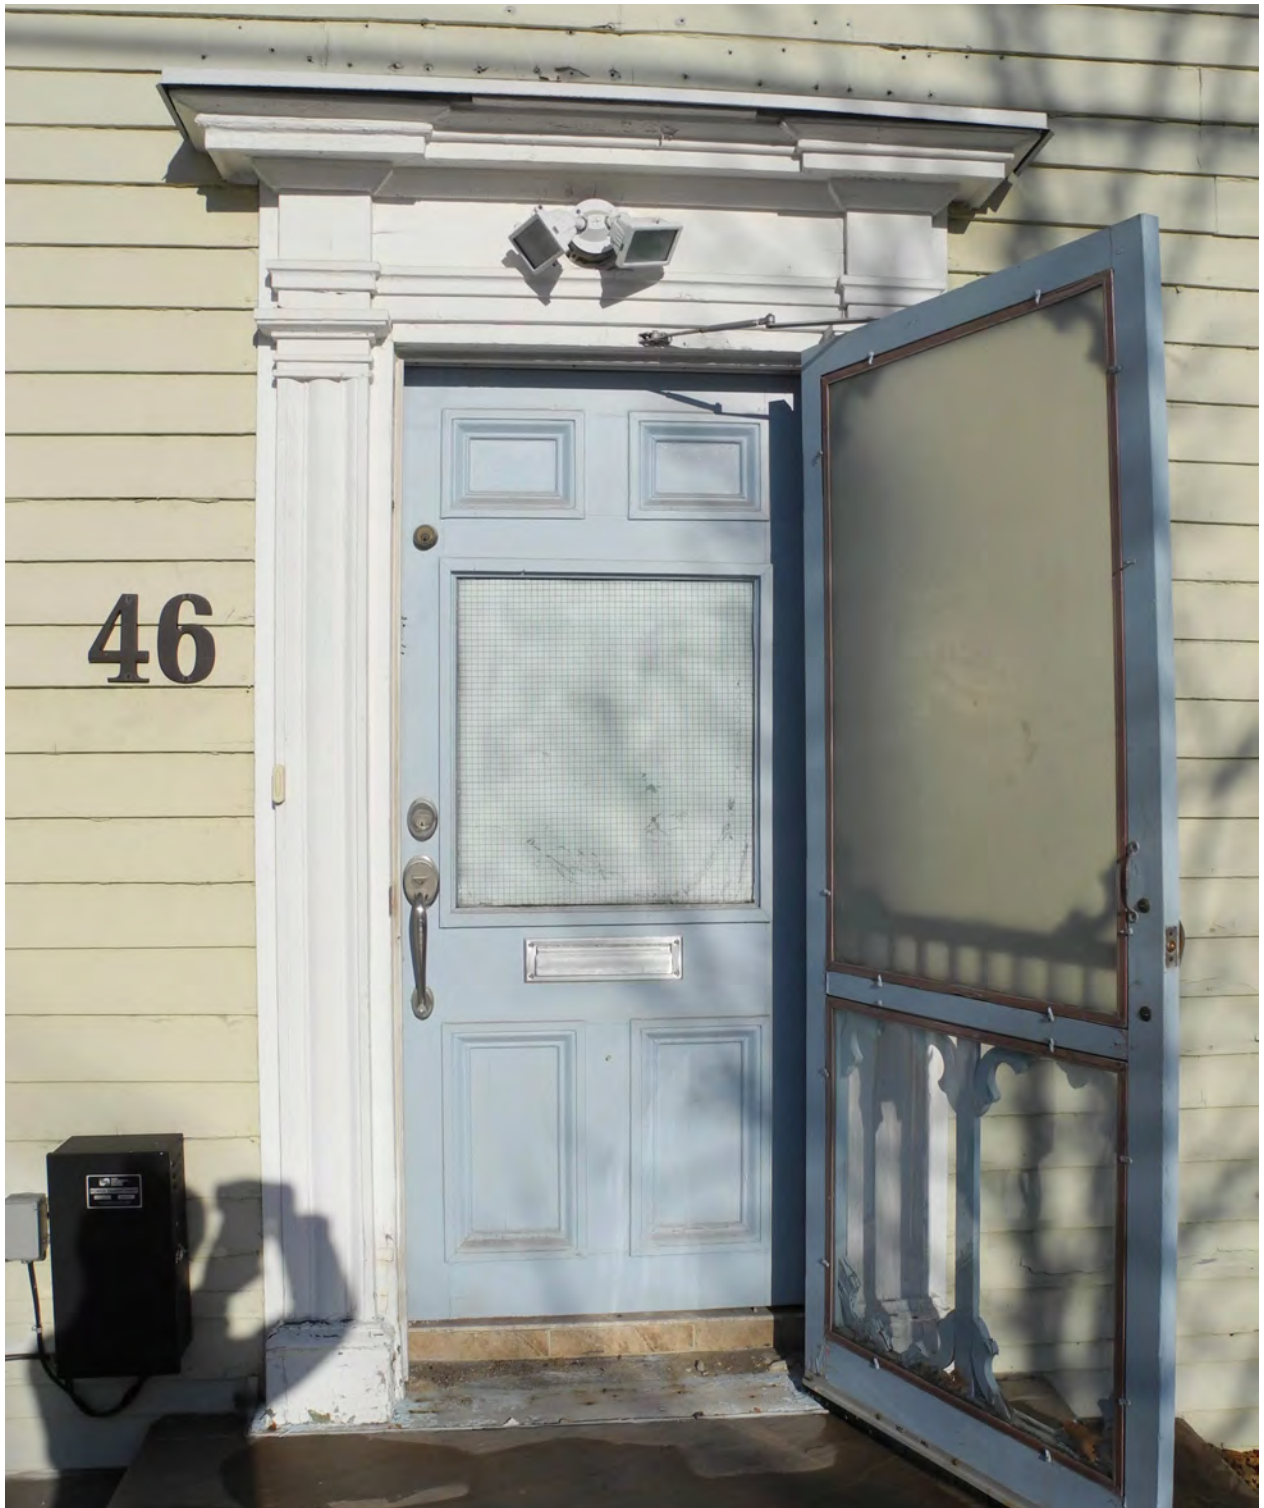
The modified panel door is in good condition, displaying minor paint failure/cracking at horizontal surfaces and joints. Door surround is in fair to good condition. Integrity of the assembly is very high, with only a small band missing material atop the west pilaster. Minor paint failure throughout, with the bases where the pilasters contact the sill displaying more paint failure and a small degree of rot (Figure 24). An inappropriate light fixture penetrates the centre of the frieze, and the flashing over the cornice does not respond to the undulations of the profile, harming the overall effect (Figure 25). The door sill is in poor condition, being highly worn from total finish failure and environmental exposure.

Figure 9: Main House front door showing modified panel door and screen door set within classical surround (*Michael Scott Architect, 2020*).

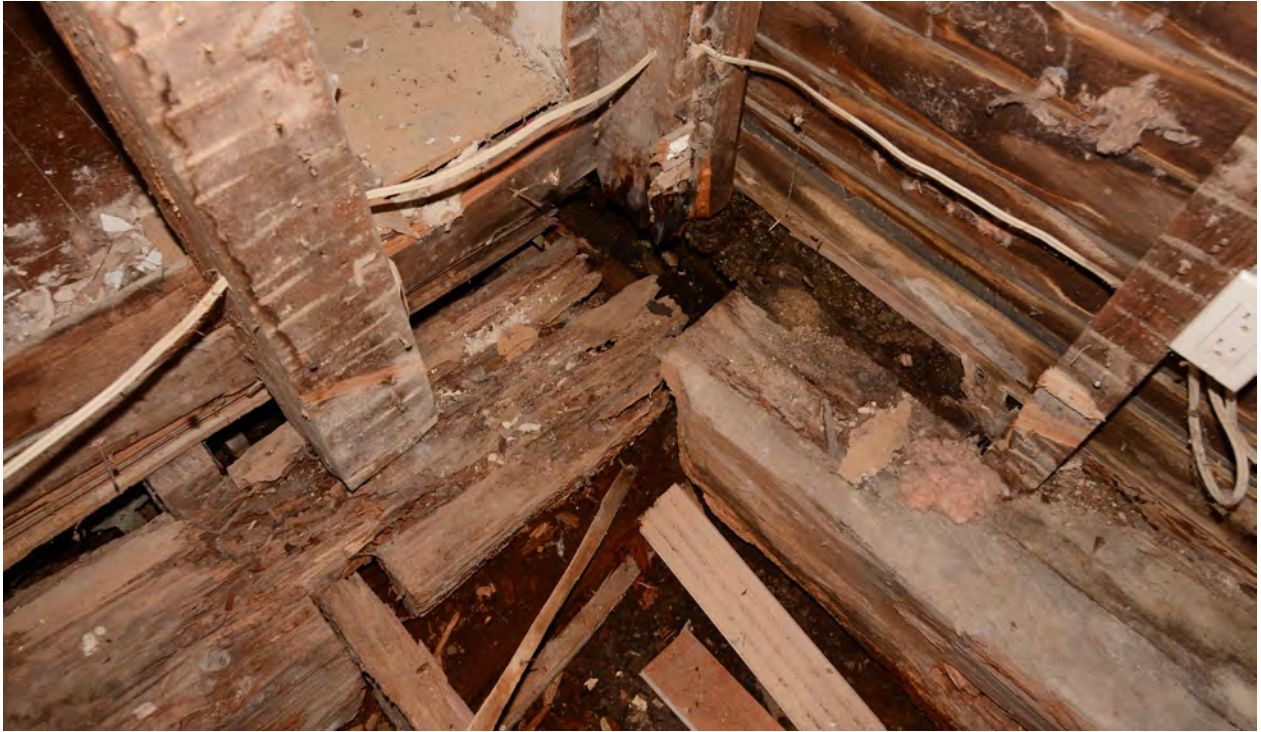
The timber sole plate and other framing shows evidence of decay to a greater or lesser extent in all locations where it is exposed for review. A substantial portion of the timber at the north-east corner is heavily decayed, resulting in complete loss of structural integrity and dropping of the building framing above by several inches (Figure 10). The decay and resulting settlement has evidently been a longstanding problem, as interior evidence shows that the floor had previously been leveled by the addition of a tapered finish. Significant water penetration under the wall is visible in the area (exacerbated at the time of review by a disconnected downspout) and this has presumably resulted in accelerated decay of the timber.

Figure 10: Detail of heavily decayed sill plate at north-east corner of Main House. Deterioration has caused sill plates to separate from each other as well as vertical posts, and drop several inches (*Michael Scott Architect, 2020*).

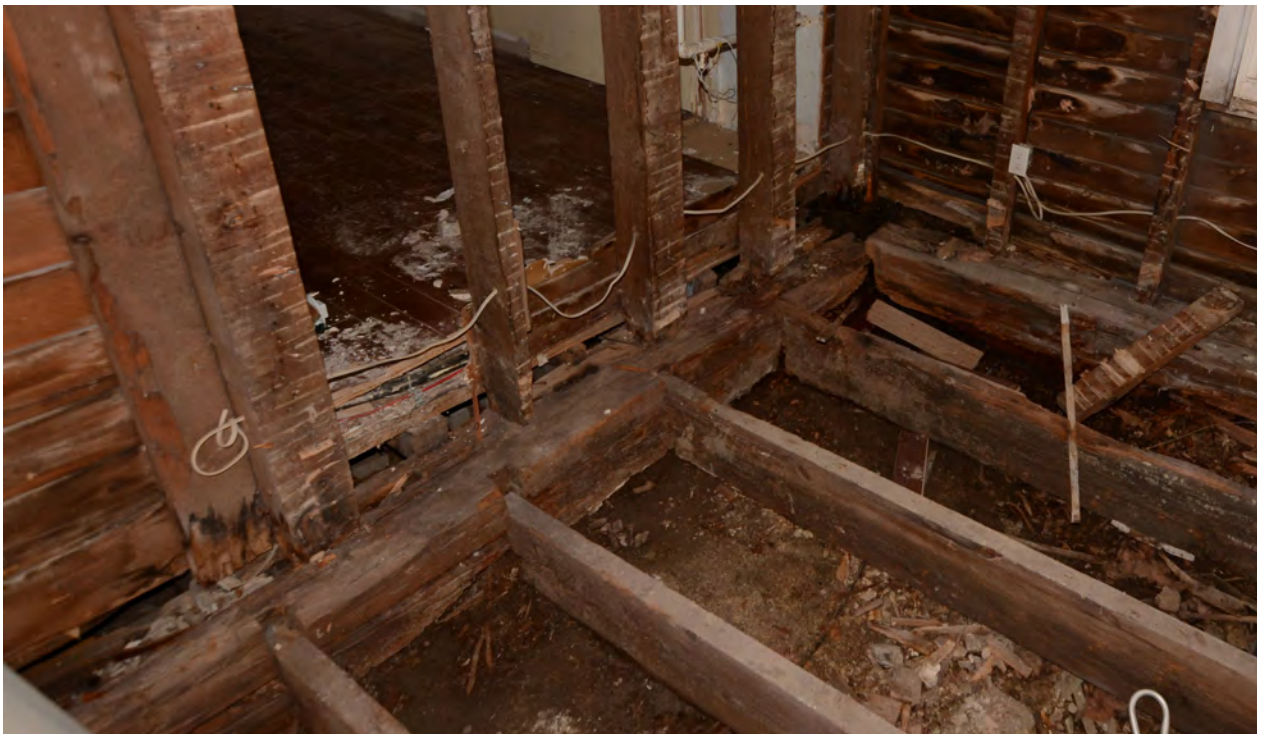
Figure 11: Detail of Main House's north wall, showing floor joists and posts mortised directly into the sill plates (*Michael Scott Architect, 2020*).

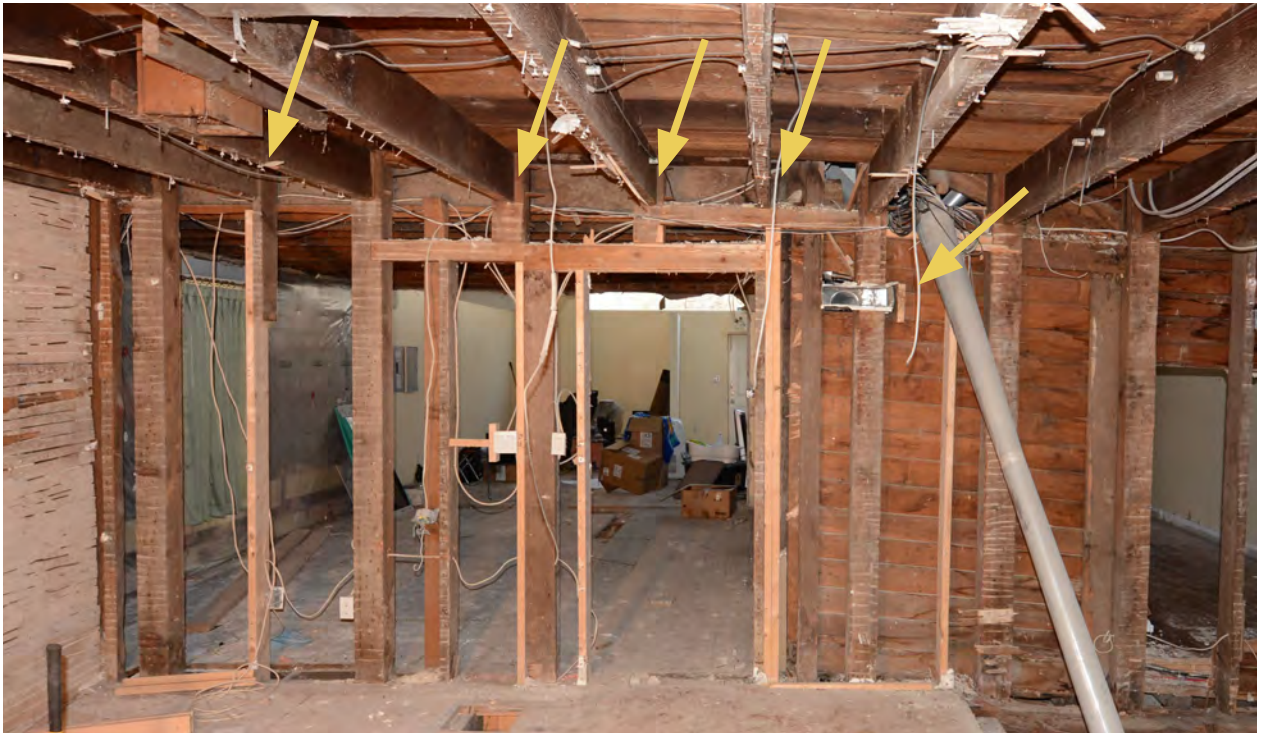
- There have been several alterations to the posts on the north wall to accommodate openings in the wall; these were carried out without regard to the structural integrity of the timber frame. There are some partial repairs in modern lumber, but the framing in this area requires further review for structural integrity (Figure 12).
- The bases of a number of wall posts in the north-east corner are heavily decayed, and in some cases are no longer attached to the sole plate.
- As a result of the decay in the north-east corner that portion of the house has dropped several inches

Figure 12: Photograph of Main House's north wall showing numerous and significant modifications to the original framing system. Yellow arrows indicate original posts that have been modified or severed (*Michael Scott Architect, 2020*).

- Some timber posts are in poor condition at their lower ends and will require repair by splicing on or sistering of new or salvaged material.
- An entirely new ground floor assembly (new joists and subfloor) will be installed.

- In order to allow for removal of the second floor and much of the north wall, a new system of lateral support for the building is required. This will consist of a steel frame, independently supported on the concrete foundation and installed inboard of the original timber frame.

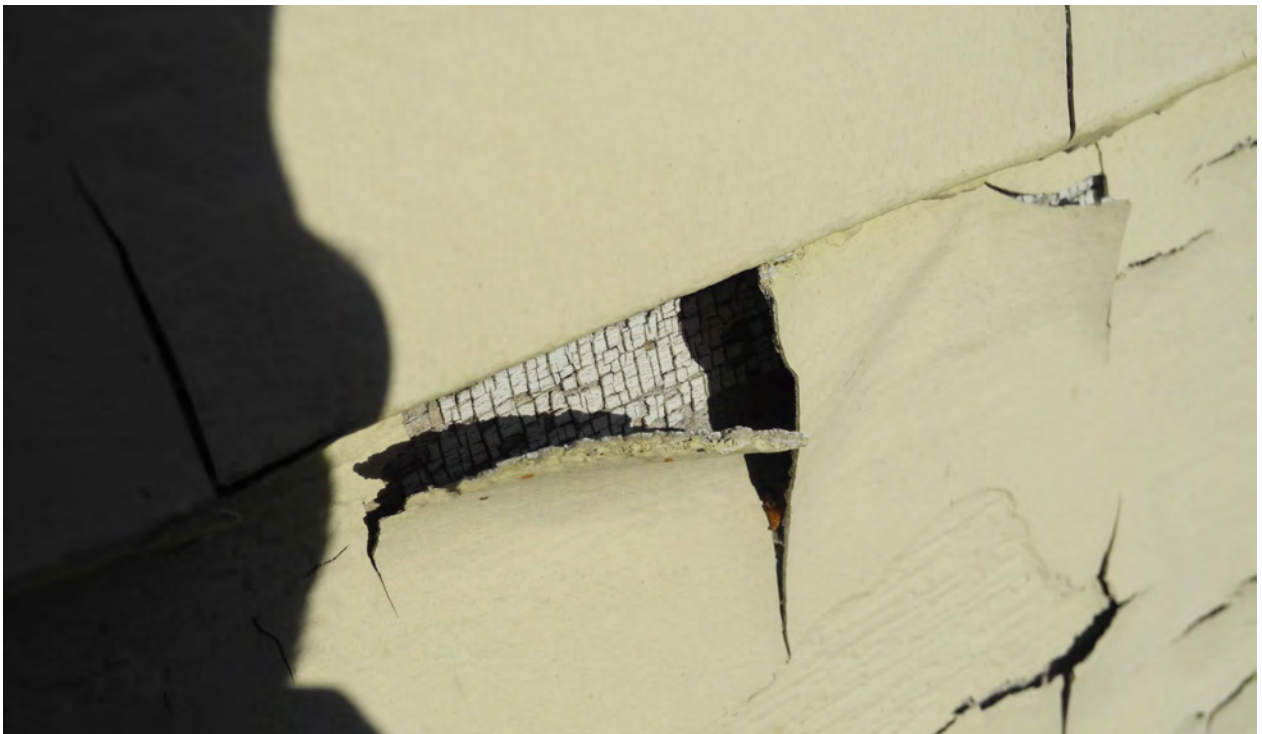
Figure 13: Detail of cladding, showing advanced paint failure revealing revealing earlier finishes beneath (*CBCollective, 2020*).

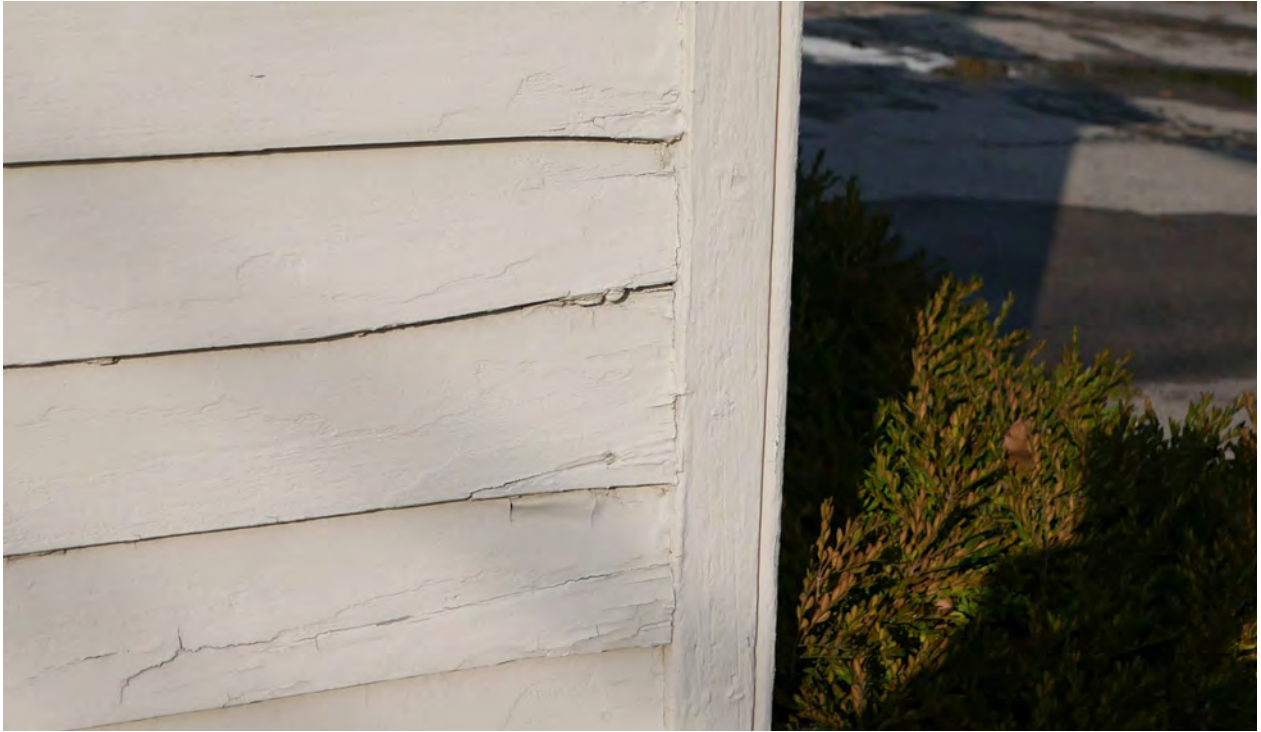
Figure 14: Detail of Main House's south-east corner, showing cracked cladding related to nail locations (CBCollective, 2020).

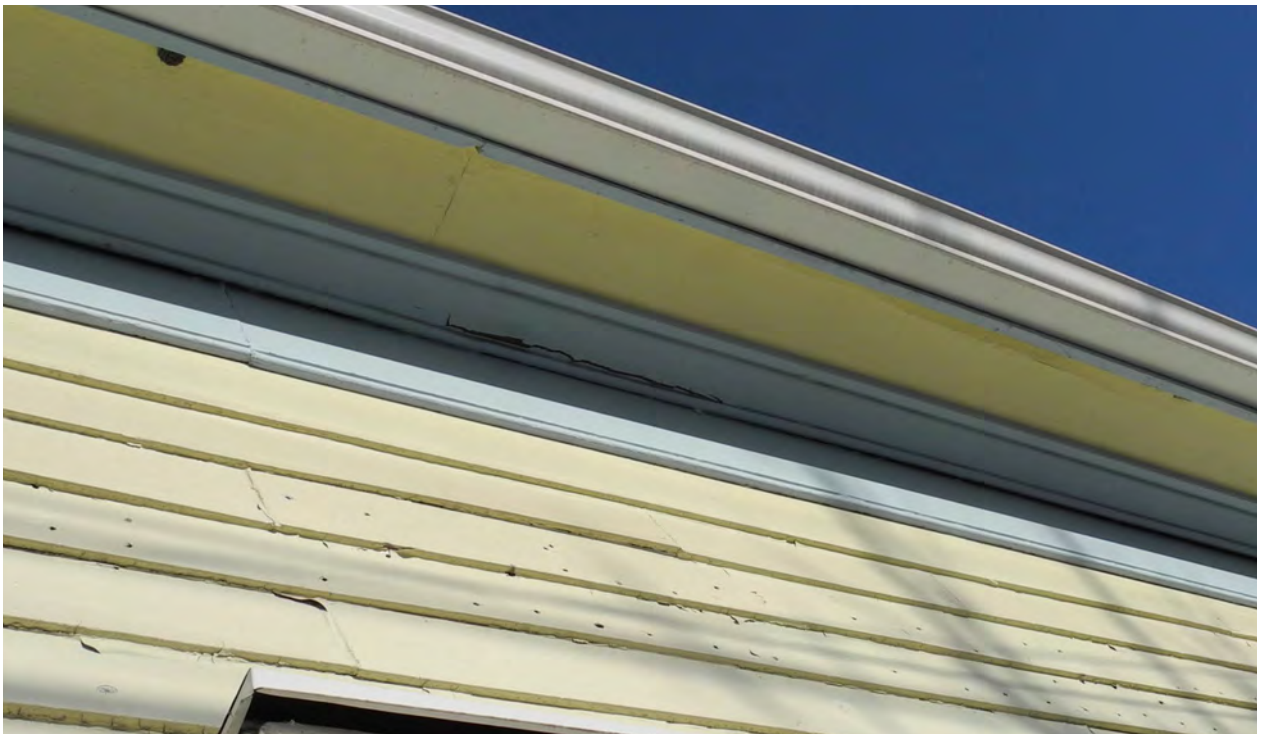
Trim at the top of the walls beneath the flat eaves consists of an ogee and beaded frieze board. On the gable ends the trim is a simple beaded board painted to match the siding. The trim is in fair condition overall. Light to moderate paint failure observed throughout, while wood generally appears sound (Figure 15). Open joints and minor misalignments throughout are commensurate with the age of the building.

Figure 15: Detail of frieze board and mouldings above front door, showing good overall condition with paint failure (CBCollective, 2020).

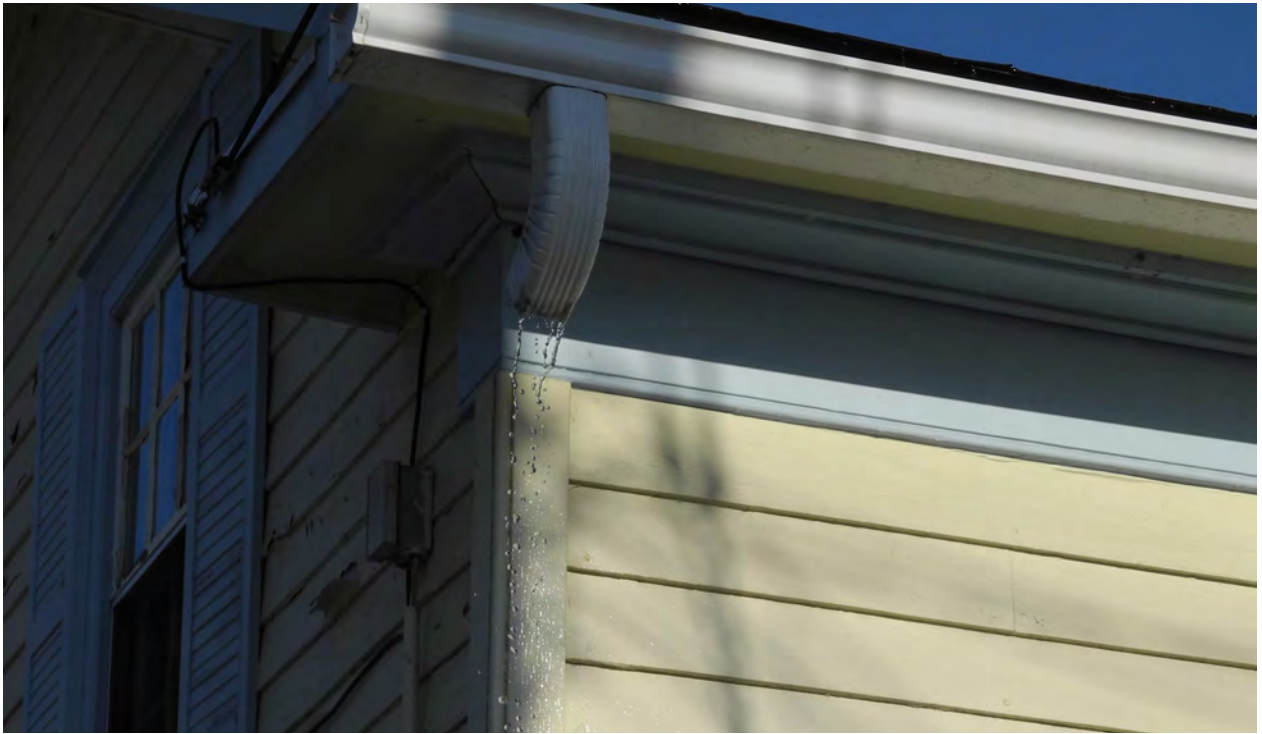
Modern aluminum eavestrough and downspouts are in fair condition where present. The front eavestrough is not properly secured, and both downspouts serving the Main House are improperly terminated and discharging water onto the siding (Figure 16).

Figure 16: Eaves and disconnected downspout at south-west corner of Main House, showing water discharging directly onto the cladding (*CBCollective, 2020*).

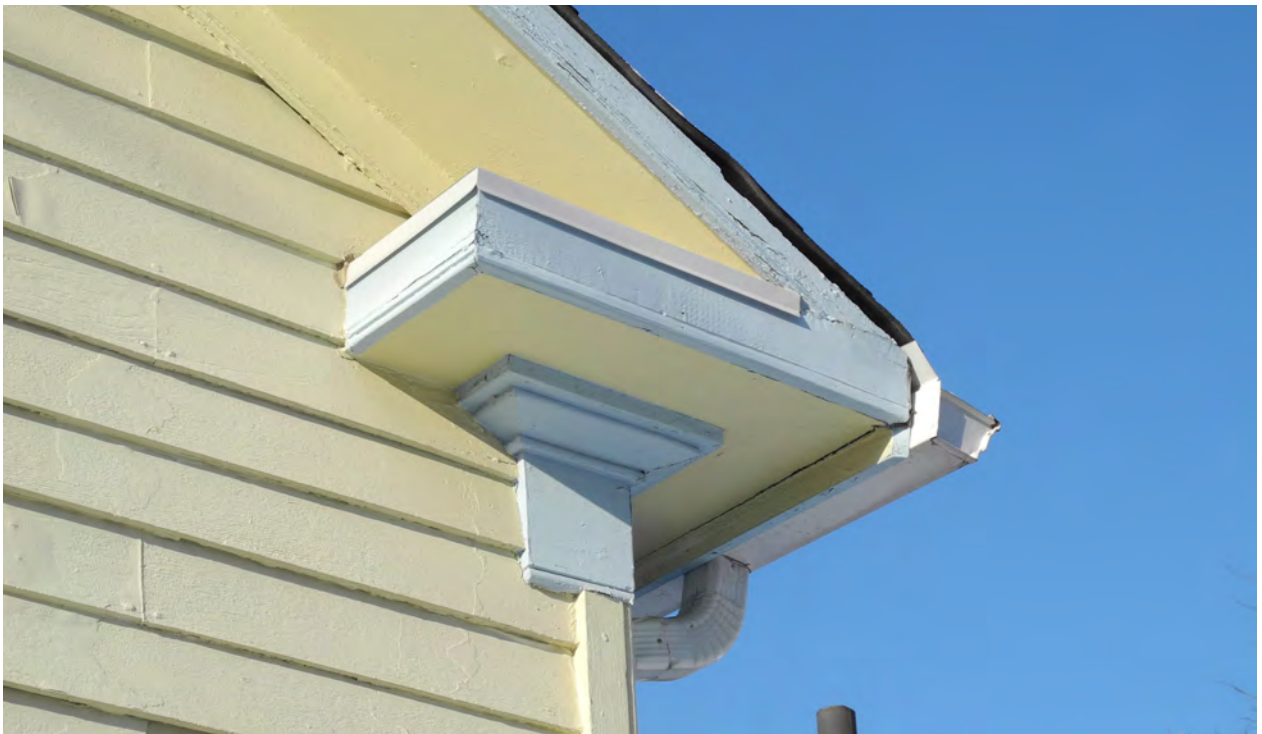
Wood fascia is used throughout both the Main House and tail addition. The fascia is a mix of unadorned dimensioned lumber and (presumably historic) fascia boards embellished with a bead profile. Fascia boards are in fair to poor condition. Paint failure was observed throughout, with decay and warped wood apparent in many cases as well (Figure 17). Boards displaying historic detailing are generally in poorer condition.

Figure 17: Detail of fascia and soffit at north-east gable return. The historic fascia board is deteriorated, and that of the return is poorly detailed. Note the oversized fascia board on the north elevation (*CBCollective, 2020*).

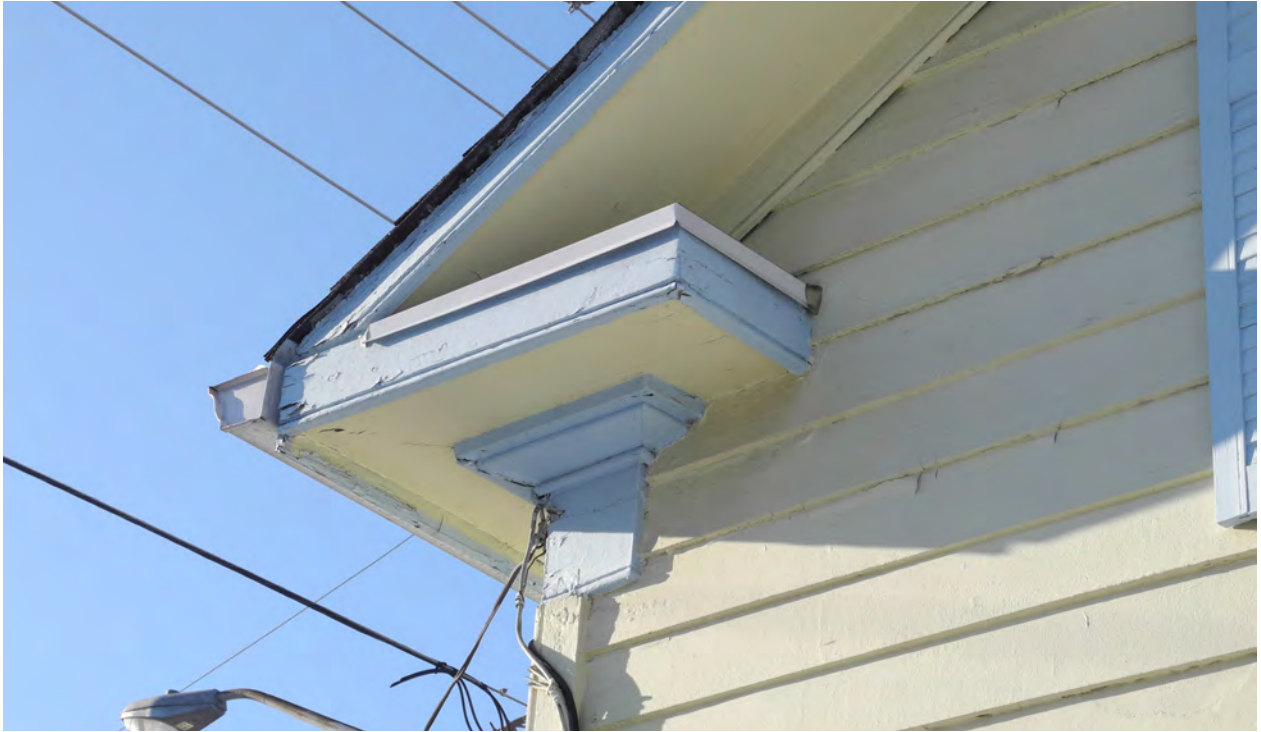
The soffit is finished in dimensioned lumber, in fair condition, displaying a moderate amount of paint failure throughout. Wood beneath is weathered, but not compromised to the degree of the fascia boards (Figure 18).

Figure 18: Detail of fascia and soffit at south-east gable return. Soffit boards are in good shape overall and display paint failure. Oversized fascia boards are apparent on the south elevation (*CBCollective, 2020*).

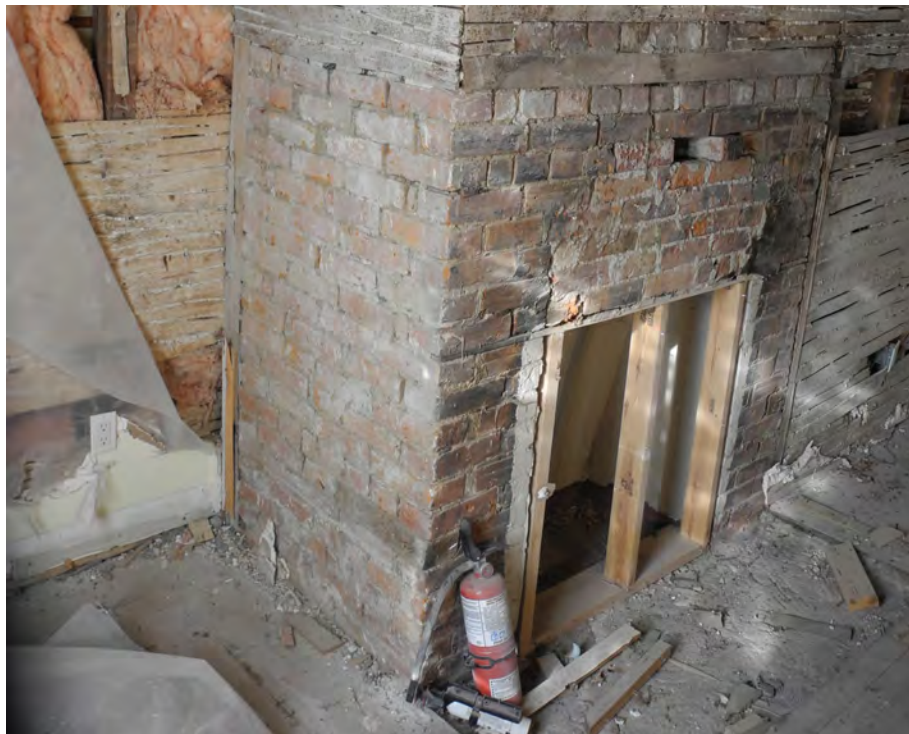
Masonry on the building is limited to the chimney and fireplace. The chimney runs completely inside the wood frame building and is not exposed on the side of the building except above the roof line (Figure 19). Where exposed on the interior the masonry appears to be original and in sound condition. The portion above the roof has been reconstructed in modern brick and appears to be in good condition. The metal chimney cap is oversized and visually unappealing (Figure 20).

Figure 19: Masonry chimney structure, built entirely within the timber structure of the Main House (*CBCollective, 2020*).

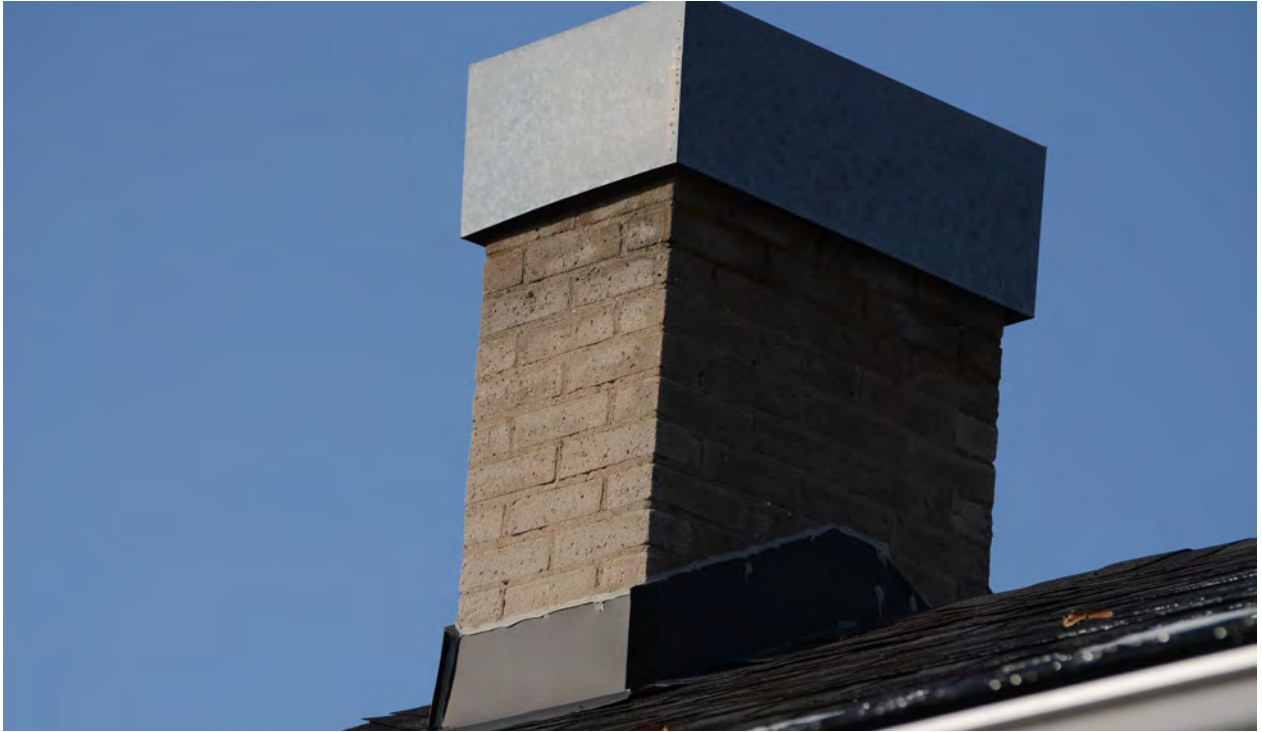
Figure 20: Detail of exterior chimney showing masonry, galvanized cap, and flashings all in good condition (*Michael Scott Architect, 2020*).

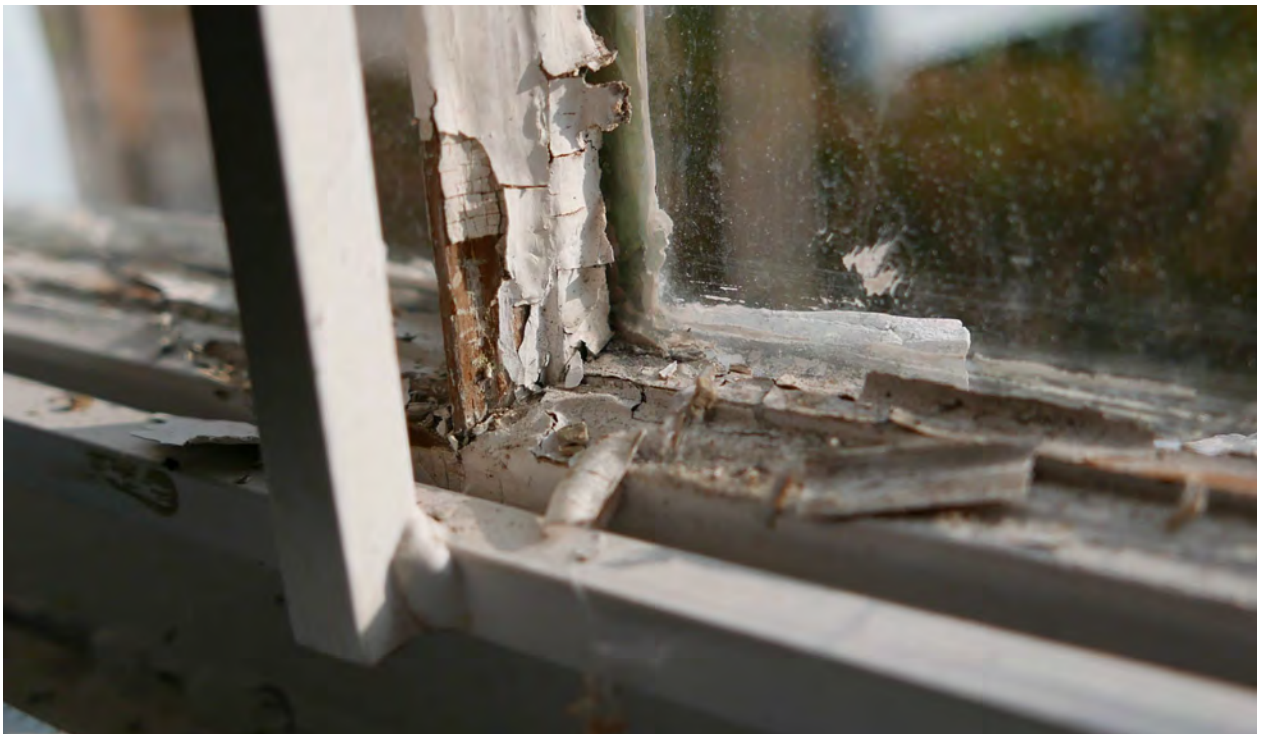
Historic window sashes are in fair condition overall. Paint failure is common throughout, with cracking exposing bare wood in isolated areas (Figure 21). Integrity of rails and stiles is generally sound. Muntin bars are in fair shape, with some damage to interior profiles, and the odd tenon missing or damaged (Figure 22). Putty failure common throughout. There are several instances of cracked glass at second storey windows.

Figure 21: Detail of south-east window, showing paint failure where the muntin bar is mortised into the rail. The wood is in good condition at this location, and older crazed finishes are visible (*CBCollective, 2020*).

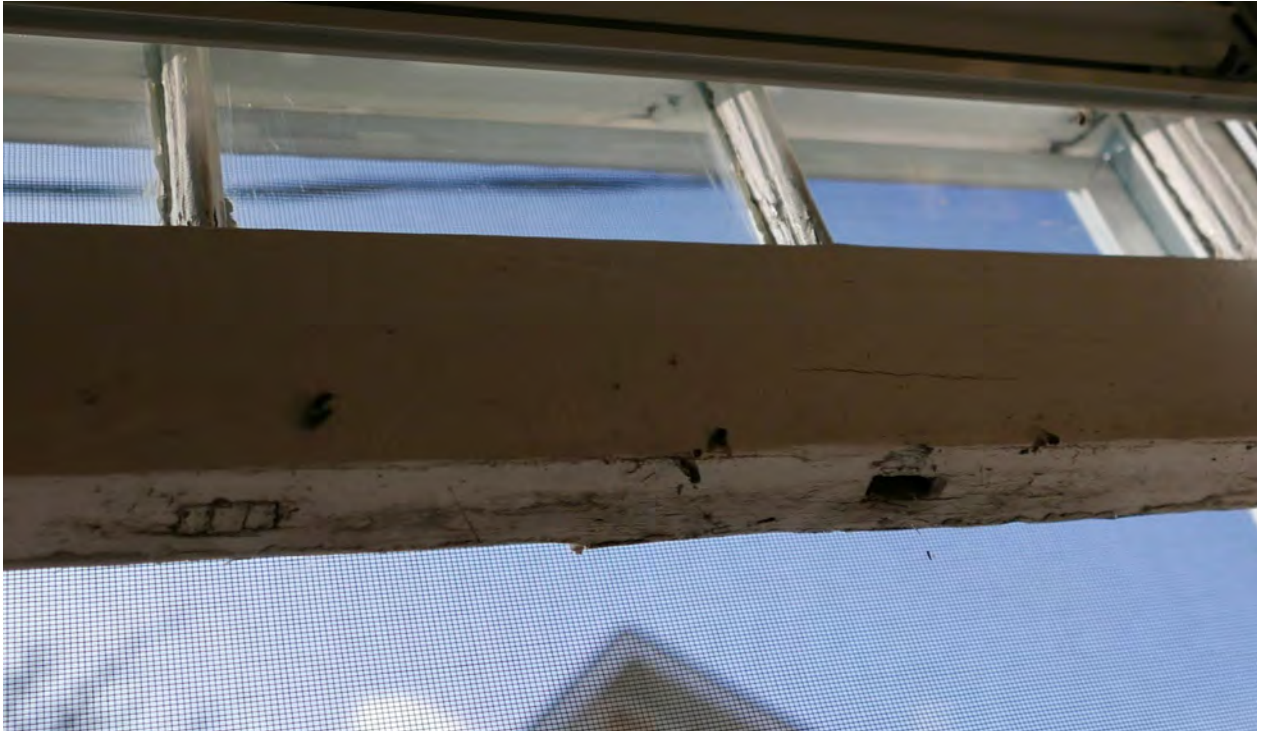
Figure 22: Detail of the bottom rail on the west elevation's south window. The muntin bar's wedge-tenon has broken off and is missing. Sash is still structurally sound but should be repaired (*CBCollective, 2020*).

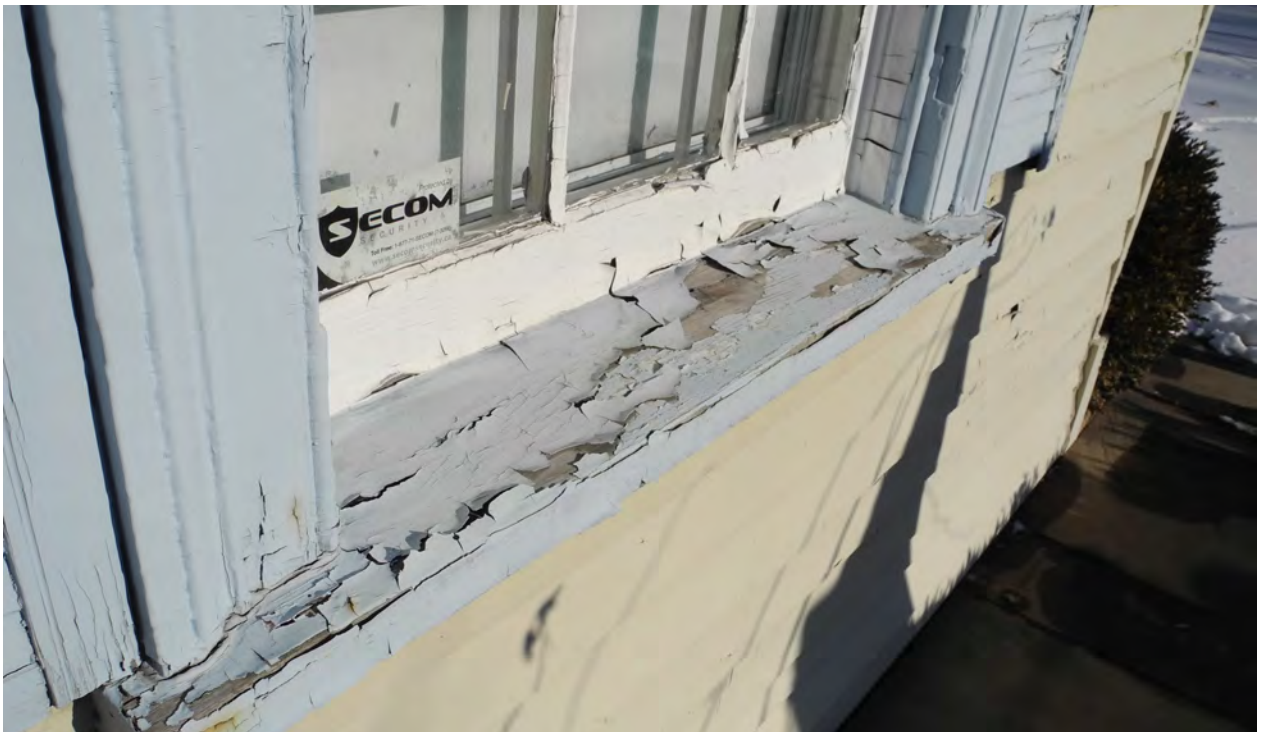
Sills are in fair to poor condition, though not beyond repair. Paint failure on sills is common revealing previous finishes and bare wood. Light paint failure found throughout surrounds, which worsens at butt connection with sill (Figure 23). Shutters are not historic; they range in condition from good to poor on an individual basis.

Figure 23: Detail of severe paint failure on sills, and at the bottom of the casings. Note mortises for earlier functional shutters on the far casing (*CBCollective, 2020*).

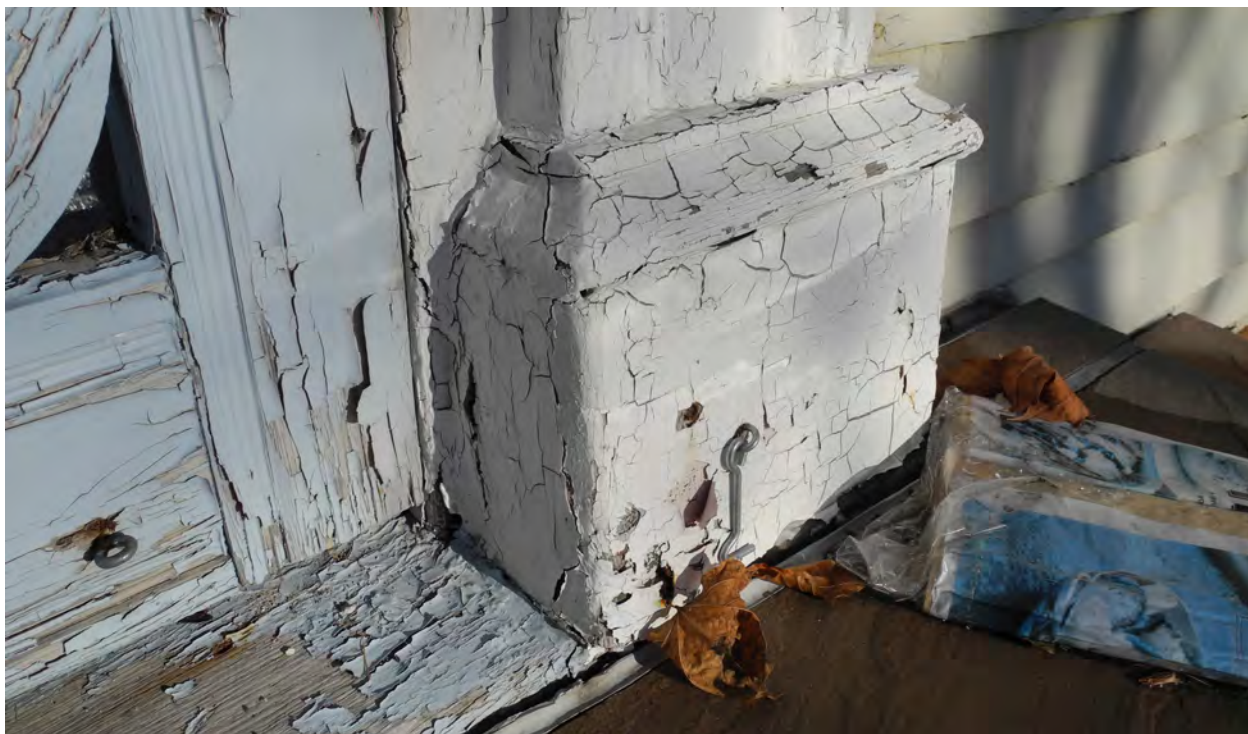
Figure 24: Door surrounds are in good shape overall, with paint failure most pronounced at the pilaster bases (CBCollective, 2020).

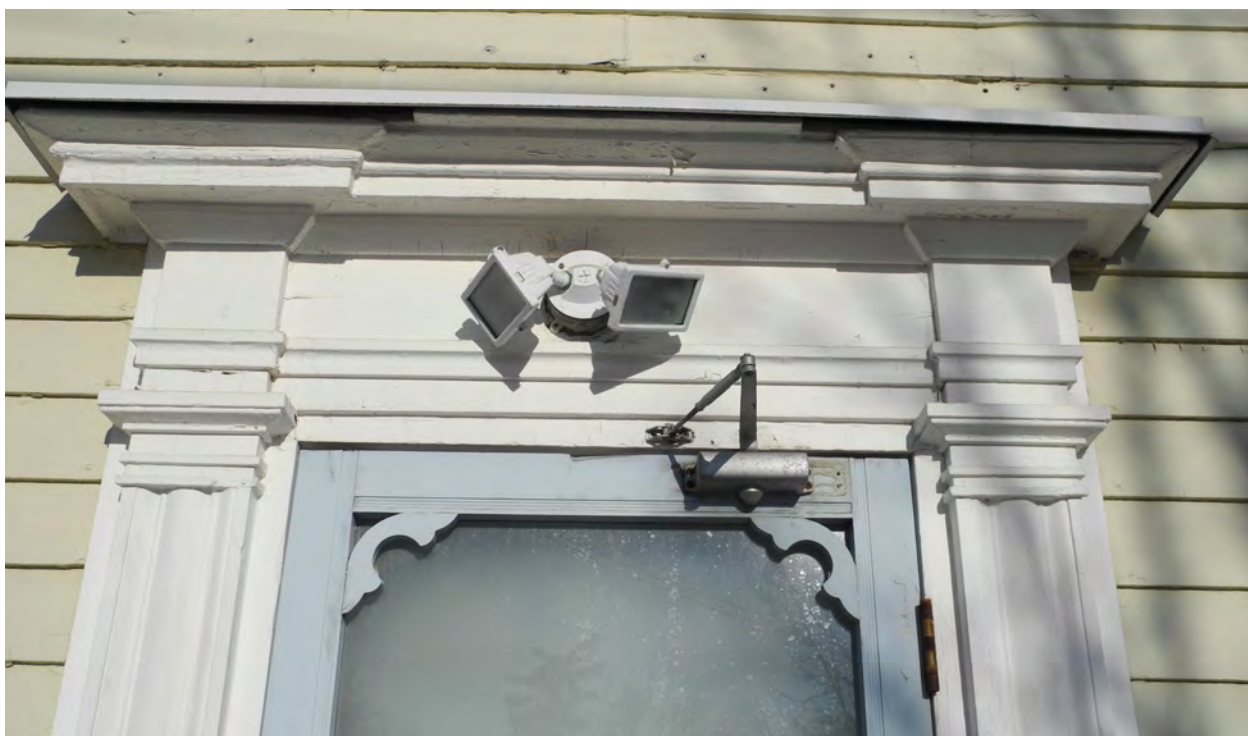
Figure 25: Flashing over the door surround is in fair condition, but it obscures the plan of the surround, effectively diminishing the detail's legibility (CBCollective, 2020).
