46 CENTRE STREET, VAUGHAN CONSERVATION PLAN

REV. I - FINAL

AUGUST 13, 2020

COMMON
BOND
COLLECTIVE

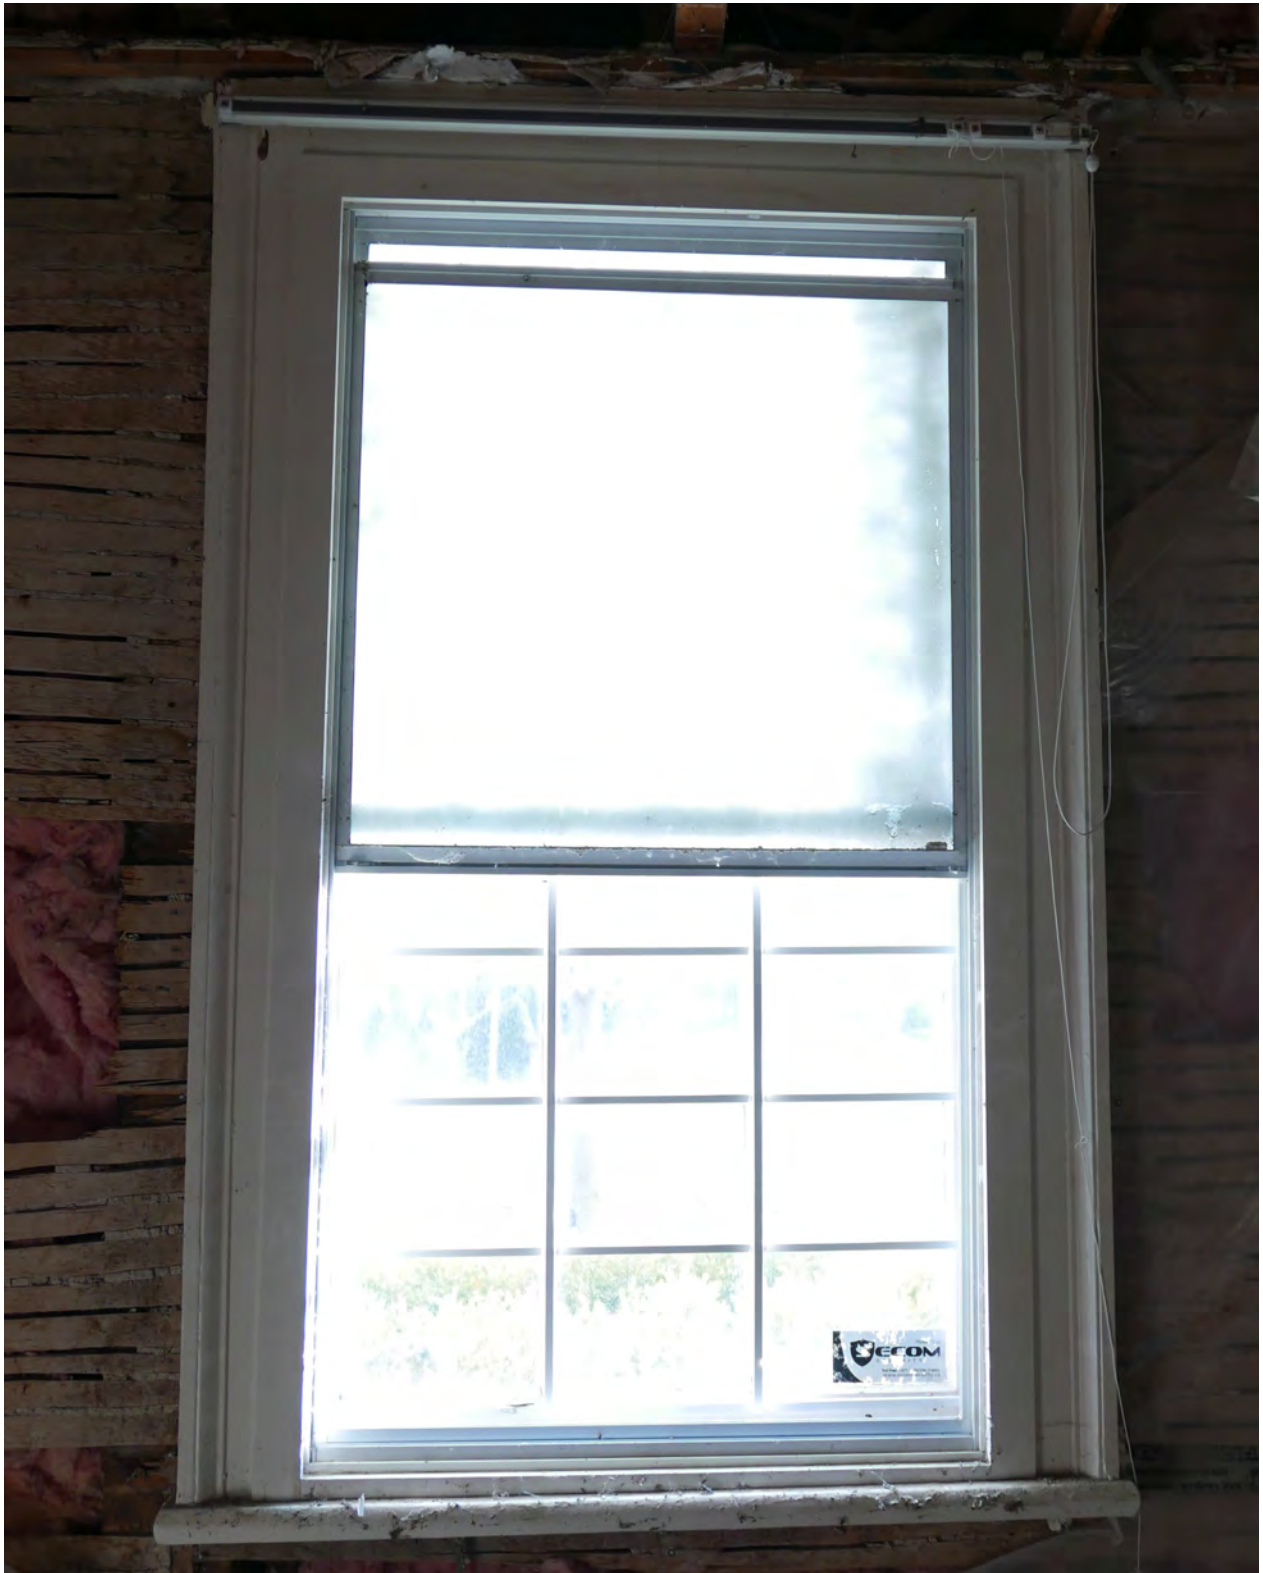
Figure 26: Historic casings remain at the Main House's interior windows, despite being obscured by storm widnows. Profiles differ slightly on the ground floor windows (CBCollective, 2020).
