**CULTURAL HERITAGE
IMPACT ASSESSMENT
And
HERITAGE DISTRICT
CONFORMITY
REPORT**

**2291 Major Mackenzie Drive West
Maple Heritage District,
Vaughan, Ontario, Canada**

19 October 2020

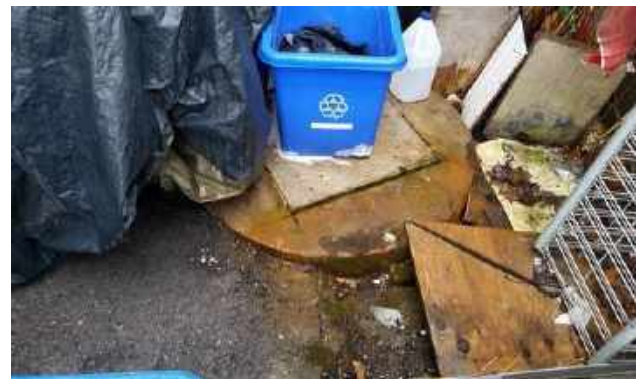
Debris noted in east side yard. Old / unused septic catch basin also noted)

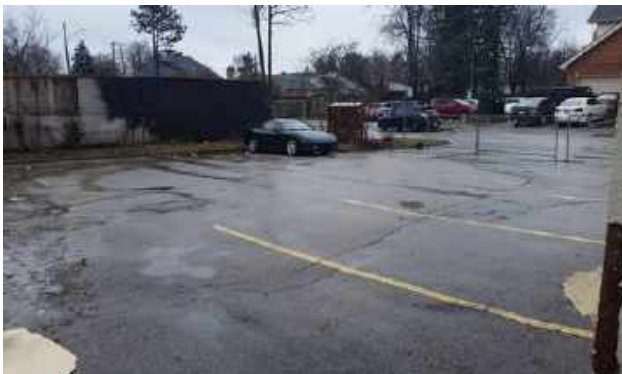
Rear yard parking area

For the most part the exterior yard areas are covered with asphalt paving to facilitate on site parking. However, some cracks / deterioration was noted, but for the most part the surfacing remains reasonably smooth and in tact.

Fill and seal cracks within the asphalt surfacing to reduce water penetration and seal the entire surface in order to extend the service life as part of a regular maintenance program.

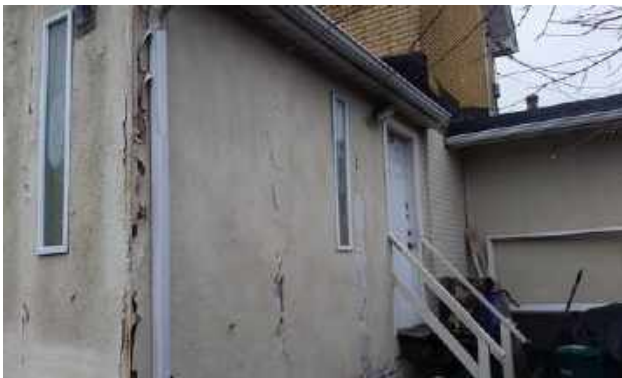
Porch enclosure, east side yard

The dwelling includes an enclosed porch on the east side of the dwelling that is a wood frame structure covered with OSB that has a stucco finish applied to it. The foundation for this structure was not visible as the exterior wall finish extends to grade level and likely below. However, this structure was noted in a poor state of repair at the time of inspection.

The condition of the exterior wall suggests that moisture has penetrated underneath the sheathing / stucco causing water related damage. The finish is peeling off and mould has formed on the surface.

Also noted were issues related to roof flashing which is not installed in a workmanlike manner and as such its condition is likely contributing to the issue of moisture penetration into the walls.

The only way to repair this structure is to remove the damaged exterior finish, evaluate the underlying wood structure, repair / replace any deteriorated components and then replace the sheathing and finish materials. In addition, doing so will likely require a mould remediation effort. Consultation with a qualified contractor specializing in mould remediation and restoration is required.

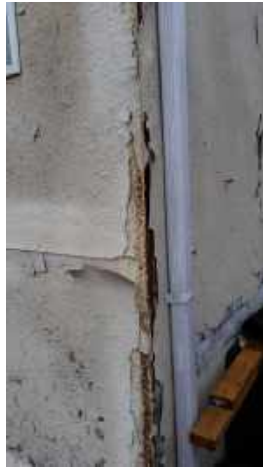
Damaged stucco corner of wall

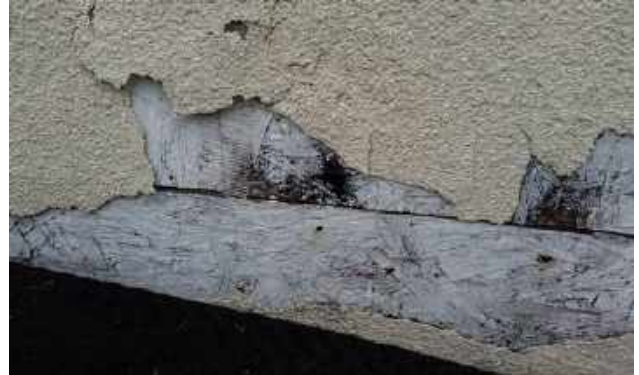
Peeling stucco due to moisture. Visible mold growth on surface of OSB.

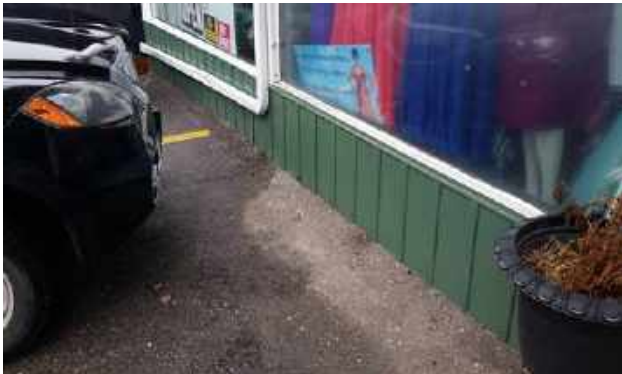
The exterior wall finishes extend to grade level along the front and a portion of the side walls as well and as such the foundation wall is not visible in these areas.

Paving installed against siding

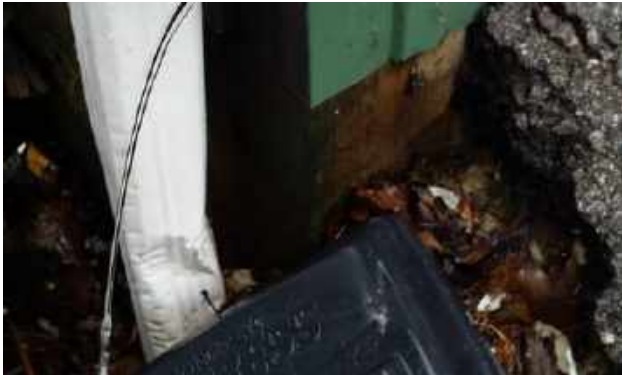
Wood to soil contact in north east corner of building

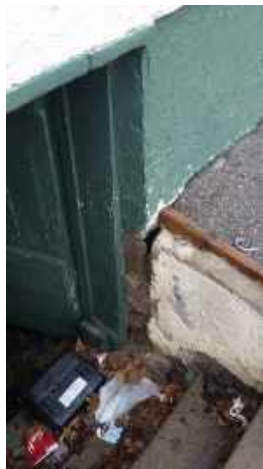
Nonetheless, significant issues were noted with the foundation wall that include cracks / holes as noted along the rear wall and on the interior of the foundation wall as viewed from within the basement. This damage has resulted in water penetration over a long period of time. Efflorescence and mould was noted present on the wall within the basement but also on the exterior block above grade level.

Damaged foundation wall at basement walk-out

Complete restoration of the foundation wall is required. This work can only be done effectively from the outside of the wall, necessitating perimeter trenching to the depth of the footing / bottom of the foundation that will allow the wall to be repaired as required before a perimeter weeping tile system and waterproofing membrane can be installed. Consultation with a qualified contractor specializing in foundation repair / restoration is recommended.

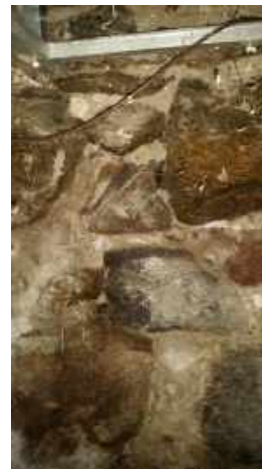
Interior view of stone / rubble foundation

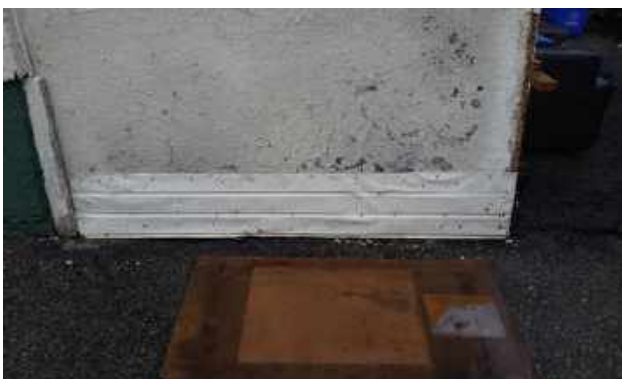
Porch foundation type not visible

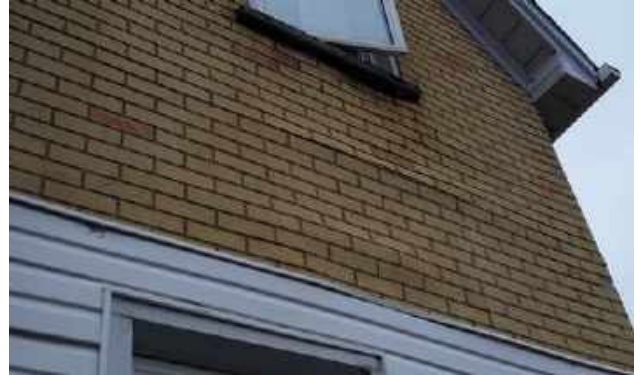
The brick tile surface is deteriorated to the point that the surface is buckling in several areas. As well, numerous areas were noted with missing, spalled and cracked brick tiles. The deterioration is due to moisture penetration into the substrate material, especially below window sills and areas where flashing has failed.

Wall area below window sill failing. Brick tile finish is buckling.

Consult with a qualified contractor specializing in building cladding installation to determine the state and extent of deterioration of all exterior wall surfaces / types. The current state of deterioration will likely involve replacement of all the brick tile surfaces and replacement of any rotted / deteriorated structural framing elements for part of the exterior walls.

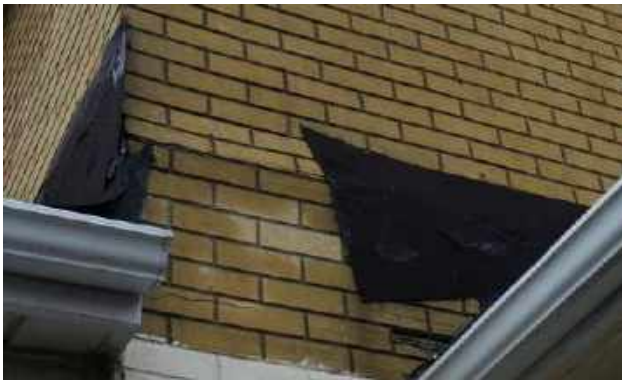
Brick tile finish noted as buckling at corner of building.

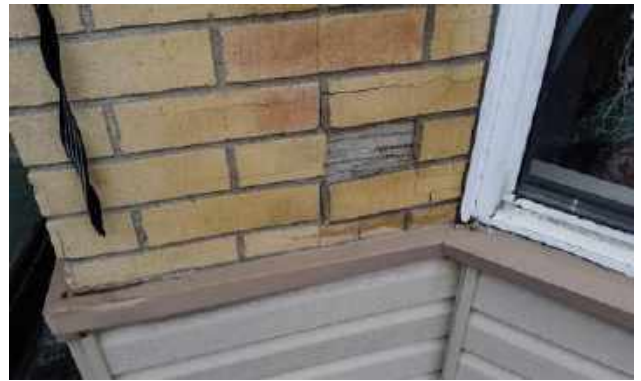
Close-up view of failing brick tile. Cracked and spalling of surface / cement substrate.

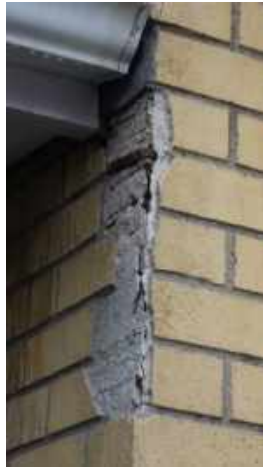
Missing area of brick tile exposing cement substrate and mesh

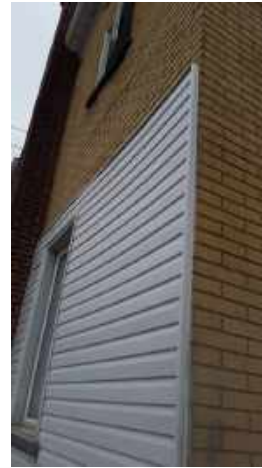
Indiscriminate wall area with siding applied over brick tile.

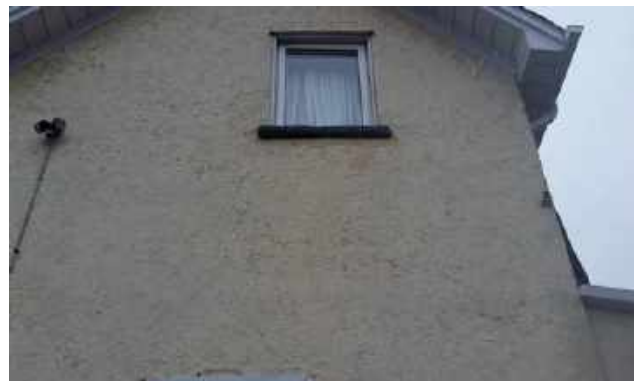
Rear stucco wall. Discoloration, especially under window sills noted.

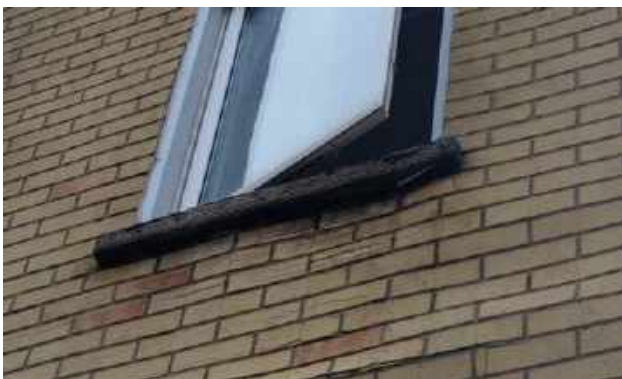
The window sills are made of cement that is also reinforced with wire mesh. These sills are badly deteriorated and enable water penetration into the wall system.

Badly deteriorated window sill on second floor level

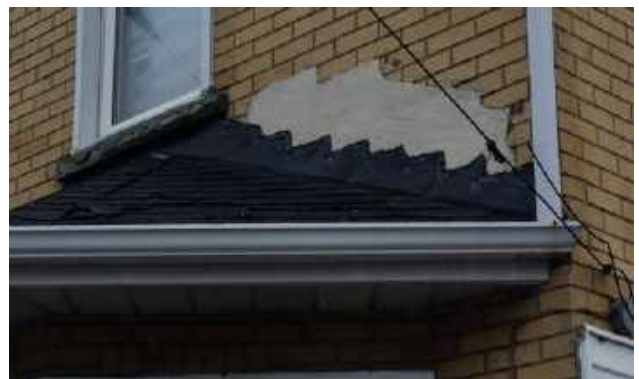
Parged wall above flashing

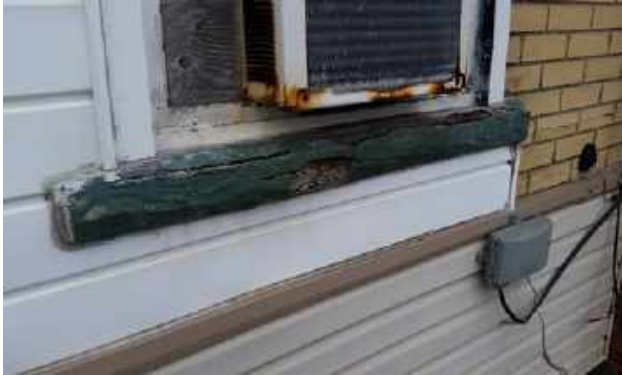
Deteriorated cement window sill has no capacity to keep water out of wall

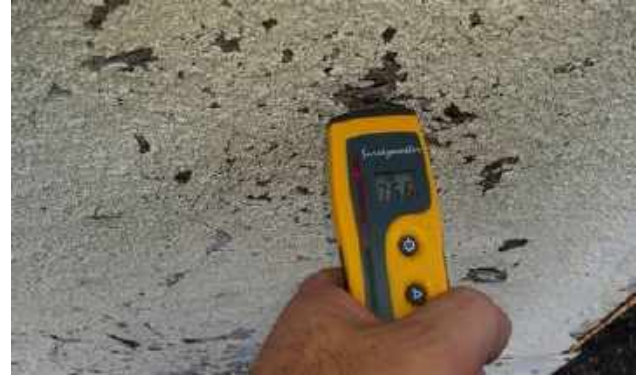
Water saturated stucco wall

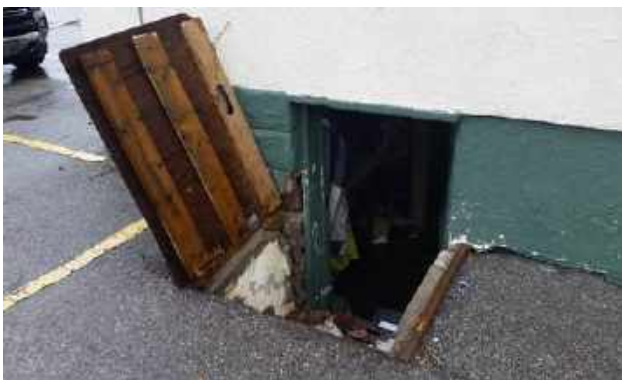
Basement walkout

The basement walkout located at the rear of the dwelling was noted as deteriorated and in a genral state of disrepair. It does not provide safe access/ egress into the basement. No landing is provided at the bottom or guard / handrail. A hinged wood panel is provided to protect the opening / stairs when the access point is not utilized.

It is recommended that the basement walk-out be demolished and replaced with a structure that facilitates access from grade into the basement. Options include an exposed stairwell that incorporates a proper foundation extending below the frost line (4 ft below the lowest exposed level of the staircase) or an enclosed structure that can be heated so that the depth of foundation can be reduced to 4 ft below the finished grade level.

Also required for the basement walkout is the installation of a drain at the bottom of the stairwell. Doing so will likely require the installation a sump pump to direct water at an appropriate discharge point, the City's infrastructure or appropriate grade area.

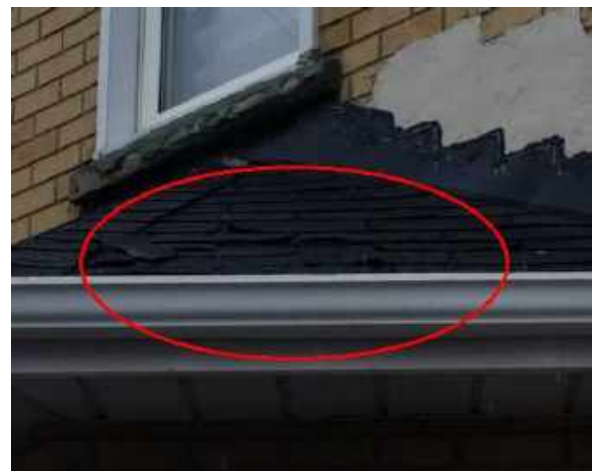
Some shingles deterioration noted in places. Likely due to moisture penetration.

The owner is advised to budget to replace the roof covering on lower roof planes within the next 3 - 5 years
based on the anticipated life cycle. Replacement of the covering should include evaluation of roof sheathing
(and replacement as required) which may have sustained damage in areas reliant on wall flashing to
maintain water tightness. Consult with a qualified roofing contractor.

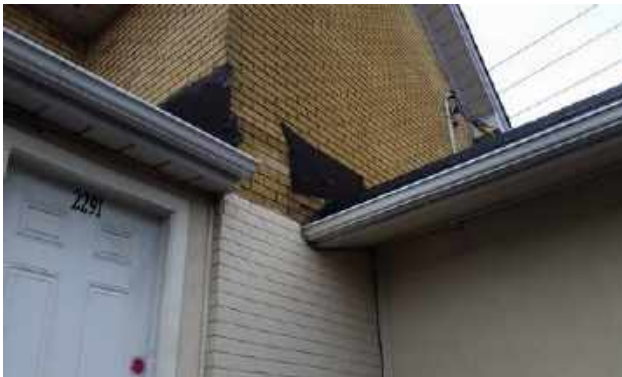
Improper wall flashing at lower roof plane

Inspect flashing on a regular basis and ensure counter measure application remain in tack / sealed and that it does not bend / incur wind damage.

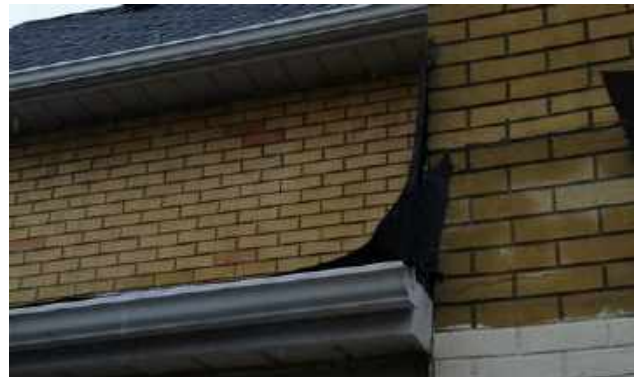
Improper wall flashing

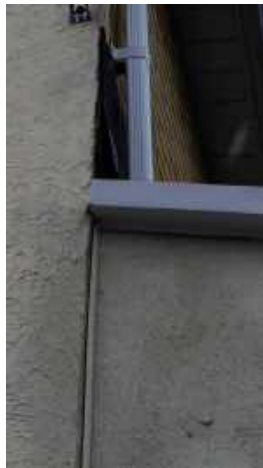
Gap in flashing at wall noted above roof

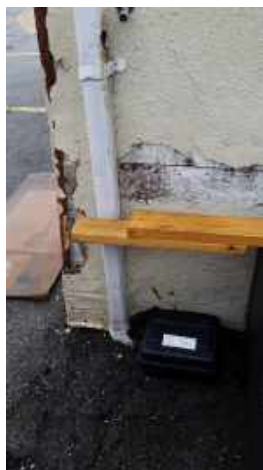
Downspout noted as extending into below grade drain pipe

Consult with a drain contractor to scope and determine the discharge point for the downspouts so as to ensure they are functional and result in removal of water away from the dwelling.

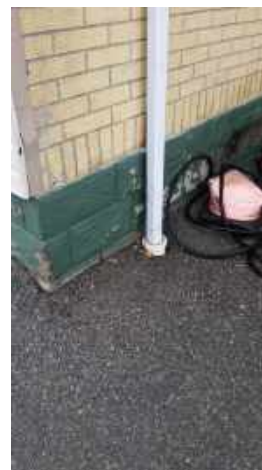
Downspout below grade discharge

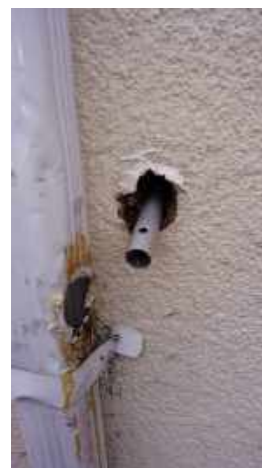
Damaged / perforated downspout

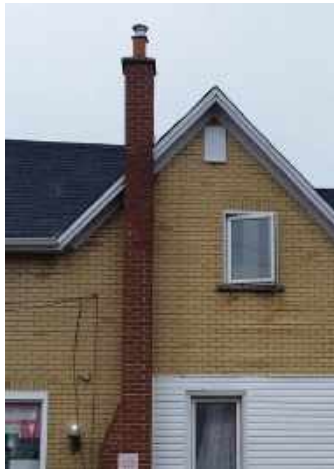
Brick Chimney

At the time of the current inspection the chimney above grade was noted in a generally good state of repair.

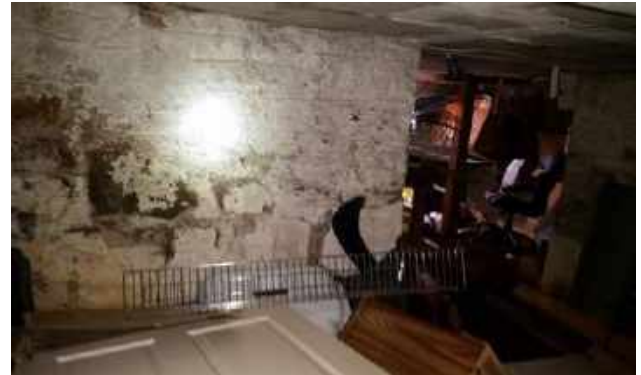
Water stained / damaged foundation wall

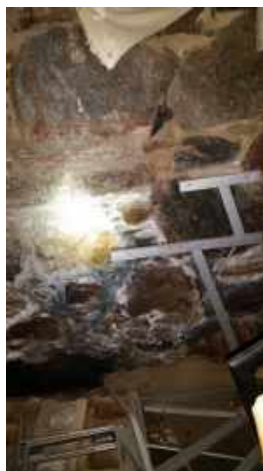
Portion of foundation noted as wet at the time of inspection

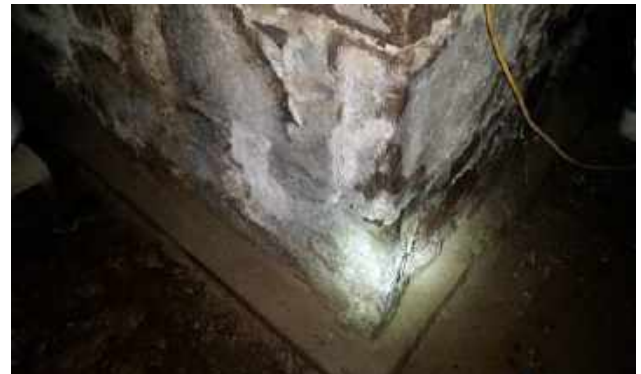
Significant amount of efflorescence on inside of foundation wall caused by moisture migration through the wall

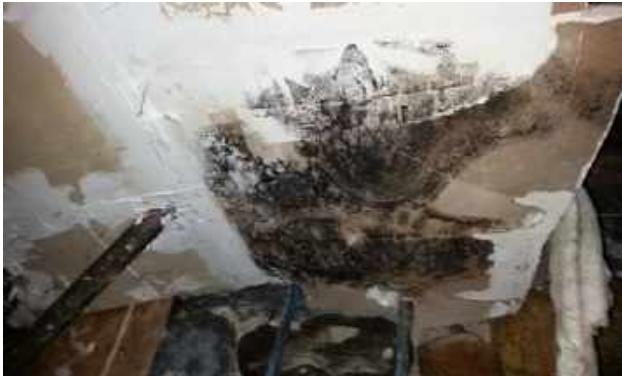
Mould growth noted on underside of ceiling drywall

Removal of all drywall as part of the required mould remediation.
Consultation with a mould remediation contractor and then a professional engineer / designer to evaluate the condition of the wood floor structure in addressing any structural damage / alterations in place intended to modify the original structure.

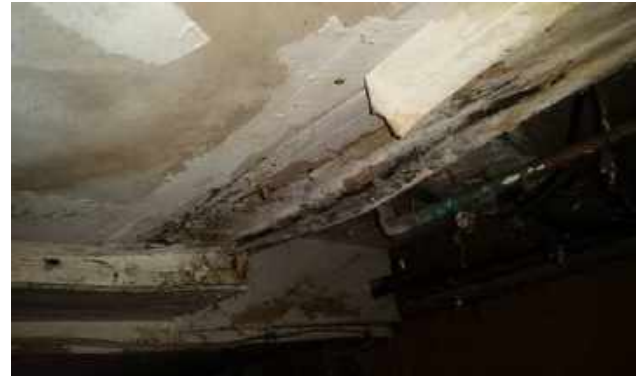
Drywall on basement ceiling is damaged by moisture. Mould growth also visible.

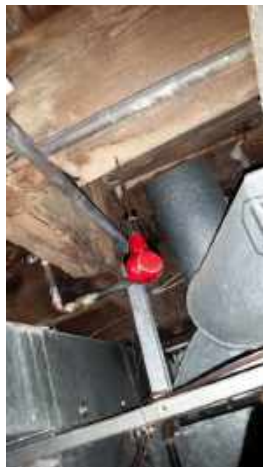
Visible wood joists not structurally compromised

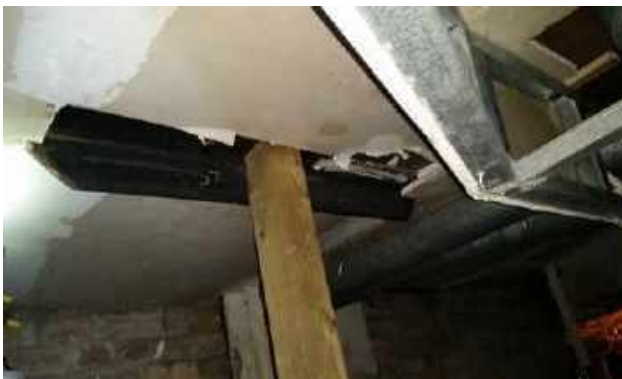
Steel angle-iron installed under floor joist and propped up by wood post

The design and condition of the vertical wood posts installed in the basement needs to be evaluated by a professional engineer / designer to determine the appropriateness / effectiveness in facilitating their intended purpose.

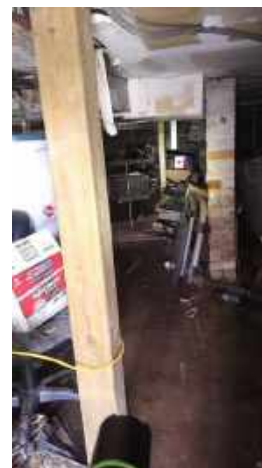
Vertical wood post supports noted in basement

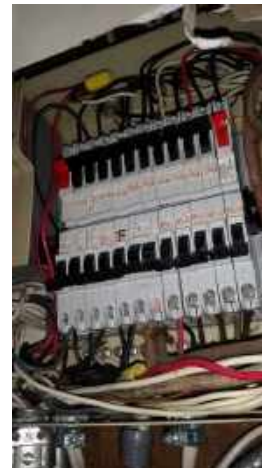
Panel noted as full. No spare circuits / breakers available

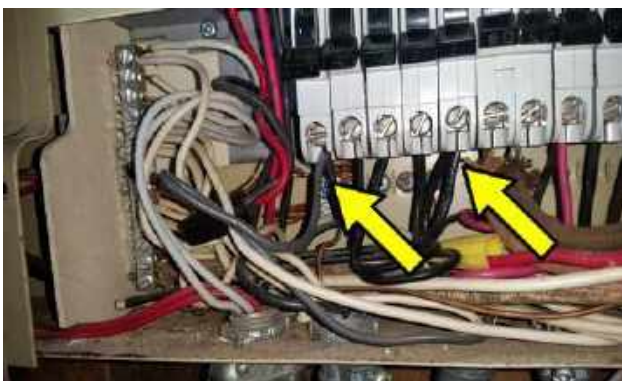
Circuit double tapping

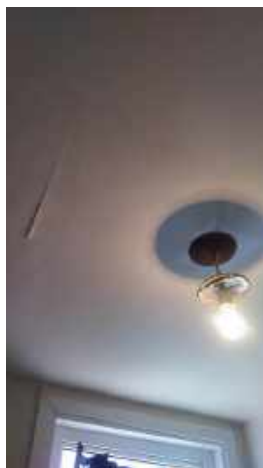
Light fixture with missing cover

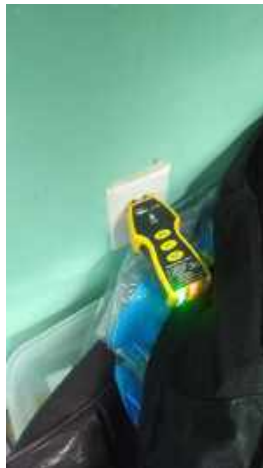
Reverse polarity condition

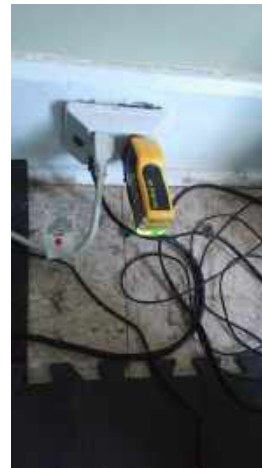
Open ground condition throughout

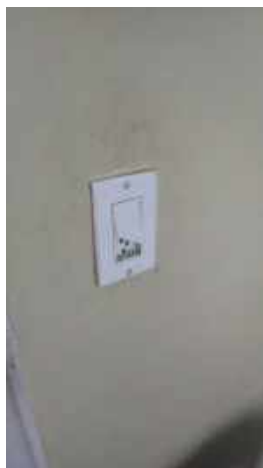
Broken bedroom light switch

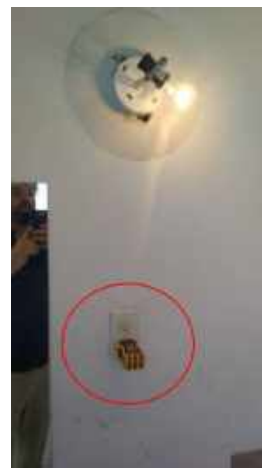
Inoperative outlet (also exposed bulb above)

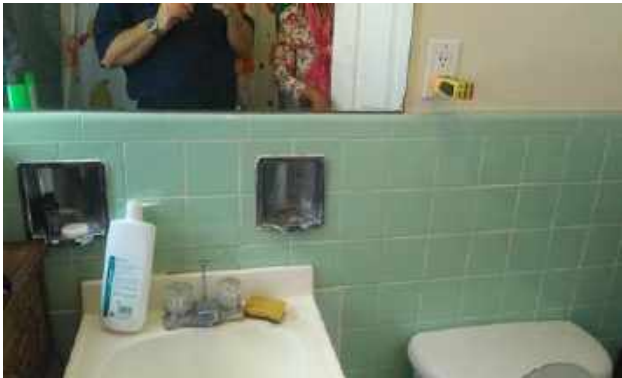
Non GFCI outlet (also open ground condition noted)

For improved safety replace outlets / circuit breaker serving electrical outlets near bathroom sinks with GFCI type. Consult with a qualified electrician as required.

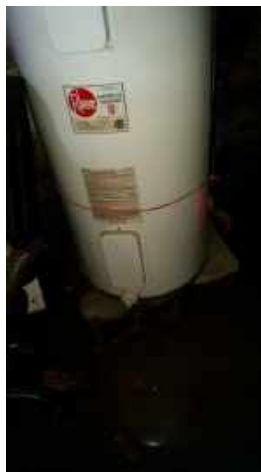
The hot water heater is likely a rental unit. It was noted as raised off the floor level using concrete blocks. However, there is no guarantee that the water level won't get to the bottom of the tank, which may cause catastrophic failure / other damage.

Electric HWT on concrete blocks in basement

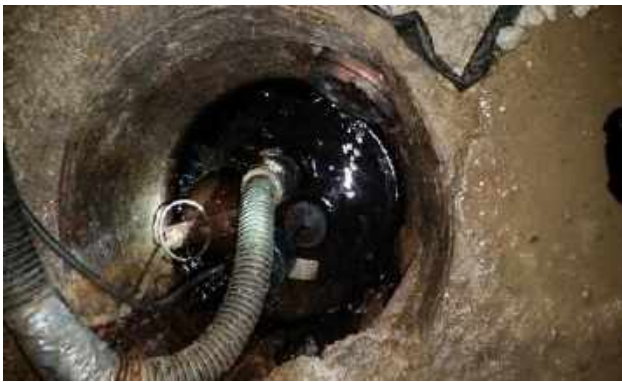
Submersible sumo pump

Consult with a qualified plumber / drain contractor to ensure that the entire basement is served by a sump pump / pumps. In addition, battery back-up systems are required to ensure continuous operation in case of a power outage / failure. In addition, confirmation that the water is being discharged from the pump to an appropriate location is also recommended.

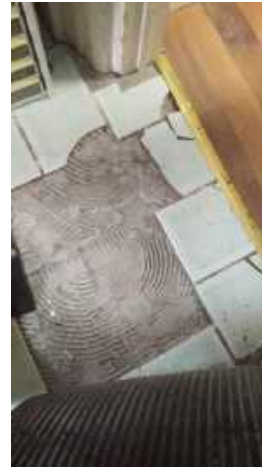
Cracked / broken floor tile

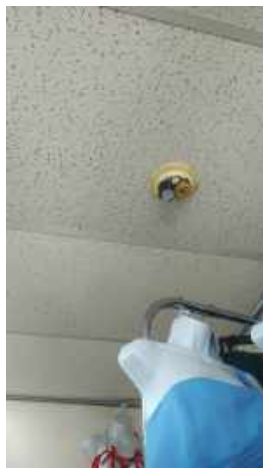
Main floor inoperative smoke detector

Provide smoke detectors on all levels of dwelling and near sleeping area as required by law for occupants safety.

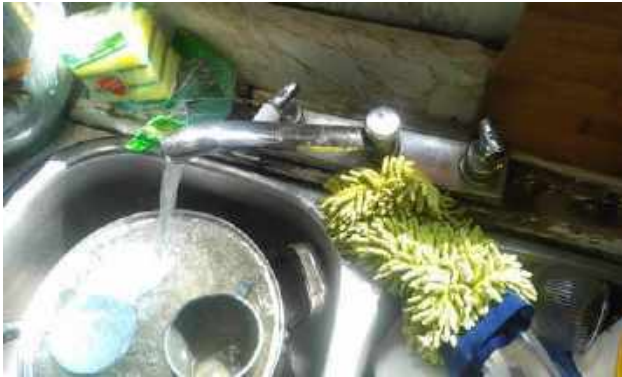
Sink Faucet mounted on section of wood over counter

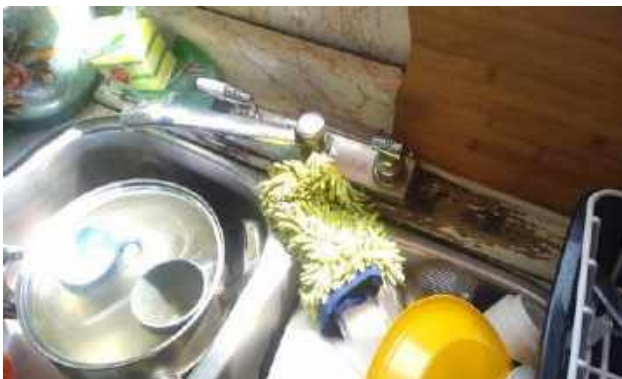
Counter deteriorated around sink area

As part of the recommendation to renew the kitchen the counter needs to be replaced.

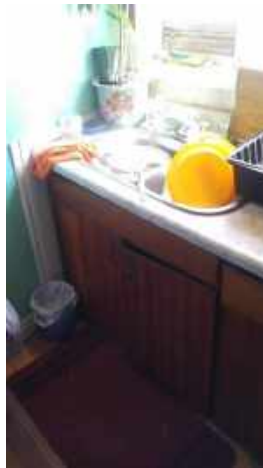
Old / tired kitchen cabinets / drawers

As part of the recommendation to renew the kitchen the cupboards need to be replaced.

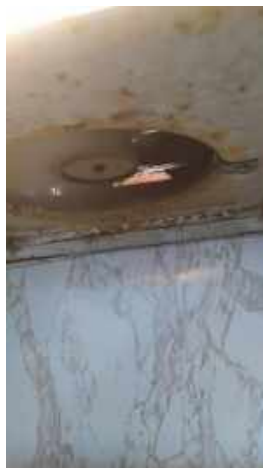
Although functional the fan was noted as old / rusted and missing filter elements.

Rusty old fan above stove with no filter elements and direct view to exterior.

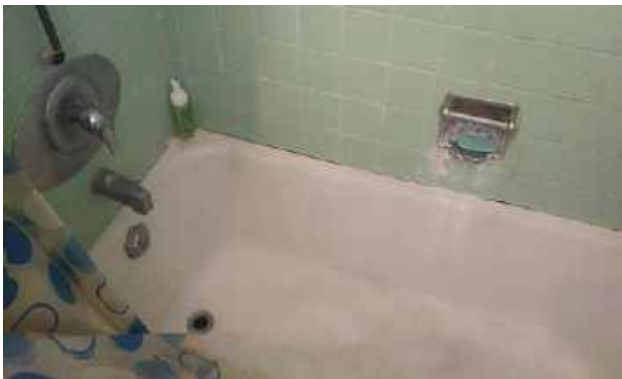
The tub is old with badly worn with deteriorated surfaces in need of re-finishing / replacement.

Main floor bathroom tub is old / worn

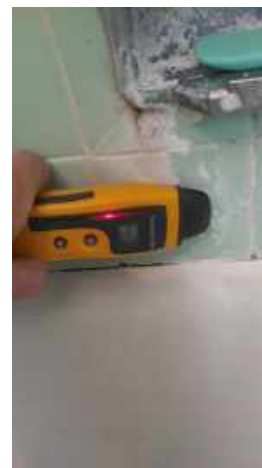
In addition a significant amount of moisture was detected in the tiled wall substrate material with the aid of a moisture meter.

Significant moisture penetration in tub enclosure wall

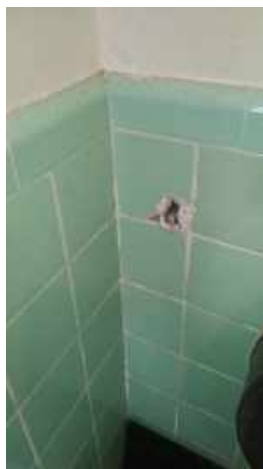
main floor bathroom with hole in tiled wall

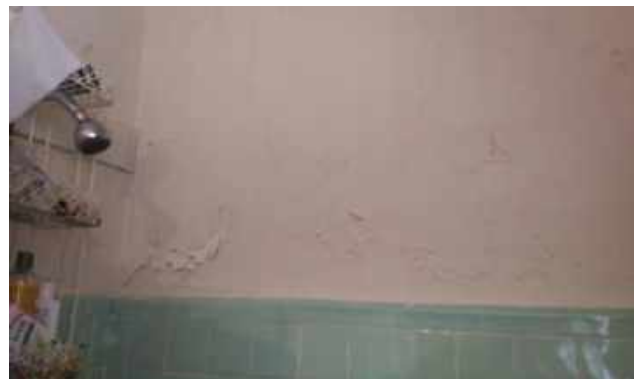
Bathroom walls were noted with deteriorated / peeling paint.

Wall above shower stall with deteriorated plaster / peeling paint
