**CULTURAL HERITAGE
IMPACT ASSESSMENT
And
HERITAGE DISTRICT
CONFORMITY
REPORT**

**2291 Major Mackenzie Drive West
Maple Heritage District,
Vaughan, Ontario, Canada**

19 October 2020

CULTURAL HERITAGE IMPACT ASSESSMENT and HERITAGE DISTRICT CONFORMITY REPORT

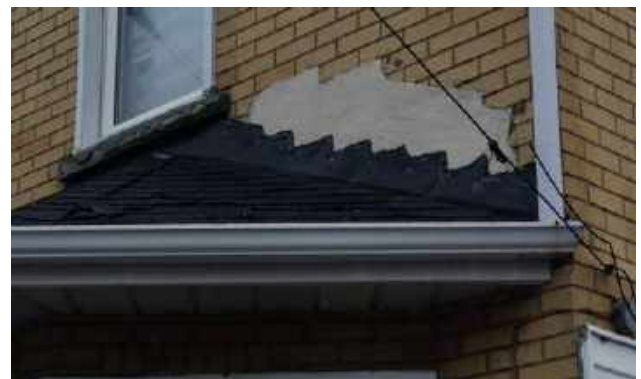
Parged wall above flashing

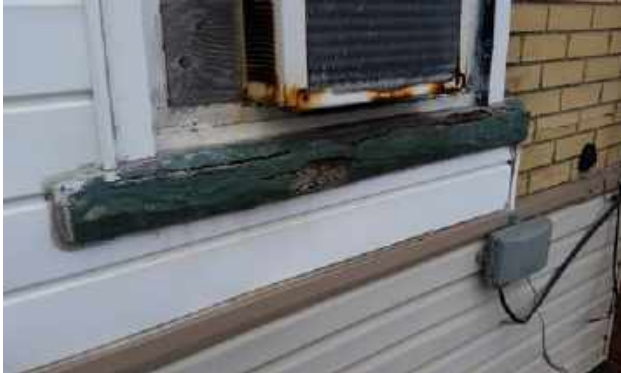
Deteriorated cement window sill has no capacity to keep water out of wall

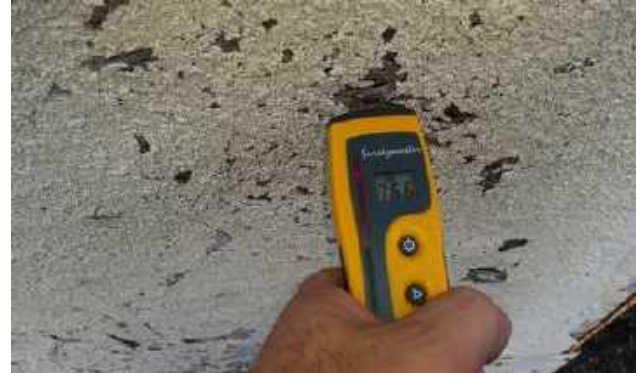
Water saturated stucco wall

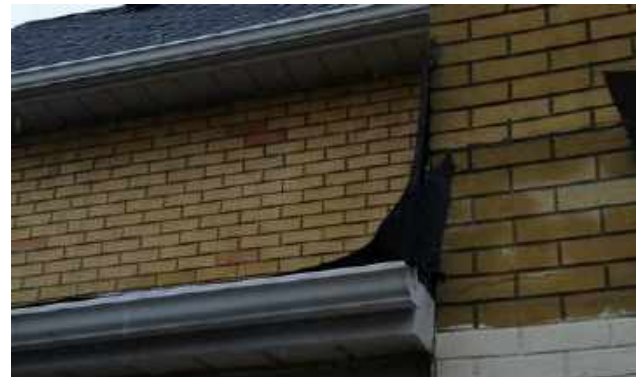
Improper wall flashing

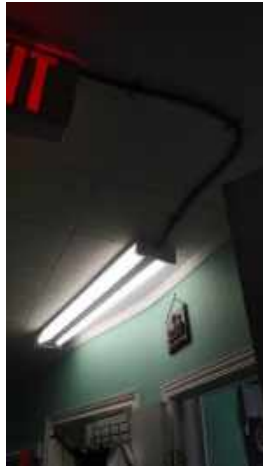
Exposed fluorescent bulbs

Replace any broken / inoperative light fixture throughout the dwelling as required in conjunction with other recommended electrical work to be conducted by a qualified professional electrician.

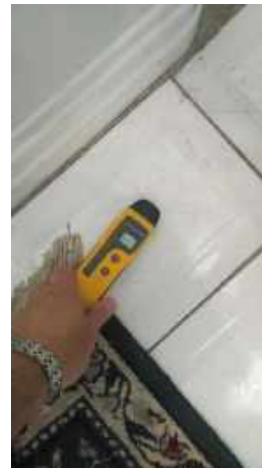
Tile floor near tub is saturated with moisture.

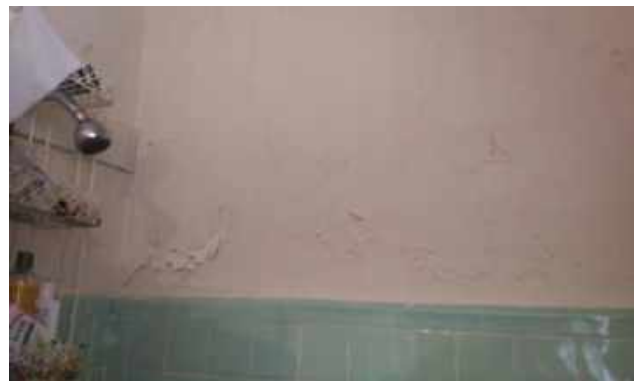
Bathroom walls were noted with deteriorated / peeling paint.

Wall above shower stall with deteriorated plaster / peeling paint
