**ENVIRO TREE CARE**  
1048 Broadview Ave Unit 1008  
Toronto, Ontario M4K 2B8  
Phone: 647-393-8733 Fax: 905-707-8734  
E-mail: [envirotreecare@yahoo.ca](mailto:envirotreecare@yahoo.ca)  
Website: [www.envirotreecare.ca](http://www.envirotreecare.ca)

This arborist report is written to supplement the Town of Vaughan Private Tree By-Law application for Development.

The property is located at 7714 Yonge Street, Thornhill.

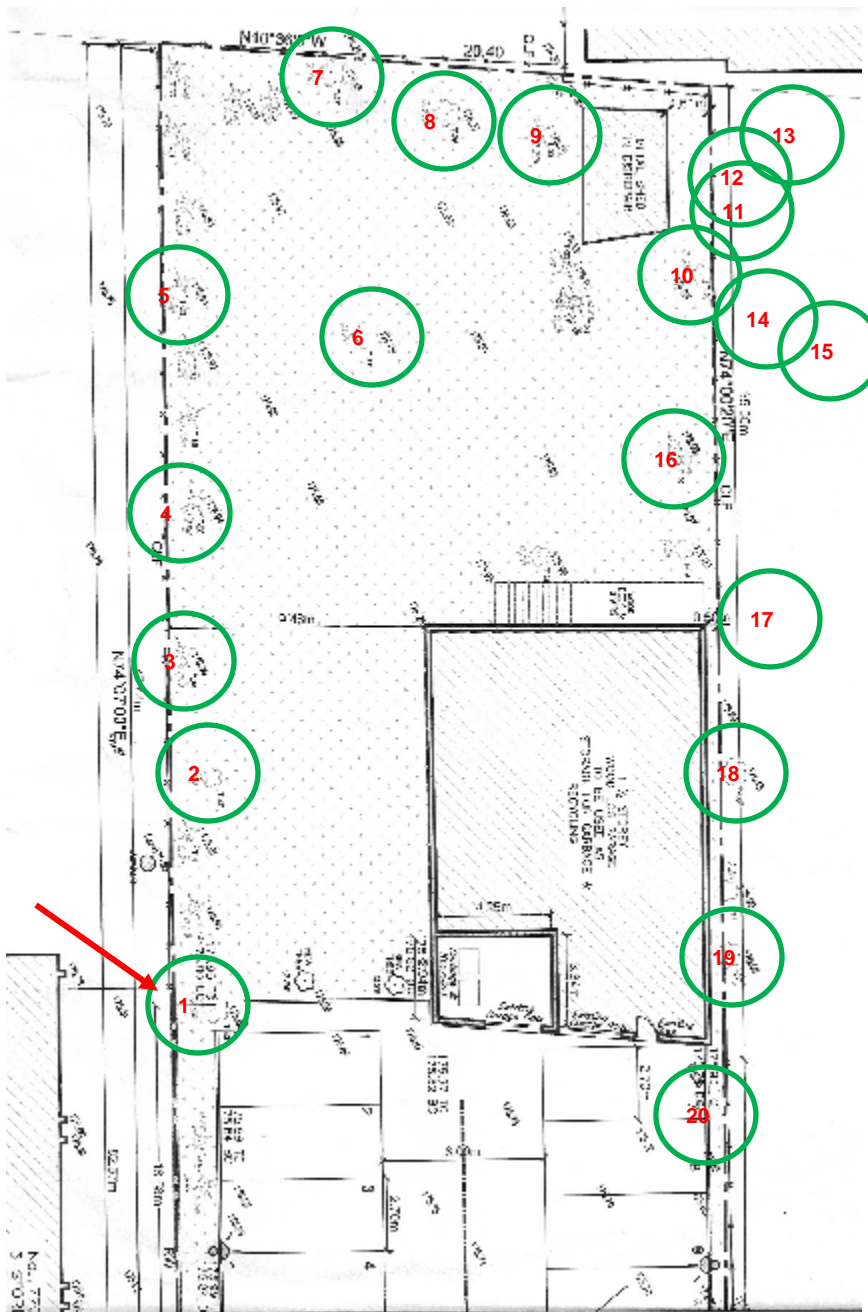
Site Plan Part 2  
(back half)

Tree #1 is a Norway Maple. It will require a 3.6 m Tree protection zone. This will reduce the number of parking spaces.

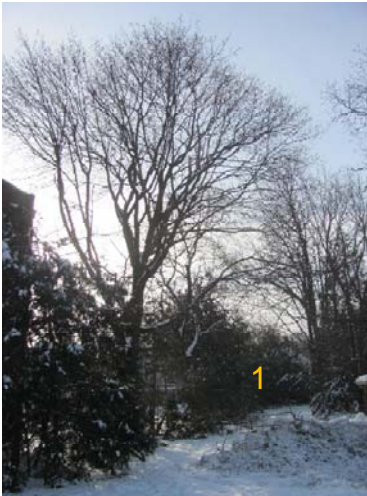
Tree numbered one has a diameter of 59cm lost a few branches in the ice storm. The root crown has a large area of exposed decay. The tree cannot be adequately protected with the extension of the proposed parking lot. It is recommended that the tree be removed unless the required TPZ can be totally protected.

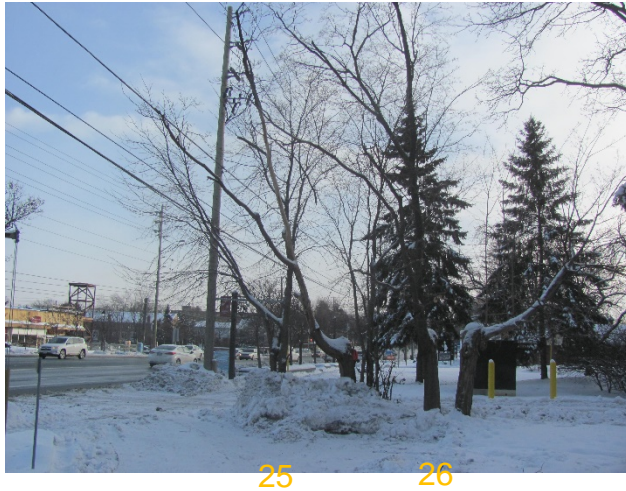
Tree number 25 and 26 are not in good shape. Their removal would be prudent.
