Pre-Construction Tree Assessment Report 357, 365 and 375 Stegman's Mill Road Kleinburg, ON Revised: April 27th, 2021

Arborist Report

Site: 357, 365, and 375 Stegman's Mill Road Kleinburg

Updated by Christopher Preece Consulting Arborist Davey Resource Group ISA ON-2547A Registered Professional Forester R.P.F. #2613 1(905)818-3583 Christopher.preece@davey.com

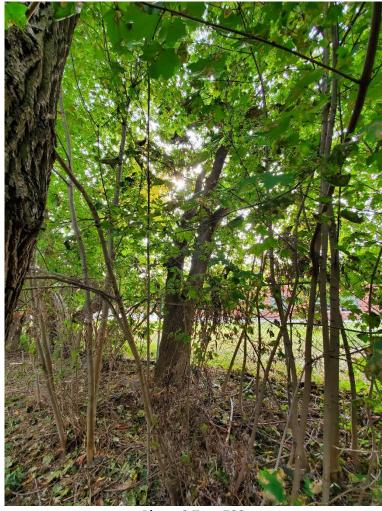
Photo 2 Tree 1

2	Green Ash	Fraxinus pennsylvanica	10	F	F	F		2	1.2	Minor bow, emerald ash borer infestation	Remove - species	Neighbouring	0
781	Manitoba Maple	Acer negundo	41,34 [53.3]	Ρ	FP	FP		10	7.2	Hazardous, history of failure, 1 scaffold branch failed resulting in major stem wound with decay, moderate epicormic branching, 1 stem dead, conflict with chain link fence, smaller stem removed with decay, co-dominant at base with heavily included bark	Remove - condition	Neighbouring	0

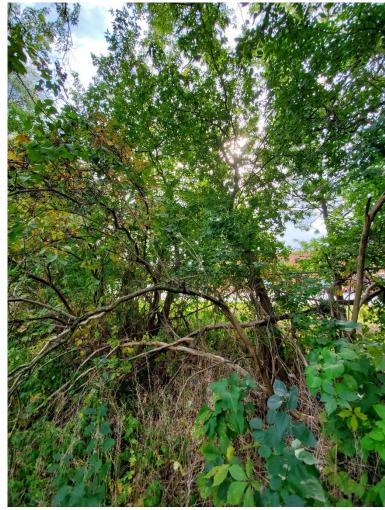
Photo 4 Trees 2, 781, 780 and 3 (right to left)

780	Manitoba Maple	Acer negundo	30,23 [37.8]	Ρ	FP	FP	4	4.8	Hazardous, stem wound at base with decay, co-dominant at 1.2m with minor included bark, small stem dead and removed, conflict with chain link fence, bowed, moderate epicormic branching, small root flare, reverse stem taper, fruiting bodies	Remove - condition	Neighbouring	0
3	Manitoba Maple	Acer negundo	15.5	FP	FP	F	3	1.2	Topped at 3m with decay, moderate lean towards the southeast, moderate epicormic branching, moderate asymmetrical crown, conflict with fence	Remove - condition	Neighbouring	0
4a	Manitoba Maple	Acer negundo	17	F	F	F	3	1.2	Moderate bow towards the east, moderate epicormic branching	Remove - development	Neighbouring	0
4b	Manitoba Maple	Acer negundo	14	F	F	F	3	1.2	Moderate bow towards the east, moderate epicormic branching, moderate asymmetrical crown	Remove - development	Shared	0
4c	Manitoba Maple	Acer negundo	19,13 [23]	FP	FP	FP	3	3.6	Hazardous, co-dominant at base with moderate included bark, moderate lean towards the southeast, smaller stem dead with decay, topped at chain link fence, previous branch failure	Remove - condition	Neighbouring	0

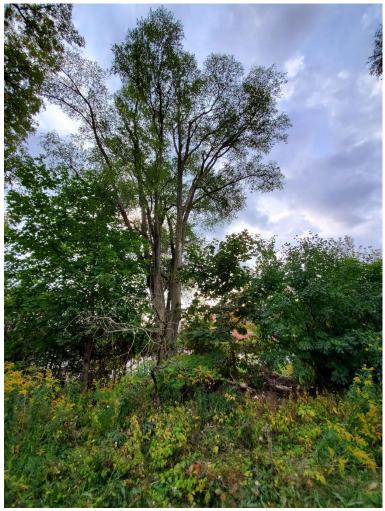
Photo 5 Tree 4a, 4b, 4c, 4d (right to left)

4d	Manitoba Maple	Acer negundo	27	F	F	F	4	3.6	Moderate coppice growth at base, moderate lean towards the east, minor epicormic branching	Remove - development	Neighbouring	1
714	Siberian Elm	Ulmus pumila	90	FP	FP	F	7	10.8	Hazardous, unions near base, 1m and 2m with moderate included bark and wetwood, previous branch failures, moderate epicormic branching	Remove - condition	Neighbouring	0
Р5	Eastern White Cedar	Thuja occidentalis	~5-10cm	F	F	F	1	1.2	Hedgerow, moderate asymmetrical crown due to competition, 3 to 6m in height, 100-200 stems	Preserve	Neighbouring	0
	Norway Maple	Acer platanoides	11	FG	F	F	3	1.2	Moderate tar spot, moderate exposed roots	Preserve	Private	0
P6	Manitoba Maple	Acer negundo	8,6 [10]	F	F	F	3	1.2	Union at base with moderate included bark, spiral fused stems, moderate epicormic branching	Preserve	Shared	0
