**CULTURAL HERITAGE IMPACT ASSESSMENT
GEORGE BAILEY PUBLIC SCHOOL
COMMUNITY OF MAPLE, CITY OF VAUGHAN, ONTARIO**

York Region District School Board
Facilities Management Centre
1260 Gorham Street
Newmarket Ontario L3Y 8W4

ASI File: 20CH-118

September 2020 (updated May 2021)

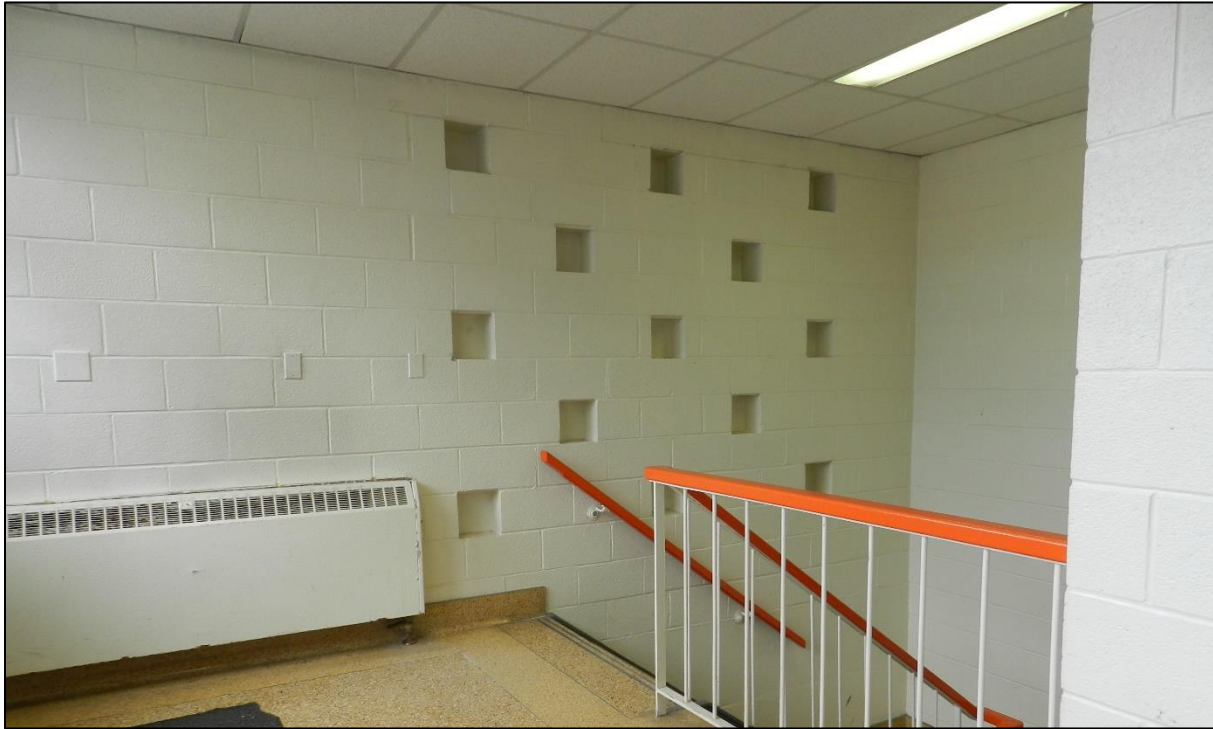
Figure 47: Recessed pattern within the staircase wall where coloured glass blocks were once located (ASI 2020)

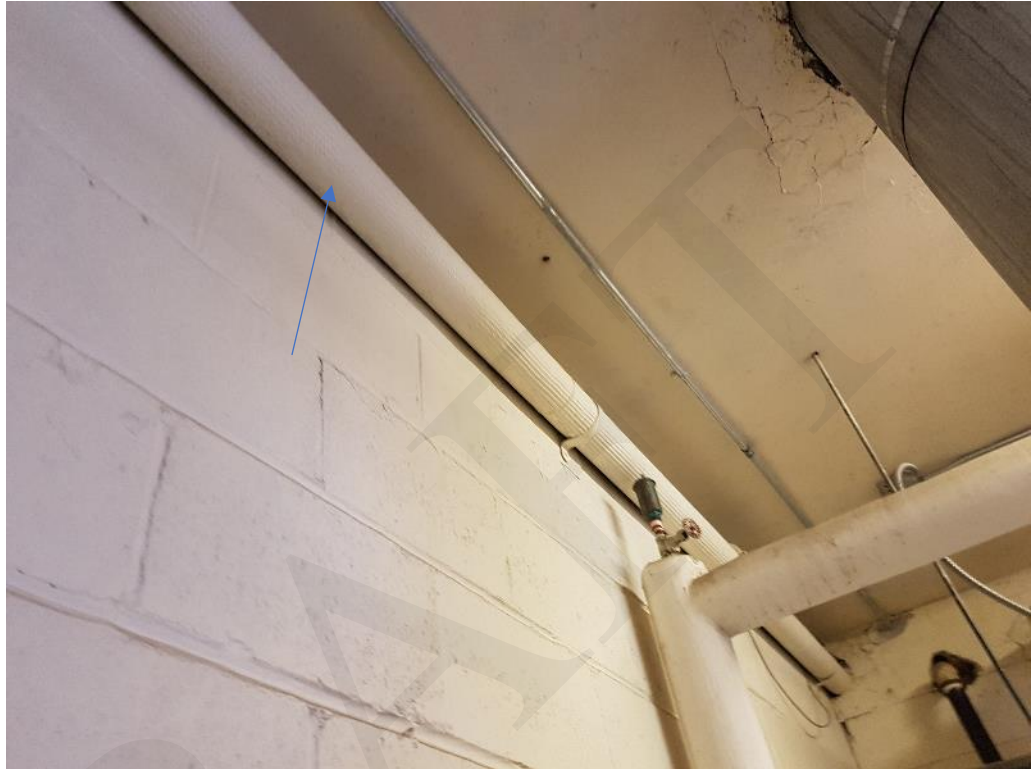
Example of asbestos-containing transite piping in the boiler room (Location 01).

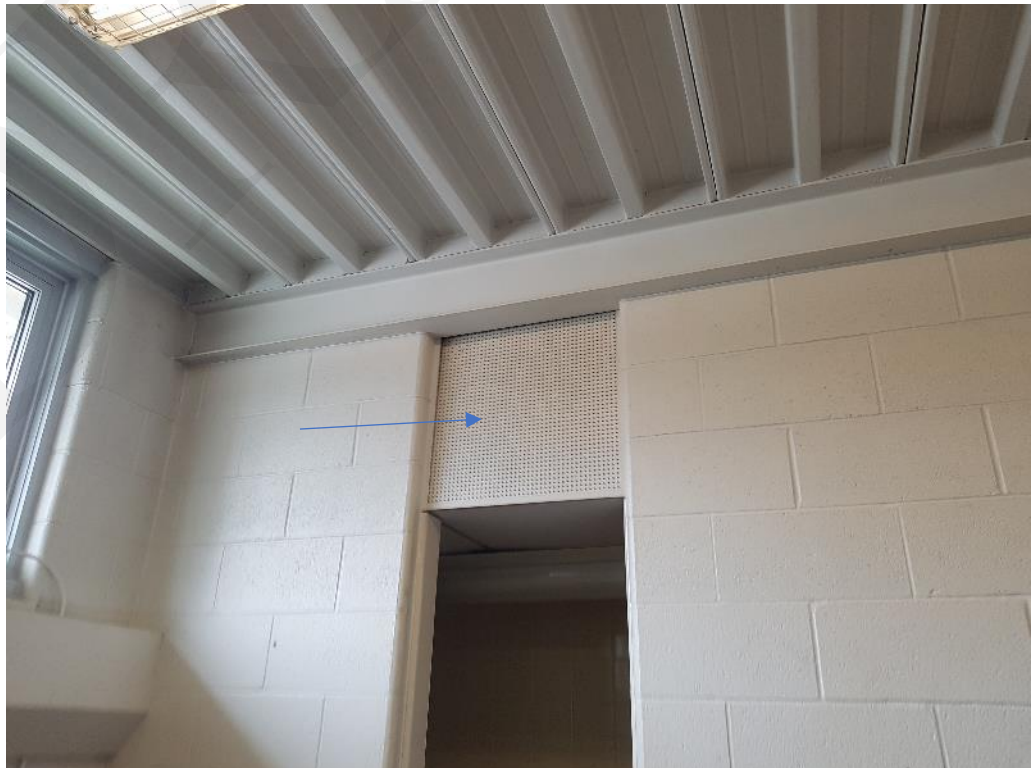
Photo No. 2.

Example of asbestos-containing transite panel in the girls change room (Location 08).

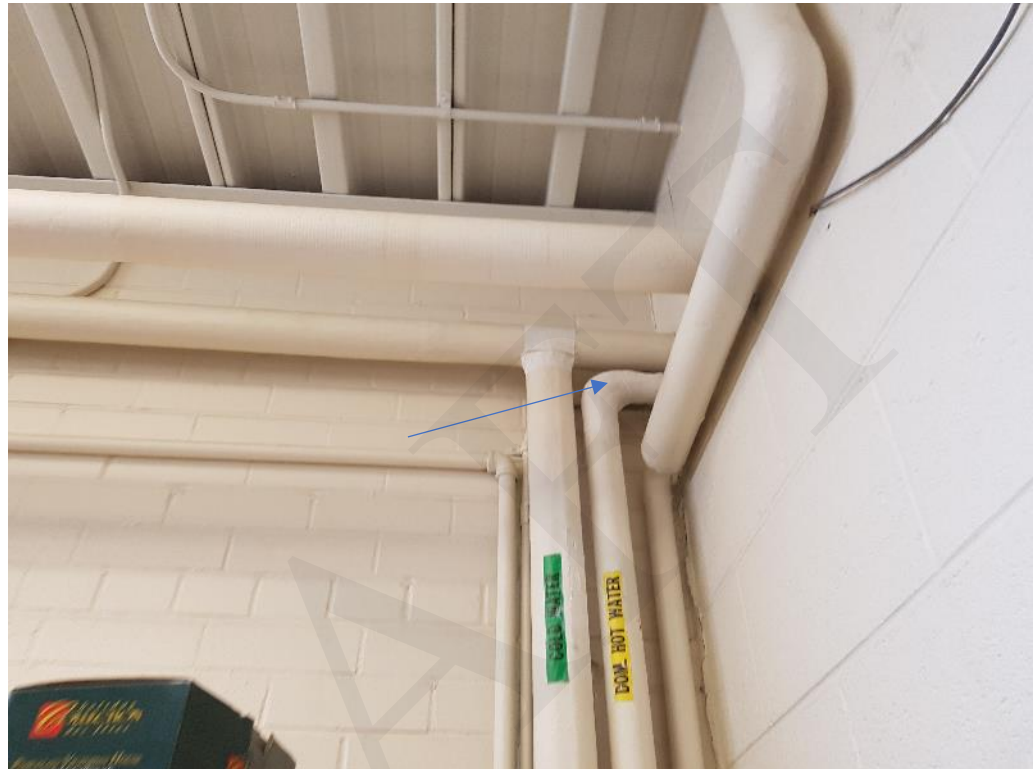
Example of asbestos-containing parging cement on piping in the work room (Location 17).

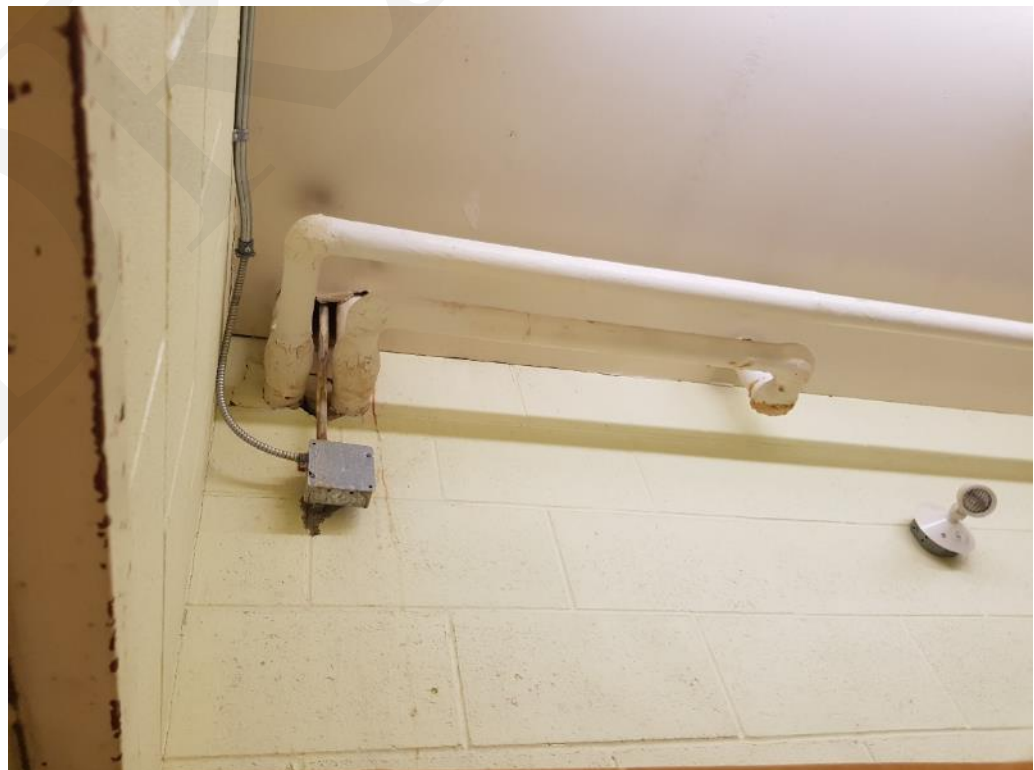
Photo No. 4.

Example of asbestos-containing drywall joint compound on the wall in the gym storage room (Location 15).

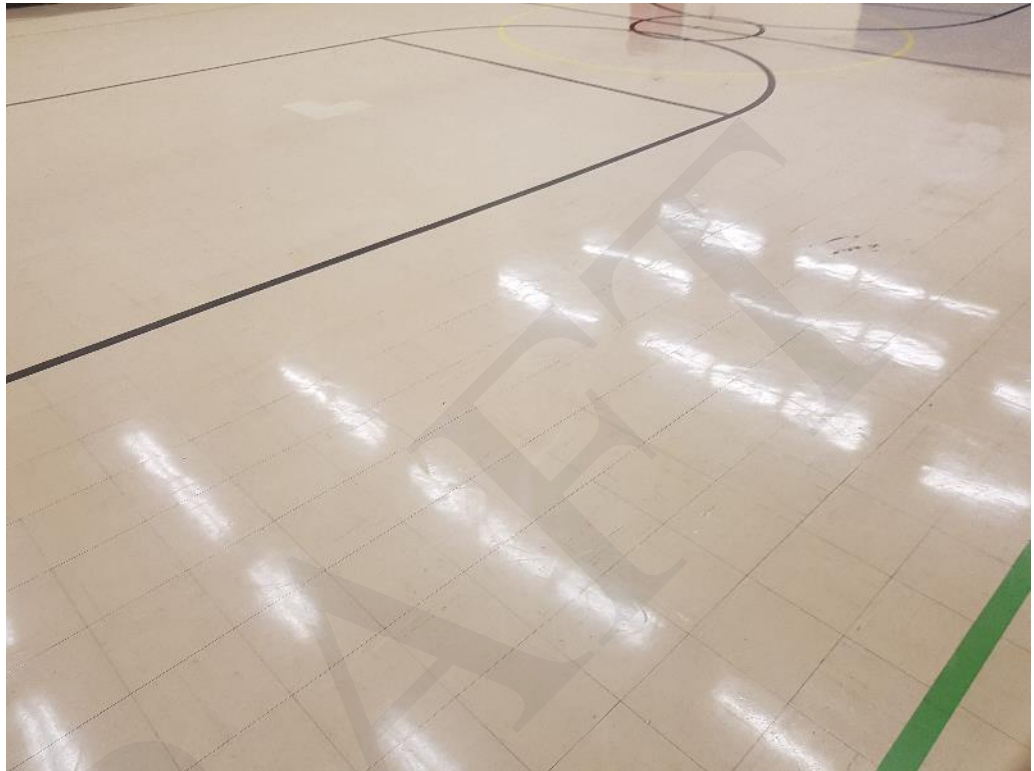
Example of asbestos-containing vinyl floor tiles in the gym (Location 16).

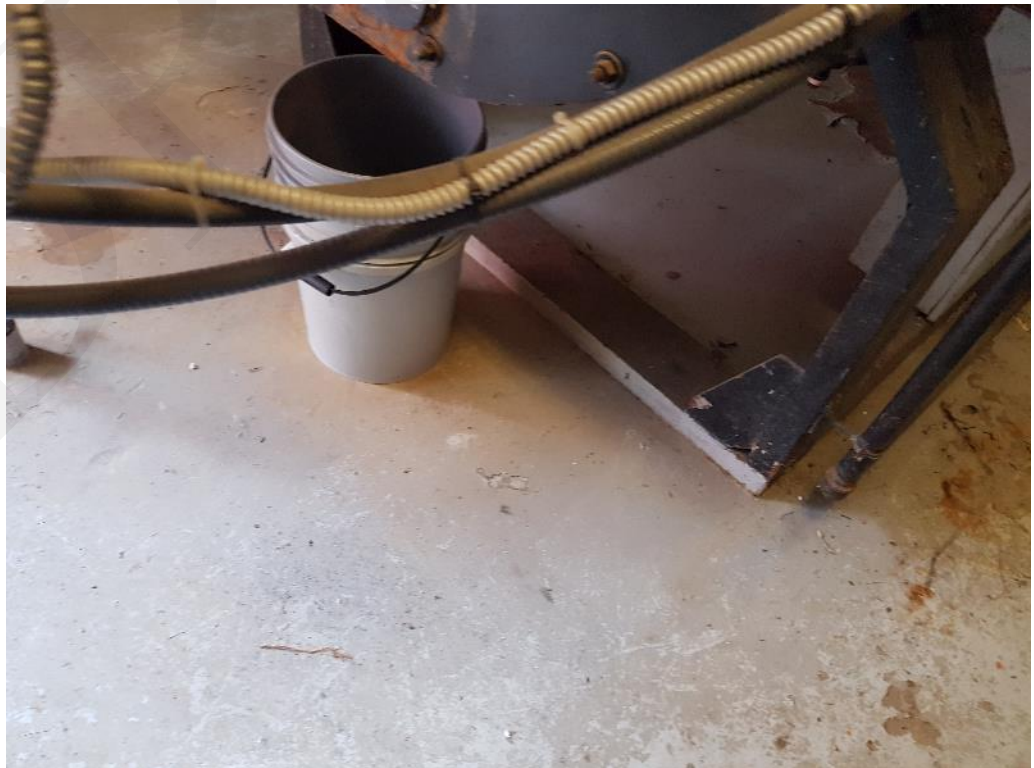
Photo No. 6.

Example of lead-containing light blue paint on the floor of the boiler room (Location 01).

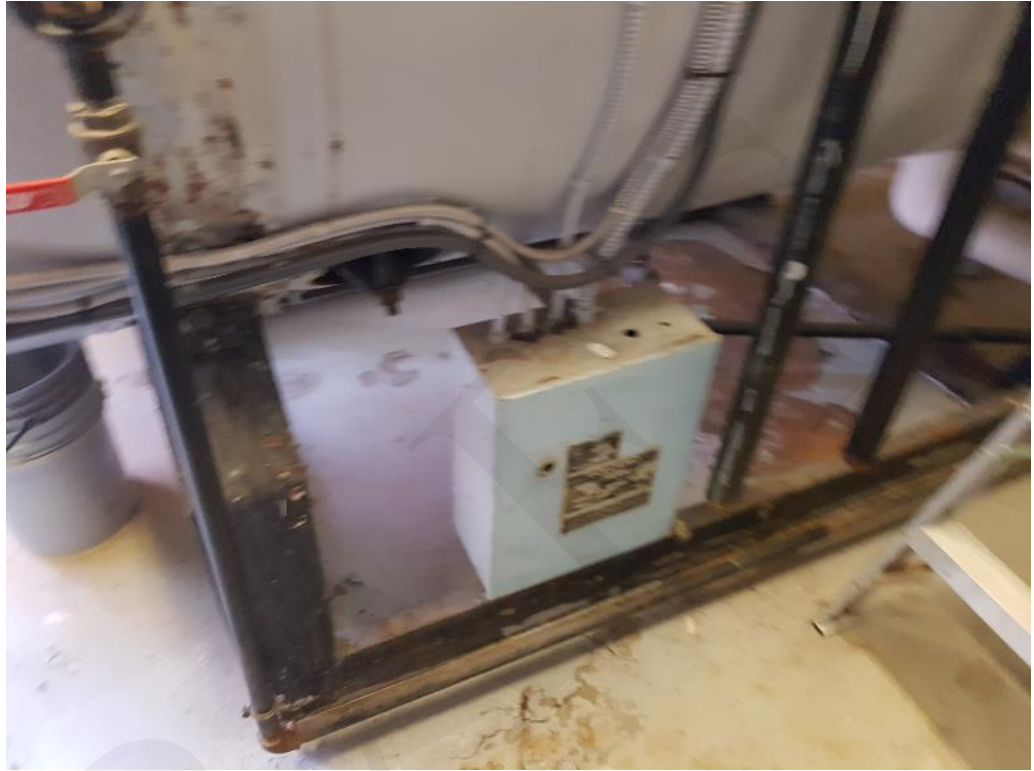
Example of lead-containing grey paint on the boiler and black paint on piping in the boiler room (Location 01).

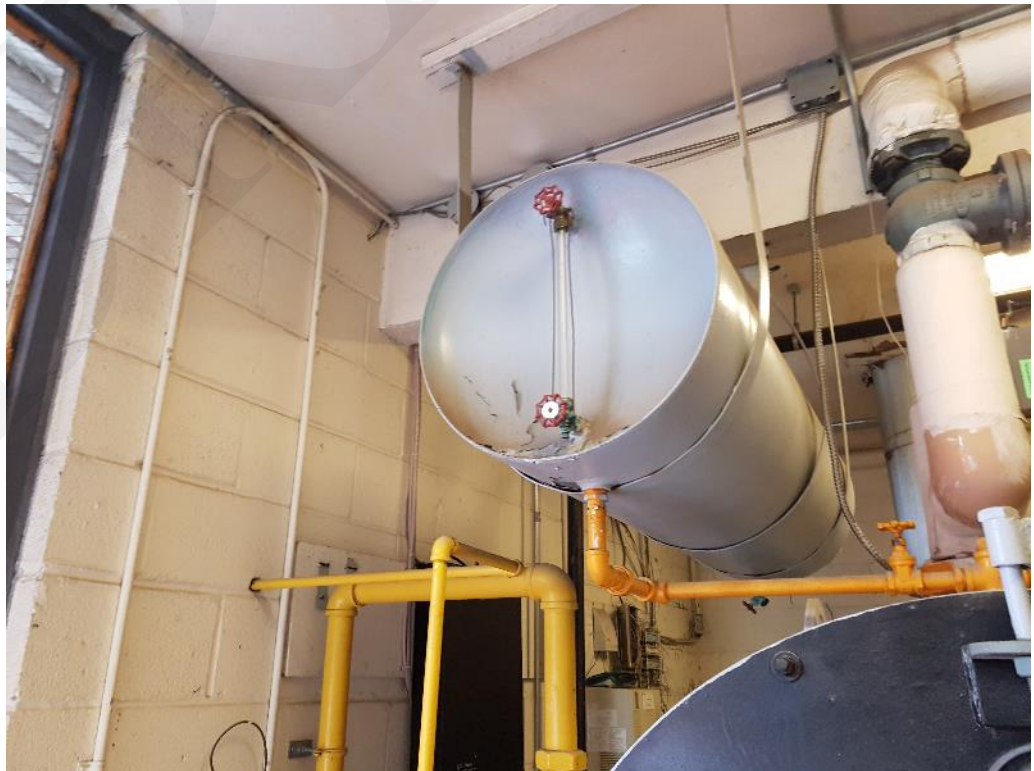
Photo No. 8.

Example of lead-based orange paint on piping and yellow paint on natural gas line in the boiler room (Location 01).

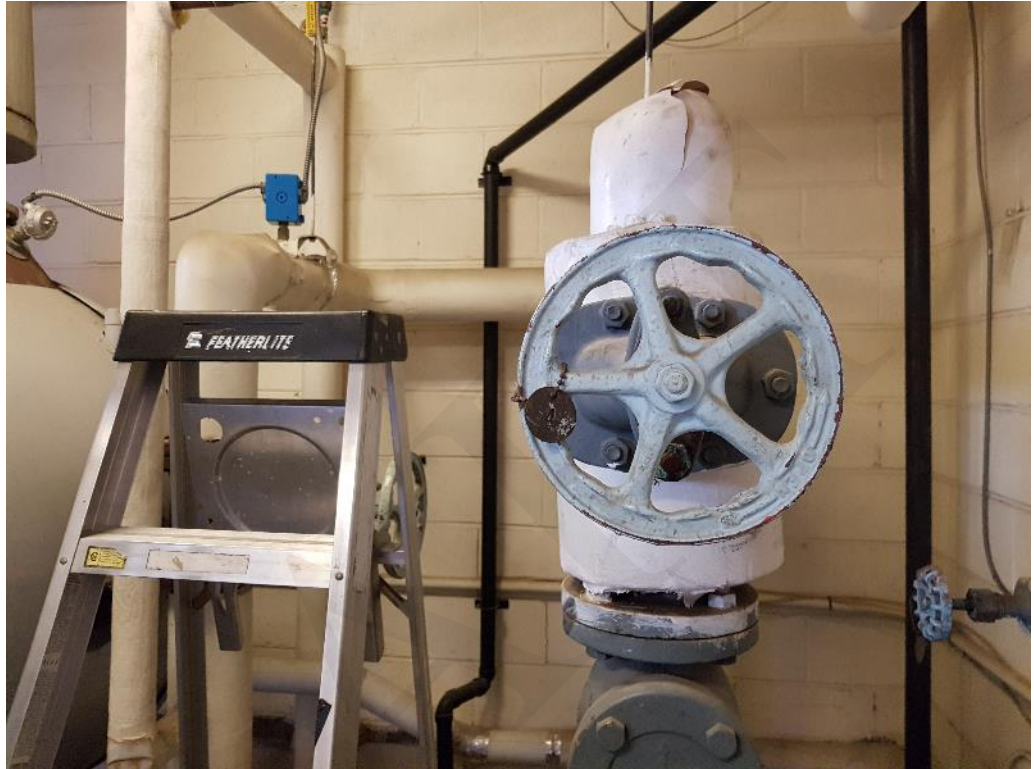
Example of lead-based light blue paint on valves in the boiler room (Location 01).

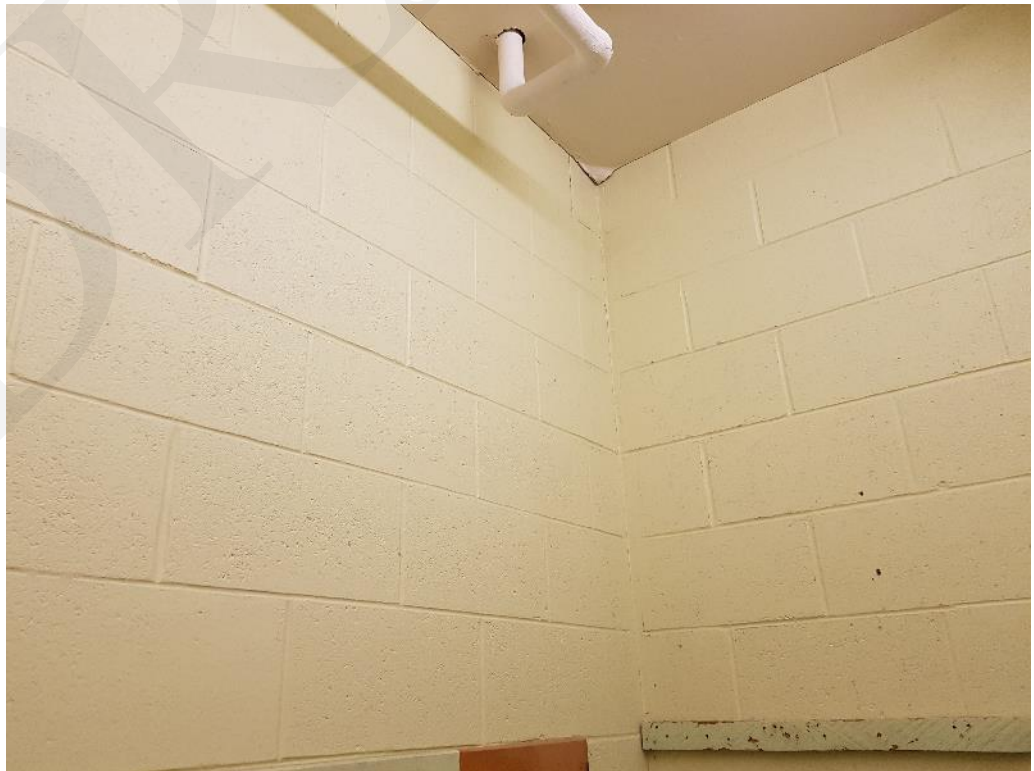
Photo No. 10.

Example of lead-based light green paint on the walls in the storage room (Location 15).

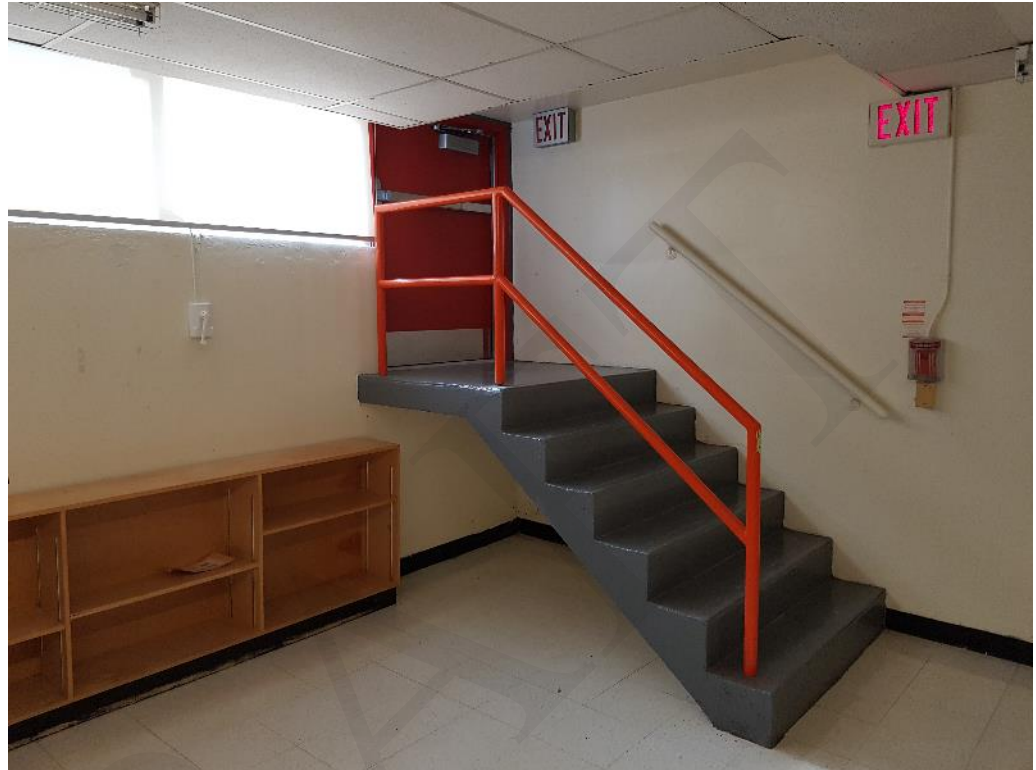
Example of lead-containing orange paint on railing in the conference room (Location 37).

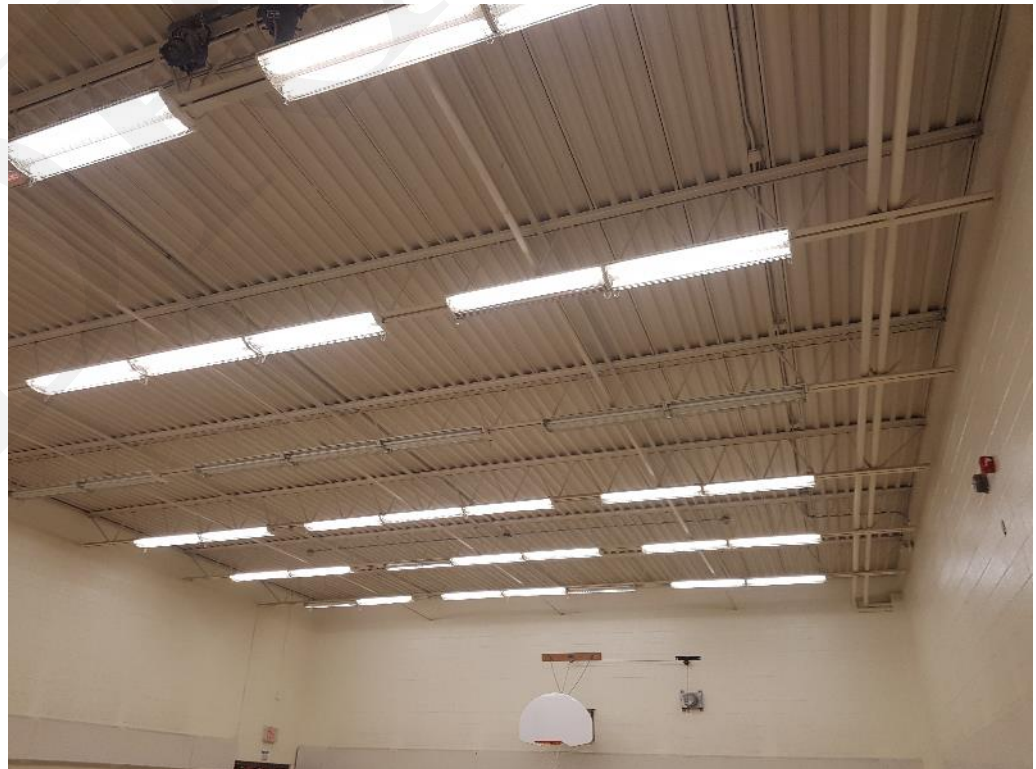
Photo No. 12.

Example of presumed PCB-containing light ballasts in the gym (location 16).

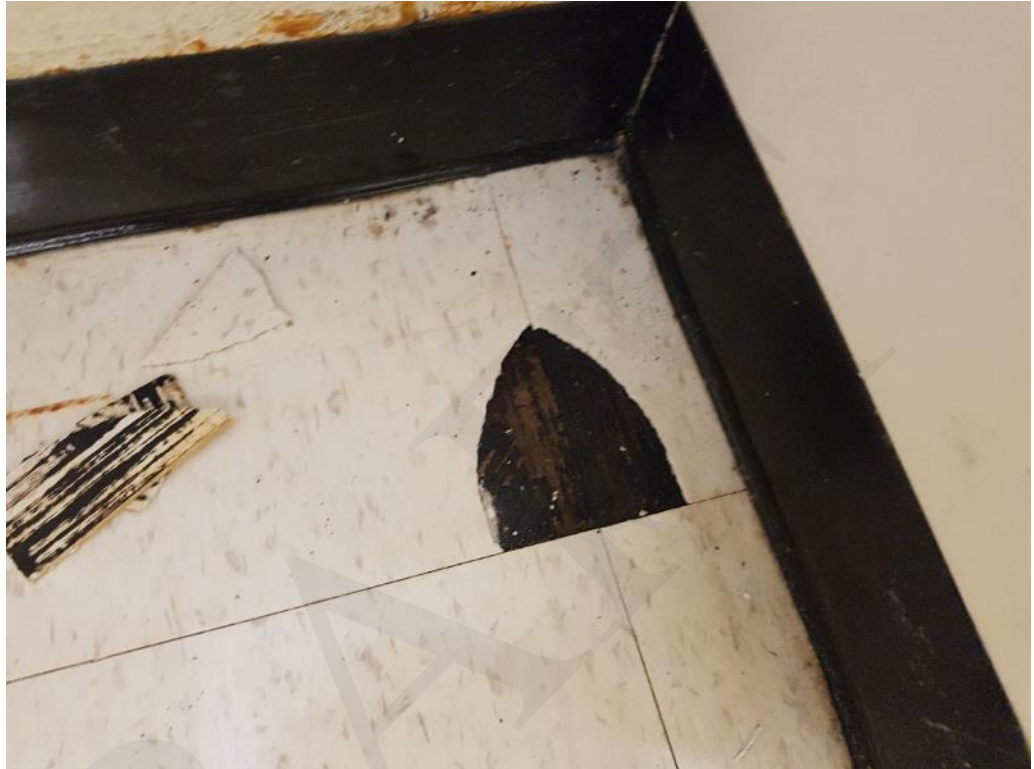
Example of asbestos-containing mastic under vinyl floor tiles in the computer lab (Location 06).
