HERITAGE VAUGHAN COMMITTEE - APRIL 21, 2021

Arborist Report

7714 Yonge Street, Vaughan, ON

7 March 2017, revised 1 April 2021

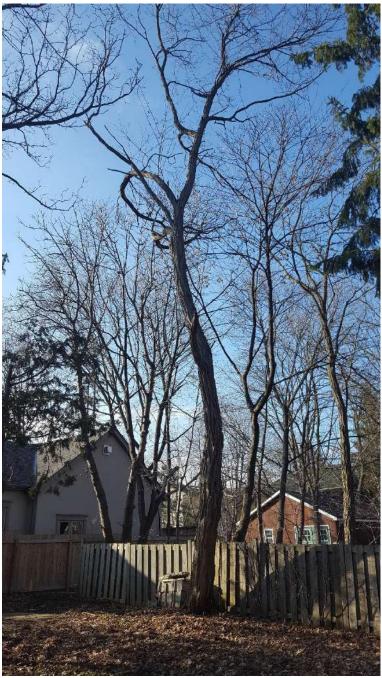
Photo 1 Trees 1, 2, 3, 4, 5 (left to right)

Any potential injury to neighbouring and shared trees should be discussed and accepted by the neighbouring property owner prior to development. Trees 2, 7, 11, 13, 17, and 22, are in poor condition or potentially hazardous and the appropriate neighbours should be notified. The tree protection hoarding for trees to be preserved should consist of a wood frame made of 2" x 4"s with plywood hoarding, to be installed according to the detail shown on the Tree Preservation Plan (Figure 1). The tree protection barriers should be installed prior to demolition and construction and remain in place throughout the construction process, as specified in the Tree Preservation Plan (Figure 1). No grade changes, storage of materials or equipment is permitted within the tree protection zone (TPZ). The tree protection hoarding detail and tree protection notes, are shown on the Tree Preservation Plan (Figure 1). Dripline distances are shown in Table 2 of this report.

Trees 2, 11, 13, 17, 20, 22, and 28 are in poor and declining condition and are recommended for removal regardless of the proposed construction. Trees 2, 7, 11, 13, 17, and 22, are located on neighbouring property or are shared trees. Trees within striking distance of the proposed development are recommended for removal to prevent injury/damage to persons/property. The neighbouring property owner should be notified of the condition of these trees and co-ordinate their removal. The removal of neighbouring and shared trees will require permission from the neighbouring property

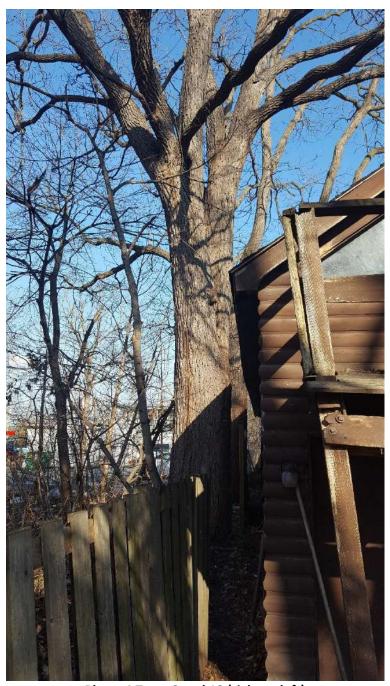
Photo 4 Trees 9 and 10 (right to left)

An existing garage is located within the driplines of Trees 9 and 12. The preservation of these trees may be possible if the existing base of the garage is used or is removed gently using hand tools only, being careful not to damage the roots. Demolition of the existing garage should be completed using hand tools or light equipment only. Tree protection hoarding around this tree must be installed immediately

It is recommended that the proposed parking area and walkway within the driplines of Trees 9 and 12 be installed using a combination of geocell and permeable materials to minimize soil compaction, and allow for water infiltration, and as close to existing grades as possible. Any work within the driplines of trees must be supervised by a Certified Arborist. These trees should be monitored for changes in health, condition and structural stability by a Certified Arborist during and following construction. The supervising Arborist must confirm that the trees are safe to be retained.

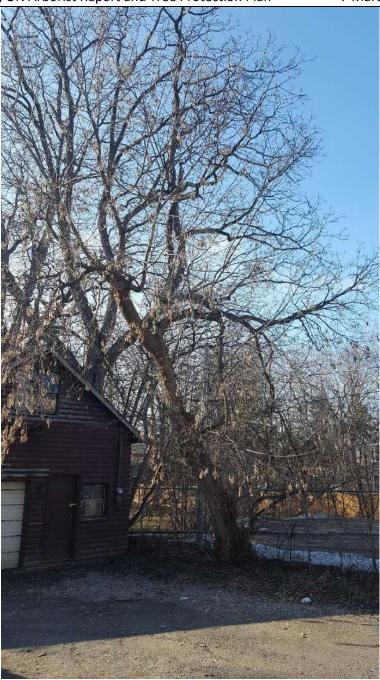
Photo 7 Tree 13

13	Manitoba Maple	Acer negundo	64	F	PF	PF	8	4.2	Moderate exposed roots, included chain link fence, moderate lean towards south, heavy epicormic branching, moderate growth deficit at base on south side, heavy pruning wounds, topped at 8m, major stem wound with cavity, transverse crack in branch failed, potential hazard => removal recommended	Remove- poor condition	Shared
14	Black Locust	Robinia pseudoacacia	~34	FG	FG	FG	3	2.4	Light lean towards north, light asymmetrical crown	Preserve- tentative	Neighbouring
15	Norway Maple	Acer platanoides	33	FG	F	F	6.5	2.4	Light lean towards northwest, moderate asymmetrical crown due to competition	Preserve	Shared
16	Norway Maple	Acer platanoides	20	G	F	F	6.5	1.8	Conflict with Tree 17, moderate asymmetrical crown due to competition	Preserve	Private
17	Manitoba Maple	Acer negundo	78	F	F	F	11	4.8	Moderate epicormic branching, U-union at 2.5m, light lean towards east, broken branches, stem wound at base with rot, dead branches with moderate decay, fruiting bodies, potential hazard => removal recommended	Remove- poor condition	Shared

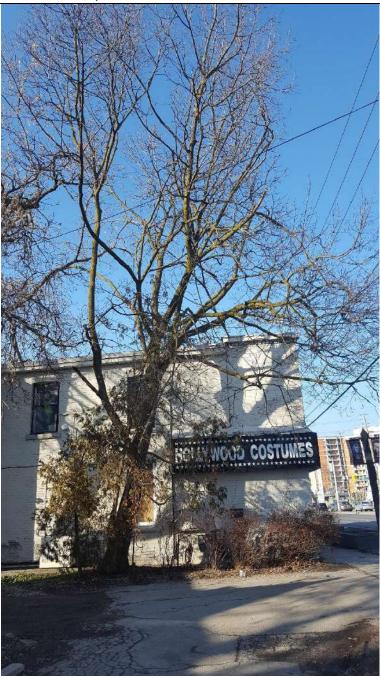
Photo 9 Tree 18

18	Norway Maple	Acer platanoides	~50	FG	FG	FG	8	3.0	Light lean towards east, light asymmetrical crown, union at 4m	Preserve- monitor	Shared
19	Ivory Silk	Syringa reticulata	14.5	F	F	F	1.5	1.8	Moderate pruning wounds, small stem flare, moderate asymmetrical crown	Remove- development	City
20	White Elm	Ulmus americana	16	DEAD		Ī	ı	Dead/dying	REMOVE- DEAD	Private	
21	Sugar Maple	Acer saccharum	33.5	Р	Р	Р	-	-	Topped at 2m, main branch dead, epicormic branches only	REMOVED	Shared
22	Sugar Maple	Acer saccharum	39.5		DEAD		-	-	Topped at 2.25m, cavity/hollow stem with rot, moderate dead branches	REMOVE- DEAD	Shared
23	Black Walnut	Juglans nigra	46	G	FG	FG	4	3.0	Light lean towards south, moderate asymmetrical crown due to competition, moderate epicormic branching	Remove- development	Shared
24	Black Walnut	Juglans nigra	58	G	F	FG	7	3.6	Moderate asymmetrical crown due to competition, moderate vertical scaffold limbs, moderate epicormic branching	Remove- development	Private

Encroachment into the driplines of Trees 1, 12, 14, 18, 31 to 35, 37, and 38, will be required to accommodate the proposed parking area, walkway, and/or hardscape. Any required excavation should be conducted by hand, air spade or hydro-vac to expose roots for assessment and pruning. It is recommended that the proposed parking area within the driplines of these trees to be installed using a combination of geocell and permeable materials to minimize soil compaction, and allow for water infiltration, and as close to existing grades as possible. Any required root pruning should be conducted by a Certified Arborist following good arboricultural standards. Any work within the dripline of trees should be supervised by a Certified Arborist. These trees should be monitored for changes in health, condition and structural stability by a Certified Arborist during and following construction. The supervising Arborist must confirm that the trees are safe to be retained. Cabling of the union of Tree 42 is recommended.

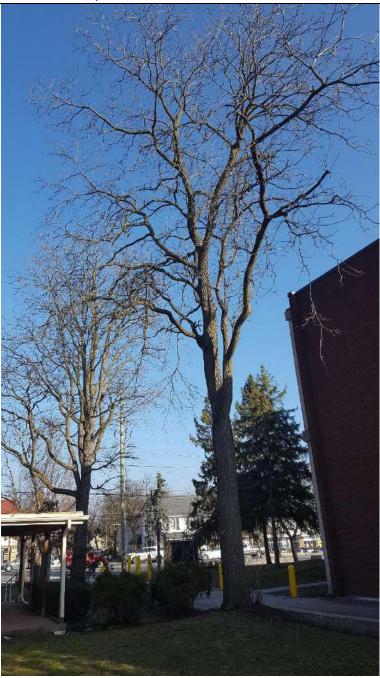
Photo 13 Tree 25

25	Black Walnut	Juglans nigra	61	G	F	FG	7.5	4.2	Adjacent retaining wall, moderate pruning wounds on neighbouring property side, improper arboricultural standards, light asymmetrical crown, light epicormic branching	Remove- development	Private
P26	Eastern White Cedar	Thuja occidentalis	17.5,13	FG	F	F	3.5	1.8	2 trees, union at base, light lean, broken leaders	Remove-	Private
F20	Norway Maple	Acer platanoides	12	F	F	F	3.5	1.8		development	Filvale
27	Eastern White Cedar	Thuja occidentalis	16,10	FG	F	F	2.5	1.8	Light lean towards east, union at base, dead leader	Remove- development	Private
28	Norway Maple	Acer platanoides	59		DEAD		6	-	Moderate growth deficit on west side, moderate girdling roots, sloughing bark at base, stem wound with rot, rot/crack at branch union, moderate dead branches, moderate asymmetrical crown, dead/dying, hazard	REMOVE- DEAD	Private
29	Eastern White Cedar	Thuja occidentalis	15,9,5	F	F	F	3	1.8	Union at base, vertical scaffold limbs	Remove- development	Private

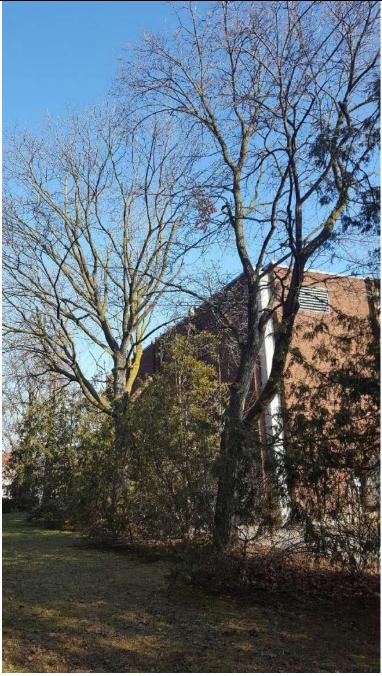
Photo 15 Tree 28, 29 and 30 (left to right)

30	Norway Maple	Acer platanoides	45	F	F	F	4	3.0	Growth deficits/ribbing at base, light lean towards south, moderate asymmetrical crown, moderate pruning wounds, minor dead and broken branches	Remove- development	Private
31	Eastern White Cedar	Thuja occidentalis	23	G	FG	PF	4	1.8	Light lean towards south	Preserve- monitor	Private
