# **Tree Inventory & Protection Plan**

**Subject Site:**  
60 Napier Street. Vaughan, ON L4H 3N5

**July 29, 2022**

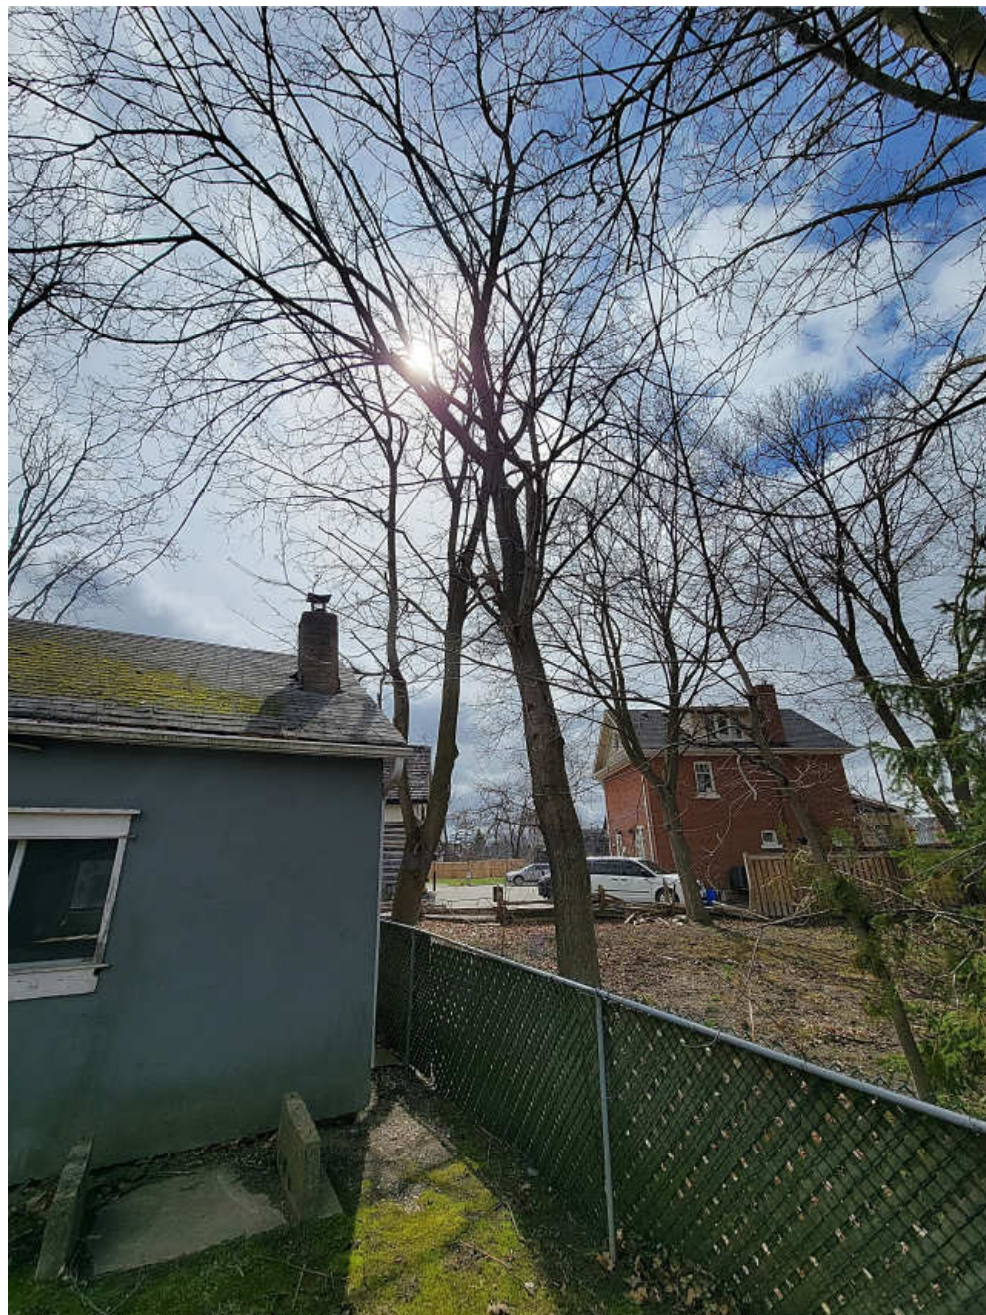
TREE 2 & 3

There 3 trees to injure. All 3 trees are on neighbouring property at the rear of the property. All 3 trees are Norway Maples that have volunteered themselves along the fence line. The existing garage has been built prior to the trees being there and a large amount of the minimum tree protection zone for trees #2 and #3 are in the footprint of the garage. The proposed tree protection barriers wrap around the existing garage as a result.

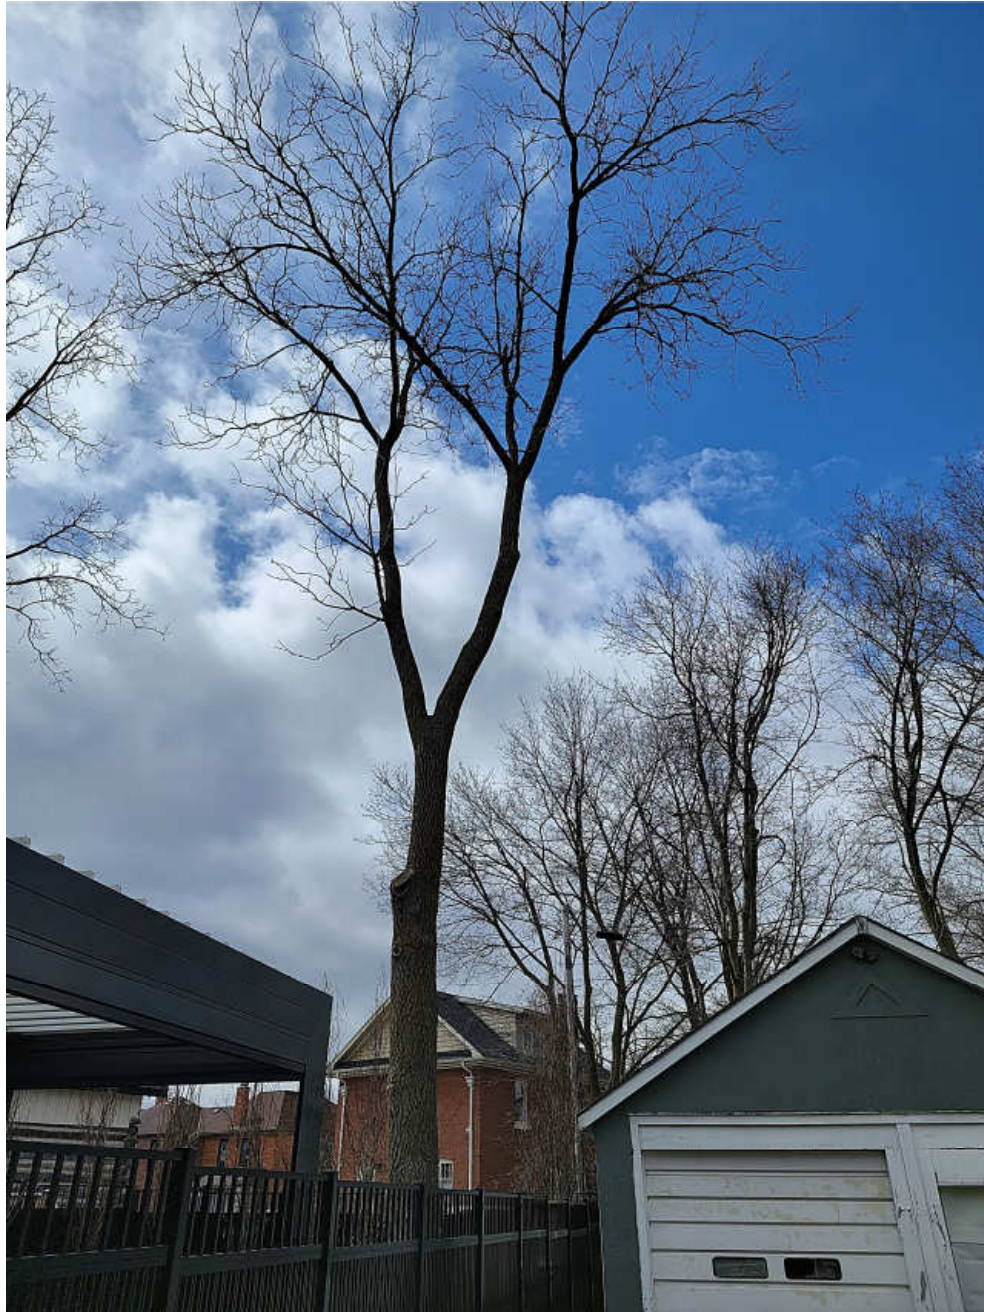
TREE 1

In the case of 60 Napier Street all trees can be preserved with the exception of tree #1. Tree #1 has been permitted by neighbour for removal.
