**Tree Inventory and Preservation Plan Report  
27 Main Street  
Vaughan, Ontario**

07 July 2021, revised 18 May 2022

KUNTZ FORESTRY CONSULTING INC Project P2851

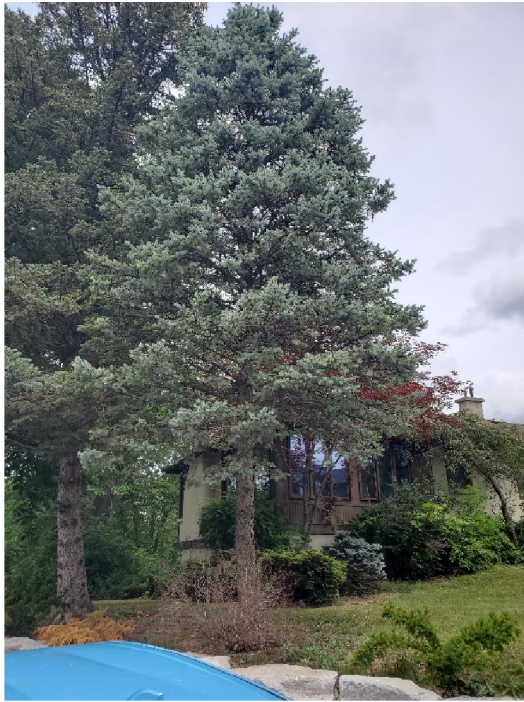
Image 1. Photo of Tree A

Trees A, B, and C are located on the neighbouring property to the east. Although the minimum tree protection zones (mTPZ) of Trees A, B, and C are located within the existing driveway of the subject property, the trees are situated at the top of an existing

retaining wall. It is not anticipated that significant roots will be found on the subject property.

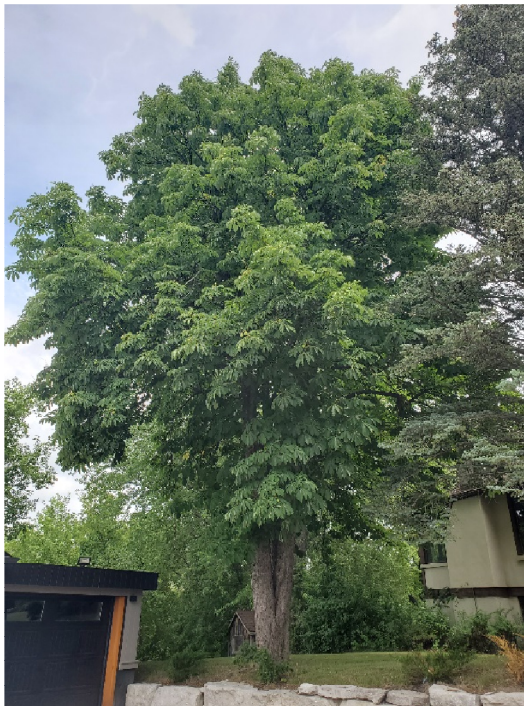
Image 3. Photo of Tree C

C	Horsechestnut	<i>Aesculus hippocastanum</i>	~37, 40, 45	F-G	G	G			3.6	Co-dominant at base, Deadwood (VL), Bow (L)	Retain	
D	Black Walnut	<i>Juglans nigra</i>	~24	G	F-G	G			1.8	Bow (L), Deadwood (VL), Pruning wounds (L), Asymmetric crown (L)	Retain	
E	Manitoba Maple	<i>Acer negundo</i>	~27	F	F	F			1.8	Co-dominant at ~2.0m with included bark (H), Stem wound @ ~2.8m, Lean (L), Asymmetric crown (L), Deadwood (L), Vine competition (L)	Retain	
F	Manitoba Maple	<i>Acer negundo</i>	~32	F	F	F			2.4	Lean (L), Bow (L) - over deck, Pruning wounds (L), Union at ~2.5m, Deadwood (L), Gypsy Moth infestation, Vine competition (M)	Retain	
G	White Pine	<i>Pinus strobus</i>	20	F	F	F			1.8	Pruning wounds (H), Lean (L), Crook at ~5.0m, Growth deficit (H)	Retain	
H	Manitoba Maple	<i>Acer negundo</i>	~22	F	F	F-G			1.8	Vine competition (H), Lean (L), Crooked stem (M), Deadwood (L)	Retain	
I	Hawthorn	<i>Crataegus spp.</i>	~18	F-G	F-G	F-G			1.8	Lean (L), Vine competition (M), Deadwood (L), Pruning wounds (M), Co-dominant at ~2.0m	Retain

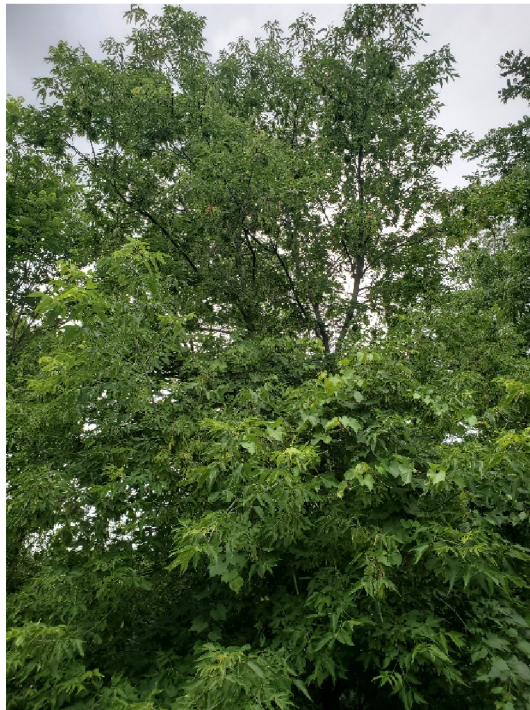
Image 4. Photo of Tree 779

Tree #	Common Name	Scientific Name	DBH	TI	CS	CV	Y C R	CDB	mTPZ	Comments	Action	Number of Replacement Trees
779	Manitoba Maple	<i>Acer negundo</i>	15.5	F	F	F-G			1.8	Crooked stem (M), Co-dominant at ~2.5m, Vine competition (H), Deadwood (L), Asymmetric crown (M)	Retain	
780	Norway Maple (Deborah)	<i>Acer platanoides</i>	33.5	F-G	F-G	F-G			2.4	Gypsy Moth infestation, Pruning wounds (L), Metal nail inclusions, Asymmetric crown (L), Crook at ~2.0m	Retain	
781	Eastern White Cedar	<i>Thuja occidentalis</i>	22.5	G	F	G			1.8	Pruning wounds (M), Lean (VL), Sweep (VL)	Retain	
782	Manitoba Maple	<i>Acer negundo</i>	24.5	F	F	F-G			1.8	Deadwood (L), Vine competition (M), Lean (L), Coppice growth (M), Asymmetric crown (L)	Retain	
783	Manitoba Maple	<i>Acer negundo</i>	28	P-F	F	F-G			1.8	Lean (M), Exposed roots (M), Crooked stem (M), Gypsy Moth infestation, Vine competition (M), Epicormic branching (M), Deadwood (L)	Retain

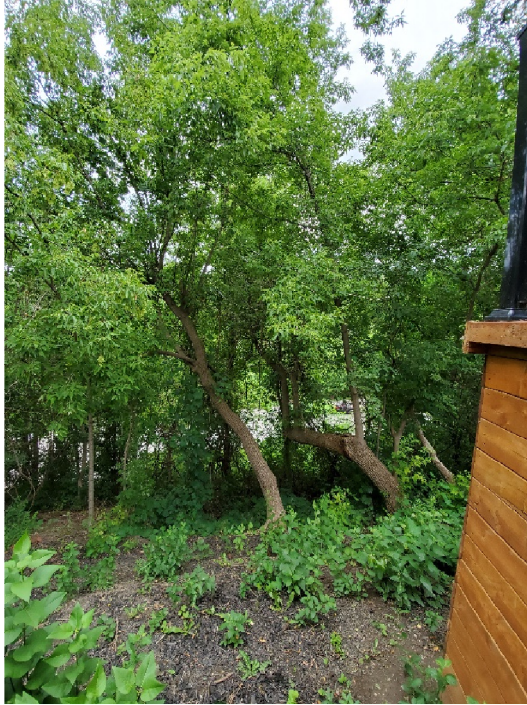
Image 9. Photo of Trees 783 and 784

784	Manitoba Maple	<i>Acer negundo</i>	~15, 29	P-F	P-F	F-G			2.4	Lean (H), Cavity (M), Crook at ~1.1m, Deadwood (L), Vine competition (M), Epicormic branching (M)	Retain	
A	Blue Spruce	<i>Picea pungens</i>	~23	F-G	F-G	F		30	1.8	Pruning wounds (L), Deadwood (M), Asymmetric crown (M), Lean (VL), Sweep (VL)	Retain	
B	Blue Spruce	<i>Picea pungens</i>	~34	F-G	F-G	F-G		10	2.4	Deadwood (L), Asymmetric crown (L), Pruning wounds (L), Lean (VL), Sweep (VL)	Retain

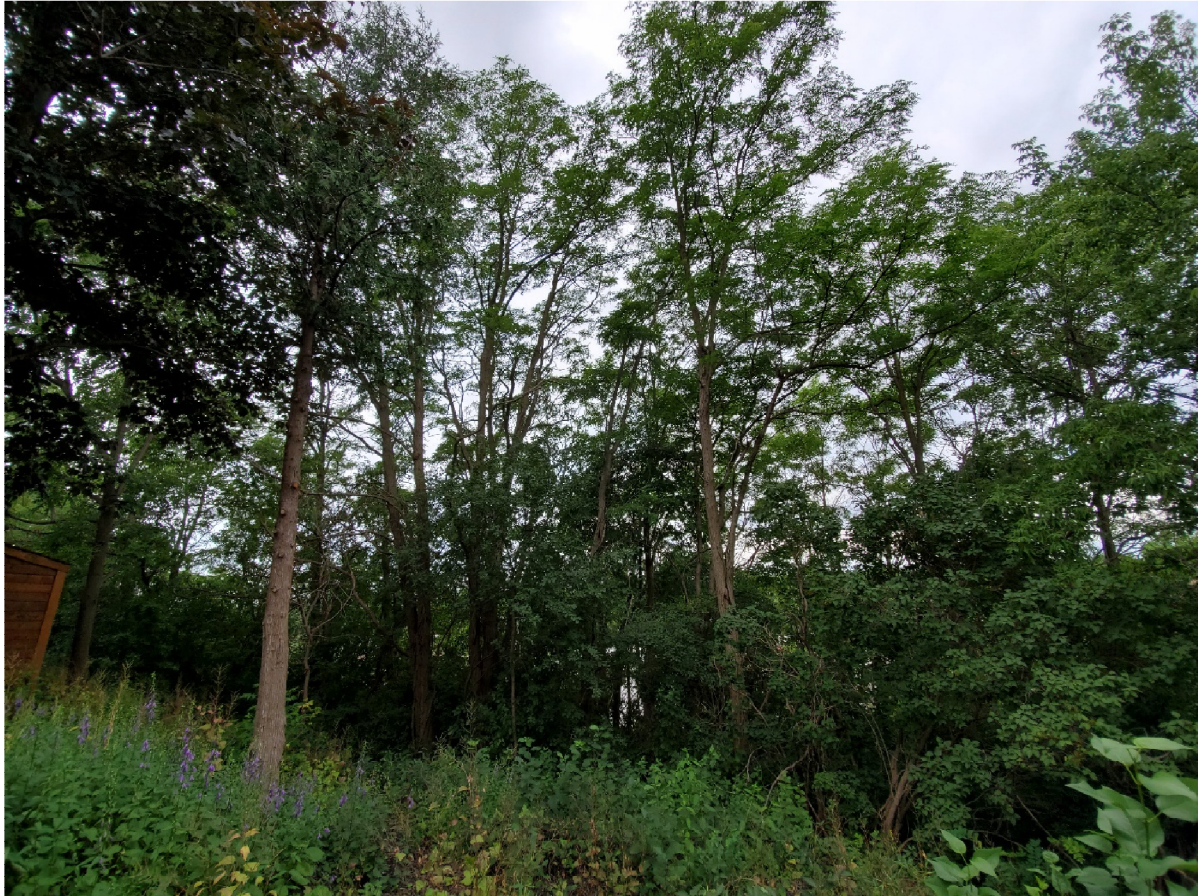
Image 13. Photo of Polygon P1

P1	Black Locust	<i>Robinia pseudoacacia</i>	~25-41, Avg. 30	F-G	F-G	F-G			3.0	~10 trees, Deadwood (L), Bow (L), Co-dominance (M), Stem wounds (L)	Retain	
----	--------------	-----------------------------	-----------------	-----	-----	-----	--	--	-----	---------------------------------------------------------------------	--------	--

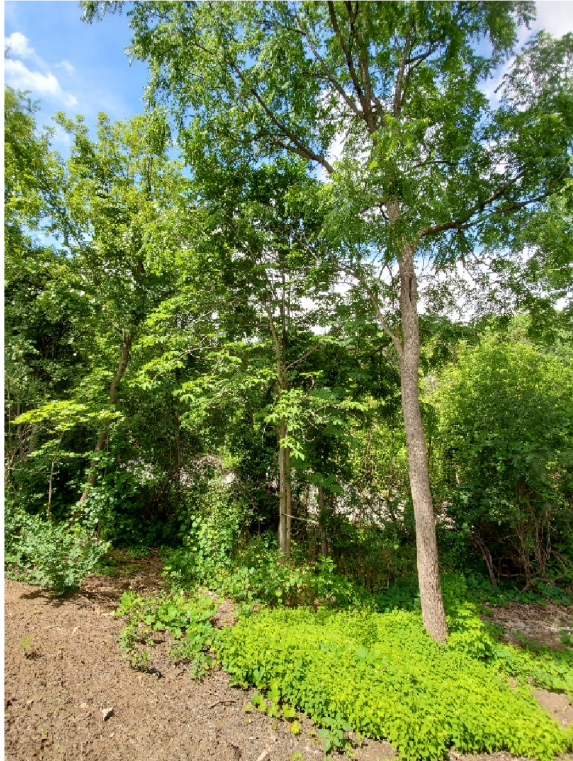
Image 16. Photo of Trees J and K (centre of photo)

J	Horsechestnut	<i>Aesculus hippocastanum</i>	~17	F-G	F	F-G			1.8	Deadwood (L), Bow (L), Competition with Trees K and L, Asymmetric crown (M)	Retain	
K	Green Ash	<i>Fraxinus pennsylvanica</i>	~15	F-G	F-G	F-G			1.8	Deadwood (L), Bow (L), Competition with Trees J and L, Asymmetric crown (L)	Retain	
L	Black Walnut	<i>Juglans nigra</i>	~35	F-G	G	G			2.4	Lean (L), Cavity (L) - sealing	Retain	
M	Manitoba Maple	<i>Acer negundo</i>	~30	F-G	F-G	F-G			2.4	Epicormic branching (H), Pruning wounds (M), Co-dominant at ~3.0m with one stem pruned	Retain

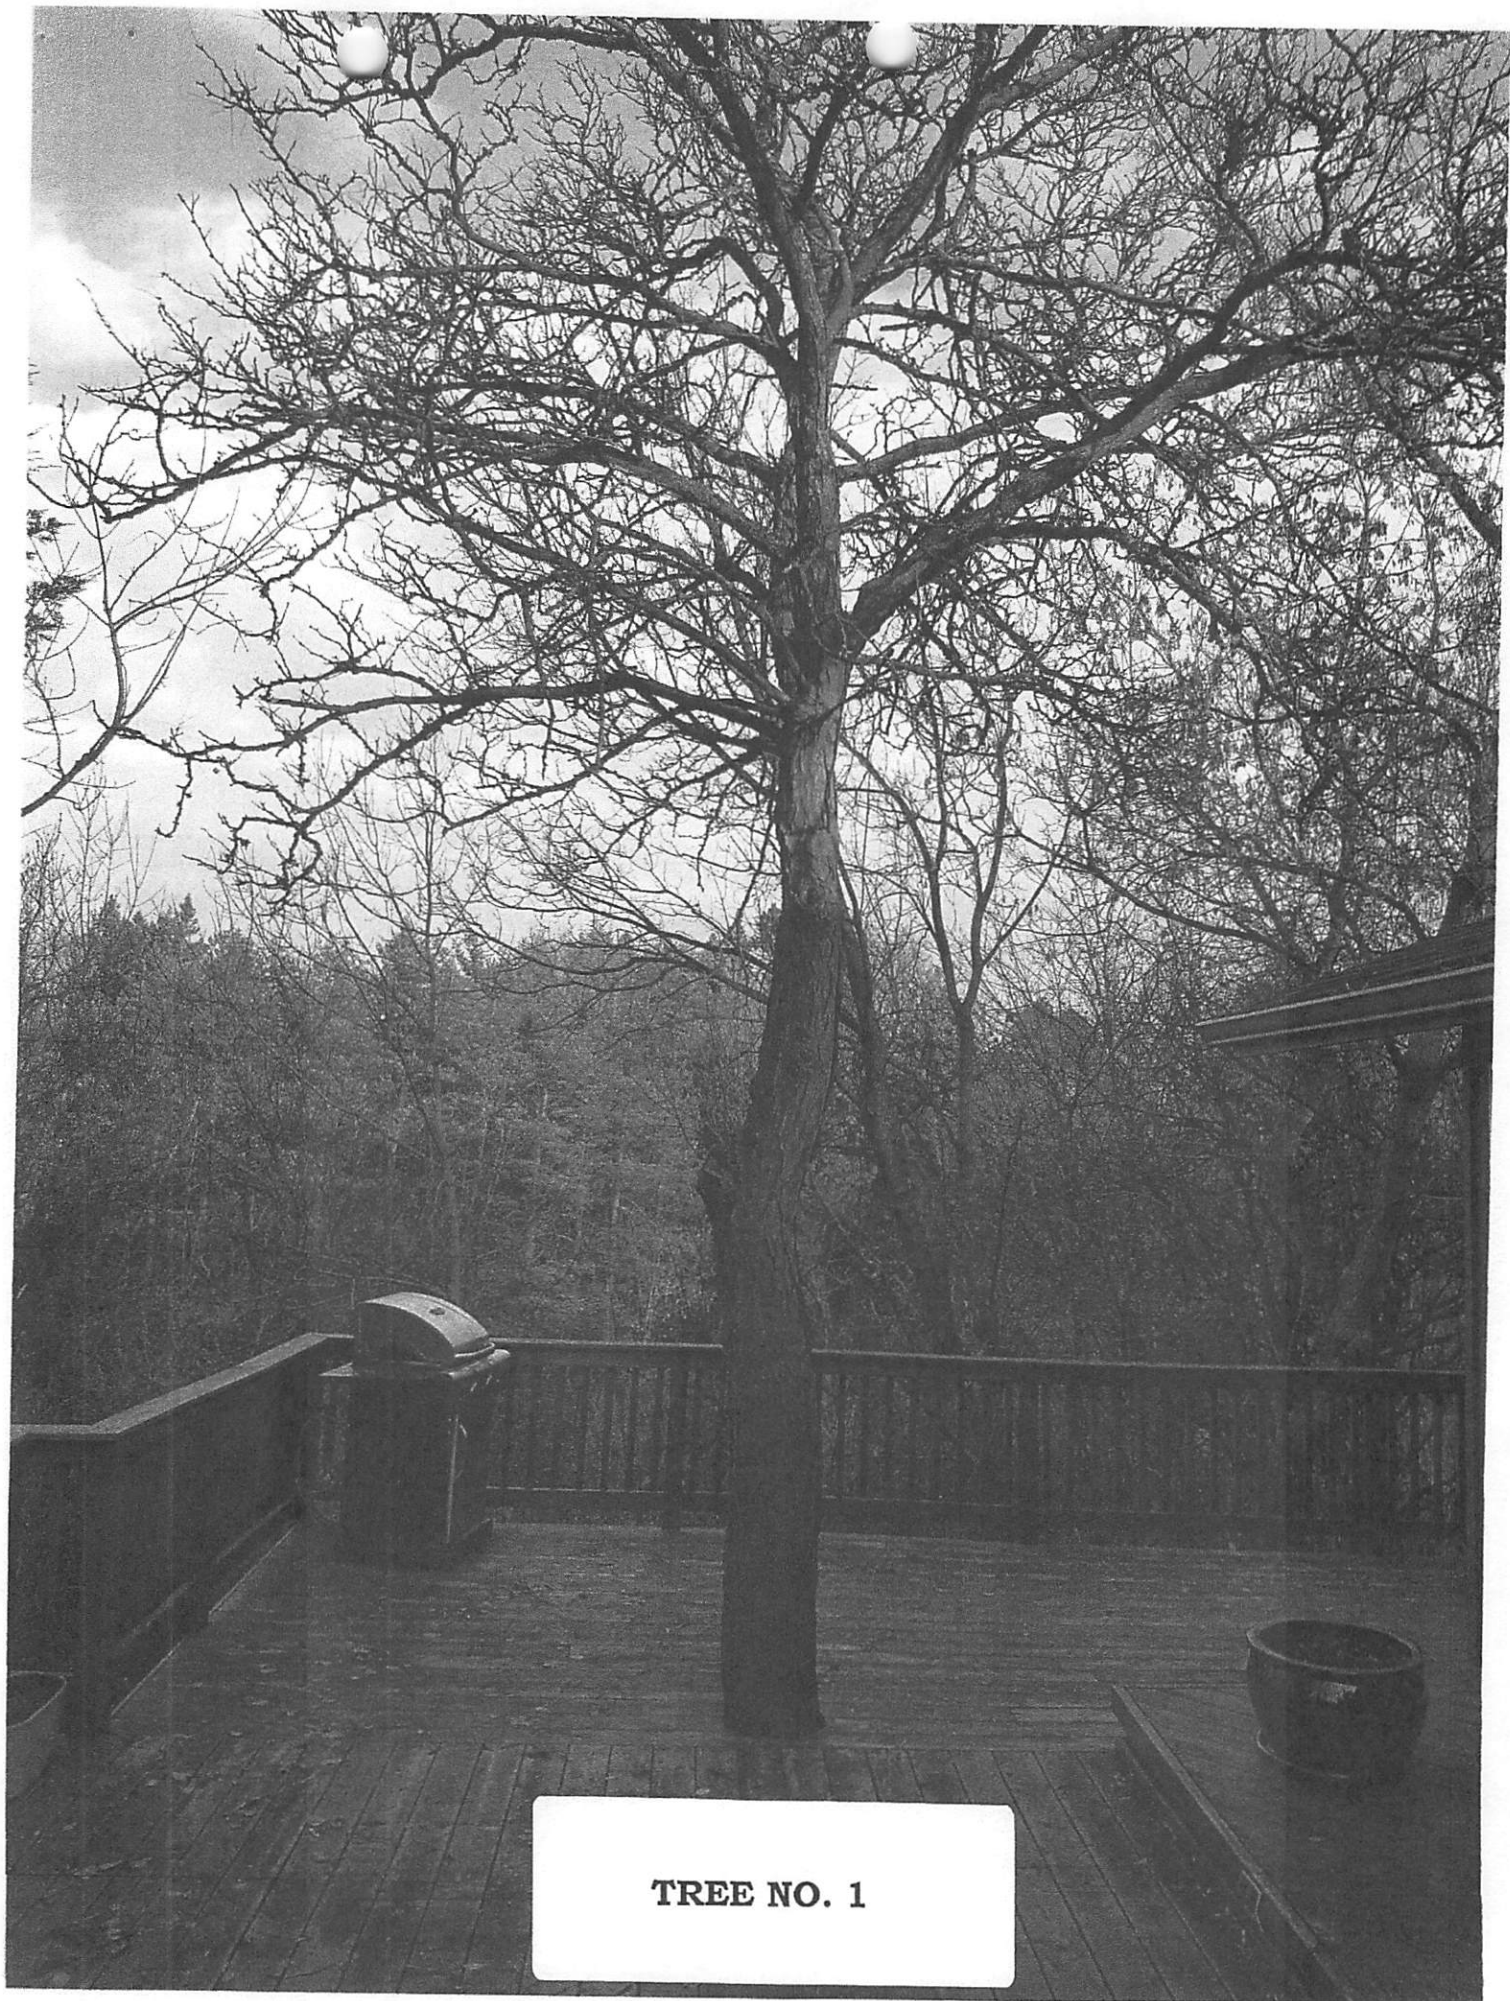
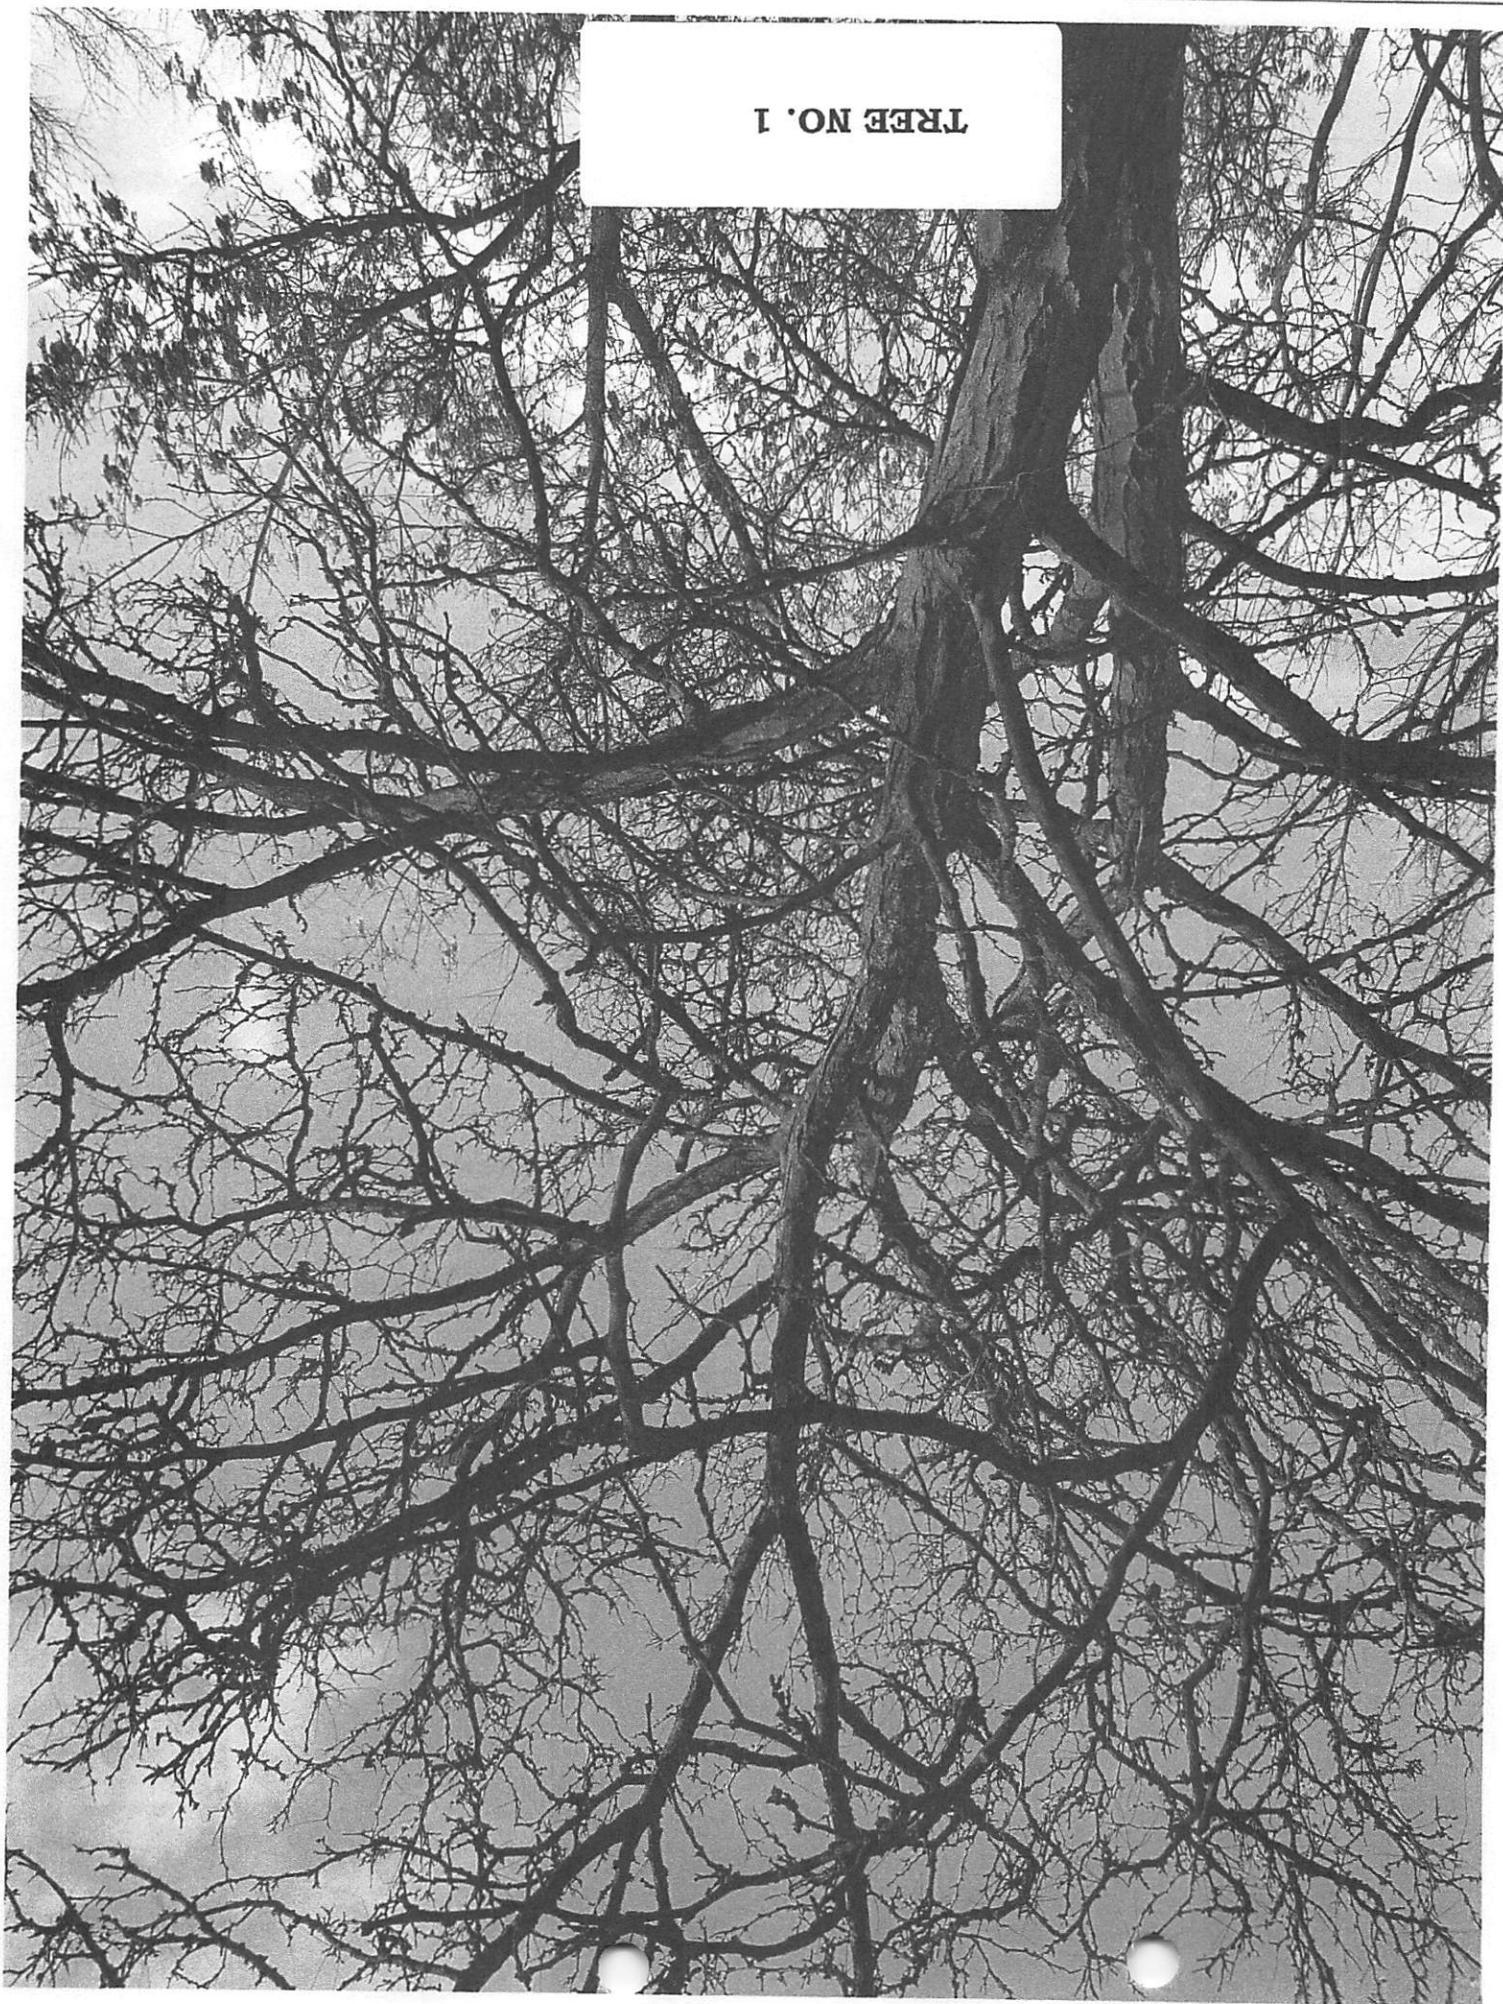
**TREE NO. 1**

This Honey Locust is in poor condition and in decline. This tree may have been a victim to the 2013 Ice Storm. Buds are very sparse and weak. The canopy contains over 30% deadwood.

This tree requires a PERMIT for removal. The removal of this tree will require a 2 to 1 replacement ratio.

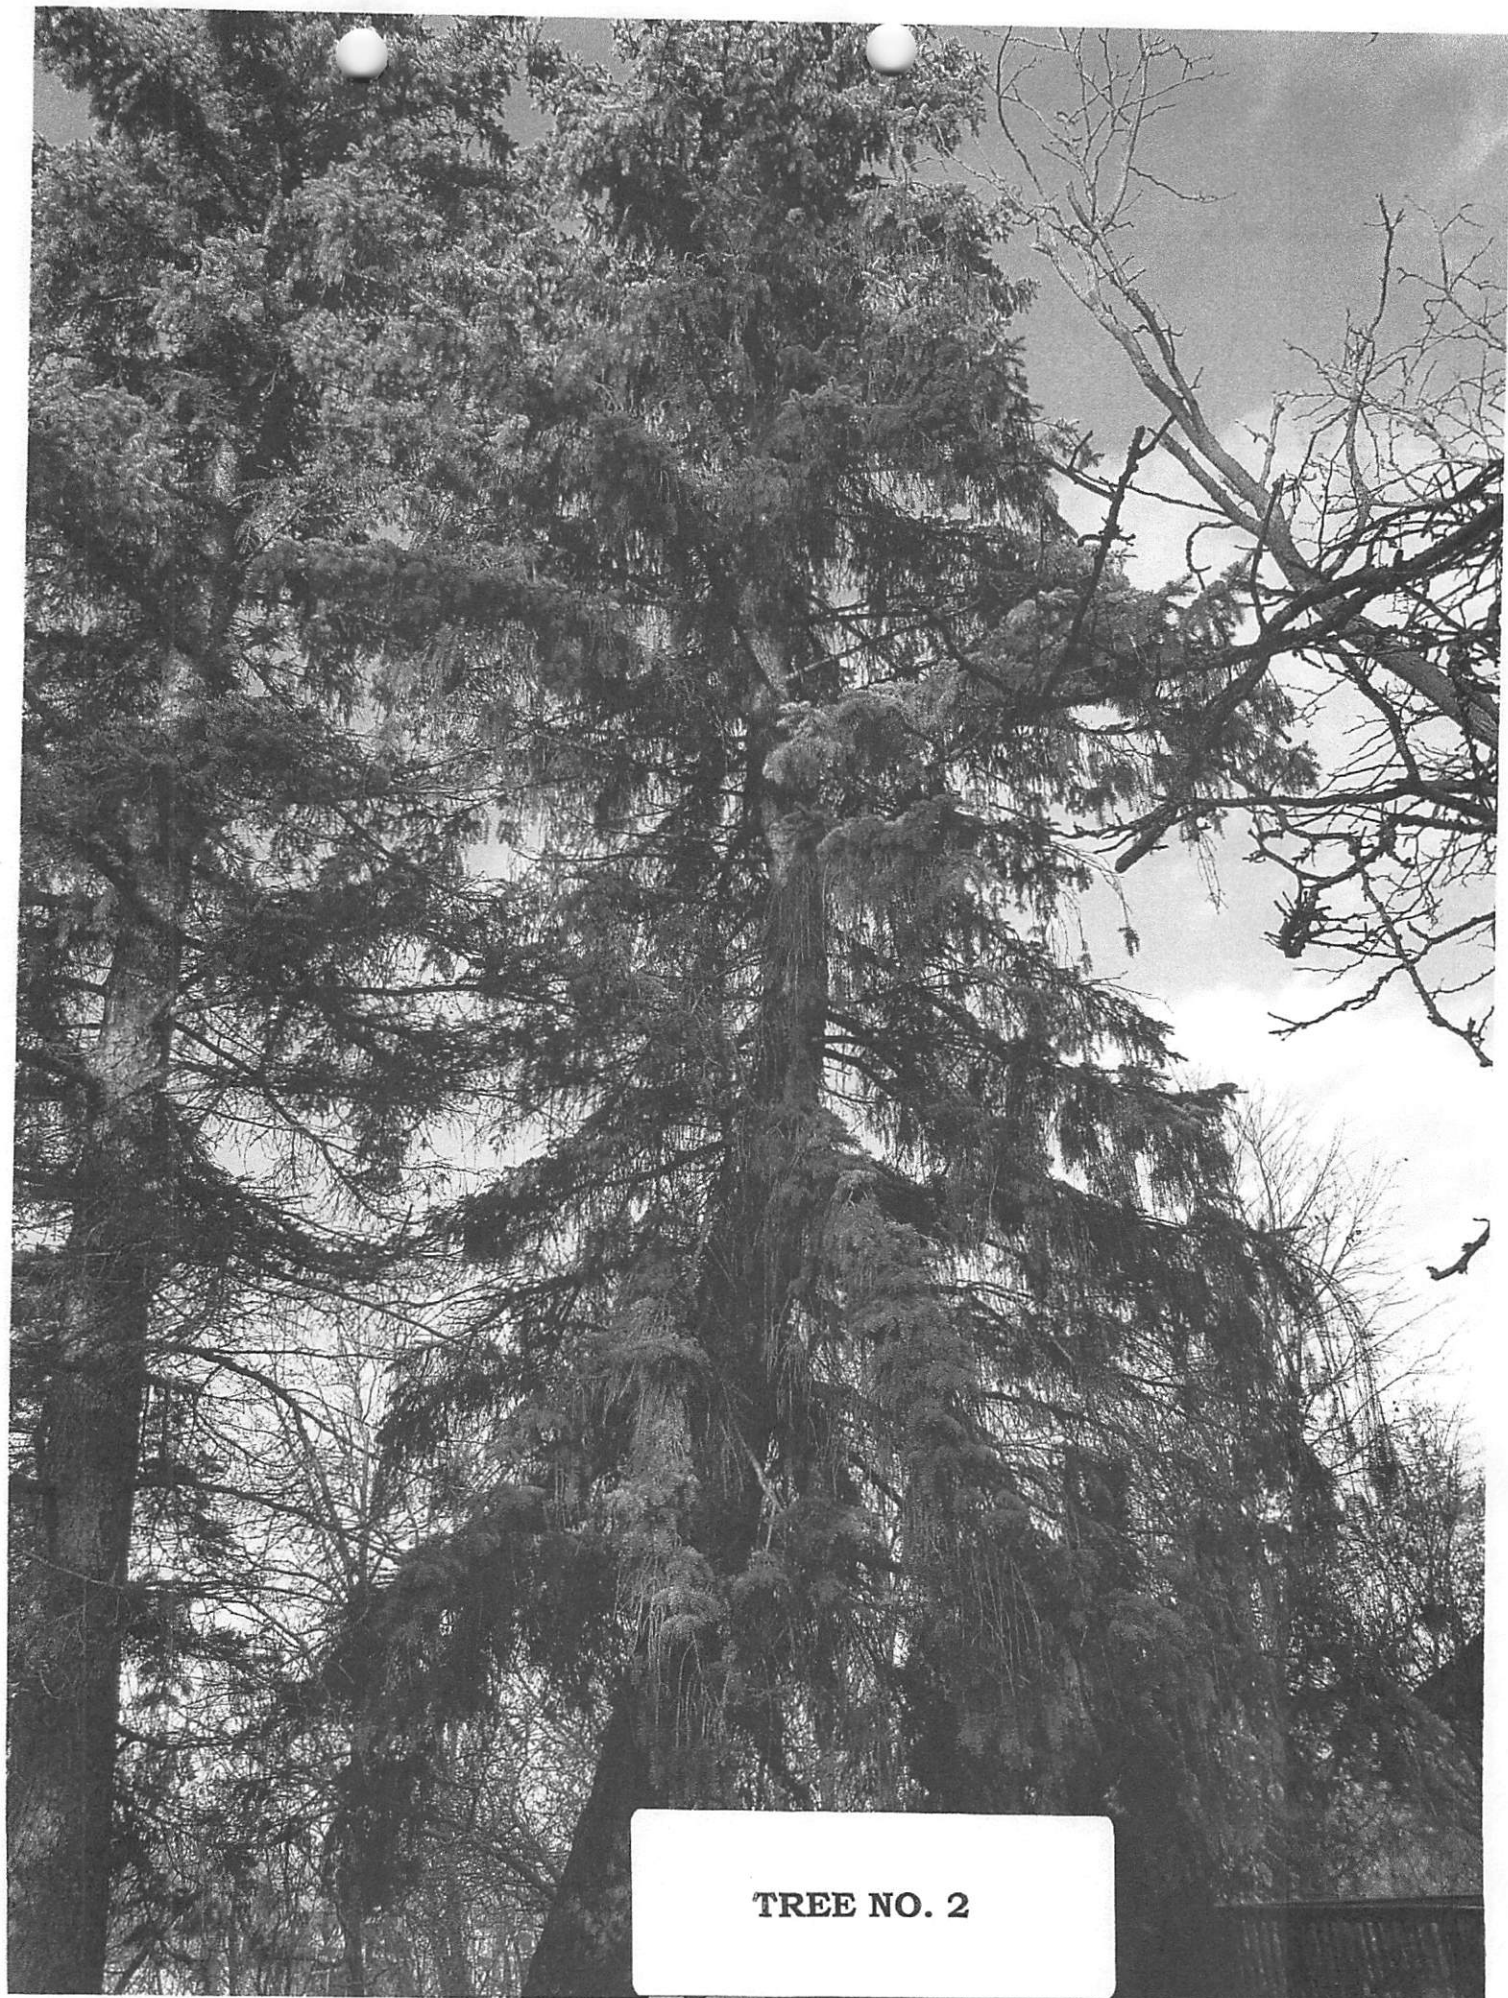
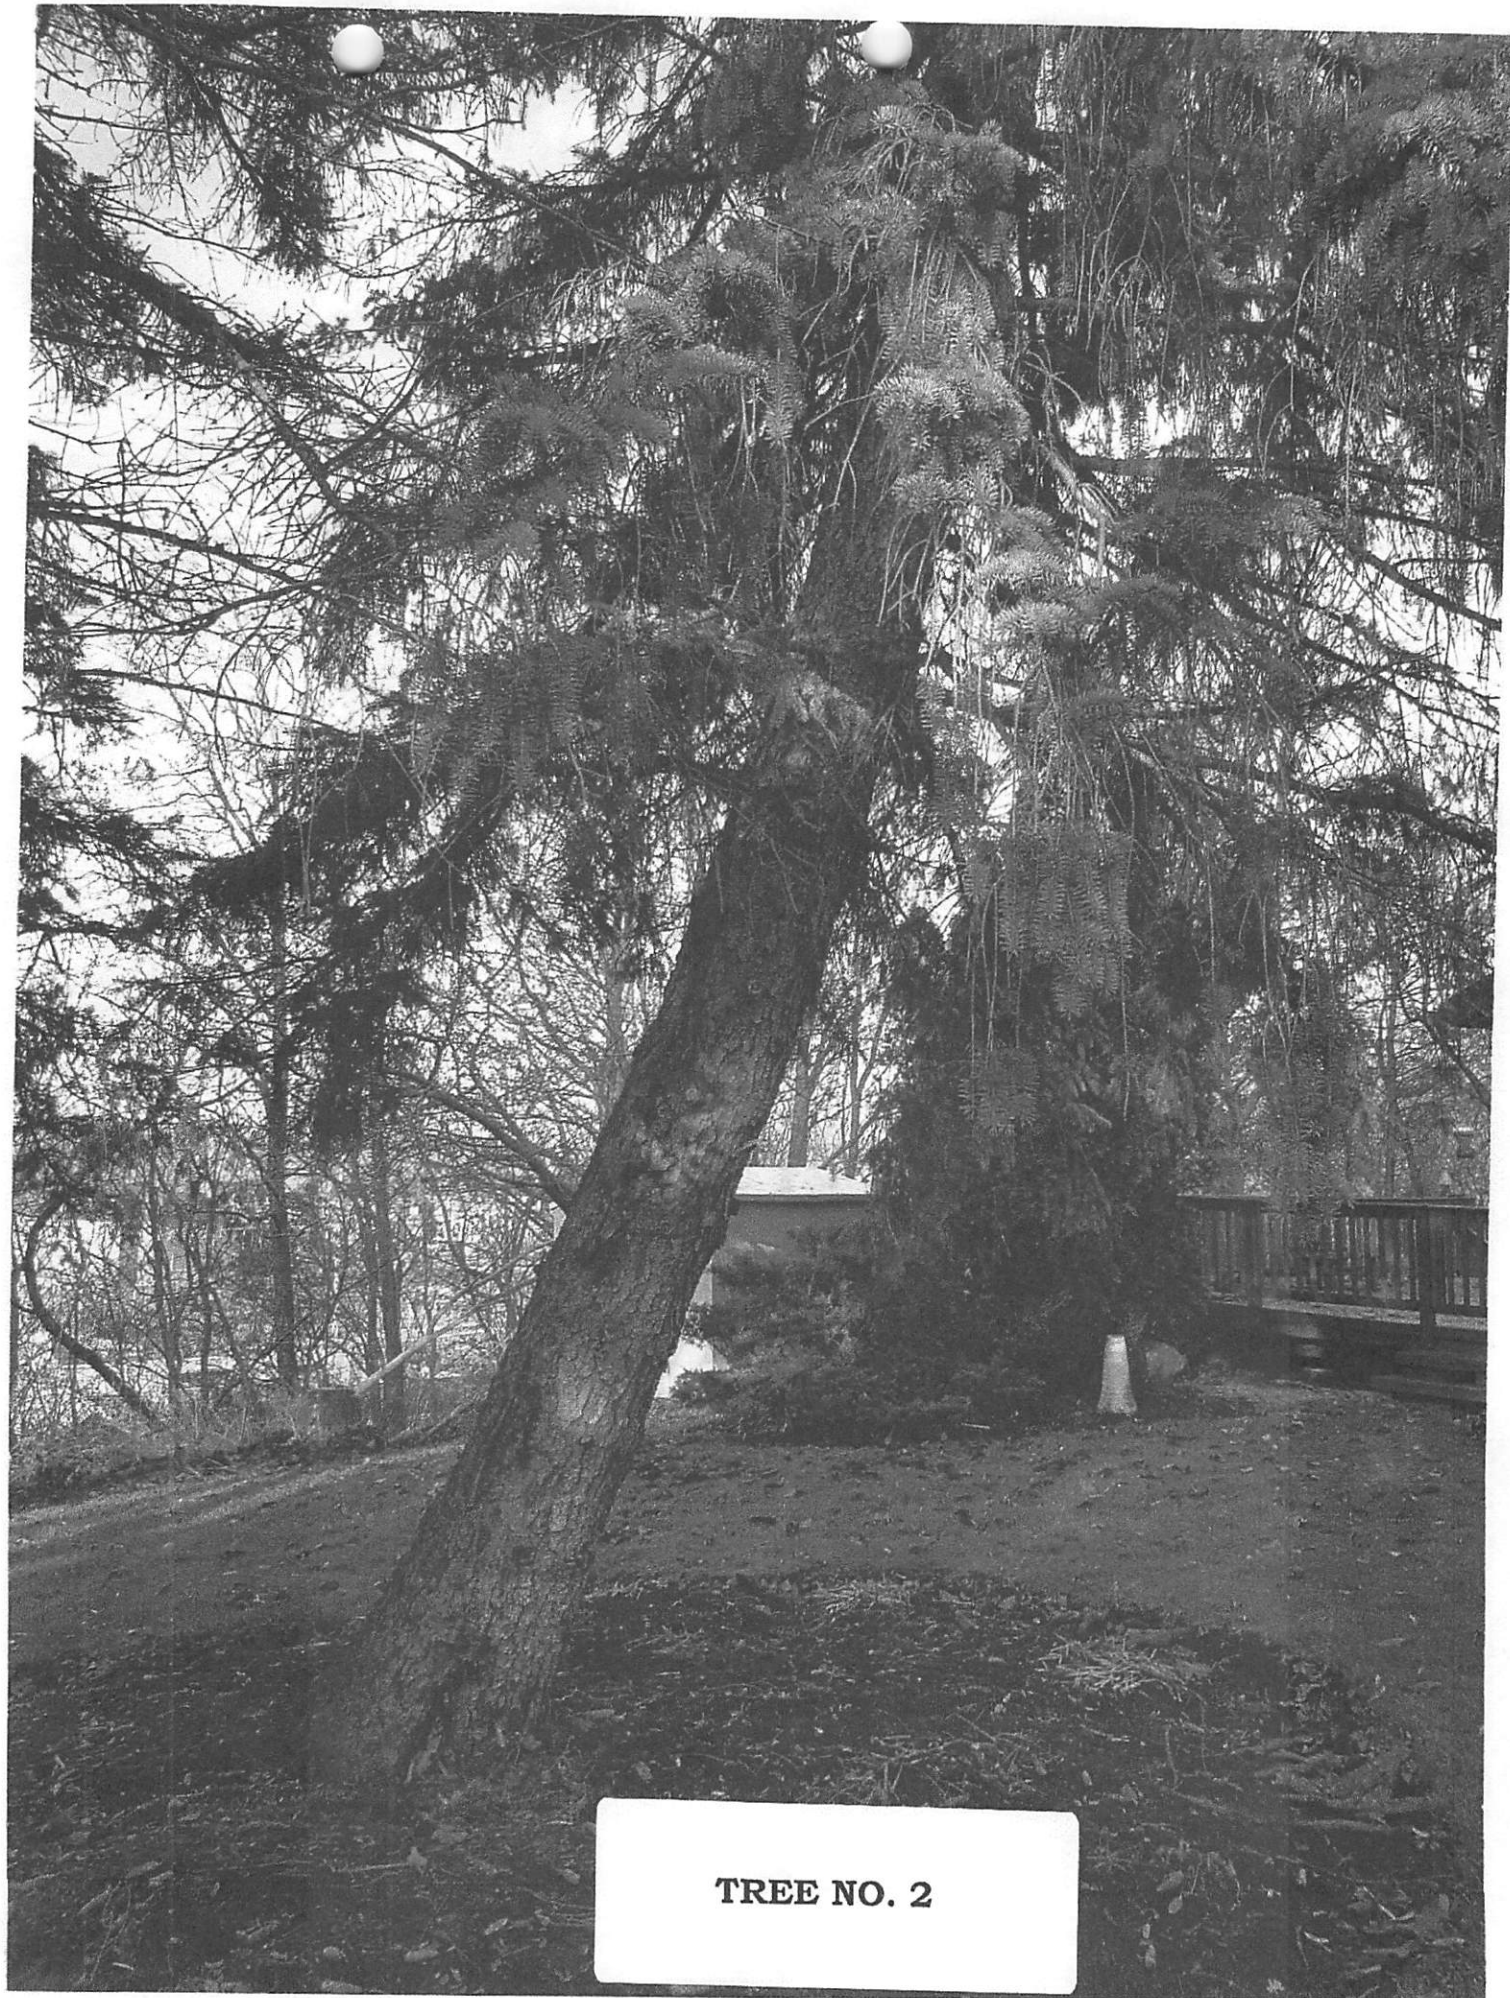
**TREE NO. 2**

This White Spruce is in fair to poor condition. It has a serious lean and damage to the base just above grade. *Basal Decay* is possible but not confirmed. This tree is also afflicted with the initial stages of *Cytospora Fungal Infection* as well as *Yellow Saw Fly Infestation*.

The removal of this tree **will require a 3 to1 replacement ratio**.
