**Tree Inventory and Preservation Plan Report  
27 Main Street  
Vaughan, Ontario**

07 July 2021, revised 18 May 2022

KUNTZ FORESTRY CONSULTING INC Project P2851

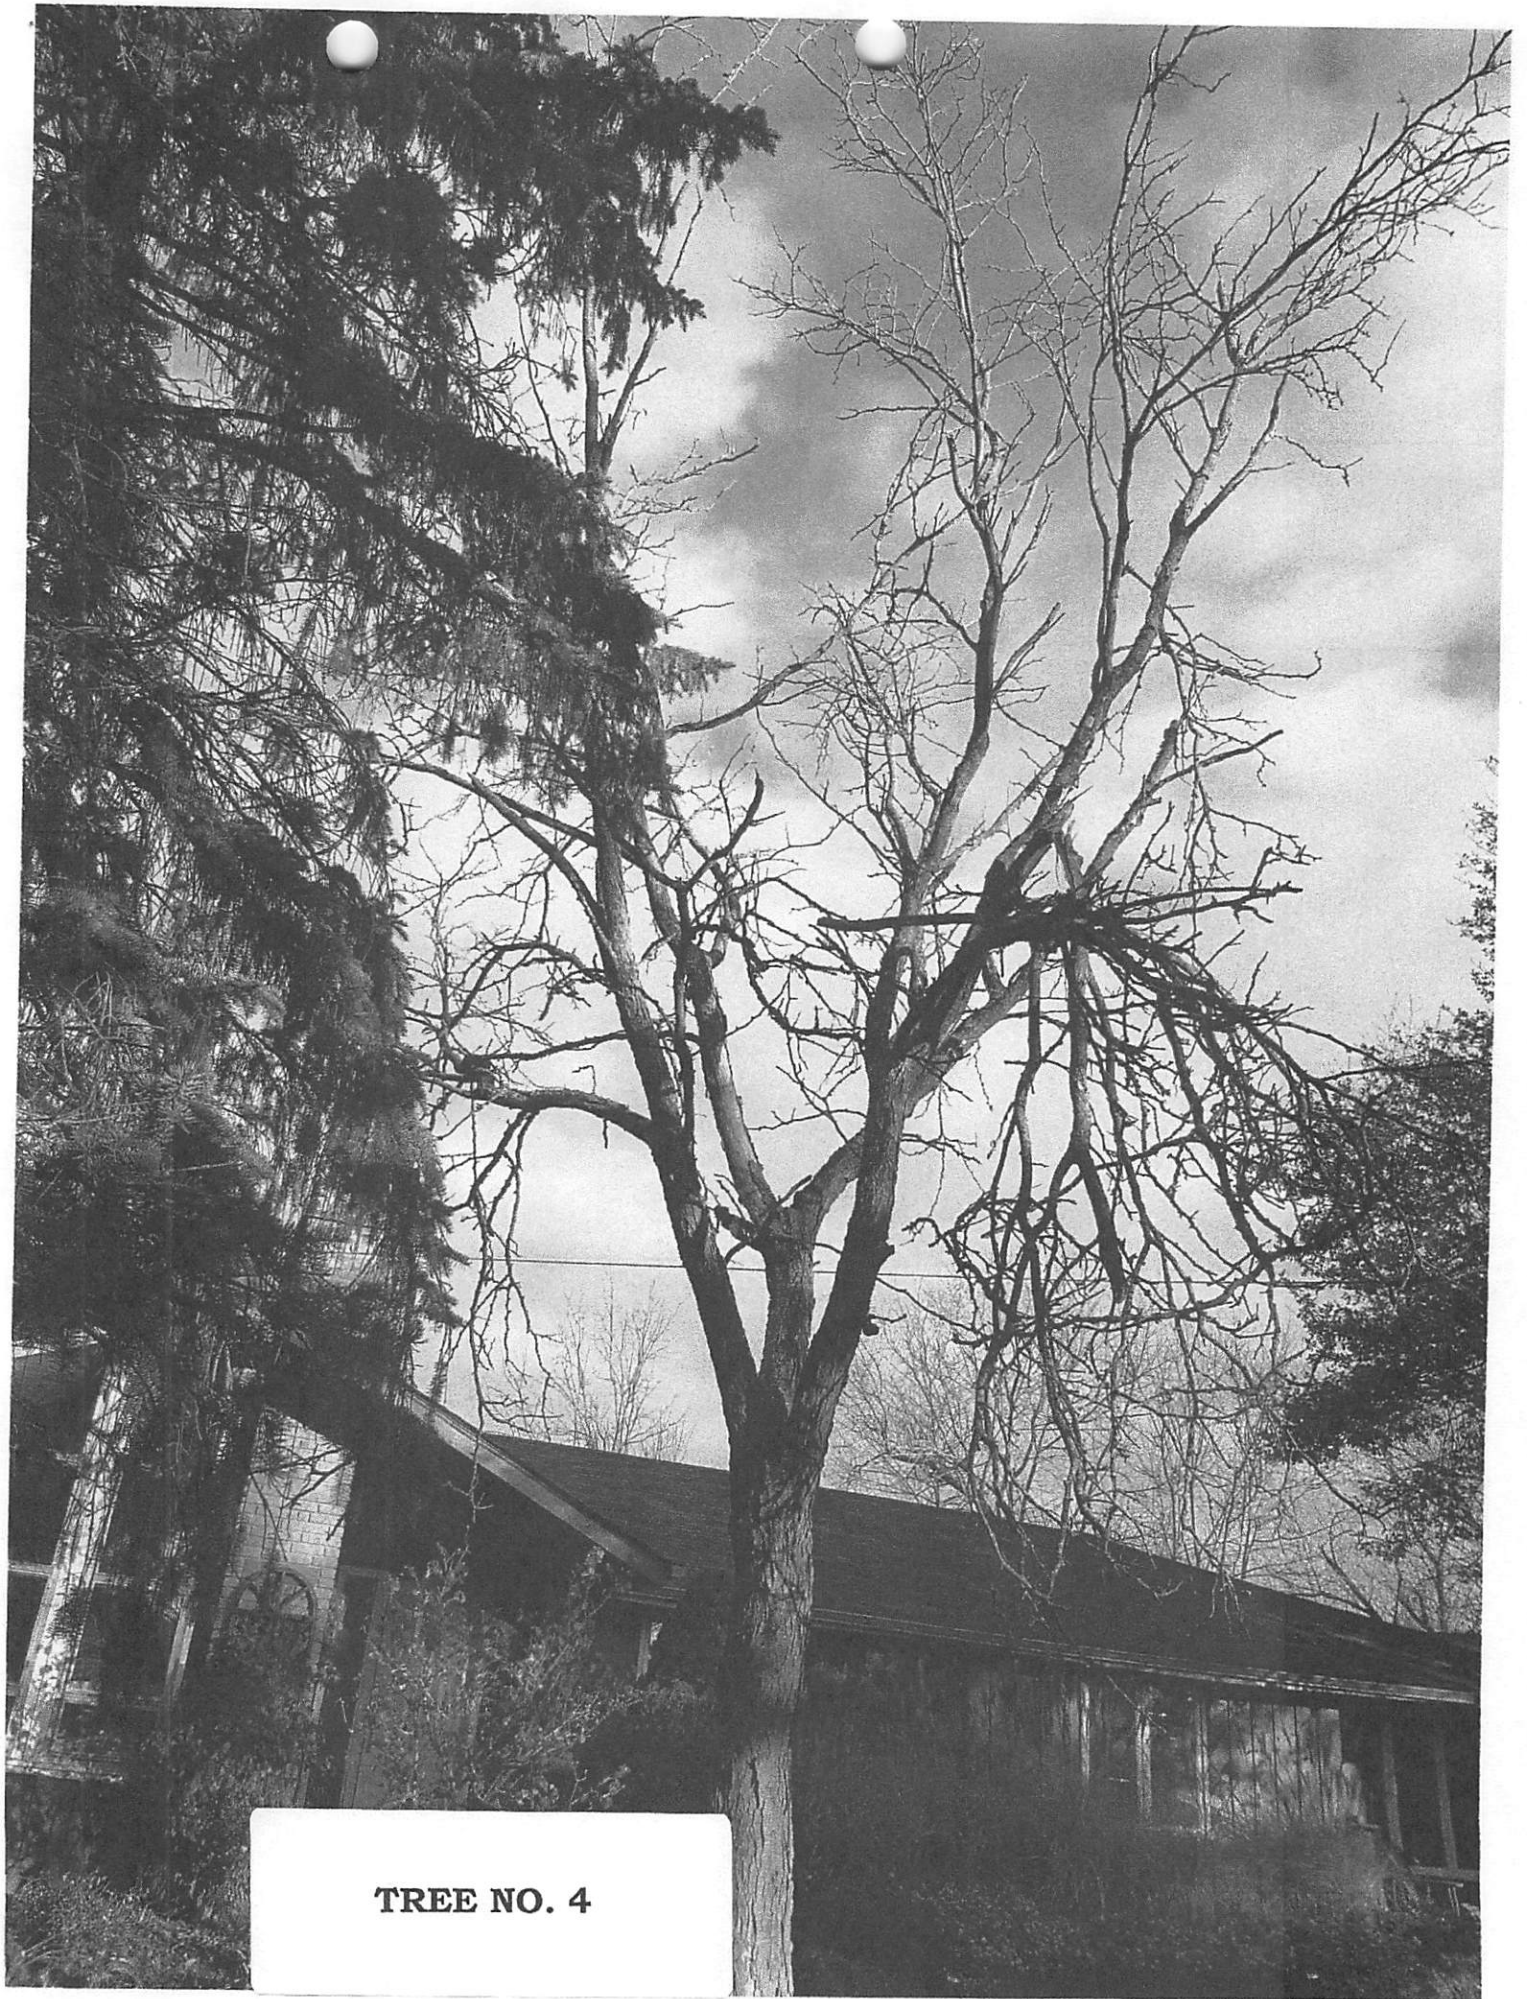
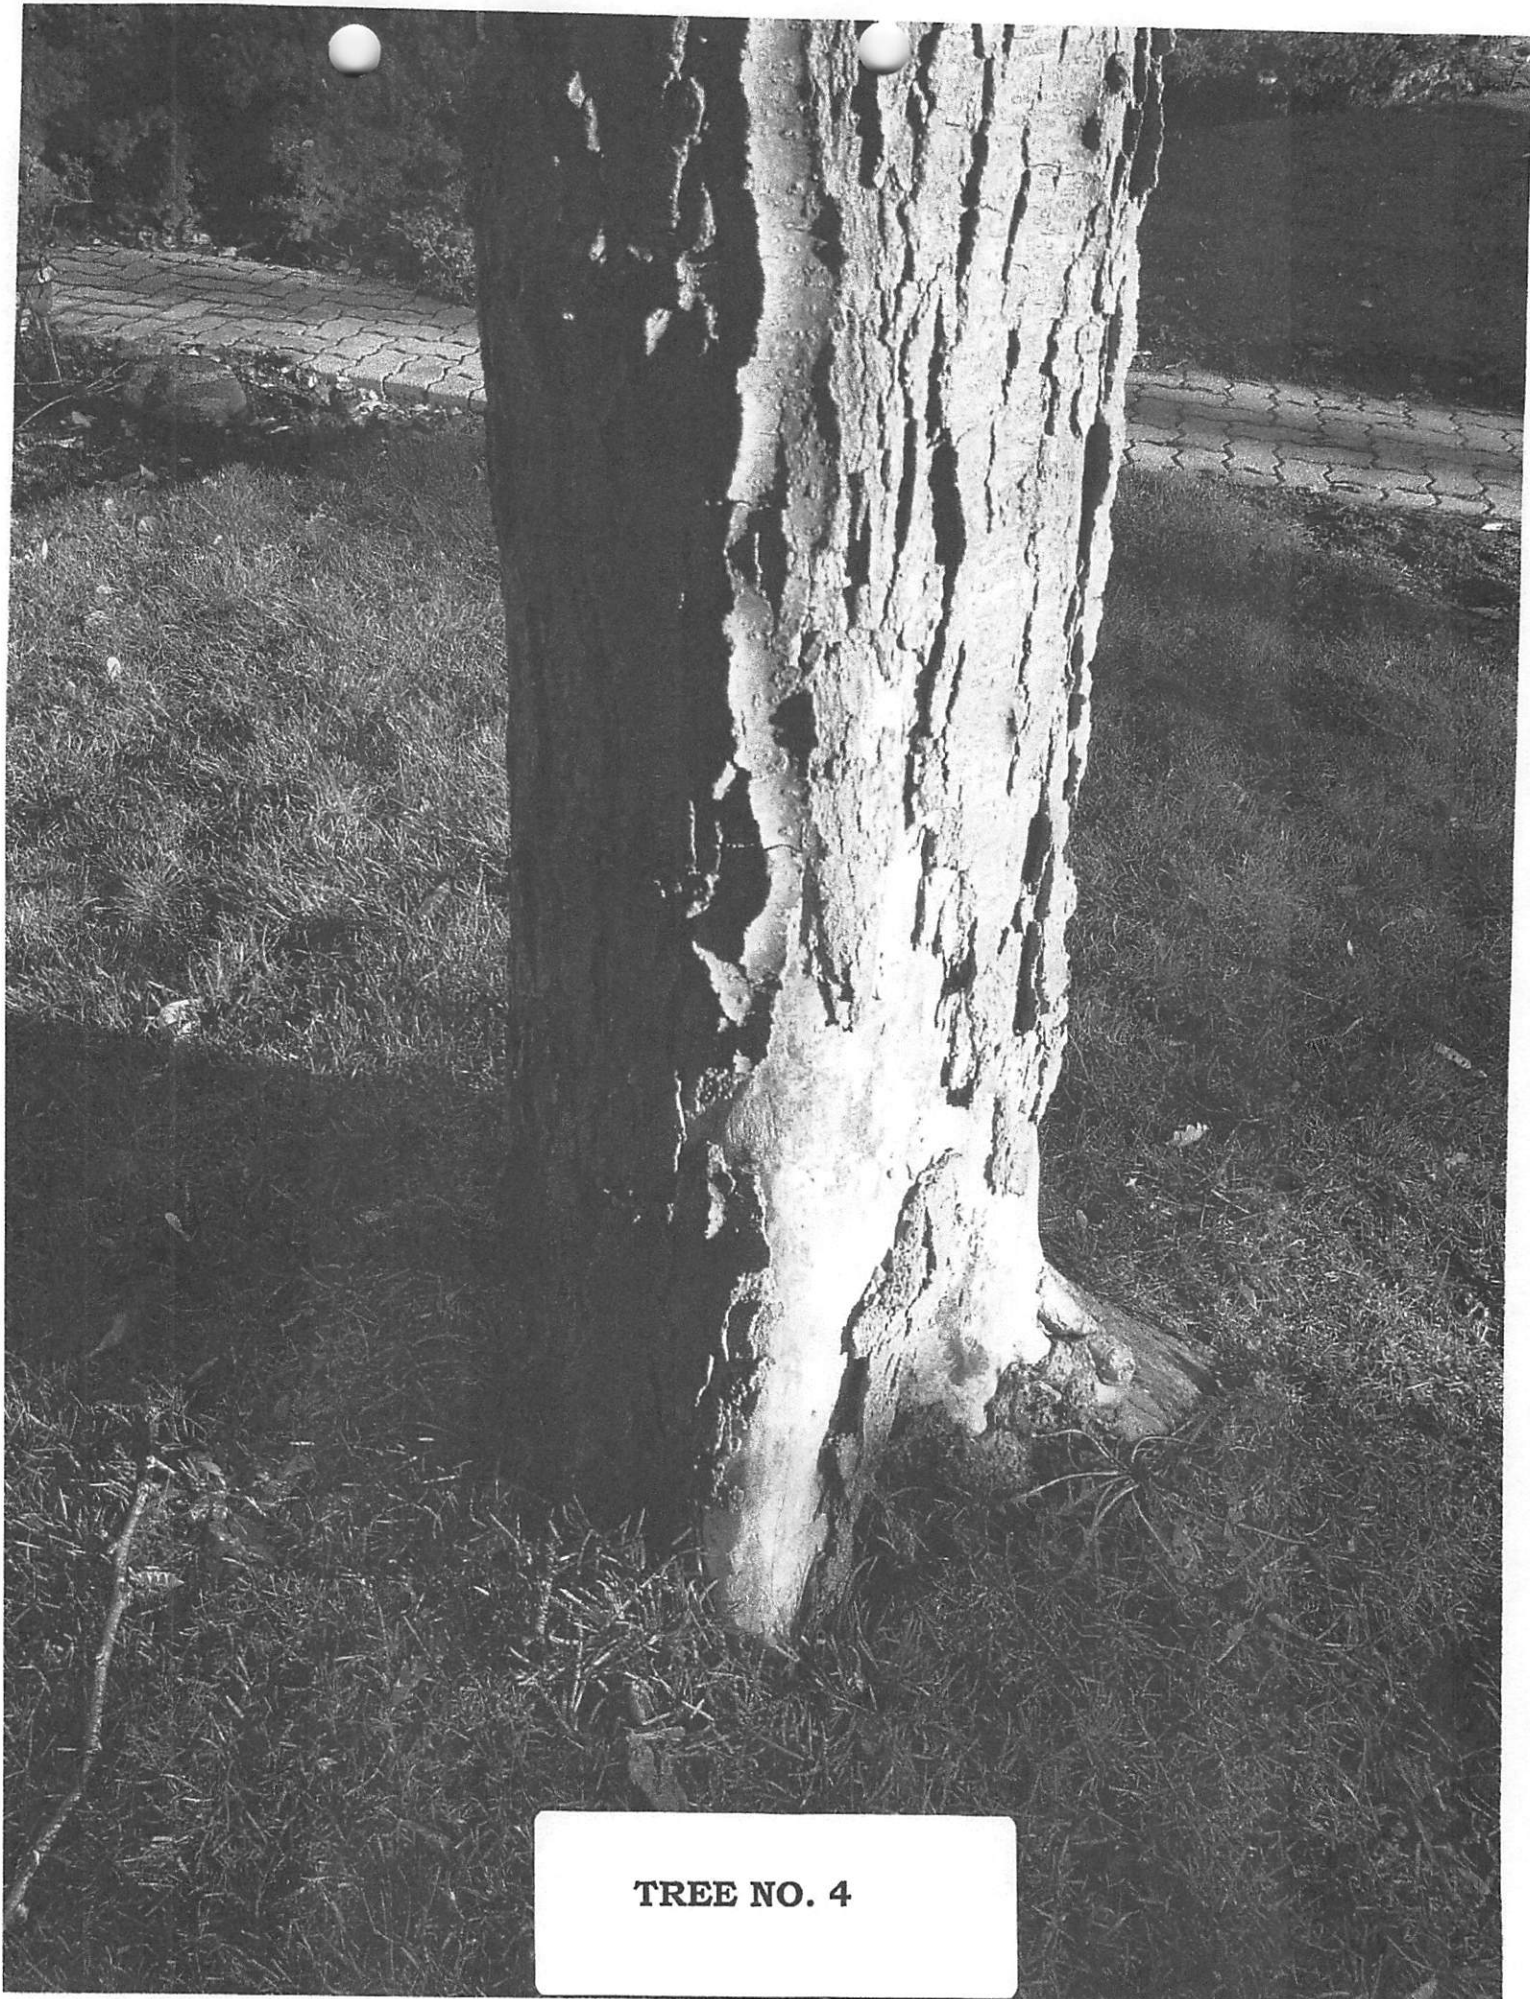
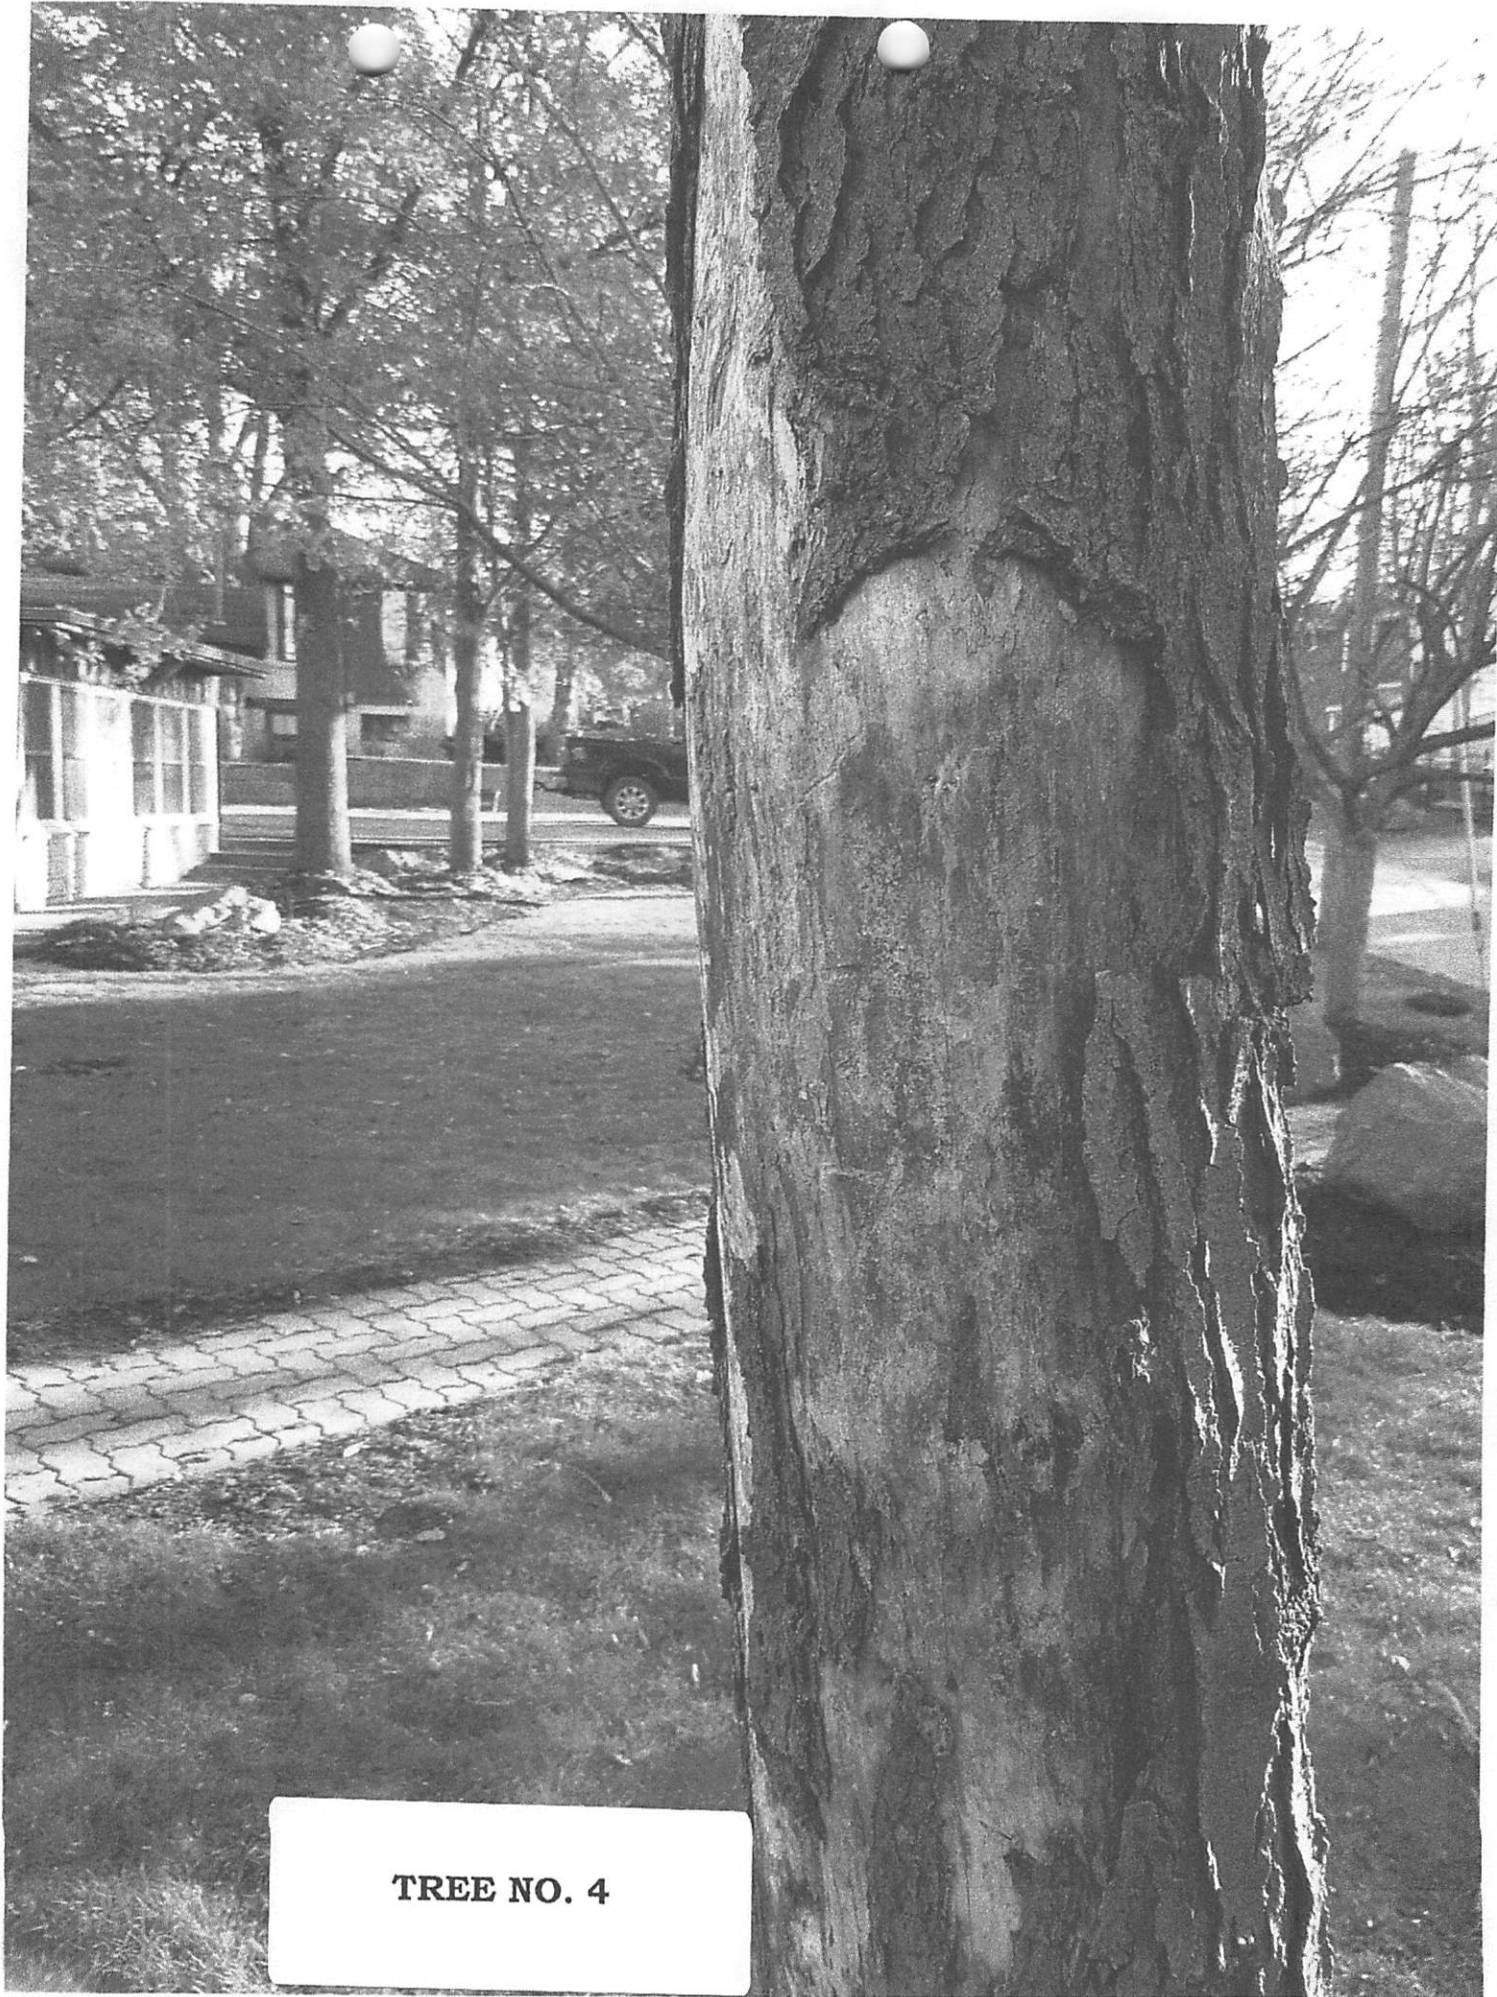
**TREE NO. 4**

This Honey Locust is dead. This tree qualifies for an exemption under the City of Vaughan Private Tree Protection Act. The tree is exempted from all permit fees and replacement obligations.

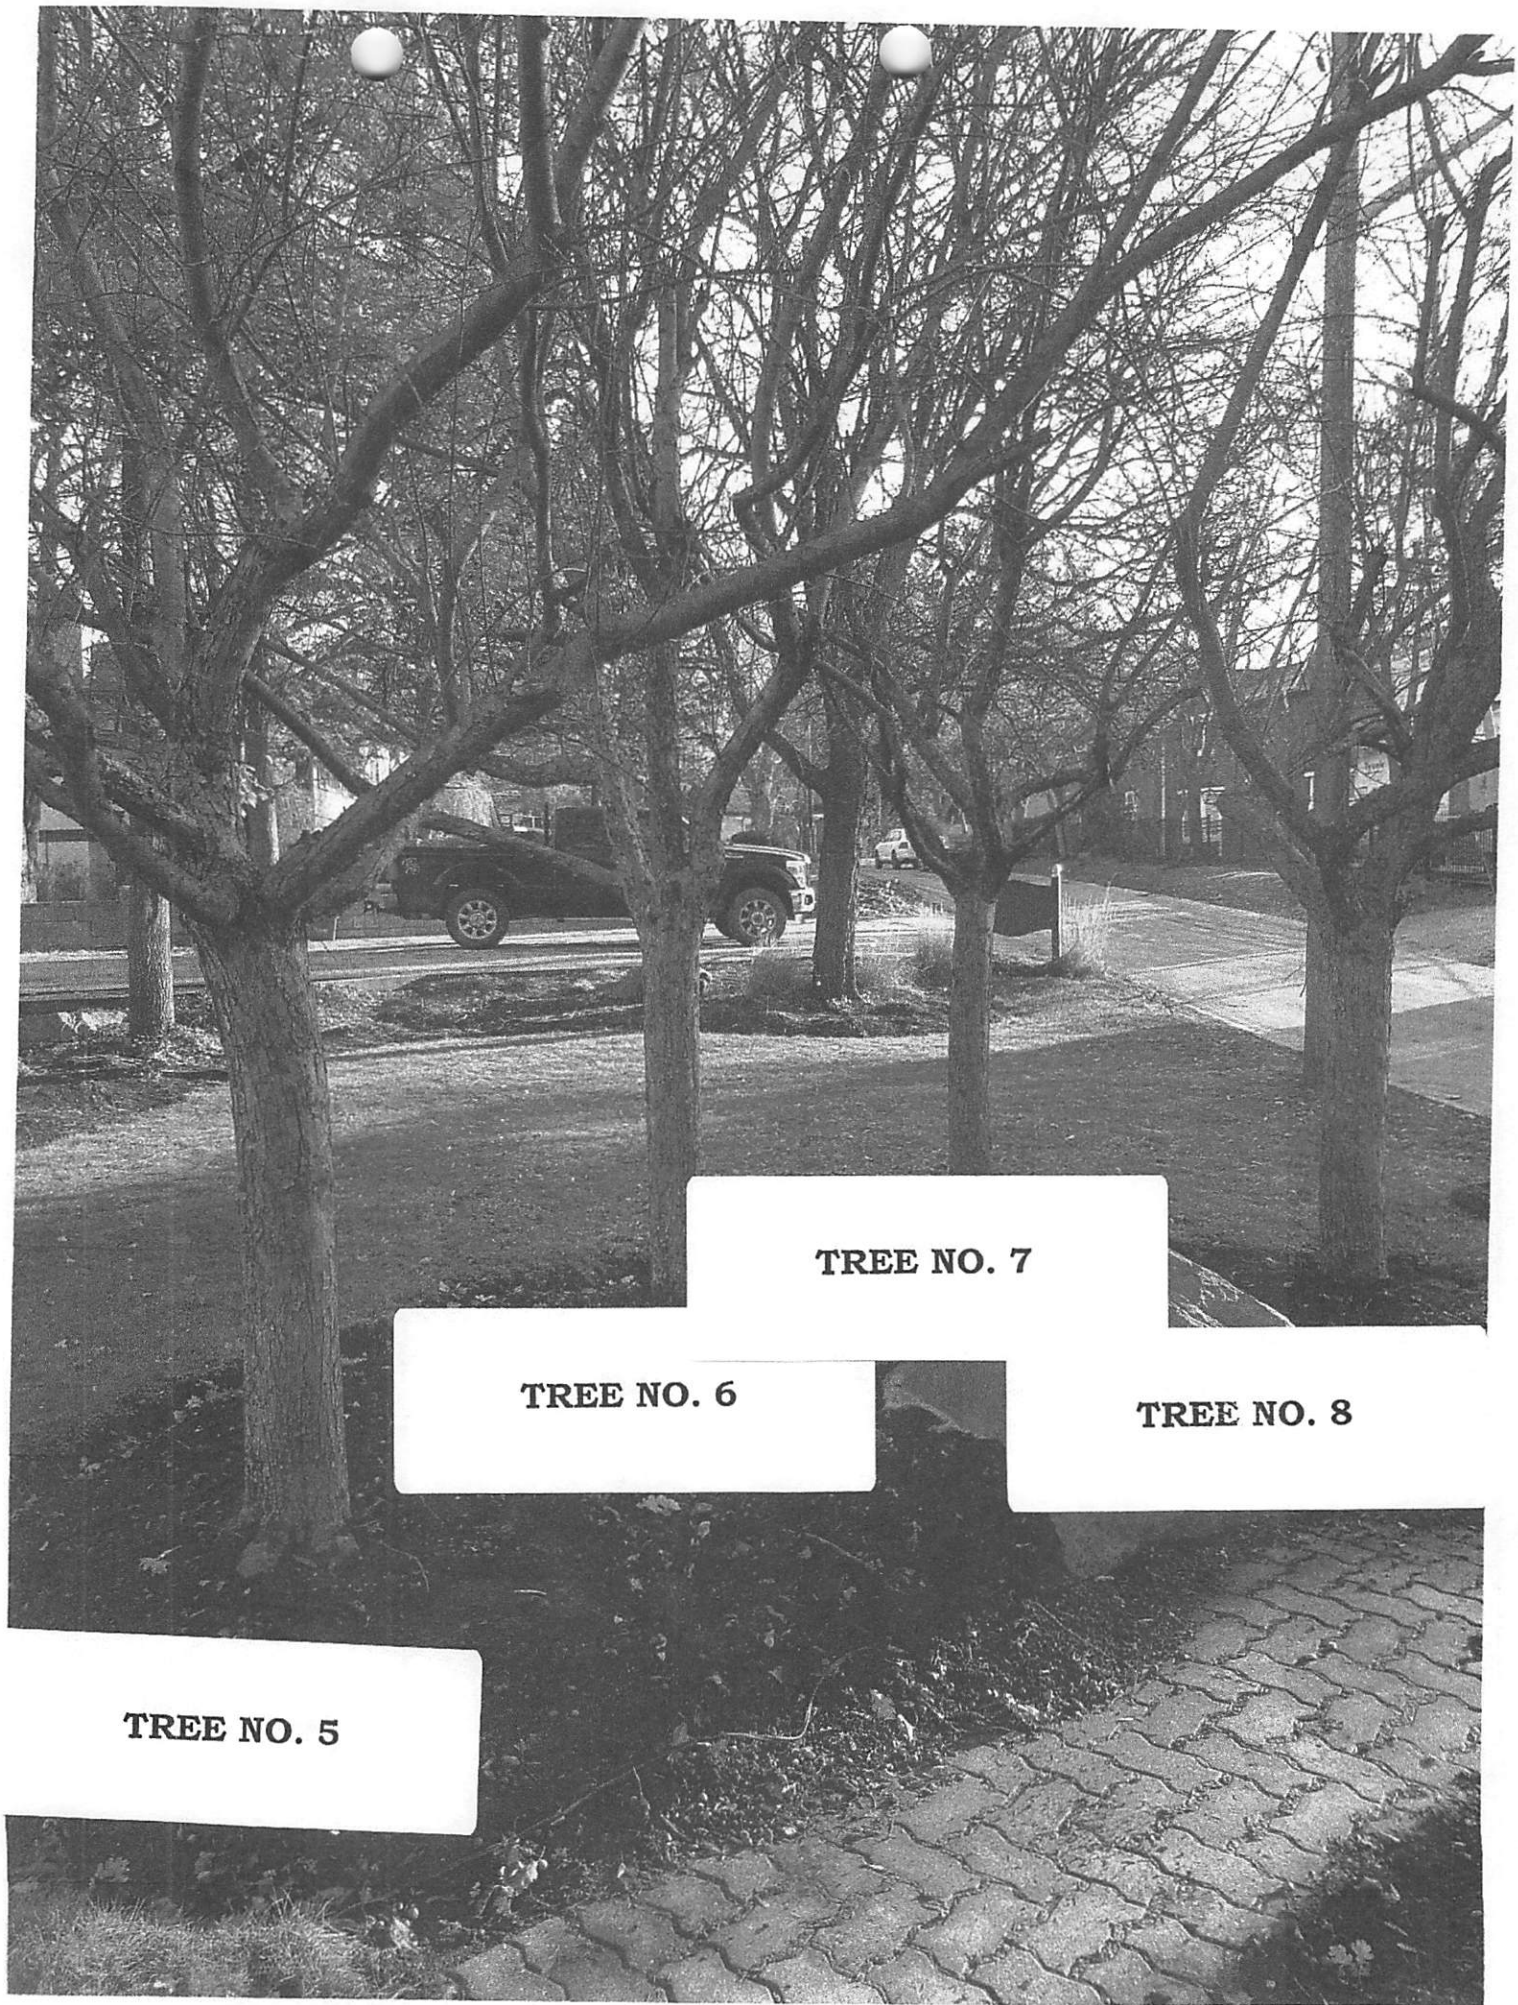
**TREE NO. 5**

This Apple tree is in fair condition. This tree demonstrates 10 to 15% deadwood. This tree requires a **PERMIT for removal**.

The removal of this tree **will require a 1 to1 replacement ratio**.

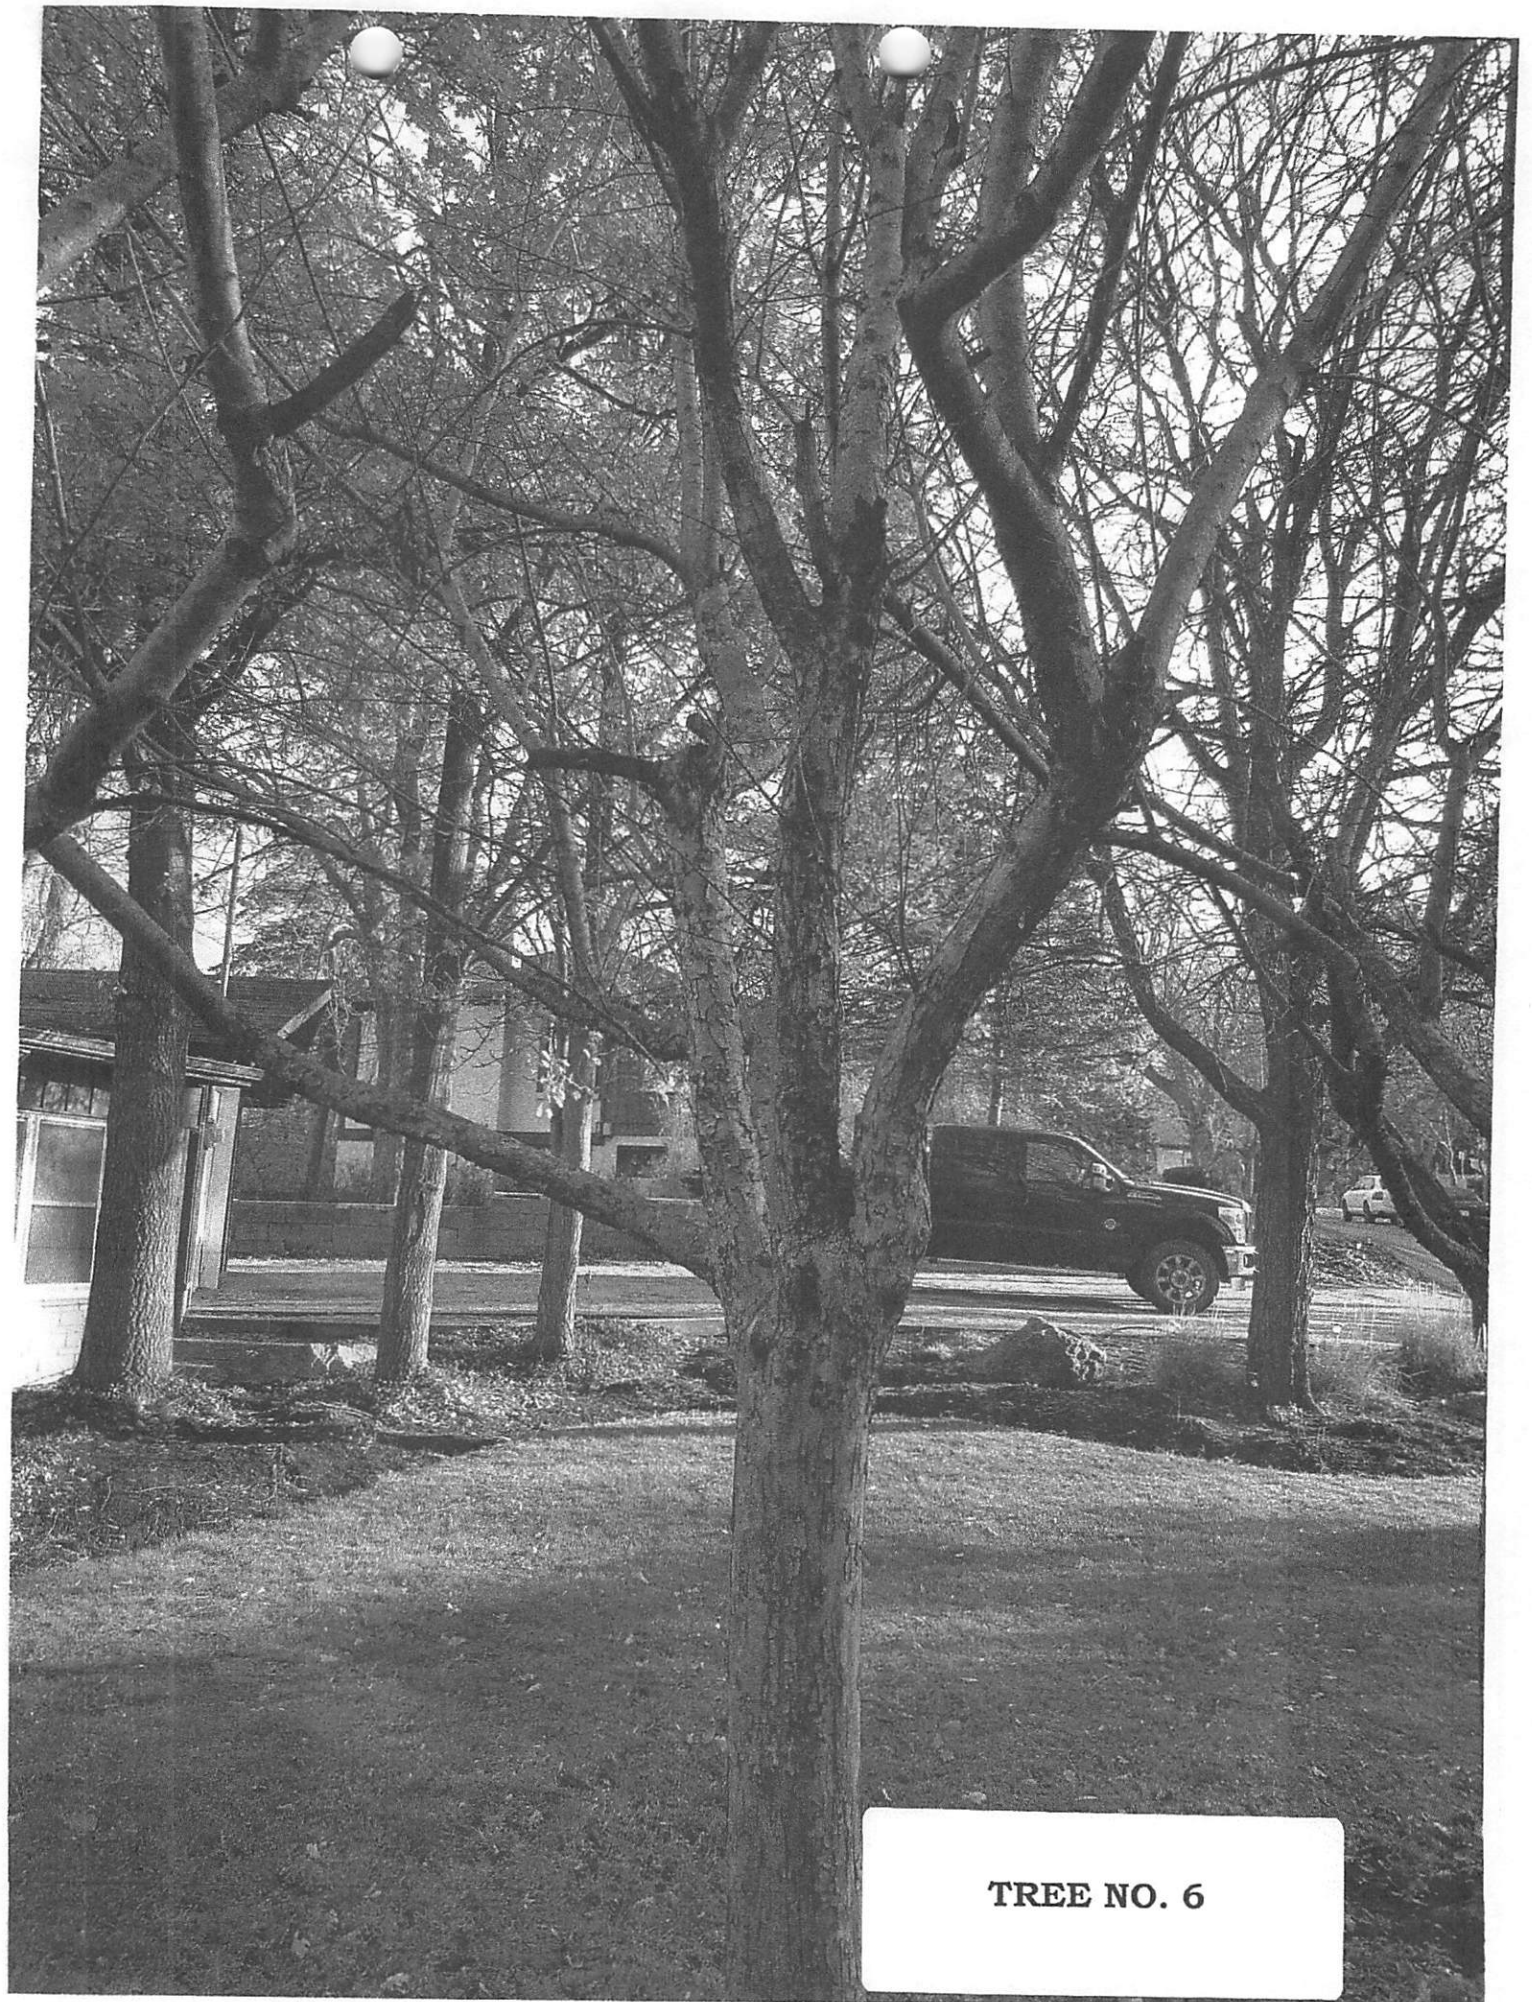
**TREE NO. 6**

This Apple tree is in fair condition. This tree demonstrates 10 to 15% deadwood. This tree requires a **PERMIT for removal**. The removal of this tree **will require a 1 to1 replacement ratio**.

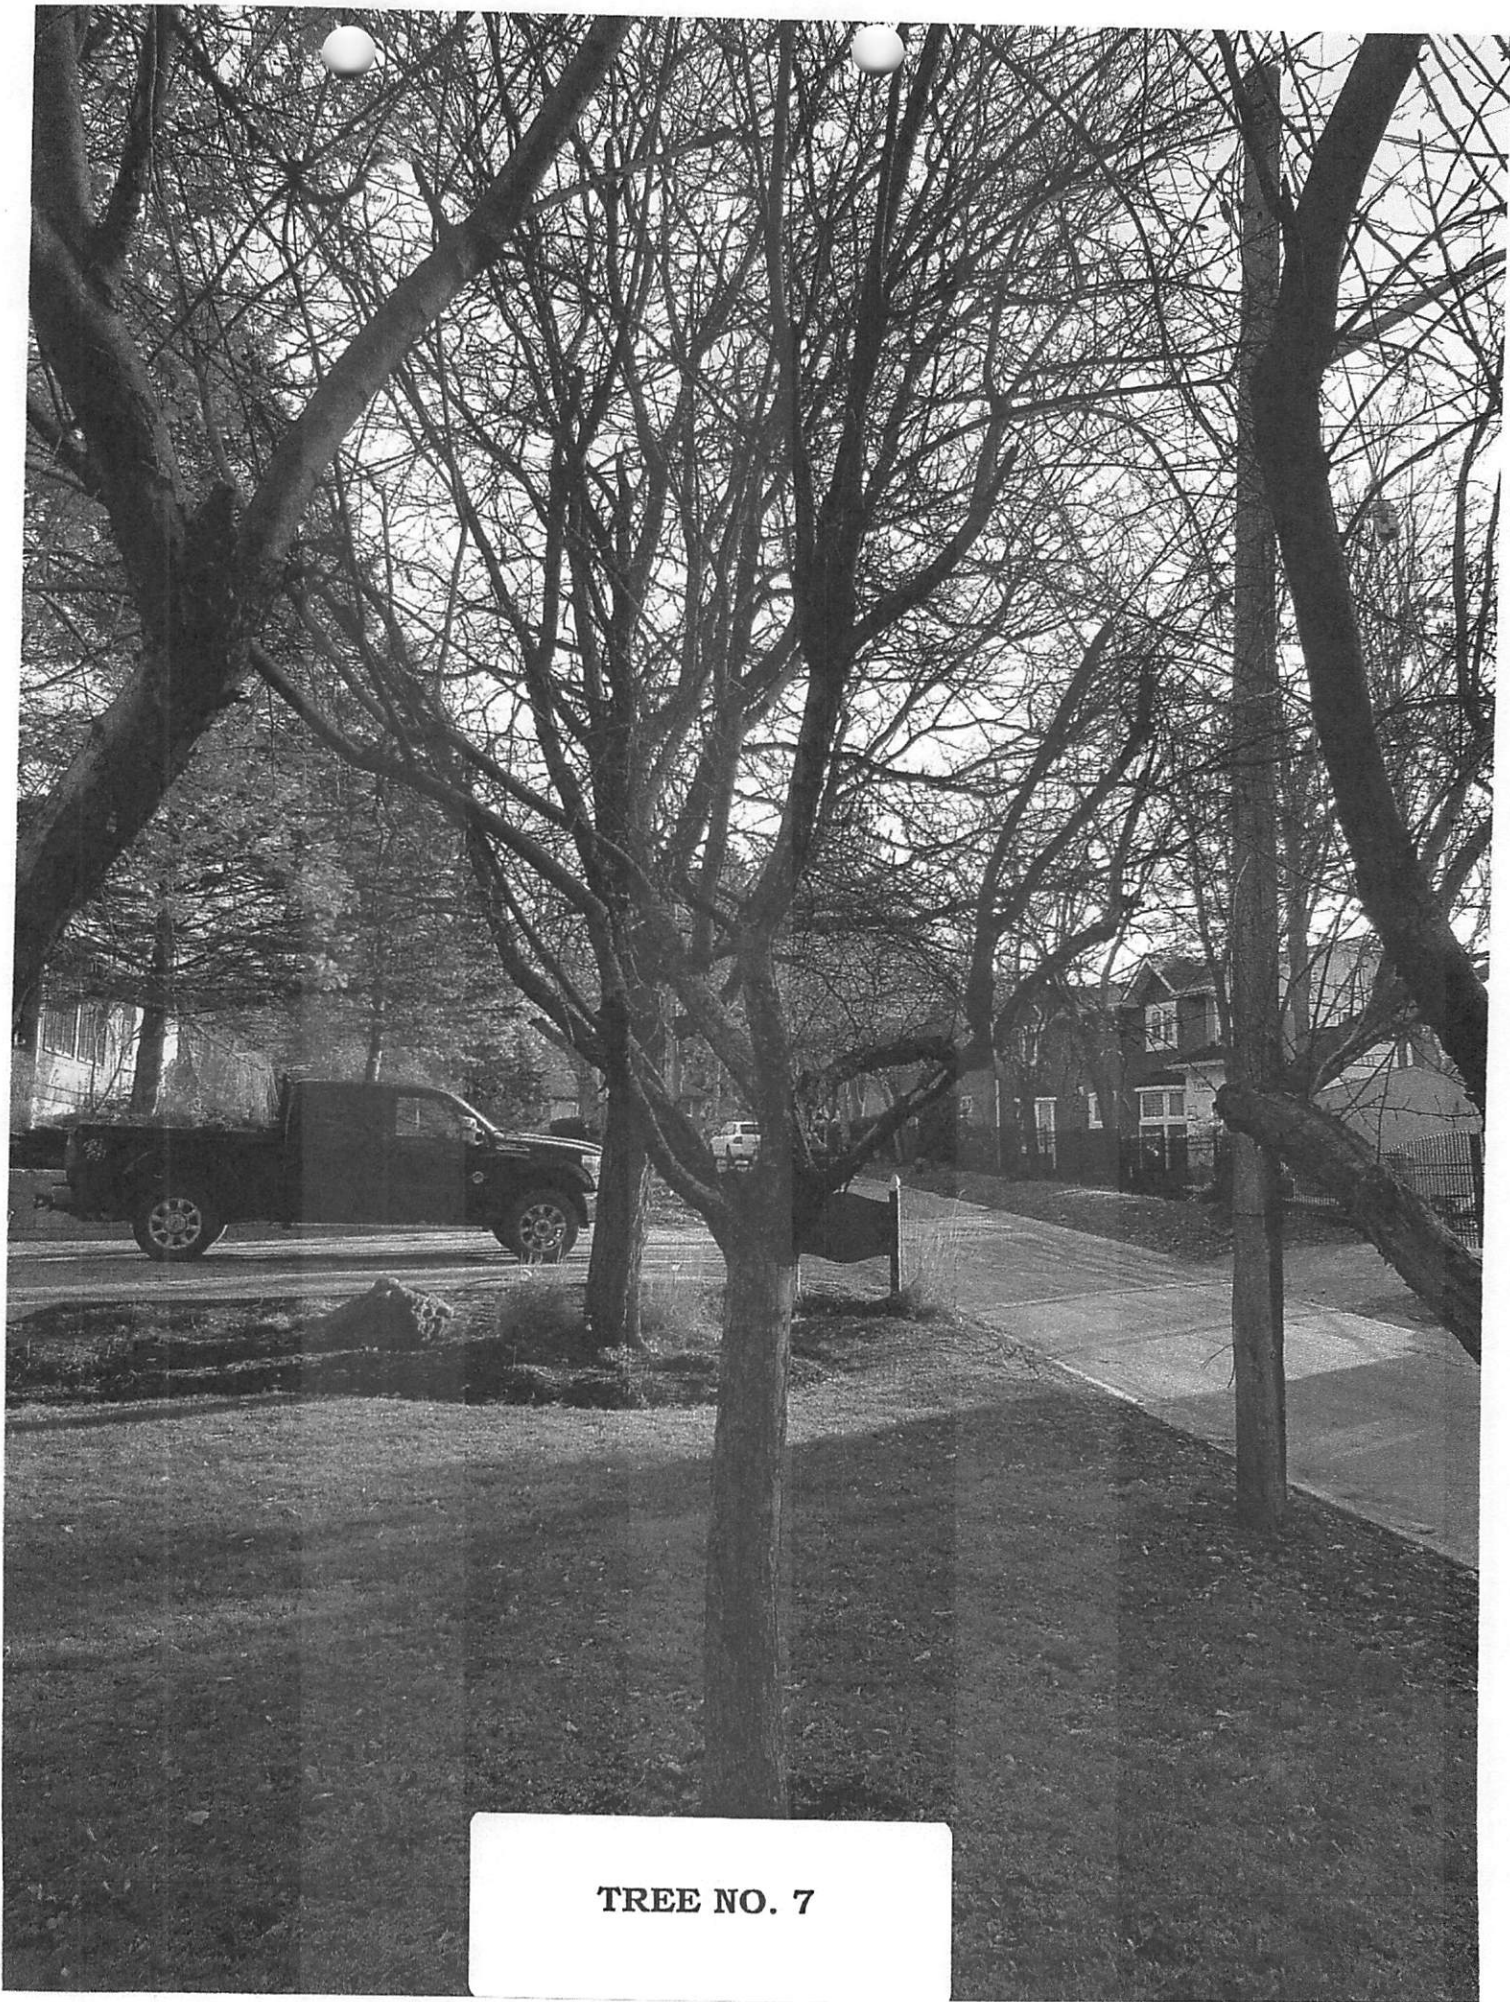
**TREE NO. 7**

This Apple tree is in fair condition. This tree demonstrates 10 to 15% deadwood. This tree requires a **PERMIT for removal**. The removal of this tree **will require a 1 to1 replacement ratio**.
