**Tree Inventory and Preservation Plan Report  
27 Main Street  
Vaughan, Ontario**

07 July 2021, revised 18 May 2022

KUNTZ FORESTRY CONSULTING INC Project P2851

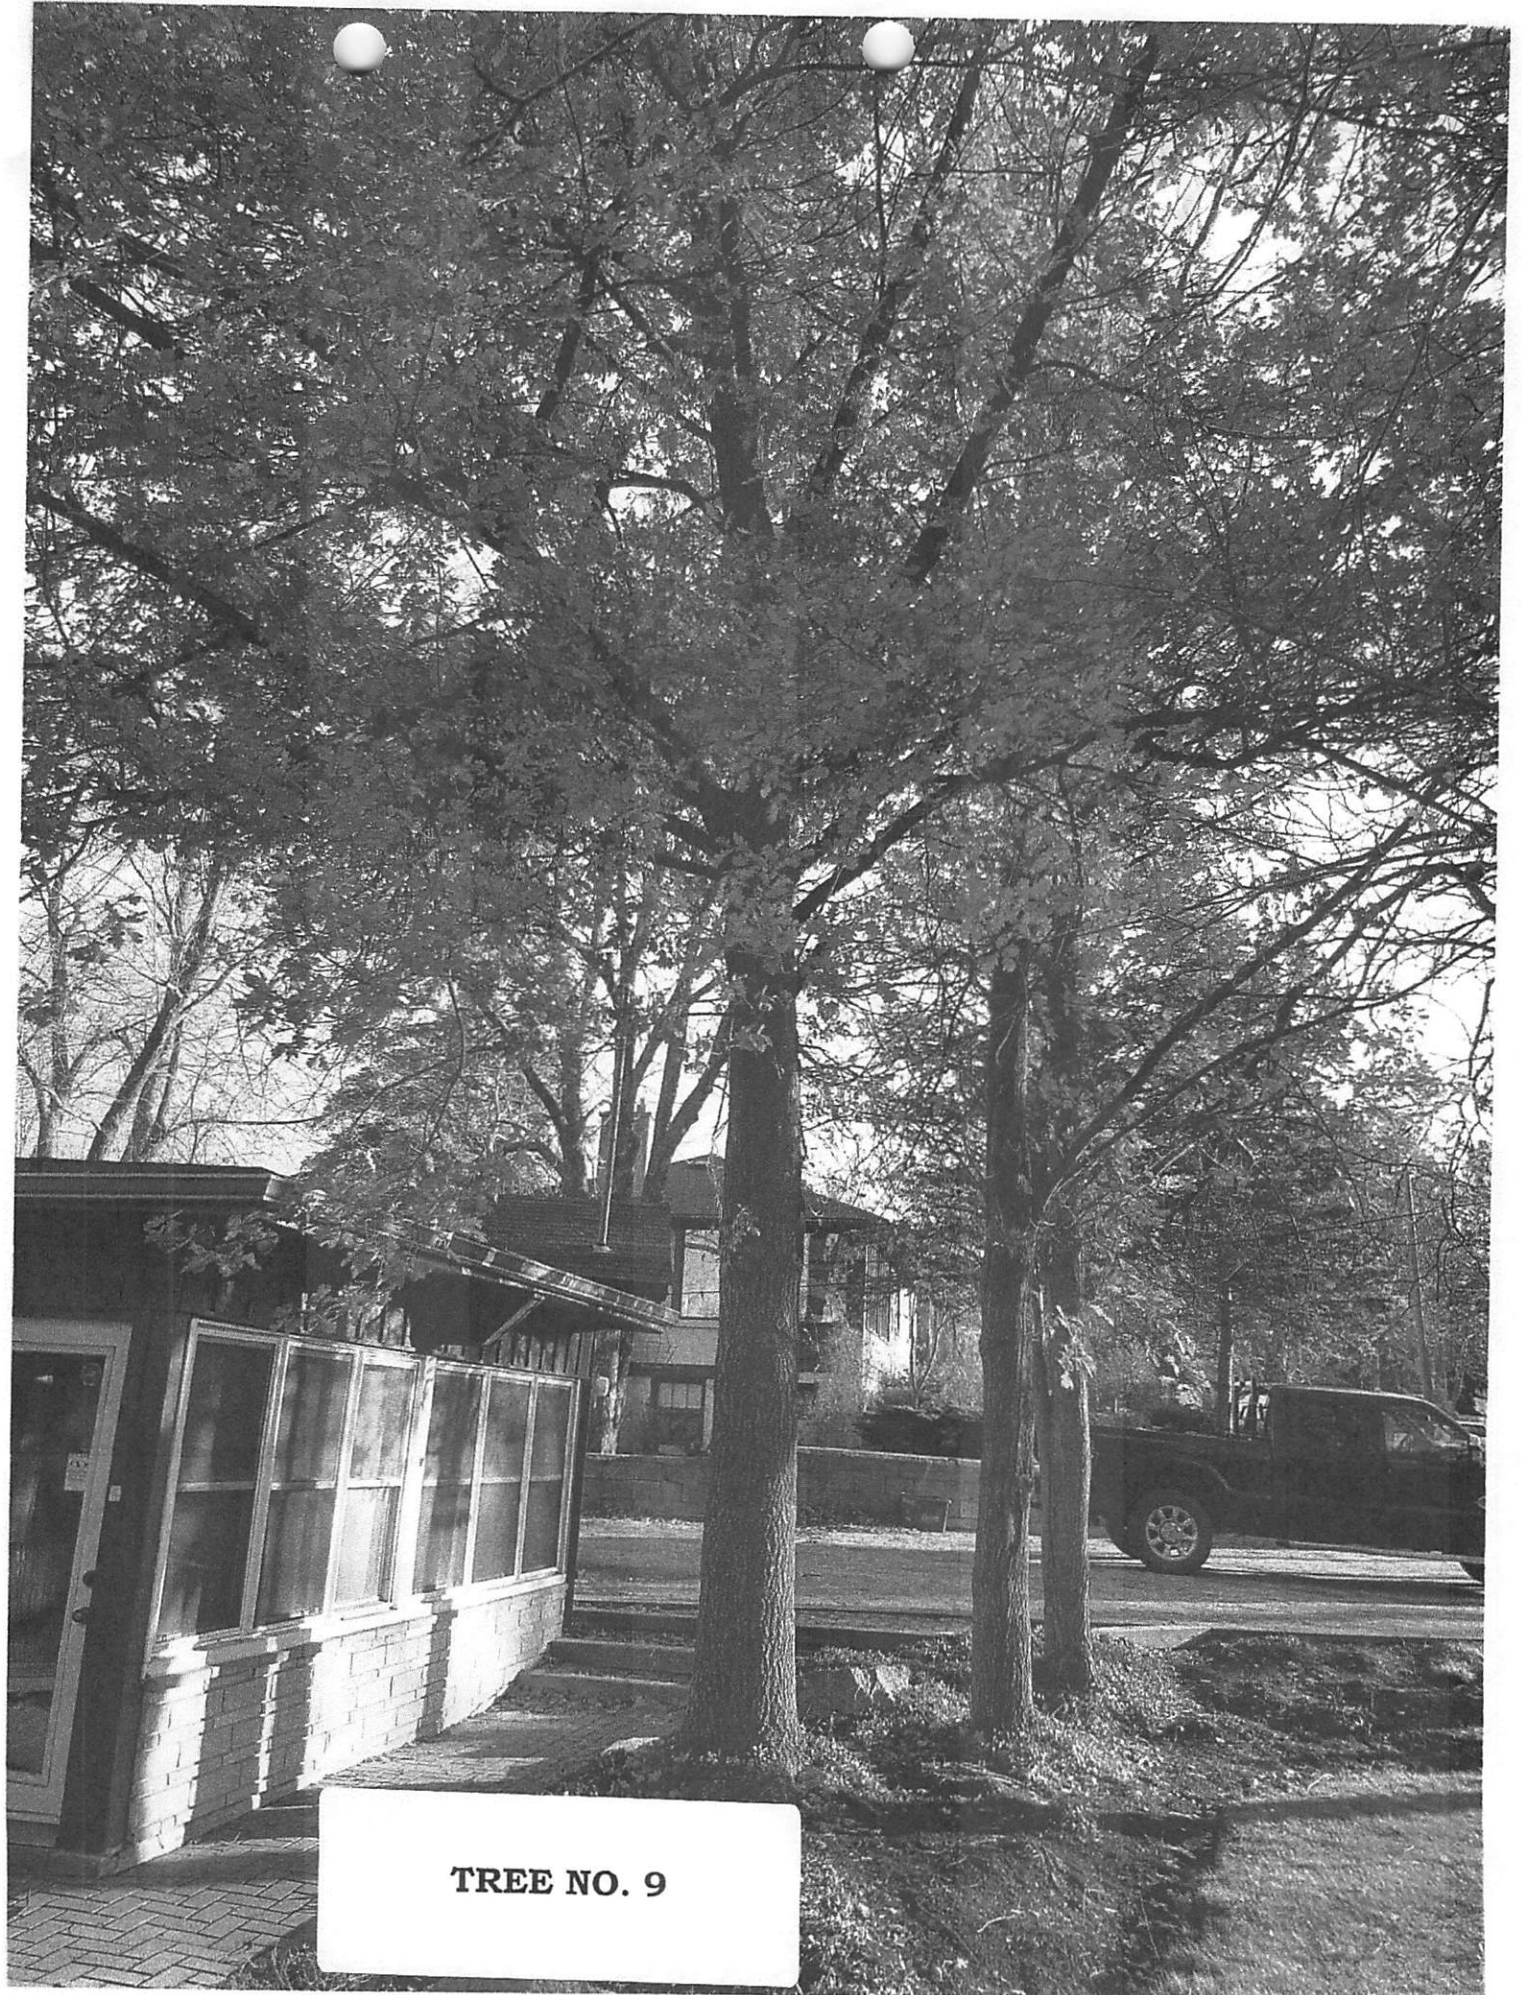
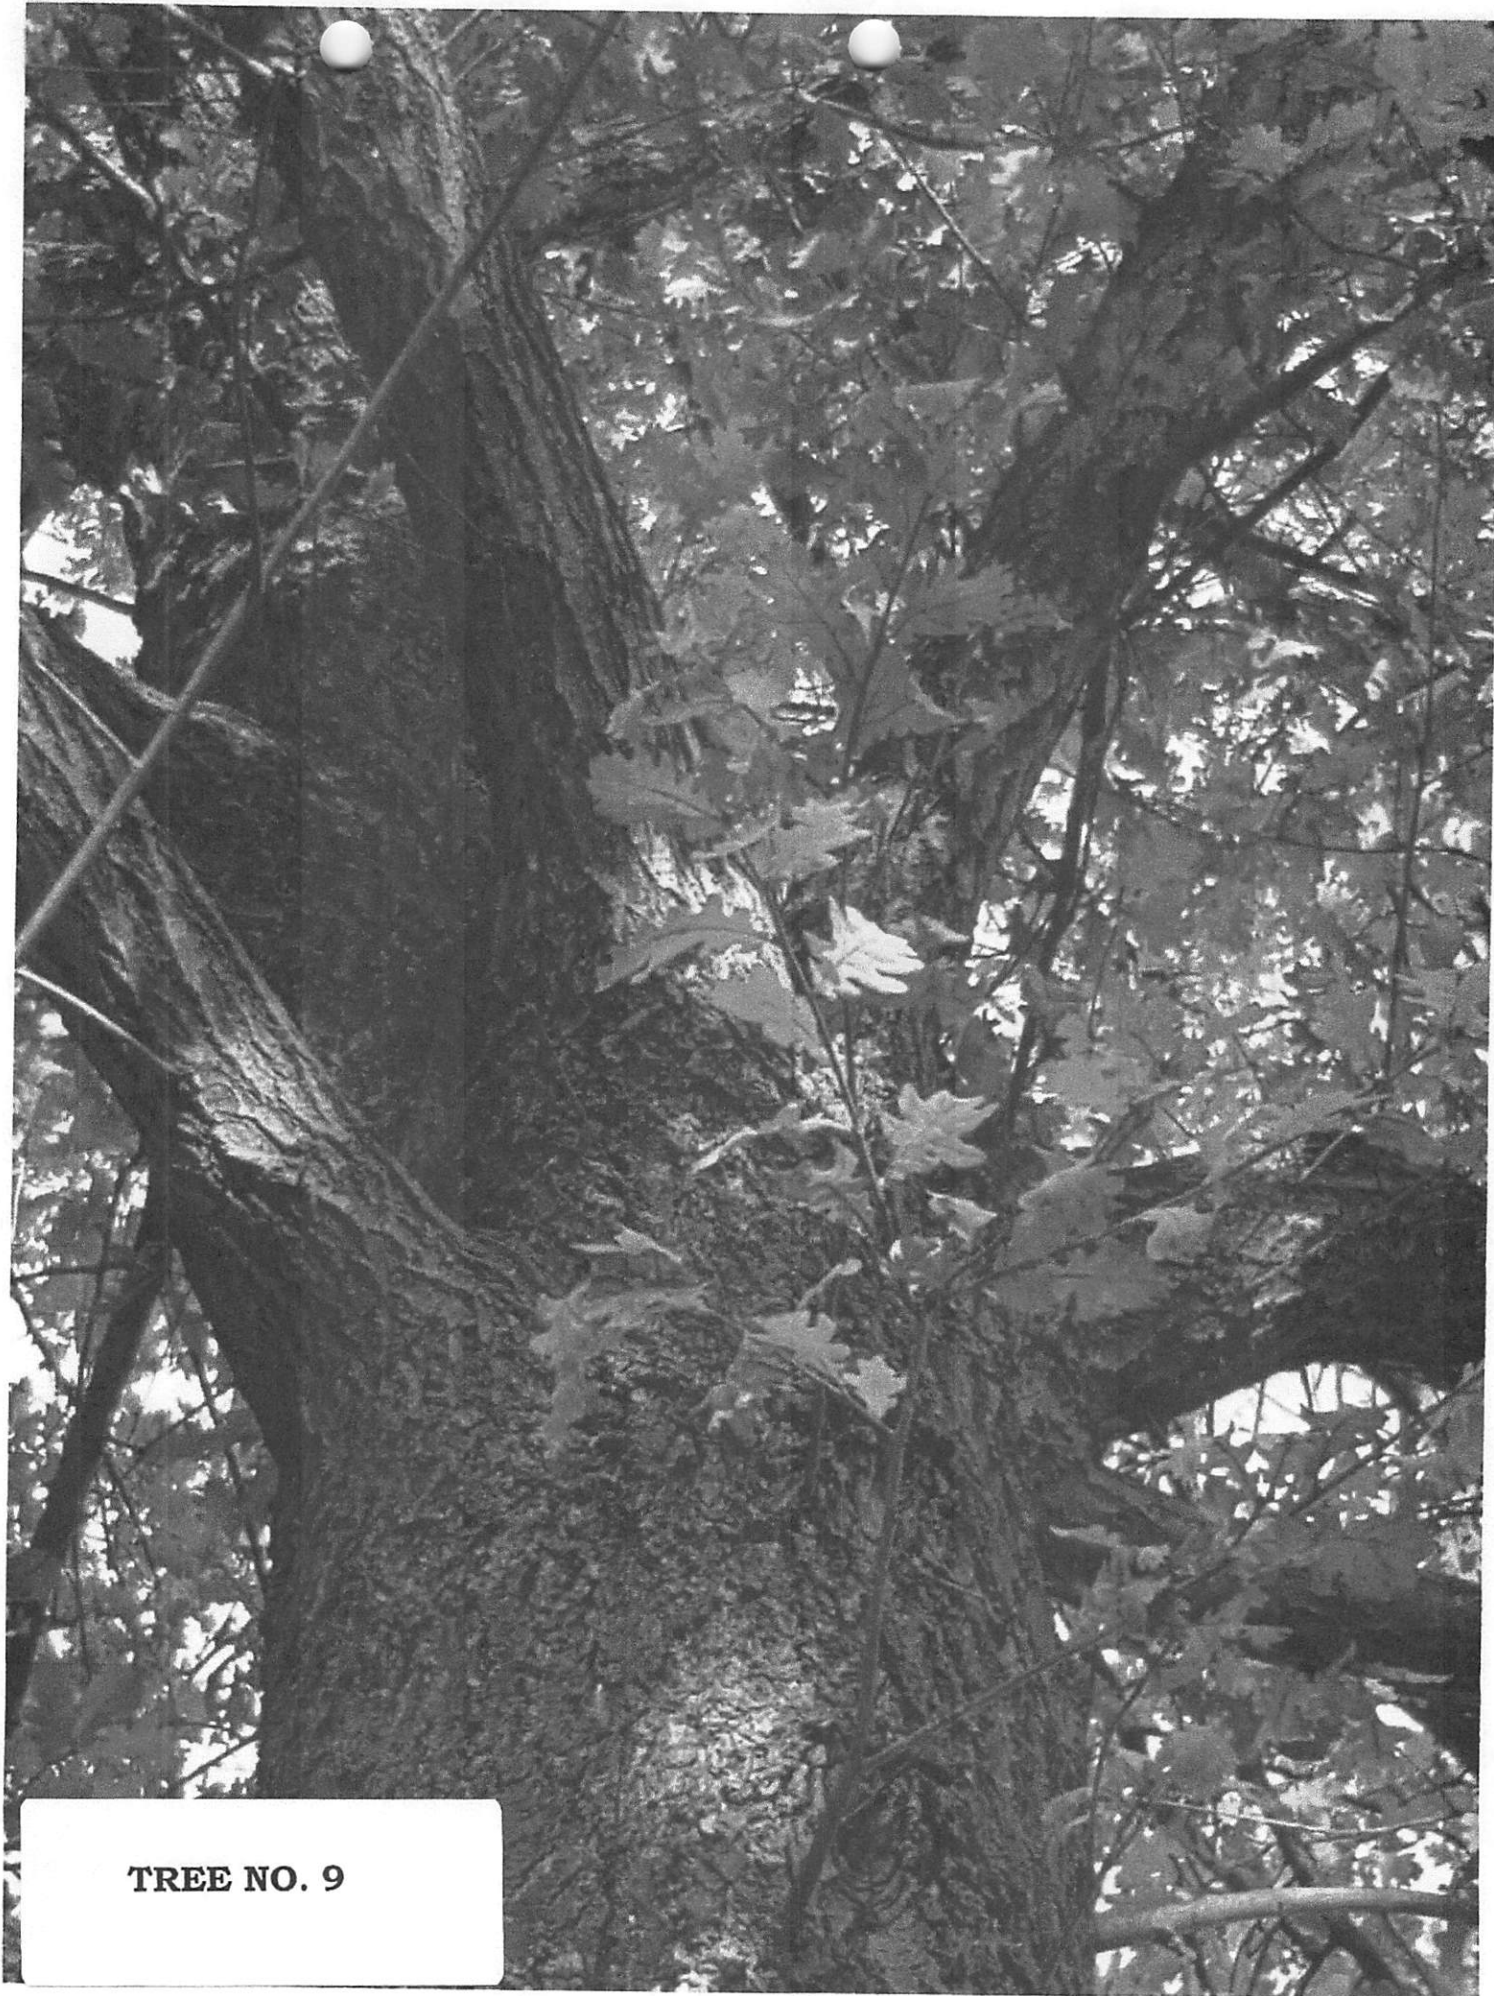
**TREE NO. 9**

This White Oak is in fair condition botanically but fair to poor structurally. This tree has a poor main union with over 60 cm of included bark. There is large number of branch unions within close proximity of each other. There is a frost crack starting at ground level up to 3m in height. This tree is within close proximity of the dwelling and secondary power stack. The possibility of large limbs failing is high.

This tree requires a **PERMIT for removal**. The removal of this tree **will require a 3 to1 replacement ratio**.

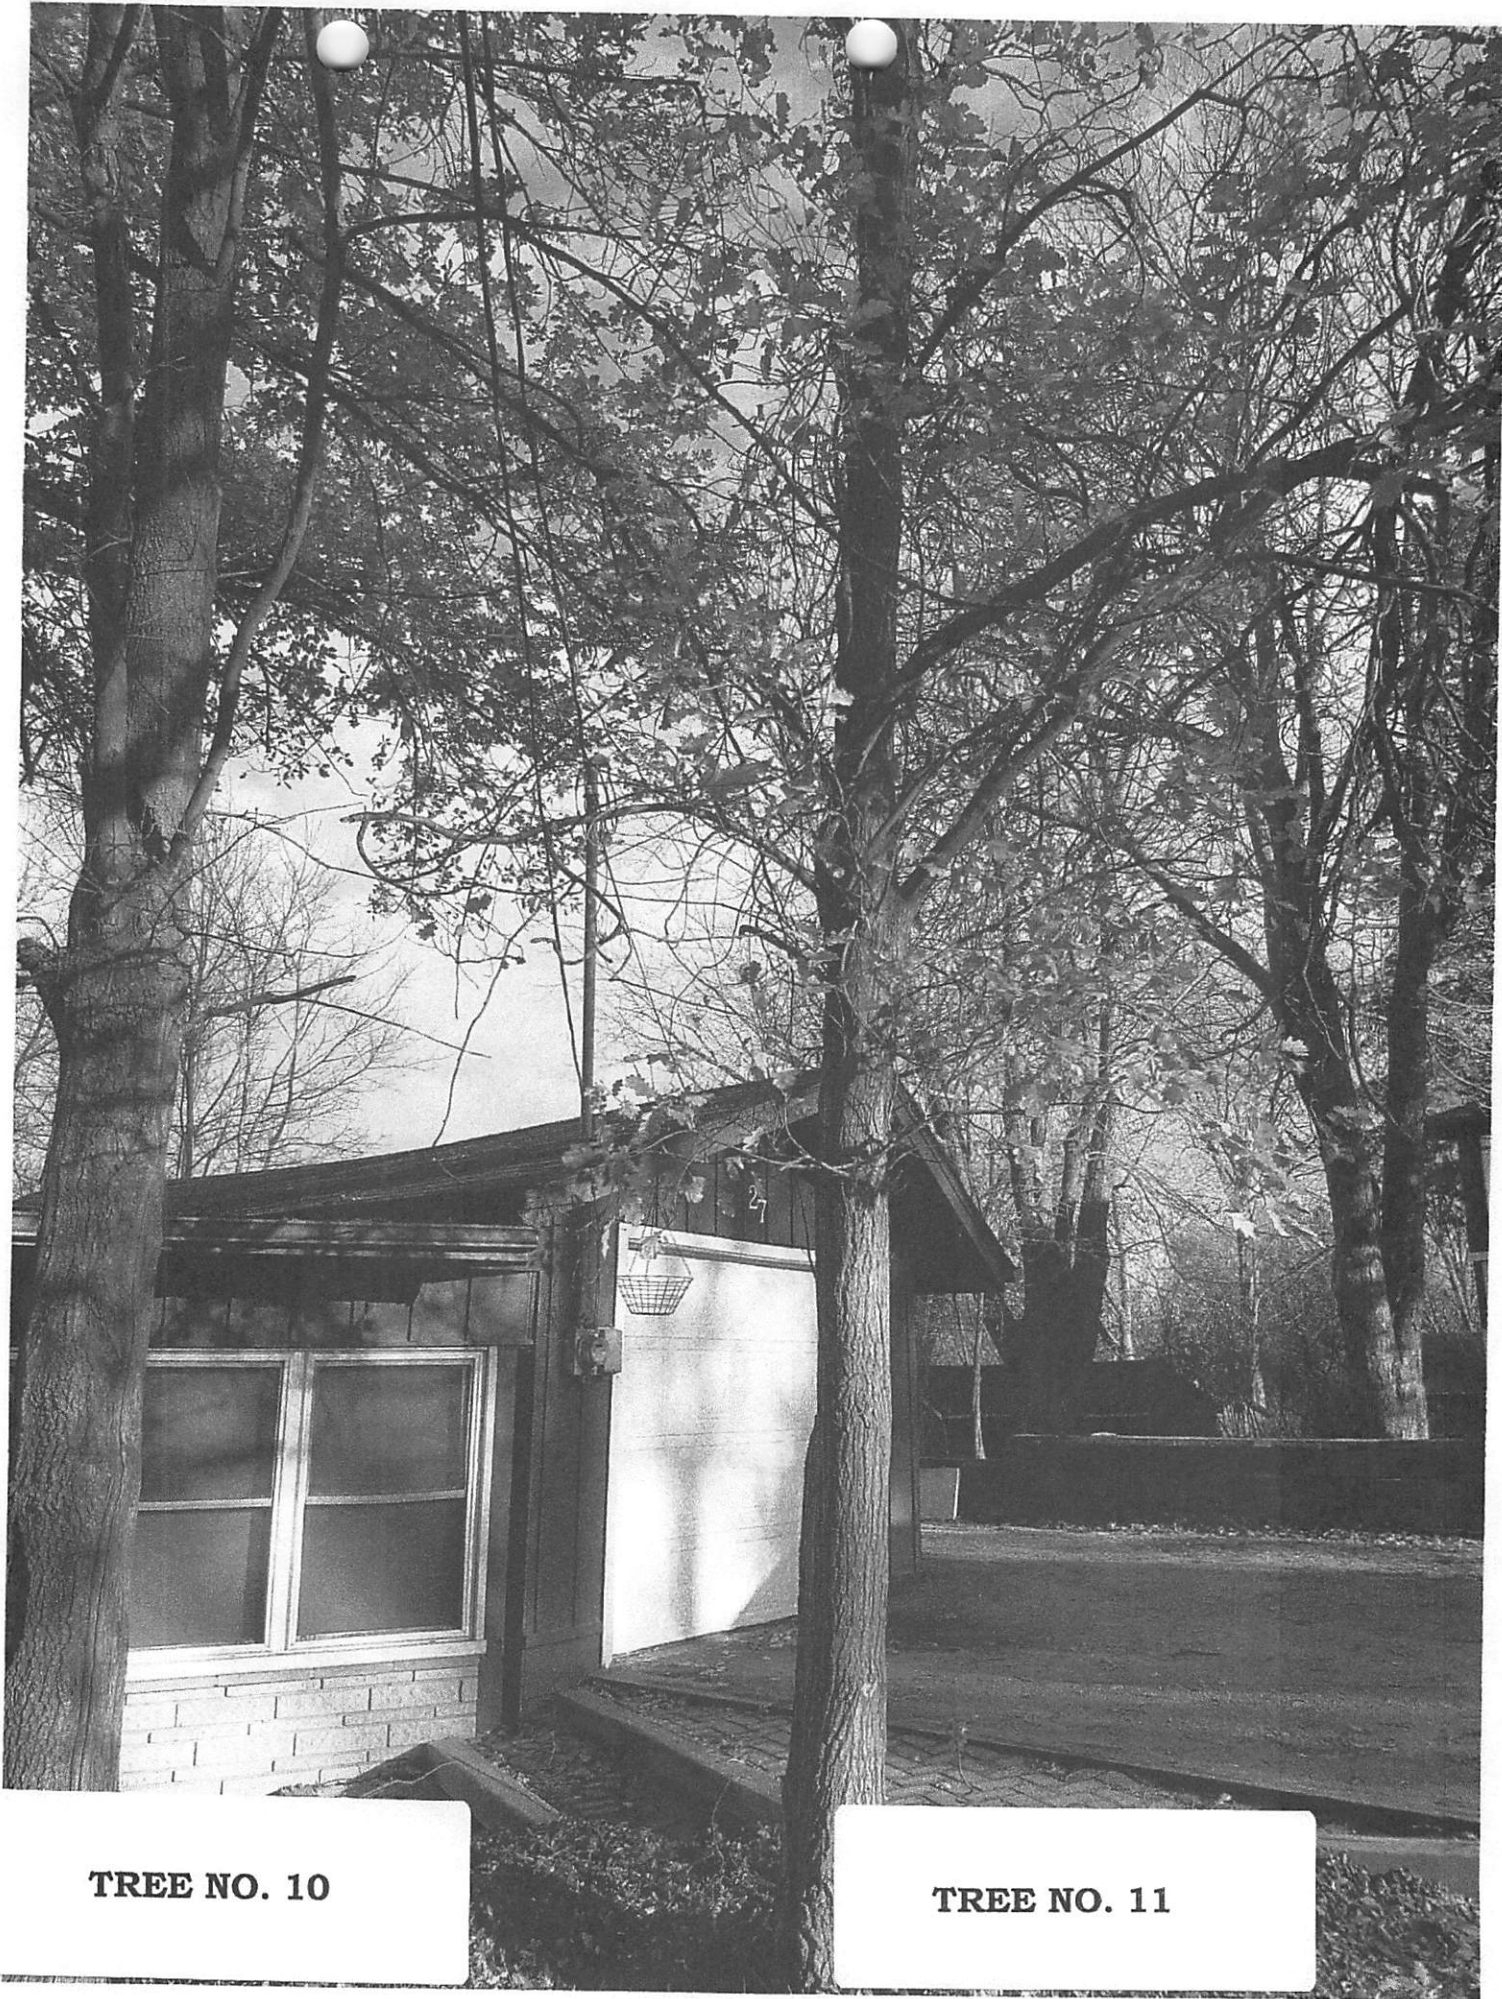
**TREE NO. 10**

This White Oak is dead. This tree qualifies for an exemption under the City of Vaughan Private Tree Protection Act. The tree is exempted from all permit fees and replacement obligations.

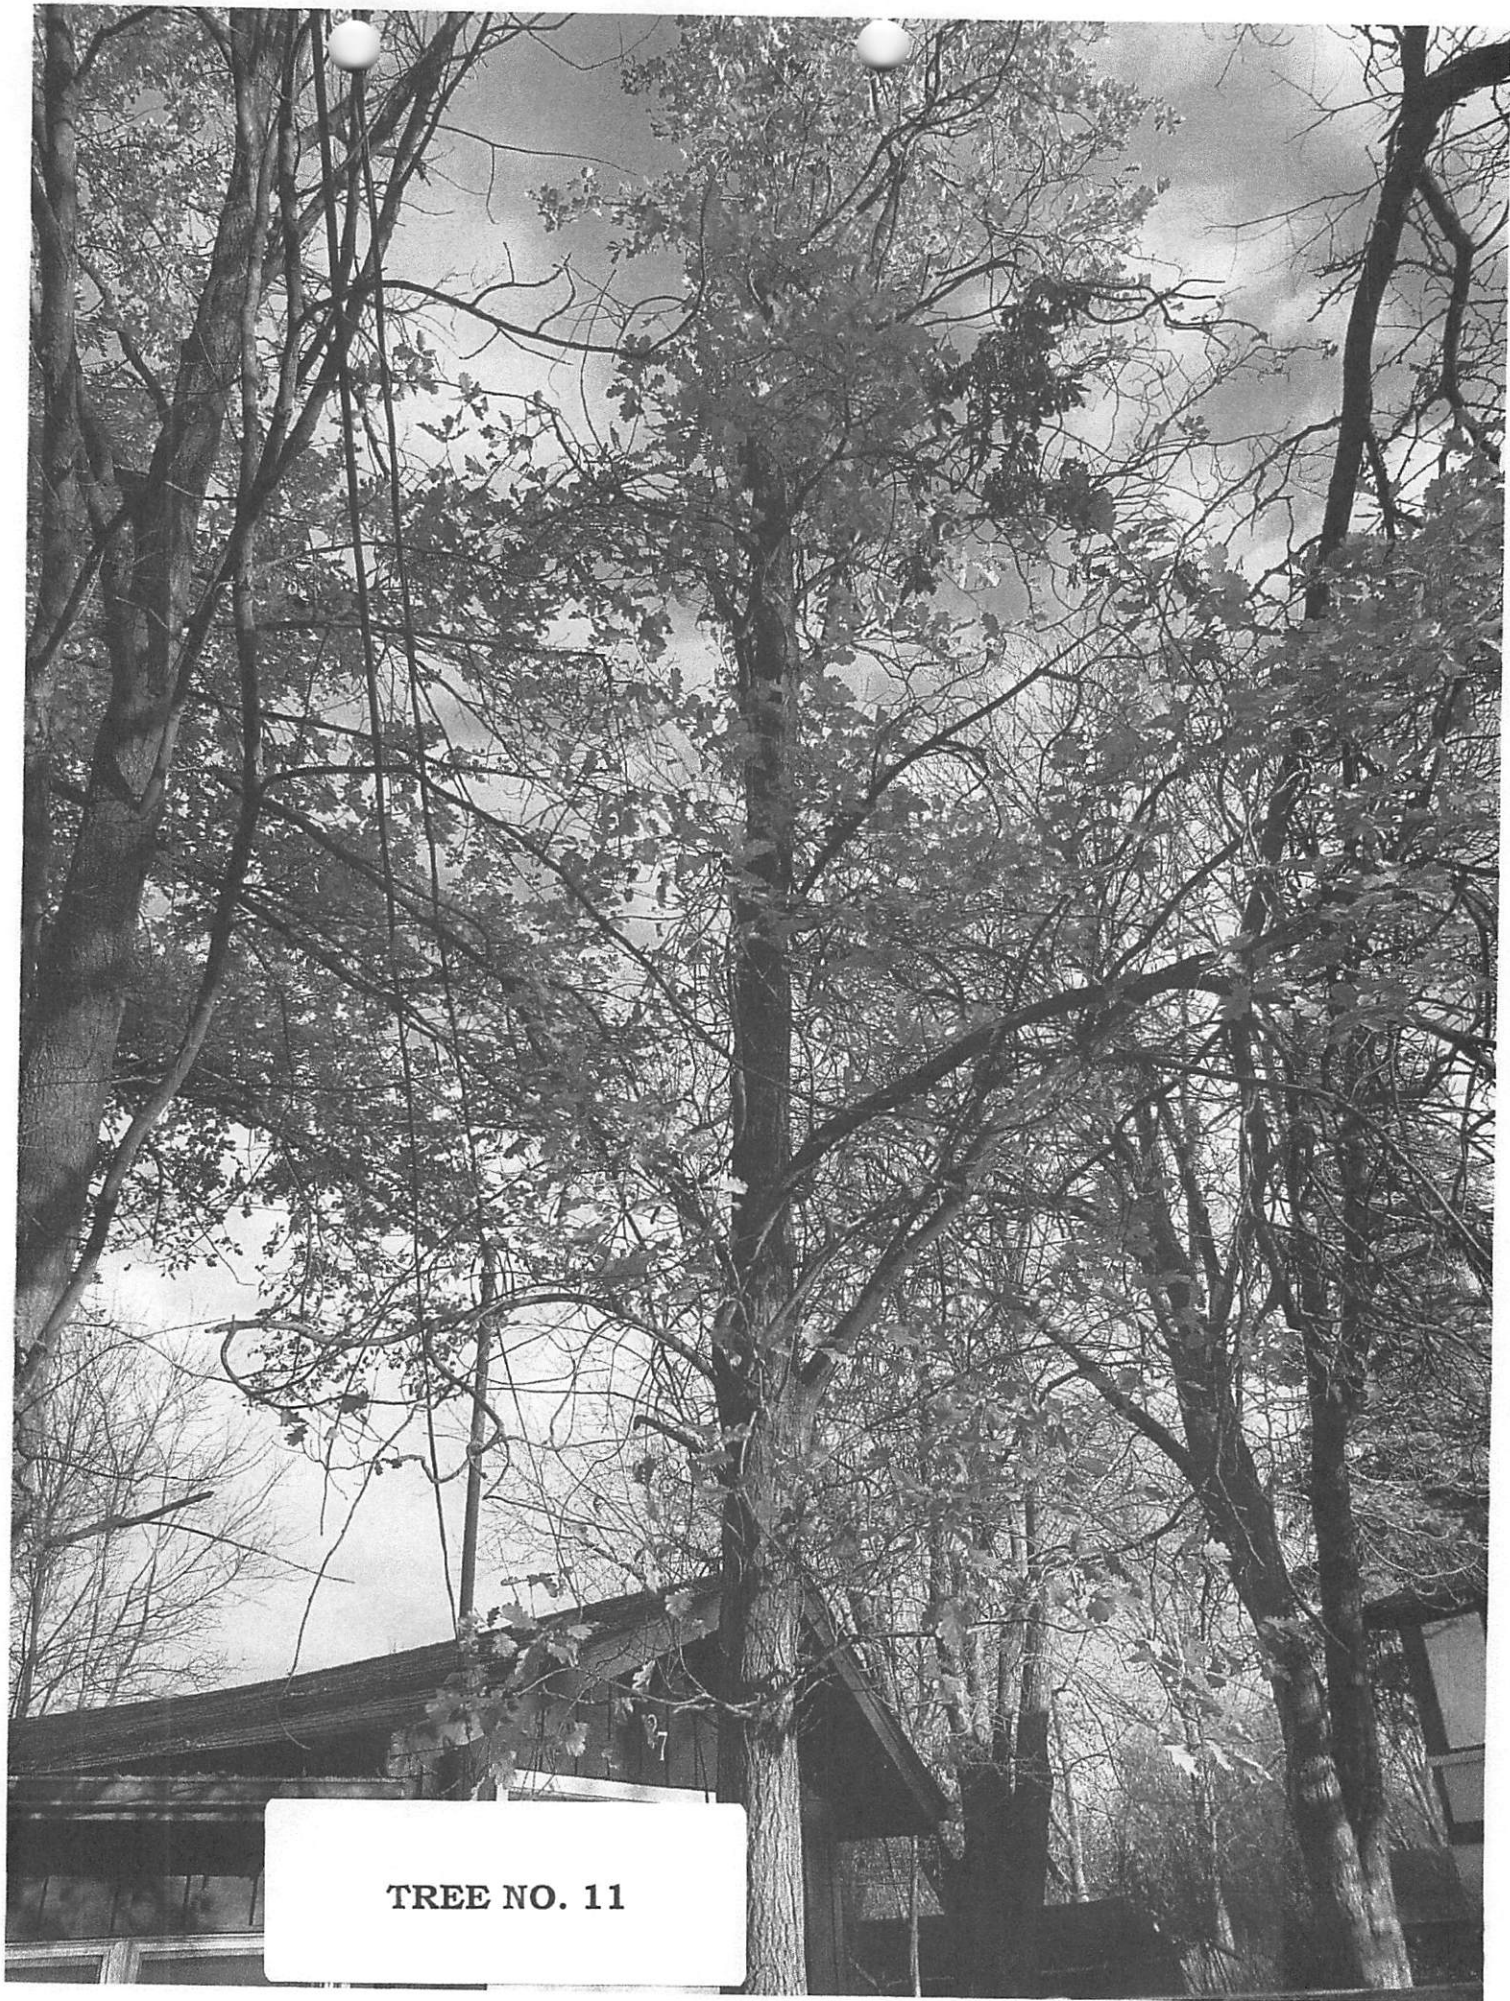
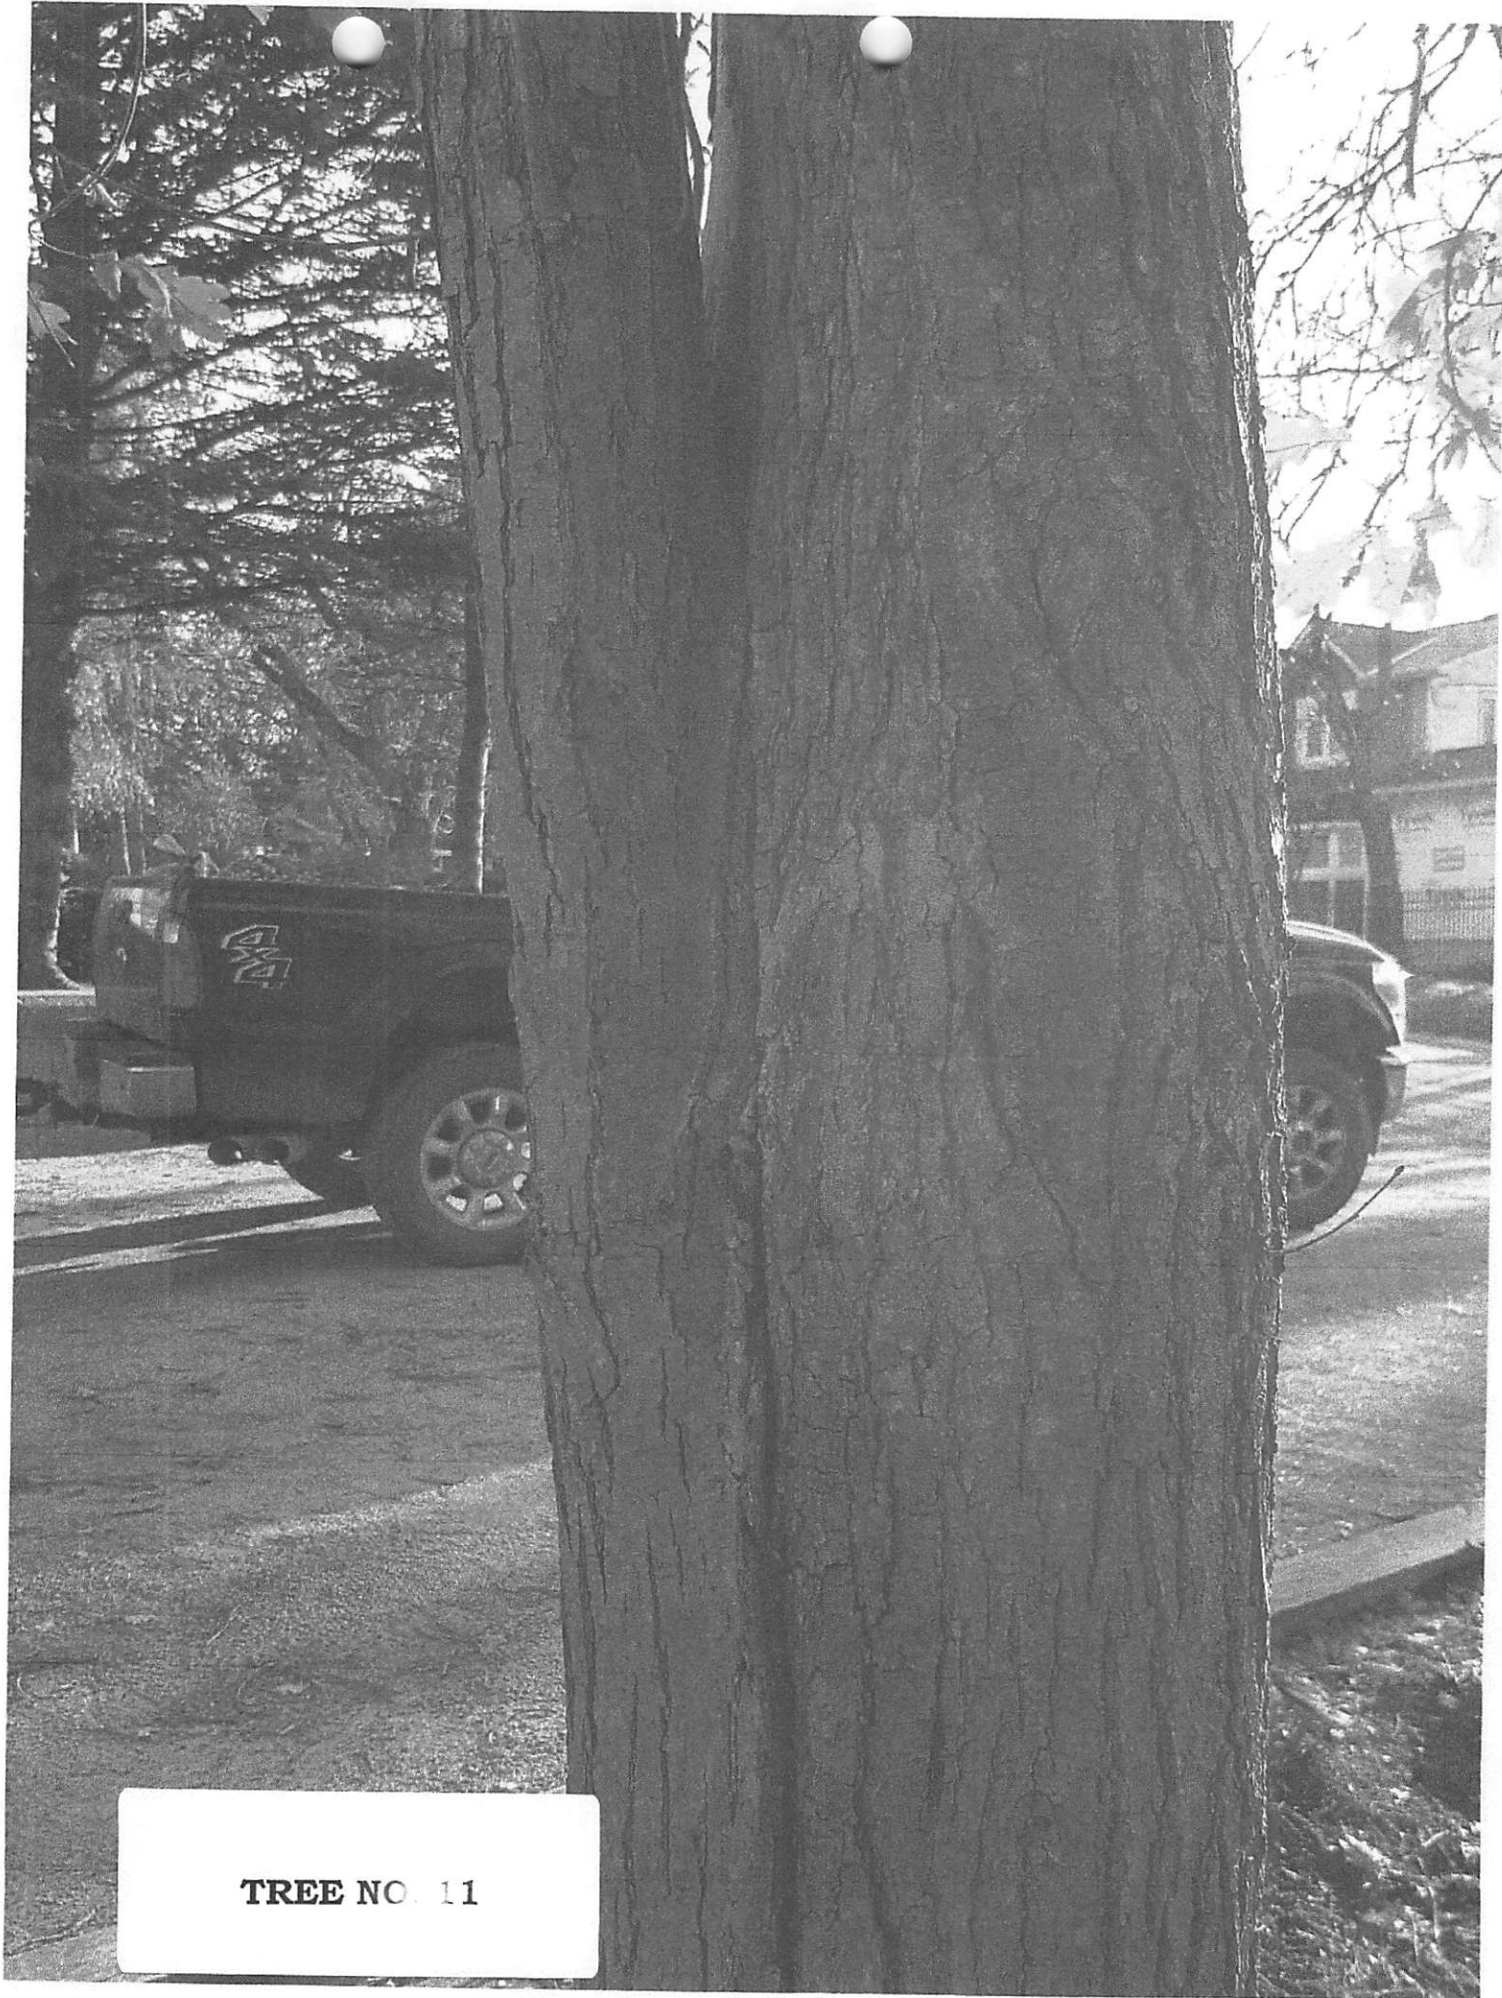
TREE NO. 11

This White Oak is in fair to poor condition. It has been growing in very crowded conditions and has a very limited crown. The main stem displays over 2m of included bark.

The removal of this tree **will require a 1 to1 replacement ratio.**

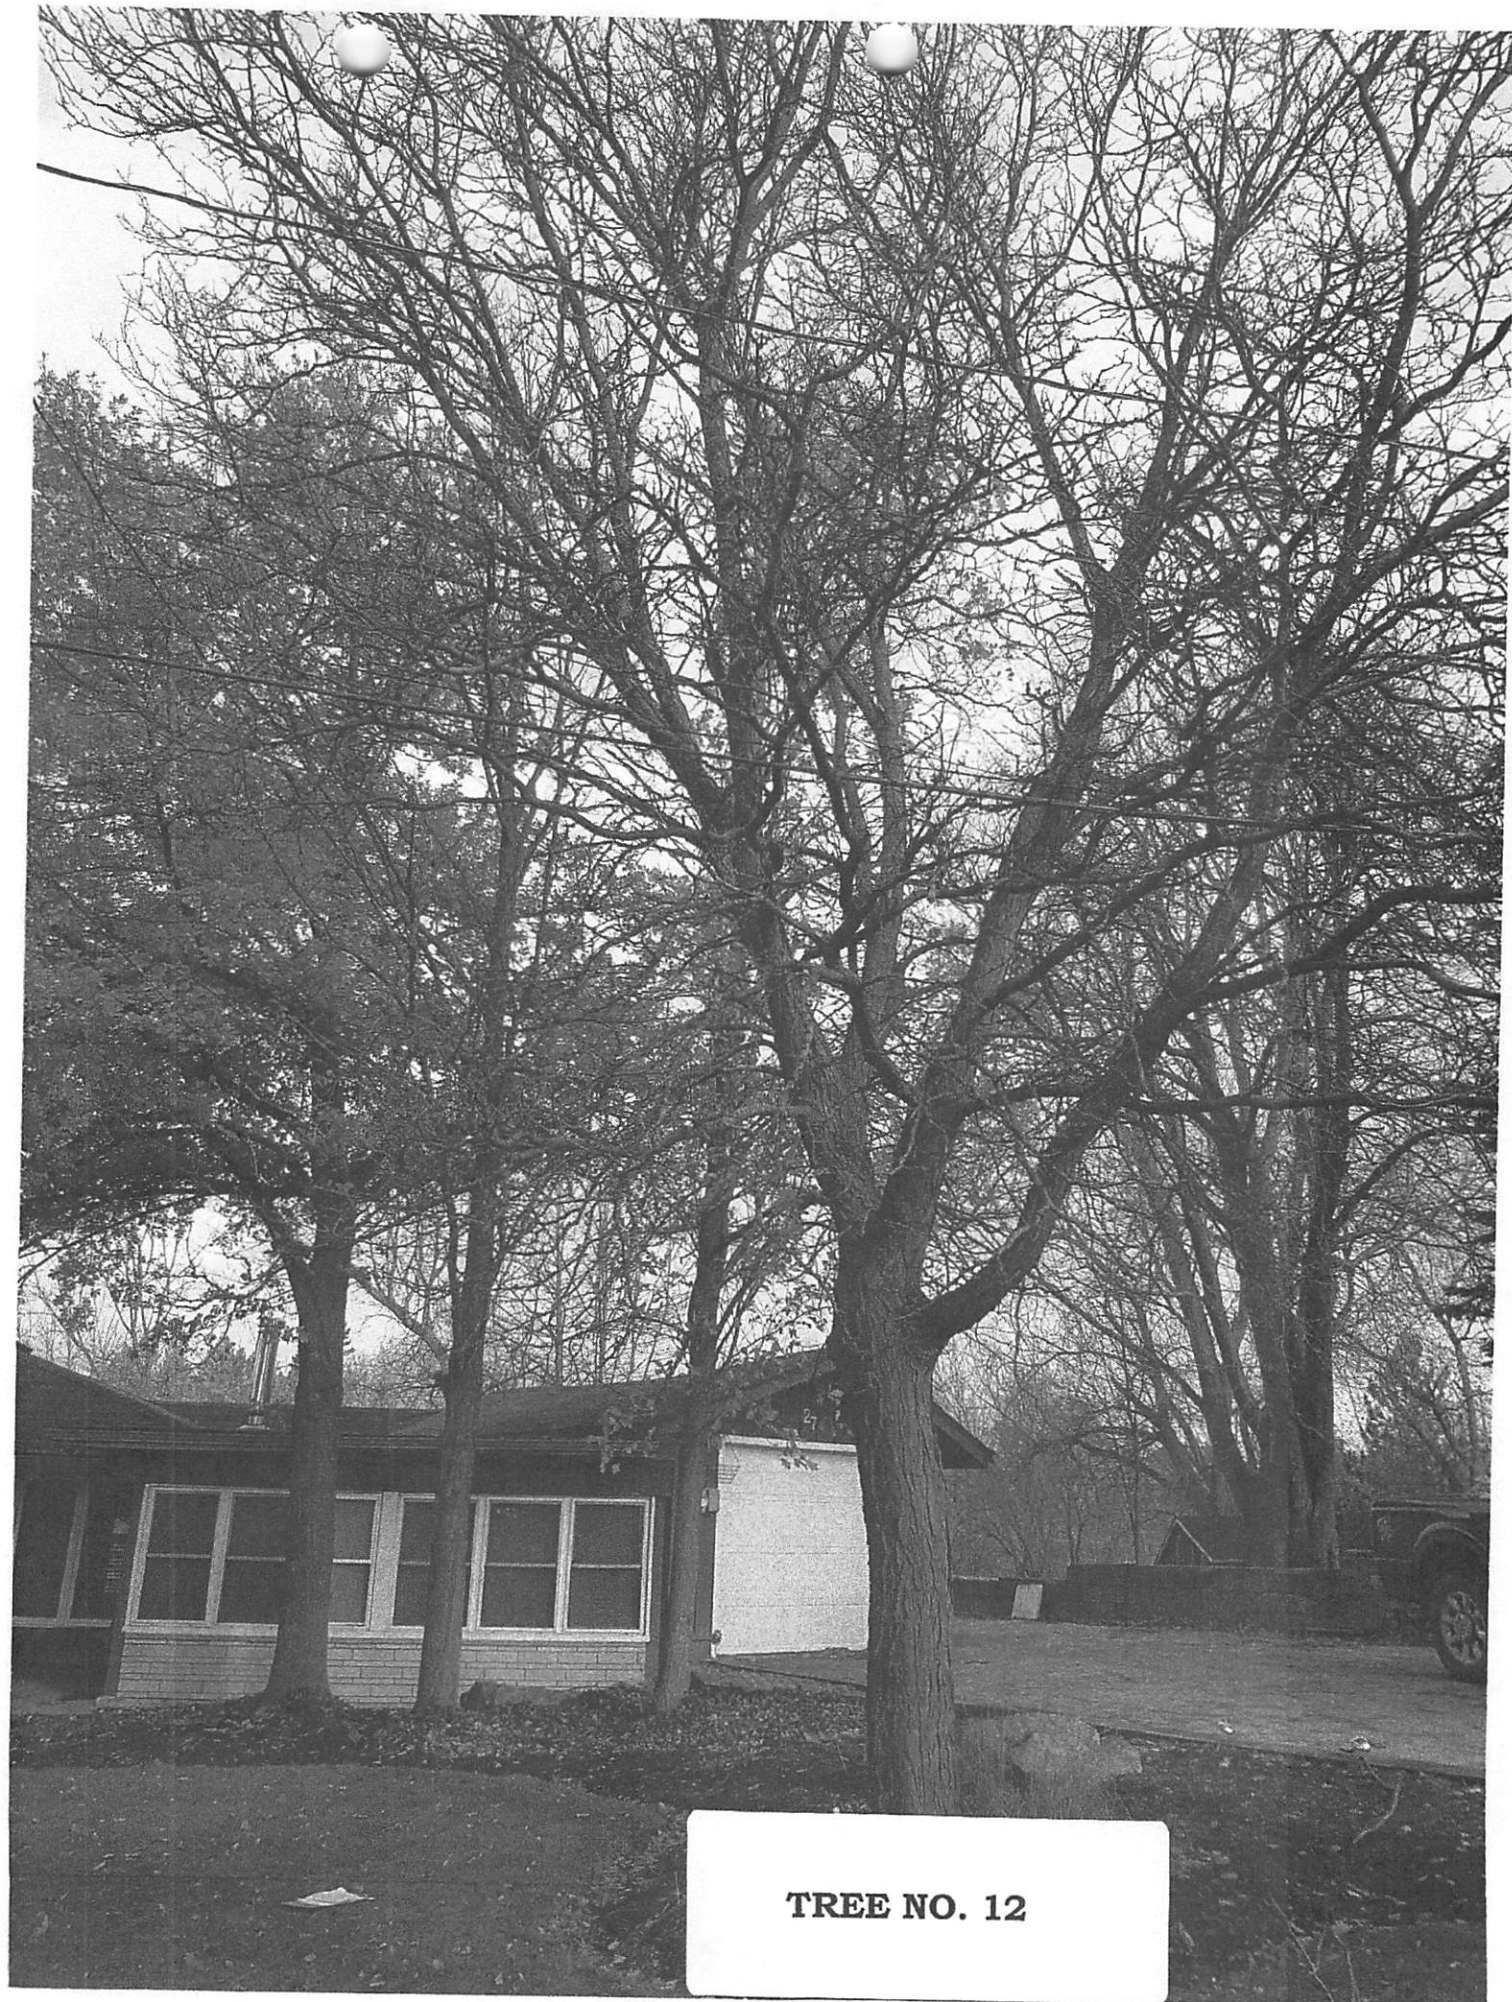
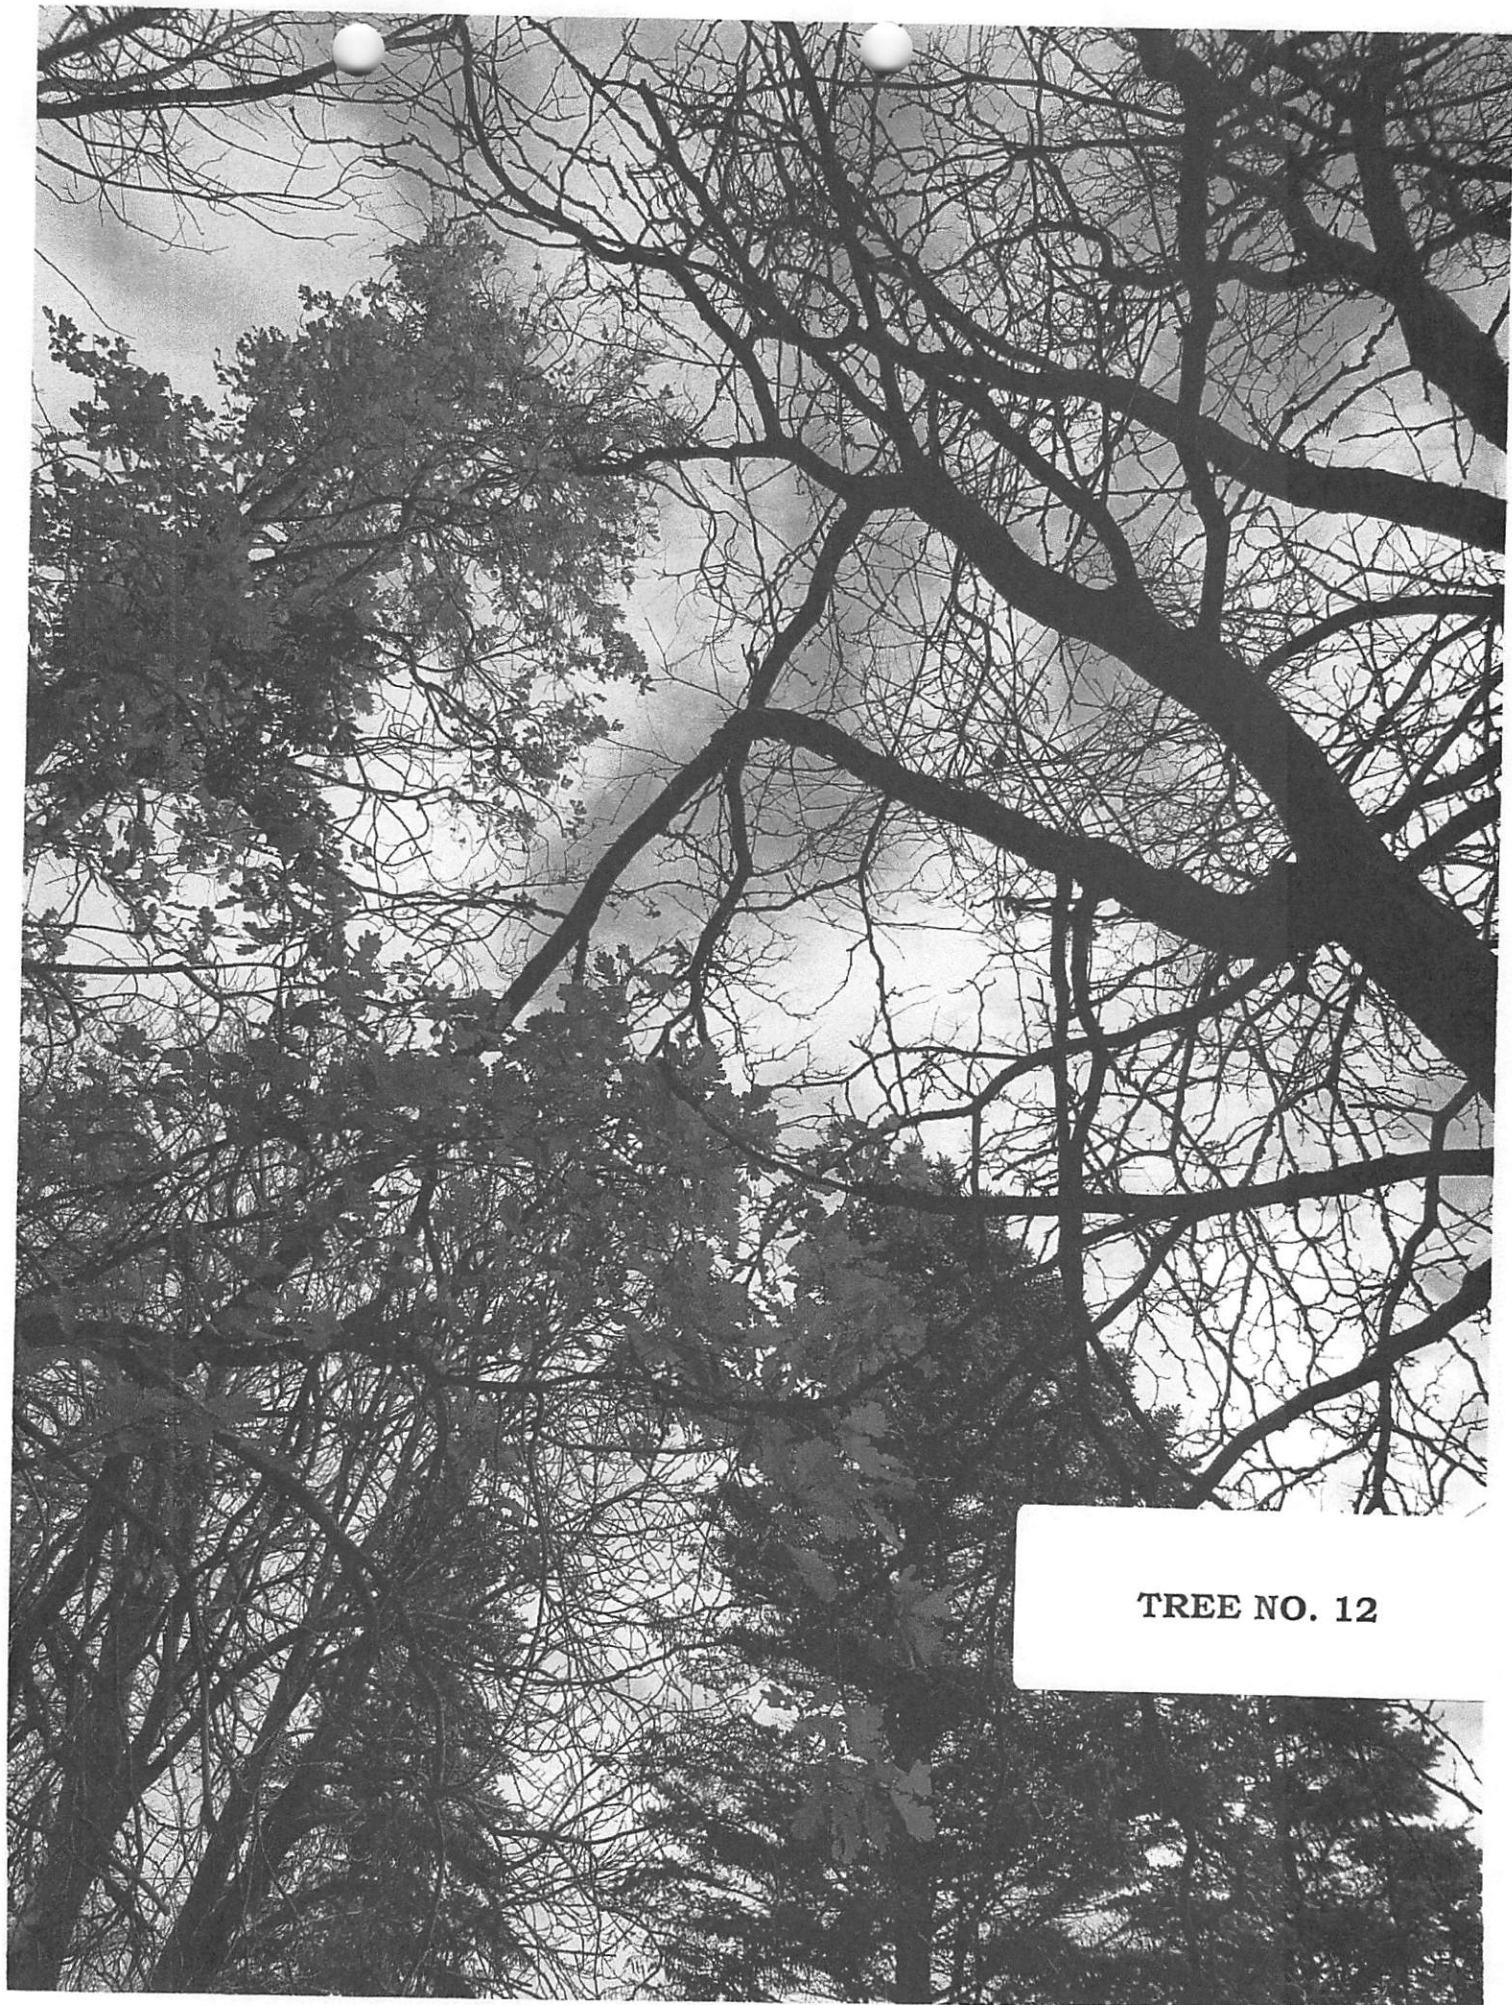
**TREE NO. 12**

This Honey Locust is in fair to poor condition. This tree is a victim of the 2013 Ice Storm with broken branches still visible in the canopy. This tree demonstrates approximately 30% deadwood. The buds are very sparse and weak. This tree is in decline.

The removal of this tree **will require a 3 to1 replacement ratio.**
