**Tree Inventory and Preservation Plan Report
9675-9697 Keele Street
Vaughan, Ontario**

30 January 2020, revised 18 February 2021, 30 July 2021, 27 May 2022, 30 August
2022, and 19 October 2022

KUNTZ FORESTRY CONSULTING INC Project P2245

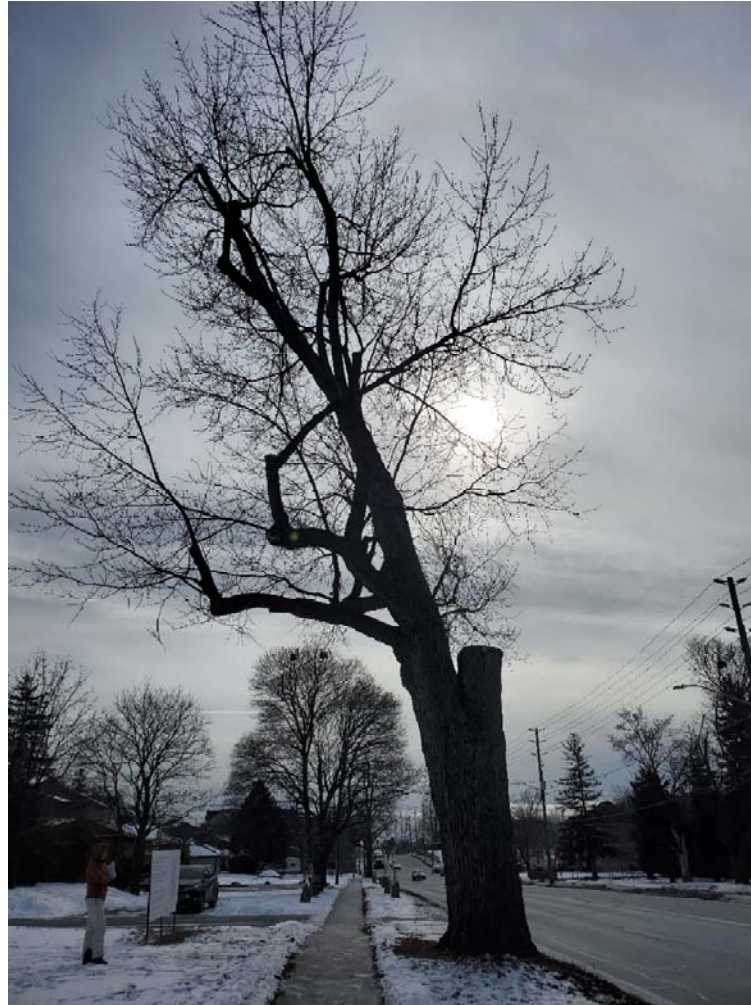
Image 12. Photo of Tree 259 (2021)

A Level 2 Tree Risk Assessment was conducted for Tree 259 in accordance with the ISA's Tree Risk Assessment Manual. The primary targets of concern include cars travelling along Keele Street and pedestrians utilizing the sidewalk. Tree 259 currently has poor-fair crown structure due to its moderately asymmetrical crown, aggressive crown pruning that appears to have occurred in recent years, and the removal of one primary stem roughly 3m above grade. Cavities and weak branch attachments were noted in the crown, the tree has evidence of limb failures, and the tree exhibits large wounds from recent crown pruning including the removal of one leader. The hazard potential of this tree appears to have been largely managed through significant crown pruning. The likelihood of crown or stem failure is "possible", the likelihood of impact of either primary target (cars and/or pedestrians) is low. The likelihood of failure and

impact is therefore unlikely and the consequences of failure and impact are severe. The overall risk rating of the tree was calculated to be “Low”.

Despite the risk rating of Low (given the currently available evidence obtained during the Level 2 risk rating), this tree is still identified for removal. This tree is in decline, as evidenced by the loss of limbs and stem in recent years. The preservation of this tree would require the relocation of the entranceway to the proposed complex, which would be a significant design compromise. KFCI and the design team has reviewed the possibility of relocating the main entranceway currently located between Units 6 and 7, to a new location between Units 2 and 3, the only other option from a design and tree preservation standpoint. This is undesirable, as the rear laneway would become quite long in the south direction behind the units. This will cause challenges during property maintenance including snow removal and create the appearance of a long alleyway. It would also make turn-around of larger vehicles behind the complex more difficult. This would have long-term impacts on the functionality of the design, for a tree that is likely to continue to decline in the coming years.

In order to complete a Level 3 risk assessment, it is recommended that either a climbing Arborist examine the upper branches of the crown to investigate rot at the unions, the branch structure, and cavities more thoroughly. Sonic tomography would also identify the extent of rot, if any, within the main stem, a possibility given the large stem that has been removed and the cavities noted within the tree.

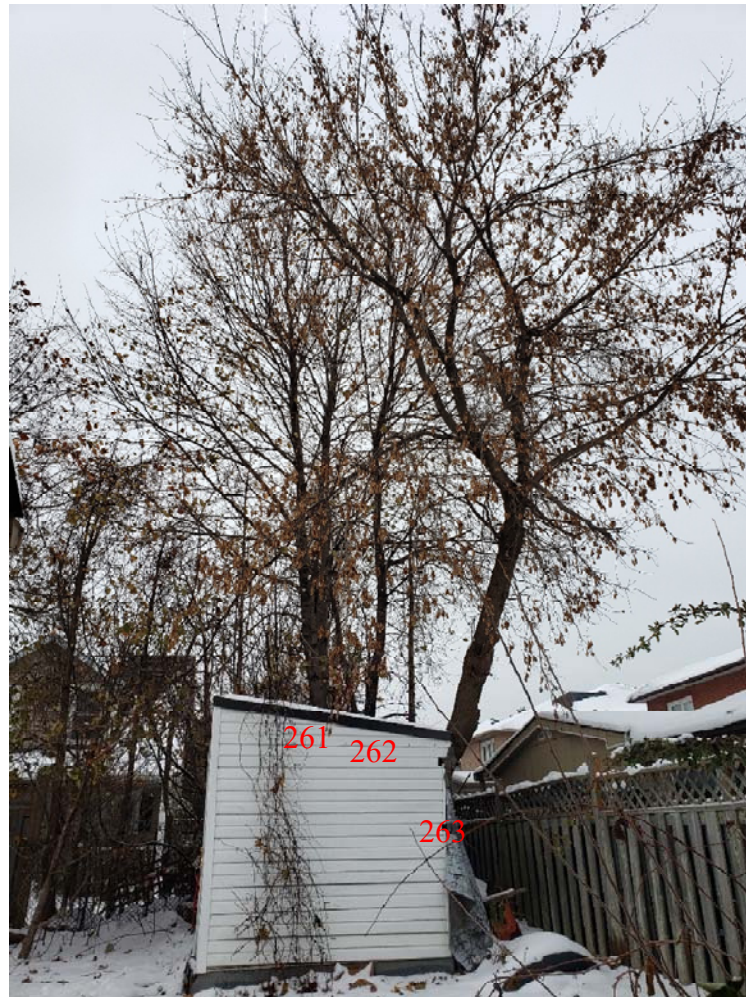
Image 14. Photo of Tree 261-263

260	Blue Spruce	<i>Picea pungens</i>	39	F-G	F-G	F-G				2.4	Lean (L), sparse crown (L)	Remove	Private	2
261	Norway Maple	<i>Acer platanoides</i>	23, 23.5	F-G	F-G	F-G				1.8	V-union at 0.1m, sparse crown (M)	Remove	Private	2

262	Norway Maple	<i>Acer platanoides</i>	19, ~13	F-G	F-G	F-G				1.8	Union at base, bowed crown (L), asymmetrical crown (M)	Remove	Private	
263	Manitoba Maple	<i>Acer negundo</i>	34	F	F	F				2.4	Bowed (H) south, poor form (M)	Remove	Private	2
264	Black Walnut	<i>Juglans nigra</i>	28, 15.5	P	F-G	F				1.8	Union at 1.3m, splitting union at 2m => remove or cable	Remove	Private	2
265	Norway Maple	<i>Acer platanoides</i>	53.5	F-G	F	F	PT	6.5	25	5.4	V-union at 1.7m, pruning wounds (L), deadwood (M)	Retain	Current ROW	
266	Norway Maple	<i>Acer platanoides</i>	55	F-G	F-G	F	PT	8		5.5	Pruning wounds (L)	Retain	Current ROW	
267	Norway Maple	<i>Acer platanoides</i>	61	F-G	F-G	F-G				4.2	Pruning wounds (L), deadwood (L), limb wounds (L)	Remove	Private	4
268	White Spruce	<i>Picea glauca</i>	32, 17	F	F	F				2.4	Union at 0.3m, 1 dead leader on smaller stem, asymmetrical crown (L)	Remove	Private	2
269	Black Walnut	<i>Juglans nigra</i>	16	G	G	G				1.8	Crown growing against roof of house	Remove	Private

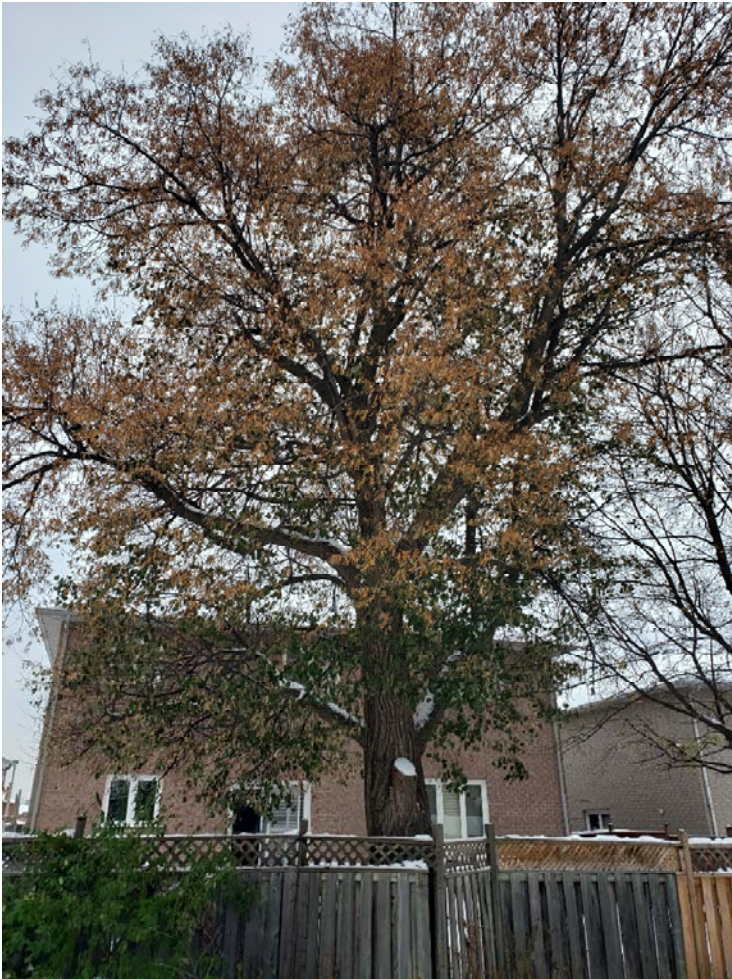
Image 15. Photo of Tree D

B	Japanese Tree Lilac	<i>Syringa reticulata</i>	~18, 13, 13	F-G	F-G	F-G				1.8	V-union at 1m	Retain	Neighbour	
C	Columnar Eastern Cottonwood	<i>Populus deltoides 'fastigiata'</i>	~43	P	P	P			90	3.0		Retain	Neighbour	
D	Littleleaf Linden	<i>Tilia cordata</i>	~92	F	F-G	F				6.0	Pruning wounds (M), probably shared tree, deadwood (L), poor form (L)	Remove	Shared (Private/Neighbour)	4

The removal of 23 trees will be required to accommodate the proposed development, including Trees 251, 253-256, 259-264, 267-275, D, G, and K. Trees 253, 260, 261, 263, 264, 267, 268, 270-272, 275, and D are greater than 20cm DBH and protected by the City of Vaughan's tree protection by-law. Tree D is likely shared with the neighbouring property to the east; permission from this property owner is required prior to its removal.

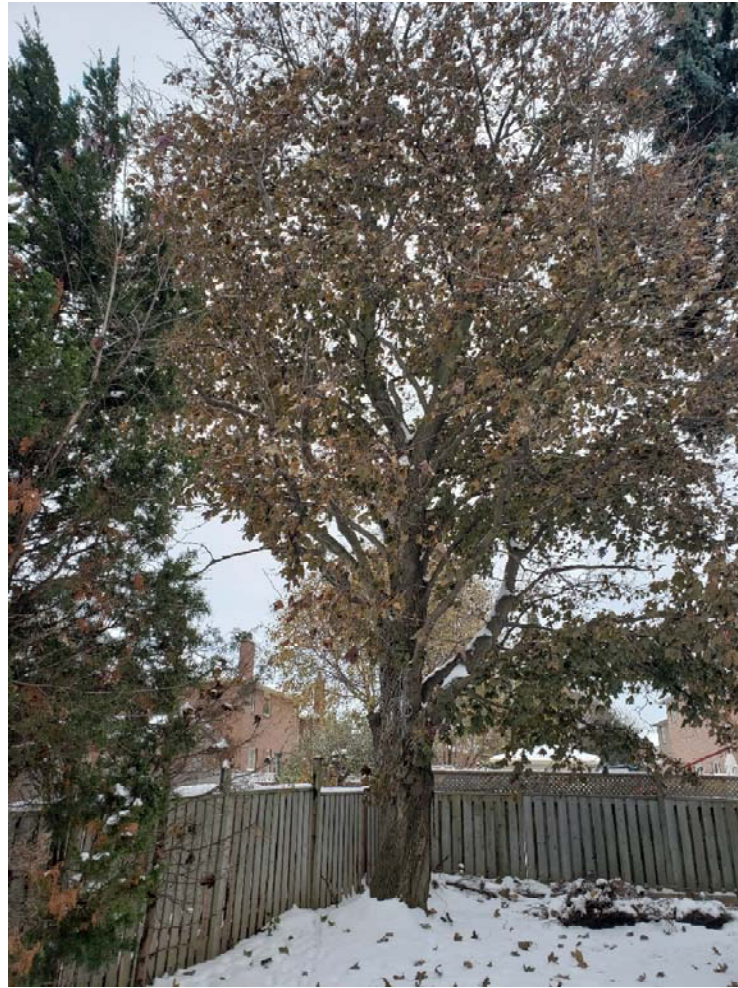
Image 24. Photo of Tree 271

270	Blue Spruce	<i>Picea pungens</i>	41	F	F-G	F				3.0	Pruning wounds (L), seam (L)	Remove	Private	3
271	Norway Maple	<i>Acer platanoides</i>	63.5	F-G	F-G	F-G				4.2	Pruning wounds (L), swollen root flare, stem wound (M)	Remove	Private	4
272	Cherry species	<i>Prunus spp.</i>	42	F	F	F				3.0	Asymmetrical crown (L), epicormic branching (M), v-union at 1.5m, fruiting bodies (M) on dead stem, pruning wounds (M)	Remove	Private	3
273	Manitoba Maple	<i>Acer negundo</i>	18, 12	F	F	F				1.8	Growing between fence and sled, union at 1.2m, asymmetrical crown (L)	Remove	Private	
274	Norway Maple	<i>Acer platanoides</i>	15.5, 7.5	F	F	F				1.8	Included fence (M), sweep (M), poor form (M), stem wound (L), asymmetrical crown (M)	Remove	Private	
275	Apple species	<i>Malus spp.</i>	42	F	F	F				3.0	Cavity (M), asymmetrical crown (M), epicormic branching (M), fruiting body, deadwood (M)	Remove	Private	3
A	Norway Maple	<i>Acer platanoides</i>	~18	G	G	G				1.8	Pruning wounds (L)	Retain	Neighbour
