LOT 9 - 9 BUCKS PLACE

ARBORIST REPORT

**PROPOSED 2 STOREY RESIDENTIAL DWELLING
9 BUCK'S PLACE
WOODBRIDGE, ONTARIO**

**February 7, 2023
Updated March 14th, 2023 Per City Comments**

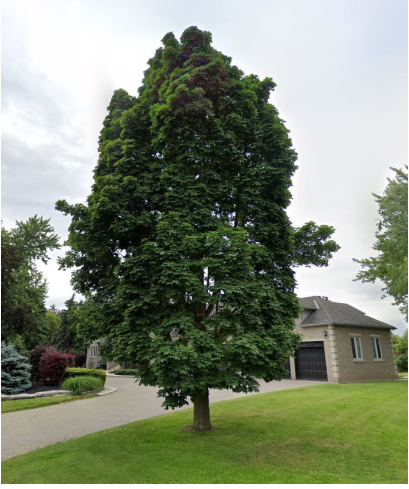
<p>Tree #'s 301 - Norway Maple to be preserved</p>	<p>Tree #'s 302 & 303 - Colorado Spruce to be removed</p>

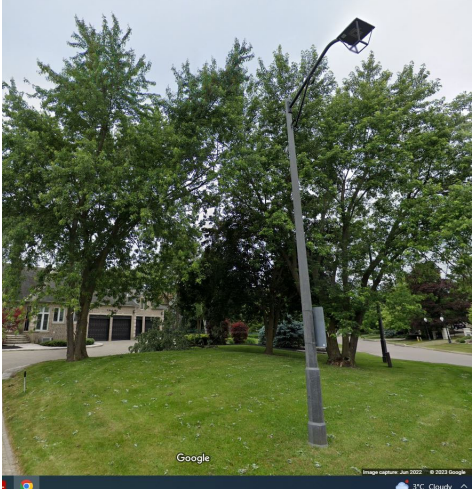
<p>Tree #'s 304-306 Norway Maple and Silver Maple Proposed Removal</p>	<p>Tree #'s 304-306 Norway Maple and Silver Maple Proposed Removal</p>

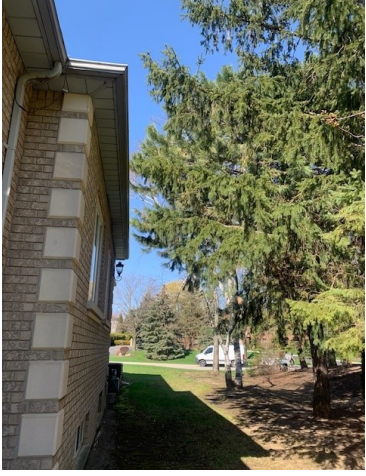
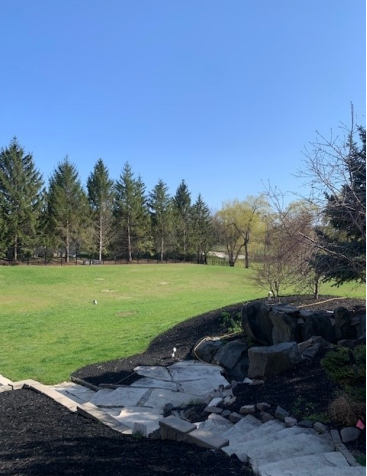
<p>Tree #'s 310 to 317 Side Yard Planting in conflict with construction access to be removed</p>	<p>Trees #'s 18 Neighbours Planting of Norway Spruce to remain. Noted dieback in needles.</p>

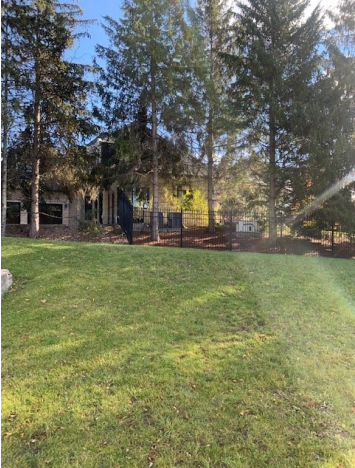
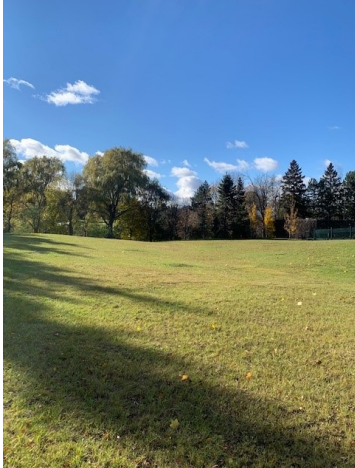
<p>Trees #'s 18 Neighbours Planting of Norway Spruce to remain. Noted dieback in needles.</p>	<p>Trees #'s 319 to 332 Rear buffer along golf course. To remain. (2 dead trees to be removed #322 & 324</p>

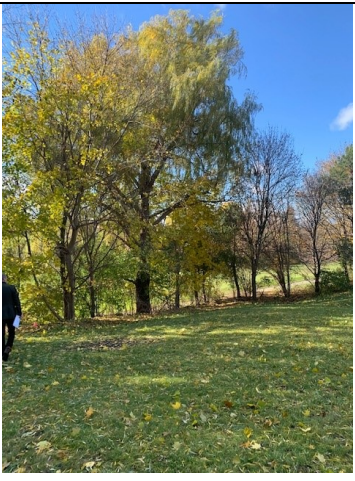
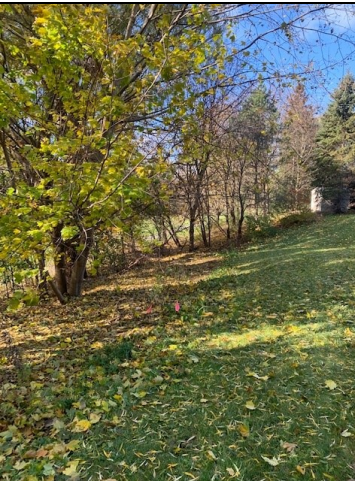
<p>Trees #'s 319 to 332 Rear buffer along golf course. To remain. (2 dead trees to be removed #322 & 324</p>	<p>Trees #'s 319 to 332 Rear buffer along golf course. To remain. (2 dead trees to be removed #322 & 324</p>

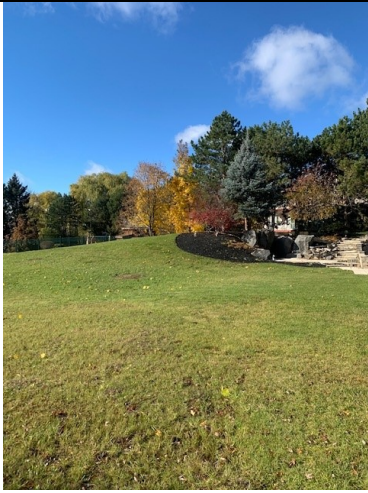
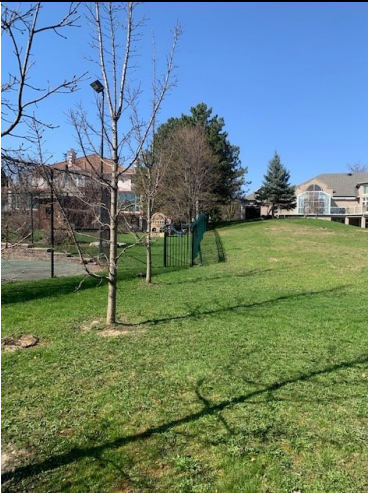
<p>Tree#'s 336-342 - View at North Neighbours Property</p>	<p>Tree#'s 333-335 North Neighbours Maples (view north)</p>
