TREE CARE & URBAN FORESTRY CONSULTANTS INC.

# TREE INVENTORY & PLAN OF PRESERVATION 158 & 166 WALLACE STREET CITY OF VAUGHAN

**Prepared for:** King Home Construction Inc.

**Our Matter:** TA-16-038

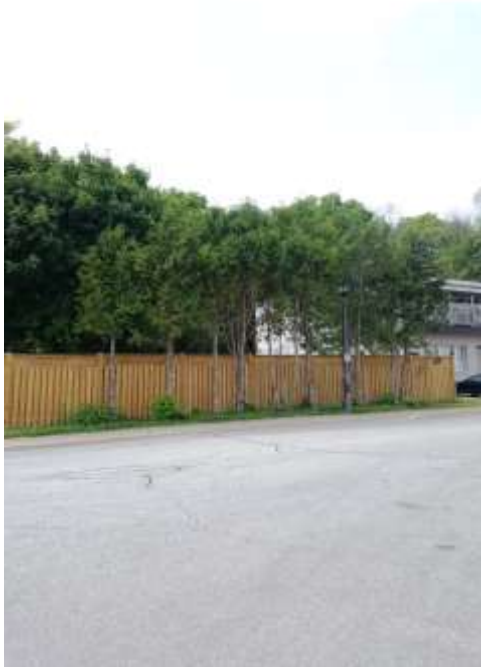
TAG #	COMMON NAME	LATIN BINOMIAL	DBH (CM)	CONDITION	REMARKS	RATIONALE FOR REMOVAL
093	Eastern Red Cedar	<i>Juniperus virginiana</i>	16	Fair	Crown has been raised	Tree conflicts with proposed construction activity
094	White Cedar	<i>Thuja occidentalis</i>	11	Fair	Crown has been raised	Tree conflicts with proposed construction activity
095	White Cedar	<i>Thuja occidentalis</i>	16 x 15	Poor	Co-dominant stems Thin crown Crown raised	Tree conflicts with proposed construction activity
096	White Cedar	<i>Thuja occidentalis</i>	13 x 11	Poor	Co-dominant stems Thin crown Crown raised	Tree conflicts with proposed construction activity
097	White Cedar	<i>Thuja occidentalis</i>	10 x 9 x 7	Poor	Co-dominant stems Thin crown Crown raised	Tree conflicts with proposed construction activity

TAG #	COMMON NAME	LATIN BINOMIAL	DBH (CM)	CONDITION	REMARKS	RATIONALE FOR REMOVAL
098	White Cedar	<i>Thuja occidentalis</i>	10 x 18	Poor	Co-dominant stems Thin crown Crown raised	Tree conflicts with proposed construction activity
099	White Cedar	<i>Thuja occidentalis</i>	11	Poor	Crown raised	Tree conflicts with proposed construction activity
100	White Cedar	<i>Thuja occidentalis</i>	18	Fair	Co-dominant stems Thin crown Crown raised	Tree conflicts with proposed construction activity
101	White Cedar	<i>Thuja occidentalis</i>	11	Fair	Crown raised	Tree conflicts with proposed construction activity

**Trees #093-101.** Located on the municipal ROW. Crowns have been raised and most trees have multiple leaders

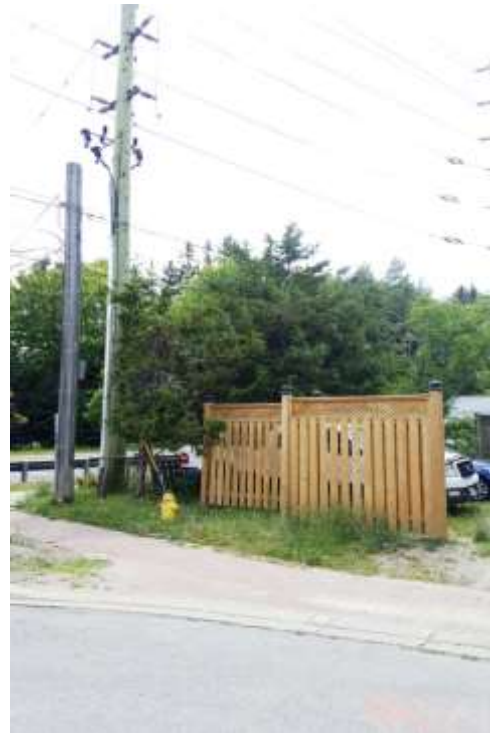
TAG #	COMMON NAME	LATIN BINOMIAL	DBH (CM)	CONDITION	REMARKS	RECOMMENDATIONS
008	Eastern Red Cedar	<i>Juniperus virginiana</i>	15	Very Poor	Extensive dieback in crown Top has died back	Due to existing condition and anticipated construction works, removal is warranted
010	Green Ash	<i>Fraxinus pennsylvanica</i>	11	Dead	Tree is dead due to EAB infestation	Tree to be removed by Regional forces
011	Manitoba Maple	<i>Acer negundo</i>	10x17x10	Poor	Tree is growing through chain link fence 3 dominant stems	Proposed retaining wall will require tree removal
012	Black Walnut	<i>Juglans nigra</i>	24	Poor	Main leader has failed in crown	Proposed retaining wall will require tree removal
013	Black Walnut	<i>Juglans nigra</i>	9	Poor	Crown is suppressed/misshapen Bole has grown through chain link fence	Proposed retaining wall will require tree removal

**Trees #008-010** at southeast corner of subject site.

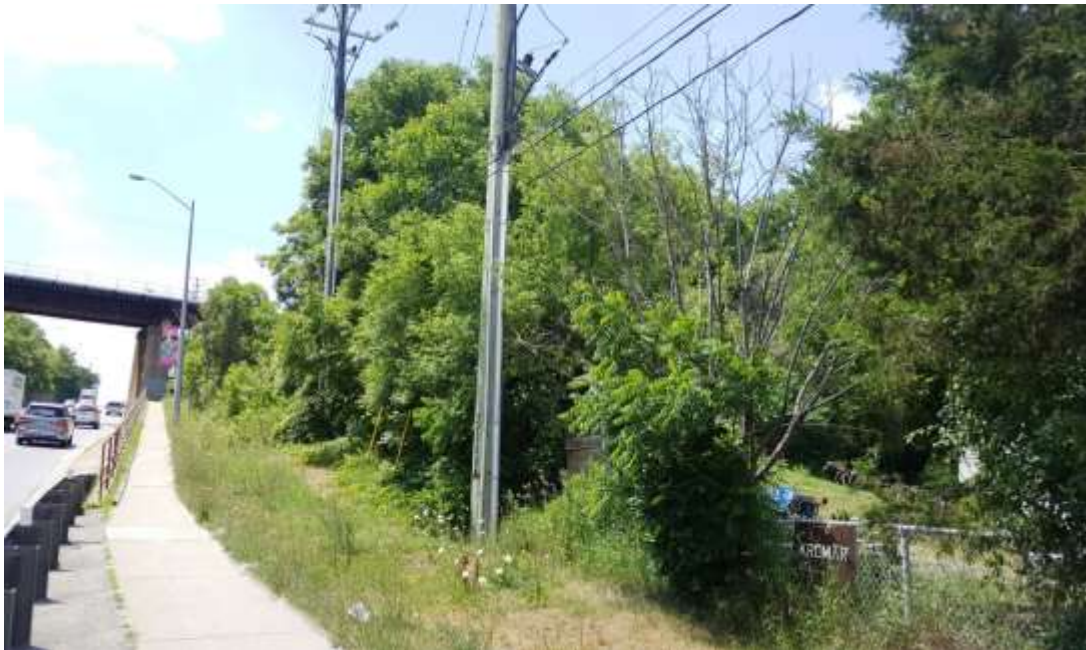
**Trees #010 (foreground); Trees #011-013.** Trees located just south of subject site on Regional right-of-way adjacent to site. Invasive Wild Grape is growing on most trees along this area

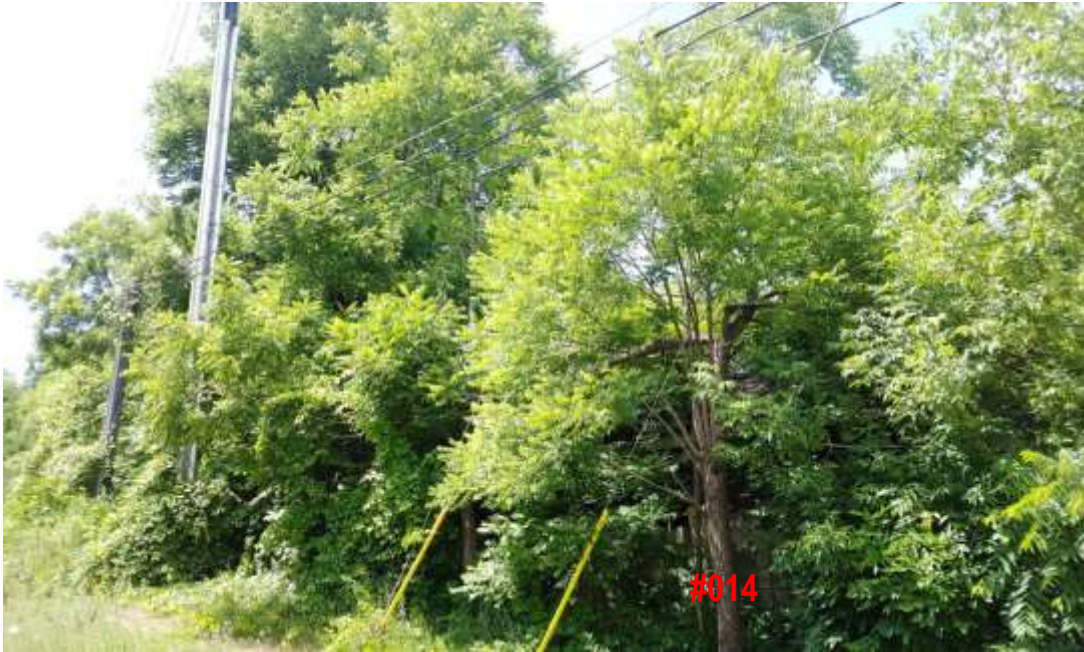
TAG #	COMMON NAME	LATIN BINOMIAL	DBH (CM)	CONDITION	REMARKS	RECOMMENDATIONS
014	Black Walnut	<i>Juglans nigra</i>	21	Fair	Limb from Tree #012 failed into tree's crown	Proposed retaining wall will require tree removal
016	Black Walnut	<i>Juglans nigra</i>	30	Good	Wild grape growing along bole and into lower crown	Tree conflicts with proposed crash wall

**Tree #014 (foreground); Trees #015-018.** Located along Regional right-of-way south of the subject site.

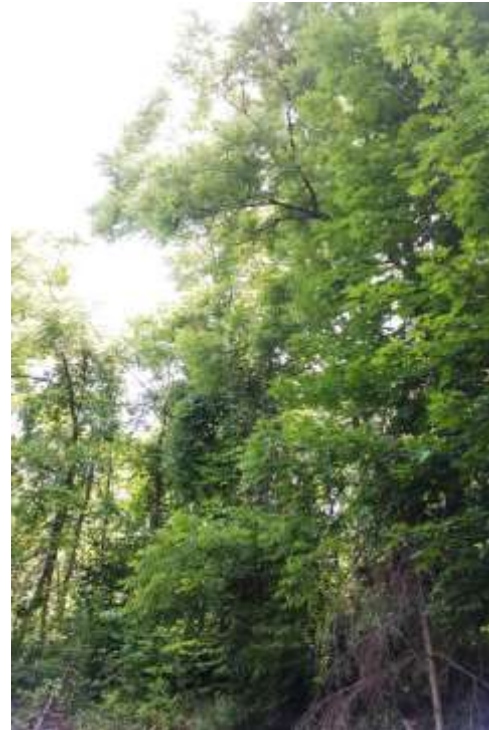
Photo showing characteristic vegetation growth within wooded area along western boundary line. Many invasive species (Wild Grape, European Buckthorn, Norway Maple) and natural regeneration of native species (Black Walnut and Green Ash)

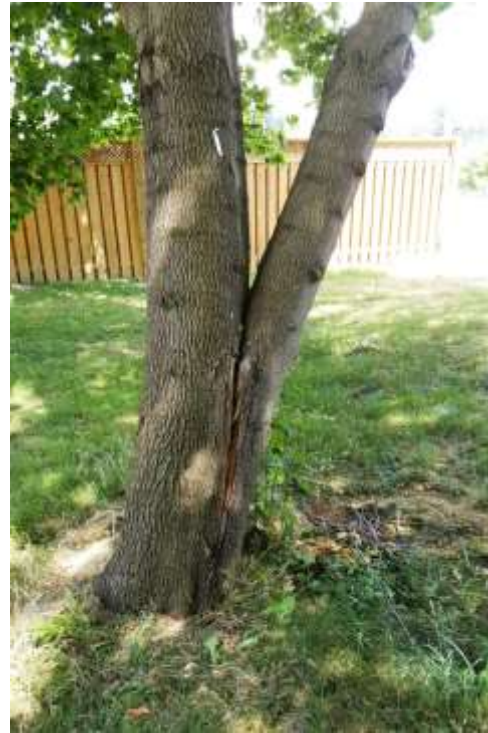
**Tree #091.** Located just north of gravel driveway.  
Tree is splitting apart and is in a hazardous condition.
