Tree Inventory & Protection Plan

Subject Site:
10680 Islington Avenue, Vaughan, ON. L4H 3N5

Prepared By:
The Urban Arborist Inc.
PO BOX #74525 Humbertown Centre,
Etobicoke Ontario M9A 3A8
Tel: 416.833.6467
info@theurbanarborist.ca

March 27, 2023

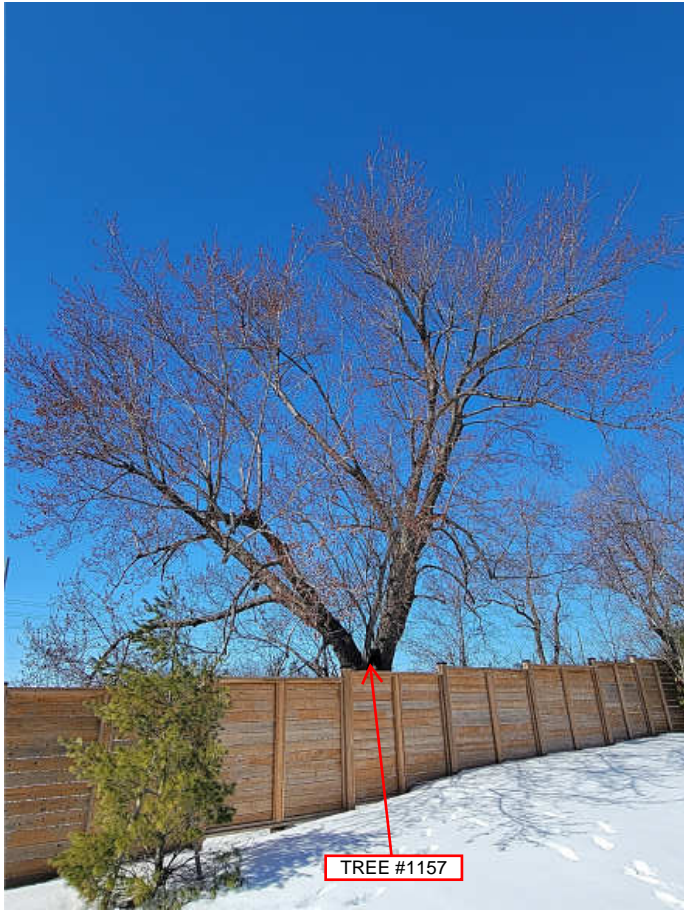
TREE #1157

1157	Silver Maple	Acer saccharinum		73	Average	Very Poor	Across the fence, no tag given. Co-dominant litres with split in union and cracked all the way to base. York Region tree. Some breakage and deadwood throughout.	York Region	Remove	7.3	-	See York Region Calculation
1158	Silver Maple	Acer saccharinum		30	Average	Poor	Irregular crown, decay in trunk lower level. 6 meters away.	York Region	Retain	3	3	-
1159	Siberian Elm	Ulmus pumila		24	Average	Average		York Region	Retain	2.4	2.4	-

Total of number of Trees to Remove requiring a permit	1
Trees Proposed to be Removed	#1157 (York Region R.O.W. Tree)

trees be planted on either side of the existing Silver Maple #1157 that is being proposed to be removed.
